**DINOSAUR RESERVOIR SHORELINE
ENHANCEMENT STRUCTURE MONITORING**

**FISH AND WILDLIFE COMPENSATION PROGRAM -
PEACE PROJECT NO. PEA-F17-F-1468**

MARCH 31, 2017

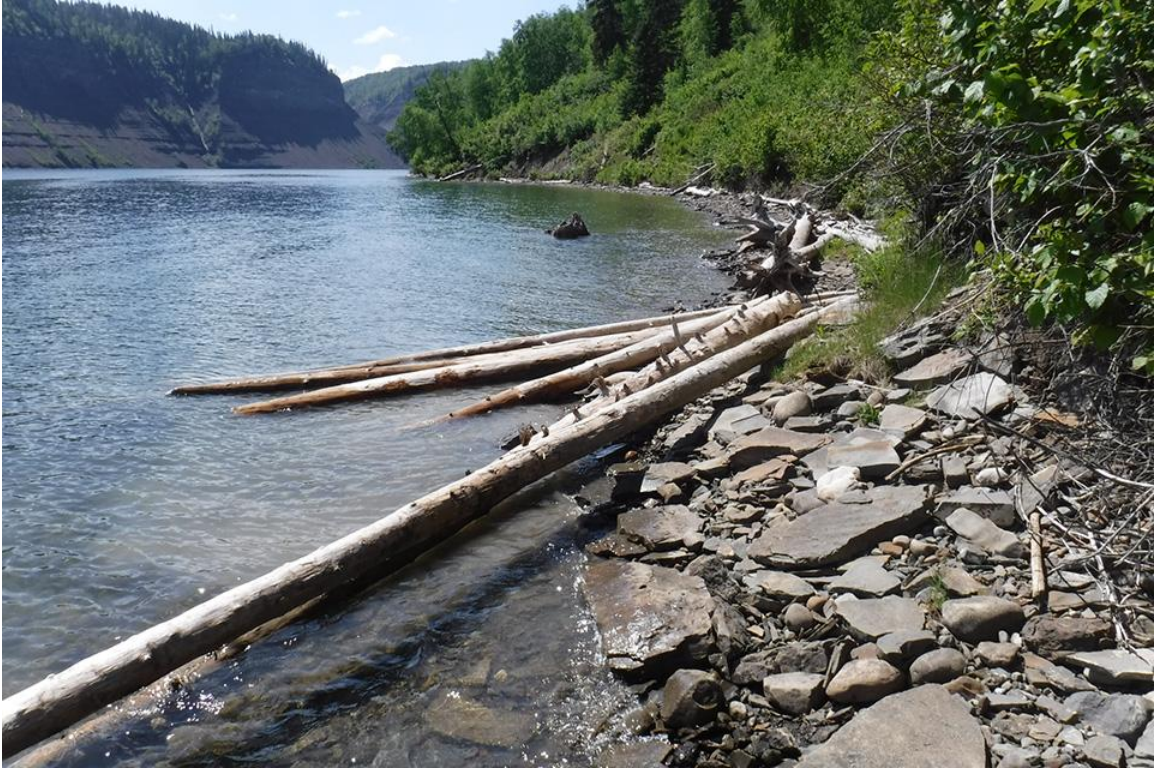
a. Site 1d, June 15, 2015.

Plate 1a and b. Example of unchanged raft shoreline enhancement structure.

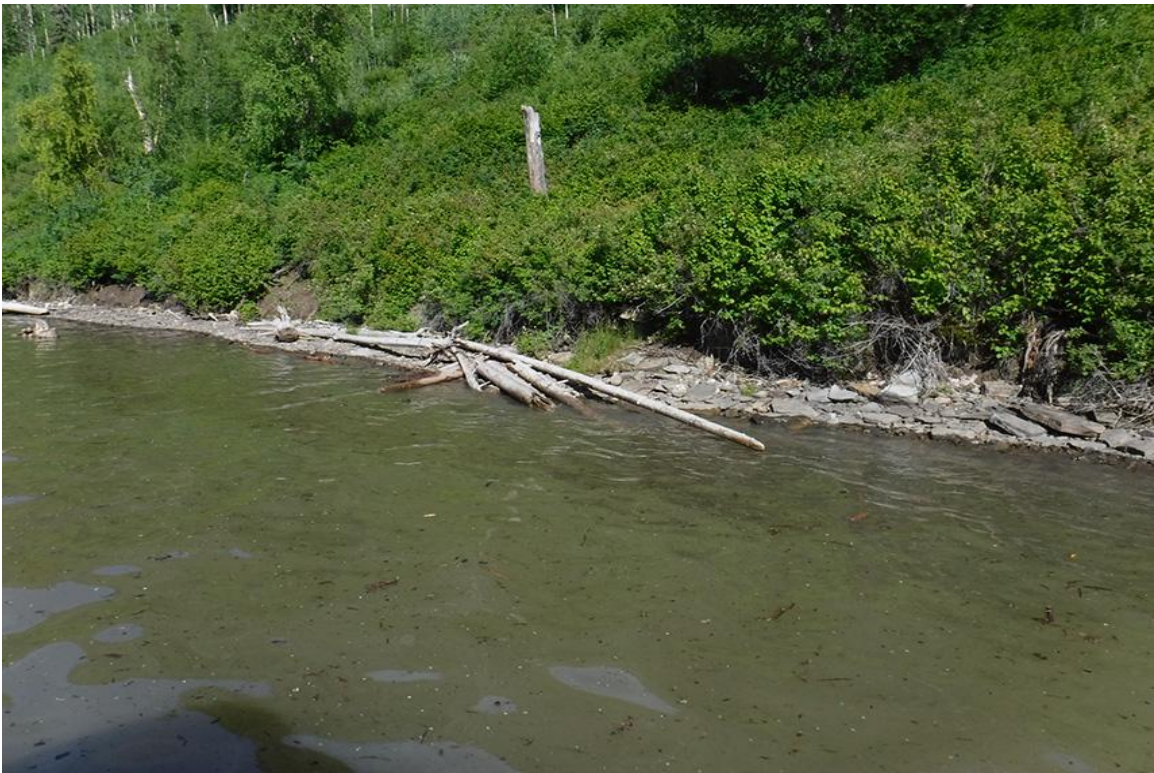
b. Site 1d, June 17, 2016.

Site #	Type	PhotoID	Status	Hazard	Change?	Comments
1a	triangle	1a-2016	F	N	N	anchor cables present but wood missing
1b	triangle		F	N	N	anchor cables present but wood missing
1c	raft	1c-2016	F	N	N	single log cabled to shore at one end, no other logs present
1d	raft	1d-2016	I	N	N	four logs cabled together and protruding into lake, partially submerged
1e	triangle		F	N	N	single log cabled to shore at one end, stranded on shore at low water, no other logs present
2a	triangle		F	N	N	single log cabled to shore at one end, stranded on shore at low water, no other logs present
2b	triangle	2b-2016	F	N	N	two logs present, each cabled to shore at one end, no longer forming apex, possibly water-logged, stranded at low water
2c	triangle	2c-2016	F	N	N	three logs present laying parallel together and ends protruding into water and submerged, possibly water-logged
2d	triangle	2d-2016	F	N	N	two logs present, each cabled to shore at one end, no longer forming apex, possibly water-logged, stranded at low water

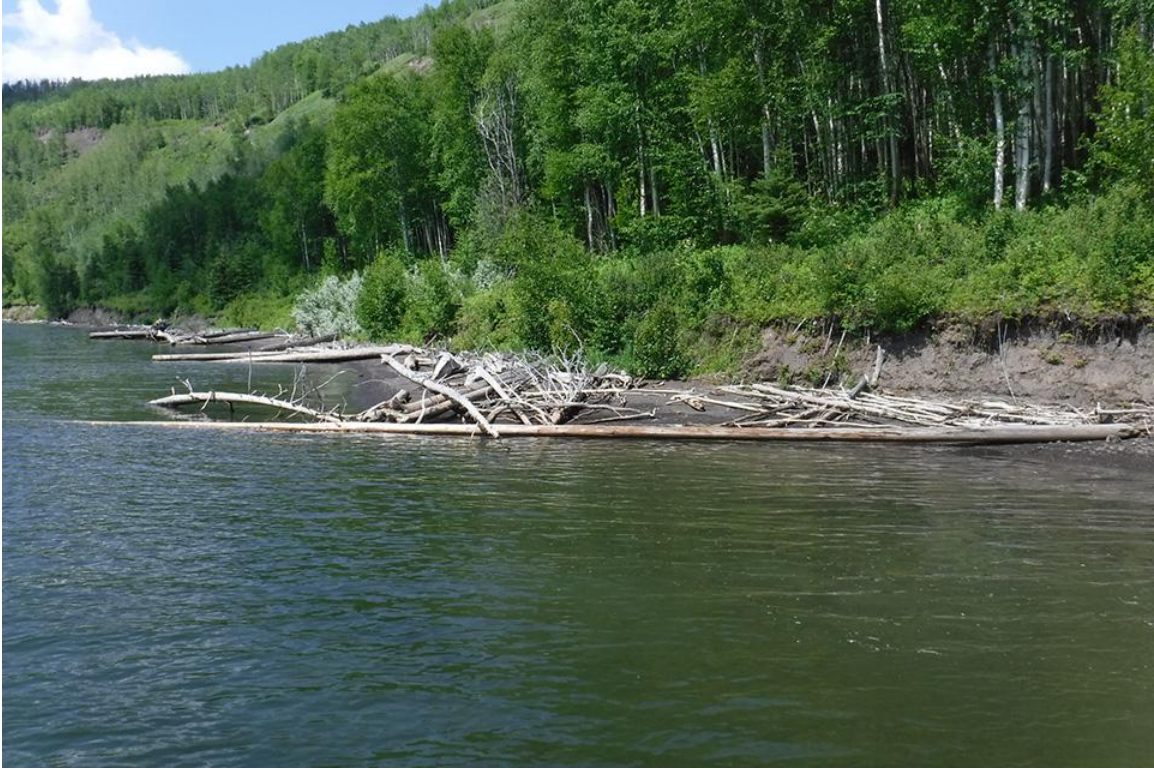
a. Site 2n, June 15, 2015.

Plate 2a and b. Example of unchanged triangle shoreline enhancement structure.

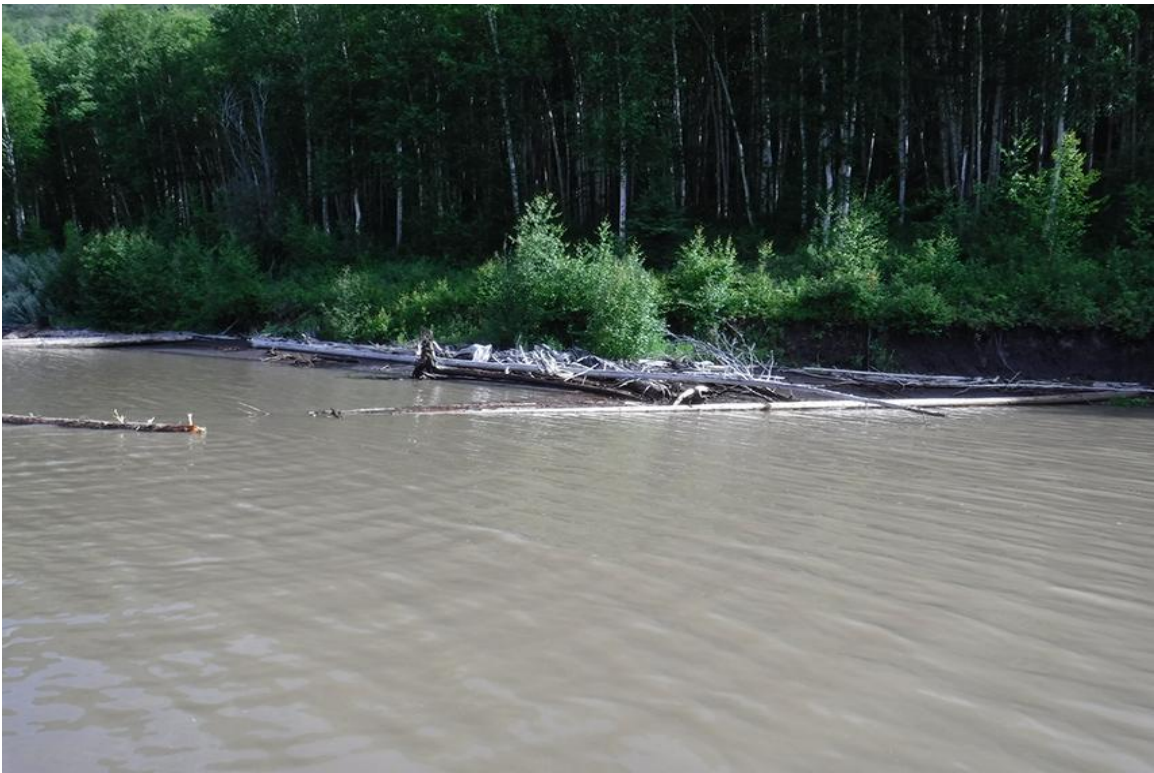
b. Site 2n, June 17, 2016.

2n	triangle	2n-2016	I	N	N	intact however stranded above wetted perimeter and infilled with sediment below wood
2o	triangle	2o-2016	I	N	N	intact however stranded above wetted perimeter and infilled with sediment below wood
2p	triangle	2p-2018	I	N	N	intact however stranded above wetted perimeter and infilled with sediment below wood
2q	triangle		I	N	N	intact however stranded above wetted perimeter and infilled with sediment below wood
3a	triangle	3a-2016	F	N	N	2 logs cabled at butts to shore and lying parallel to shore above present water level, flagged in 2014
3b1	triangle	3b1-2016	I	N	N	intact however stranded above wetted perimeter and infilled with sediment below wood
3b2	triangle	3b2-2016	F	N	N	three logs cabled together forming a triangle but stranded at present water level, no wood inside
3c1	triangle		F	N	N	2 logs cabled together lying parallel to each other and protruding into water

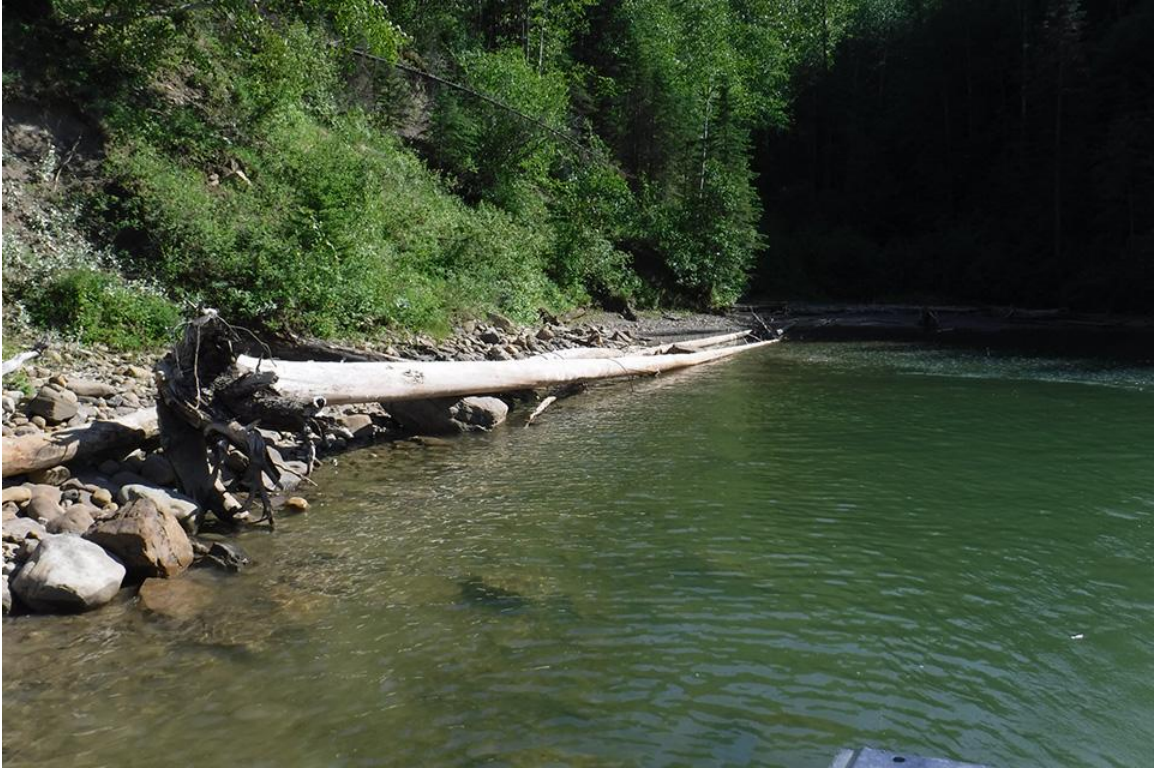
a. Site 7a, June 15, 2015.

Plate 3a and b. Example of unchanged log boom shoreline enhancement structure.
