Heart Creek Fish Passage Improvements – Phase 2

COL-F17-F-1400

15-Mar-2017

Re: Heart Creek Culvert No. 2 (07240) Replacement Project
Hydrotechnical Assessment of Replacement Options - Draft

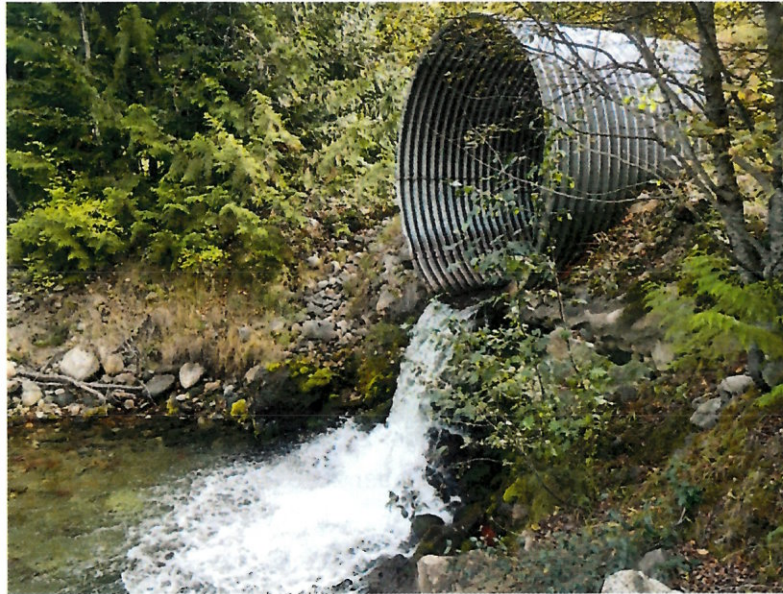
Figure # 1 - Culvert under Highway 6 – September 2014

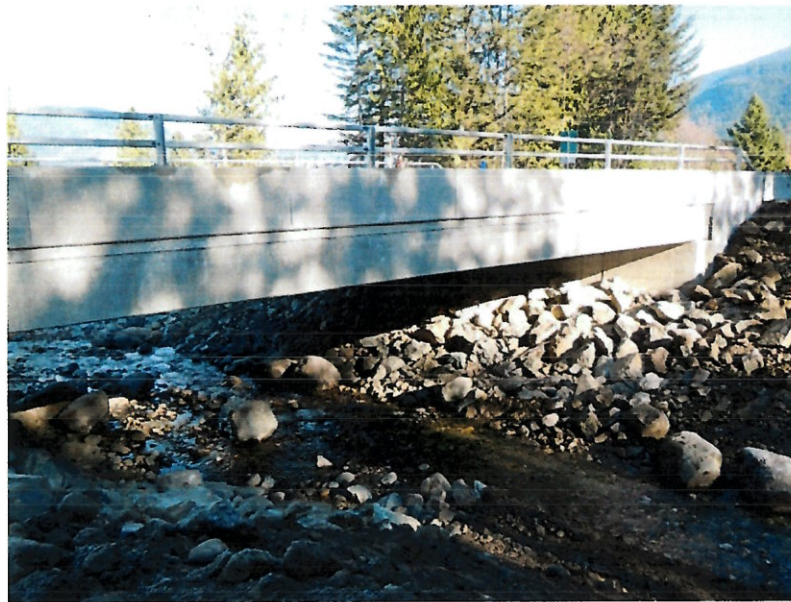
Figure # 2 – New Bridge over Highway 6 – September 2016

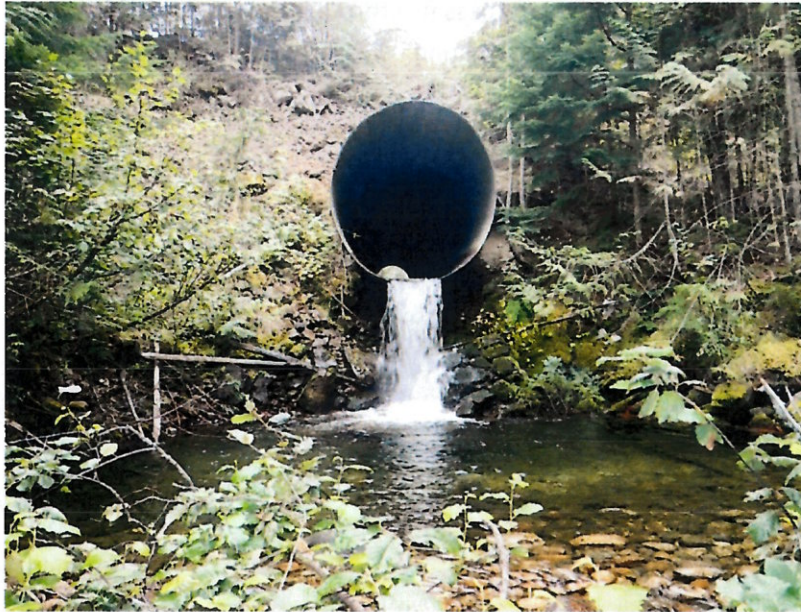
The construction of the Highway 6 clear span bridge was big in itself, but the real gains of the project come from the elimination of the second barrier on Heart Creek, the Applegrove Road Crossing (Figure 3). Similar in nature to the Highway 6 crossing, there is a 3.3 metre wide culvert that is perched approximately 3 metres above the stream channel making it impossible for fish to access the upper reaches of the stream. With the elimination of this barrier an additional 1.2 kilometres of good quality fish habitat is available upstream.

Figure 3 – Applegrove Road Barrier

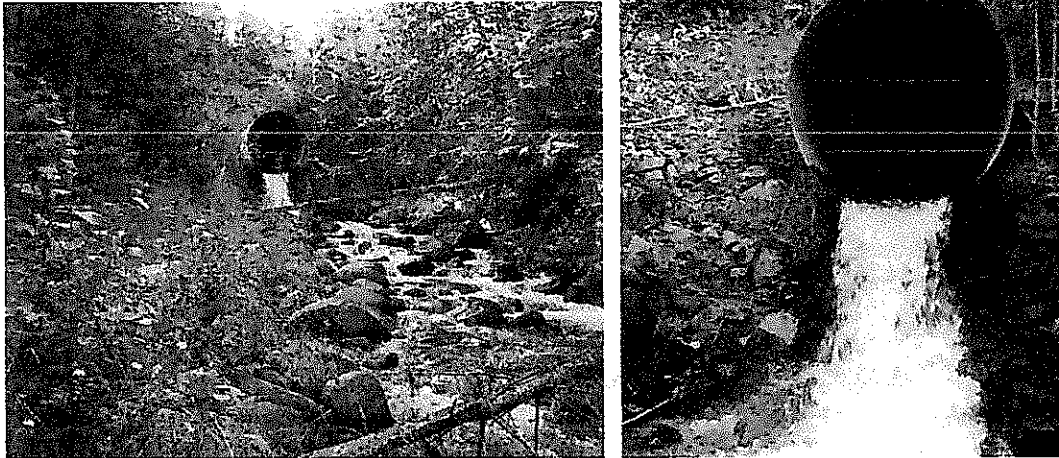
Structure 07240 is a 3300 mm diameter, structural steel plate pipe culvert. It is not adequately sized for the passage of sediment and debris in Heart Creek. The small size and low barrel roughness of the culvert, relative to size and roughness of the natural stream, have caused considerable instability in Heart Creek both upstream (aggradation and channel mis-alignment) and downstream (perched culvert and severe scour and degradation). In addition, there are clear signs of soil piping underneath the culvert barrel and in the fill slope to the east of the culvert, where a portion of the fill slope sloughed during a flood in 2004. The shape of the pipe has begun to warp slightly due to the loss of supporting fill and the bolts and plates of the culvert are worn. The deficiencies of the culvert are well documented in past Condition Inspection Reports prepared by MoTI's Bridge Area Manager, Arn Von Maydell and in the Scour and Erosion Evaluation Report (SER) prepared by NHC in 2011.

Photo 1 and 2. Looking upstream to the outlet
