**Grilse Creek LWD Post Construction  
Maintenance and Monitoring,  
2016**

**FWCP Project #COA-F17-F-1189**

Prepared by:  
**Jamieson Atkinson B.Sc. B.I.T**  
**Fisheries Biologist**  
**BC Conservation Foundation**

March 31, 2017

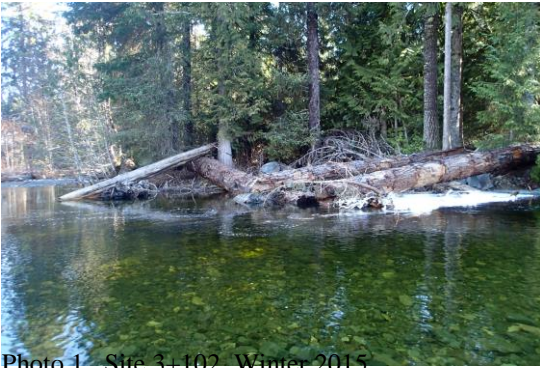
Photo 1. Site 3+102, Winter 2015.

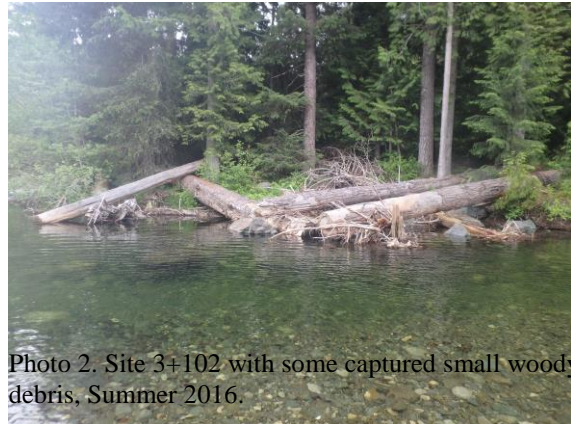
Photo 2. Site 3+102 with some captured small woody debris, Summer 2016.

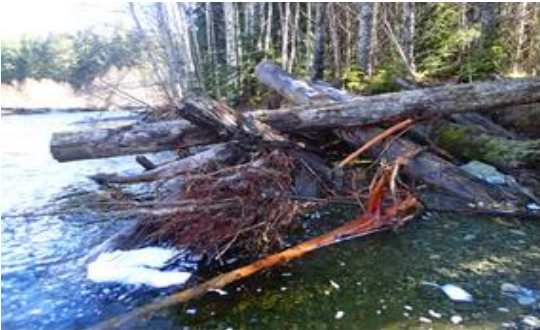
Photo 3. Site 1+187, Winter 2015.

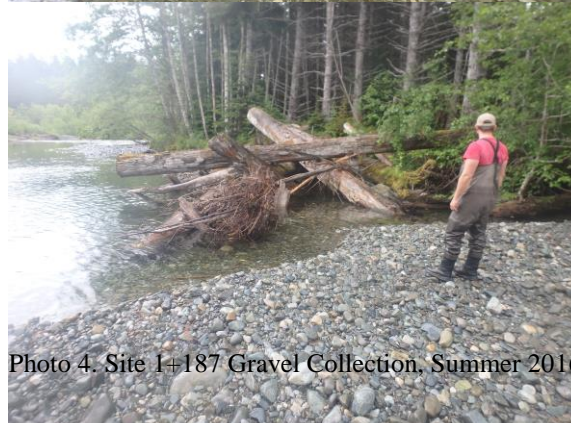
Photo 4. Site 1+187 Gravel Collection, Summer 2016

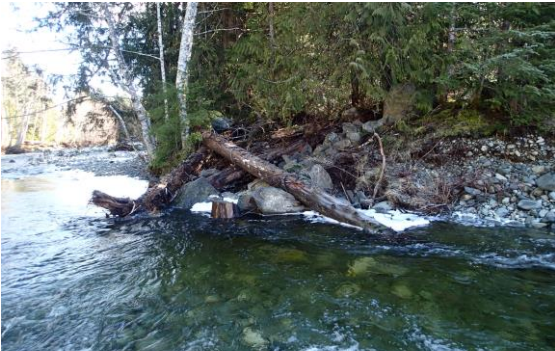
Photo 5. Site 3+661 Winter 2015 flows prior to river movement.

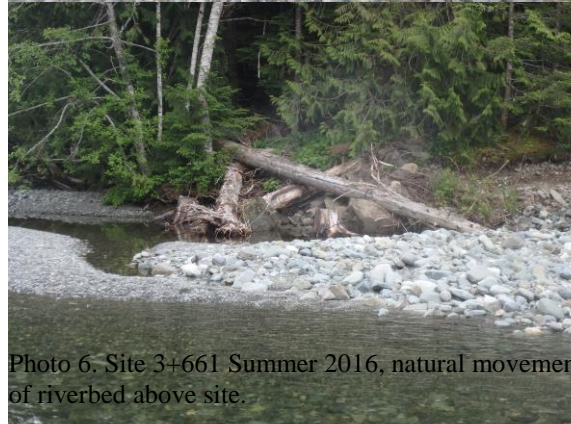
Most sites were performing as expected (Fig. 1). Due to the fluidness of Grilse Creek some sites had large amounts of gravel collection either above, below or within the site, additionally the river migrated resulting in two sites (3+661, 2+219) being left dry in low summer flows (Appendix 3).

Photo 6. Site 3+661 Summer 2016, natural movement of riverbed above site.

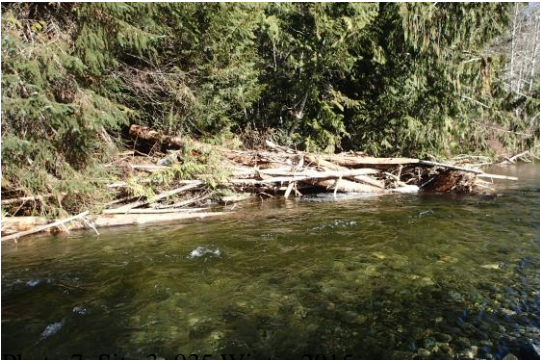
Photo 7. Site 3+055 Winter 2015.

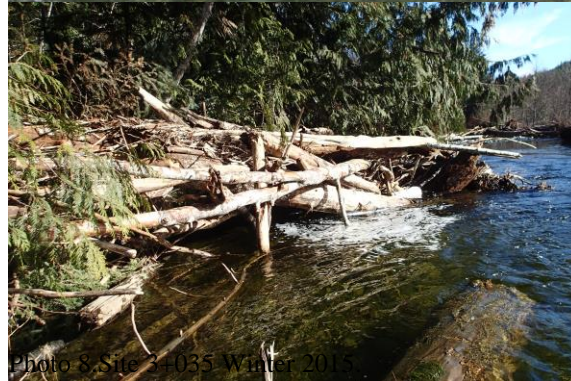
In the spring of 2015 an REE was conducted on all 18 sites built in the 2014 Grilse Creek LWD Rehabilitation Project. The REE revealed that one site (3+035) had been altered during the high flows of the previous fall/winter.

Photo 8. Site 3+035 Winter 2015.

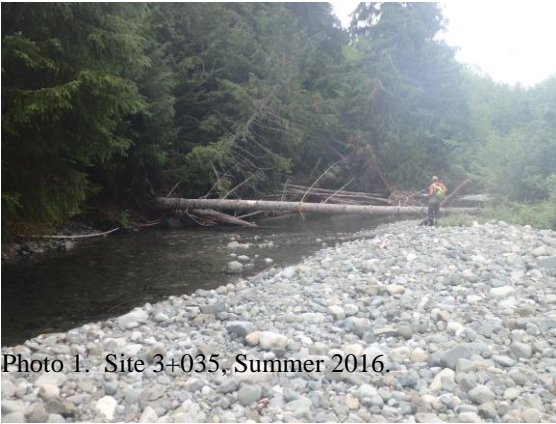
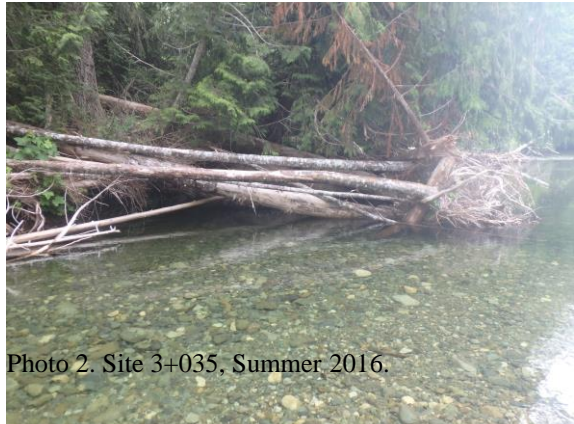
Photo 1. Site 3+035, Summer 2016.

Photo 2. Site 3+035, Summer 2016.

<b>Site #</b>	<b>Site Description</b>	<b>Maintenance Required</b>
<b>3+455</b>	<b>LTR-4</b>	<b>Armor Bank With Rock (Not Applicable Without Excavator)</b>
<b>3+035</b>	<b>LT-2, DJ5</b>	<b>Lower Structure Needs Float-ins cabled, Upper Structure Needs Re-Cabling Due to Movement</b>
<b>2+089</b>	<b>DJ-5X2</b>	<b>Add Staples to Loosened Cable</b>

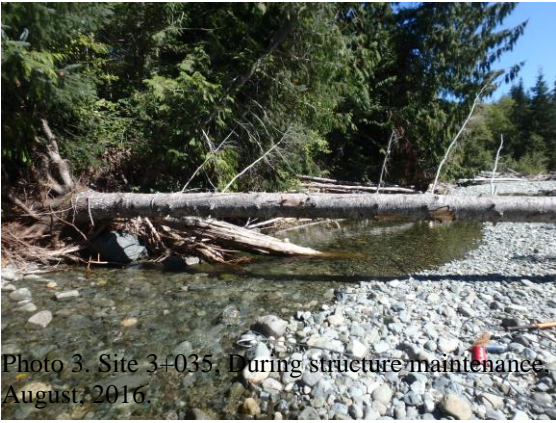
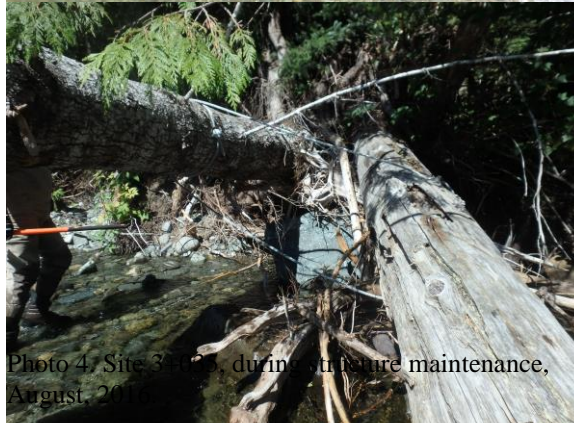
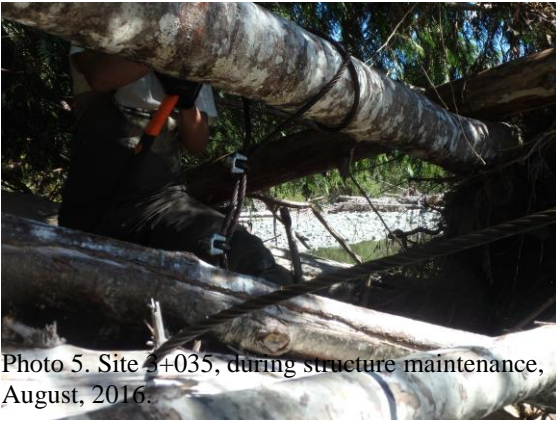
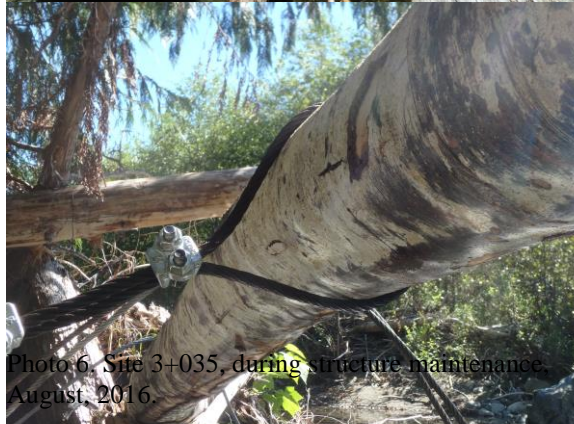
Photo 3. Site 3+035, During structure maintenance, August 2016.

Photo 4. Site 3+035, during structure maintenance, August, 2016.

Photo 5. Site 3+035, during structure maintenance, August, 2016.

Photo 6. Site 3+035, during structure maintenance, August, 2016.

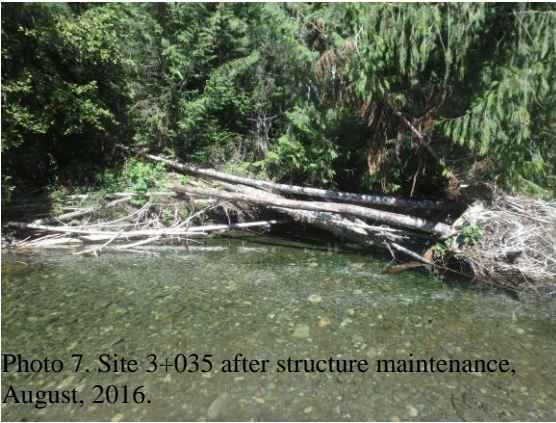
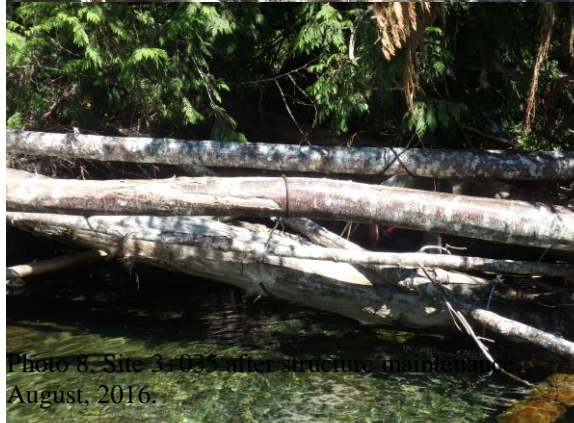
Photo 7. Site 3+035 after structure maintenance, August, 2016.

Photo 8. Site 3+035 after structure maintenance, August, 2016.
