Deer Creek Drawdown Zone Fish Habitat Enhancement: A Pilot Study (Phase II) for Lower Arrow Lakes Tributary Access Improvements 2016 – 2017

FWCP # COL-F17-F-1450

Evan Smith, B.Sc., BIT and Michael Zimmer, M.Sc., R.P.Bio
Okanagan Nation Alliance
L2 – 1444 Columbia Ave.
Castlegar, BC, V1N 3K3

June 2018

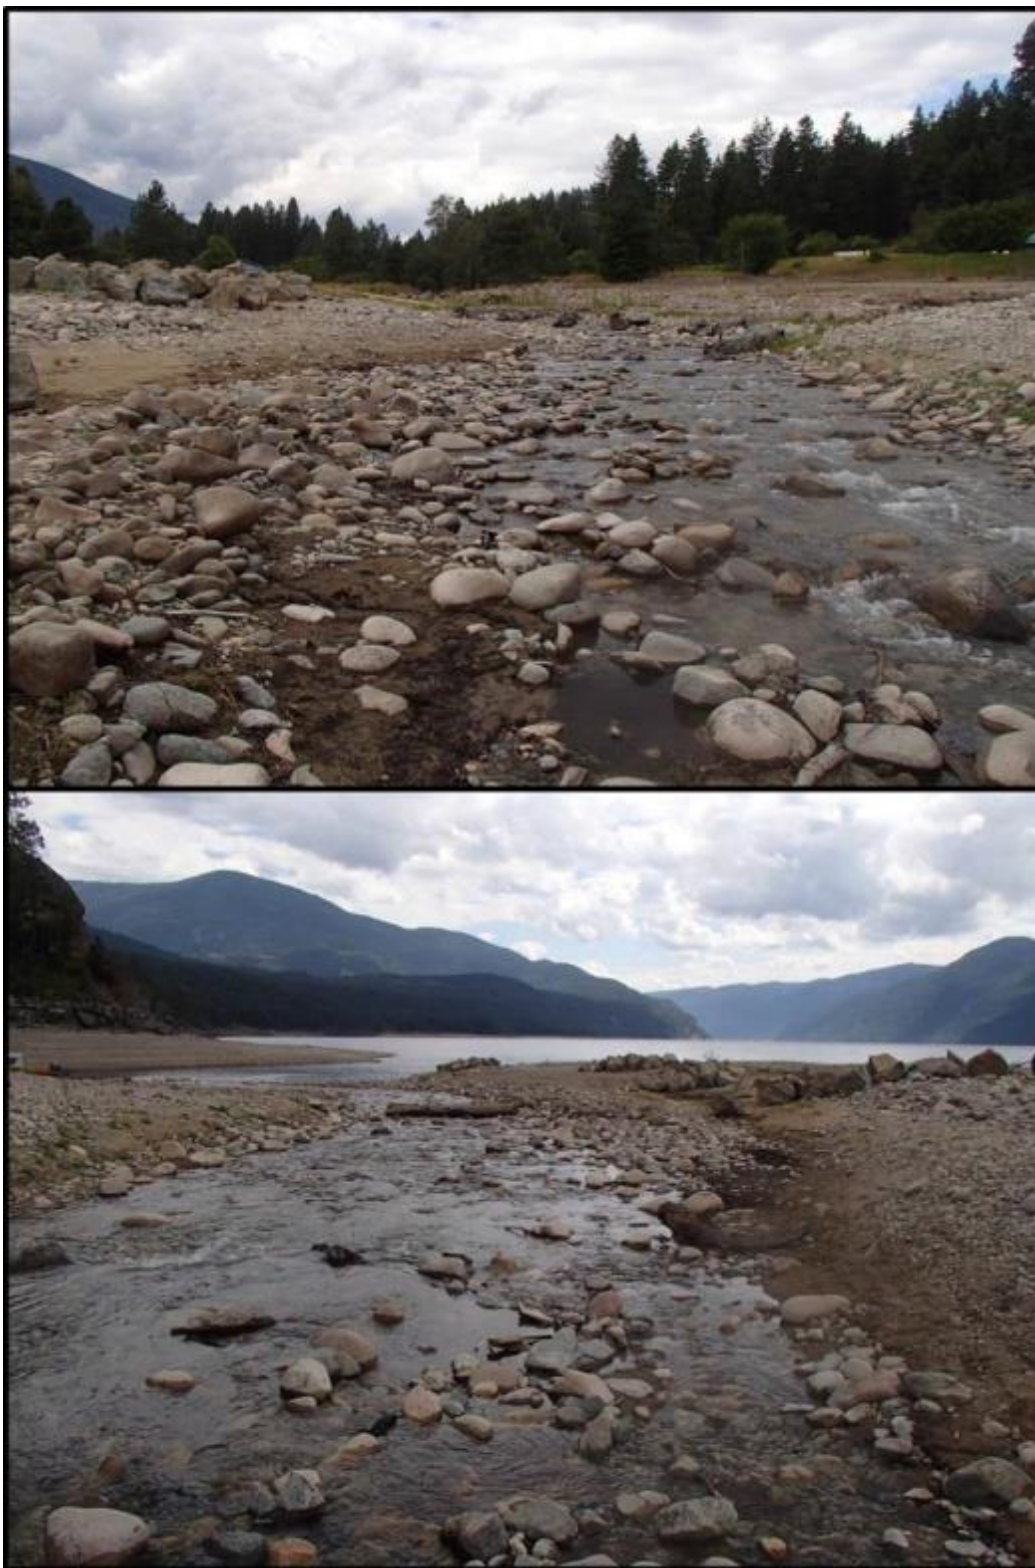
Figure 2. (Top) Deer Creek's lower reach within the drawdown zone from a downstream perspective showing an absence of cover and shallow water impeding Kokanee access; (bottom) Deer Creek's lower reach within the lower drawdown zone from an upstream perspective which is prone to braiding. Photos by Evan Smith, Okanagan Nation Alliance, August 2016.

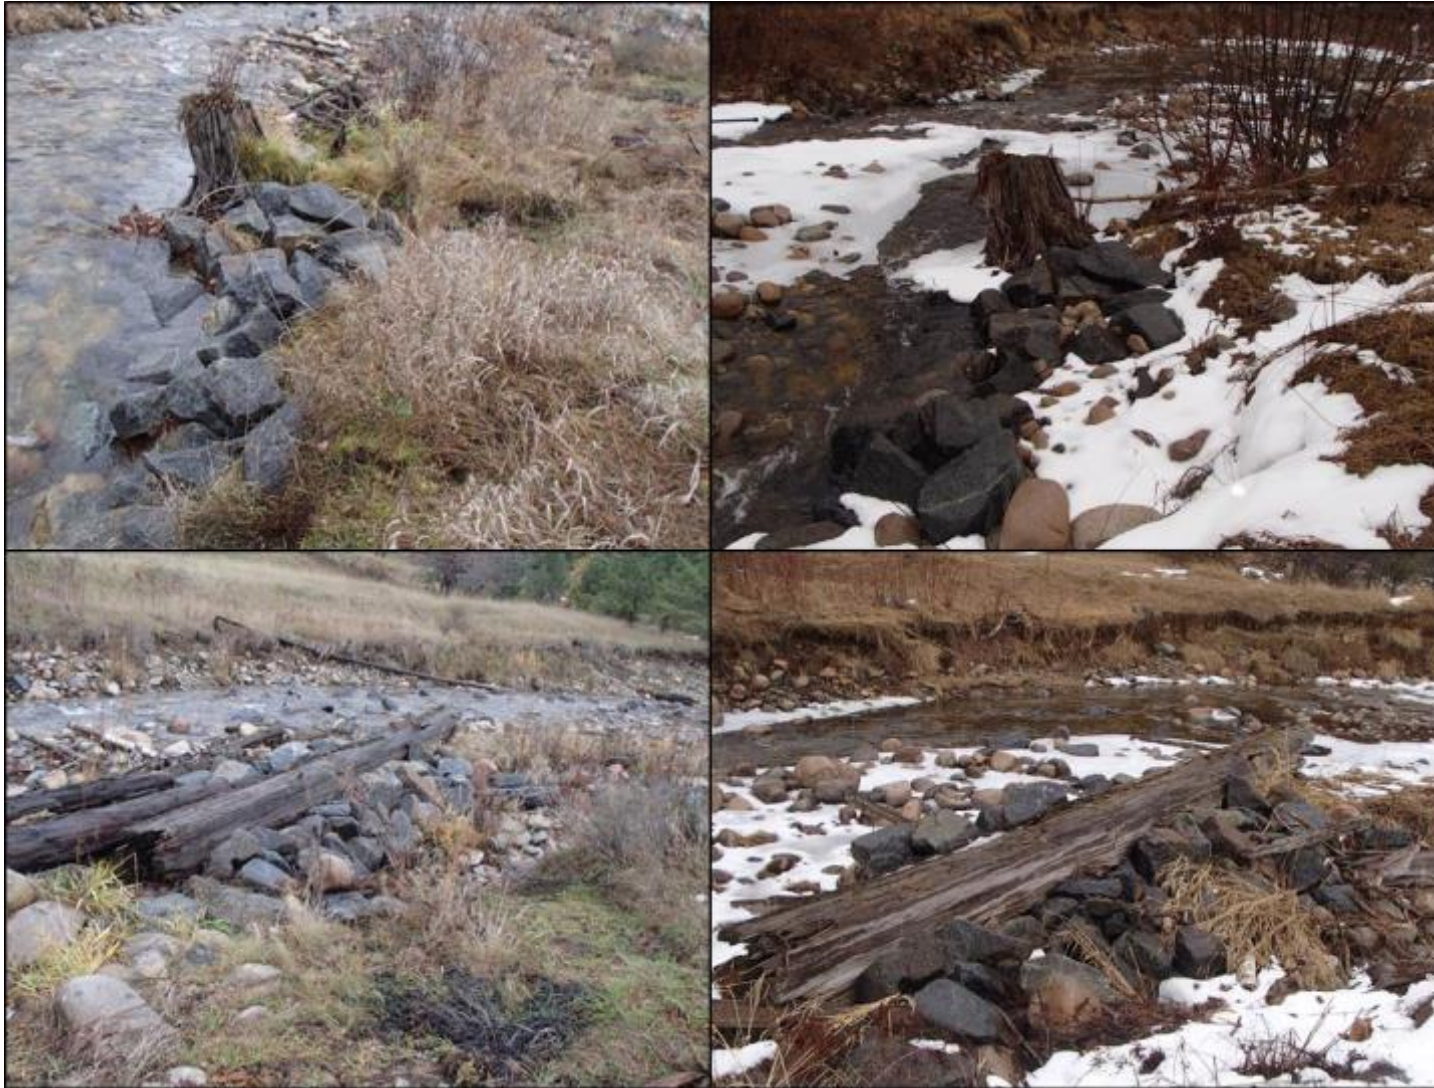
Structure	Fig.	Description	Condition
1	Fig 21	Small rip-rap bank	Bank Slumped; 19-21/49 rocks remain the rest washed away
2	Fig 21	Rip rap and existing log	Intact
3	Fig 22	Boulder Garden (~40 boulders)	21 - 25/40 rocks remain, possibly added from Structure 1, the rest washed away
4	Fig 22	Rock Weir	30/43 rocks remain, most removed by freshet; remanence of structure still visible on right and left bank.
5	Fig 23	Root wads and rock wall	All roots present; two ballast rocks fallen into stream between Root 3 and 4 (1.06 - 1.27 m in size); large pools formed behind moved rocks
5a	Fig 24	Single root/log with rock	Intact
6	Fig 25	Two-part, log and rock revetments with small woody debris shelving	Upstream side of structure partially collapsed, possibly from velocity of smaller side channel; Log 1 has become misaligned and Root 2 is missing
7	Fig 26	Series of root wad and rock structures	All intact except for the 4 th structure from the downstream end which is missing; large pool formed under Roots 9 & 10

Figure 21. (Top Left) Structure 1 post -construction in November 2015; (top right) Structure 1 in March 2018 after two years of being subjected to freshet and reservoir inundation; (bottom left) Structure 2 post-construction in November 2015; (bottom right) Structure 2 in March 2018 after two years of being subjected to freshet and reservoir inundation. Photos by Evan Smith, Okanagan Nation Alliance, November 2015 and March 2018).

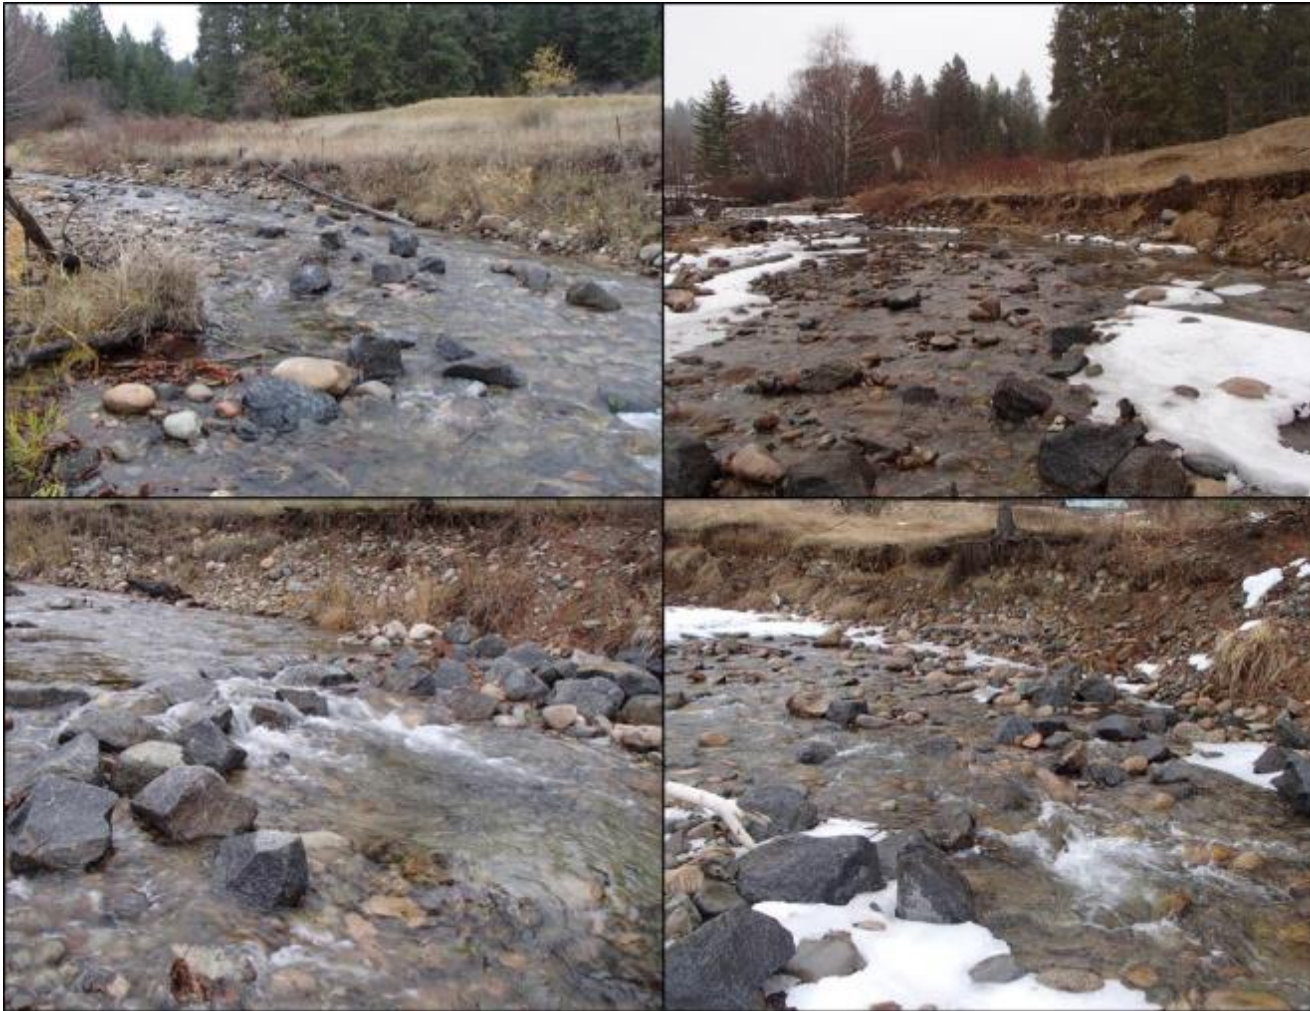
Figure 22. (Top Left) Structure 3 post -construction in November 2015; (top right) Structure 3 in March 2018 after two years of being subjected to freshet and reservoir inundation; (bottom left) Structure 4 post-construction in November 2015; (bottom right) Structure 4 in March 2018 after two years of being subjected to freshet and reservoir inundation. Photos by Evan Smith, Okanagan Nation Alliance, November 2015 and March 2018).

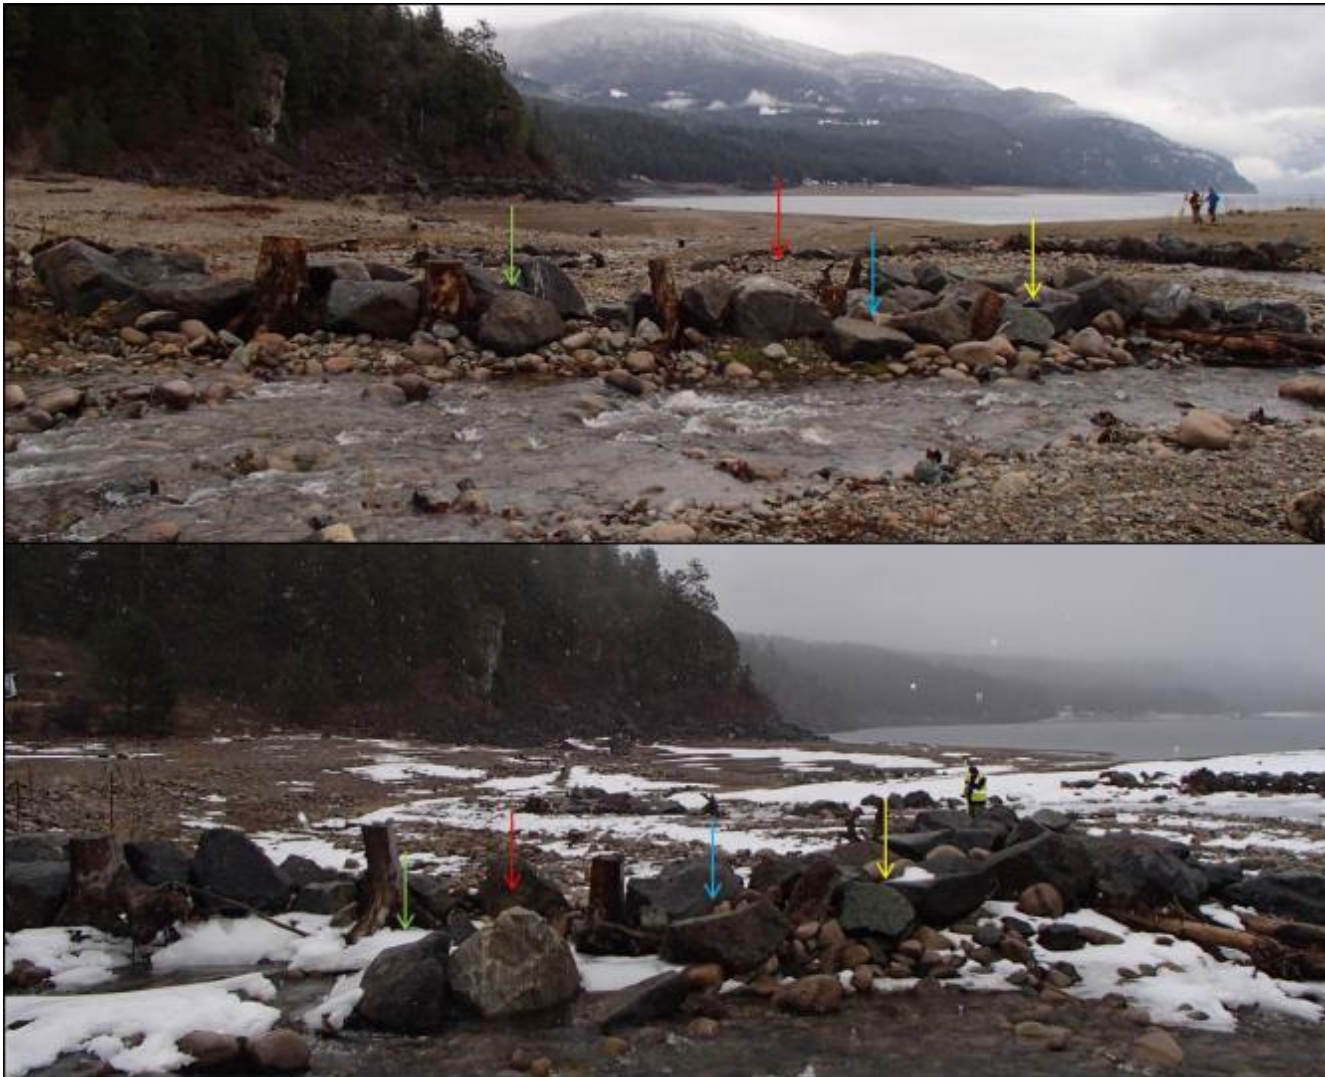
Figure 23.(Top) Structure 5 post -construction in November 2015 with coloured arrows (green, red, blue, yellow) highlighting the positions of four specific rocks; (bottom) Structure 5 in March 2018 after two years of being subjected to freshet and reservoir inundation with coloured arrows (green, red, blue, yellow) highlighting the movements of specific rocks. Photos by Evan Smith, Okanagan Nation Alliance, November 2015 and March 2018).

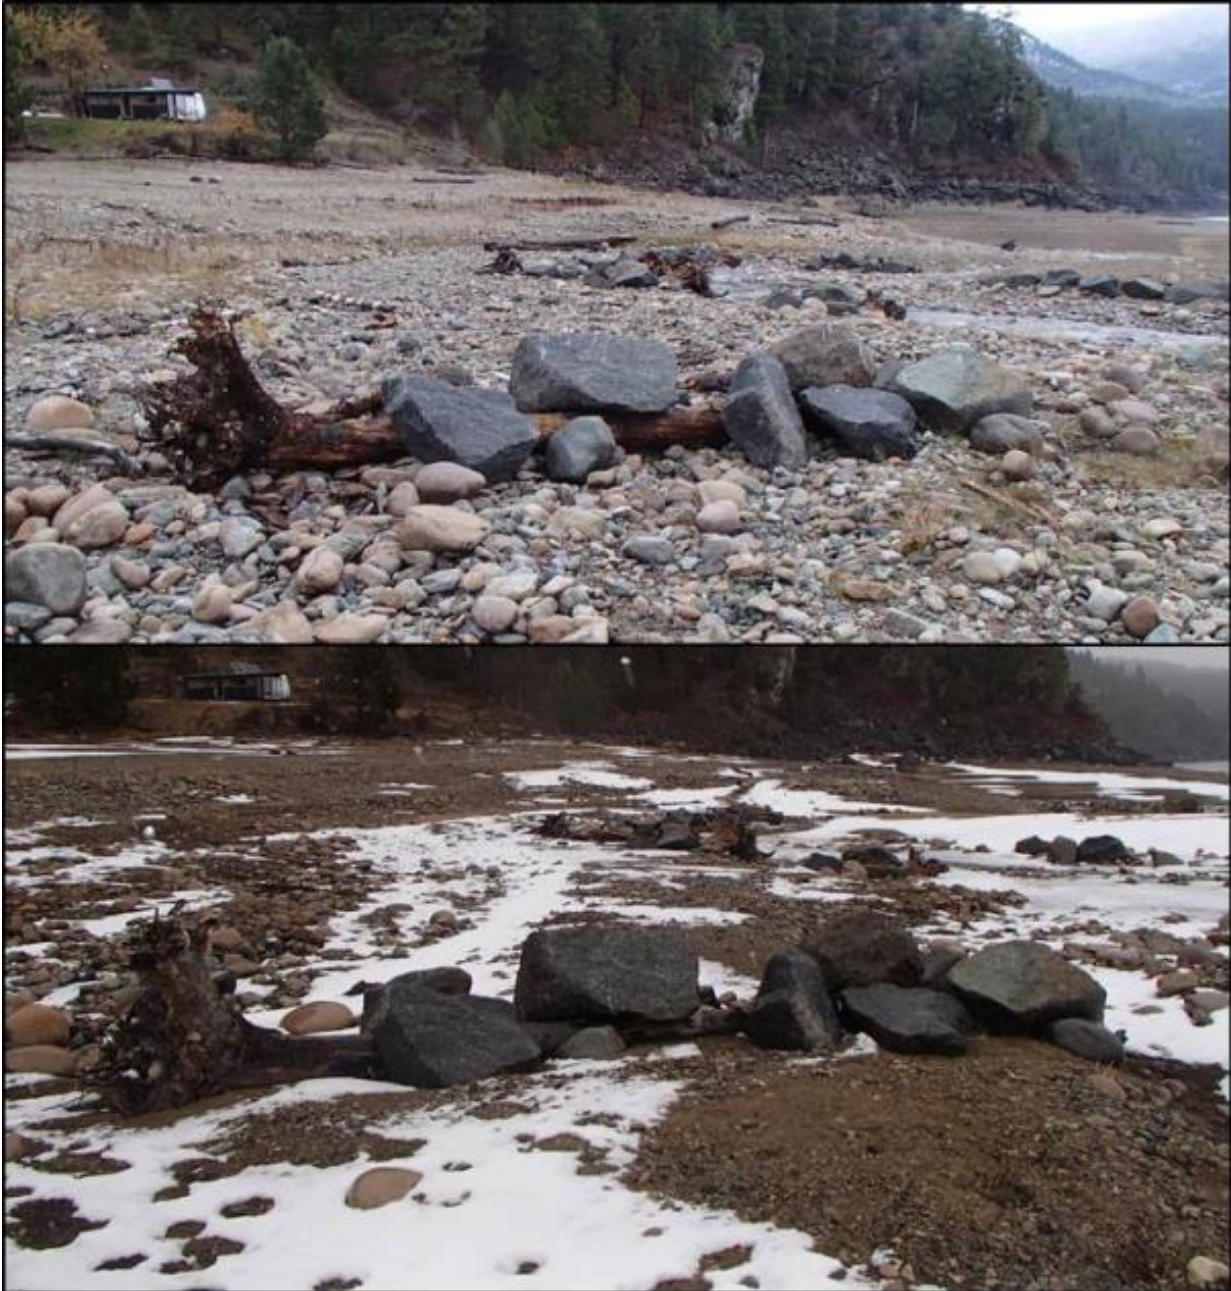
Figure 24. (Top) Structure 5a post -construction in November 2015; (bottom) Structure 5 in March 2018 after two years of being subjected to freshet and reservoir inundation. Photos by Evan Smith, Okanagan Nation Alliance, November 2015 and March 2018).

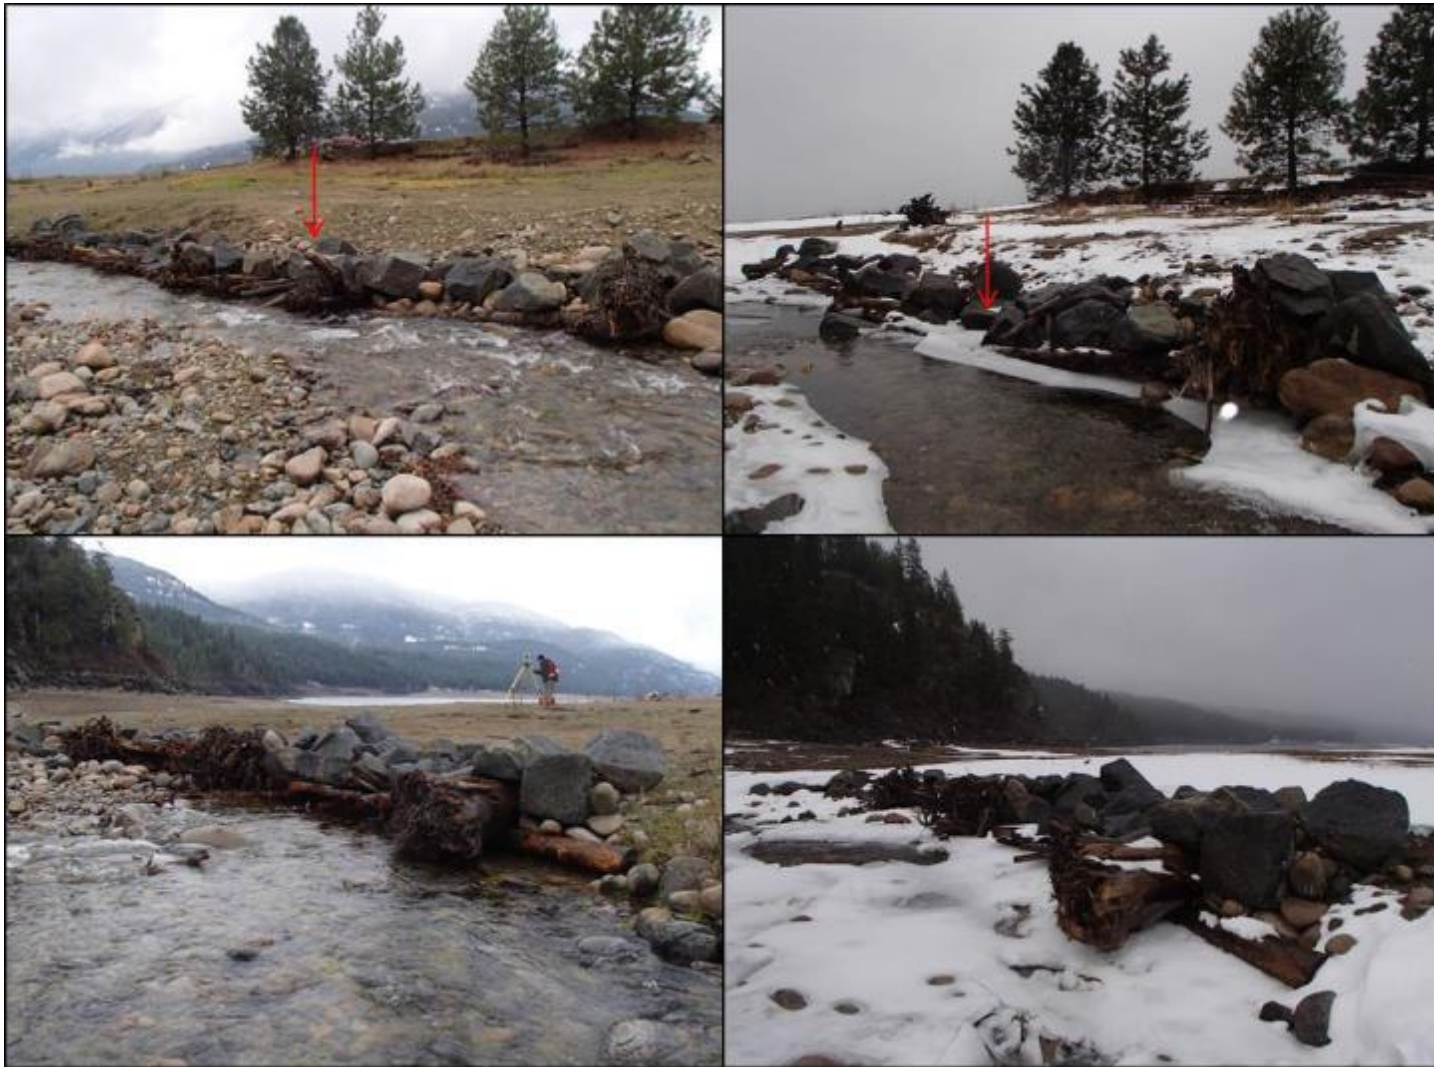
Figure 25. (Top Left) upstream portion of Structure 6 post -construction in November 2015 with red arrow highlighting Root 2; (top right) upstream portion of Structure 6 in March 2018 after two years of being subjected to freshet and reservoir inundation with red arrow highlighting the absence of Root 2; (bottom left) downstream portion of Structure 6 post-construction in November 2015; (bottom right) downstream portion of Structure 6 in March 2018 after two years of being subjected to freshet and reservoir inundation. Photos by Evan Smith, Okanagan Nation Alliance, November 2015 and March 2018).

Post freshet monitoring in March 2018 resulted in some observations of movement and/or missing components of Phase I & II Structures. Changes may be attributed to a high freshet (peaking at 13.0 m³/s) in 2017 (green line; Fig 18). Observations indicated at these flows approximately 50% of rock less than 1 m in size was moved downstream. Therefore future efforts should consider using rock greater than 1 m in size in streams likely to reach flows above 13 m³/s. Some larger ballast rocks (1.00 – 1.25 m) had also shifted, primarily in Structures 5 and 6 (Phase I). However, movement of these rocks appears to be the result of undercutting/erosion and not velocity as they moved less than 1 m from their original position. Roots from Structures 6, 7, and 10 were confirmed missing while roots from Structures 17, 18 and 19 were not observed, but may have been buried in reservoir sediment. Roots from Structures 7 and 10 may have been lost due to insufficient ballast for the volume of wood, while the mobilization of Root 2 from Structure 6 may have resulted from erosion.

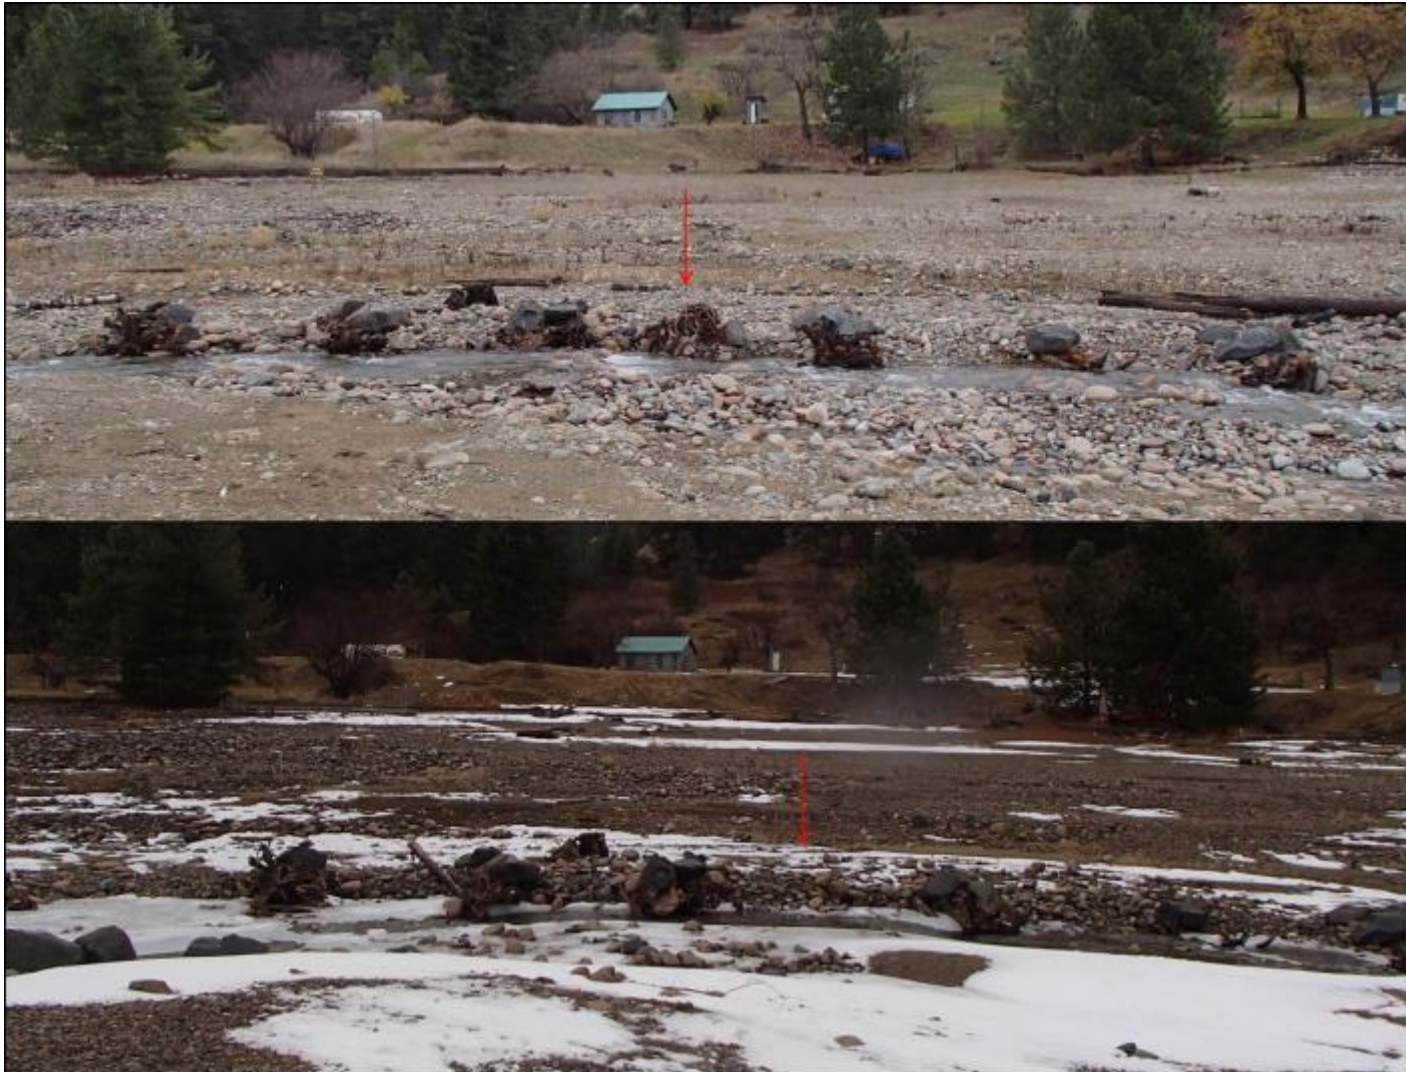
Figure 26. (Top) Structure 7 post -construction in November 2015 with a red arrow highlighting Roots 7 & 8; (bottom) Structure 7 in March 2018 after two years of being subjected to freshet and reservoir inundation with a red arrow highlighting the missing root structure consisting of Roots 7 & 8. Photos by Evan Smith, Okanagan Nation Alliance, November 2015 and March 2018).

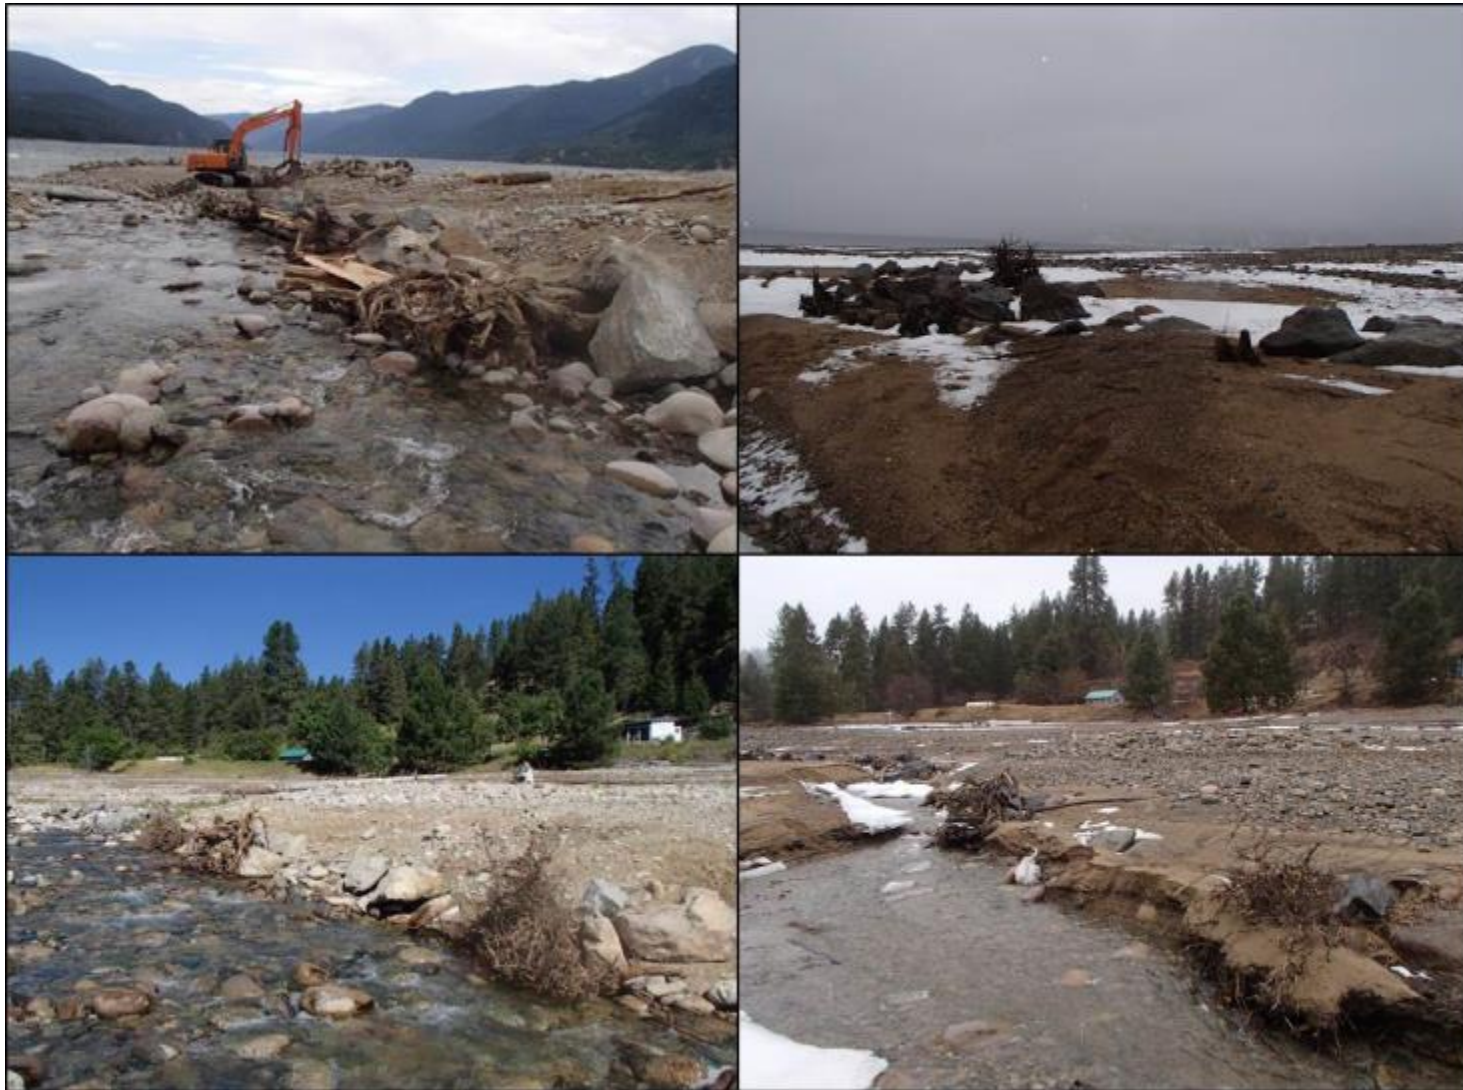
8	Fig 27	Multiple logs and rock	Intact; some sediment deposition on structure; 1 rock missing or imbedded
9	Fig 28	Log and rock revetments with small woody debris shelving	Intact; almost all imbedded in reservoir sediment
10	Fig 28	Series of root wad and rock structures	Upstream root missing (Root 1) and rocks are imbedded in reservoir sediment; other two roots (Root 2 and 3) are partially imbedded but look intact
11	Fig 29	Single log with rock	Intact; partially imbedded in reservoir sediment
12	Fig 29	Log and rock revetments with small woody debris shelving	Intact; partially imbedded in reservoir sediment
13	Fig 30	Log and Root structure with rock ballast	Intact; partially imbedded in reservoir sediment
14	Fig 30	Single log with rock	Intact; partially imbedded in reservoir sediment
15	Fig 31	Rock deflection	Intact; partially imbedded in reservoir sediment
16	Fig 31	Vertical roots, horizontal roots, and cover logs ballasted by rock	Intact; partially imbedded in reservoir sediment

Figure 28. (Top Left) Structure 9 post -construction in August 2016; (top right) Structure 9 in March 2018 after one year of being subjected to freshet and reservoir inundation: note the amount of sediment deposition on top of the structure; (bottom left) Structure 10 post-construction in August 2016; (bottom right) Structure 10 in March 2018 after one year of being subjected to freshet and reservoir inundation. Photos by Evan Smith, Okanagan Nation Alliance, August 2016 and March 2018).

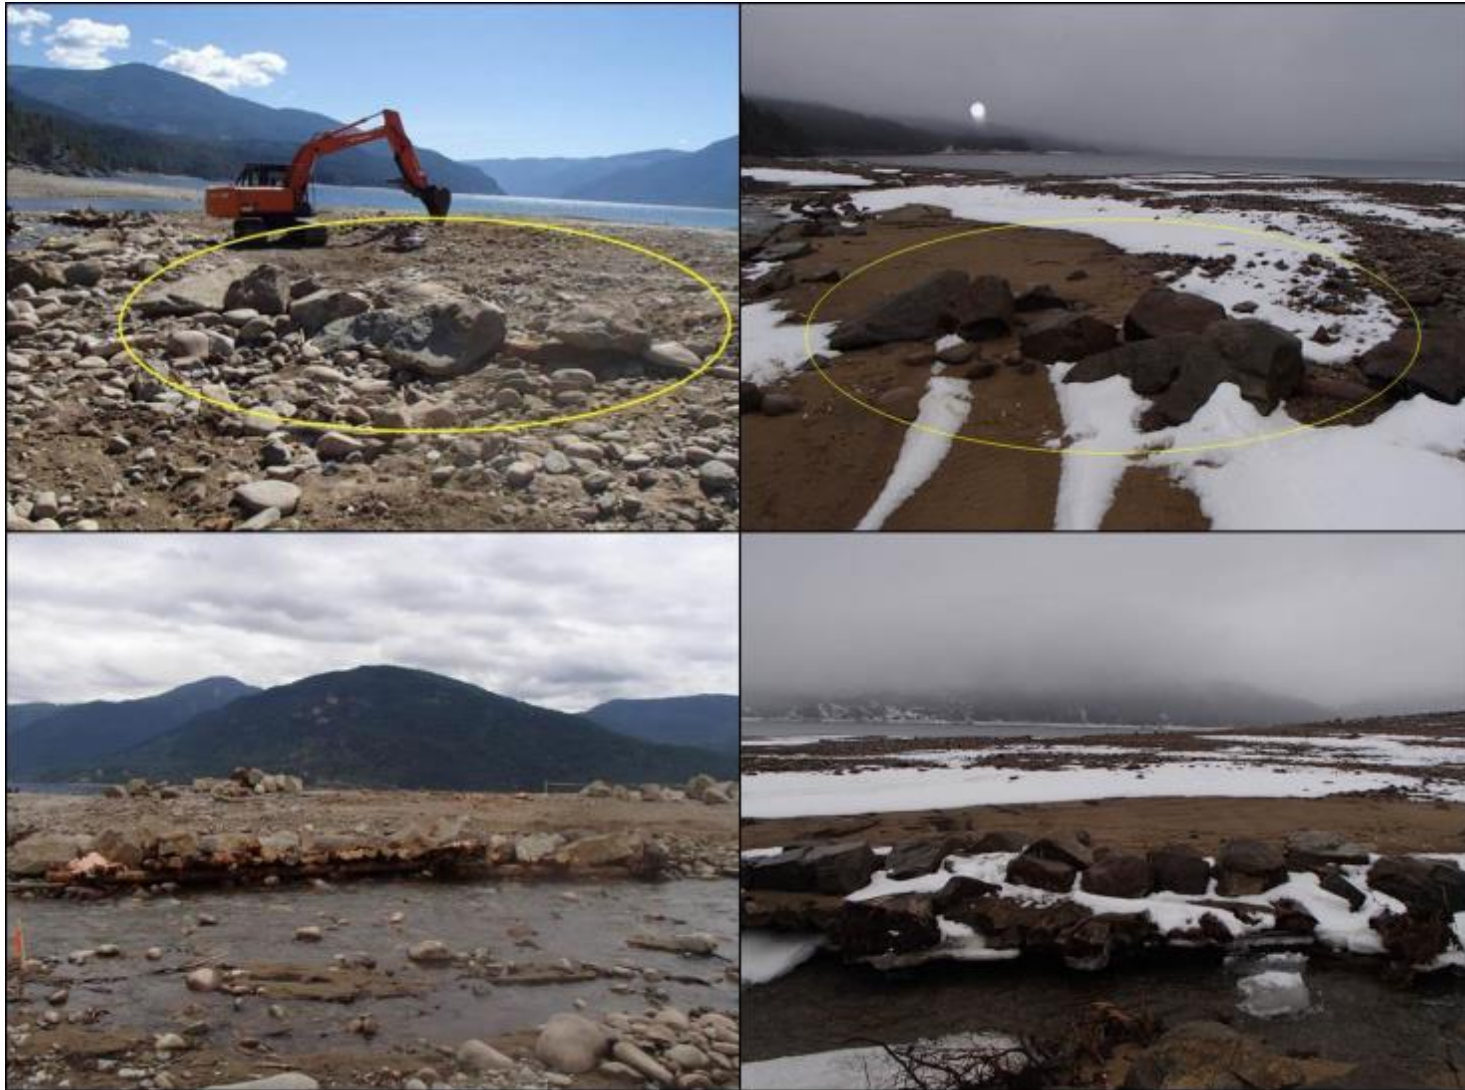
Figure 29. (Top Left) Structure 11 post -construction in August 2016; (top right) Structure 11 in March 2018 after one year of being subjected to freshet and reservoir inundation; (bottom left) Structure 12 post-construction in August 2016; (bottom right) Structure 12 in March 2018 after one year of being subjected to freshet and reservoir inundation. Photos by Evan Smith, Okanagan Nation Alliance, August 2016 and March 2018).

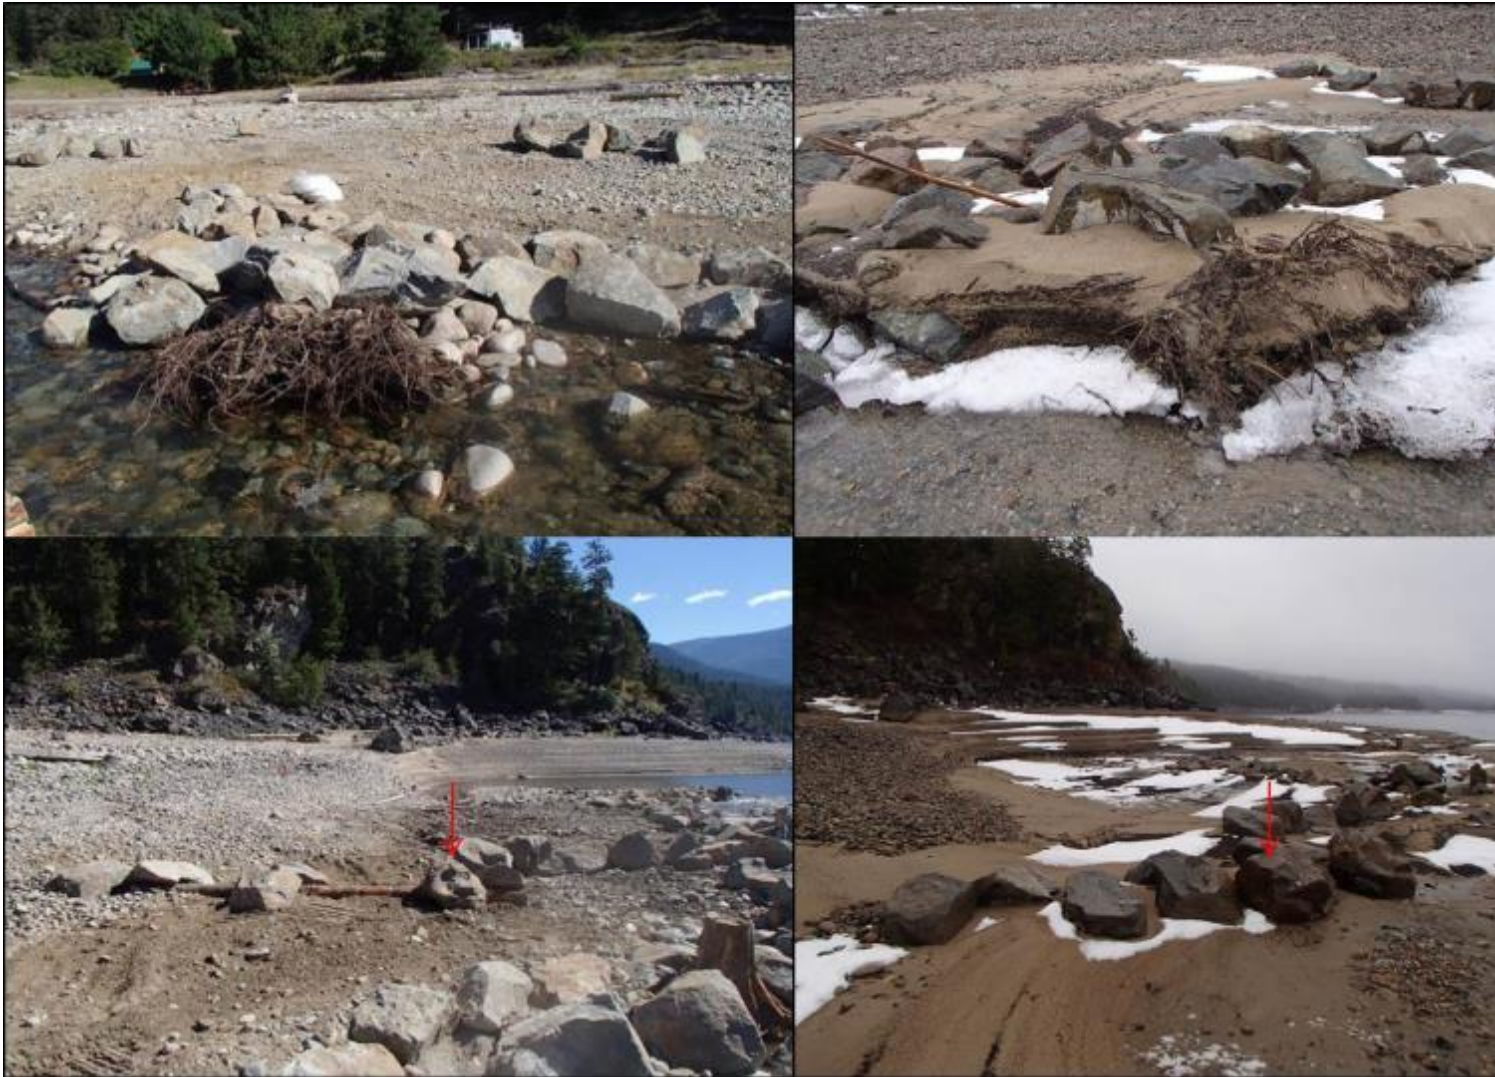
Figure 30. (Top Left) Structure 13 post -construction in August 2016; (top right) Structure 13 in March 2018 after one year of being subjected to freshet and reservoir inundation; (bottom left) Structure 14 post-construction in August 2016 highlighted with a red arrow; (bottom right) Structure 14 in March 2018 after one year of being subjected to freshet and reservoir inundation highlighted by a red arrow. Photos by Evan Smith, Okanagan Nation Alliance, August 2016 and March 2018).

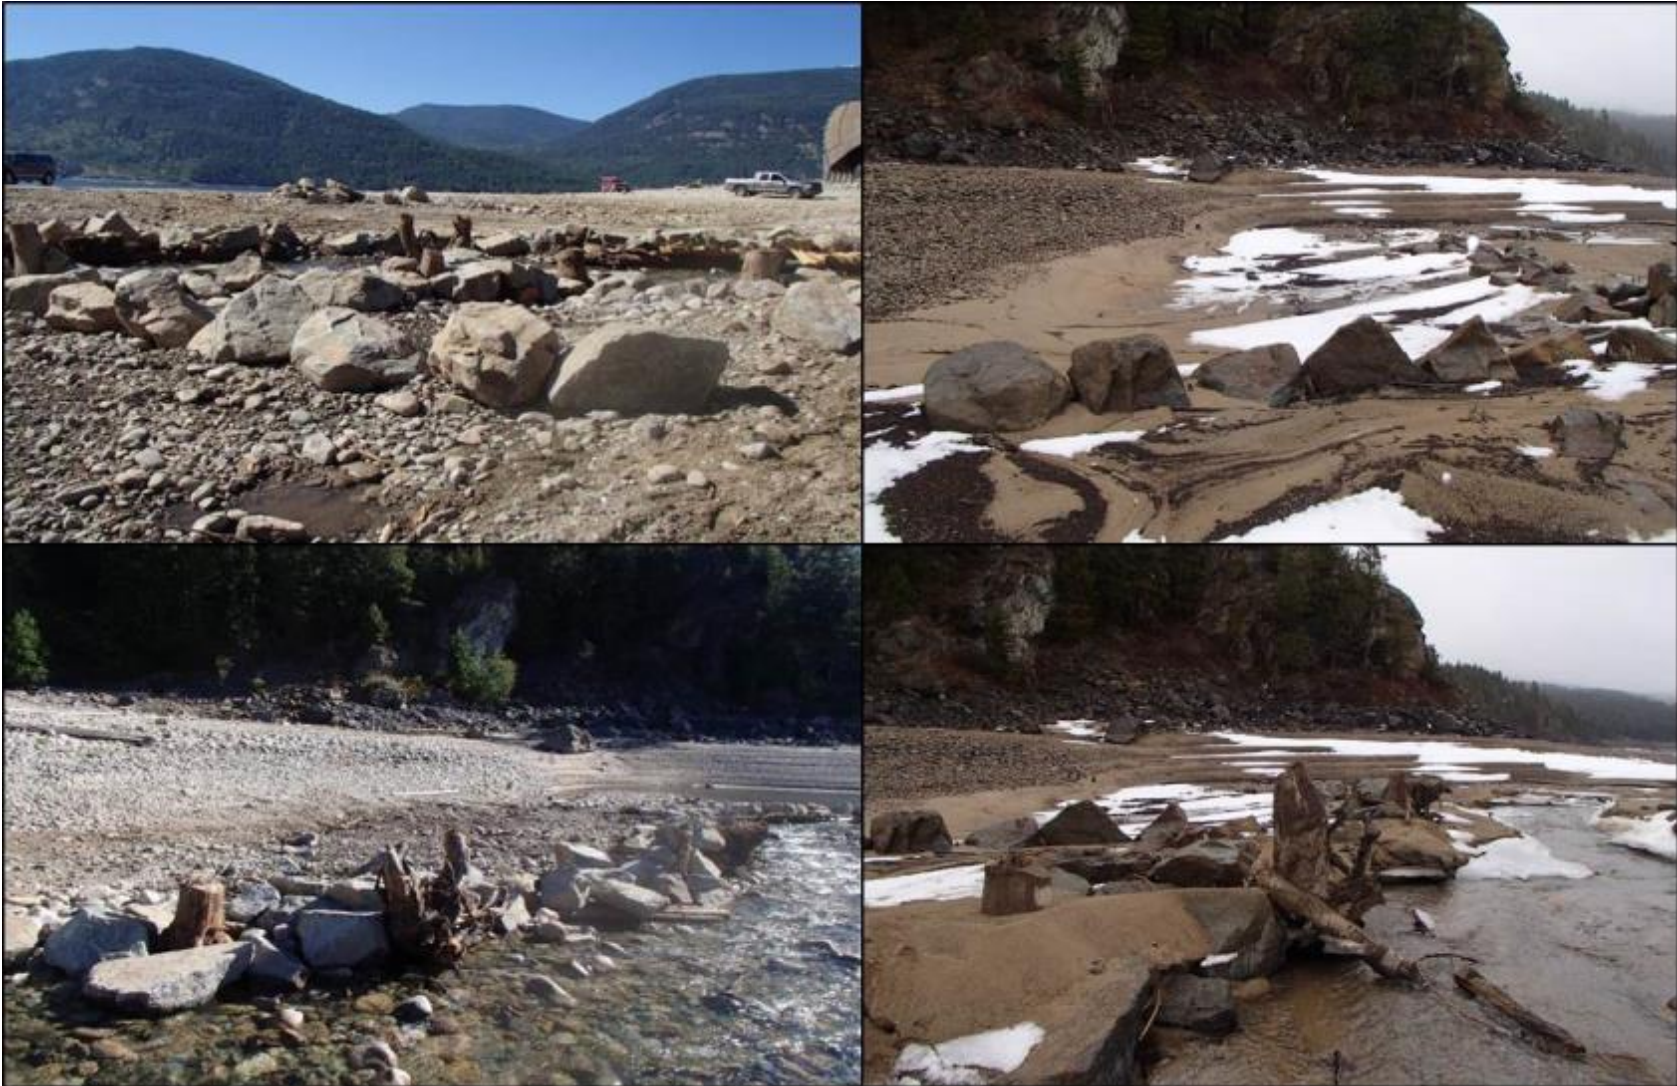
Figure 31. (Top Left) Structure 15 post -construction in August 2016; (top right) Structure 15 in March 2018 after one year of being subjected to freshet and reservoir inundation; (bottom left) Structure 16 post-construction in August 2016; (bottom right) Structure 16 in March 2018 after one year of being subjected to freshet and reservoir inundation. Photos by Evan Smith, Okanagan Nation Alliance, August 2016 and March 2018).

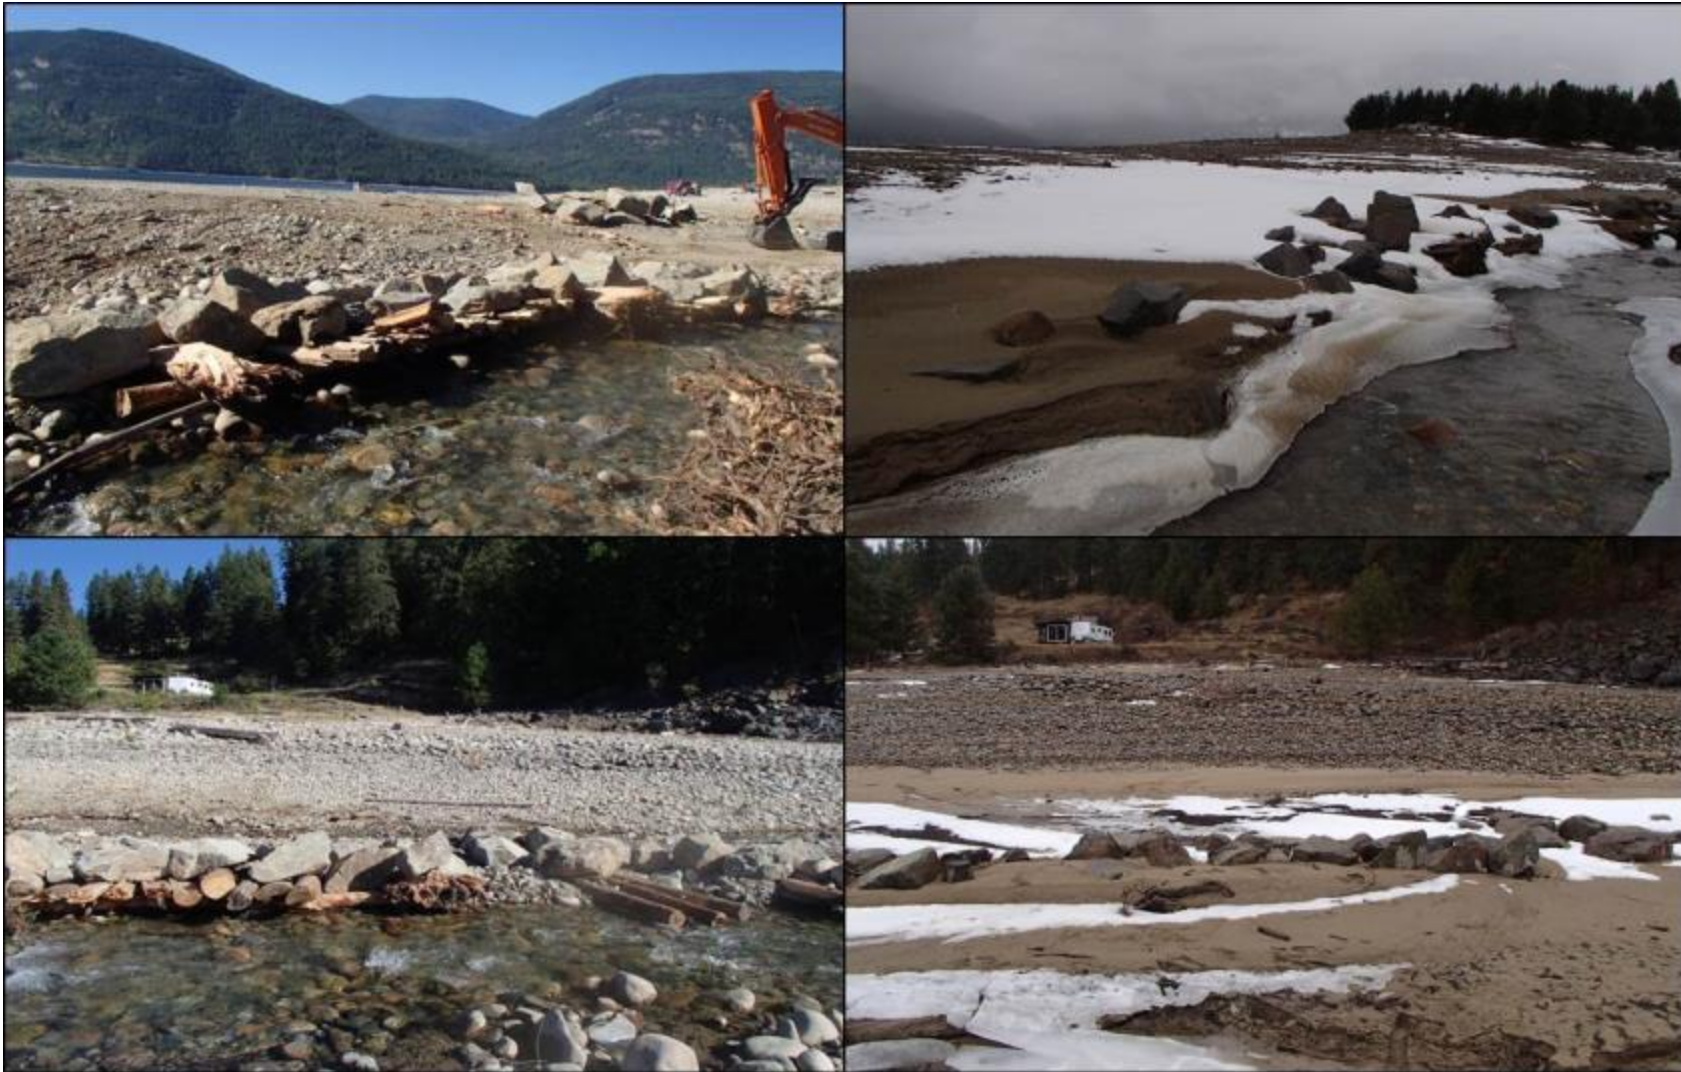
17	Fig 32	Log and rock revetments with small woody debris shelving	Missing downstream root (Root 4); some cover logs missing or miss-aligned; upstream end difficult to discern due to being partially imbedded in reservoir sediment
18	Fig 32	Log and rock revetments with small woody debris shelving	Mostly imbedded in reservoir sediment; downstream root (Root 5) missing or buried
19	Fig 33	Log and rock revetments with small woody debris shelving	Mostly imbedded in reservoir sediment; all roots gone or buried

Figure 32. (Top Left) Structure 17 post -construction in August 2016; (top right) Structure 17 in March 2018 after one year of being subjected to freshet and reservoir inundation; (bottom left) Structure 18 post-construction in August 2016; (bottom right) Structure 18 in March 2018 after one year of being subjected to freshet and reservoir inundation. Photos by Evan Smith, Okanagan Nation Alliance, August 2016 and March 2018).
