Deer Creek Drawdown Zone Fish Habitat Enhancement: A Pilot Study (Phase II) for Lower Arrow Lakes Tributary Access Improvements 2016 – 2017

FWCP # COL-F17-F-1450

Evan Smith, B.Sc., BIT and Michael Zimmer, M.Sc., R.P.Bio
Okanagan Nation Alliance
L2 – 1444 Columbia Ave.
Castlegar, BC, V1N 3K3

June 2018

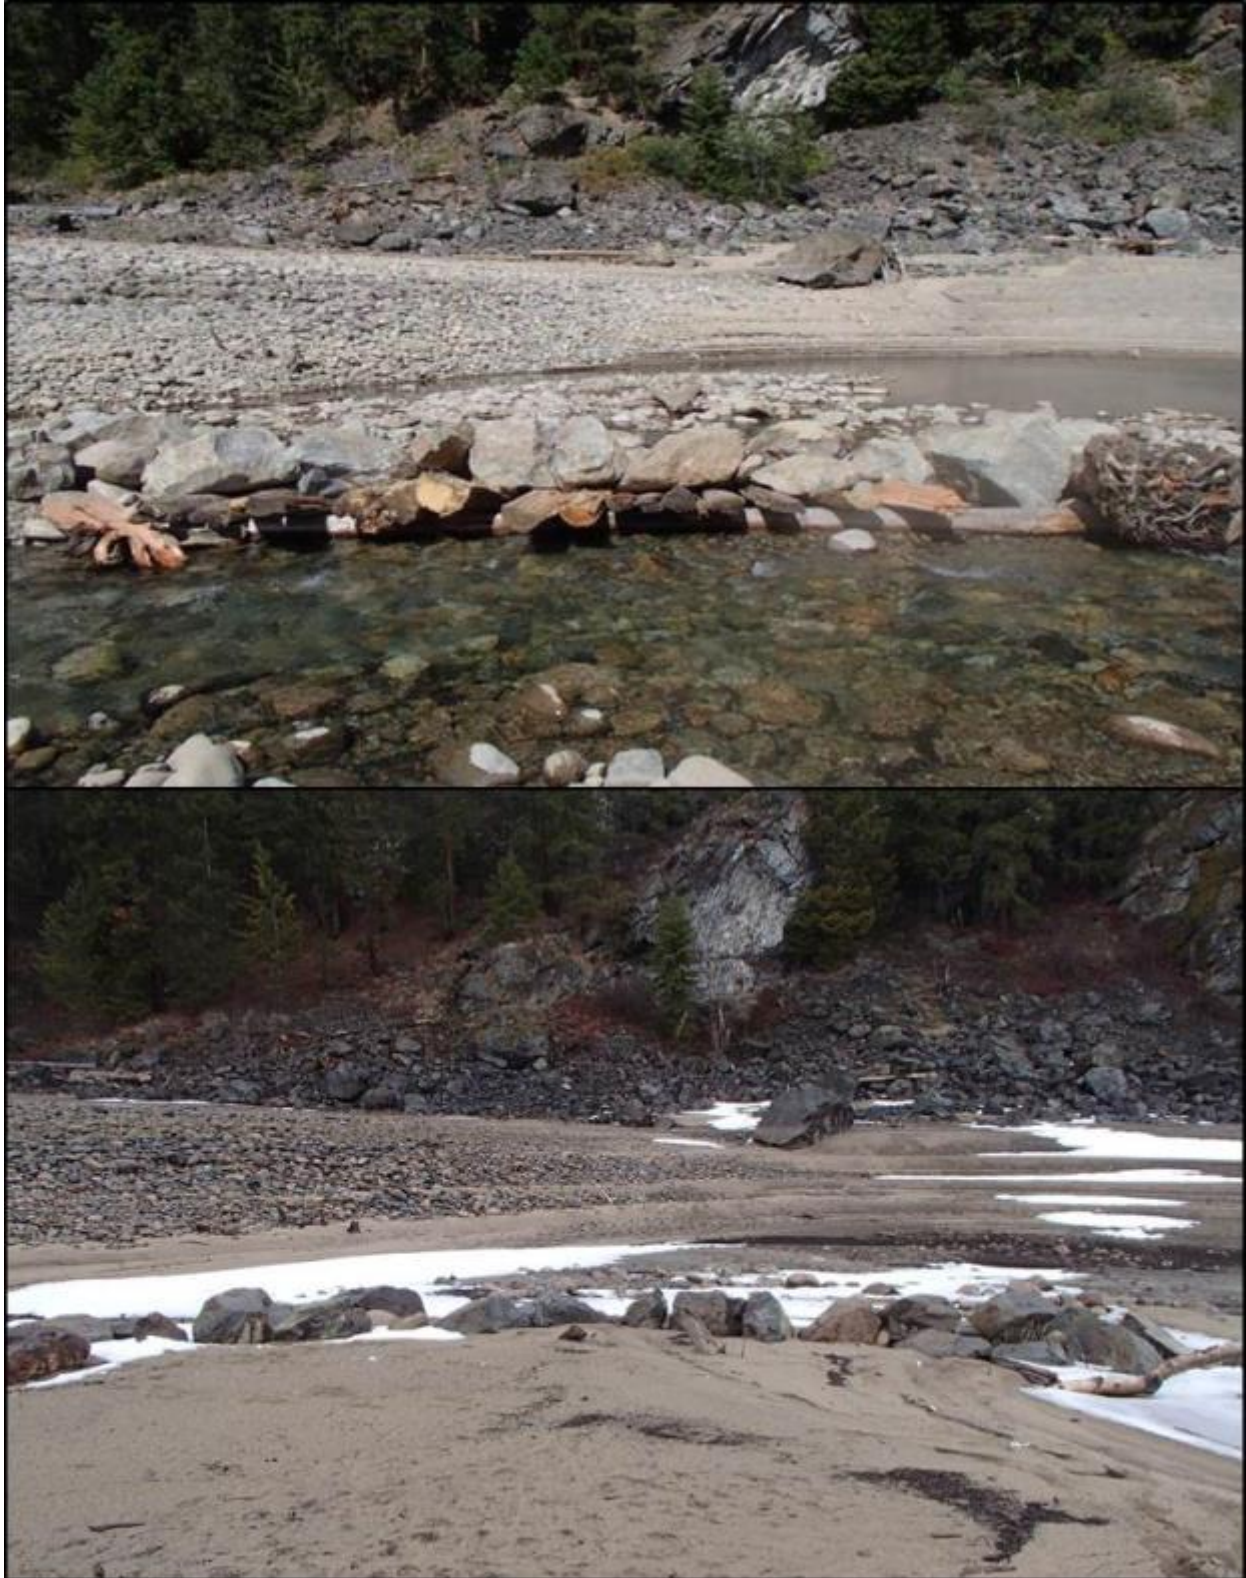
Figure 33. (Top) Structure 19 post -construction in August 2016; (bottom) Structure 17 in March 2018 after one year of being subjected to freshet and reservoir inundation. Photos by Evan Smith, Okanagan Nation Alliance, August 2016 and March 2018).

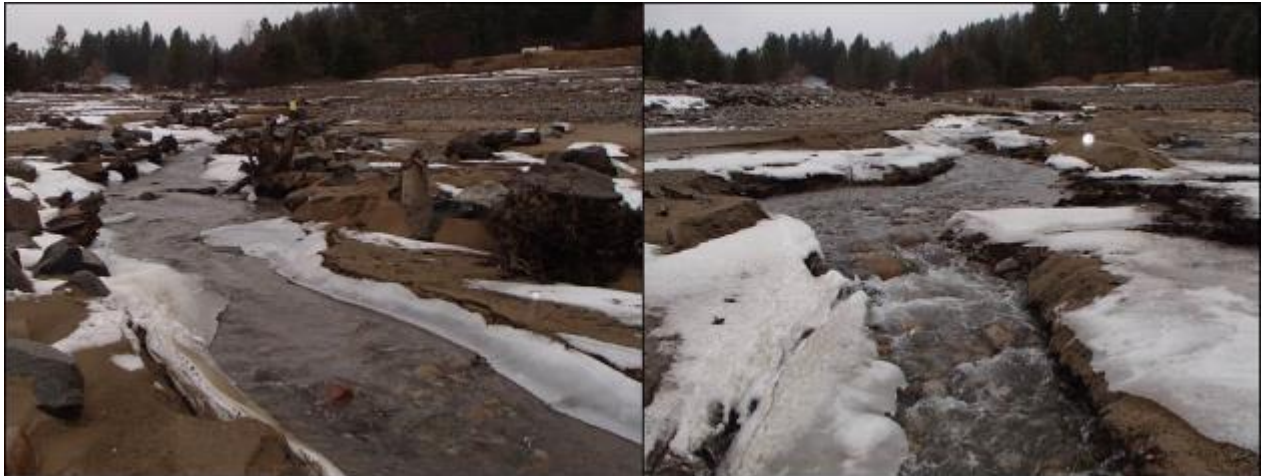
Although movement and displacement of some structure components has occurred, the overall goal of the project was achieved. Natural bank formation and single channel definition was observed in March 2018 (Fig 36). Channel width through the drawdown zone varied from 1.5 – 5 m which resembles the natural channel width in reaches above the drawdown zone. Structures which have been imbedded in reservoir sediment are no longer providing cover for Kokanee, but still work to provide structure for bank creation (addressing Goal 1, Objective 2). Structures which are not fully imbedded in sediment are still functioning as habitat/cover structures for migrating Kokanee (addressing Goal 1, Objective 2).

Figure 36. (Left) Phase II Habitat structures, from a downstream perspective, forming banks in the drawdown zone contributing to the formation of a single defined channel; (right) Deer Creek in a defined channel flowing through the drawdown zone downstream of Phase I & II structures from a downstream perspective. Photos by Evan Smith, Okanagan Nation Alliance, March 2018.

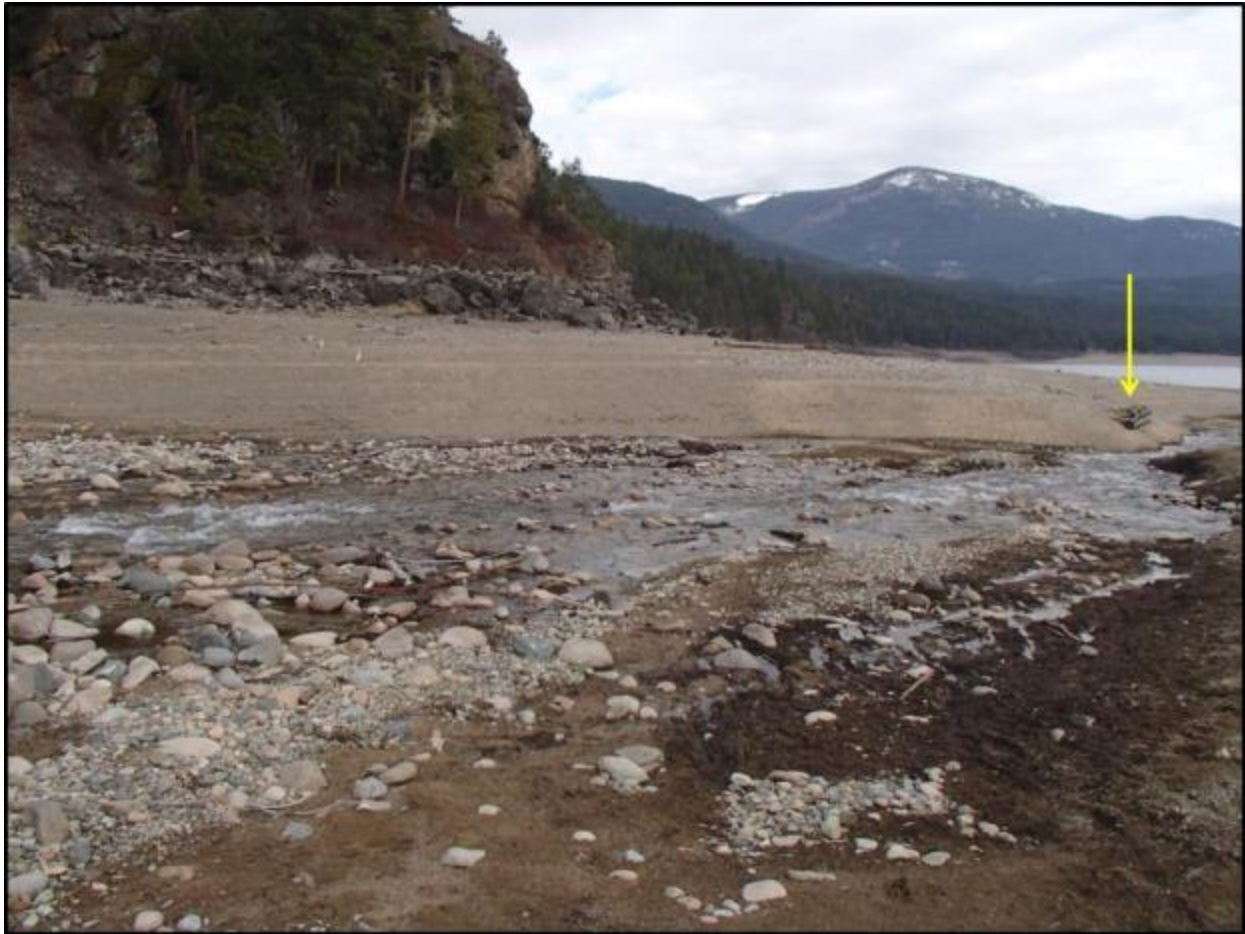
Figure 38. Untreated area of the Deer Creek drawdown zone downstream of Phase I and II which may require additional work (Phase III) which would extend from the bottom of Phase II downstream to an old bridge cribbing (yellow arrow) depending on future monitoring results. Photo by Evan Smith, Okanagan Nation Alliance, March 2016.

As the reservoir level during the in-stream work window did not allow construction in the full 100 m planned in 2016, additional installation of habitat structures from the end of Phase II downstream to the old bridge cribbing is recommended (i.e., Phase III; Fig. 38). However, if monitoring indicates the existing structures are sufficient for significantly improving Kokanee access into Deer Creek, then the existing completed work may suffice.
