**2018 Dinosaur Reservoir
Habitat Structure Monitoring**

**Fish and Wildlife Compensation Program
Peace Region**

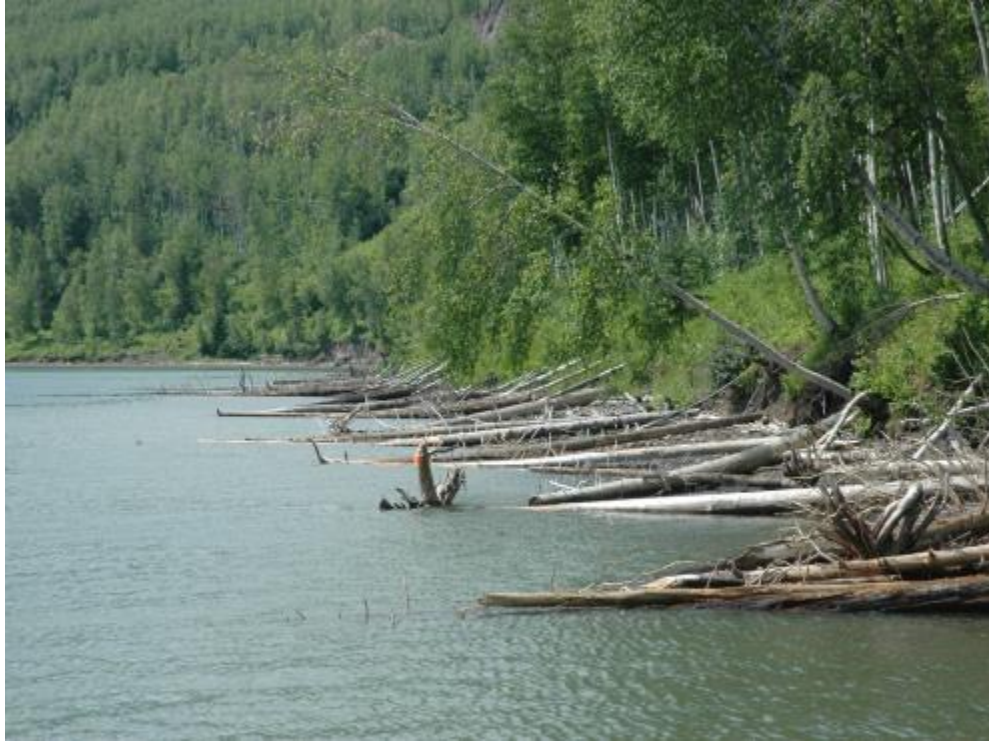
Figure 9: Multiple “triangle” structures along the north shore.

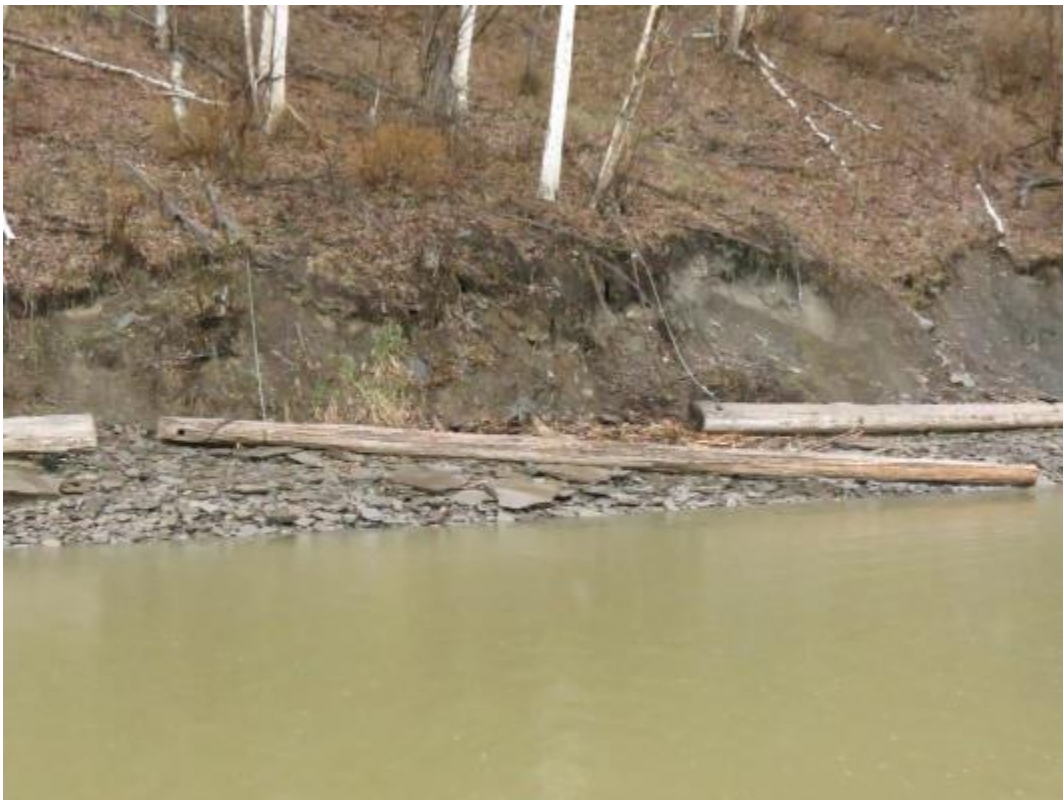
Site 2b and 2c: single anchors but can be a boat hazard at higher water levels.

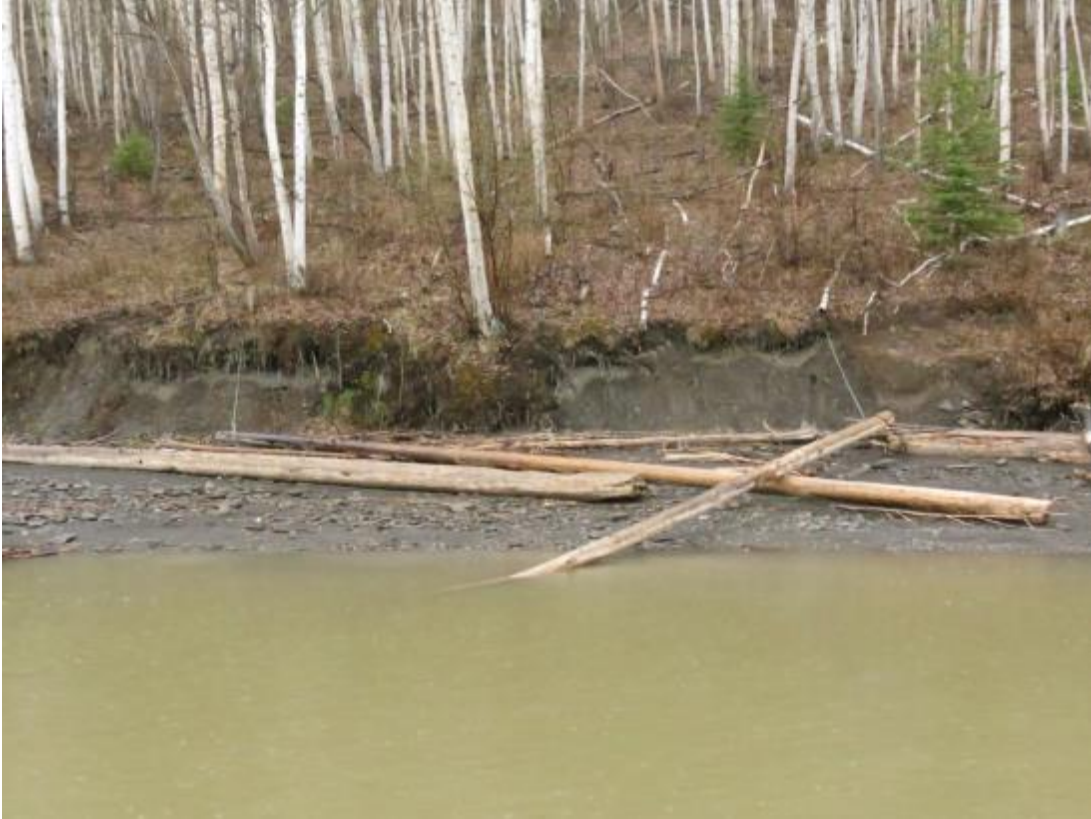
Site 2i triangle: structure secured with 2 earth anchors but came apart in the middle.

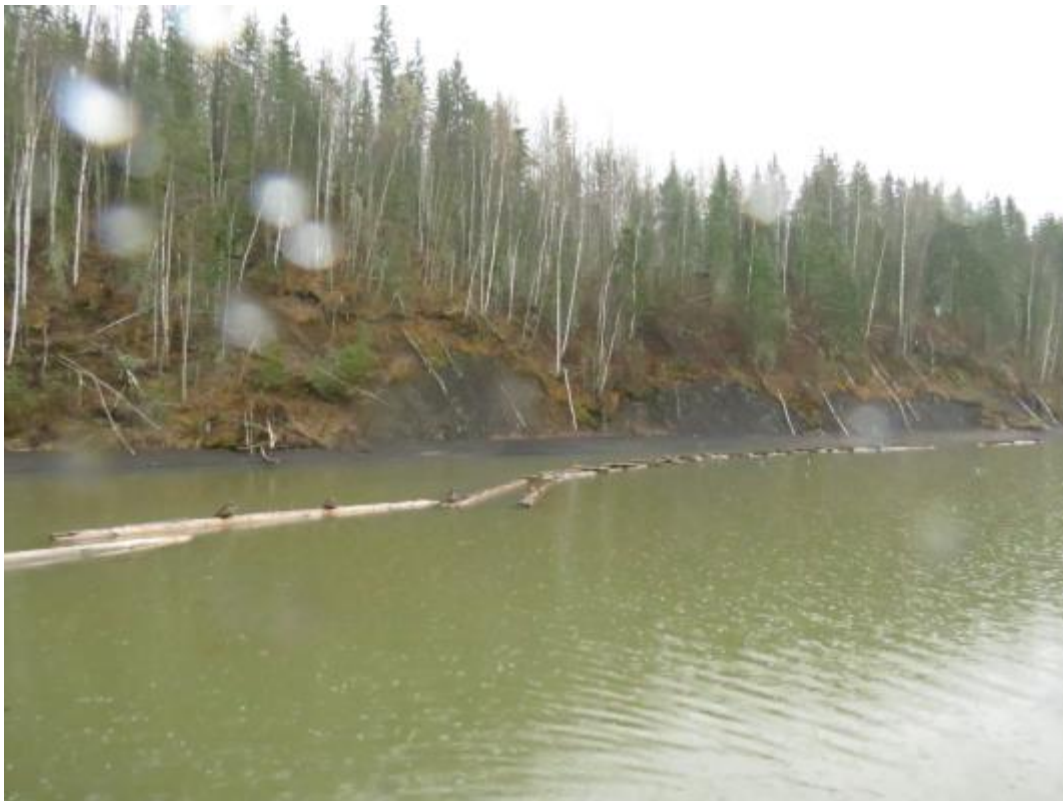
Site 3 boom: log boom has broken apart near east shore.

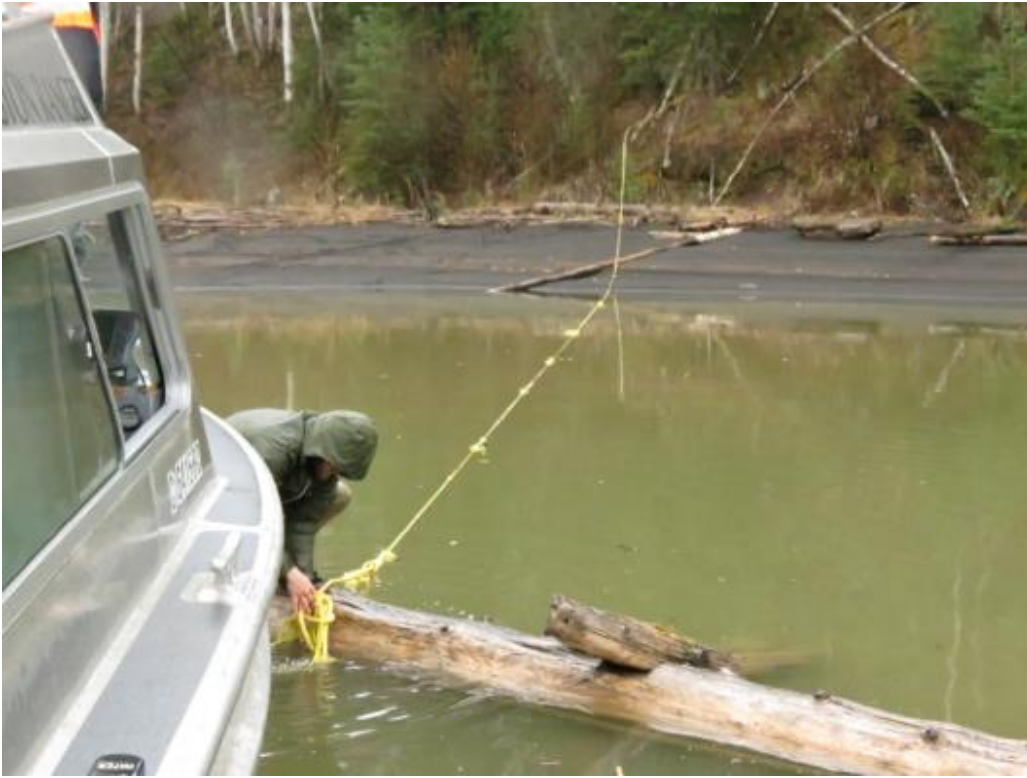
Site 3 boom: boom is resecured to land with poly rope.

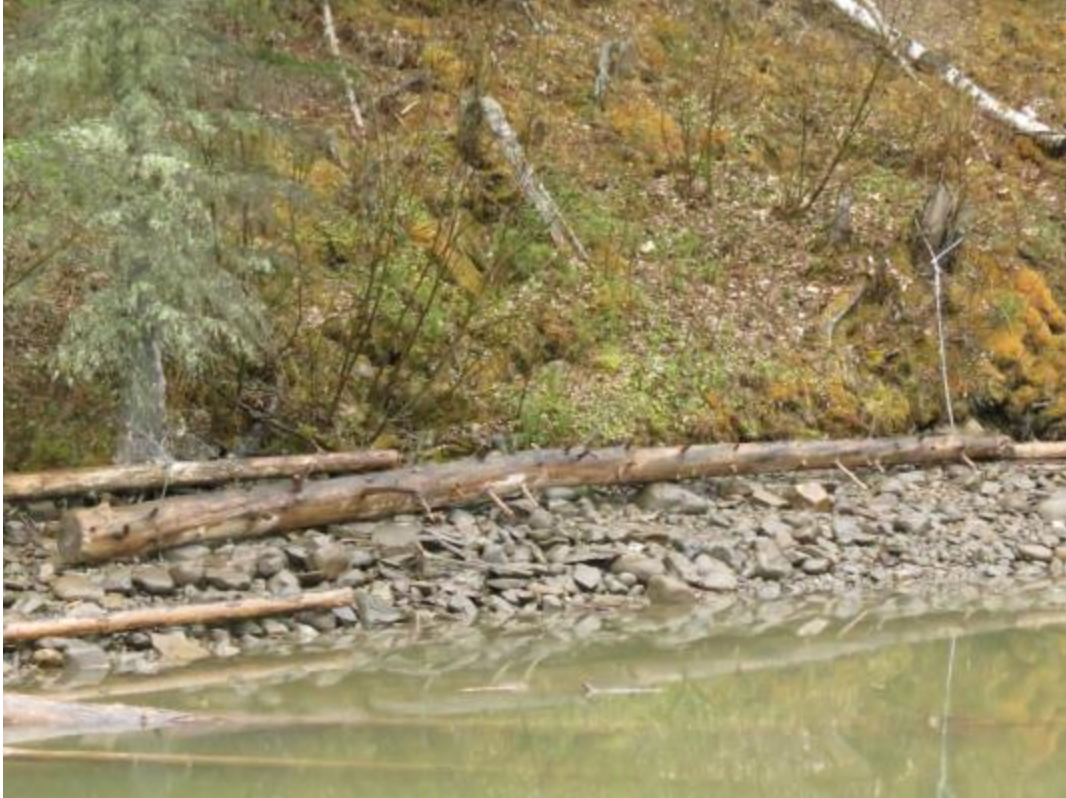
Site 3j2 triangle: note right anchor is tied to a stump, may come loose after a year

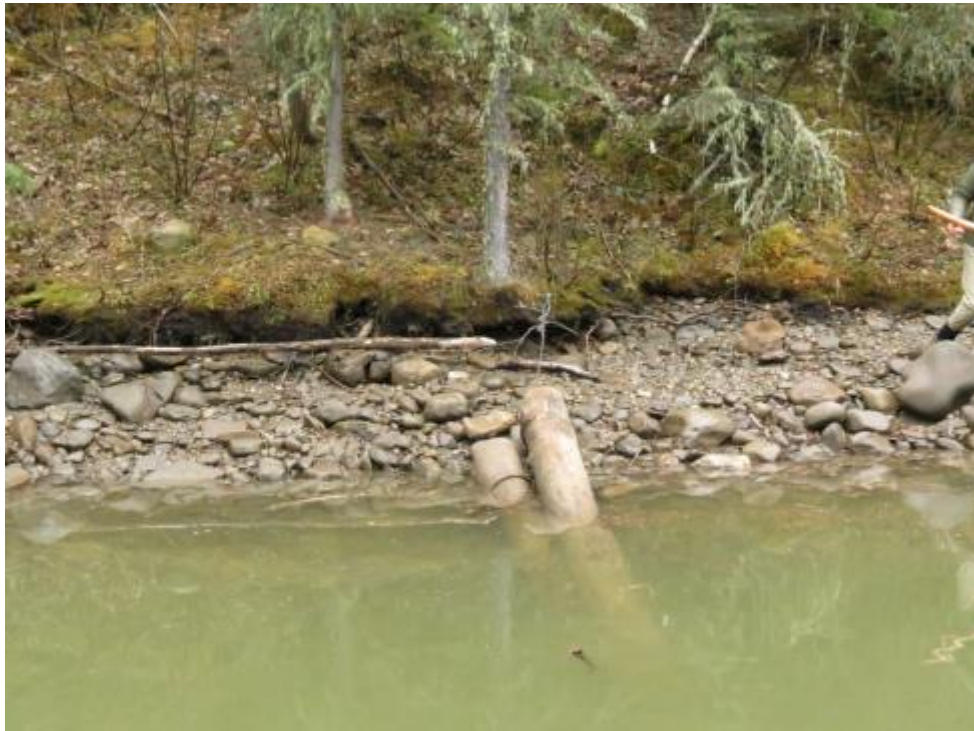
Site 8l triangle: structure submerged, unknown if attached at apex

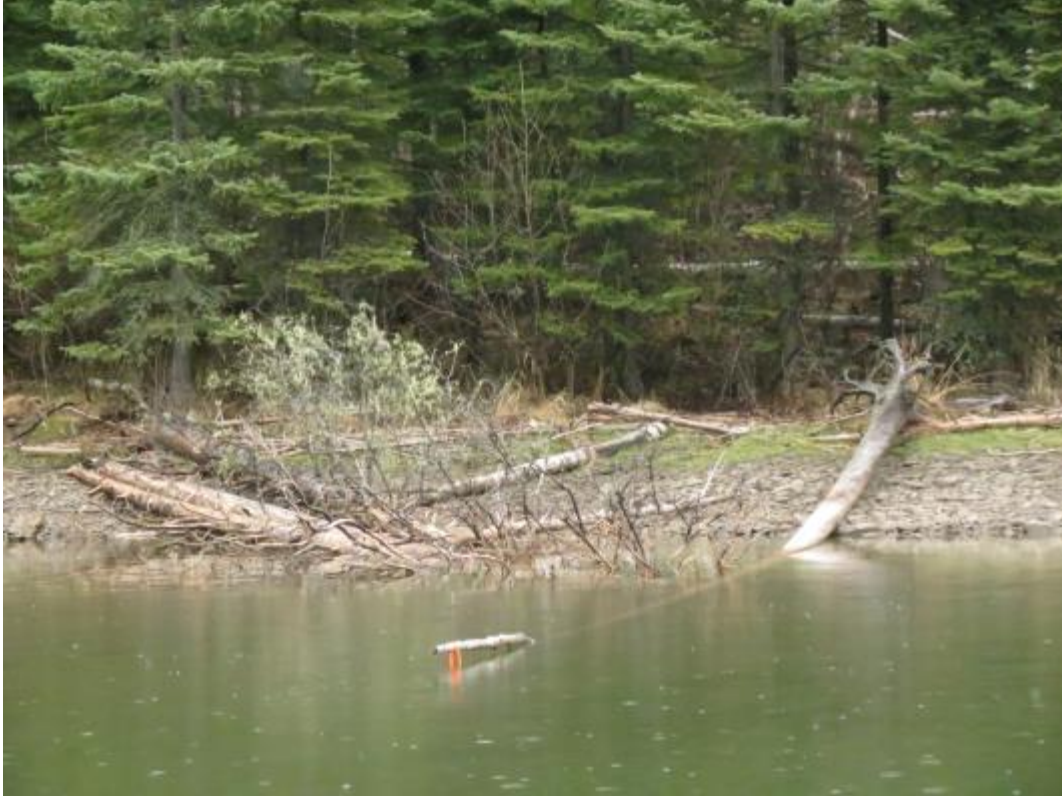
Site 10i triangle: apex is apart and possibly a boating hazard now

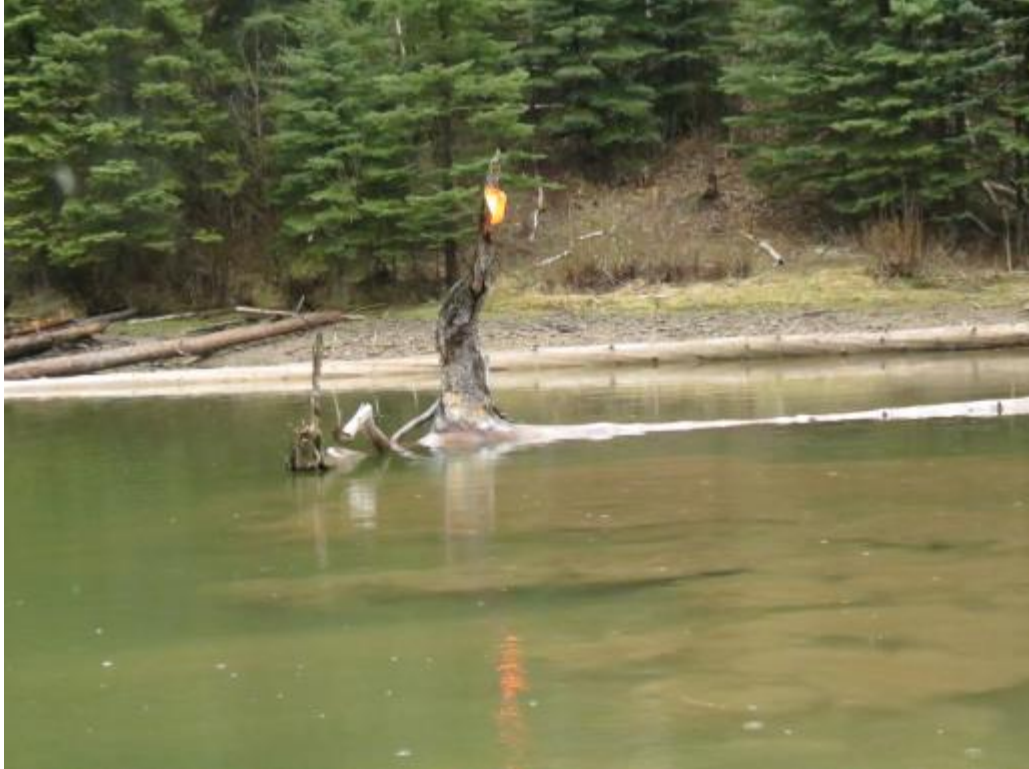
Site 10j triangle: root wad forms a possible boating hazard.

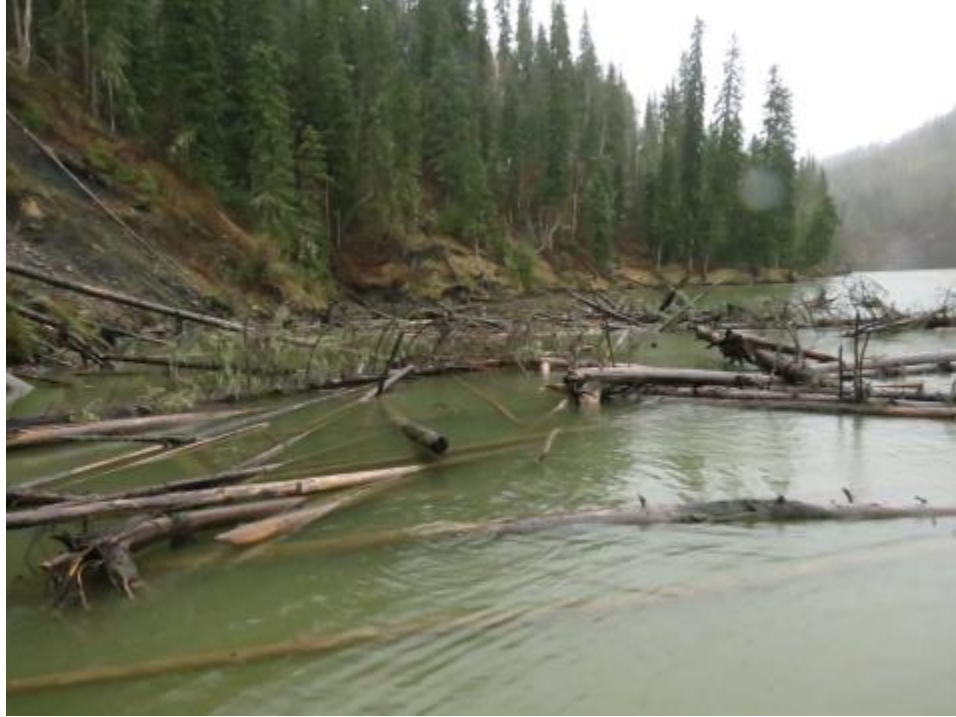
Site 13a: a natural slide created this floating debris pile.

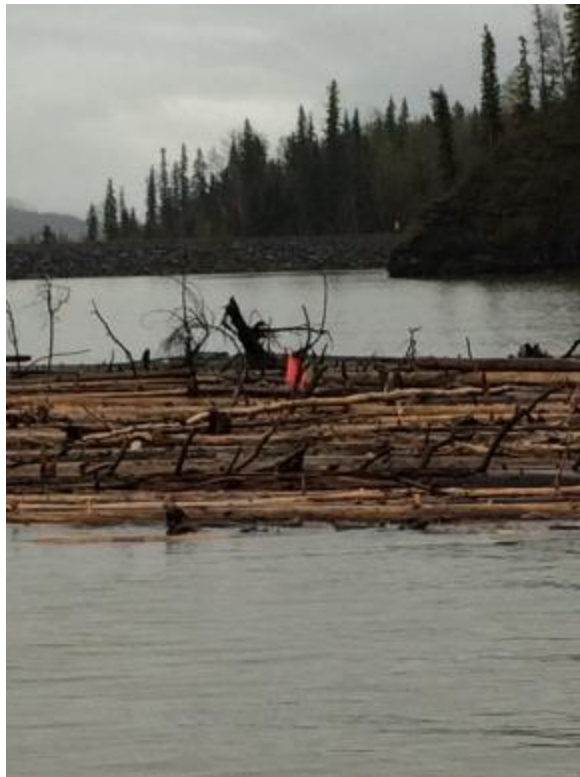
PCN Dam (lost structure): one habitat structure appears to have broken free and floated to the dam forebay site.

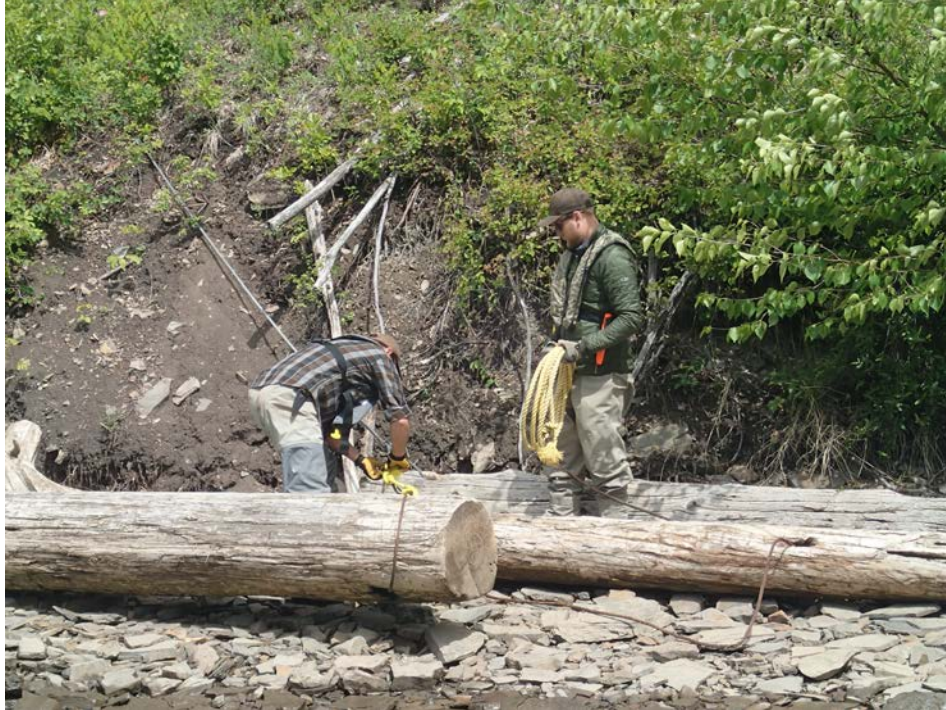
Site 1: An example on how cables are broken and structures are to be secured to the earth anchor again.

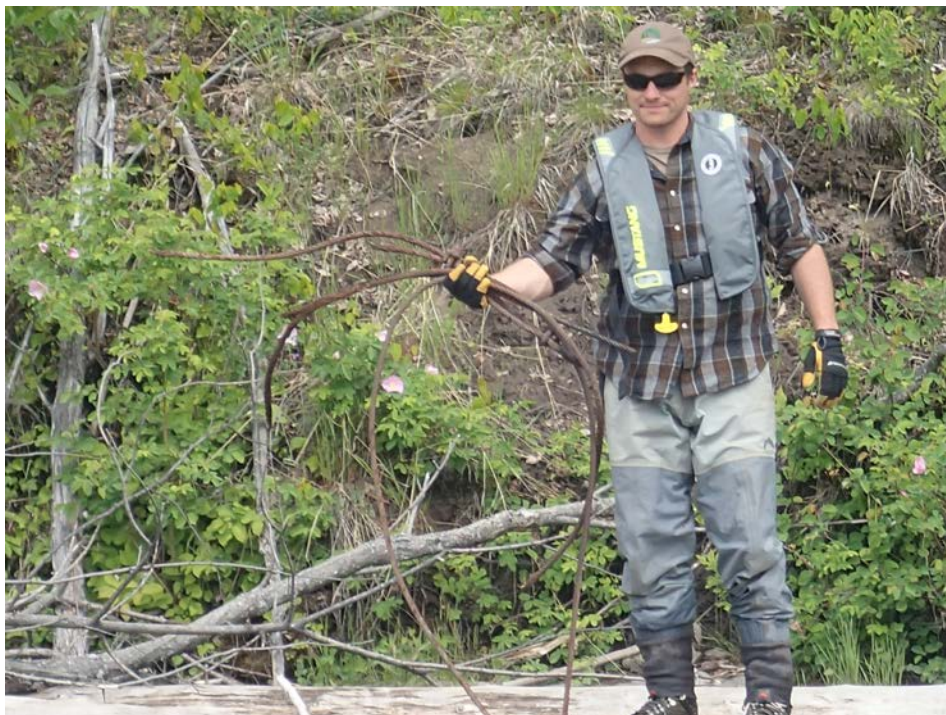
Site 1: An example of the broken cables found on shore that have come apart and requiring salvage.

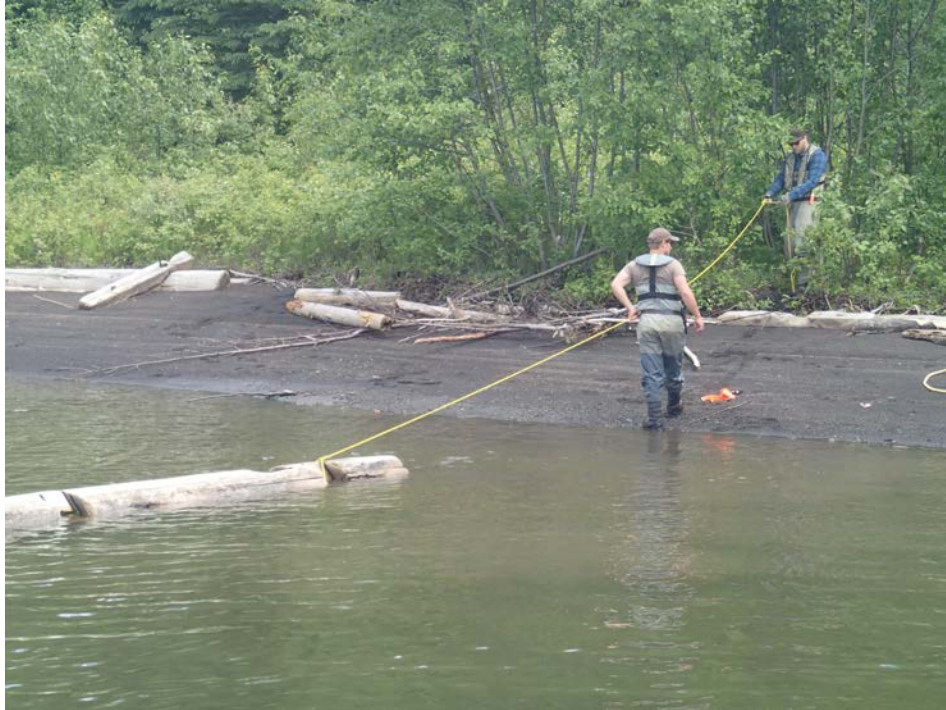
Site 3: Log boom is not secure at normal water level. Crew secured to shore with rope.

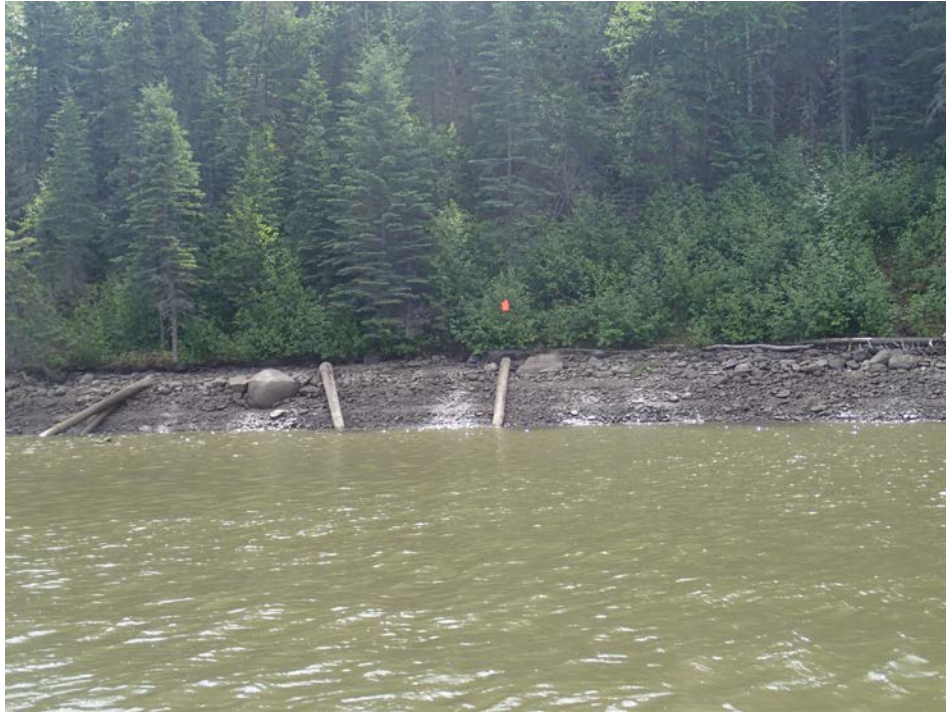
An example of little habitat existing when structure is broken apart.

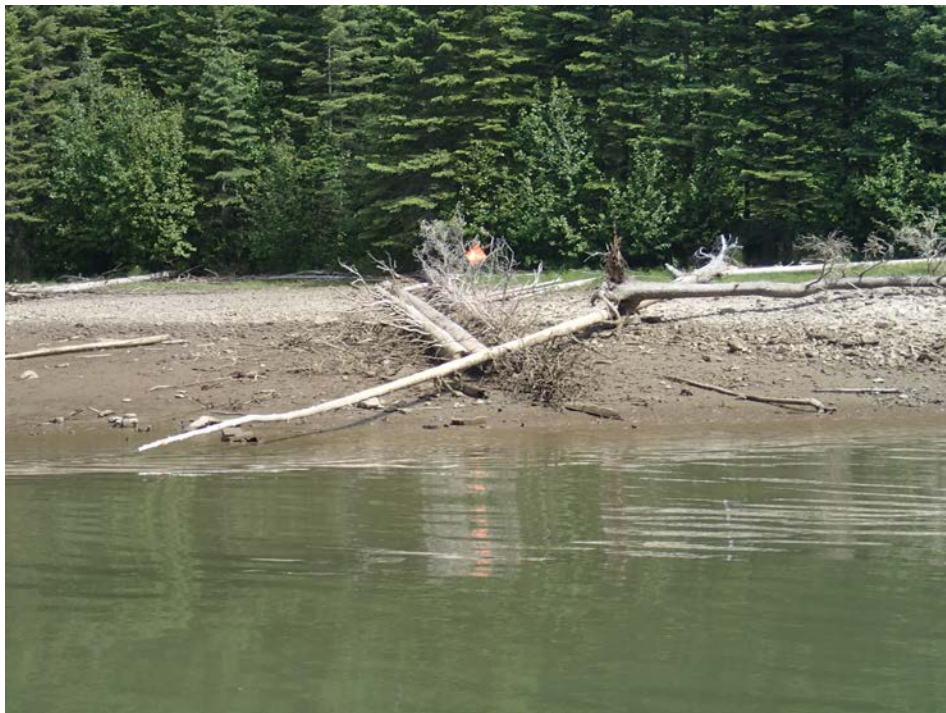
Site 10. This structure is still providing some habitat when at normal water levels.

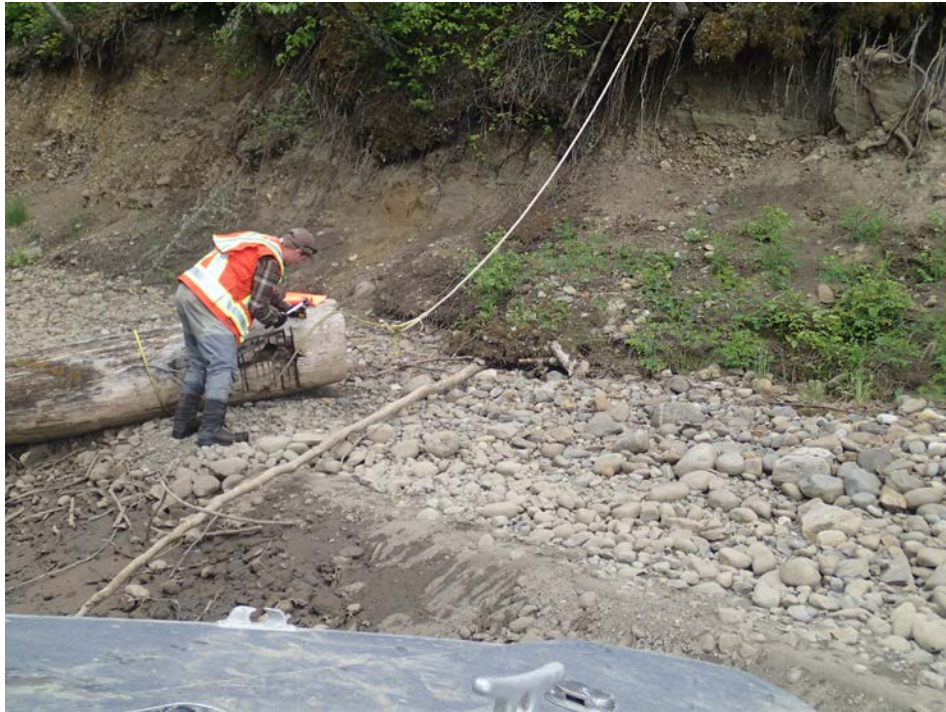
Site 5: Another example where cable clamps rust out and structure is free which can become a boating hazard.

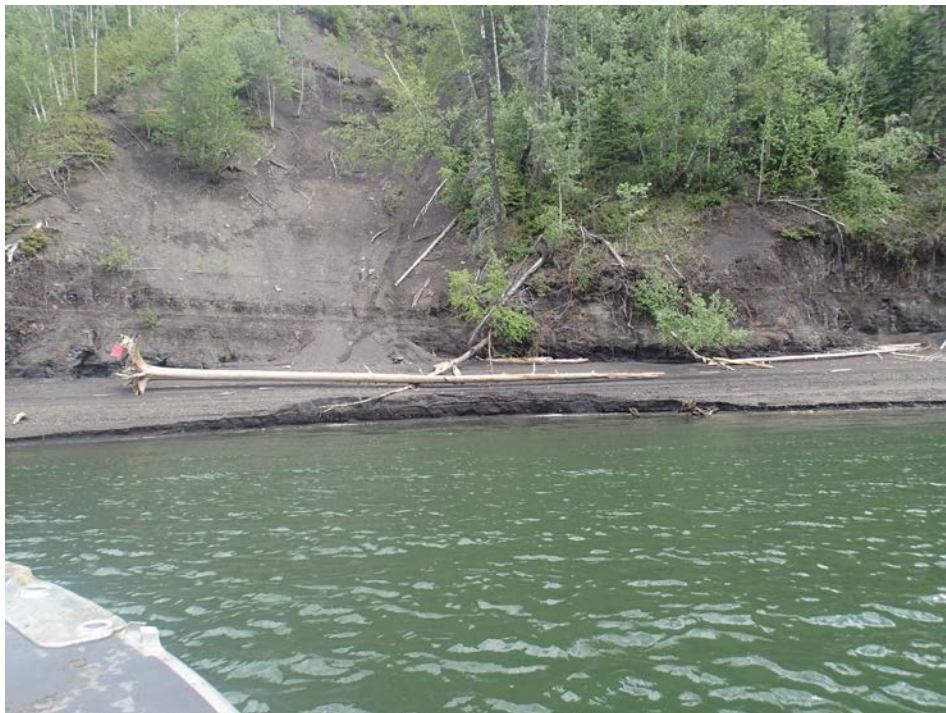
New Observation: From a previous site, no cables were present, but flag was removed.
