MEMORANDUM

SUBJECT Comox Drainage Problem, D.L. 244, Plan 29089

## Comox Drainage Problem

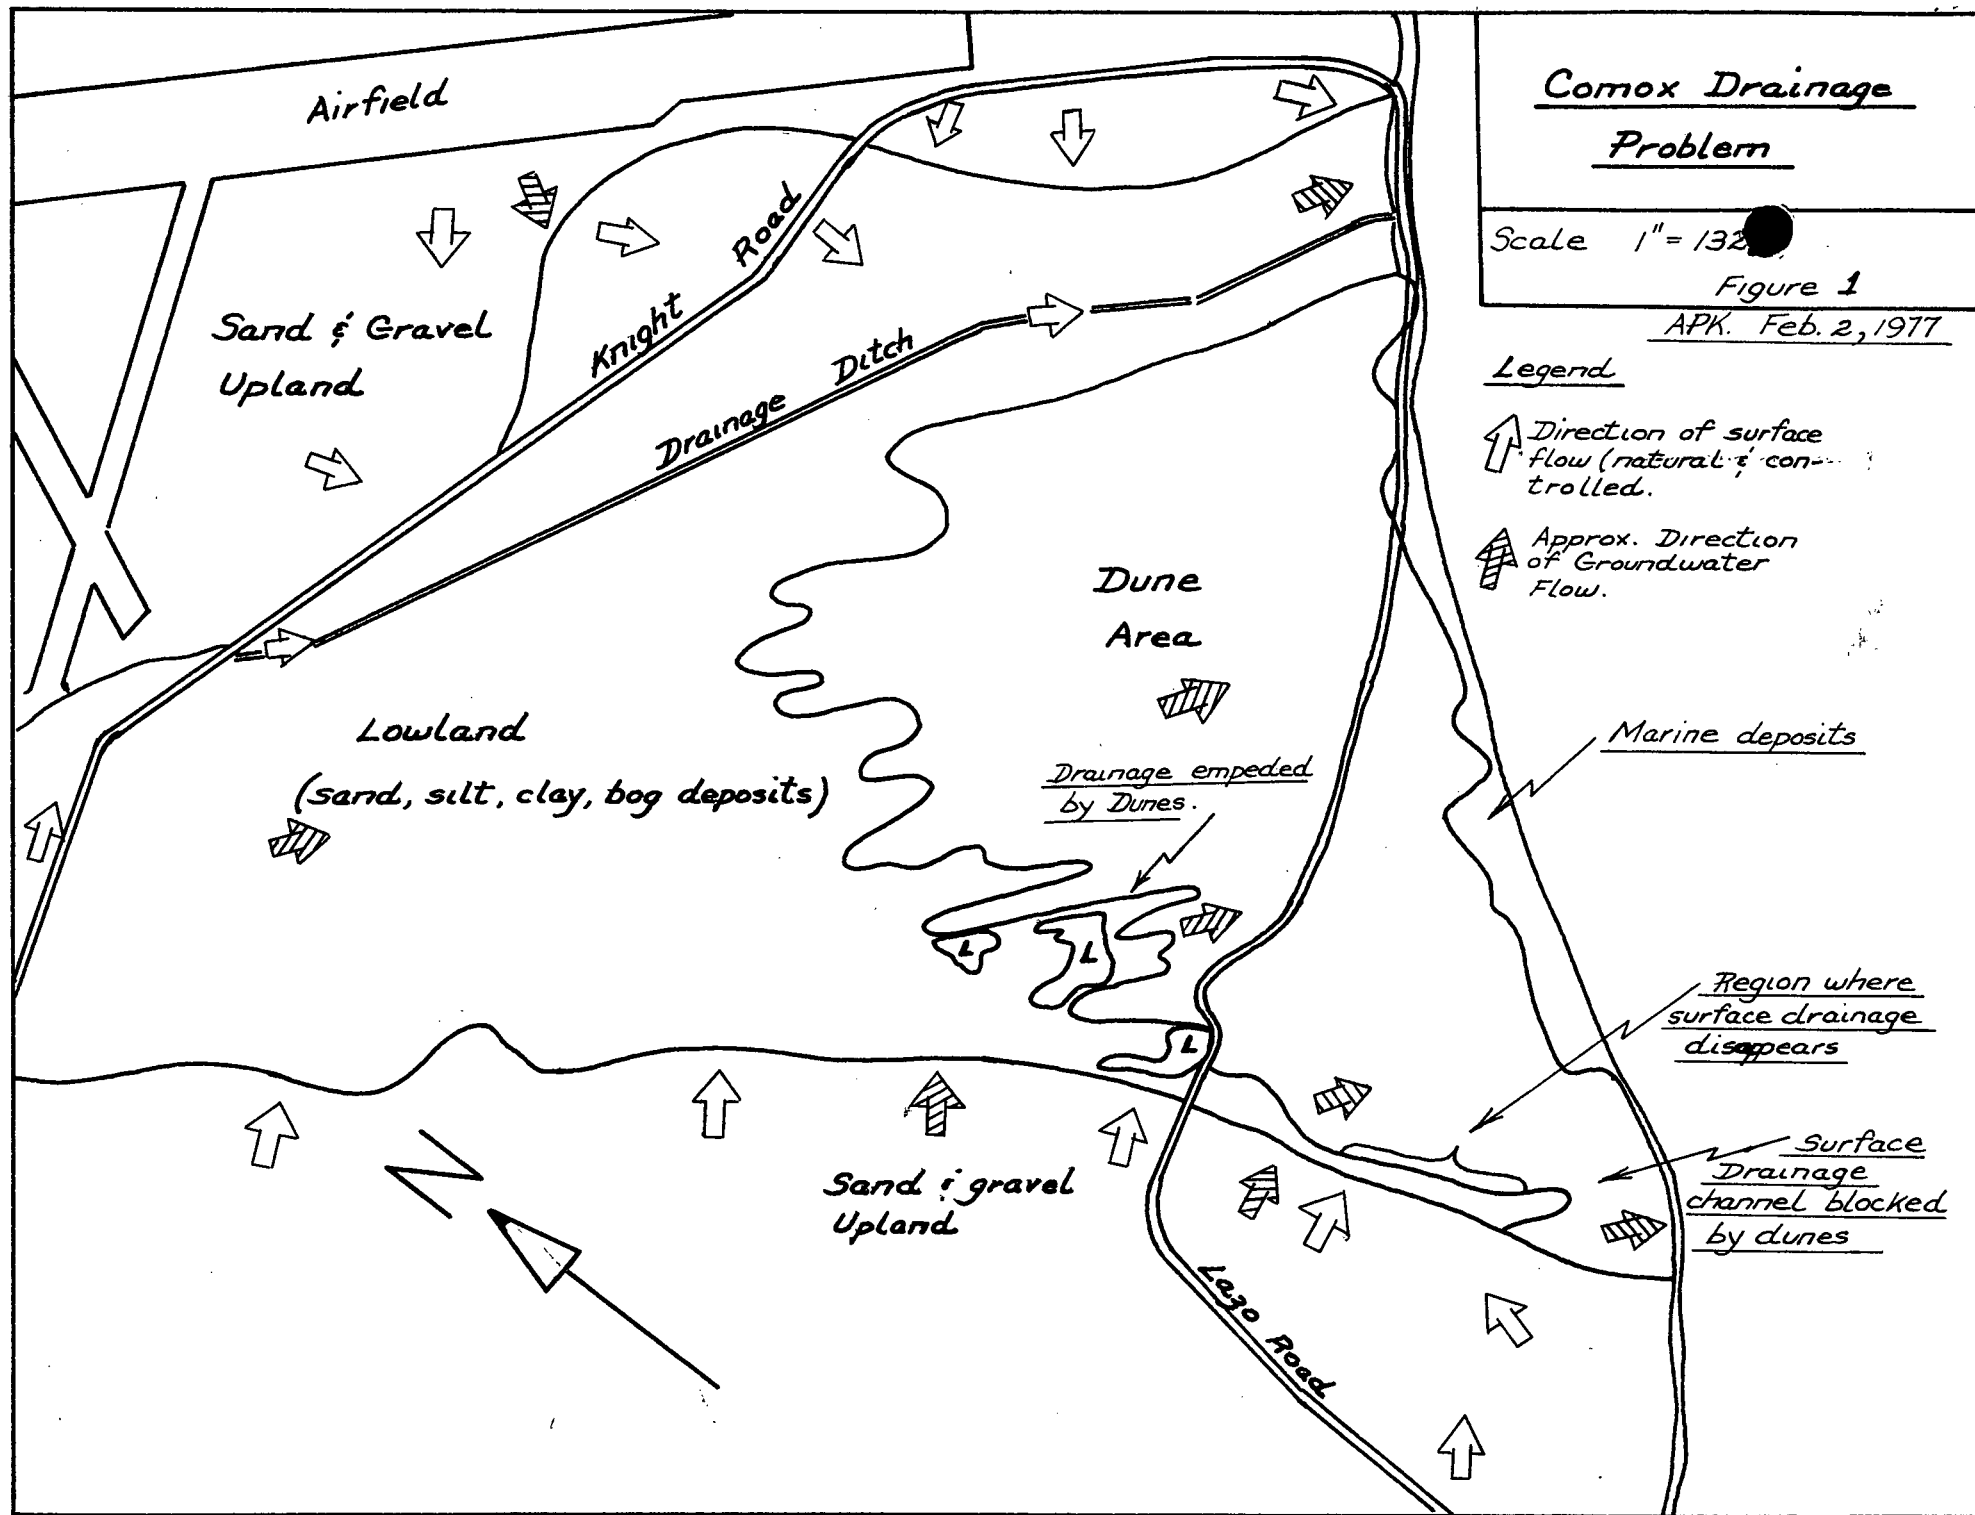
Figure 1

Available water level data indicates the natural gradient of the water table generally coincides with the topographic gradient. Shallow groundwater flow is directed from the southwest, west and northeast into the low-lying region northwest of the dune area (Figure 1). Water table contours run parallel to the topographic contours on the upland areas, but within the low-lying region the water table is relatively flat. Minor groundwater discharge along the beach east

In general, surface water moves downslope from the upland areas into the lowland northeast of the dune area from the southwest, west and northeast (Figure 1). The only surface outlet for this region is a drainage ditch which has been constructed parallel to Knight Road south of the airfield. On January 27, 1977 a flow of 5 cubic feet per second was observed discharging into the sea from this ditch. North of Knight Road several tributary drains have been constructed to drain the upland. Flow was observed in most of these ditches and relatively high conductivity of the discharging waters (165 umhos/cm) indicates a significant groundwater component in the flow. Seepage areas and high water-table conditions, moreover, are prevalent along Knight Road.

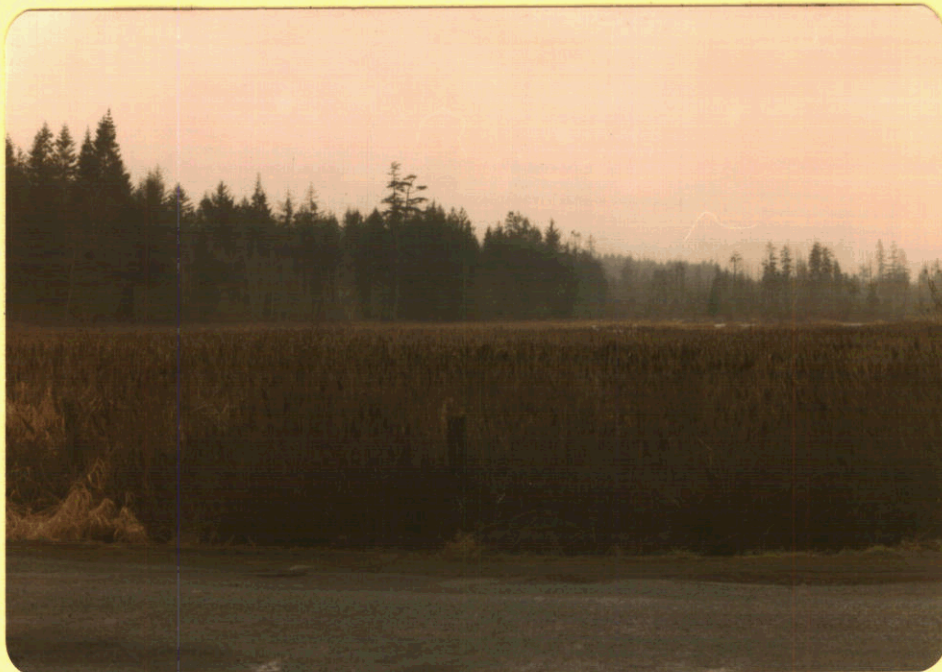
1. COMOX DRAINAGE PROBLEM - Looking north from Lazo Road to swampy lake area. (January 1977)

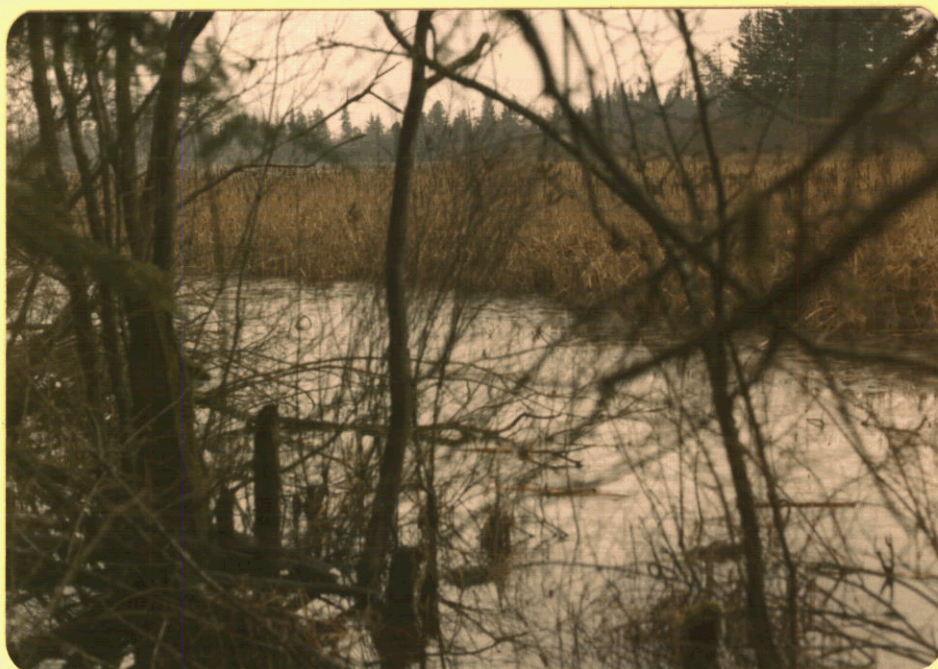
2. COMOX DRAINAGE PROBLEM - Looking northwest from gravel uplands north of Lazo Road (January 1977)

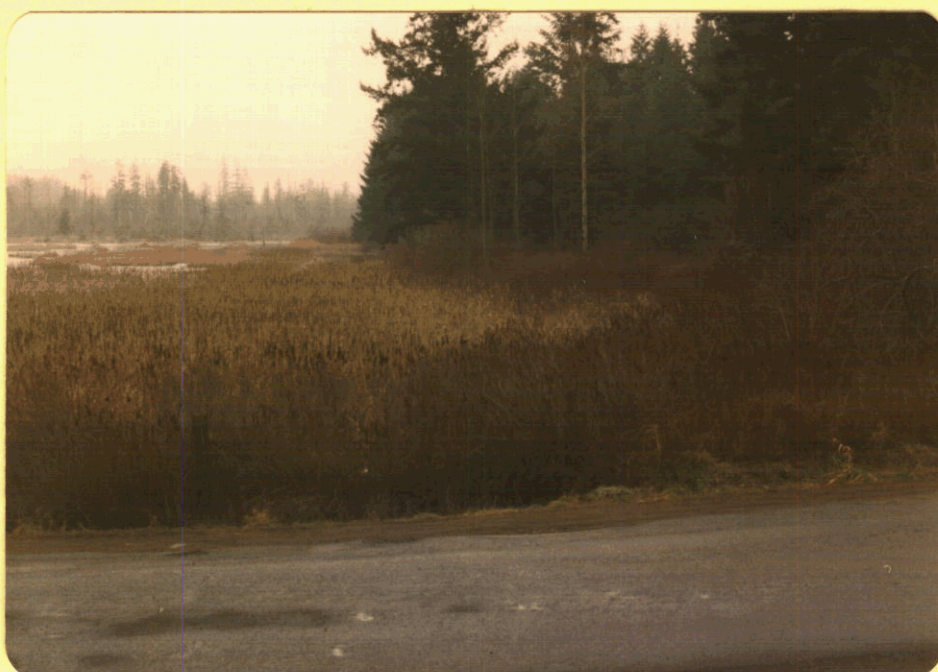
3. COMOX DRAINAGE PROBLEM - Looking north from Lazo Road to swampy lake area (January 1977)

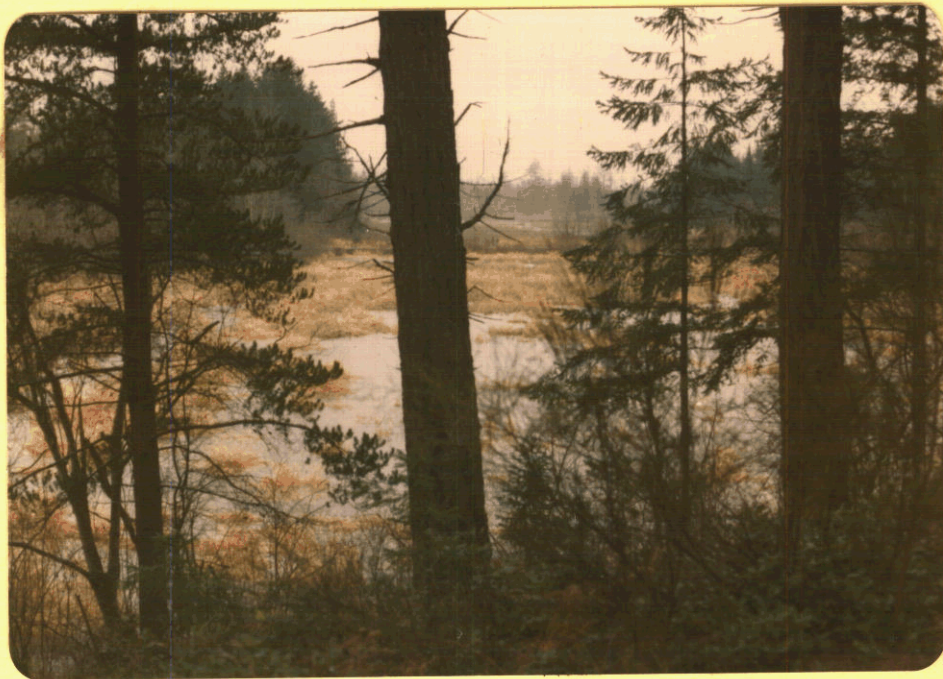
4. COMOX DRAINAGE PROBLEM - Looking north from dunes east of swamp south of Lazo Road (January 1977)

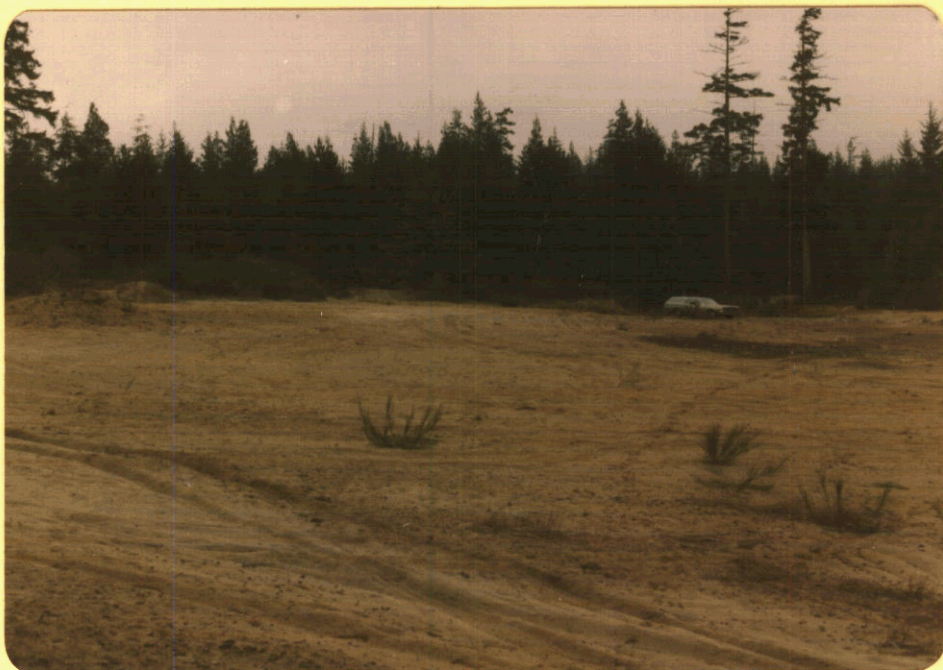
5. COMOX DRAINAGE PROBLEM - Sand pit north of Lazo Road in Dune area (January 1977)

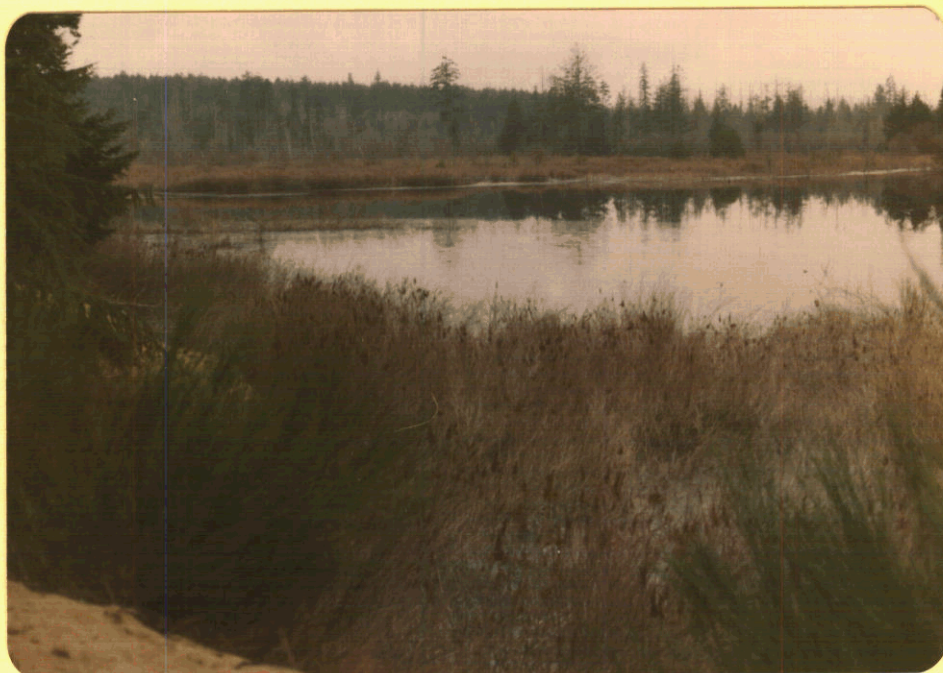
6. COMOX DRAINAGE PROBLEM - Lake drainage impeded by Dunes north of Lazo Road (January 1977)

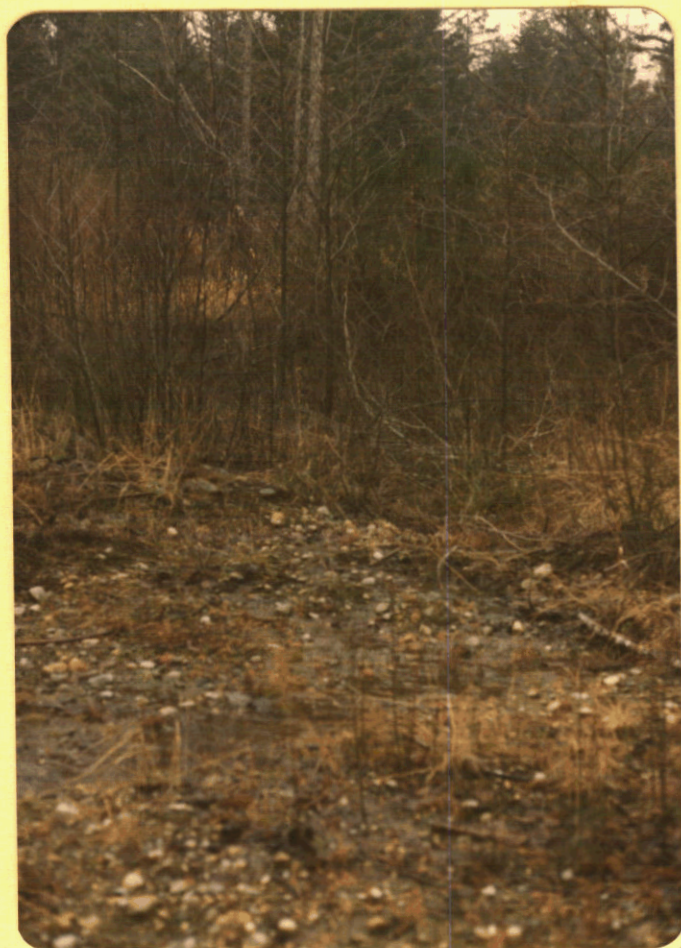
7. COMOX DRAINAGE PROBLEM - Seepage from gravels on Upland south of Lazo Road west of swamp (January 1977)

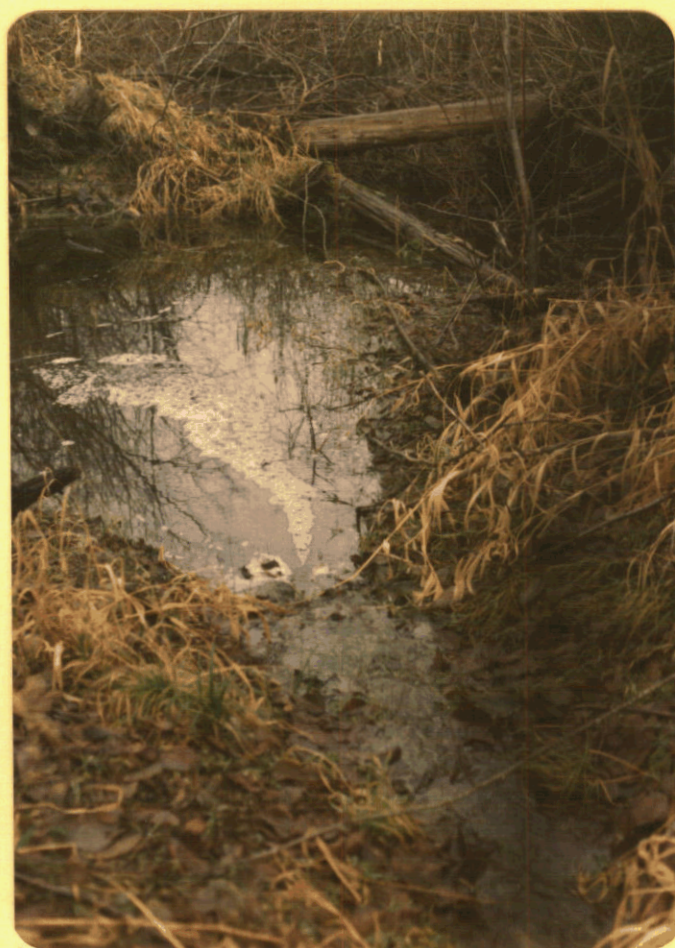
8. COMOX DRAINAGE PROBLEM - Flow to swamp from small gravel pits, same location as Photo 7 (January 1977)

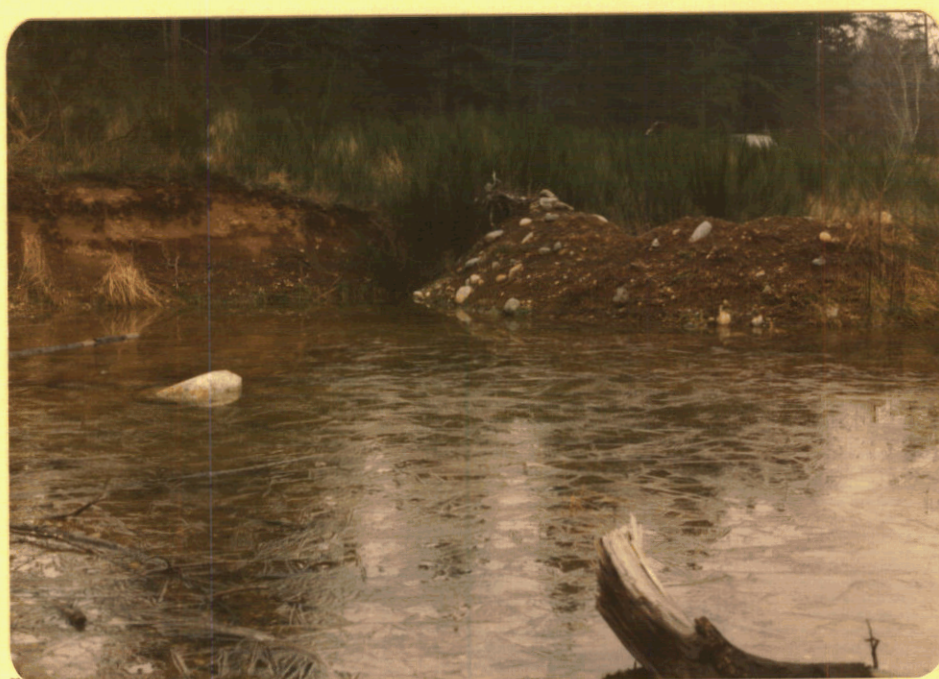
9. COMOX DRAINAGE PROBLEM - Gravel pit with seepage south of Lazo Road west of swamp (January 1977)

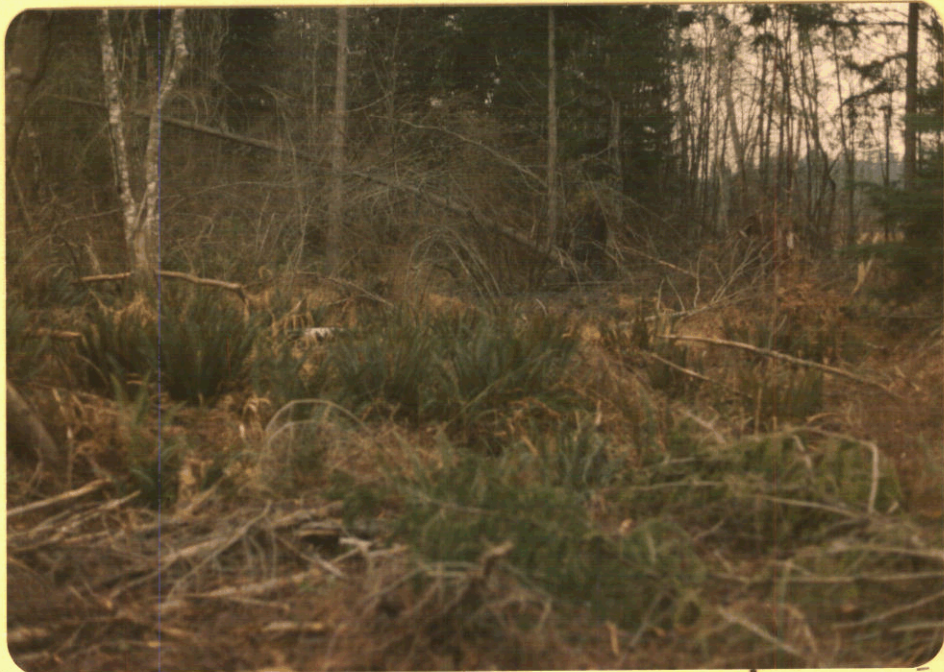
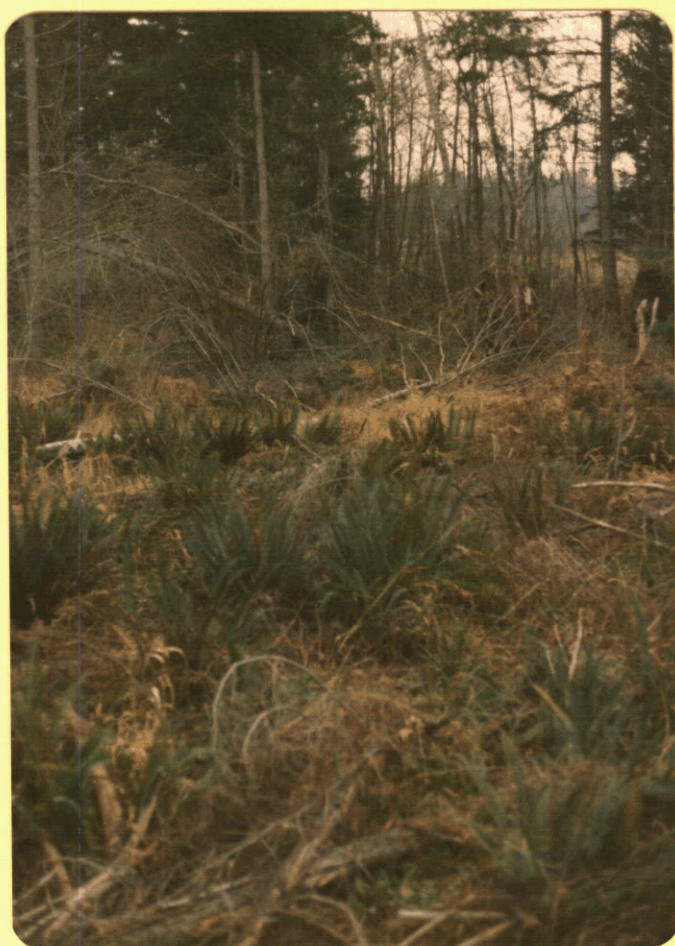
10. COMOX DRAINAGE PROBLEM - Wet area, high water table on west upland north of Lazo Road (January 1977)

11. COMOX DRAINAGE PROBLEM - As Photo 10

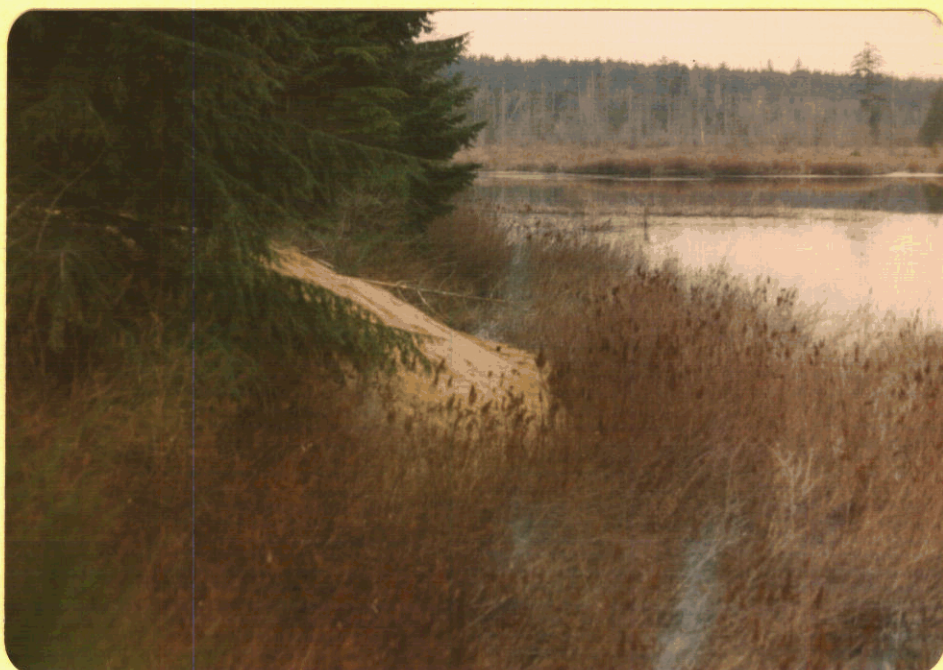
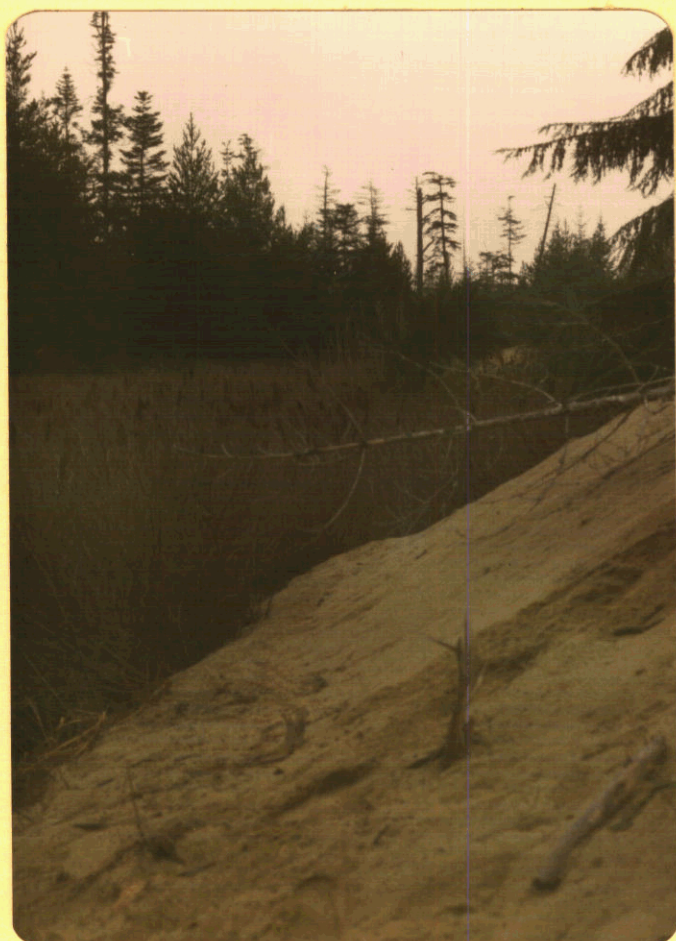
12. COMOX DRAINAGE PROBLEM - Dunes empeding lake drainage north of Lazo Road (January 1977)

13. COMOX DRAINAGE PROBLEM - As Photo 12  
(January 1977)

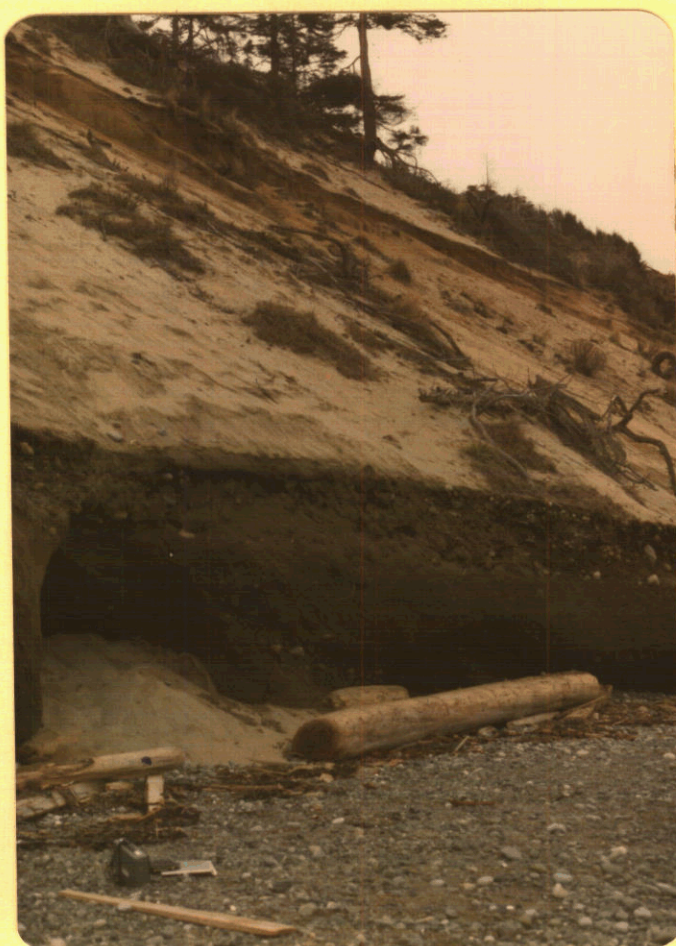
14. COMOX DRAINAGE PROBLEM - Quadra and Dune  
sands overlying stoney clay till along coast  
(January 1977)

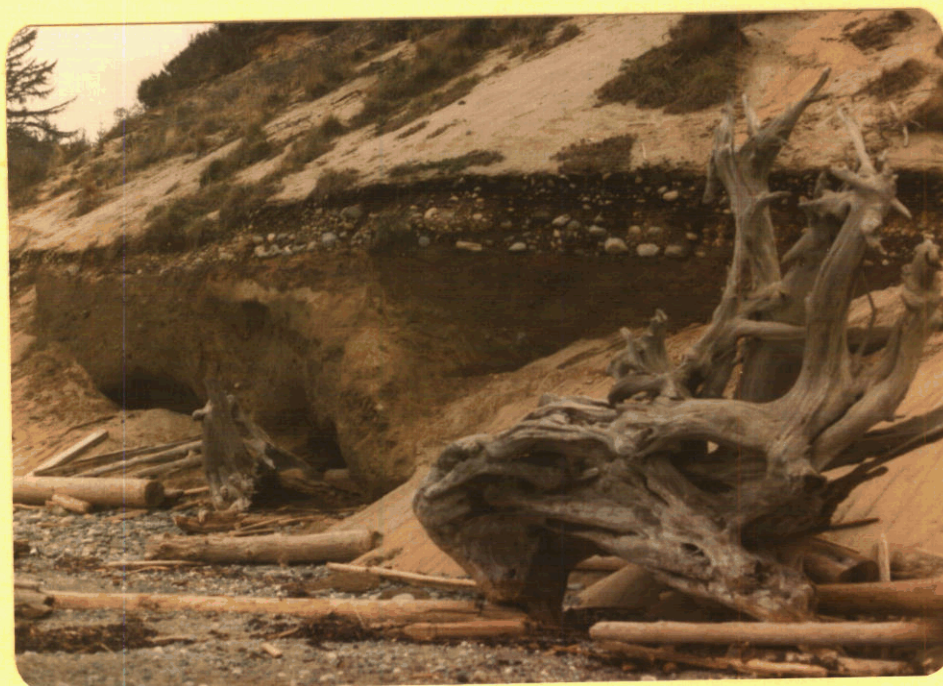
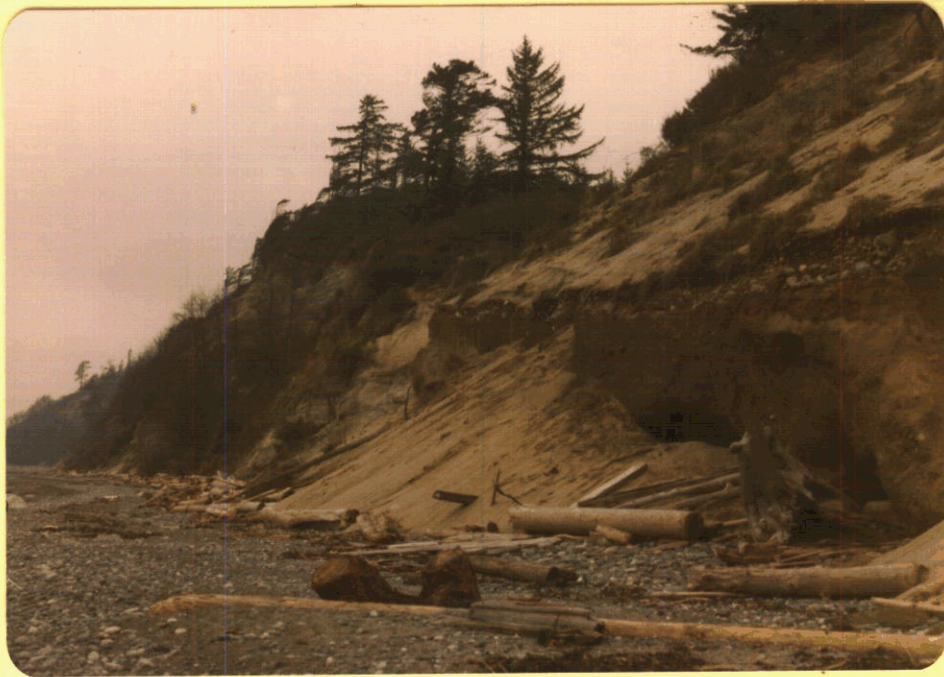
15. COMOX DRAINAGE PROBLEM - Marine gravel overlying stoney clay till  
and quadra (January 1977)

16. COMOX DRAINAGE PROBLEM - As Photo 15  
(January 1977)
