Enhancing Waterfowl Nesting Opportunities in the Parsnip Arm

Fish and Wildlife Compensation Program

Final Report - R0

Blackbird File No.: 20011
FWCP Project No.: PEA-F21-W-3193

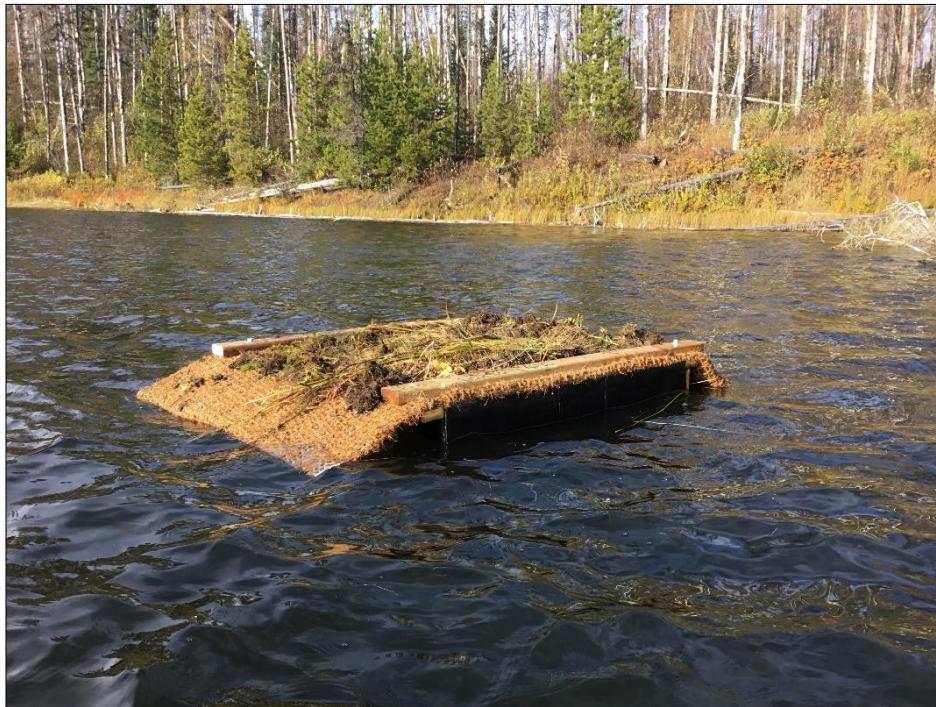
Photo 1: Photo of new floating island Mug1-Is1-2020 deployed at Mugaha Bay.

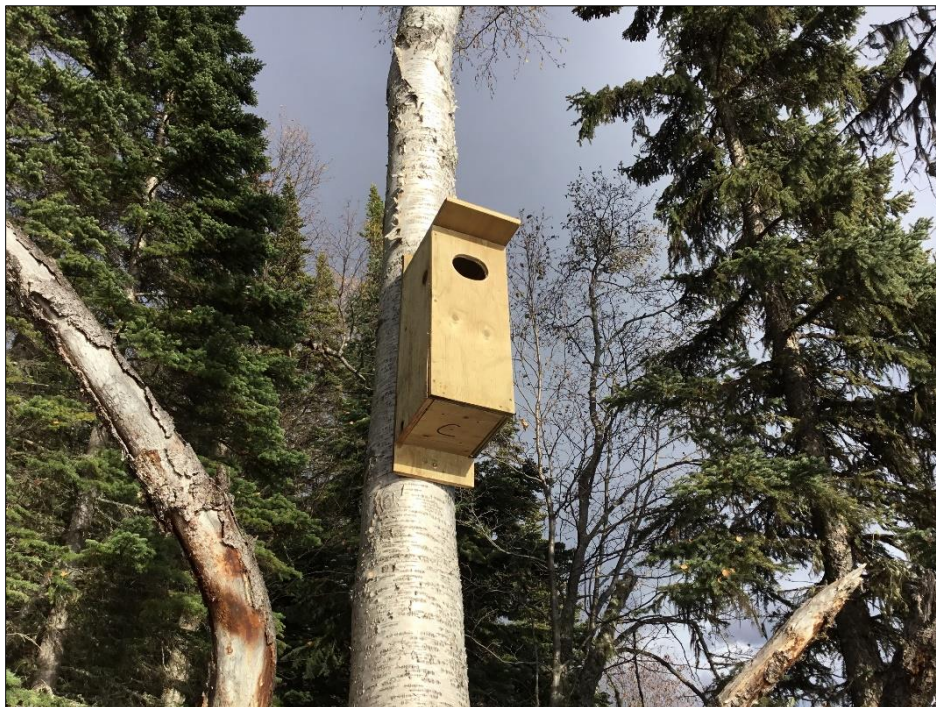
Photo 2: View of newly installed nest box D2-2020 at Dina Lake.

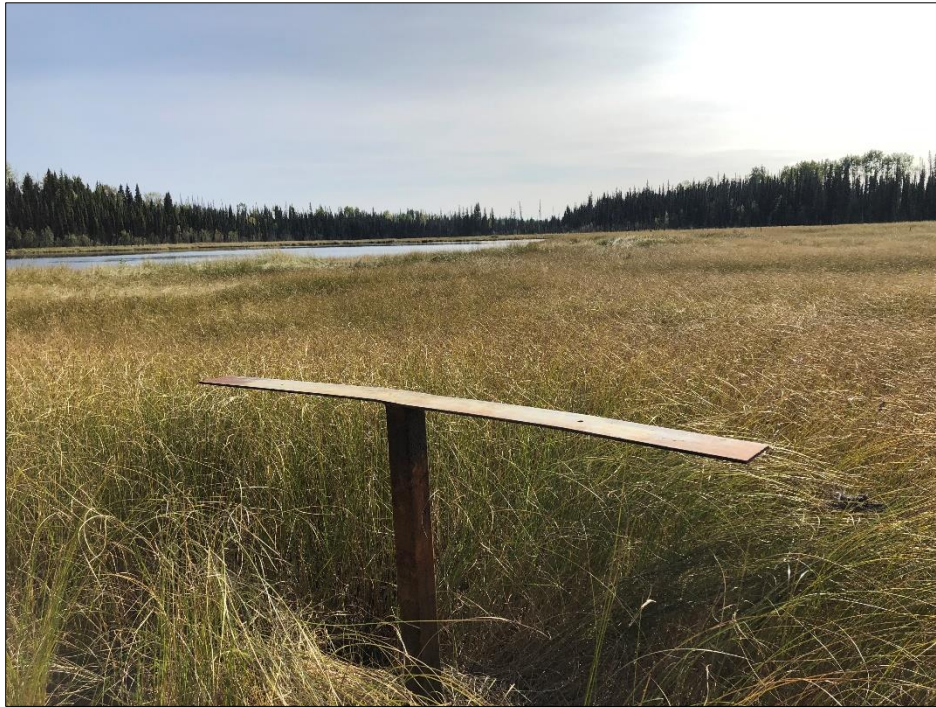
Photo 3: View of a metal perching platform at Rocky Marsh, which has been converted from a historic nesting tunnel.

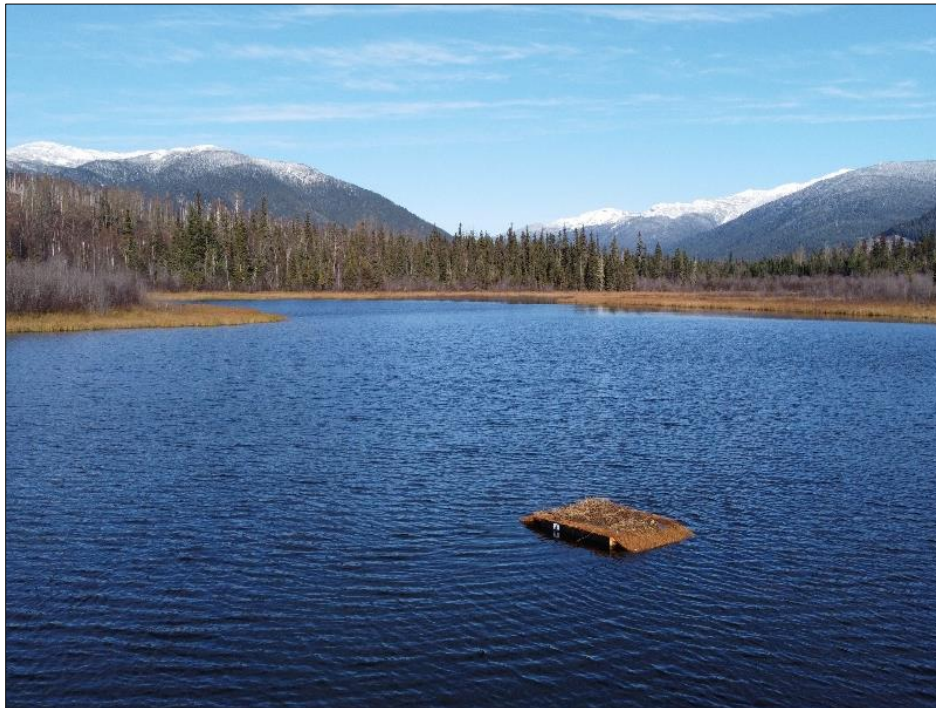
Photo 4: View of a newly installed floating island at Misinchinka marsh in the Pine Pass.

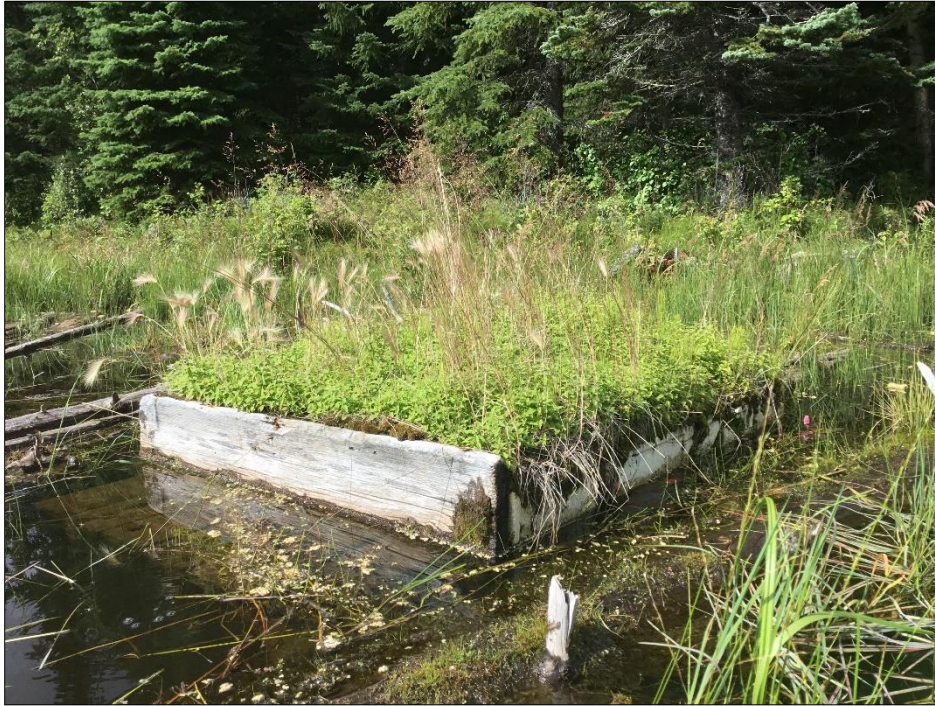
Historic floating islands that were removed during 2020 fieldwork showed signs of deterioration including waterlogging, exposed Styrofoam, and detachment from anchoring systems. The replacement islands have been designed to have an extended life expectancy relative to the traditional wooden islands and to avoid any waste being released into the surrounding environment.

Photo 5: View of a historic floating island removed from Tutu Bay in 2020, which had detached from its anchoring system and drifted to shore. Note the Styrofoam floating in the surrounding water.

At Mugaha G and Tutu Bay, we removed and did not replace the floating islands based on a variety of factors. Mugaha G is directly connected to the Williston Reservoir and initial scouting assessments concluded that regularly fluctuating water levels likely significantly reduce the lifespan of the floating islands, due to excessive wear on the subframe and anchoring system. The historic island from this site showed no evidence of use by waterfowl. A new floating island was not deployed at Tutu Bay based on the previous maintenance recommendations to remove and not replace (Ecofor 2015), paired with no evidence or signs of use during the 2020 assessment.

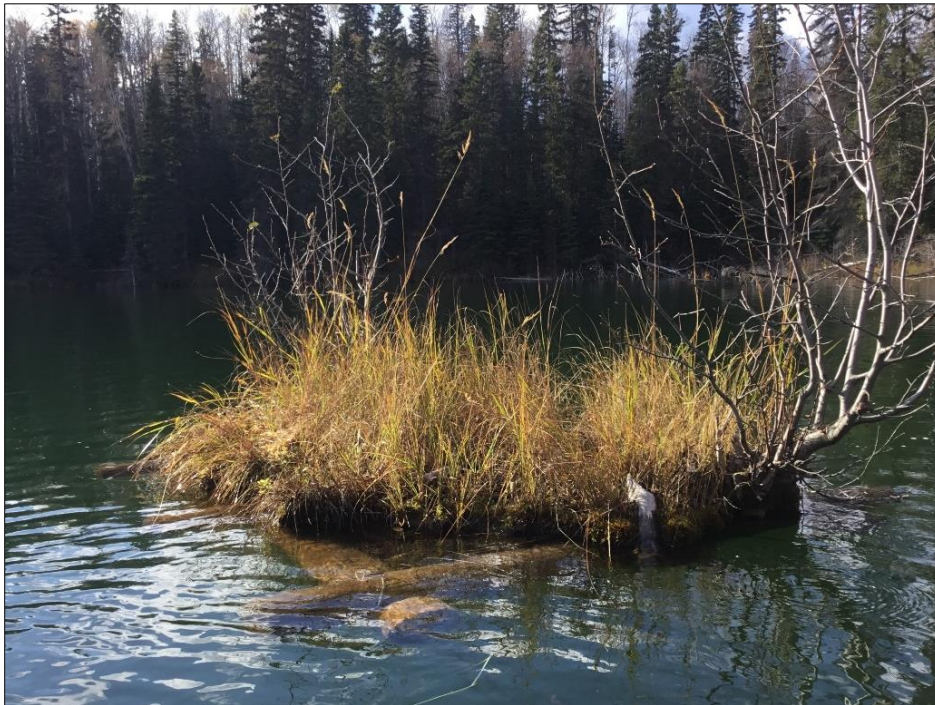
Photo 6: View of floating island D1-IsI-2014 at Dina Lake. Assessed to be in good condition, aside from having drifted to shore. The island was anchored at a new location with a new anchoring system.

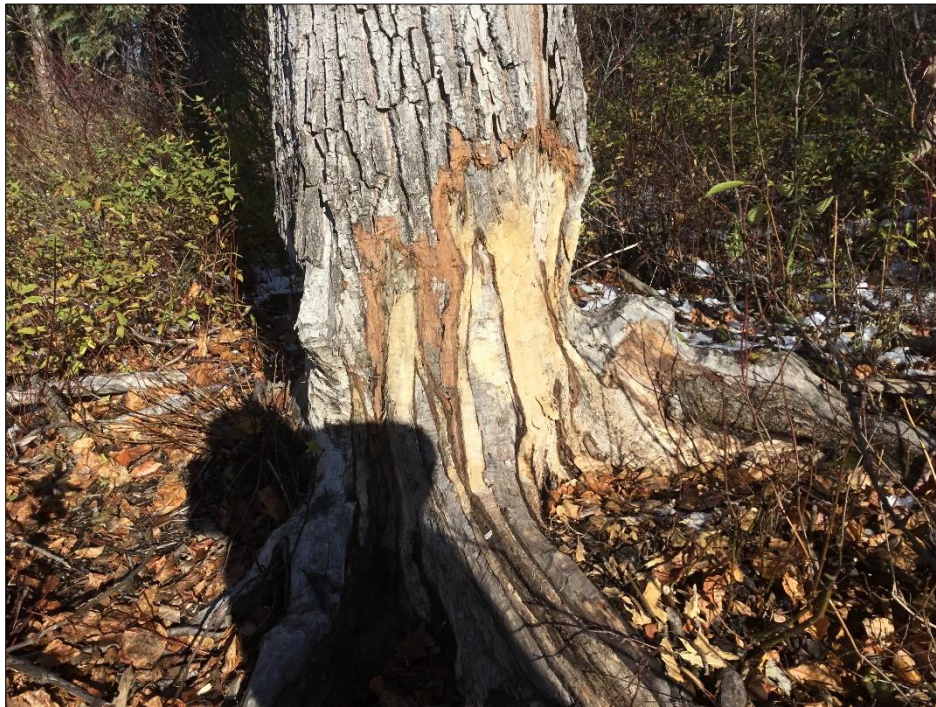
On occasion, a nest box condition was found to be poor due to excessive beaver activity on the nest box mounting tree (notably, to trees at the Crooked River site). Nest box trees at Crooked River are predicted to not last more than five years, and nest boxes at this site should be considered for relocation or tree protection measures. Where beaver activity put the midterm viability of a nest box at risk, future monitoring/replacement recommendations were made but the box was not replaced. Please refer to Section 7.2 and Appendix B for site specific maintenance recommendations for nest boxes observed to be in poor condition.

Sites that showed beaver damage to nest box mounting trees during the 2020 maintenance program (i.e., Crooked River) may require more extensive maintenance during the next round of monitoring. Tudyah North required nest box replacement in 2014 due to downed trees from beaver activity. At the time of the 2020 maintenance program, however, all nest boxes at Tudyah North were on healthy, stable trees which showed no signs of beaver damage.

Photo 7: View of beaver damage to the nest box tree at Crooked River site C#1-31-2014.

Future maintenance programs should consider adding chicken wire or a suitable alternative material around the base of nest box trees at sites which show frequent or increased beaver activity (i.e., Crooked River and Tudyah North). The chicken wire is intended to discourage beaver foraging on the nest box trees to aid in nest box longevity and ultimately reduce maintenance efforts (i.e., replacement and relocation) required in the future.

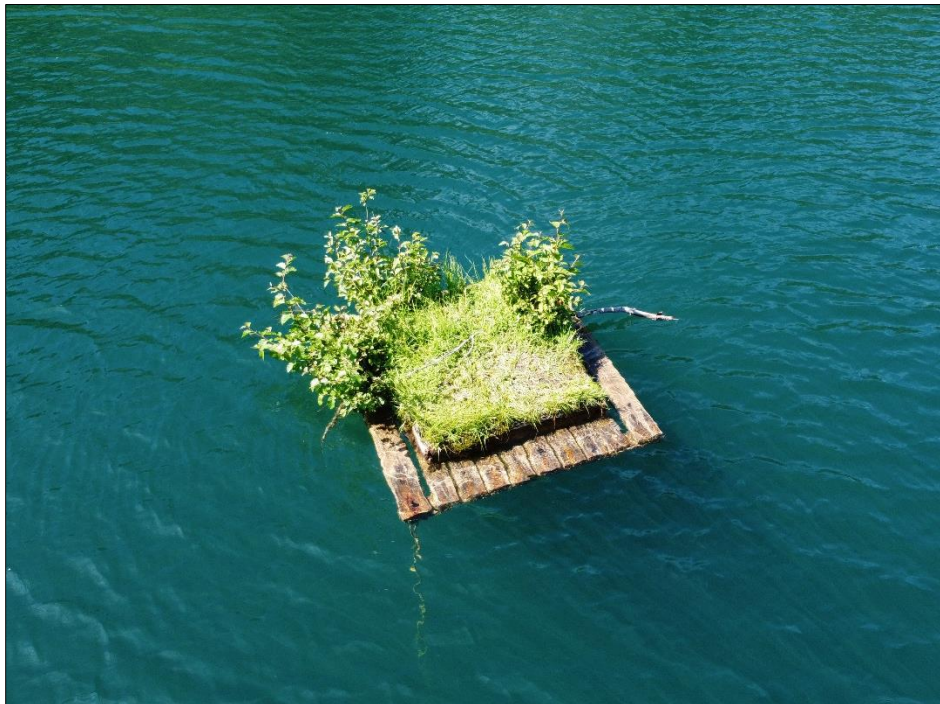
Photo 8: View of floating island Tudi-2014 at Tudyah North. The historic island was assessed as being in good condition. A trail camera documented wildlife use of the island and it was left in place.
