November 18, 2021  
File: 2019-8475-000

**Re: COMPLETION REPORT FOR BOAT LAUNCH DREDGE CONDUCTED ON KALAMALKA LAKE, COLDSTREAM, BC**

District of Coldstream  
Kalavista Boat Launch Dredging

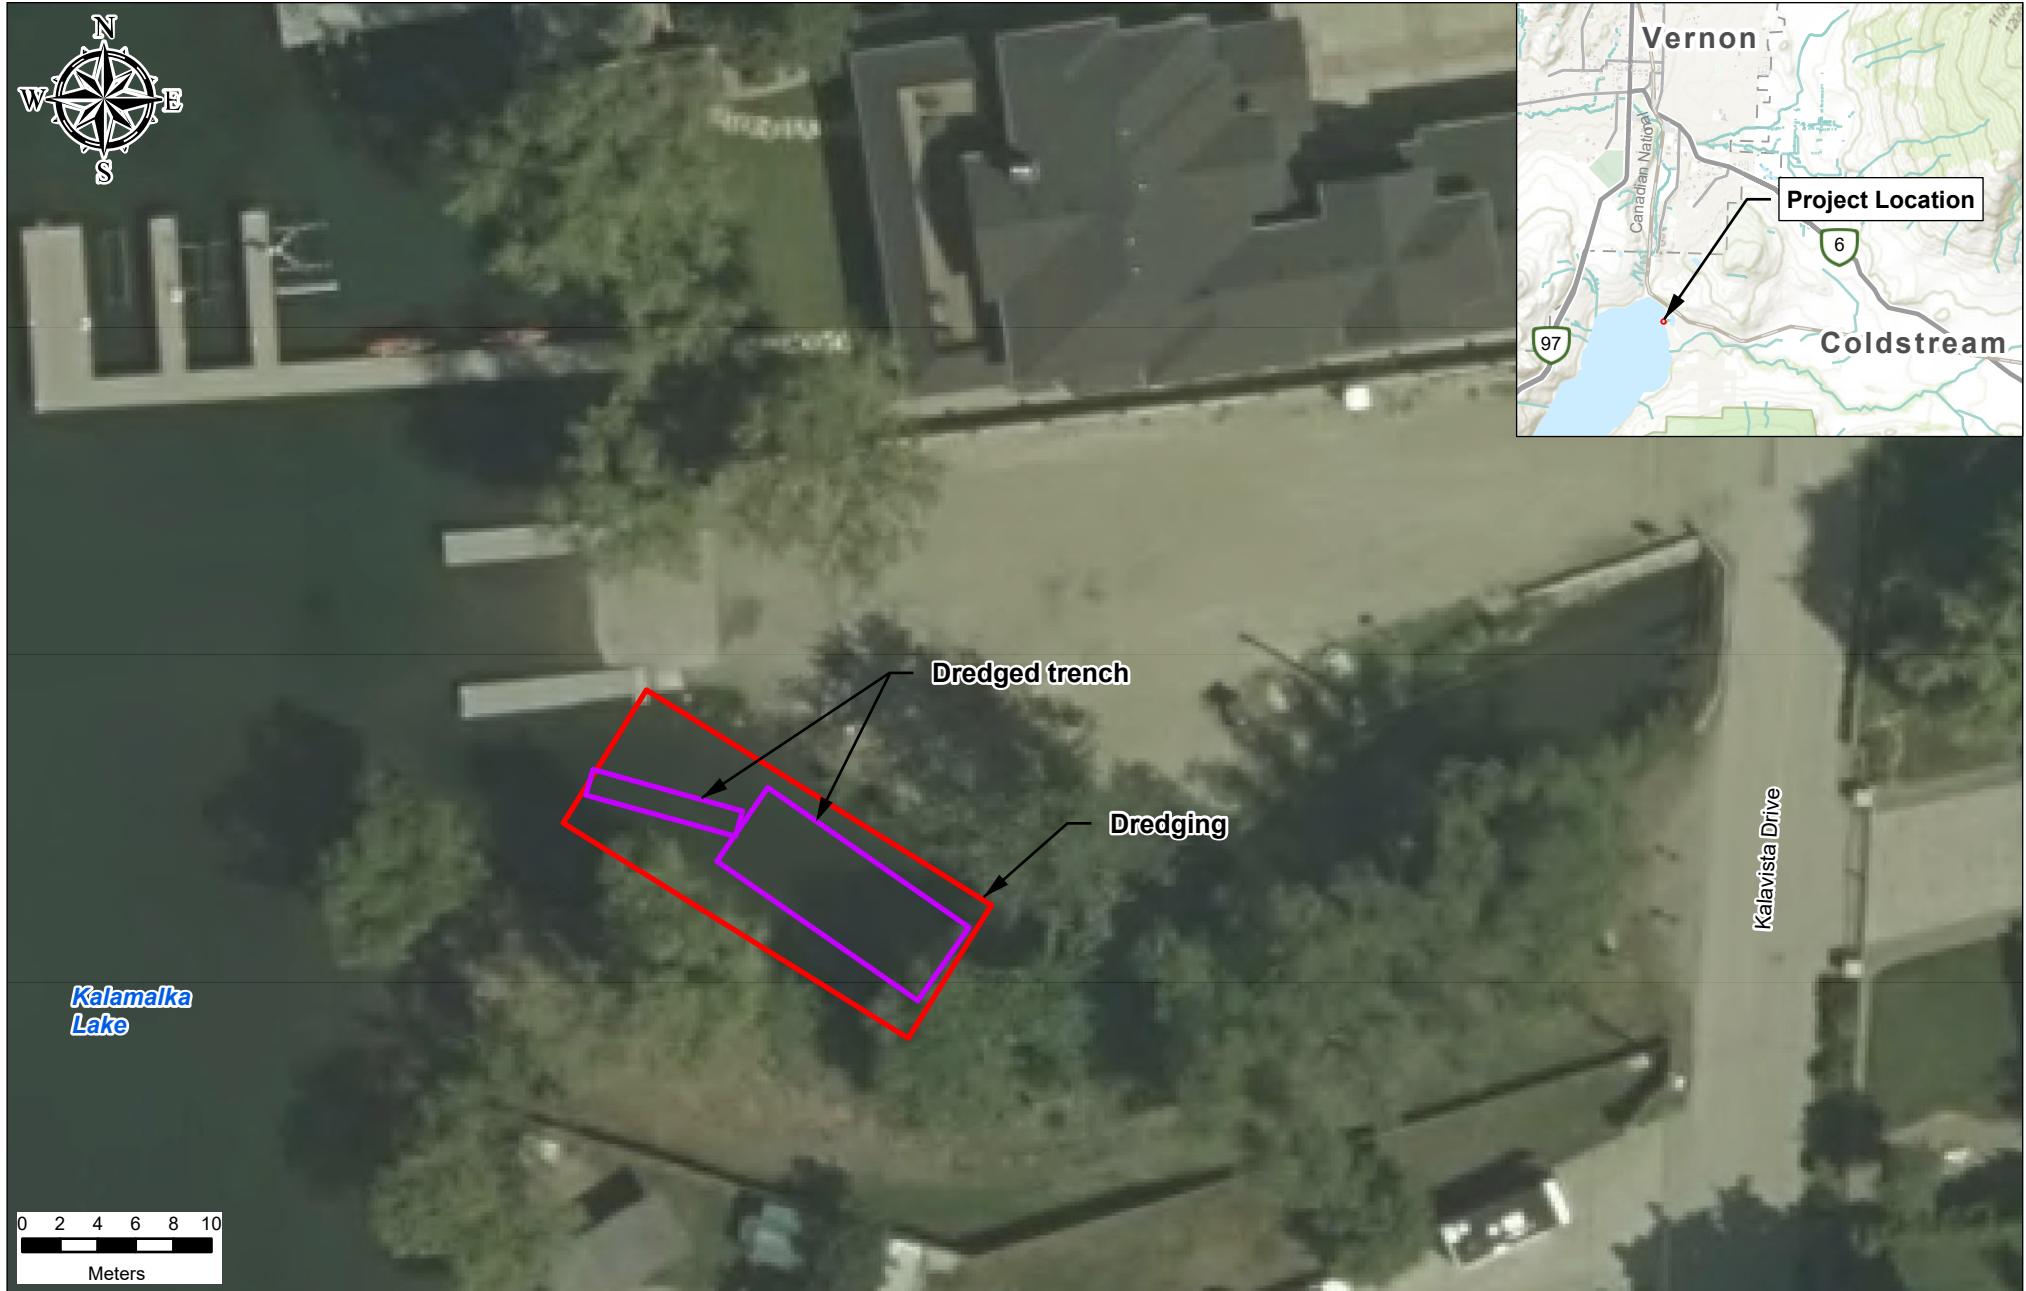
**FIGURE 1: DREDGING AREAS**

The dredging works began with a small excavator walking out onto the sediment bar and removing the sediment from the south side of the work area (Photo 3). Afterwards, the excavator dredged the remaining sediment from the sediment bar in the south bank of the lagoon leaving a 0.4 to 0.8 m wide trench from the base of the lagoon to the lake (Photo 4) for a total approximate area of 300 m<sup>2</sup>. Approximately 30 cubic meters of accumulated sediment was removed from the lake (five partial dump truck loads; each truck load could hold approximately 10 cubic metres at full capacity). A mix of fine textured organics and sand was excavated from the channel. Substrates were removed from the work area and were placed directly into the dump truck. The depth of excavation (i.e., approximately 0.5 m) conformed to the figures provided in the Environmental Management Plan<sup>1</sup>. The area dredged extended outside of the proposed dredging area because of the extend of sediment (Photo 5) – Figure 1. No vegetation was disturbed or removed during the dredging works.

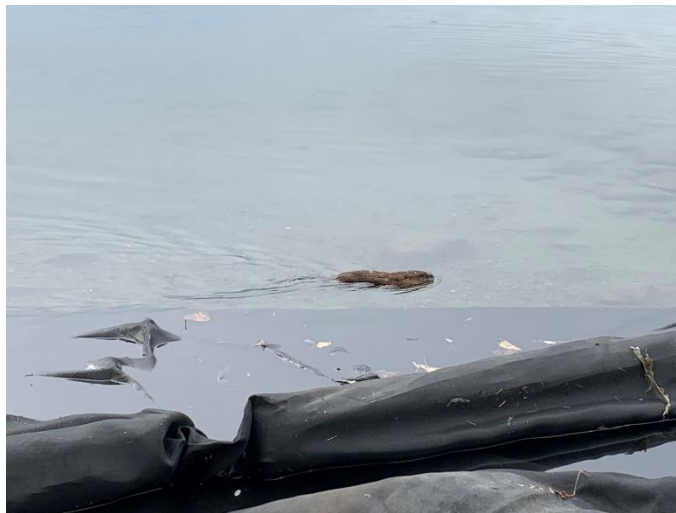
The dredging operation conformed to the Water Manager's conditions outlined in Conditional Water Licence. The silt curtain was installed and dredging activities occurred on October 5, 2021. Immediately prior to dredging, a visual sweep of the work area was conducted by the QEP. The fish salvage was conducted under a Scientific Fish Collection Permit (#PE21-621690f). No fish were detected or captured. No turtles or evidence of Rocky Mountain Ridged Mussels were observed. A muskrat (*Ondatra zibethicus*) entered the work area by entering under the silt curtain, mid-way through construction (Photo 2). The QEP asked that construction be paused for 30 minutes to allow the muskrat access to the lagoon area. No additional observations of the muskrat were made.

Photo 2 - Muskrat (*Ondatra zibethicus*) observed entering project site

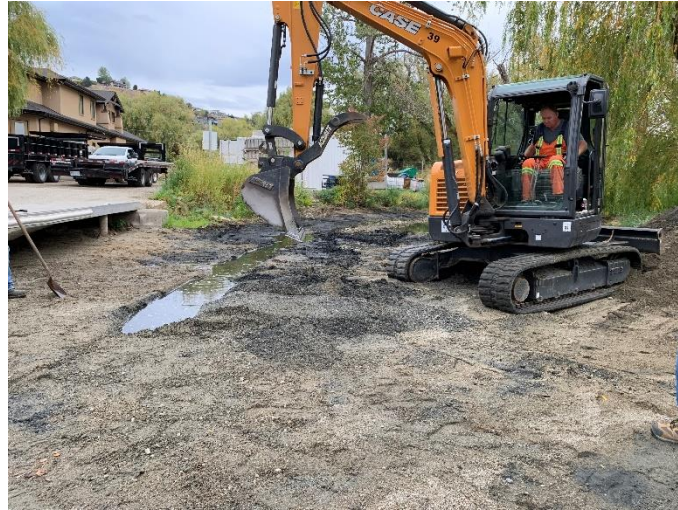
**Photo 3 – A small excavator walked out onto the sediment bar and removed the sediment from the south side of the work area**

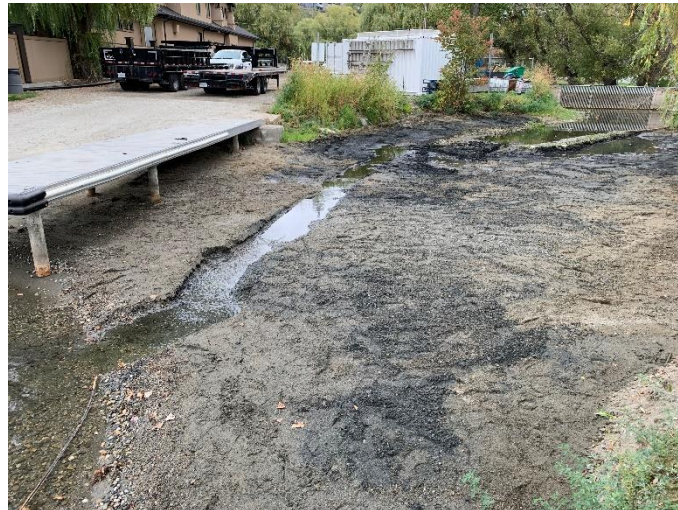
**Photo 4 - Excavator dredged out sediment in the work area leaving a 0.4 m wide trench from the base of the lagoon to the lake**

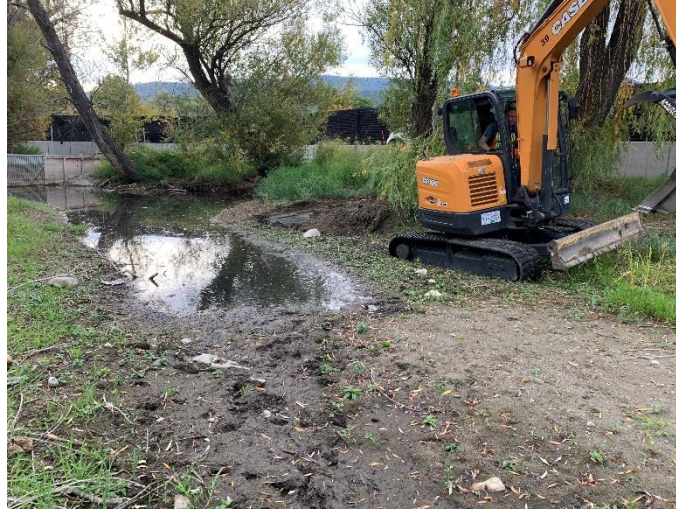
**Photo 5 - The dredged area extended outside of the proposed dredging area because of the extent of sediment**
