May 21st, 1971

NOTES ON GROUNDWATER INVESTIGATIONS

FOR SISKA FLAT INDIAN RESERVE #3

SOUTH OF LYTTON, B. C.

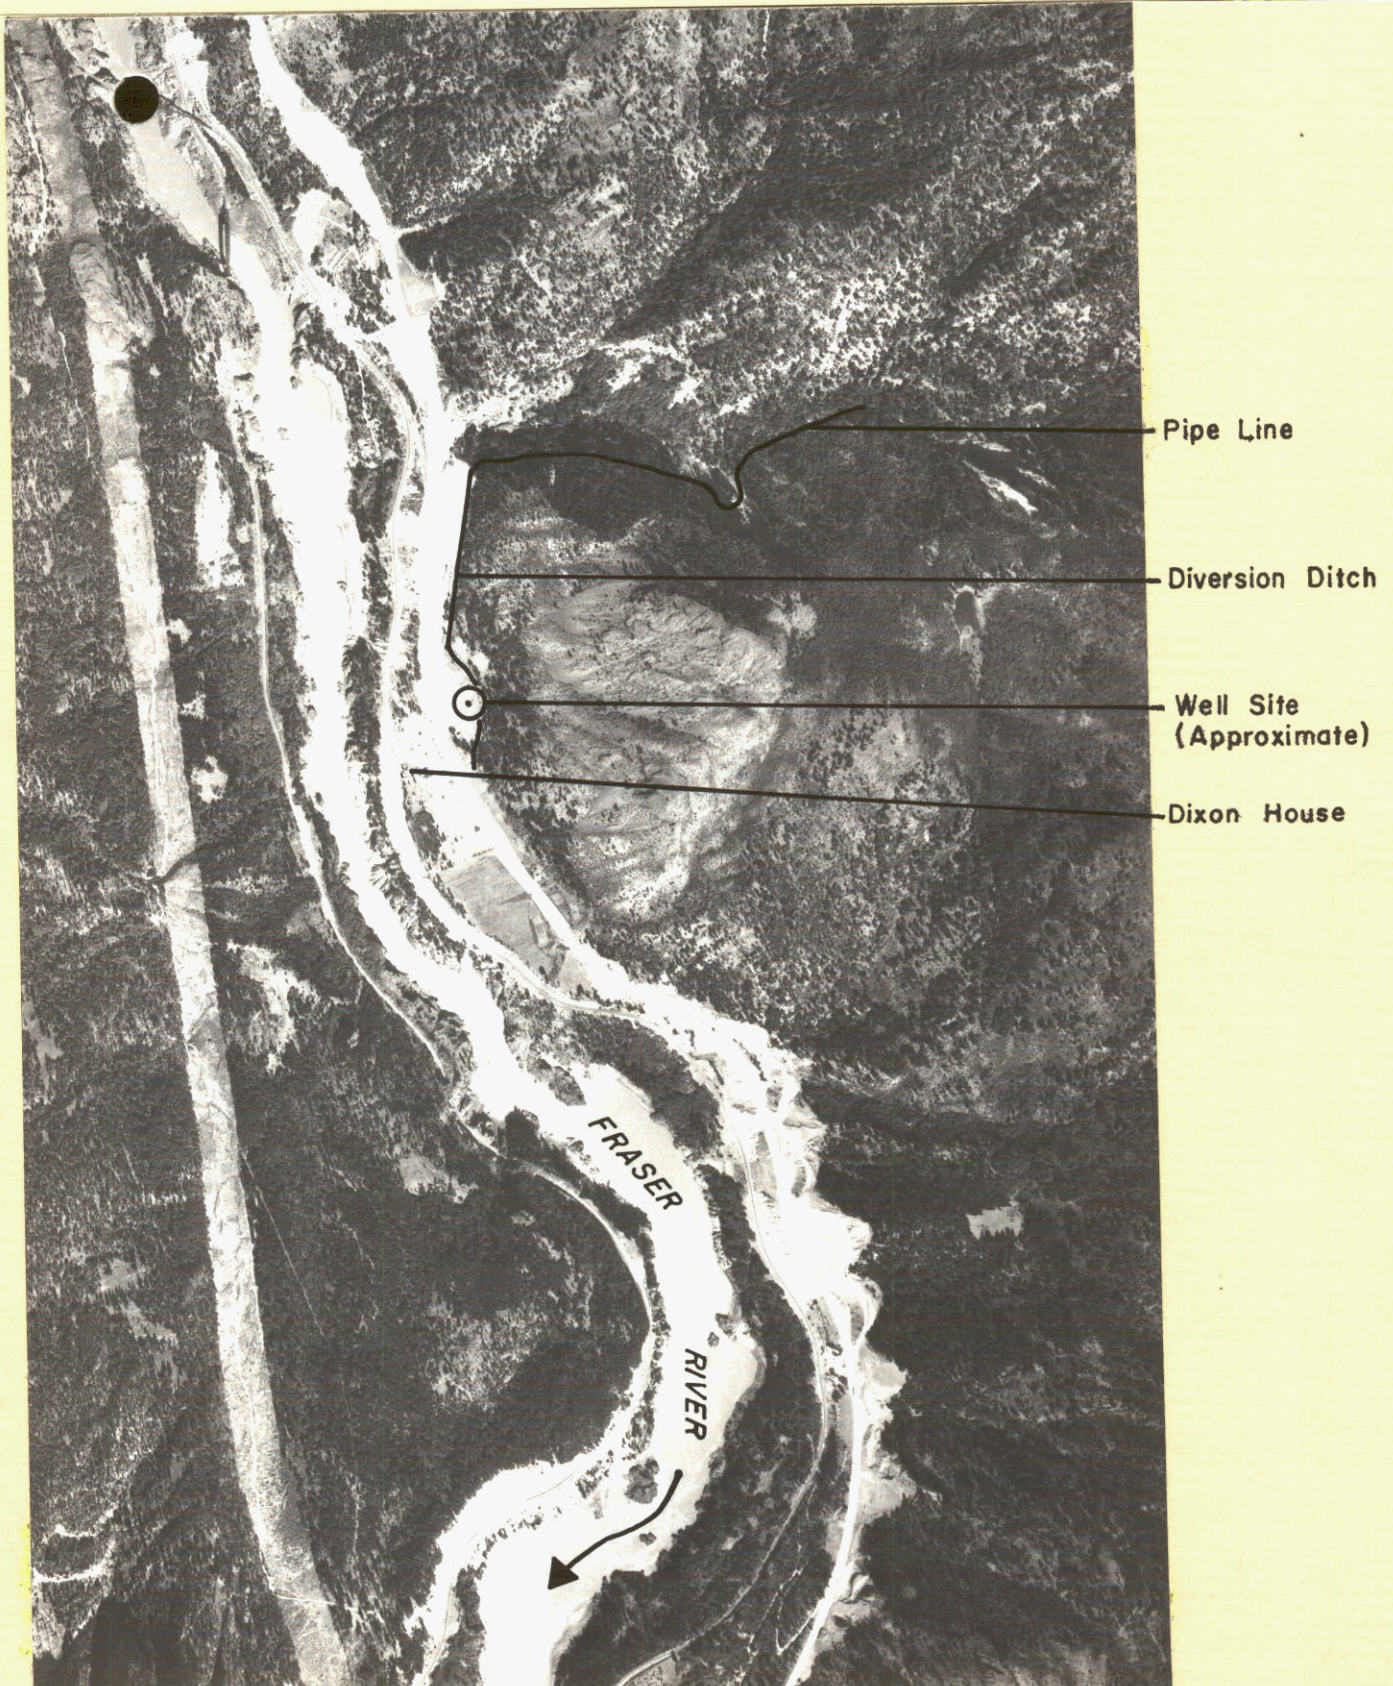
AERIAL PHOTOGRAPH TO ACCOMPANY "NOTES ON GROUNDWATER INVESTIGATIONS
FOR SISKIA FLATS INDIAN RESERVE #3 BY J.C. FOWERAKER
FILE 023 9014A MAY 1971

The existing water system is supplied from Siska Creek (see photo). A temporary boulder dam is made each year out into Siska Creek and this is lined with plastic.

The location suggested for a test well is downstream from the spring on a small fan (see photo). The site is accessible to a drilling truck and water is available from the diversion (during the summer) at the site.
