**Project Title: Salmo River Instream Enhancement Program (Phase 2)**

**FWCP Project No: FWCP: COL-F22-F-3438**

# Effectiveness Monitoring and Maintenance Report (EMMR) for Salmo River Watershed Instream Restoration Project (SRWIRP) Phase 2

Project #16,731: Site A – Casey, Site B –Nelson Nordic Ski Club (NNSC): Columbia Basin Trust, Fish and Wildlife Compensation Program Project COL-F22-F-3348

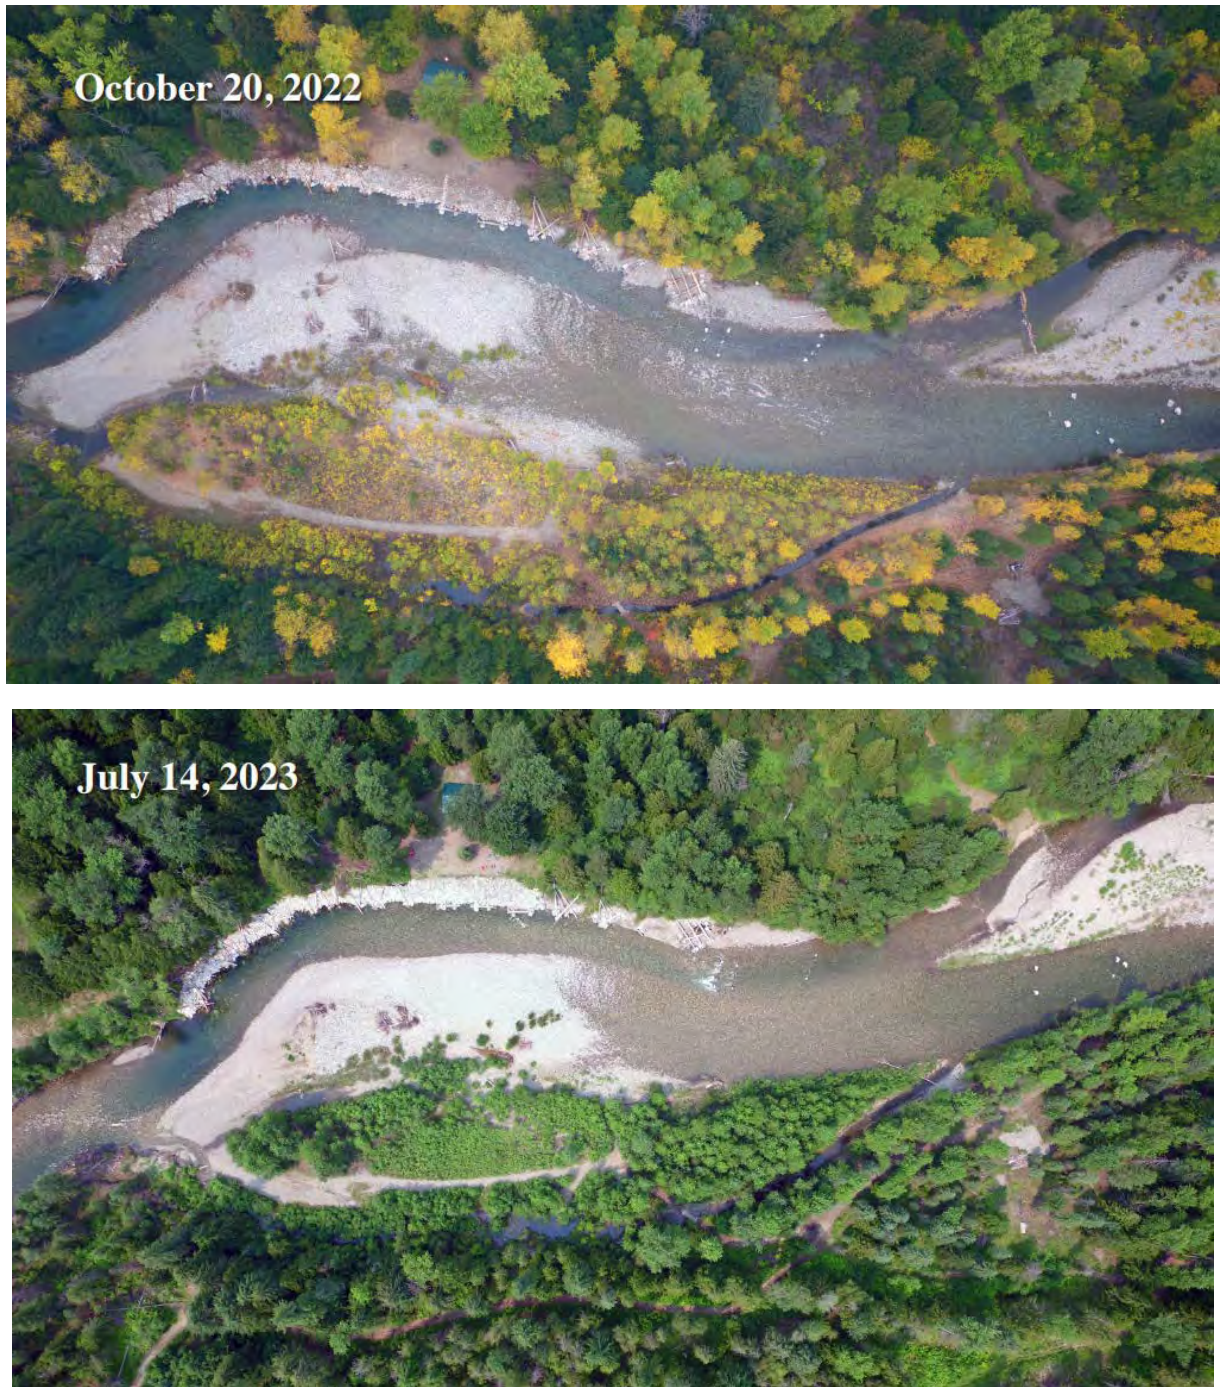
*Figure 3. The images above depict an aerial view captured by a drone, showcasing the Casey site at Site A along the Salmo River. A comparison between the drone shots taken on October 20<sup>th</sup> 2022 and July 14<sup>th</sup> 2023 no noticeable structure shifting.*

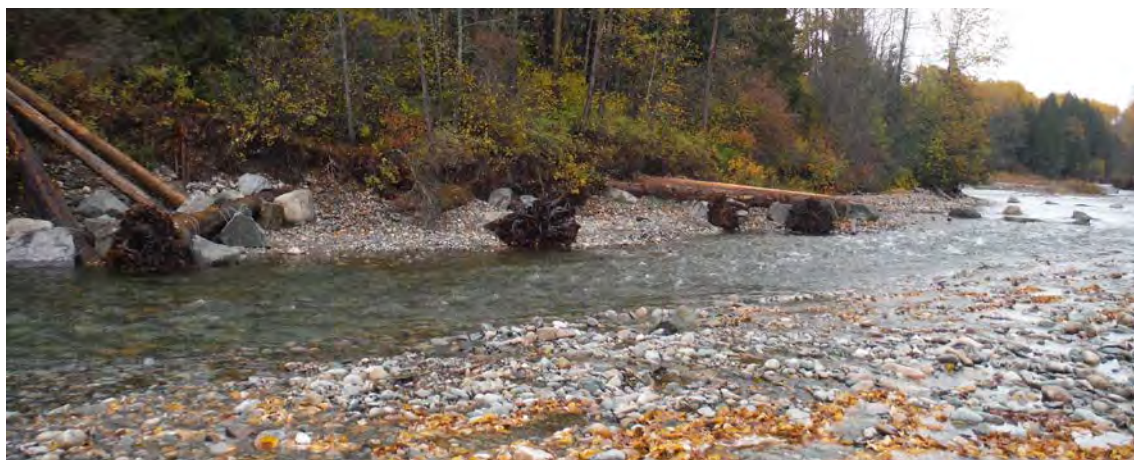
*Figure 30*

The 2024 photos show strong sun activated log bleaching and the addition of post construction additional rock stabilization.

Shows upper Triangle above left, a Lateral Log structure and end view of the Debris Catcher.

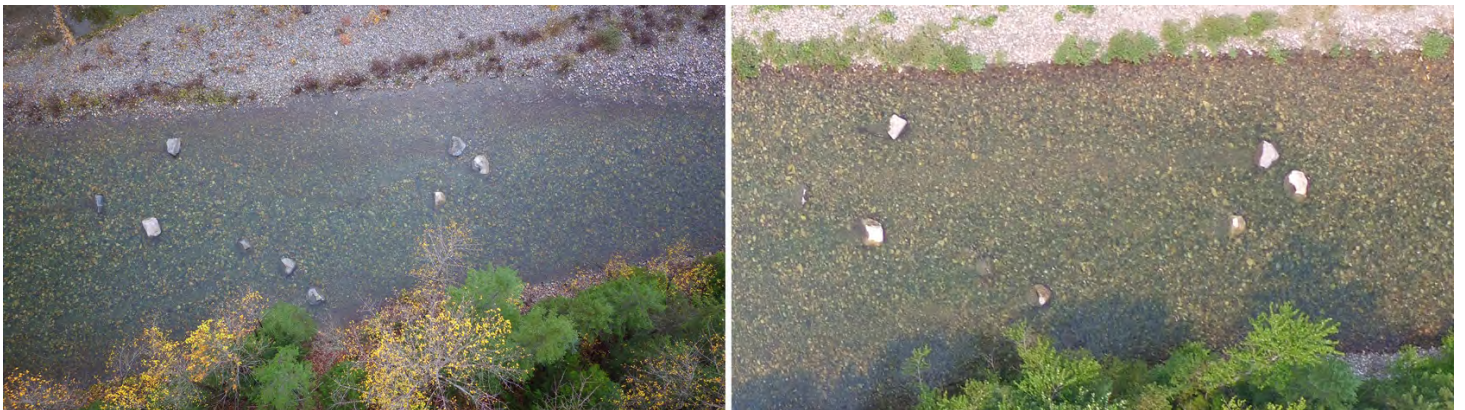
Figure 42

Photo #6, shows 3 additional Boulder Clusters and end of site.

Review of photos confirm the structures remain stable over 3 high water events, freshet 2023 and 2 additional rain activated high water events. The only readily observable change in structure 'layout' is on the Photo #5, Debris Catcher. It has begun to serve its purpose capturing debris in the upper quadrant and close in on the upstream boulder bar as well as on the structure itself. Just to upstream end of the first downstream W the River has contributed an additional piece of large woody debris. What is apparent is the obvious log bleaching that has occurred since construction.

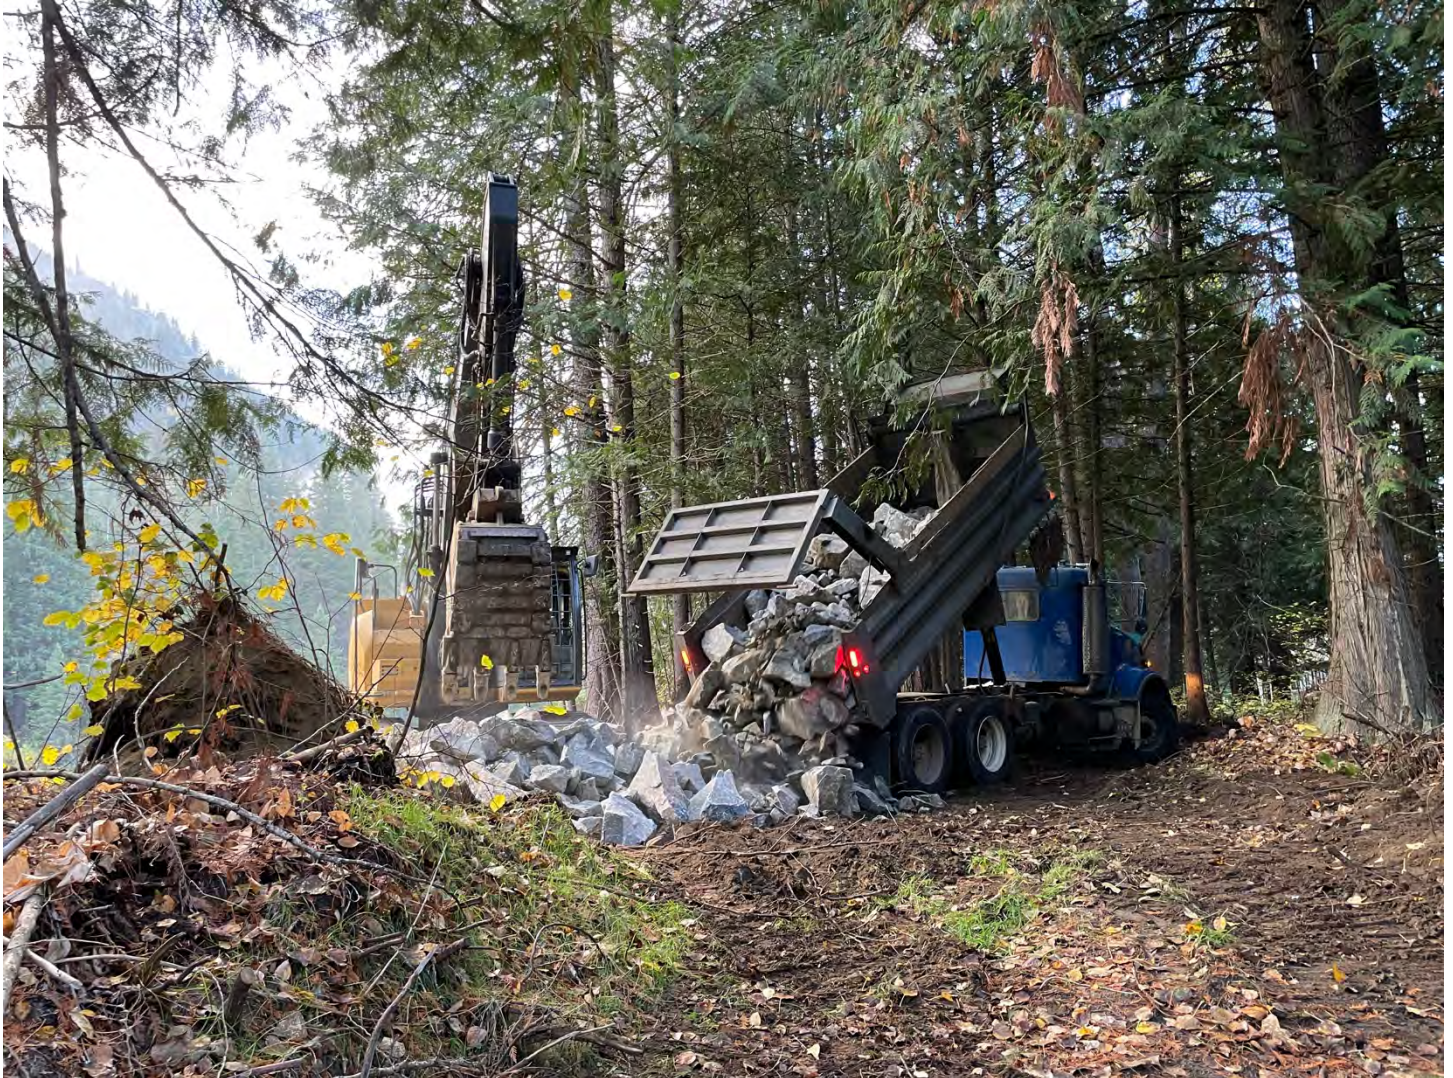
Figure 43

Three high water events – Freshet 2023 and two rain activated high water events resulted in some ballast and between structures stabilization rock movement. No wood structure movement was detected. Stabilization rock ‘roll down’ and settling was relieved with replacement rock being gently replaced/located using a 280 Cat Excavator from Mountain Movers Equipment. Mountain Movers Equipment operators were involved in the original Site A construction work. Rock, predominantly from 15 – 40+ cm’s - often placed as singles was used to tighten and reinforce slope stability. Placement was followed by curling the bucket and gentle tamping to ‘set’ the placement.

A four day detailed maintenance program was undertaken by SWSS personnel from Tues. Oct. 10<sup>th</sup> to Friday Oct. 13<sup>th</sup> 2023 inclusive. Working in collaboration with Rob Roy Trucking, Silverking Contracting, Mountain Movers Equipment and Custom Dozing Ltd. two SWSS persons carefully directed access and placement of rock.

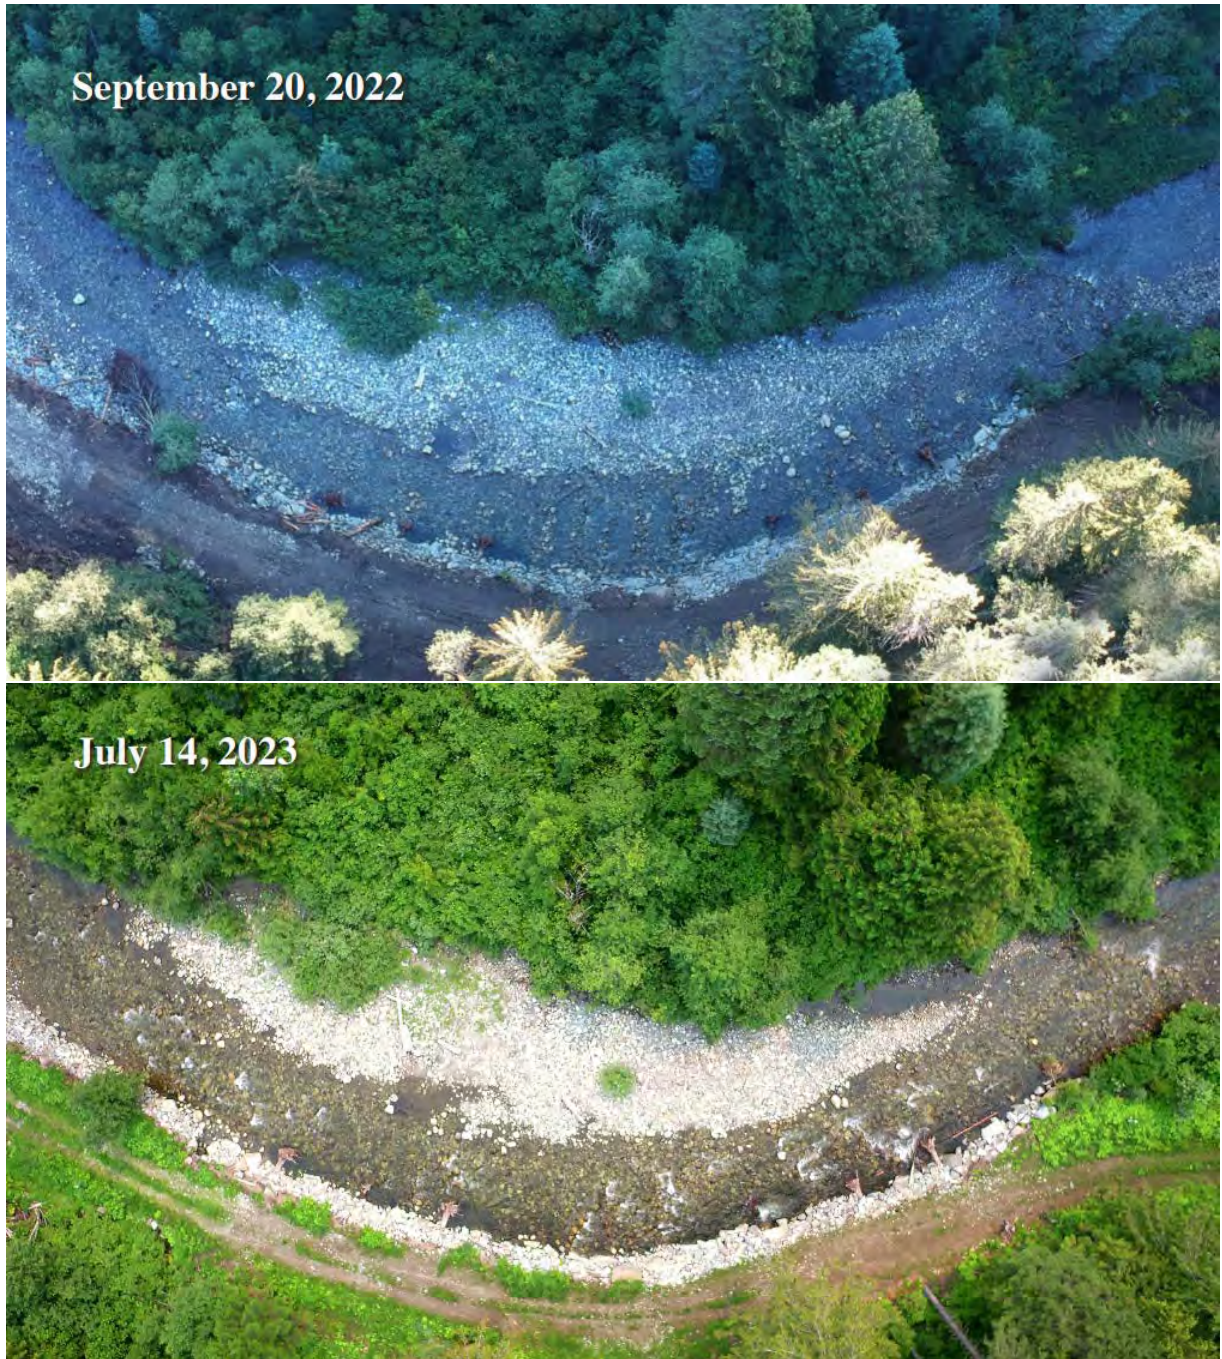
*Figure 44. The images above are an aerial view captured by a drone, showcasing the NNSC site along the upper Salmo River. A comparison between the drone shots taken on September 20th 2022 and July 14th 2023 reveals no changes in the positioning of the structures.*
