**Project Title: Salmo River Instream Enhancement Program (Phase 2)**

**FWCP Project No: FWCP: COL-F22-F-3438**

# AS-BUILT REPORT

Salmo River Instream Enhancement Project (SRIEP) (Phase Two) March 1, 2022

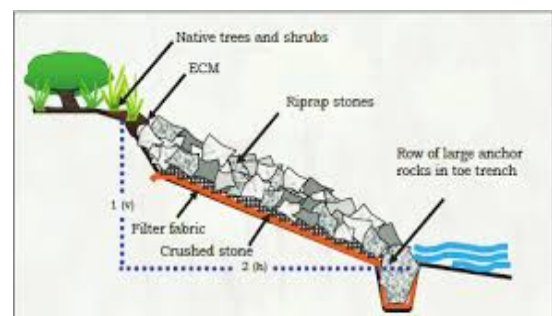
Figure 3: Geofabric/Toe Trench

Geotextile fabric was placed in a manner to cover both the slope and the bottom of a 'toe trench,' creating a "J" shape in the fabric to form fit a 'toe trench' within the River substrate. This provided additional protection against erosion undermining the base of bank stabilization (See Figure 4). At least one meter of overlap with the geofabric was employed when necessary in a fashion that would accommodate relief with the direction of water

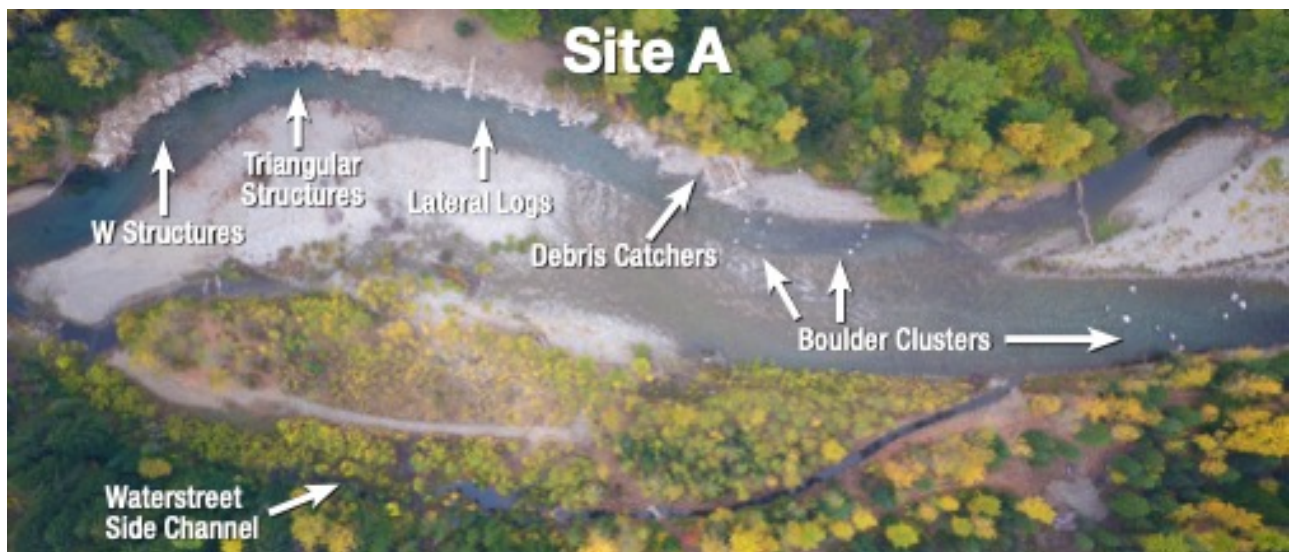
Figure 4: Entire 'Site A' overview. Notice Waterstreet Side Channel, bottom of the photo

Close observation of Fig. 4 will illustrate that three lateral logs were installed beginning at the upstream end of the bank stabilization and carrying on downstream. These were situated in an area where the riparian vegetation was not present. Continuing downstream, one triangular structure was constructed, then four W-LWD structures were built and finally another triangle structure at the furthest downstream end of the site. In total four lateral logs, four triangle and four W-LWD structures were installed along the streambank. For the installation of Triangle and W-LWD structures, a portion of the upper bank was excavated and a large ballasting rock was situated in the bank. Logs were then embedded in the bank and cabled to the ballasting rocks (Figure 6, also Appendix 1)

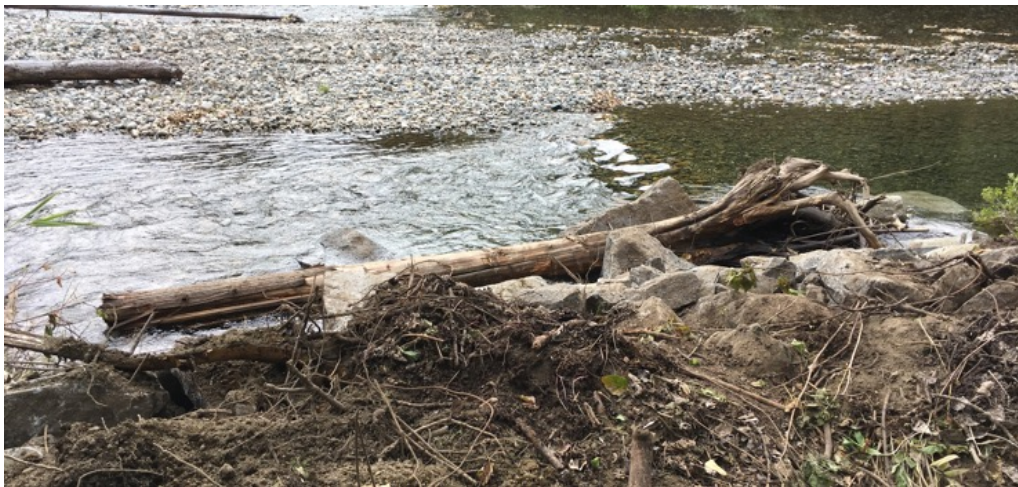
### 2) Photo of a Lateral Log Structure: This Lateral Log is Complete With a Rootwad.

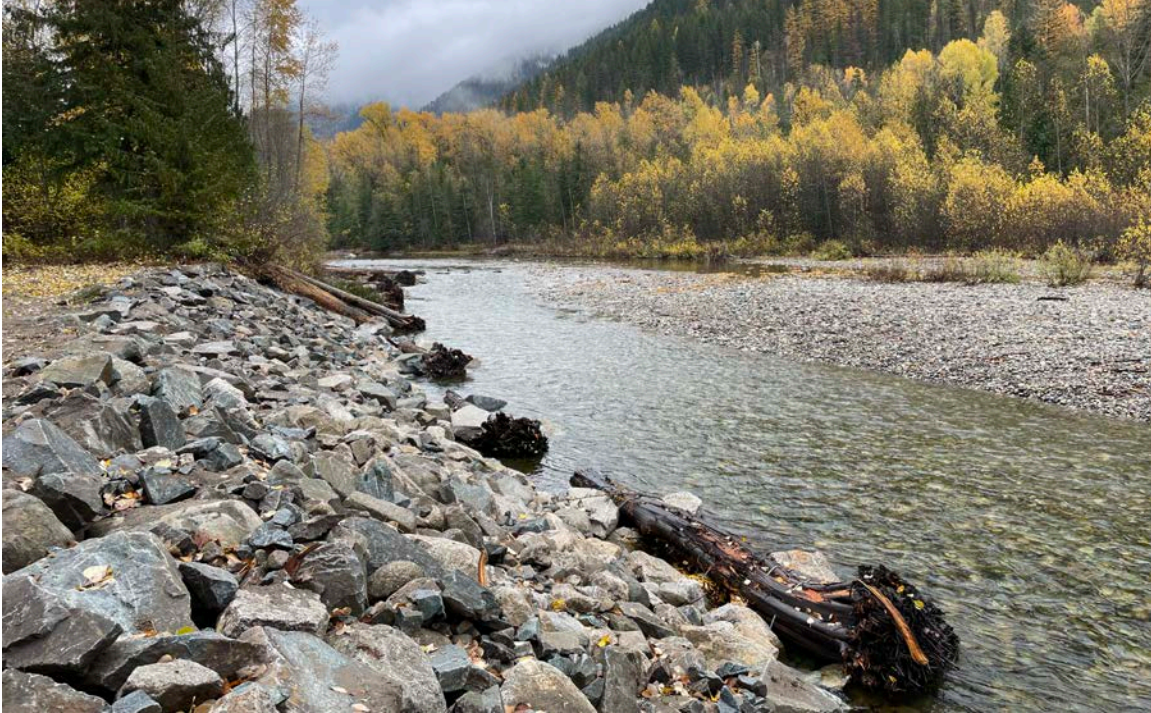
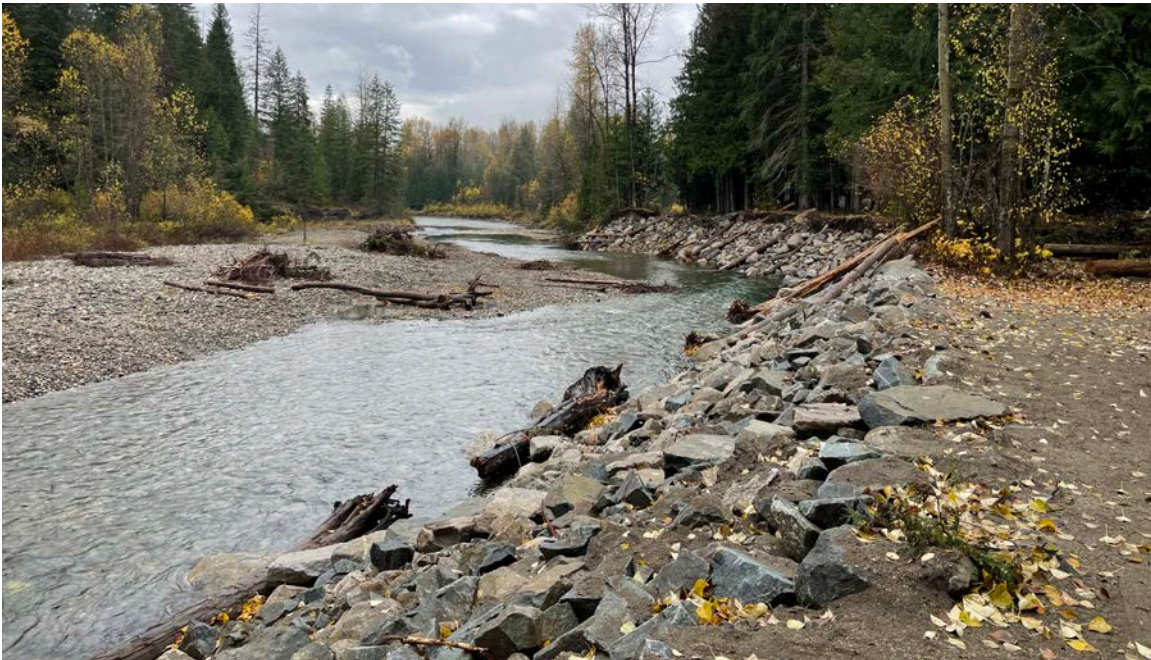
Site A Complete: Looking Upstream (above)   Looking Downstream (below)

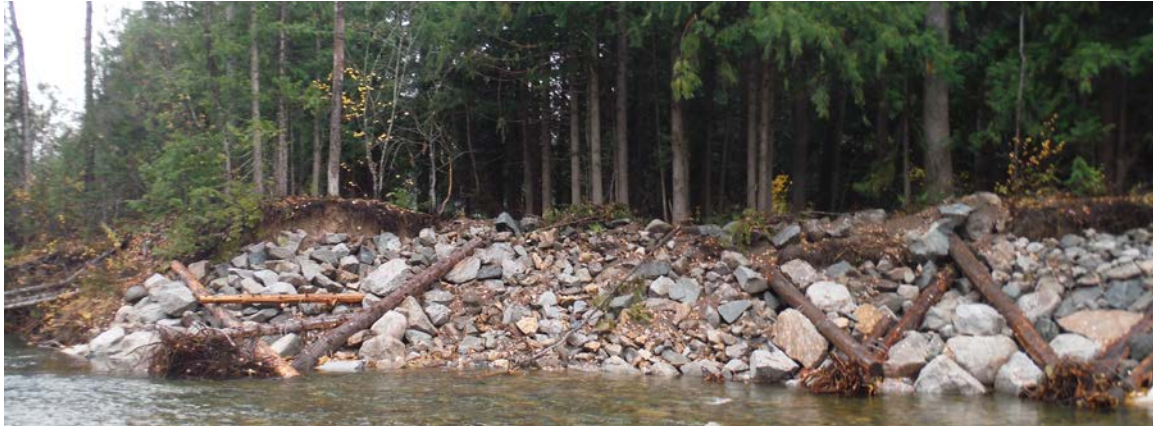
Downstream end of Site A: shows Triangular Structure C/W 2 Ramp logs and a 'W' structure

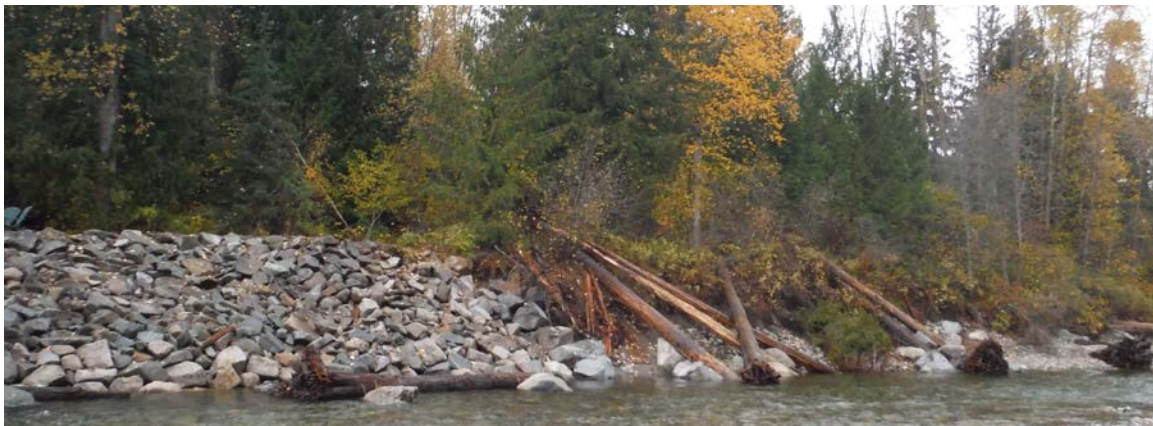
Upper end of Stabilization: Shows a Lateral Log C/W rootwad and 2 Triangular structures.

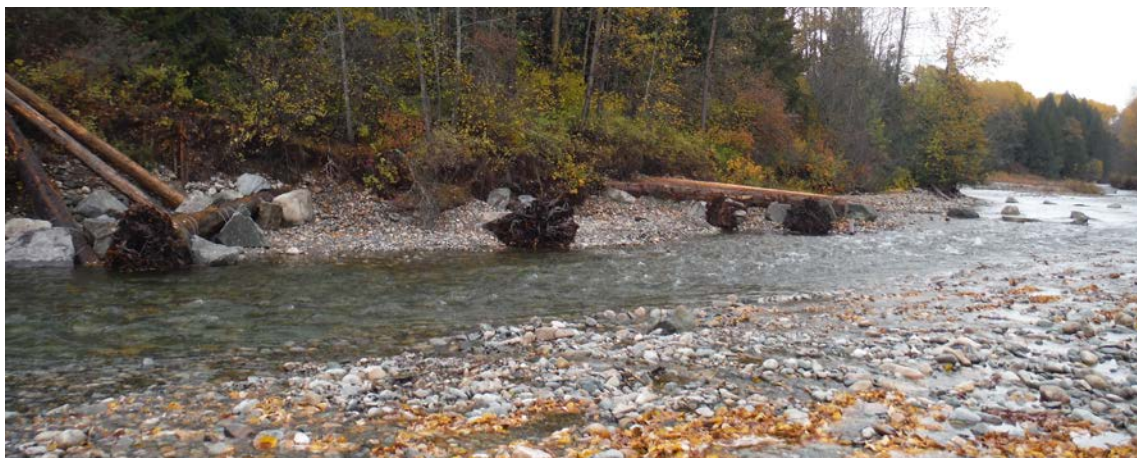
Shows upper Triangle above left, a Lateral Log structure and end view of the Debris Catcher.

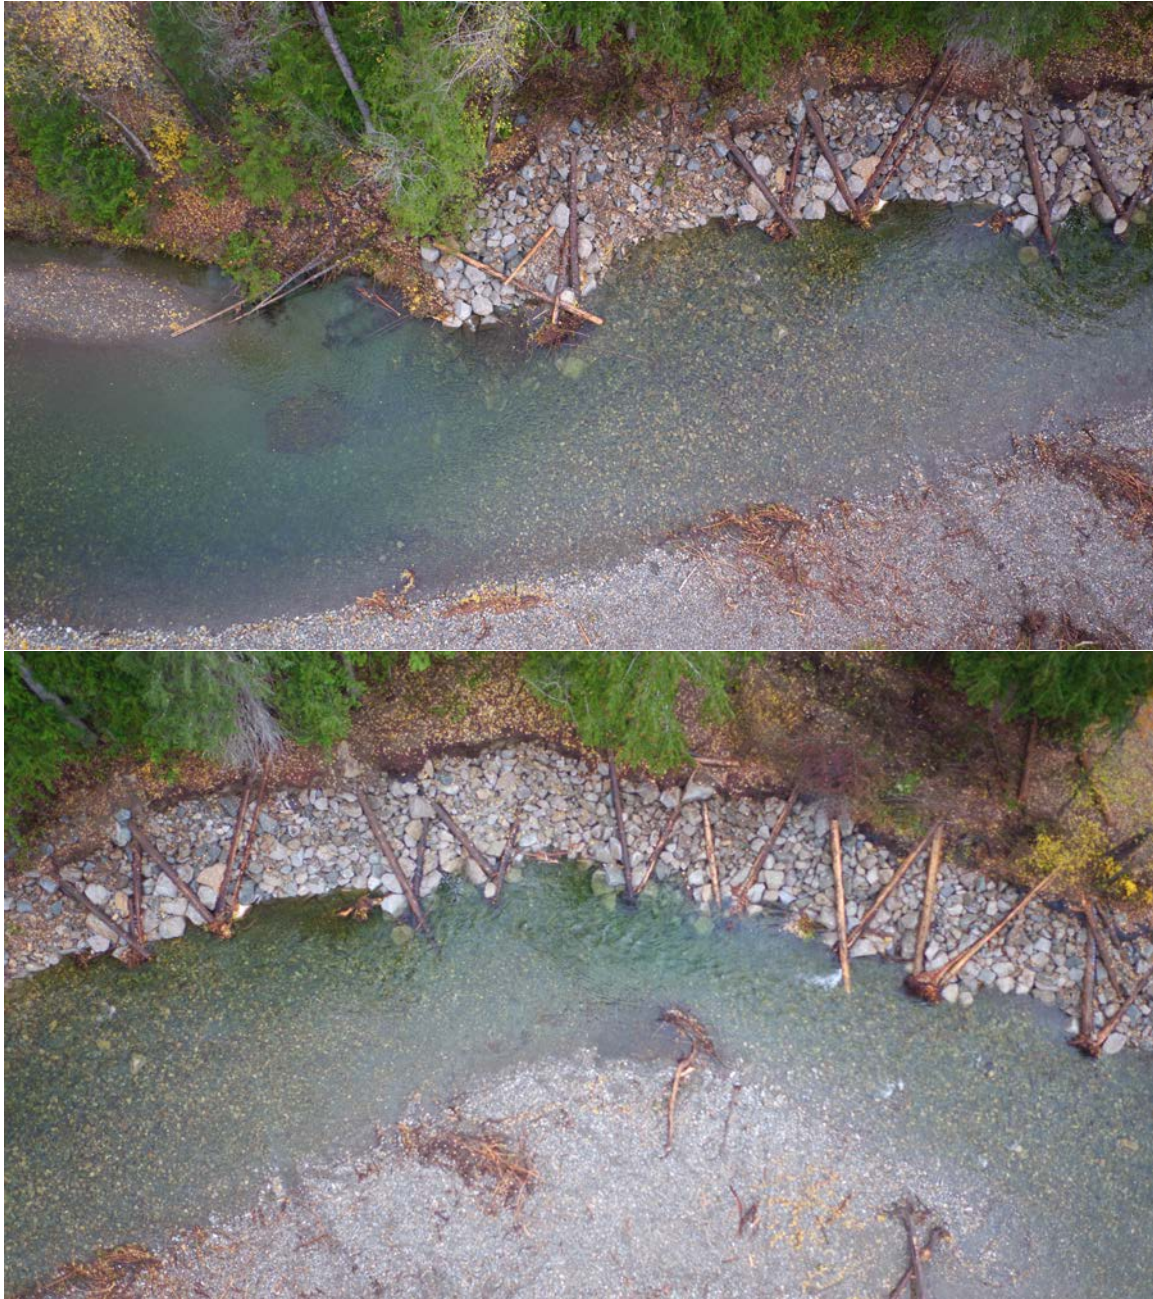
Upper Photo, Downstream end of Site A: Captures Lower Triangle with 2 Ramp Logs and 2 'W' Structures.

Lower Photo, Moving Upstream: Captures 4 'W' Structures.

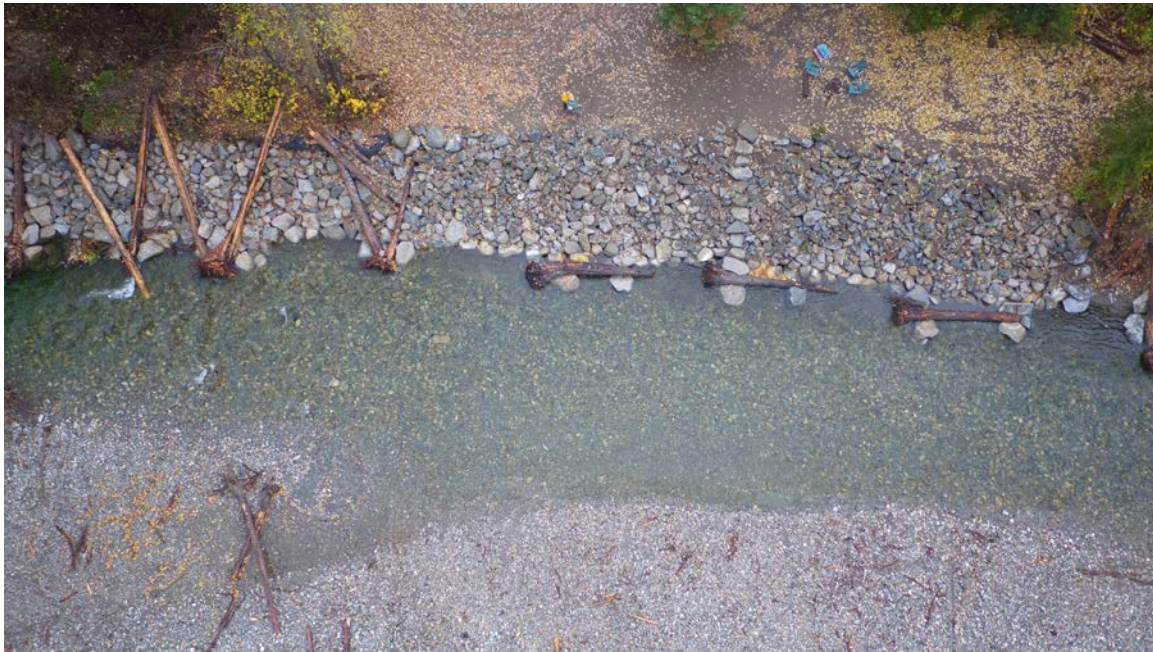
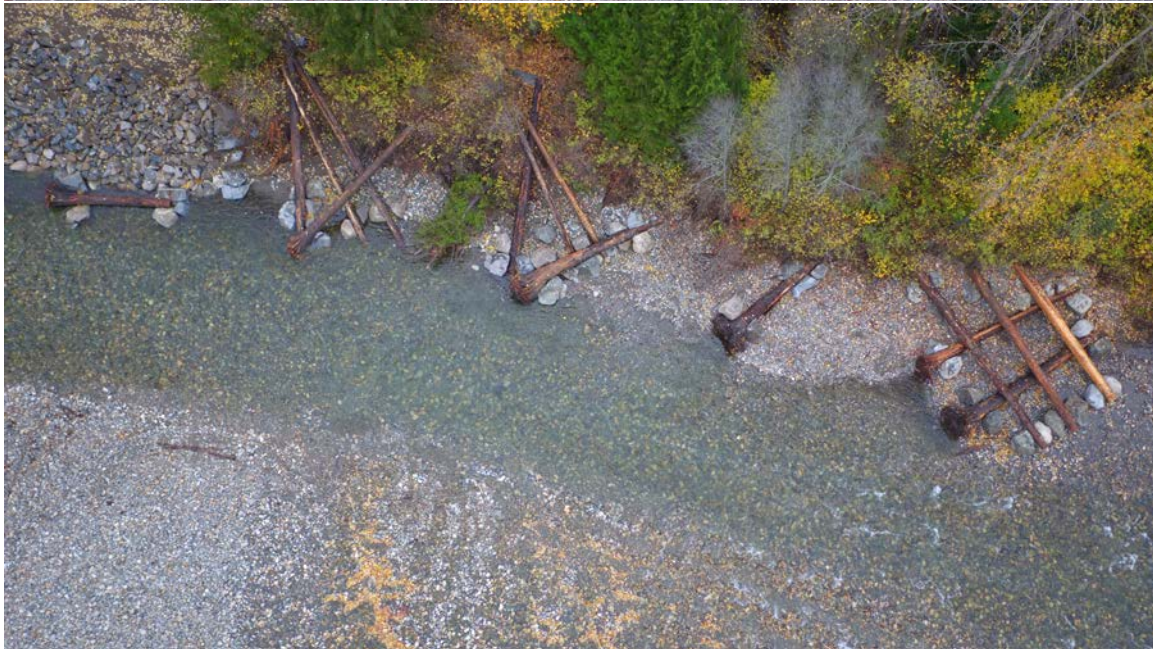
Upper Photo, shows repeat of upstream 'W' 1 Triangle, c/w 1 ramp log and 3 Lateral Log Structures.

Lower Photo, shows repeat of upper Lateral Log, 2 Triangles c/w 2 ramp Logs, a Lateral Log and the Debris Catcher.

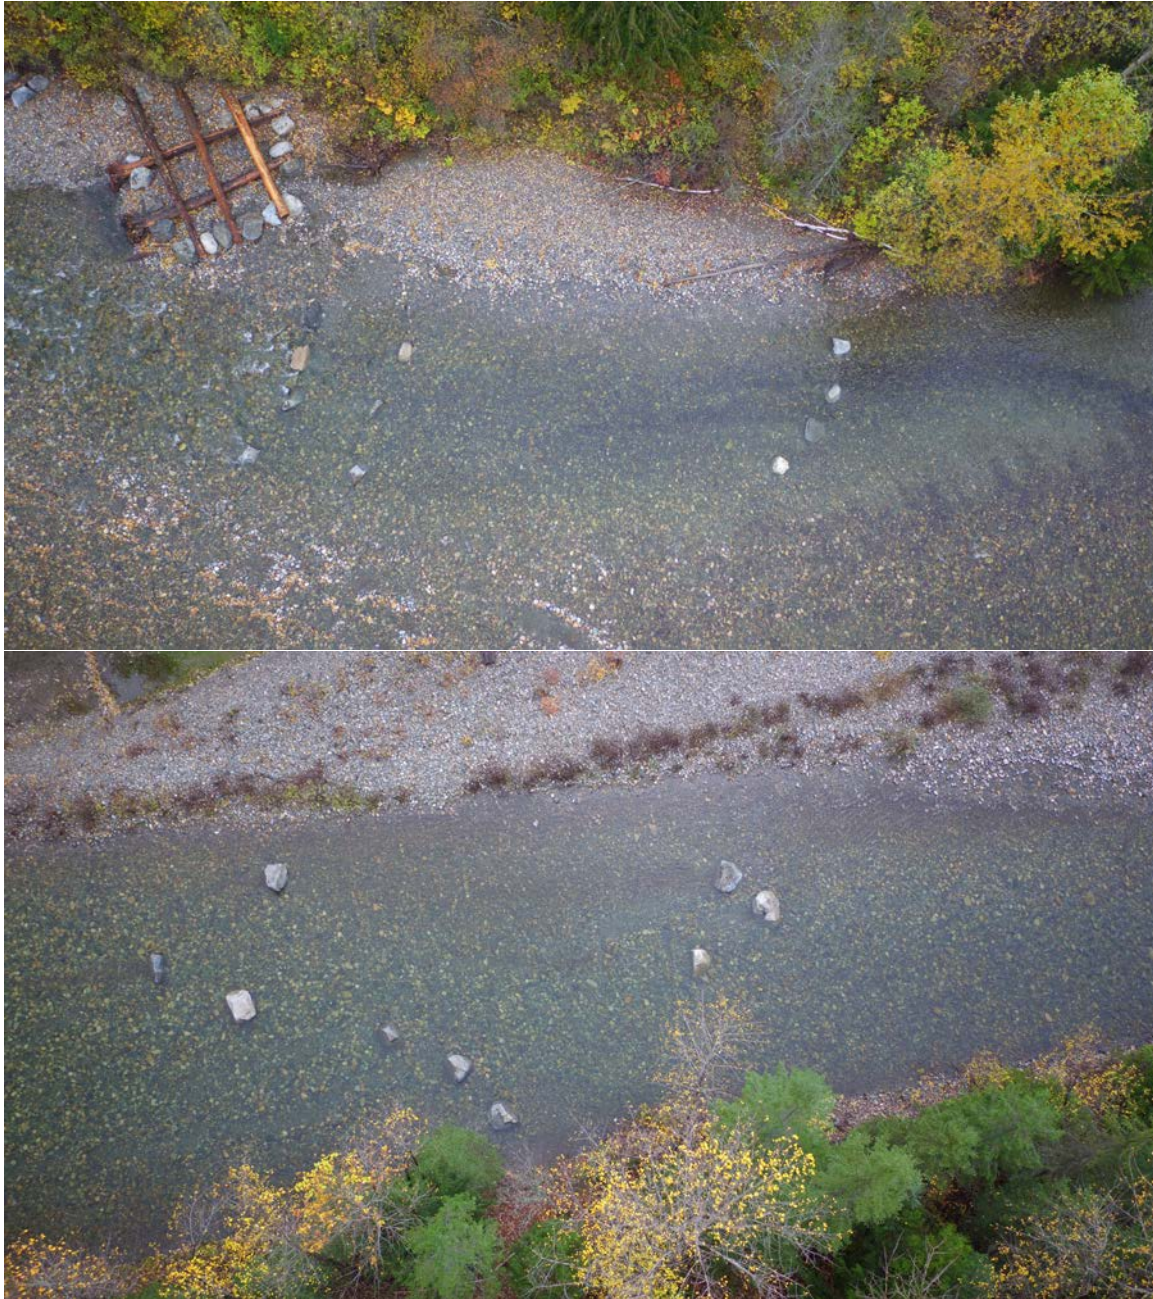
Upper Photo, shows repeat of Debris Catcher and the beginning of the upstream of site 'Boulder Clusters'. (3 Clusters)

Lower Photo, shows 2 additional Boulder Clusters.

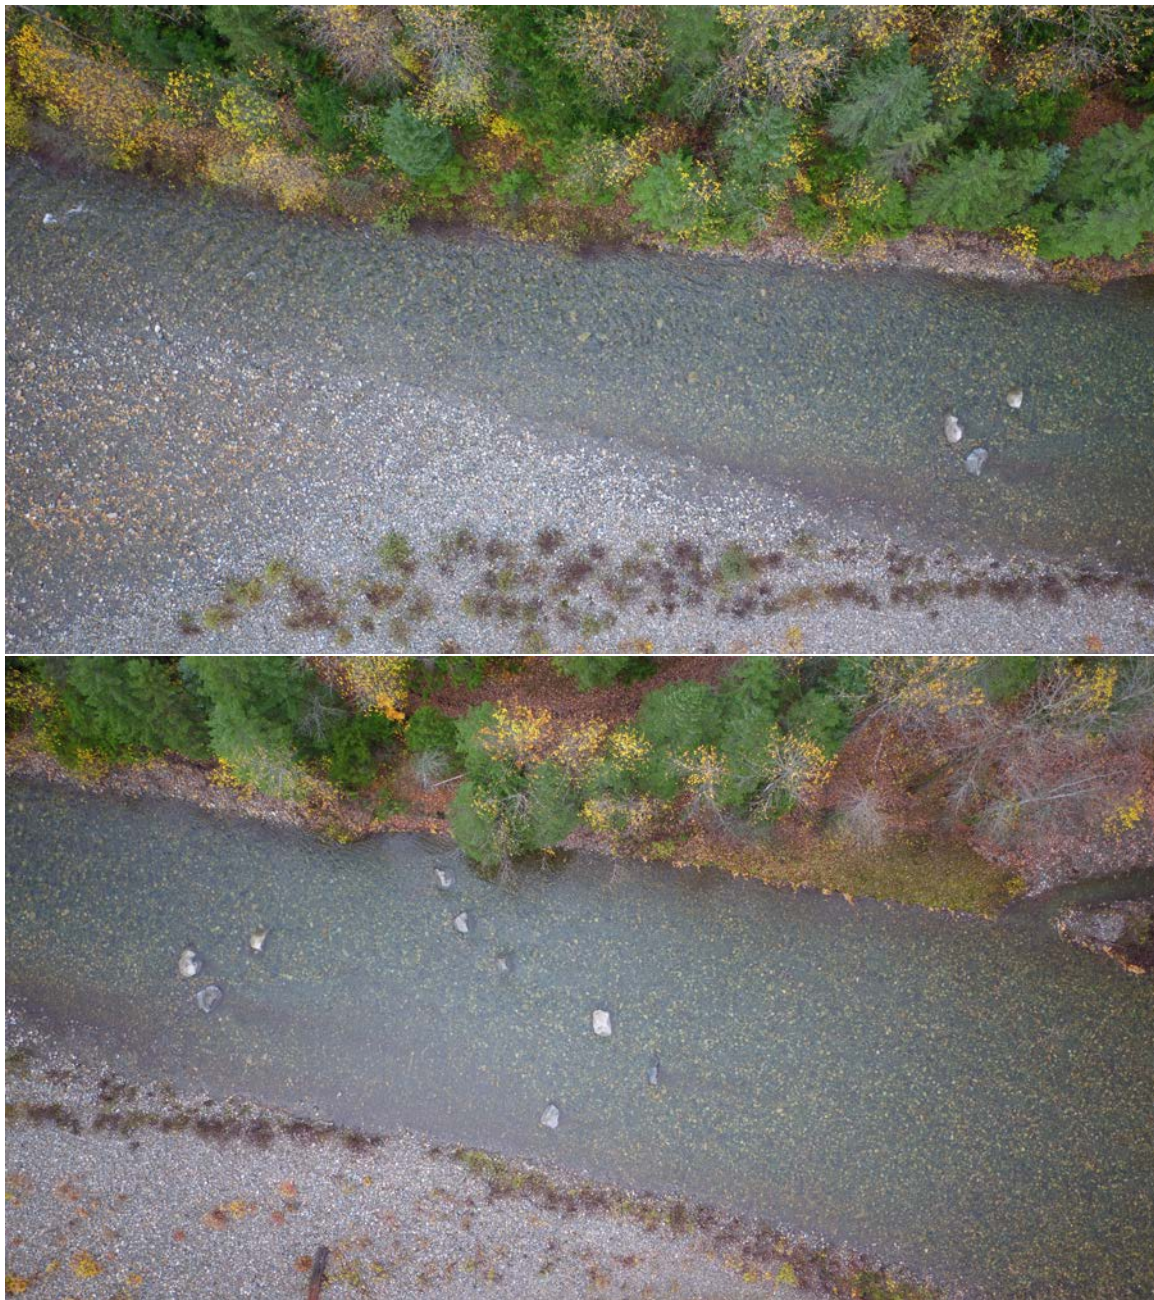
Upper Photo, moving upstream (left to right) shows 2 Boulder Clusters

Lower Photo, shows repeat of lower Boulder Cluster. And an additional Boulder Cluster and upper end of site.

Notice toward upper right of the lower photo the 'intake' for Waterstreet side Channel.

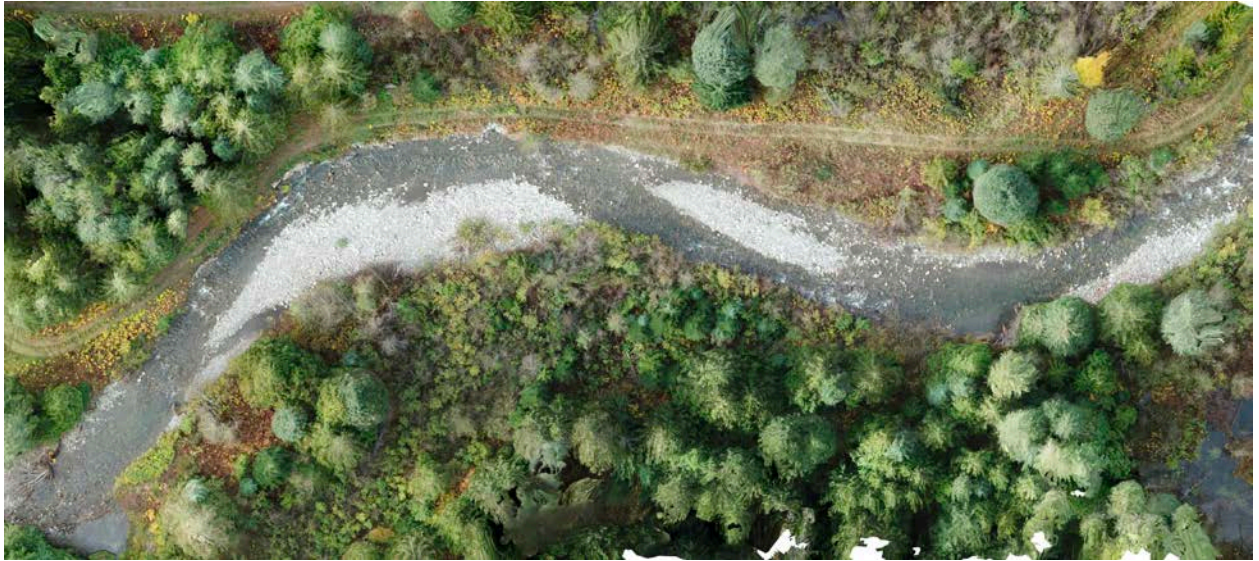
SITE B: Before Stabilization/Enhancement

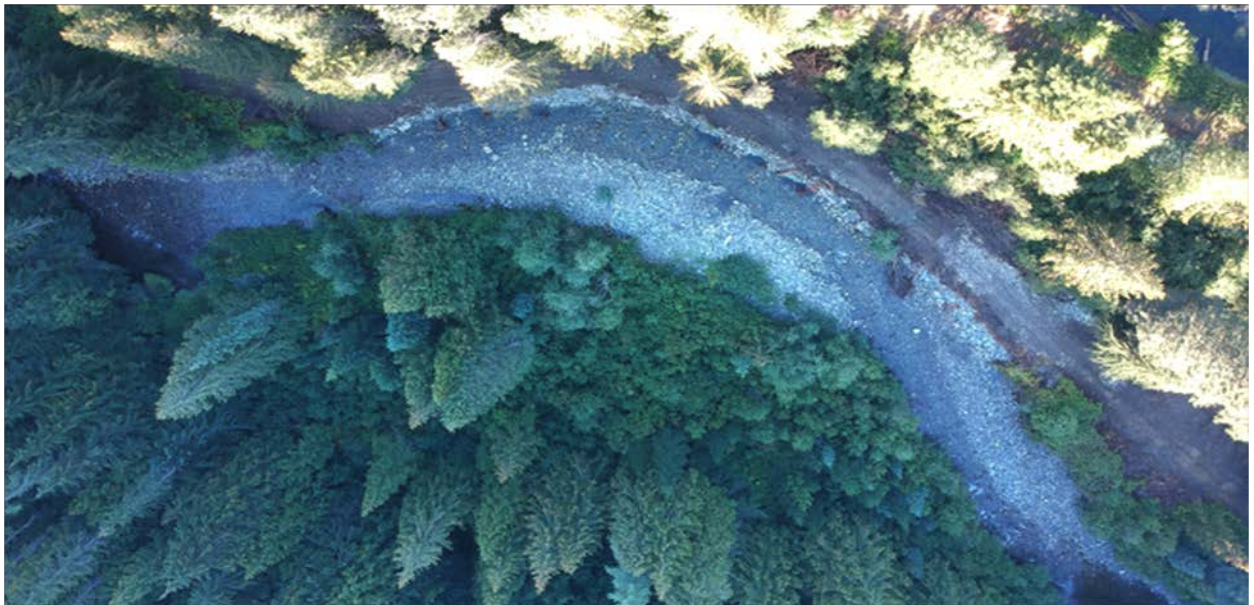
After Stabilization/Enhancement

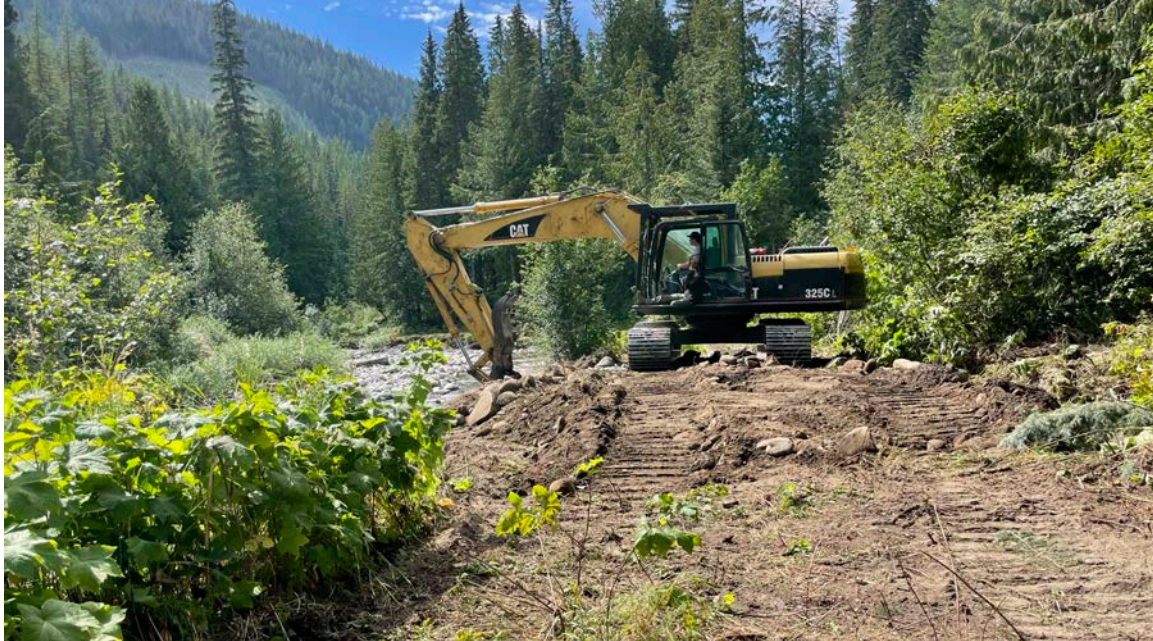
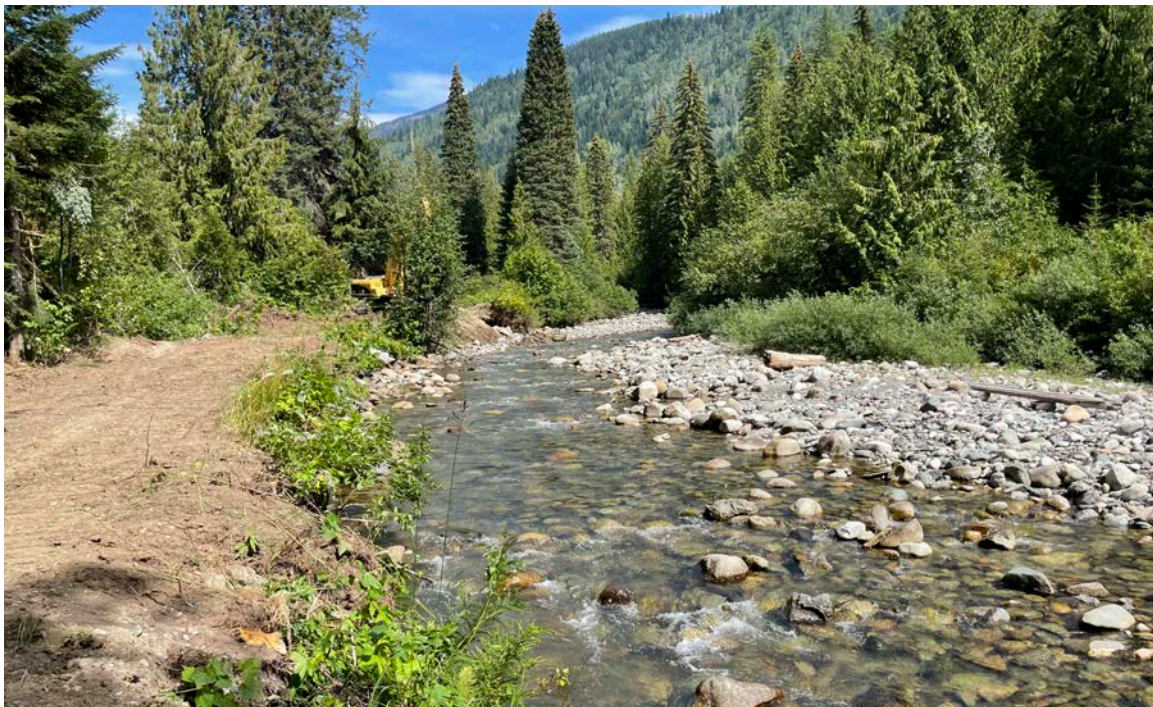
SITE B: Site Preparation:

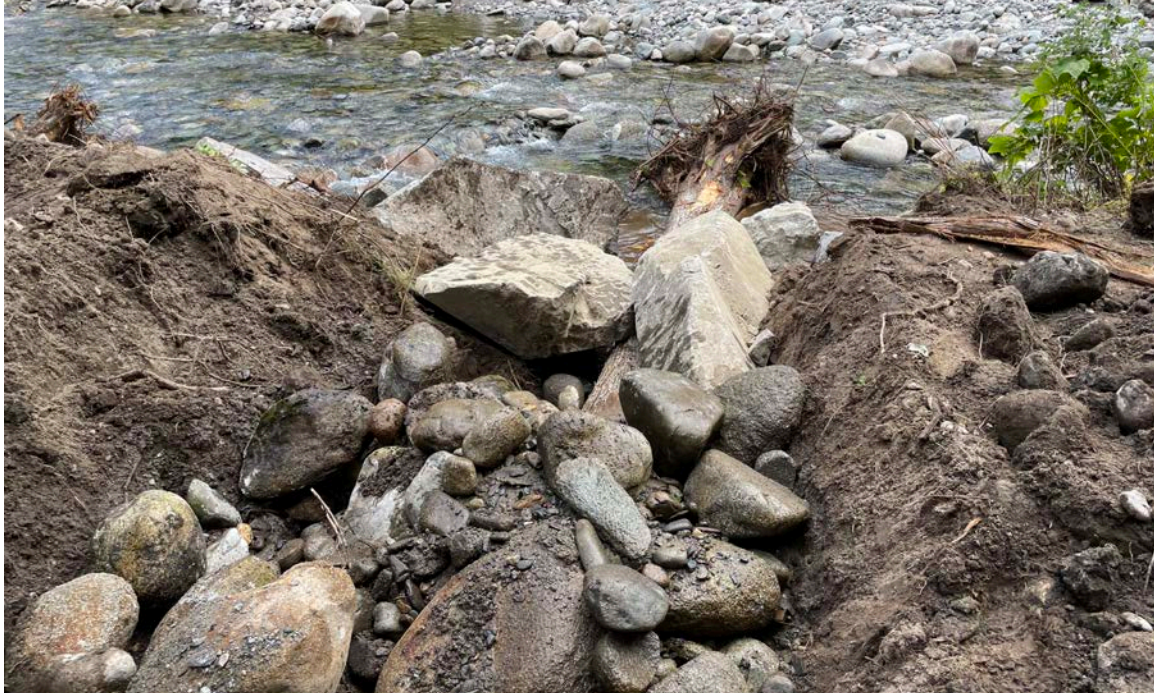
Site B: Rootwad Trenching/Ballasting: One Meter Extension into the River.

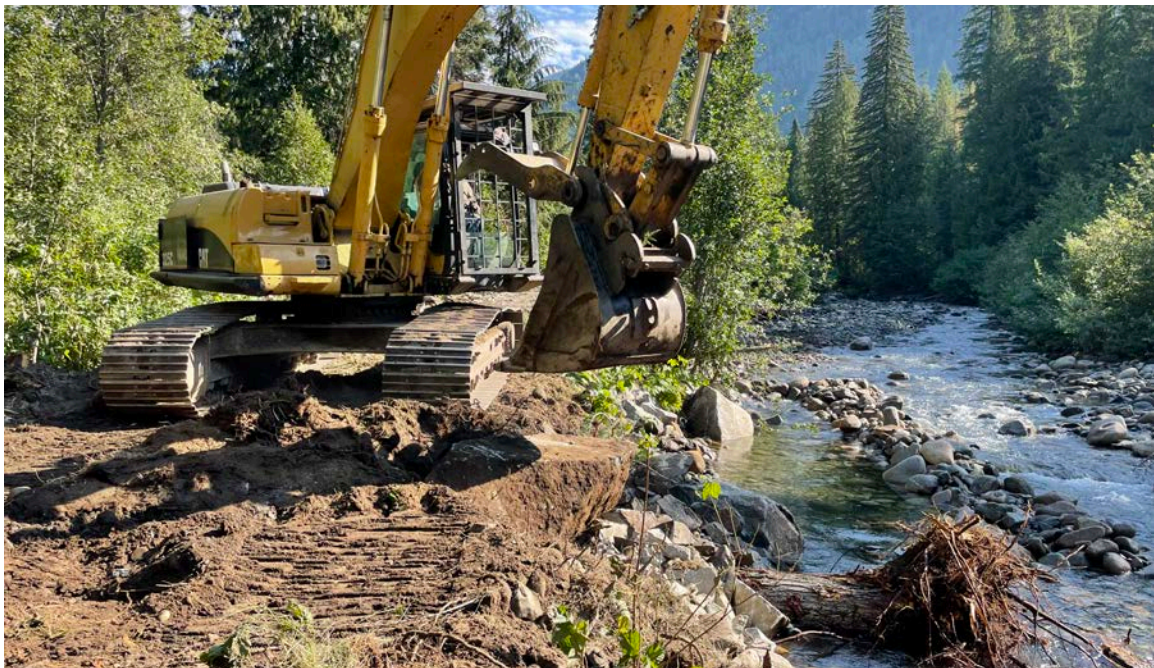
Site B: Rootwad 'Tamped' Into Place.
