## Appendix - Phase 1 Fish Passage Assessment Data and Photos

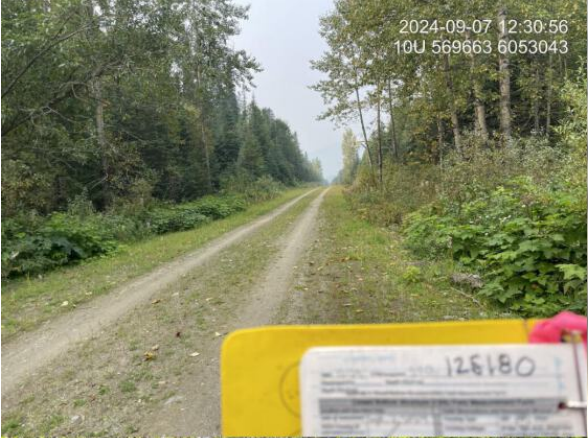
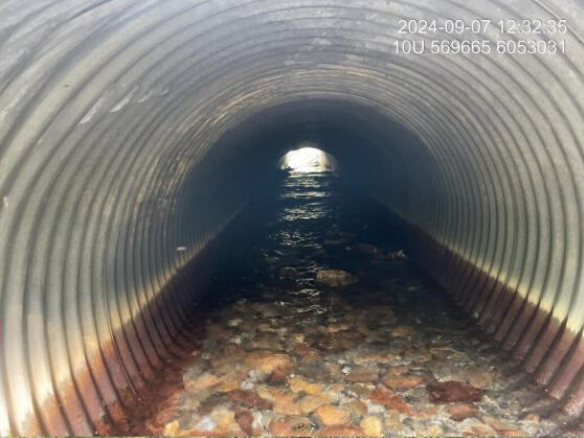
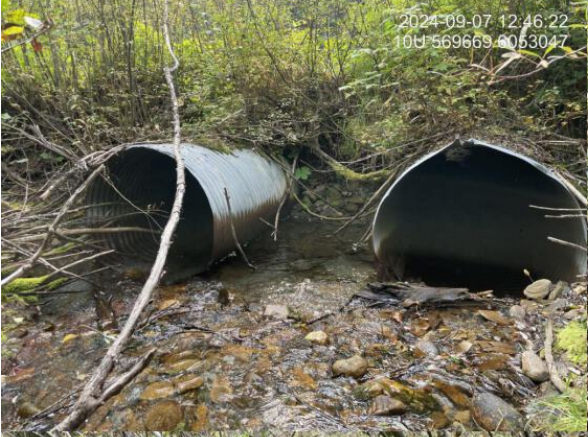
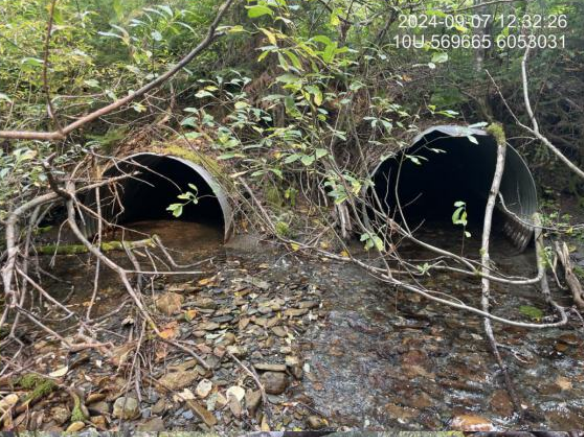
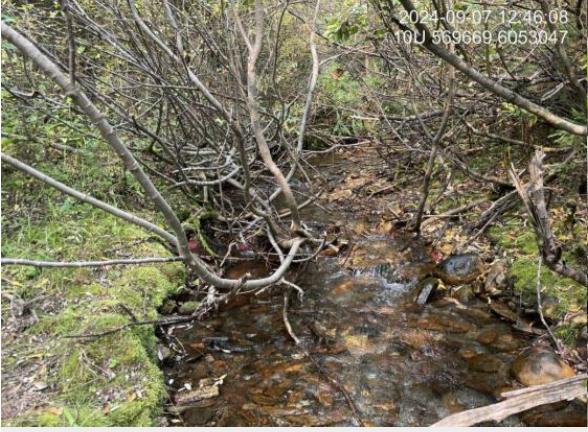
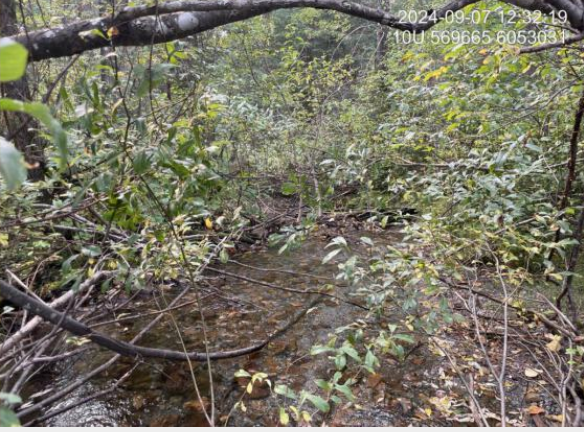
| Location and Stream Data | . | Crossing Characteristics | – |
|---|---|---|---|
| Final score | 19 | Barrier Result | Potential |
| Comments: Two pipes each at 1.2m in diameter, with one showing an inlet drop. Both pipes are embedded, except for 1 m at the inlet of one pipe, allowing them to function as embedded culverts, resulting in a low priority for replacement. The habitat is high quality, featuring deep pools and gravels. Rainbow trout ranging from 40-140 mm were captured during sampling.. 12:26:48 | | | |

| Location and Stream Data | . | Crossing Characteristics | – |
|---|---|---|---|
| Fix type | Replace with New Open Bottom Structure | Fix Span / Diameter | 15 |

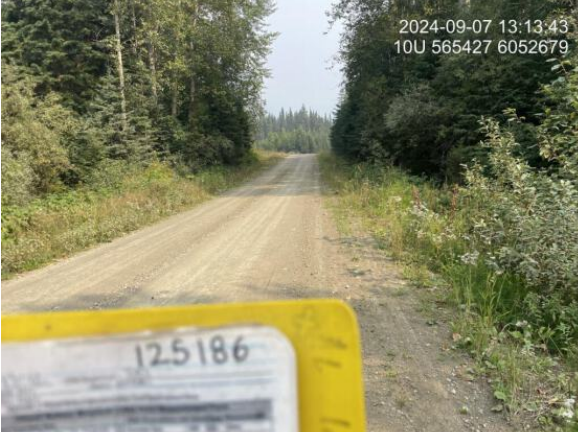
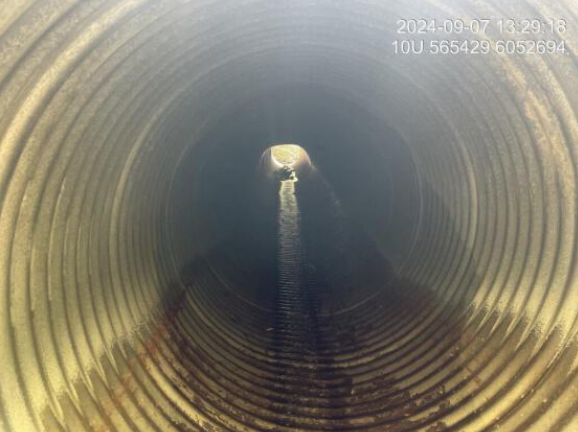
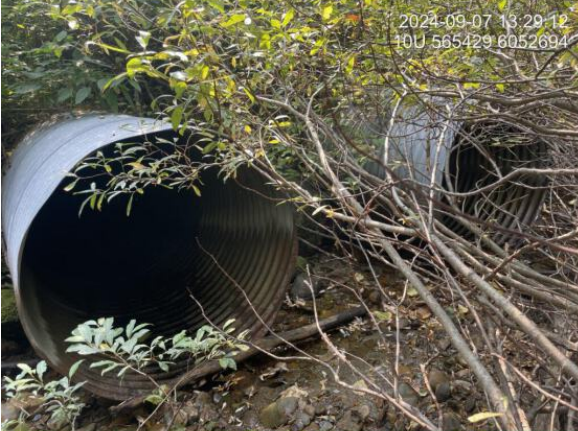
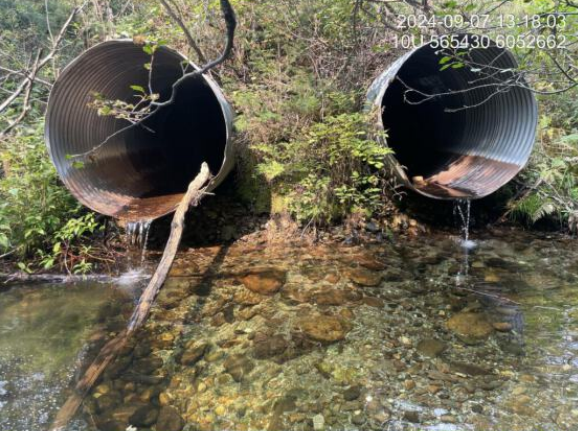
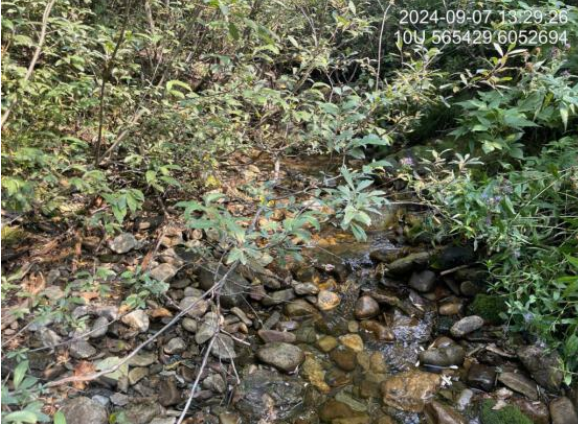
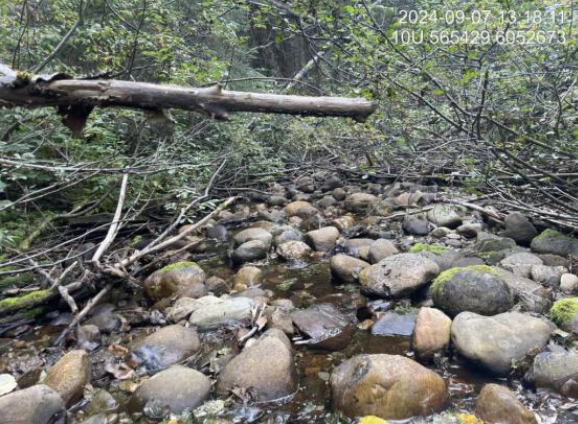
| Location and Stream Data | • | Crossing Characteristics | – |
|---|---|---|---|
| Final score | 36 | Barrier Result | Barrier |
| Comments: Two 1.2 m diameter pipes are present, with a significant outlet drop and a deep outlet pool. The habitat was good and consisted of cobbles, boulders, and woody debris, providing complexity and cover for fish. The stream flows into the inlet from the east but goes subsurface approximately 10 m upstream, with occasional small, shallow pools. The well-defined stream channel suggests it often carries higher flows. A wetland area to the east of the inlet likely contributes flow to the stream. An ~8 m wide area directly in front of the inlet was dry at the time of assessment but showed evidence of flowing water during higher flows.. 13:14:10 | | | |

| Location and Stream Data | • | Crossing Characteristics | – |
|---|---|---|---|
| Fix type | Replace with New Open Bottom Structure | Fix Span / Diameter | 15 |

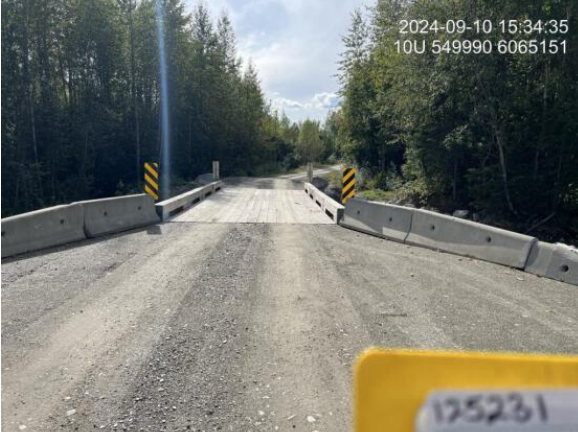
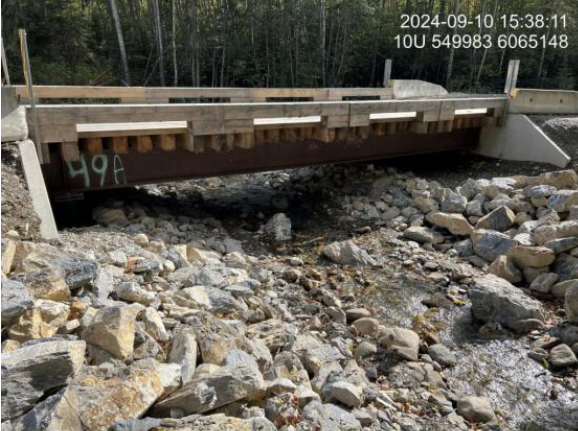
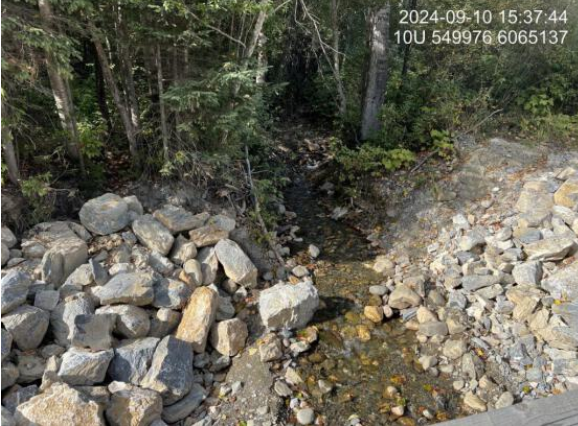
| Location and Stream Data | • | Crossing Characteristics | – |
|---|---|---|---|
| Comments: Culvert replaced with Bridge by Canfor in the summer of 2024 with environmental oversight and engineering from DWB. Very nicely designed structure that fits the stream channel well. Minimal rock placement within areas likely to be within the natural channel with not constricting the channel. It is recommended that future projects incorporate vegetated riprap and reinstall the vegetation removed from the construction footprint within the same area.. 15:35:51 | | | |

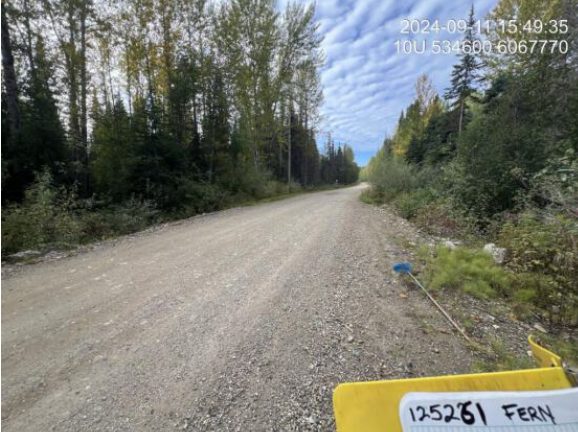
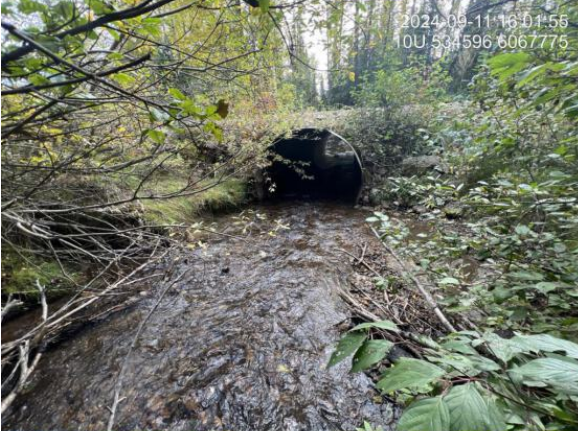
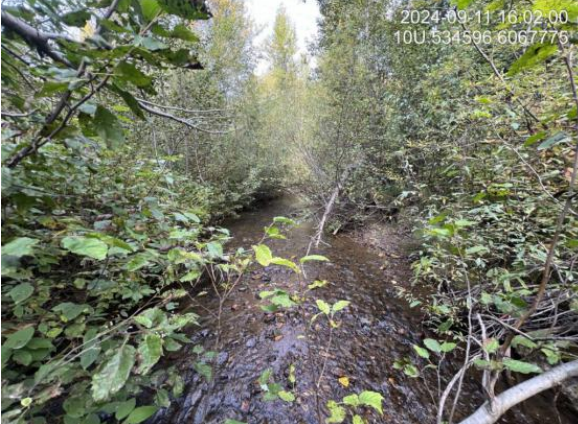
| Location and Stream Data | • | Crossing Characteristics | – |
|---|---|---|---|
| Final score | 26 | Barrier Result | Barrier |
| Comments: Reassessed as part of a baseline assessment before hopeful future replacement. Fish sampling was conducted in a 75-meter stretch downstream and a 50-meter stretch upstream of the culvert, and fish 60 mm or greater were tagged with PIT tags. There are baffles made of metal in the culvert and ~æ of the pipe is embedded with streambed material. The outlet of the pipe sits on a large pile of rip rap creating a 30 cm cascade that occurs approximately a meter after the outlet of the pipe. There are two overflow pipes each at 0.9 m in diameter. . 15:58:48 | | | |

| Location and Stream Data | • | Crossing Characteristics | – |
|---|---|---|---|
| Fix type | Replace with New Open Bottom Structure | Fix Span / Diameter | 15 |

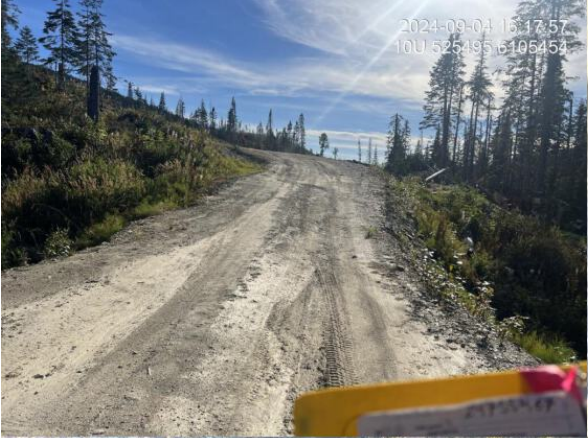
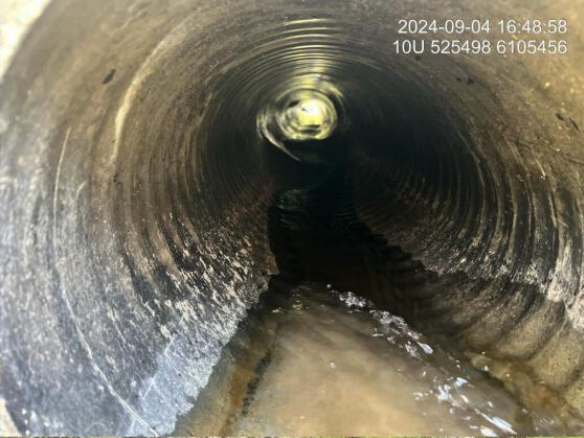
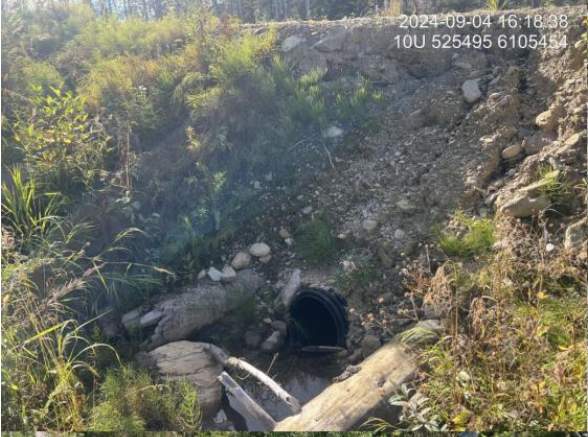
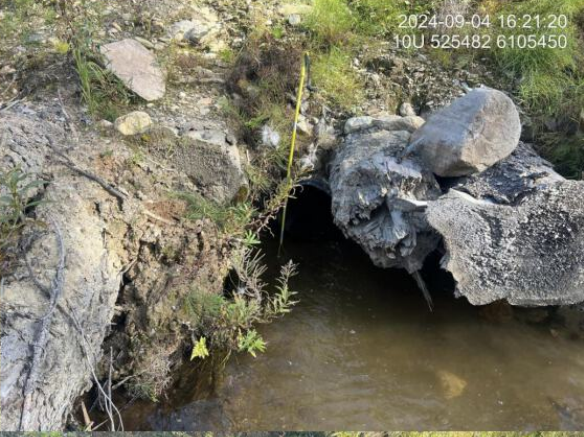
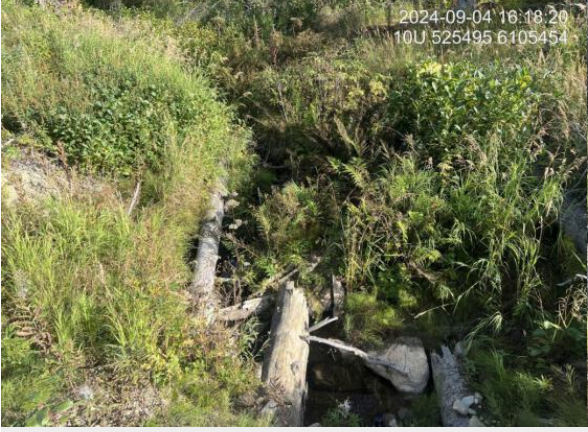
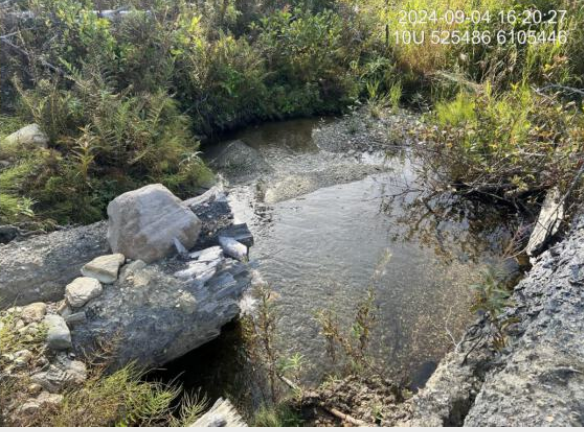
| Location and Stream Data | . | Crossing Characteristics | – |
|---|---|---|---|
| Final score | 26 | Barrier Result | Barrier |
| Comments: Small stream system with low habitat value. Limited flow volume and minimal channel structure, with sparse instream features such as large woody debris, pools, or gravels. Riparian vegetation consists of grasses, ferns, and small shrubs, providing minimal shading and bank stability. Slope estimated visually. . 16:12:04 | | | |

| Location and Stream Data | . | Crossing Characteristics | – |
|---|---|---|---|
| Fix type | Replace Structure with Streambed Simulation CBS | Fix Span / Diameter | 3 |

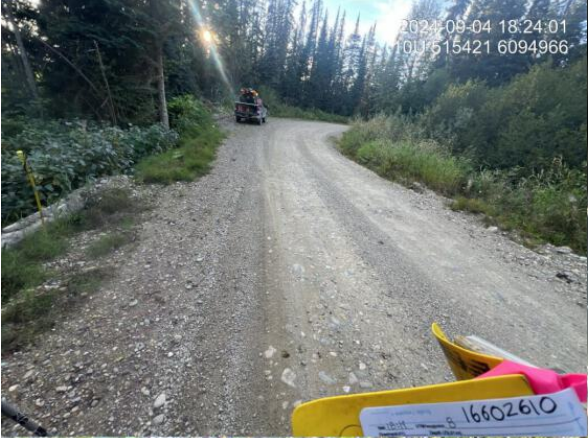
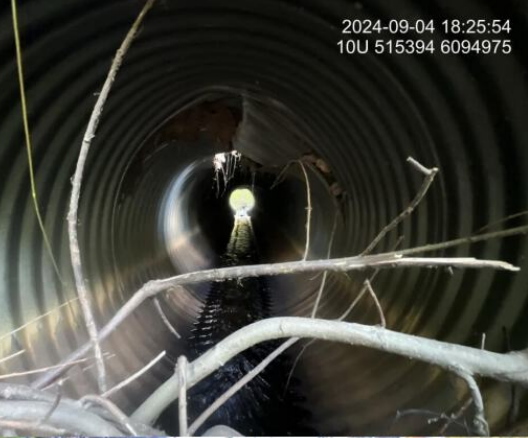
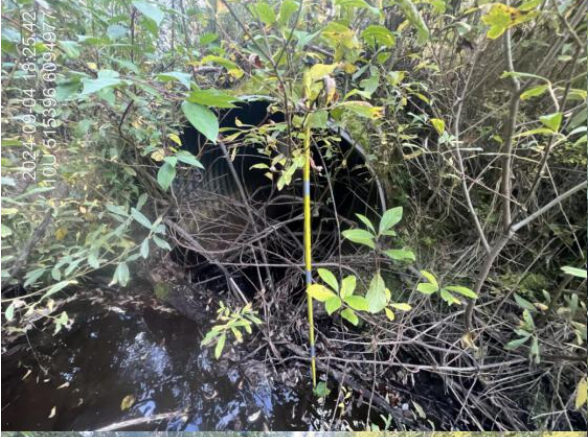
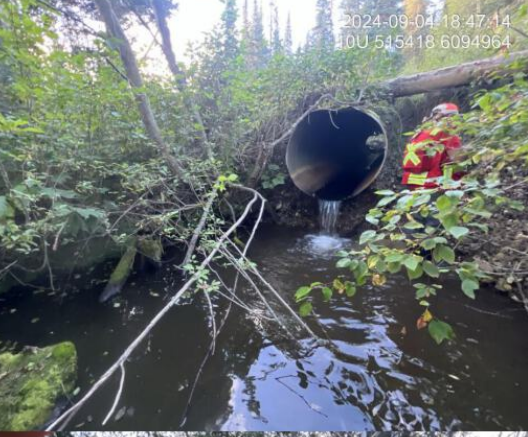
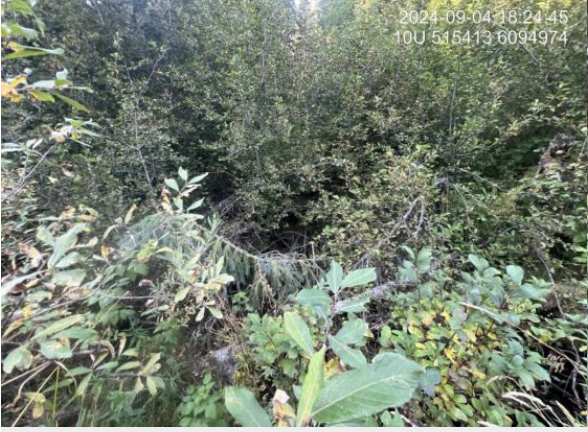
Photos: PSCIS ID 16602610. From top left clockwise: Road/Site Card, Barrel, Outlet, Downstream, Upstream, Inlet.

| Location and Stream Data | • | Crossing Characteristics | – |
|---|---|---|---|
| Final score | 36 | Barrier Result | Barrier |

Comments: The system has good flow and a significant outlet drop. Upstream substrate consists primarily of fine materials, likely indicating limited habitat complexity for fish.. 18:21:40

| Location and Stream Data | • | Crossing Characteristics | – |
|---|---|---|---|
| Fix type | Replace with New Open Bottom Structure | Fix Span / Diameter | 15 |

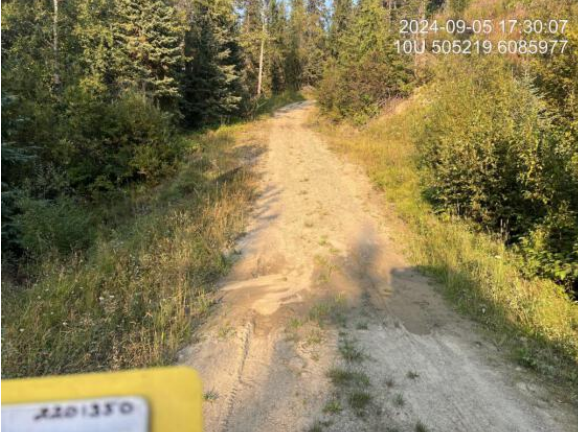
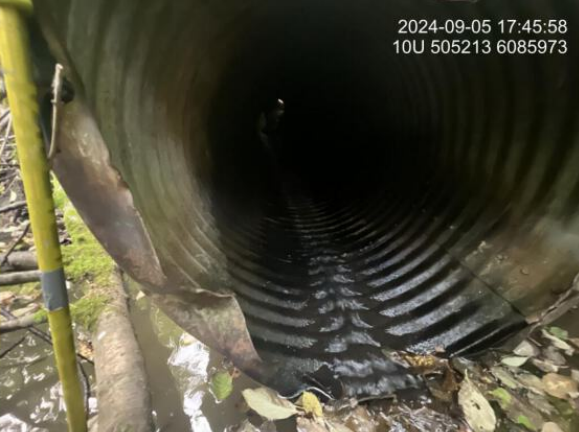
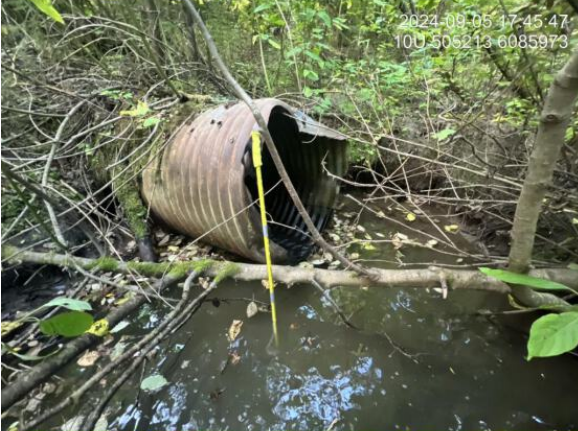
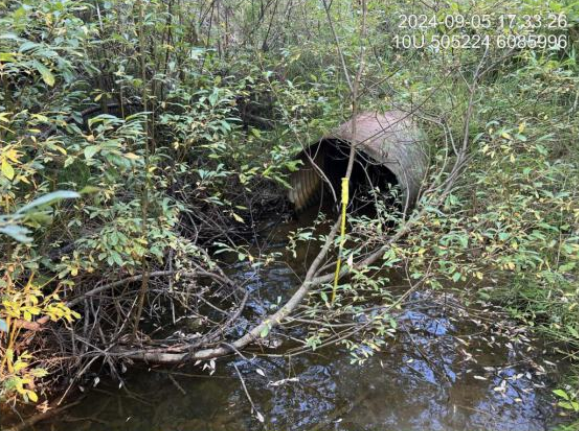
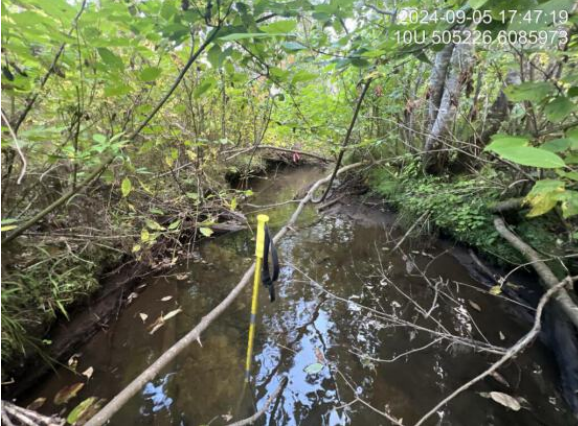
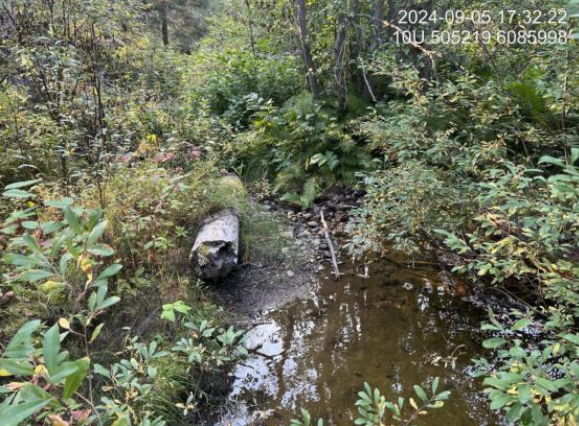
| Location and Stream Data | • | Crossing Characteristics | – |
|---|---|---|---|
| Final score | 32 | Barrier Result | Barrier |
| Comments: A low-gradient, low-energy system with moderate flow. Fish were observed downstream near the highway crossing. The culvert was deteriorating and was poorly installed, causing significant upstream water backup. Medium value habitat due to dense riparian vegetation, including shrubs and ferns.NULL. 17:35:22 | | | |

| Location and Stream Data | • | Crossing Characteristics | – |
|---|---|---|---|
| Fix type | Replace with New Open Bottom Structure | Fix Span / Diameter | 19.5 |

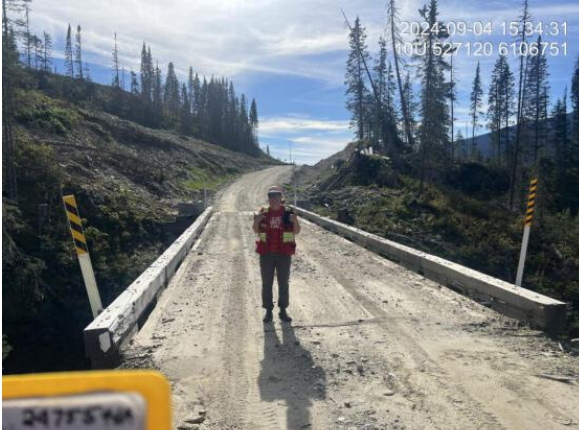
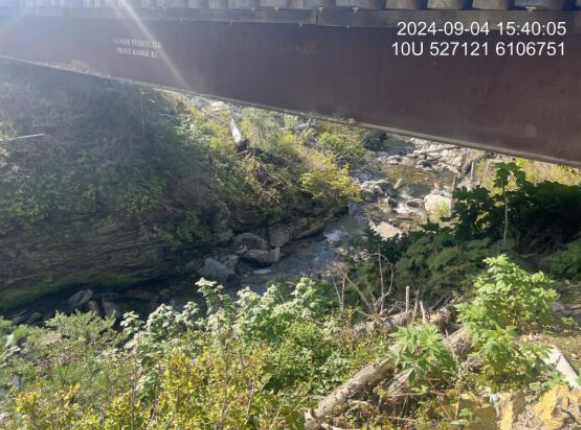
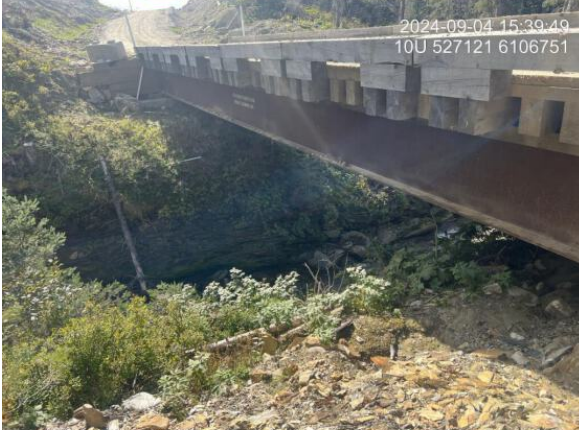
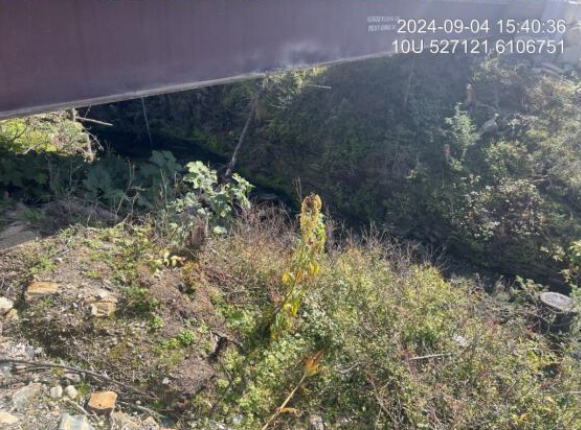
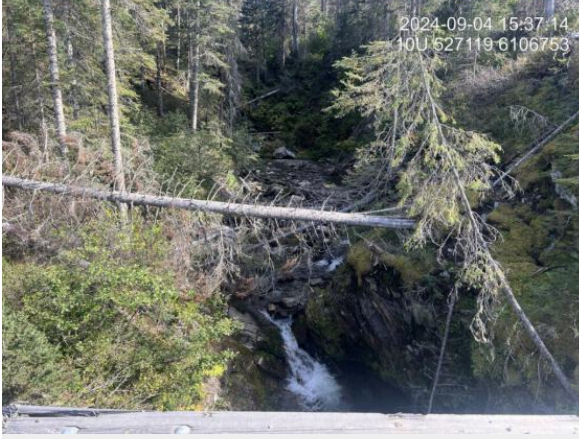
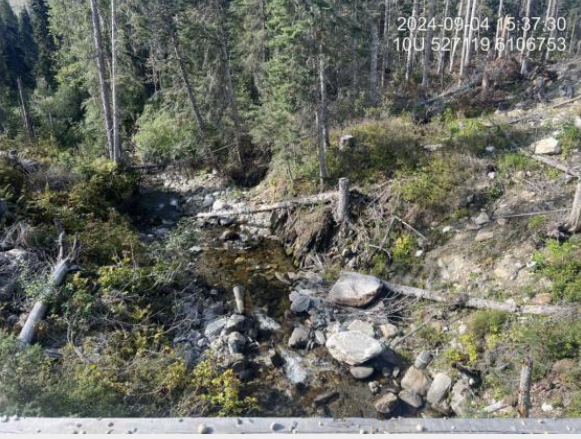
| Location and Stream Data | • | Crossing Characteristics | – |
|---|---|---|---|
| Photos: PSCIS ID 24755464. From top left clockwise: Road/Site Card, Barrel, Outlet, Downstream, Upstream, Inlet. | | | |

| Location and Stream Data | • | Crossing Characteristics | – |
|---|---|---|---|
| Comments: New bridge in 2024. Small cascades upstream.. 15:27:12 | | | |

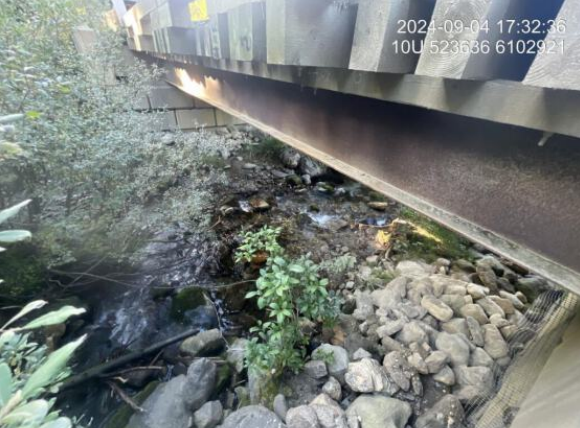
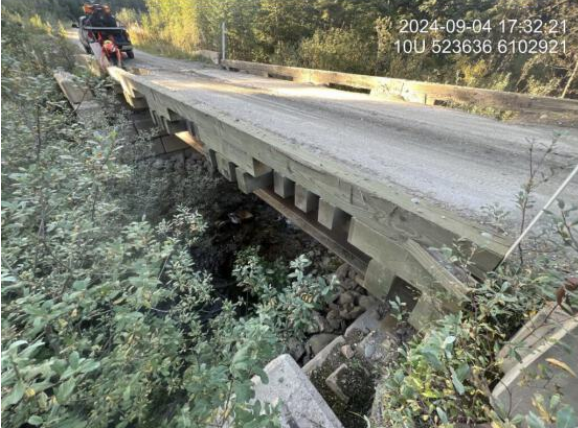
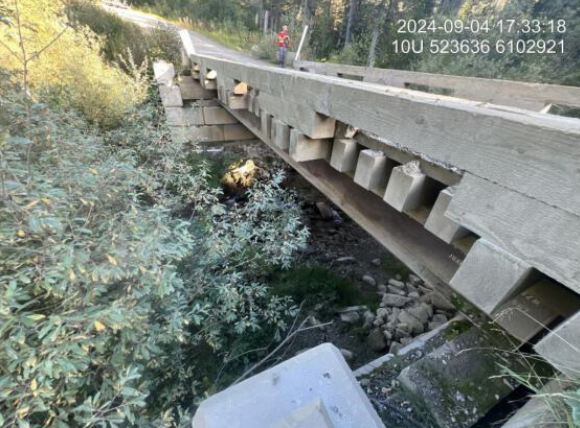
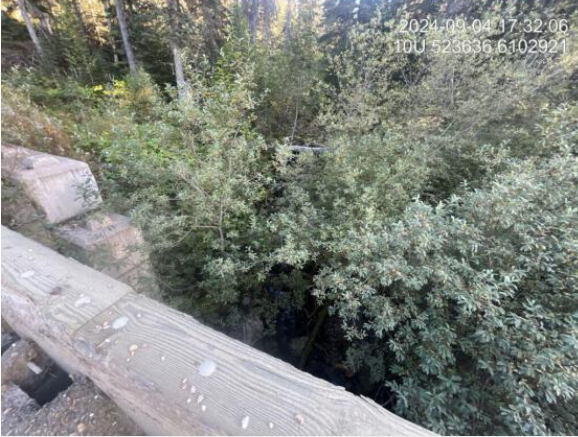
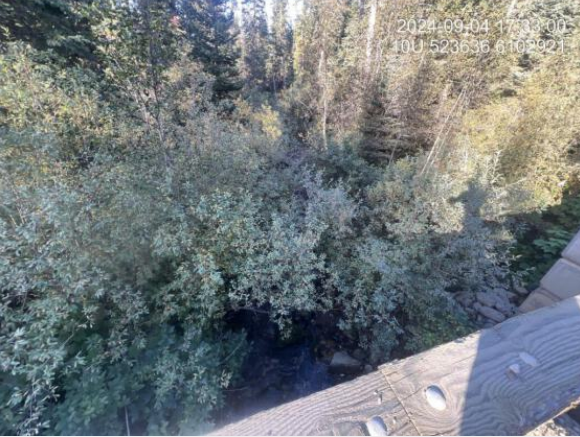
| Location and Stream Data | • | Crossing Characteristics | – |
|---|---|---|---|
| Photos: PSCIS ID 16602771. From top left clockwise: Road/Site Card, Barrel, Outlet, Downstream, Upstream, Inlet. | | | |

| Location and Stream Data | • | Crossing Characteristics | – |
|---|---|---|---|
| A 3 m high beaver dam is located just upstream of the road, with a large wetland area upstream.. 18:03:41 | | | |
