**TOLKO INDUSTRIES LTD., LAVINGTON  
INTERIM INTERIOR WATERSHED  
ASSESSMENT PROCEDURE  
UPPER CREIGHTON CREEK and  
FERRY CREEK**

**Project No. 0808-98-90481**

**March 1999**

EBA ENGINEERING CONSULTANTS LTD.  
Vancouver, B.C.

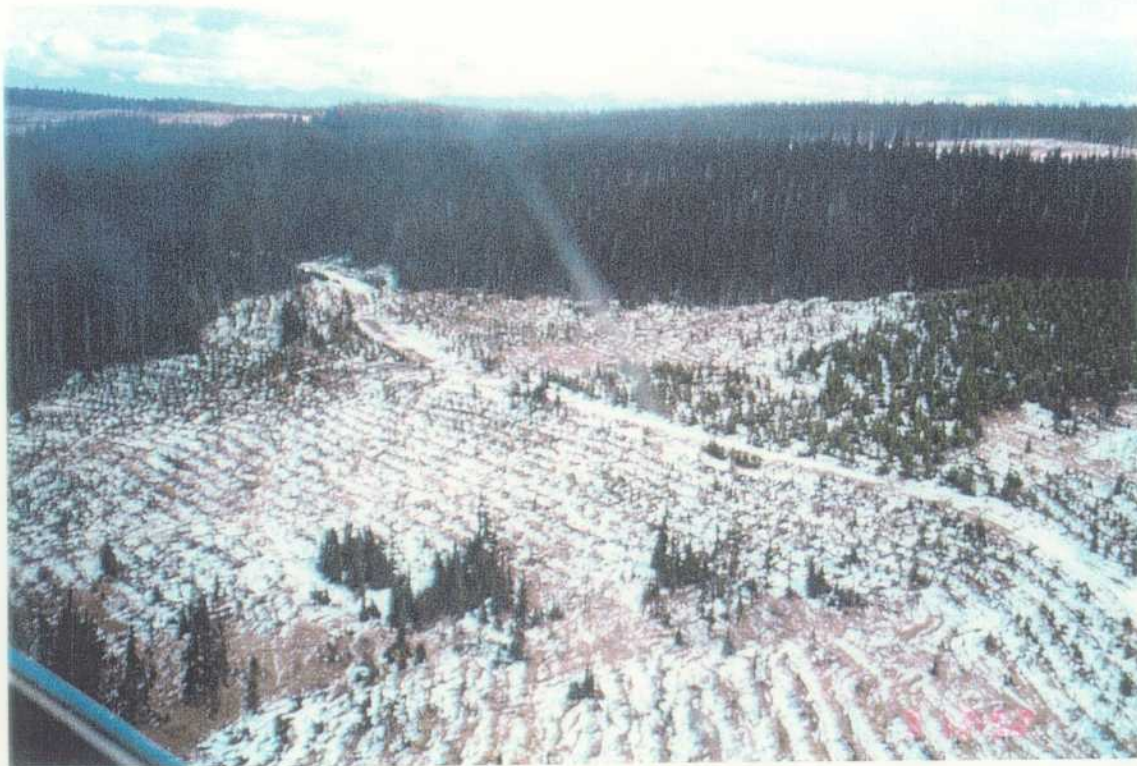
Photo 1. Upper Creighton Creek, Southern Upland Plateau.

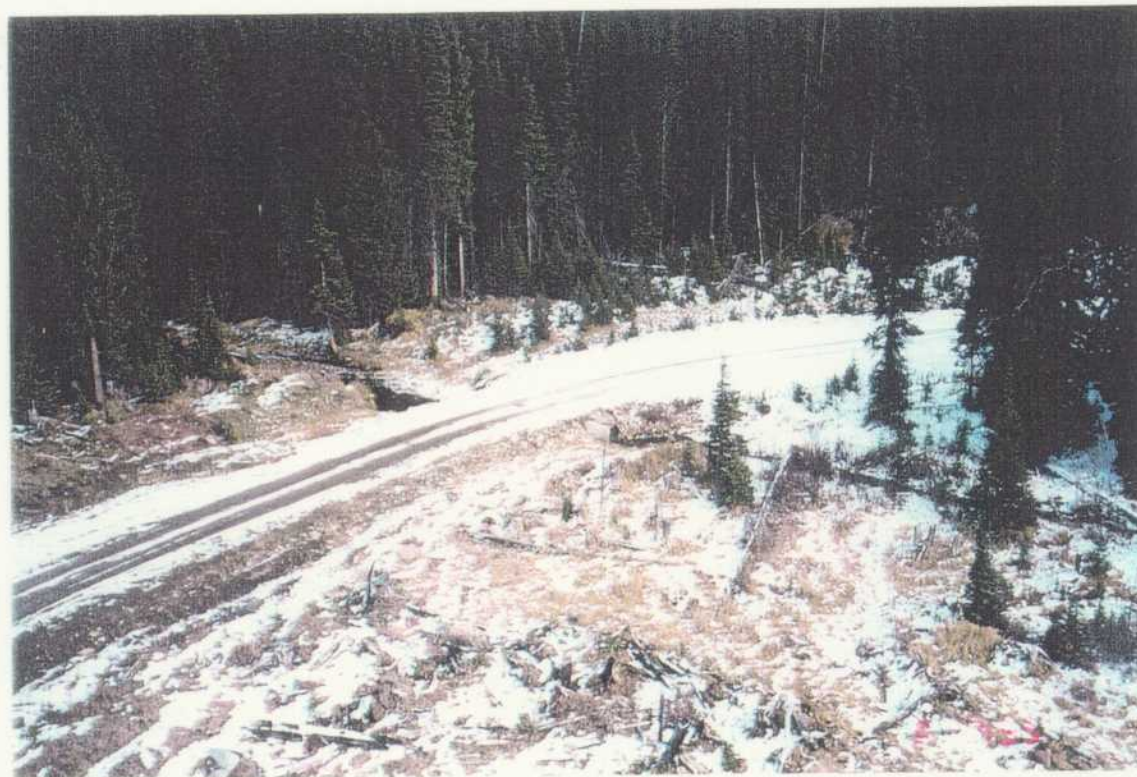
Photo 2. Upper Creighton Creek, Southern Upland Plateau. Typical road/stream crossing.

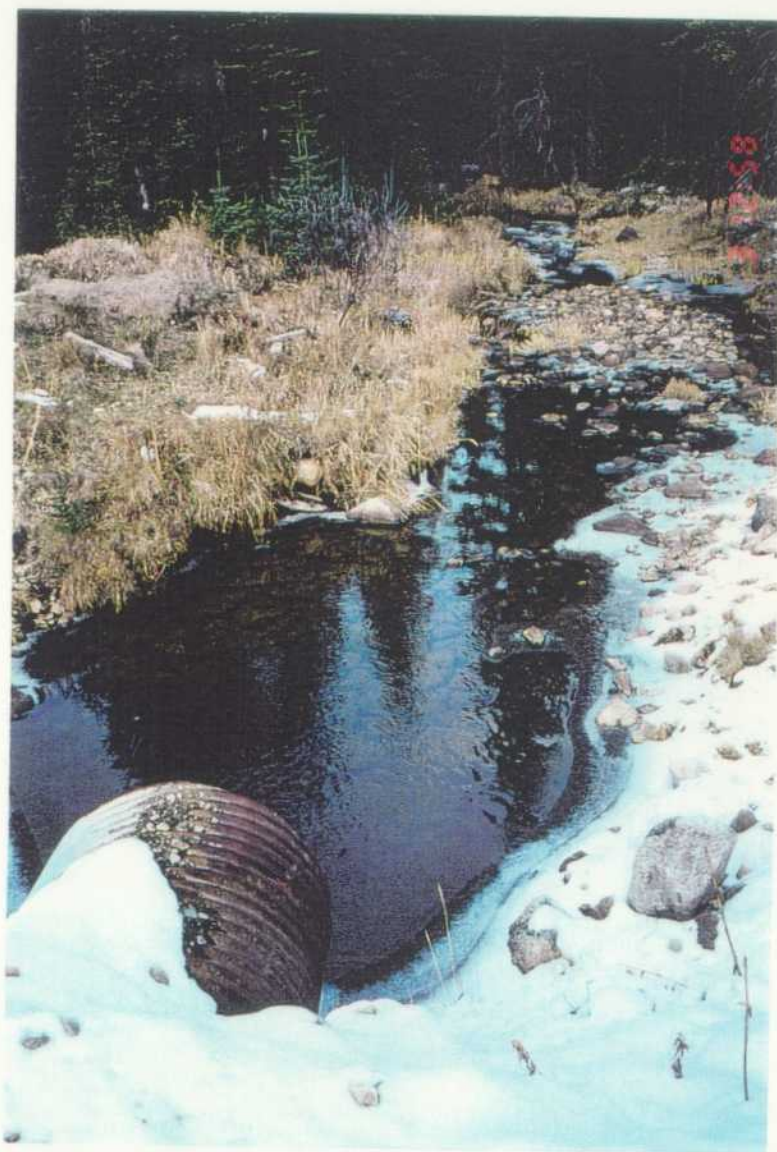
Photo 3. Upper Creighton Creek, Southern Upland Plateau. Typical stream reach.

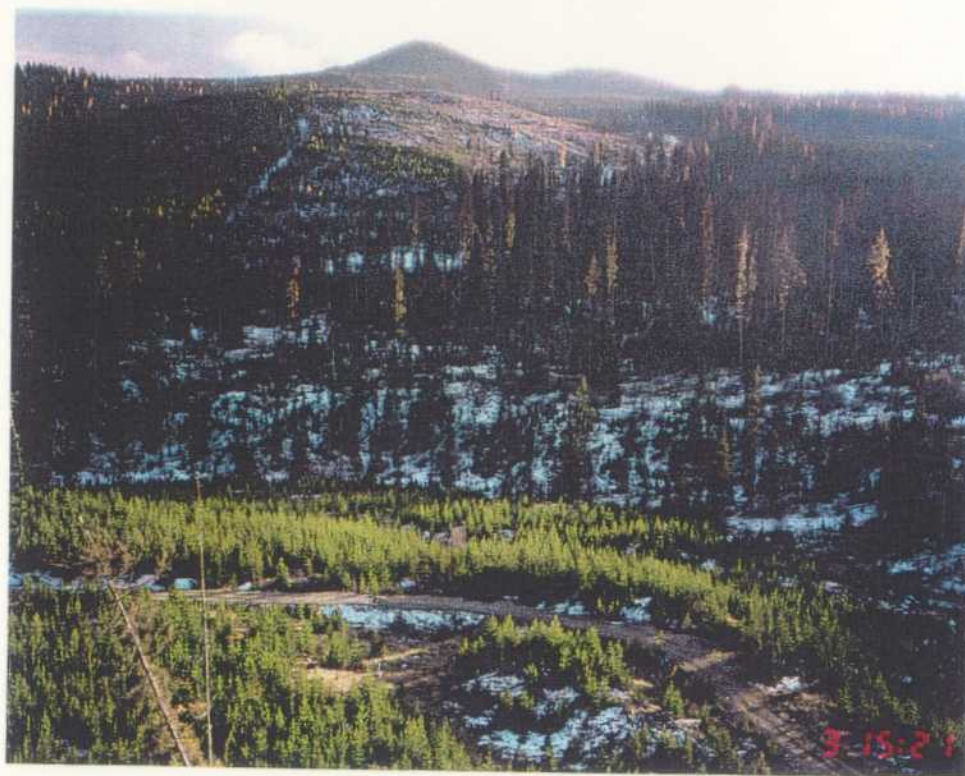
Photo 4. Upper Creighton Creek, West Tributary. Typical gentle to moderately sloping terrain. Main channel of Tributary A in foreground.

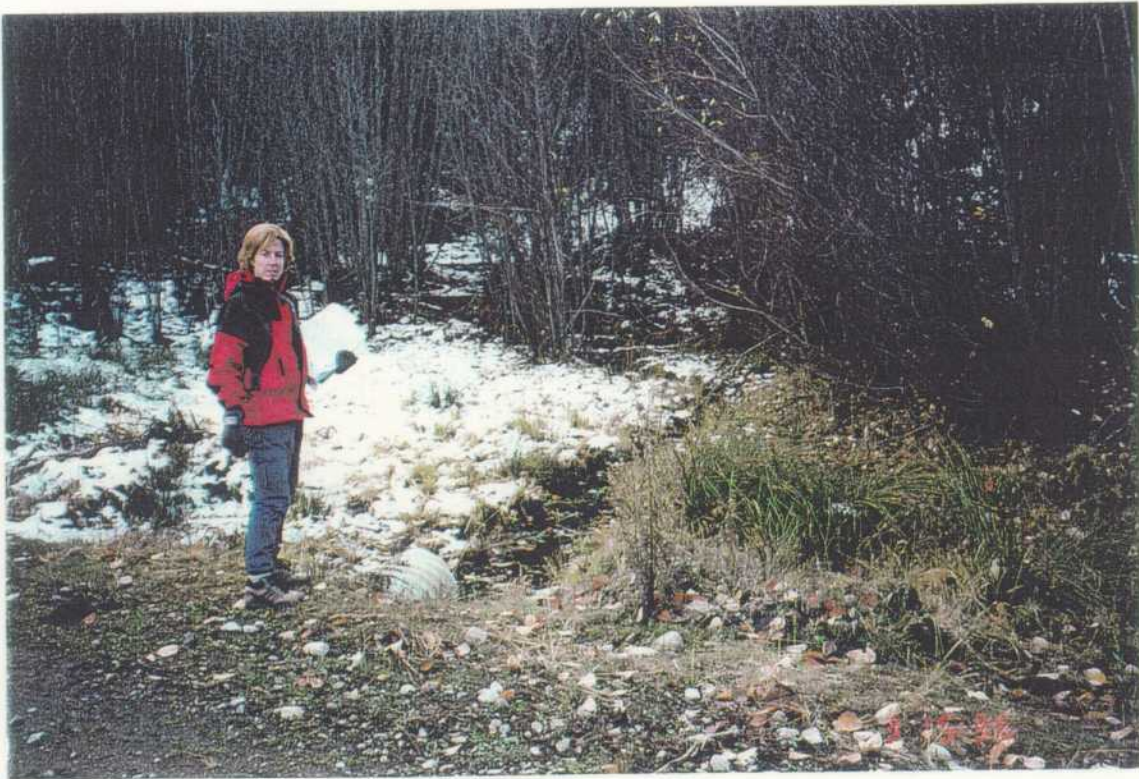
Photo 5. Upper Creighton Creek, West Tributary. Typical creek/road crossing. Low slope and stream gradients.

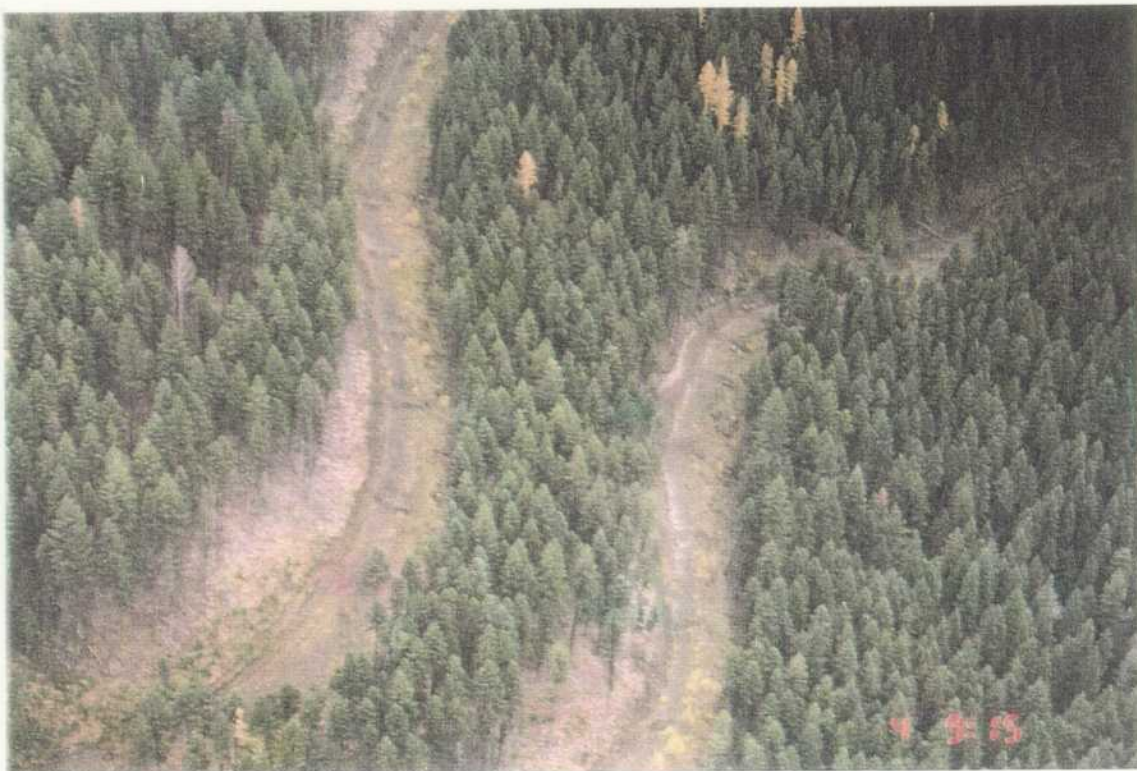
Photo 6. Upper Ferry Creek, Road FE4, Section 1. Semi-permanent deactivation. Frequent water bars.

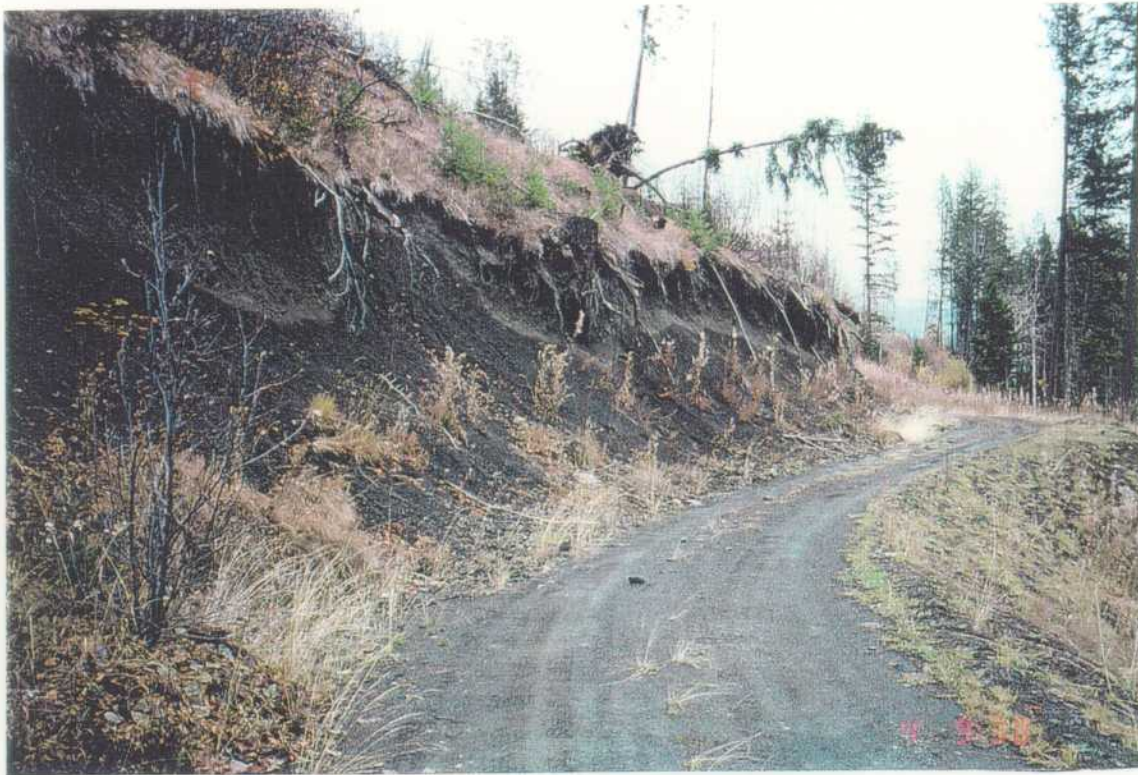
There are several high work priority road alignments. One is on FE4, Sec. 2 (Map 5). The road crosses an ephemeral creek in a steep gully and has sloughing cutslopes, and water directed across the road onto fillslopes supported by organic material (Photos 7-9). There is judged to be a high risk here, and upgrading of road drainage and some pullback is recommended. Little sediment has been transported to the main channel to date from the existing fillslope failure.

**Photo 7.** FE4, Section 2. Sloughed cutslope. No functioning ditch. Blocked culverts intakes.

Mitigation of all the high work priority sites is recommended. This will generally mean rip-rapping and possibly some drainage control.

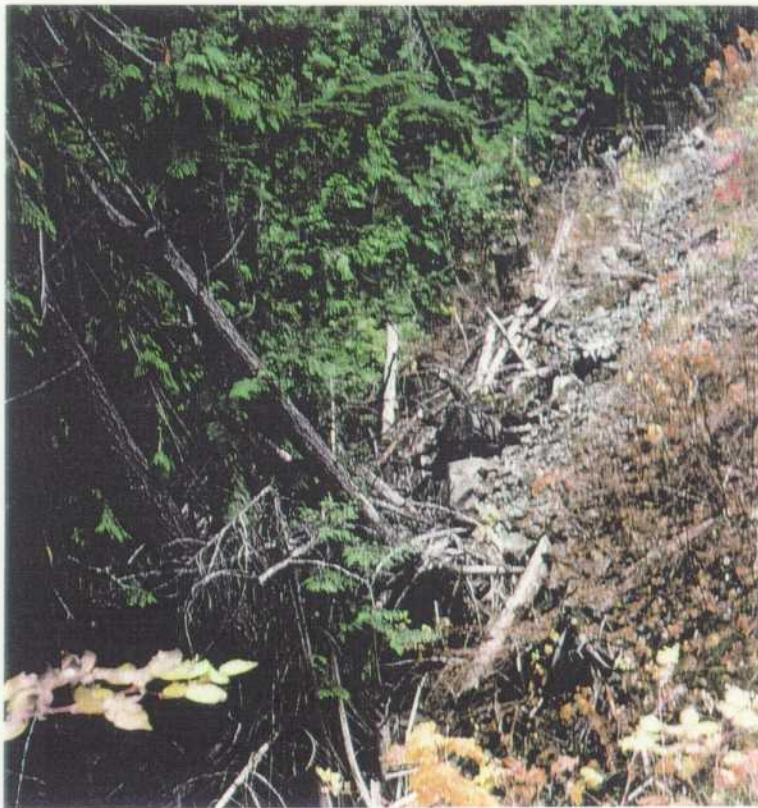
**Photo 8.** FE4. Fillslope supported by organics and trees, on 80% sideslopes of gully connected to Reach 7 of Ferry Creek (see Photo 9).

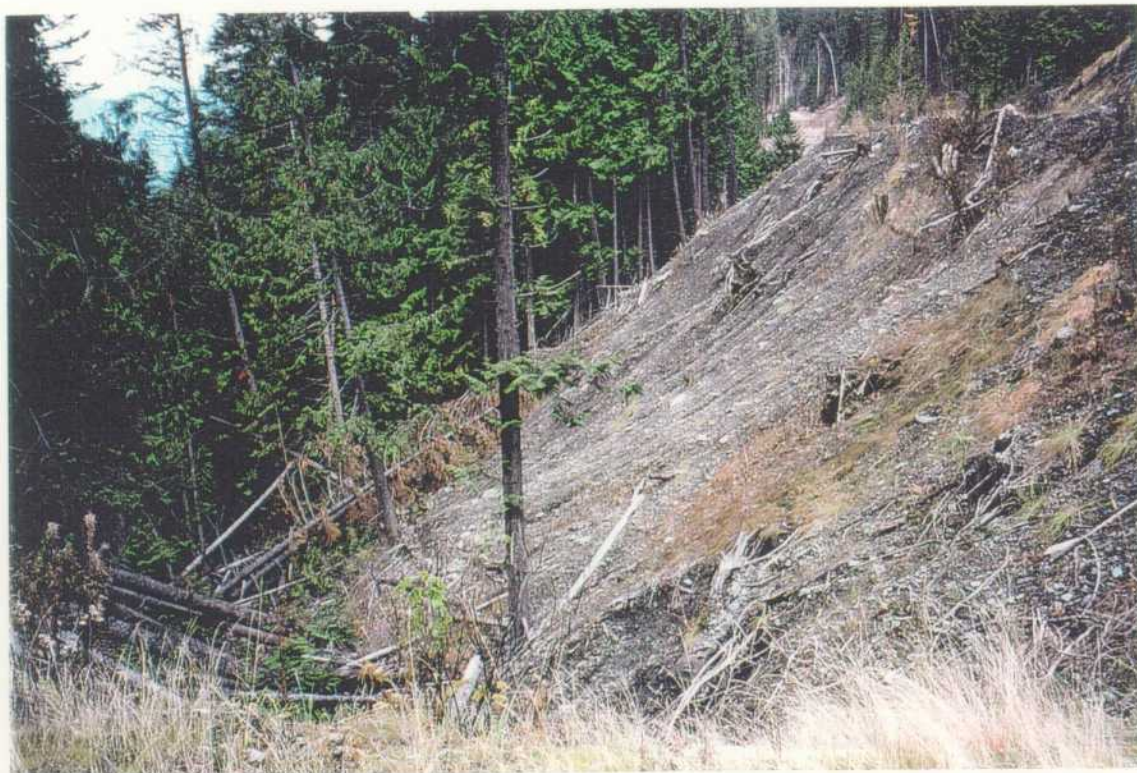
Photo 9. FE4. Failed fillslope into a gully connected to Reach 7 of Ferry Creek. Near TP11.

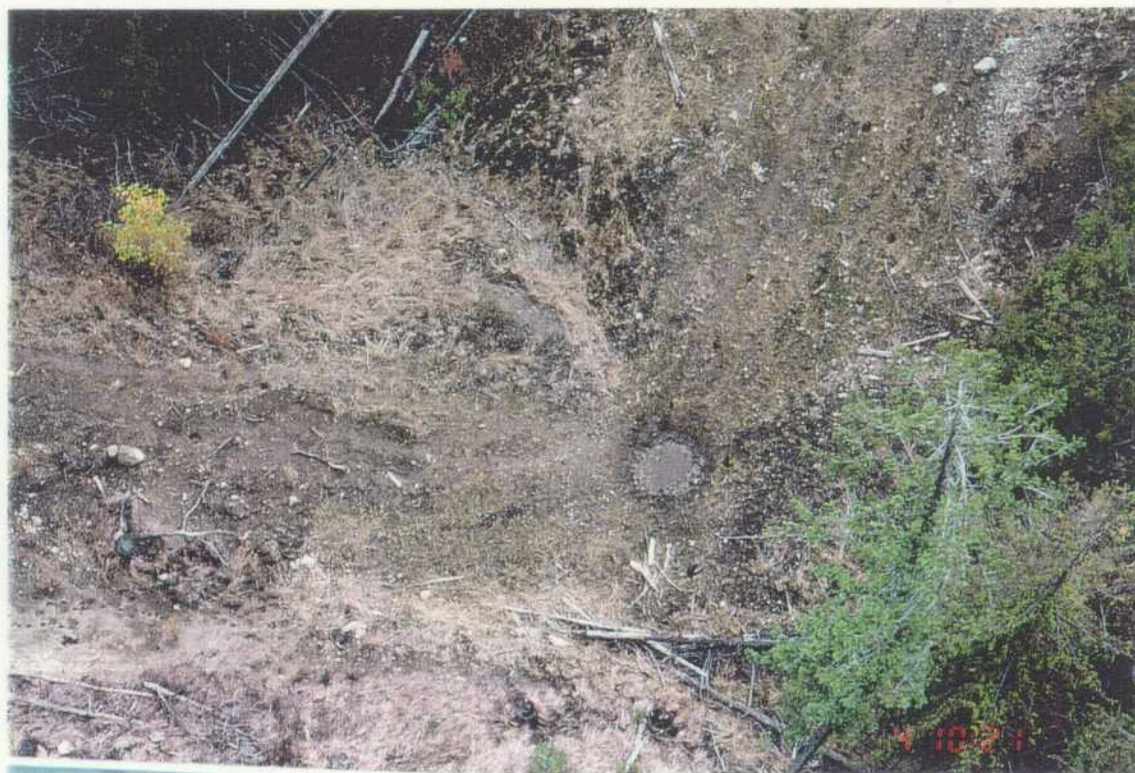
Photo 10. FE7, TP12. No culvert at gully crossing. Water and sediment crossing the road. Potential for failure below the road (see Photo 11).

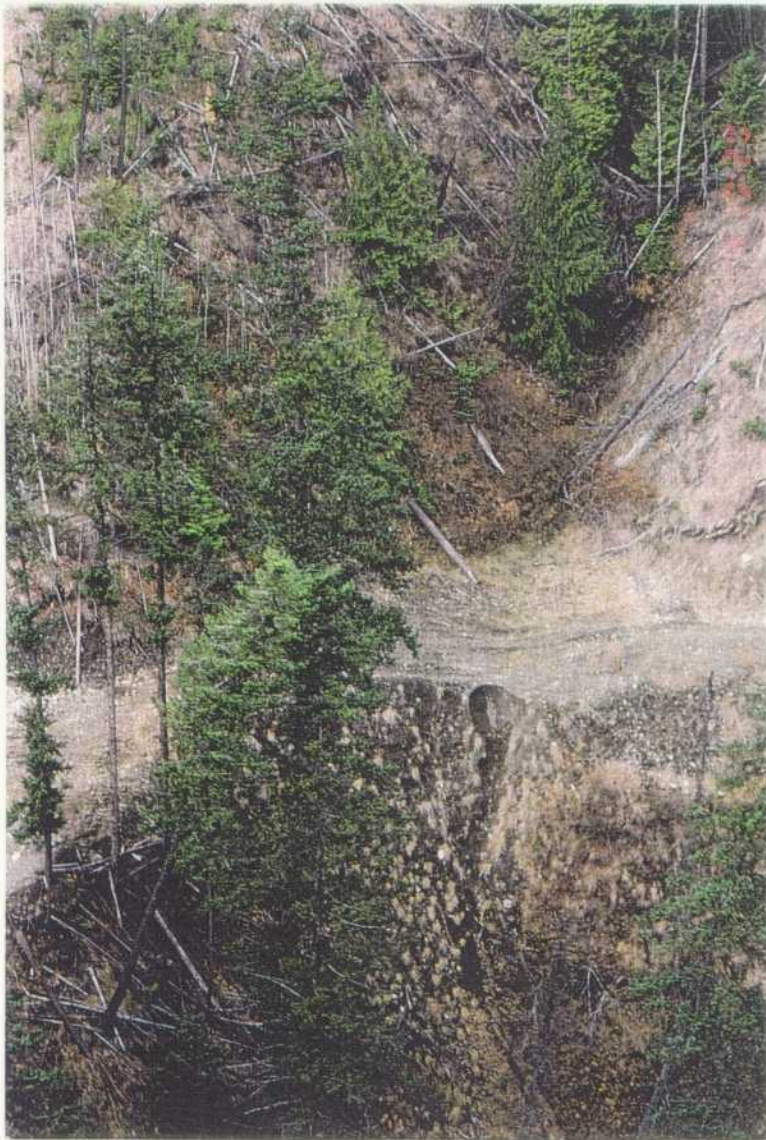
Photo 11. FE7, TP13. No culvert at gully crossing. Water across road initiating fillslope failure.

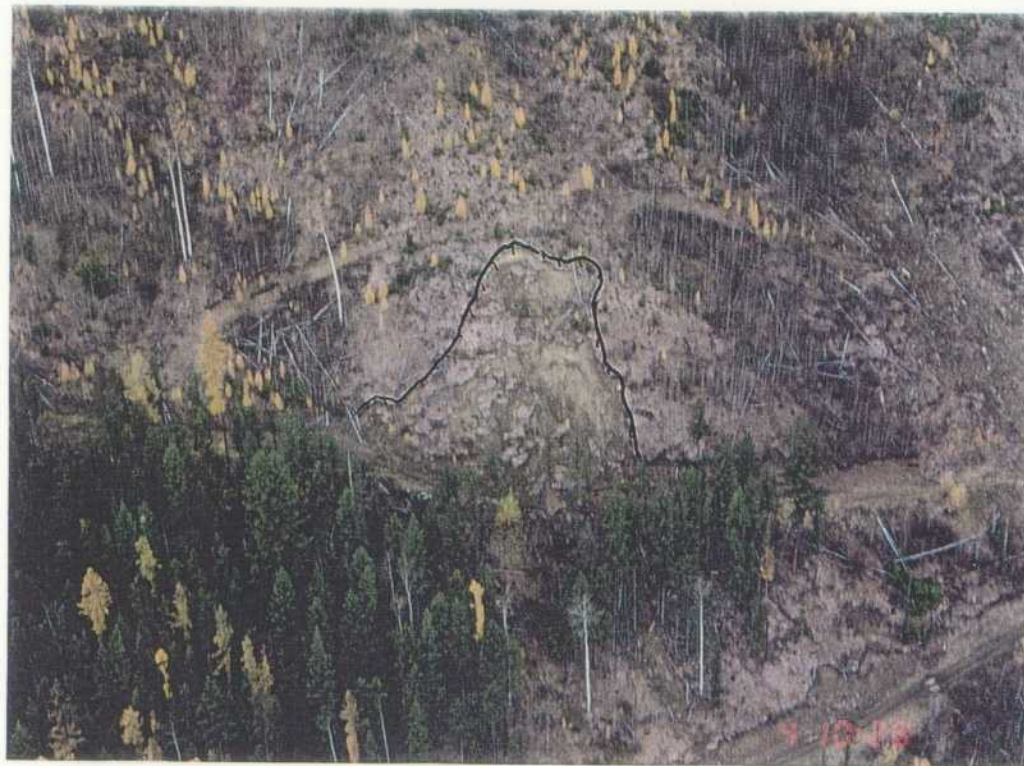
On road FE8 there is a large earth slump resting on the road prism, blocking access (Photos 12 and 13). A particle size analysis of a near surface soil sample was carried out (Figure 5). It had 48.5 % silt and clay and over 24% clay. This is a very high percentage of fine grained material, and it can be expected that high road cuts through this kind of soil will result in similar slopes failures. These kind of large, relatively deep-seated earth slumps are difficult to remediate. Fortunately, almost no sediment is moving beyond the immediate road prism and the slide may stabilize where it is. A second road surface is located a short distance downslope and would likely prevent further sediment movement. However, if the toe of the slide is removed to gain access, further movement of the slide is likely, and it will prove difficult to keep the road open for any length of time.

Photo 12. FE8, TP23. Large slump in fine grained soils. No sediment transfer below lower road. Road is blocked by the toe of the slide.

If the road is to be re-opened to access CP 326-4, it is recommended that an engineered fill be constructed to limit cut slope height, or the road be relocated. The extent of these soils, or the presence of other steep slope sections which would require a high cut slope are not known for existing road FE8, or the proposed

extension to access CP 326-4. An assessment by a qualified geotechnical professional is recommended to prevent further problems along this road. This slide has had no impact on any channel to date, nor is any expected in the future, if it is managed properly.

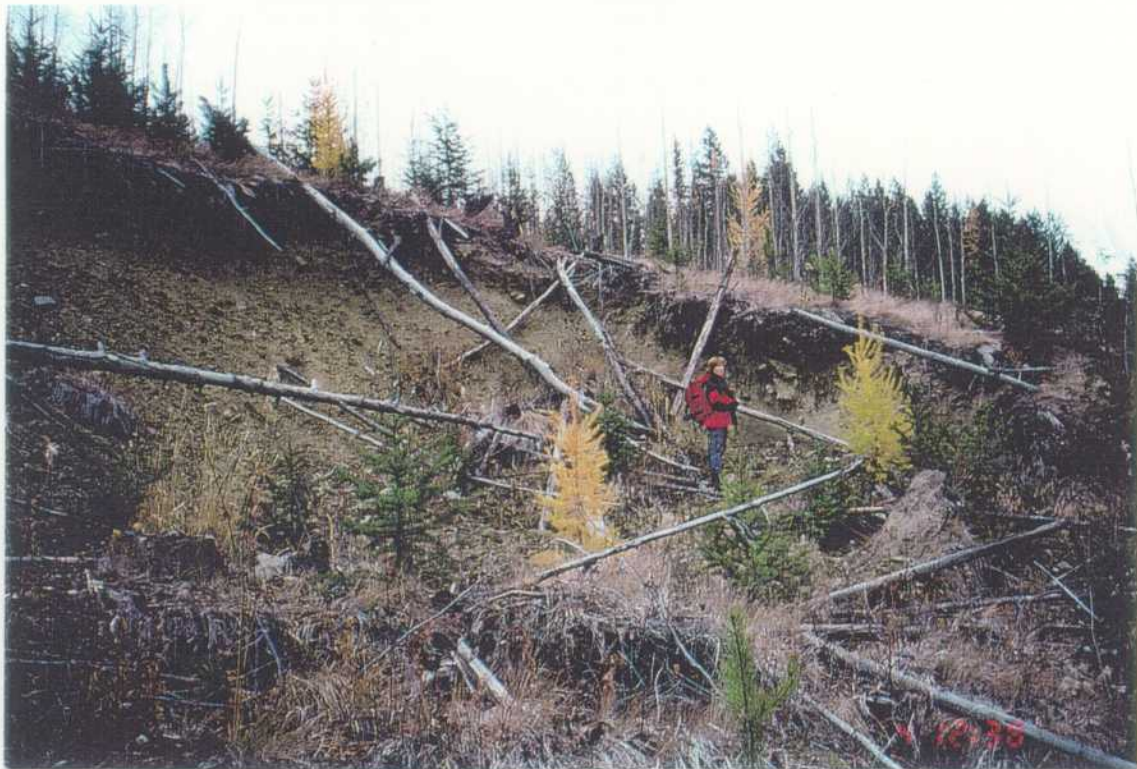
Photo 13. FE8, TP23. Back scarp of large earth slump (see Photo 12).

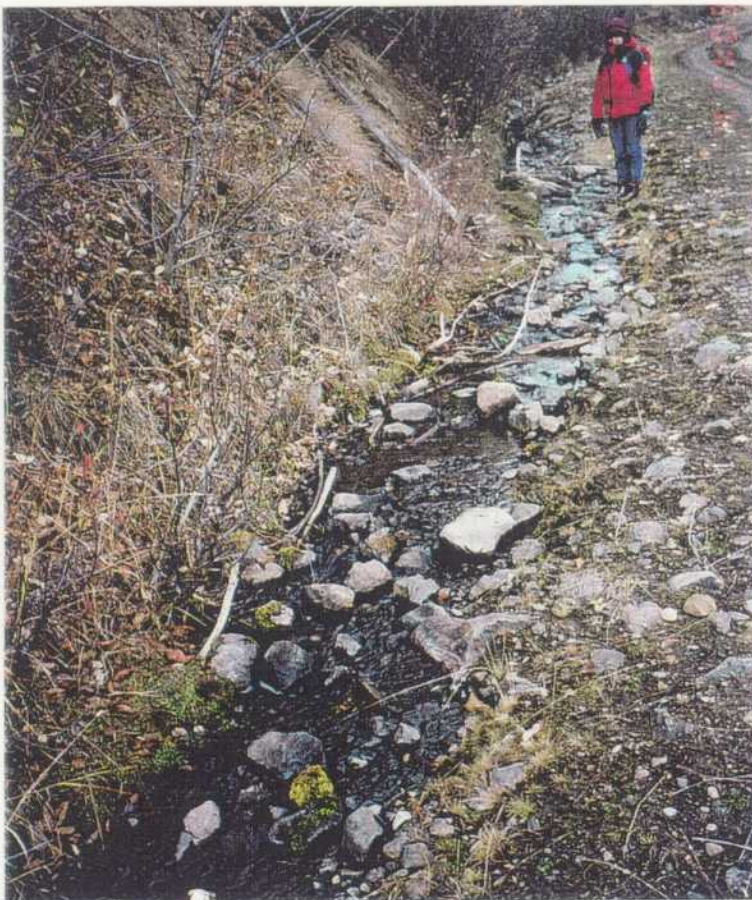
Photo 14. BS, TP14. Creek flow diverted down ditchline. Run-out on flat bench.

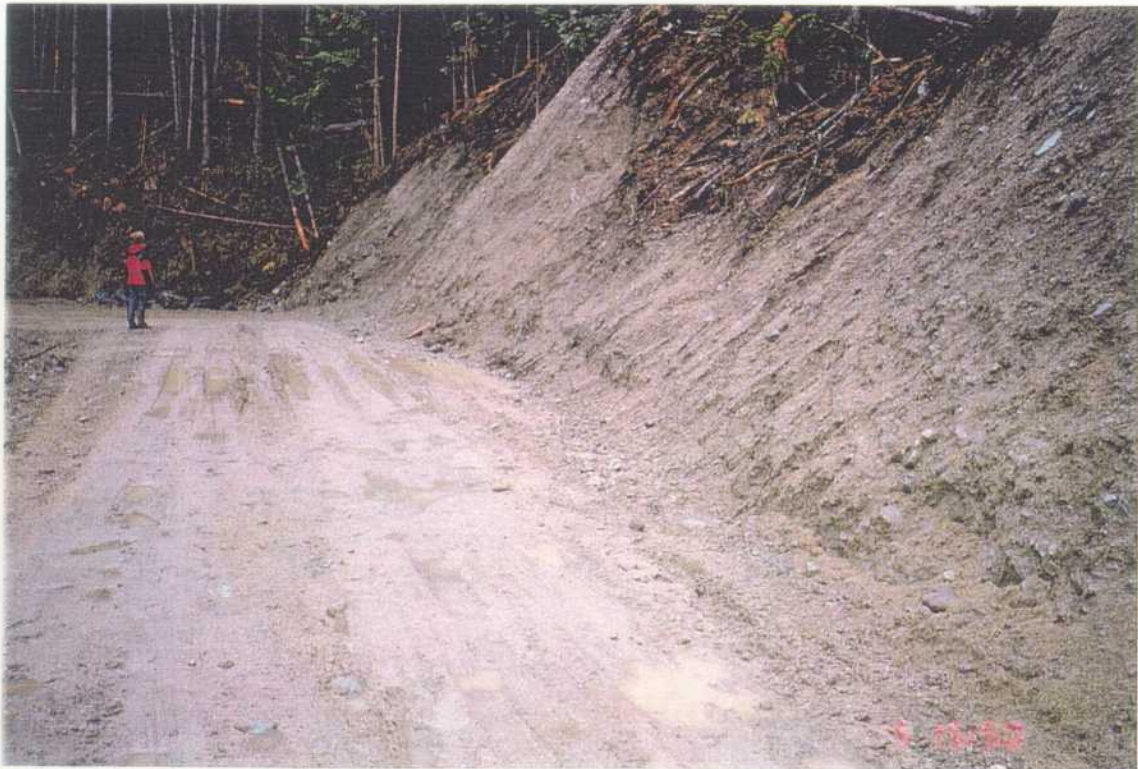
FE6 is newly constructed road, also crossing an ephemeral creek with steep gully sidewalls underlain by till and glaciofluvial silt and sand. Cutslope sloughing has infilled the ditch and water is directed onto large fillslopes in which tension cracks are evident (Photos 15,16). There is a high risk, and upgrading drainage and possibly some pullback is recommended. This has not been a significant downslope sediment source to date.

Photo 15. FE6, TP48. Sloughing cutslope, no functioning ditch. Low road grade crossing gully sidewalls. Water draining to fillslope – see Photo 16.

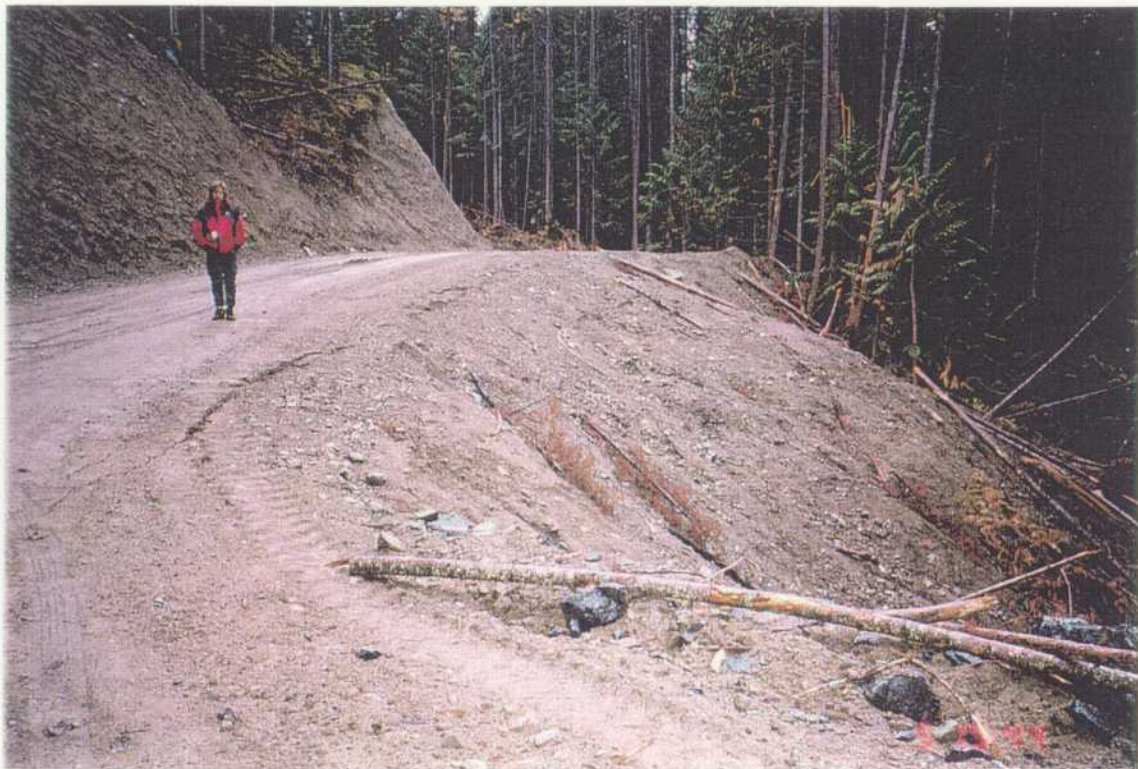
Photo 16. FE6, TP48. Long tension crack in large fill leading into ephemeral gully.

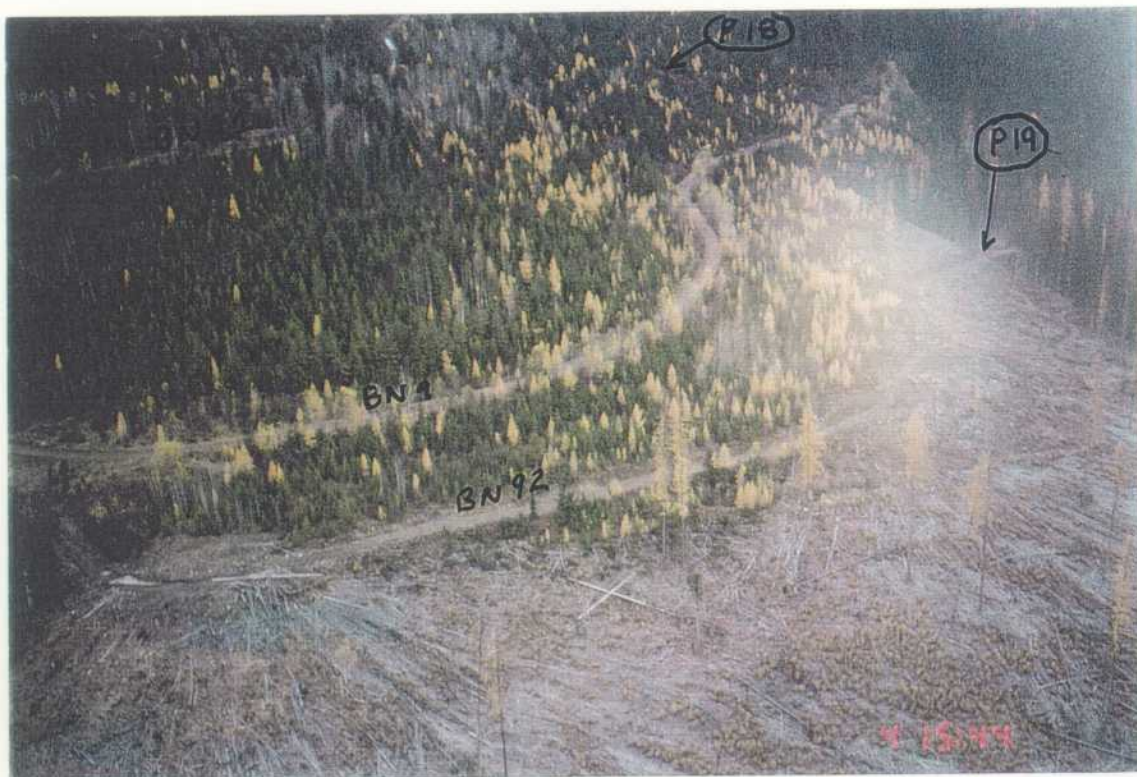
Photo 17. BN9. Road alignments on moderately steep (30 to 50%) slopes. Little sediment movement to perennial streams.

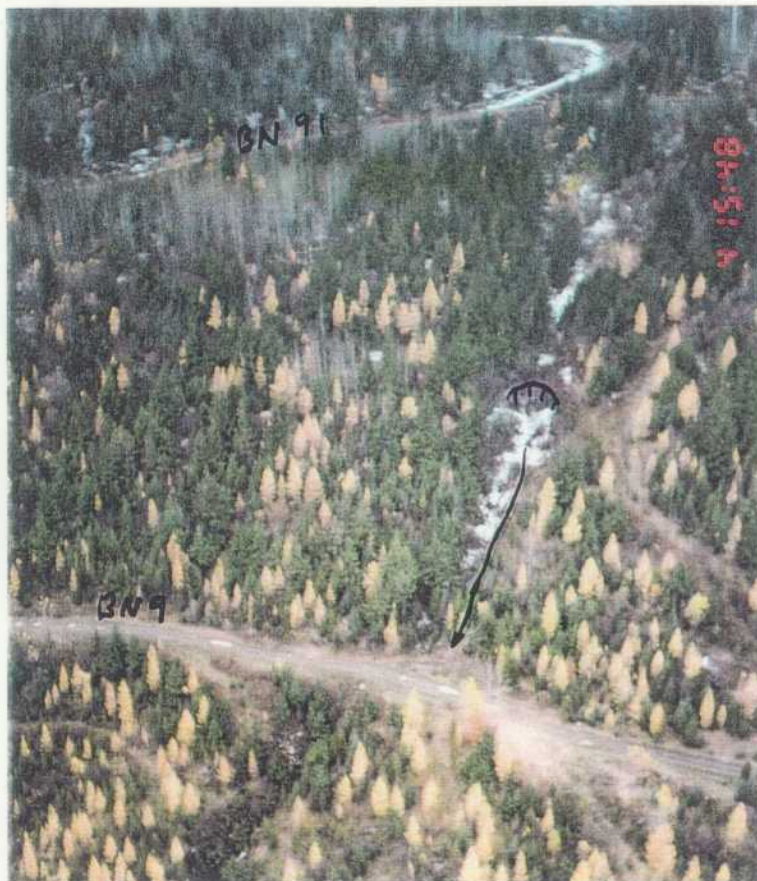
Photo 18. BN9. Old mid-slope failure from skid trail drainage? Appears greened-up with little current sediment movement (see Photo 19).

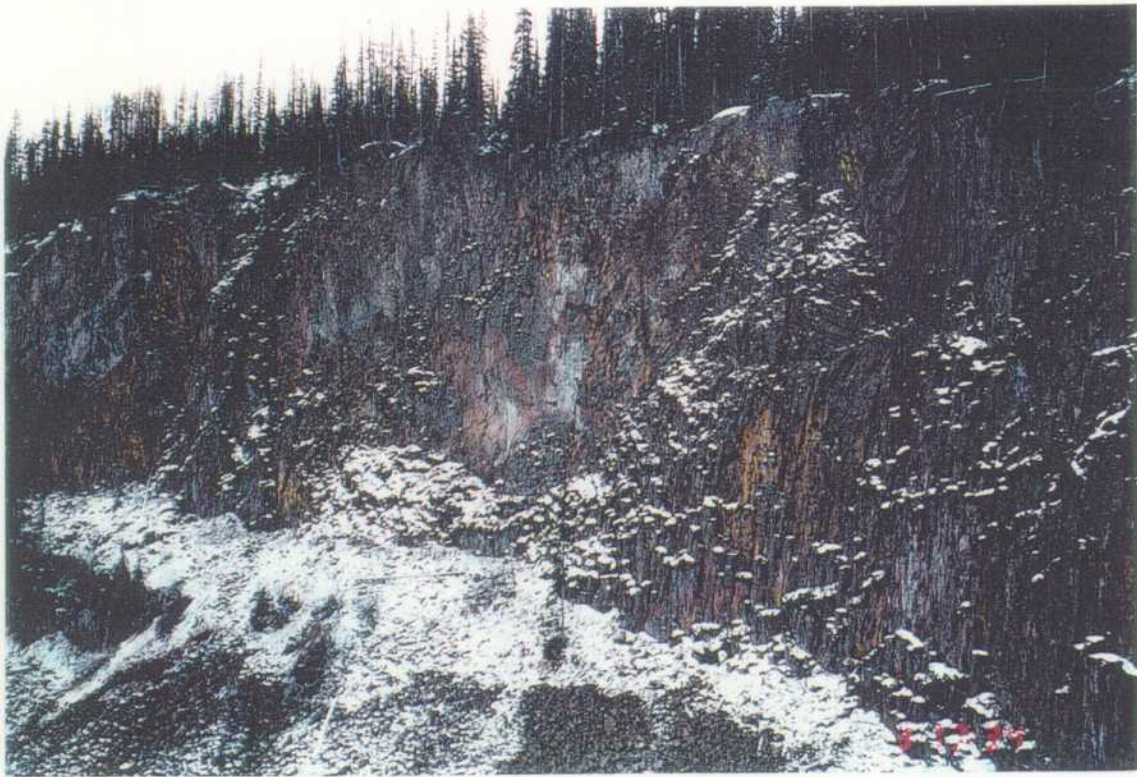
Photo 21. S43, Columnar Tertiary basalt in mid-Creighton Creek watershed.

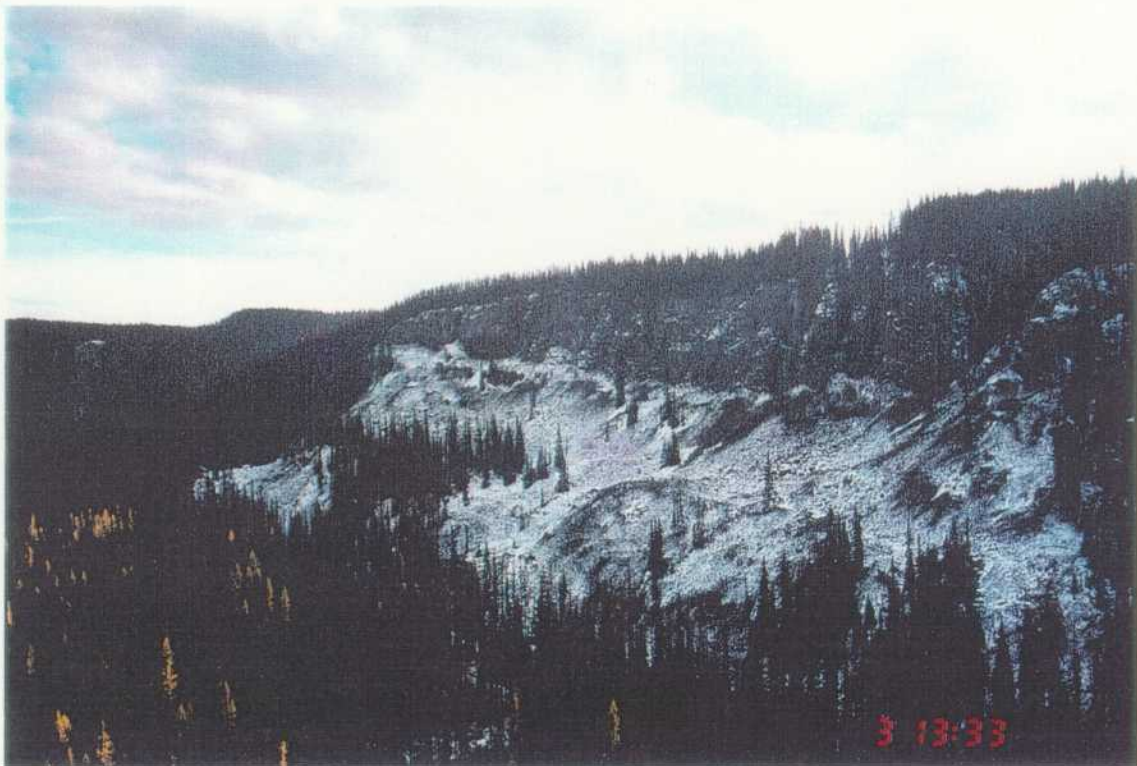
Photo 22. S43, basalt scarp and talus slopes. Harvesting proposed just below foot of exposed talus.

However, any development which has any potential to impact the active slump feature (S50) and the presumably inactive bedrock based slump and lateral-spreading type slides (S41, S42, S43 and RS51) should not proceed until a detailed assessment of the potential hazards and risks associated with these features is carried out by a professional with experience in these types

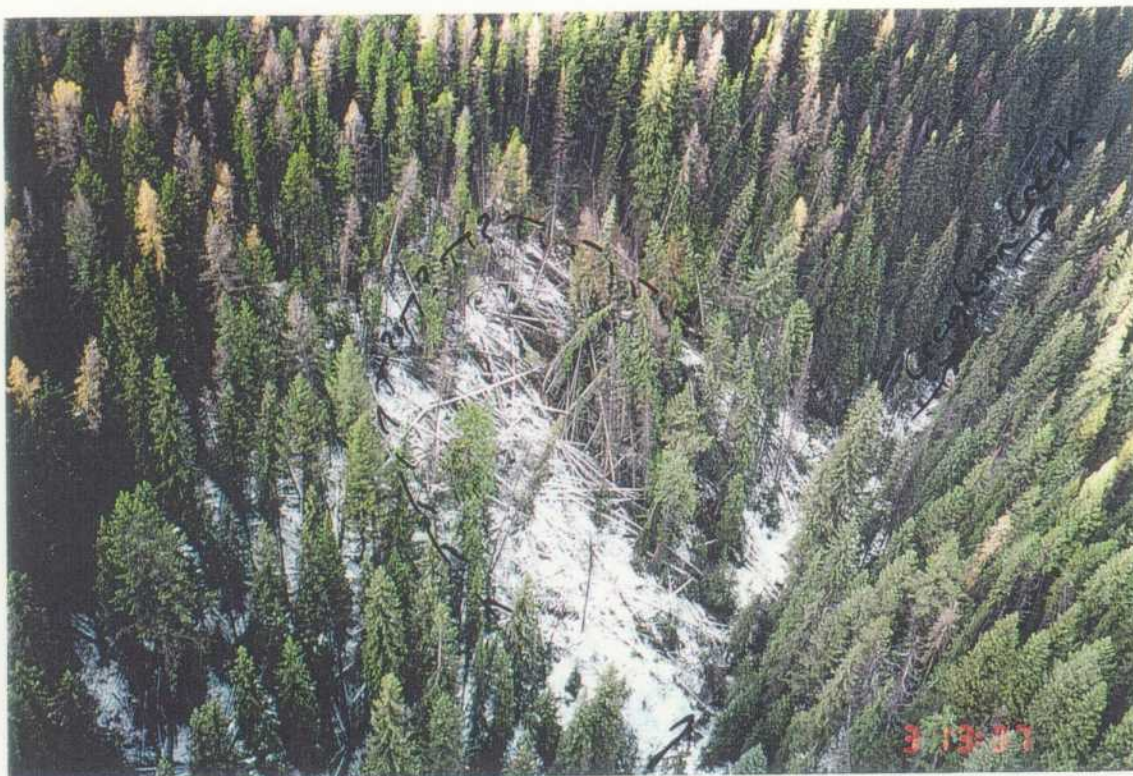
Several large to very large, active to inactive (relic), earth and rock slump and possibly lateral spreading type landslides were noted. Slide S50 is a currently active natural earth slump and has the potential to contribute substantial amounts of sediment to, and even fill the existing channel of Creighton Creek.

**Photo 23.** S50. Earth slump ~170m wide, adjacent to Creighton Creek.

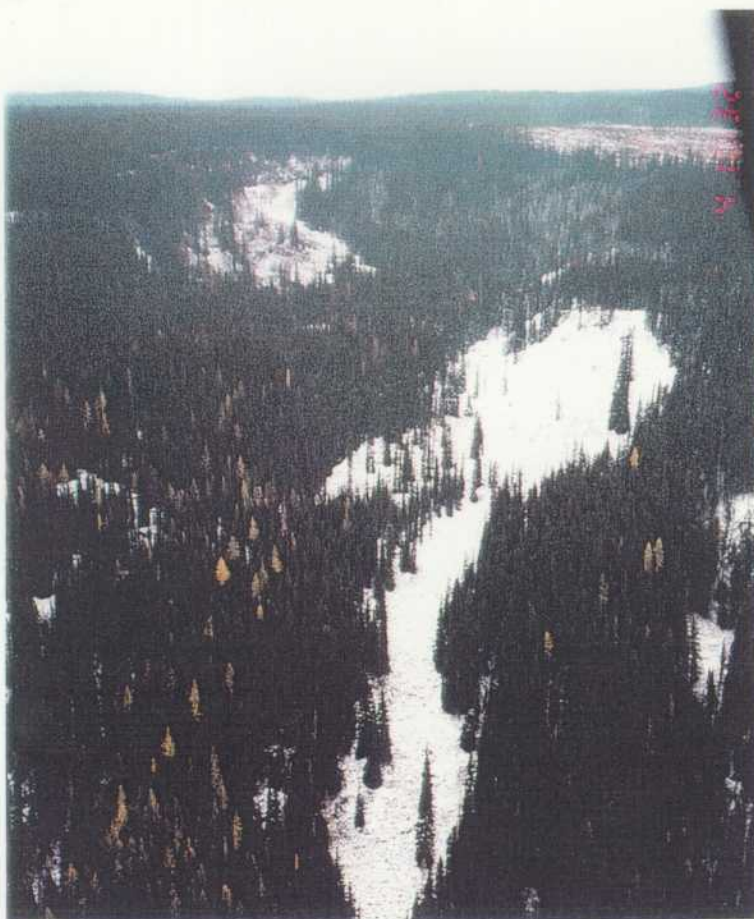
A large (>1 km) lateral-spreading type landslide (RS 52) has deferred block CP326-1 located in it. While it is probable that this is a relic feature (Evans, 1983), the area should be assessed by a qualified professional with experience in these types of slope failures before any development proceeds.

**Photo 24.** RS 52. Creighton Creek. Possible very large relic lateral spreading slide in Tertiary Volcanics.
