# **Watershed Condition Report**

## **Twig Creek**

**Tree Farm License 49**  
***(Vernon Forest District)***

**March 2001**

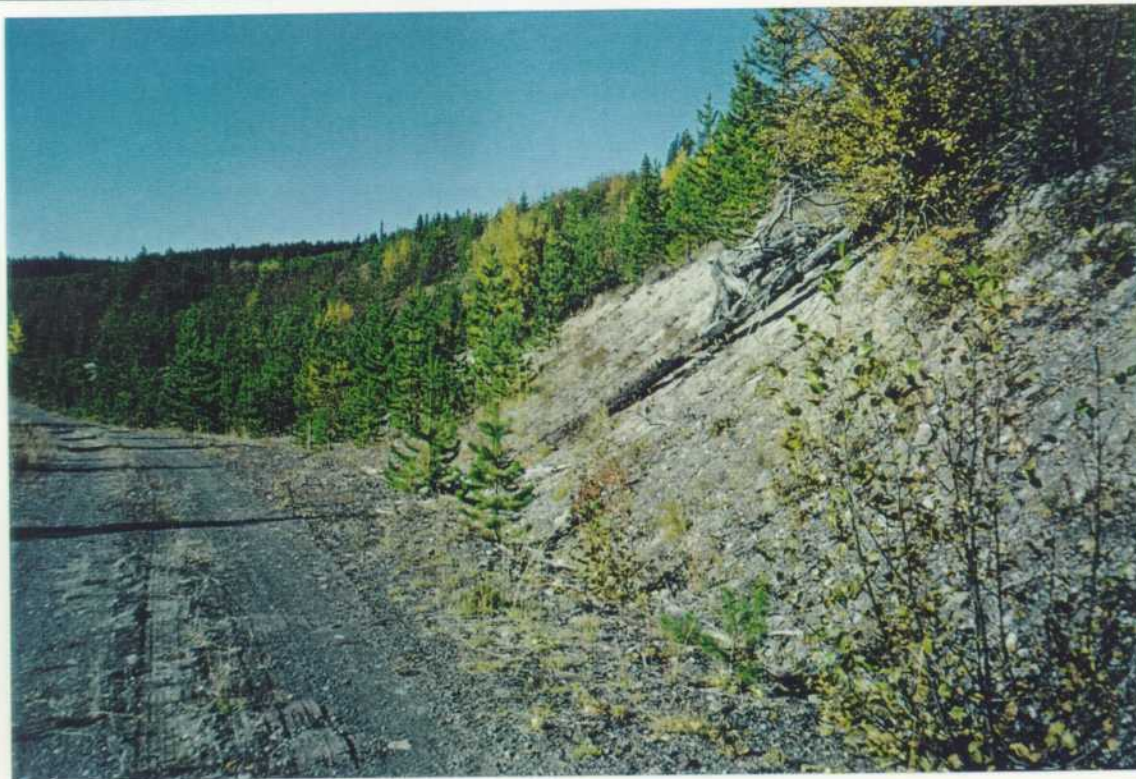
| IWRP SSS Site # | Sediment Source Type | IWRP SSS Risk | IWRP SSS Priority | Review Comments | Recommendation |
|---|---|---|---|---|--|
| 29 | Road | M | M | Exposed cutslope, no visible erosion and not connected to a watercourse | No action required |

**PHOTO 1.** SSS site 29 on the Twig Road. Example of a typical moderate risk and priority site likely not reviewed in the field. There is no connectivity to a watercourse from this dry raveling cutslope.

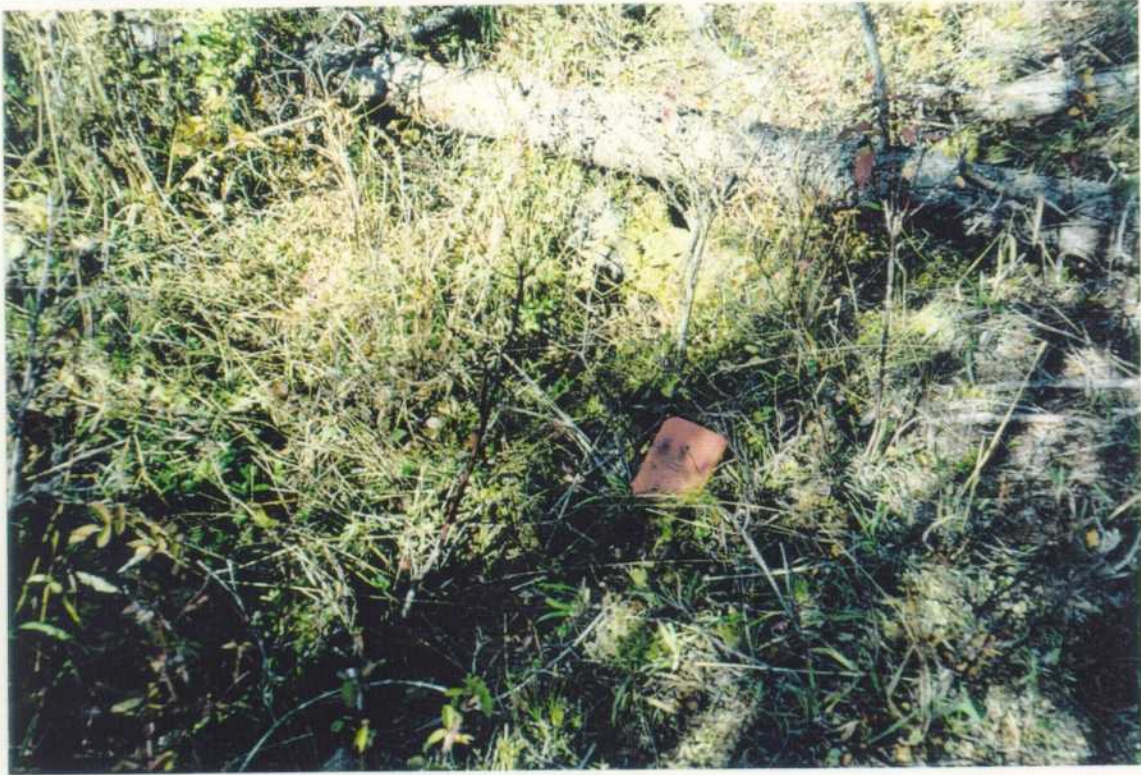
**PHOTO 3.** Small tributary downstream of site 936. Low sediment transport potential.

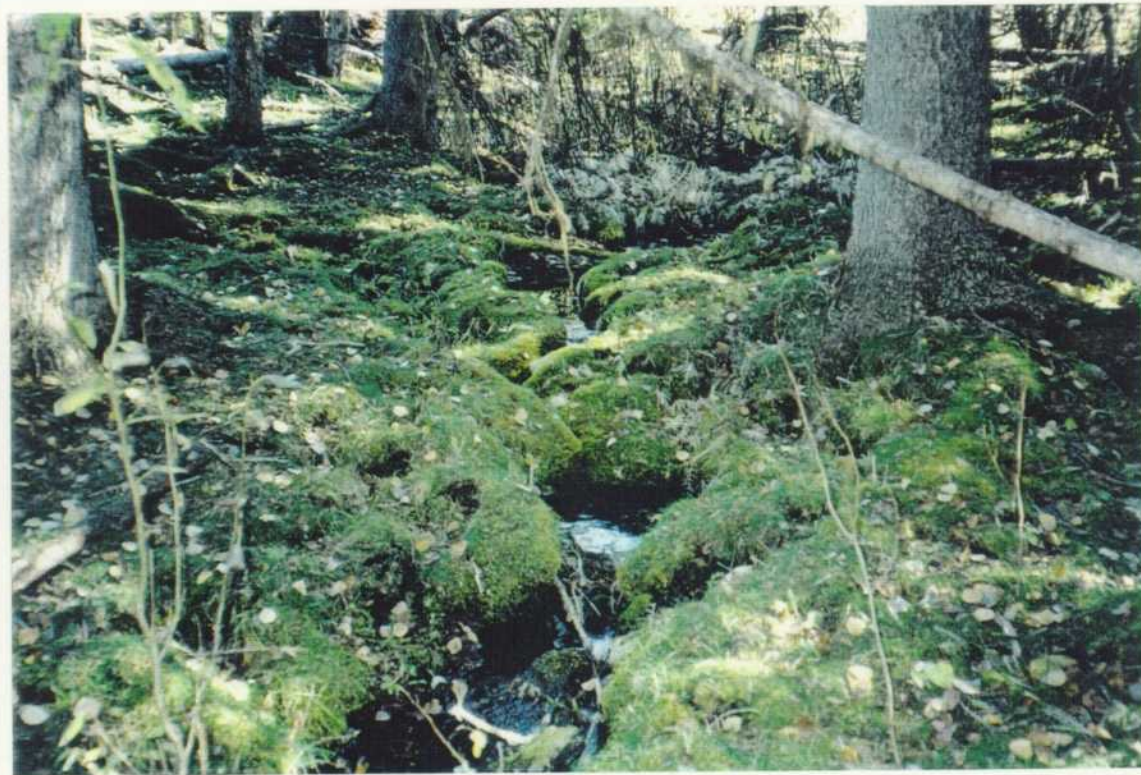
Jupiter Creek is stable with a sand and gravel bed, moss covered banks, and no evidence of increased sedimentation or runoff effects [Photo 4]. The channel was assessed throughout the basin and on the lower mainstem at the Wood 200 Road crossing. The size of the main Jupiter channel is abnormally small when compared to upstream drainage area. This observation can only be explained by high soil infiltration capabilities and low drainage density (length of stream per km<sup>2</sup>) that is present in the watershed. These characteristics permit a large

**PHOTO 4.** Jupiter Creek downstream of the Wood 200 crossing. No sedimentation, channel or bank disturbance concerns.

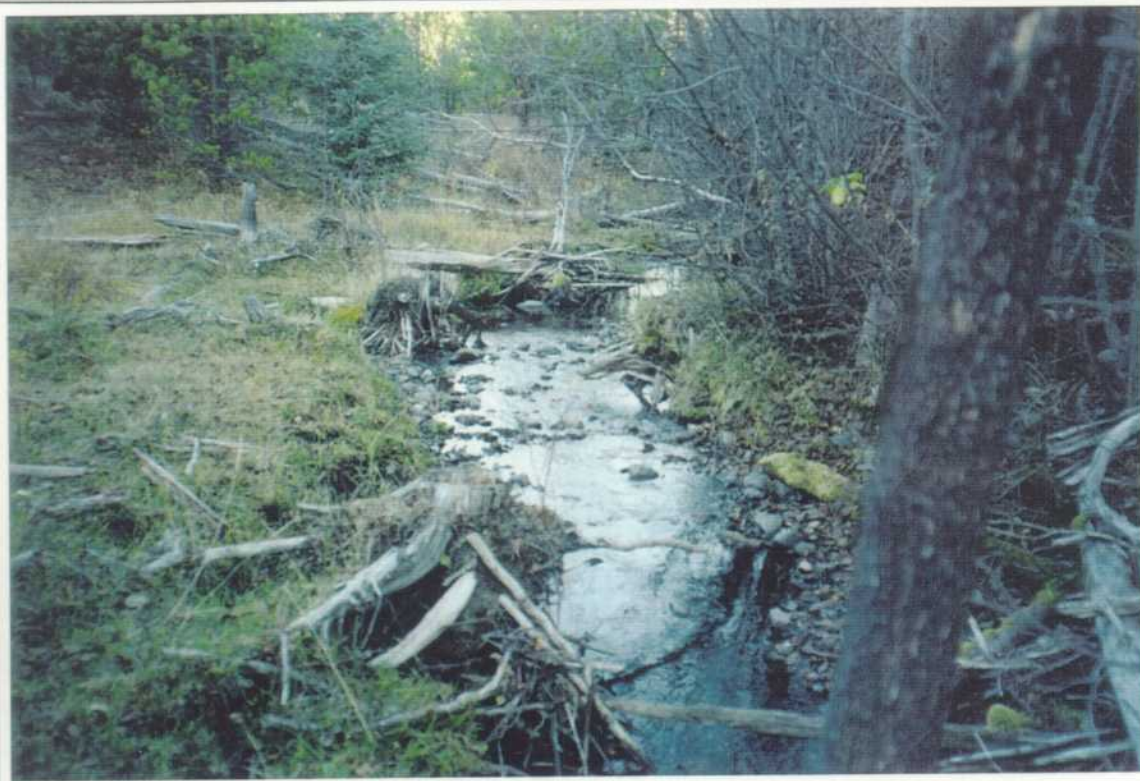
**PHOTO 5.** Upper Twig tributary on fan initially disturbed by past harvesting in the riparian zone. Note erosion around root wads and grazing on the banks.

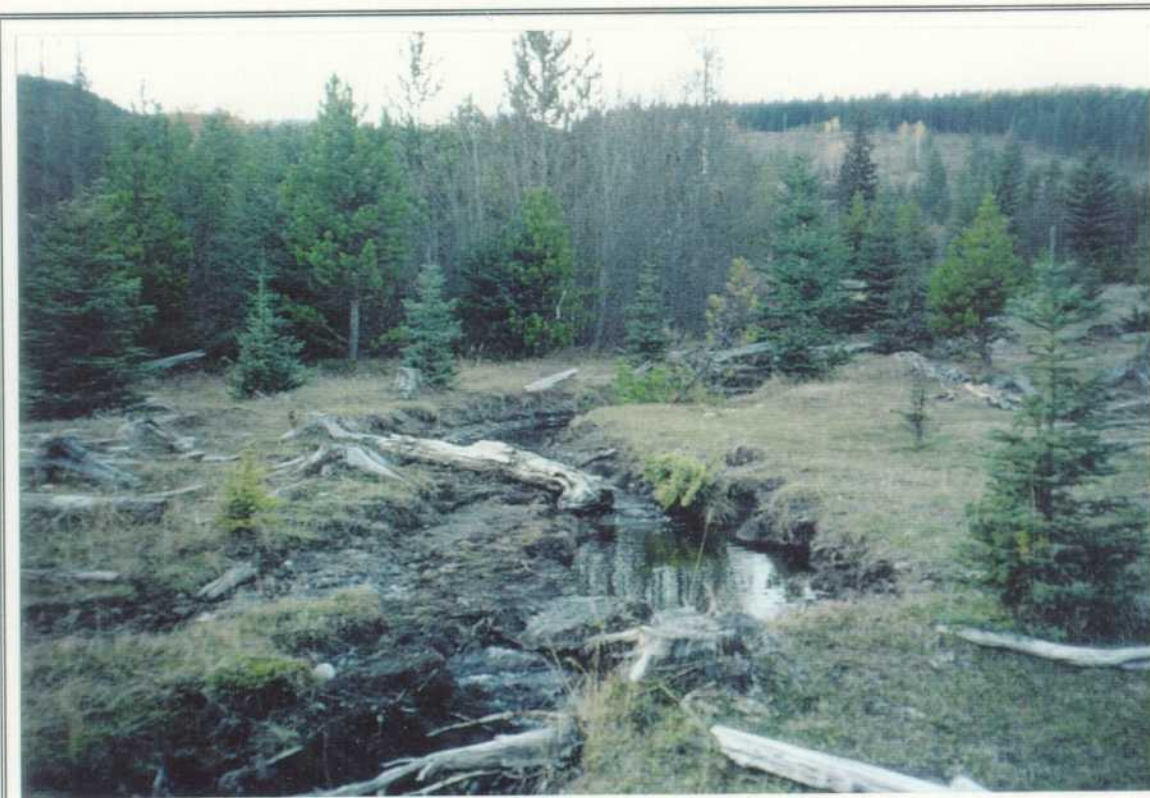
Upper Twig Creek is also proportionally small with respect to drainage area, and the basin possesses similar well-drained soils and a low drainage density. The entire Upper Twig tributary system has remained stable with past forest harvesting and road construction, with the exception of the site-specific effects on the fan channel [Photo 5]. As discussed previously, the disturbance on the fan is not related to cumulative effects, but rather ongoing site-specific disturbance initiated by past harvesting, and exacerbated by ongoing cattle access [Photo 6].

**PHOTO 6.** Upper Twig tributary on the lower fan showing past harvesting to the banks and cattle access to the stream. Sediment delivery to Twig Creek from this site is not possible, but local water quality and resident fish habitat has likely been impaired.

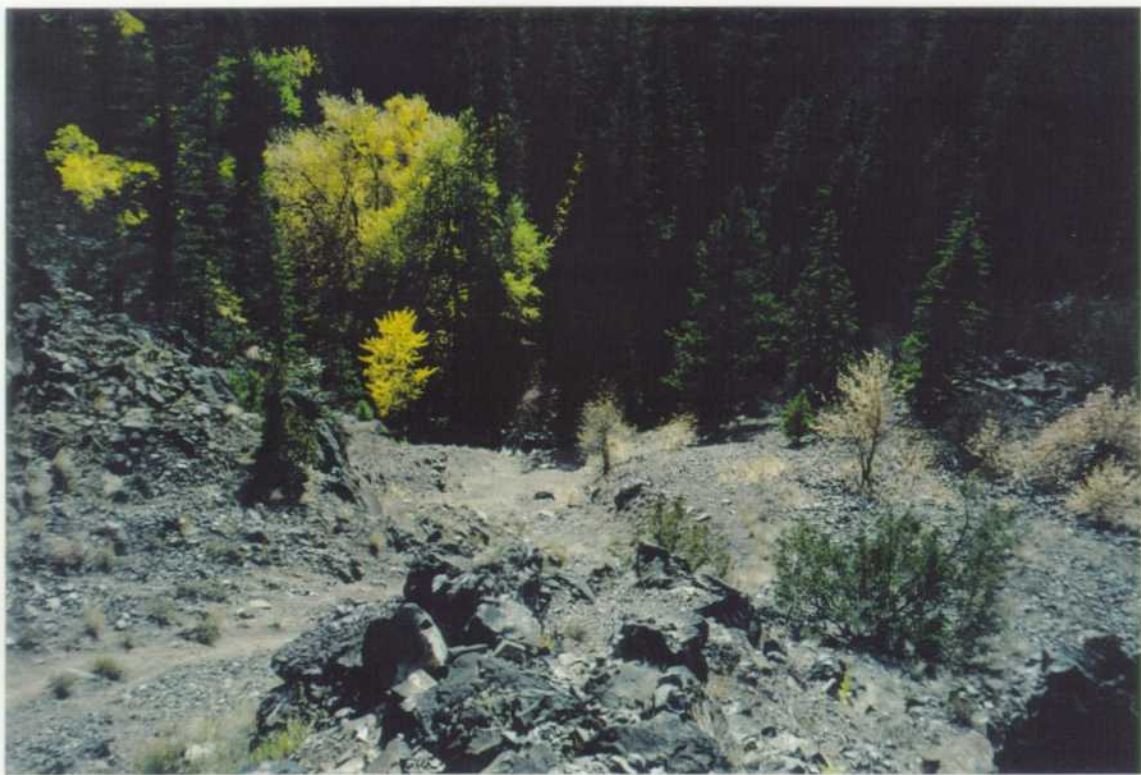
**PHOTO 7.** Natural raveling slopes directly connected to Twig Creek in the canyon. Note blocks present from upslope columnar basalts.

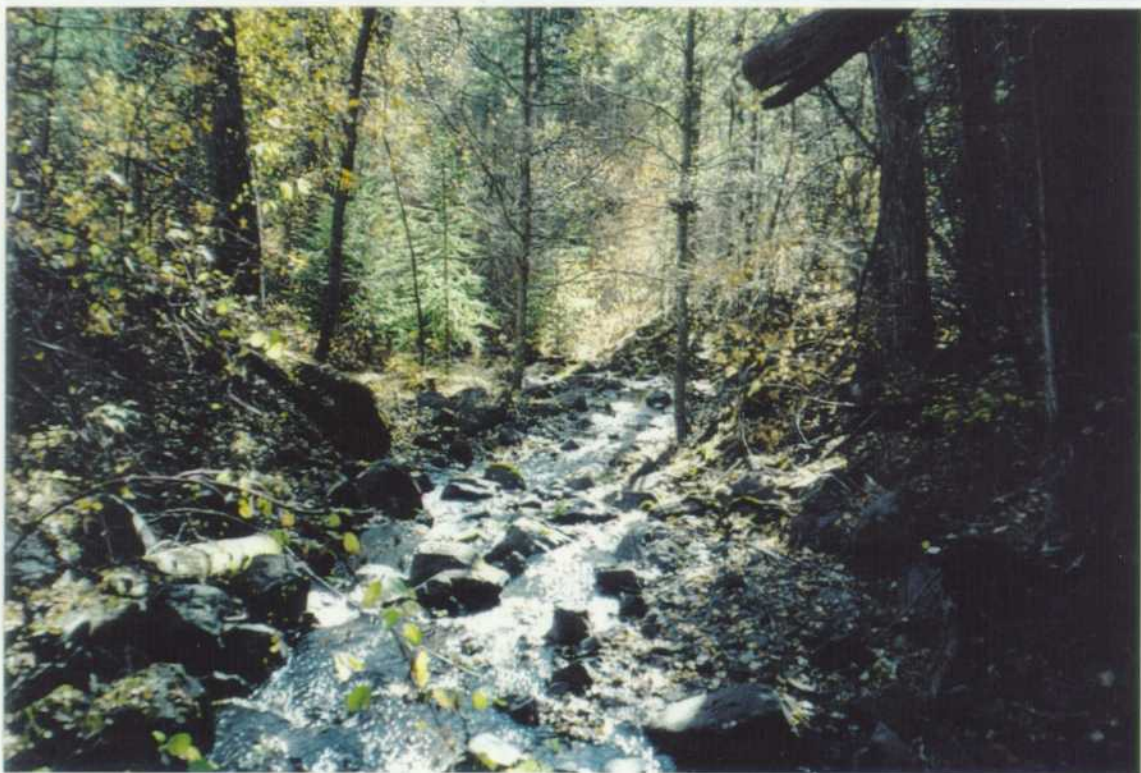
**PHOTO 8.** Twig Creek mainstem at the apex of the alluvial fan at the Salmon River. Note elevated boulder and rubble banks in the background and blocky bed material from rockfall input in the canyon.

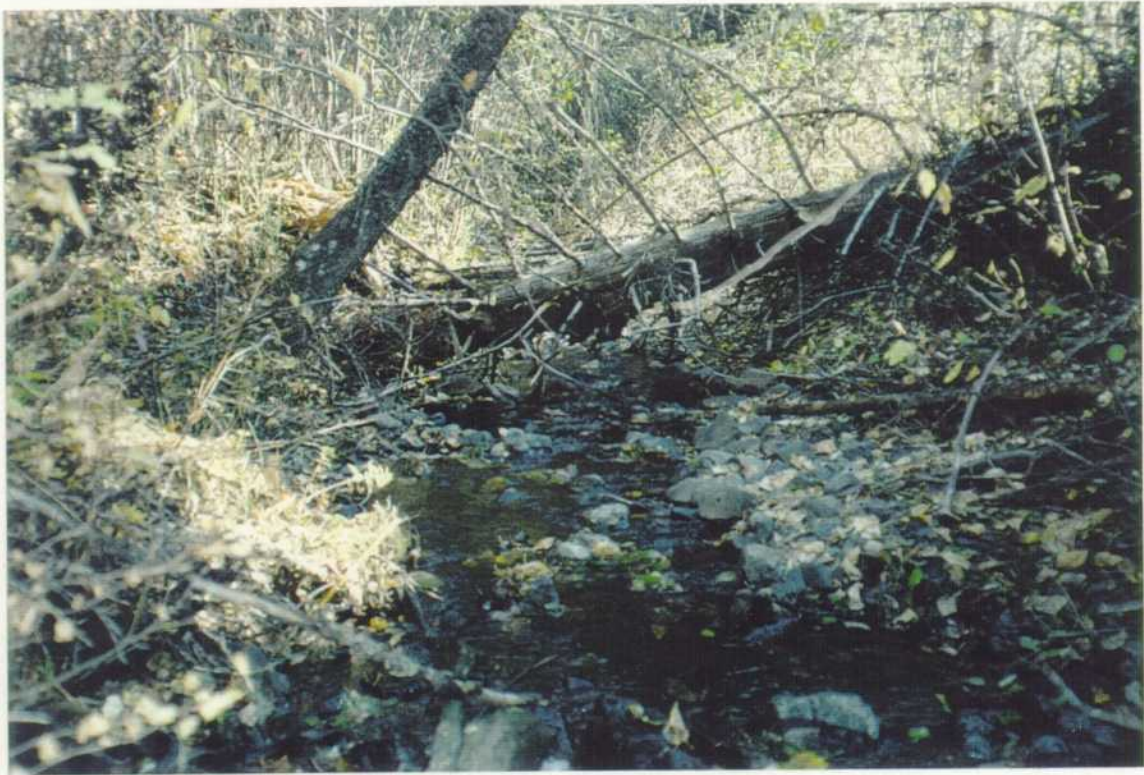
**PHOTO 9.** Lower Twig mainstem approximately 20 m upstream of the Salmon River confluence. Stable channel with functional riparian zone.
