Results of the Interior Watershed Assessment Procedure

WAP CREEK WATERSHED

By
DOBSON ENGINEERING LTD.
#4, 1960 Springfield Road
Kelowna, BC
V1Y 5V7

June 2000

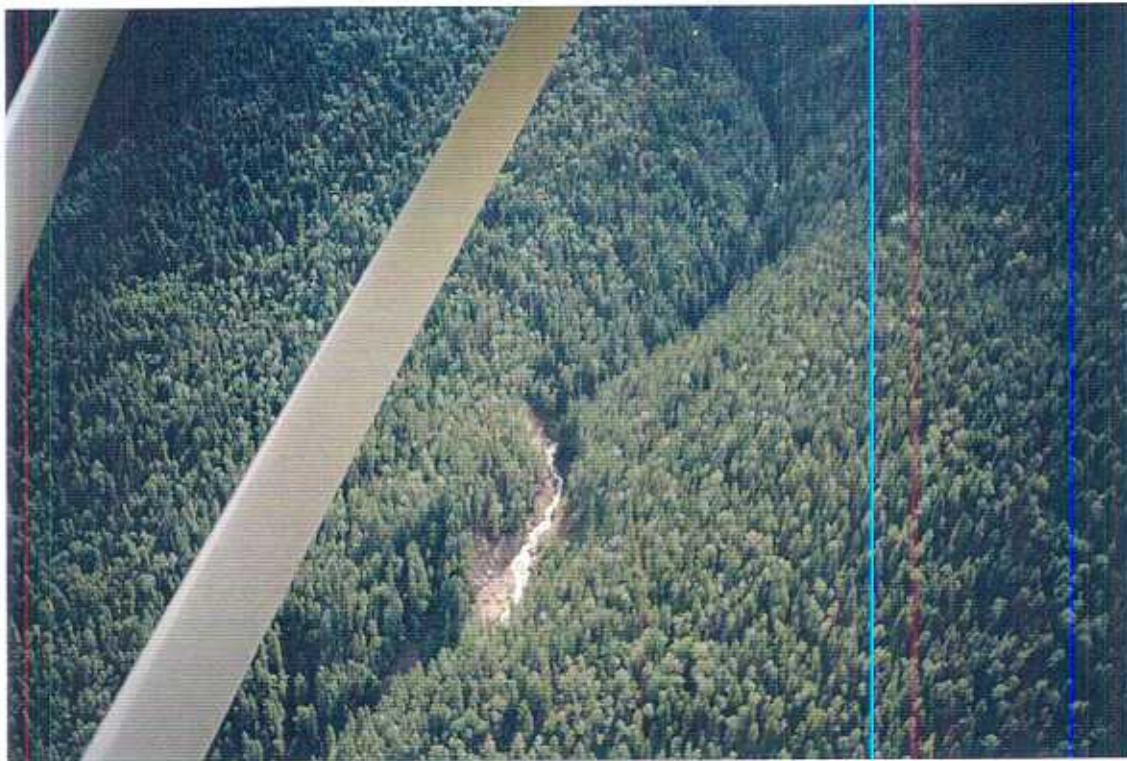
Devil Creek is the largest source of fine sediment to the lower Wap Creek system. Continual raveling and surface erosion on old bank failures created by a 1980s debris torrent, and the occurrence of new bank failures in 1999, are the main concerns in the sub-basin [Photo 1 – Appendix E]. Minor surface erosion on the Iron Road system is also a concern that could be addressed with drainage improvements noted in section 4.1. Rehabilitation of the numerous old bank failures along the Devil Creek channel would be very difficult, and may not have a worthwhile effect in reducing sediment load. Natural recovery is occurring where residual soil depth has permitted but the time frame for recovery appears to be approximately 20 years (based on the torrent occurrence in or around 1980 and recovery in upper mainstem locations). Grass seeding efforts on the

PHOTO 1. Lower Devil Creek showing the bank failures that caused the debris flood onto the fan in the spring of 1999.

recent bank failures located approximately 200 m upstream of the fan could reduce sediment input to the channel over the short term and should be considered based on accessibility. The cause of the recent failures and possible mitigation alternatives to avoid similar events is discussed in section 4.3. Based on the turbidity observed during the aerial overview the surface erosion hazard rating for Devil Creek is high [Table 3]. Natural recovery on exposed soils combined with road drainage improvements could reduce this hazard.

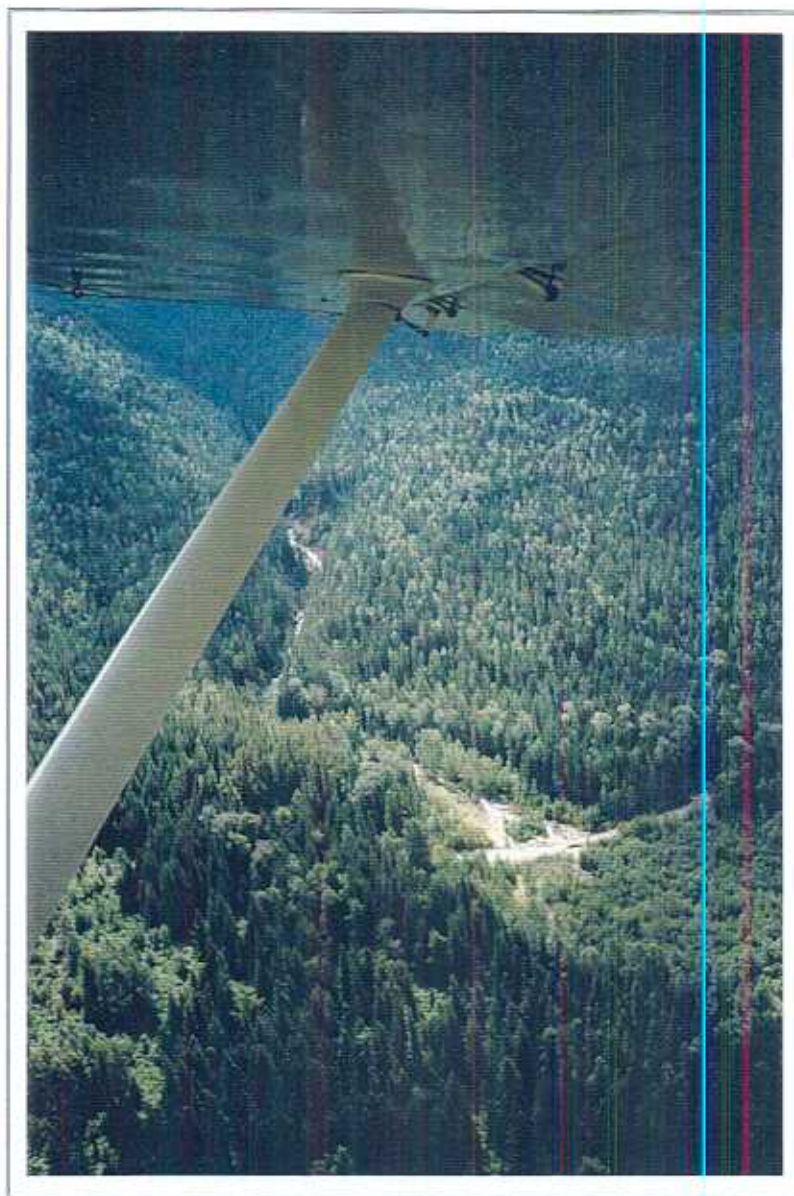
Dale Creek was also turbid during the rain-on-snow event but to a lesser degree than Devil Creek. Secondary erosion and raveling is occurring on bank failures that were caused by mainstem debris flows in the late 1970's and early 1990's [Photo 2]. Limited re-vegetation has occurred on the failures following the latest debris flow, but no new bank failures were noted. Fill failures from the Bunny road system in the upper sub-basin, that initiated the debris flows, were rehabilitated as much as possible in the fall of 1998. A short section of the Iron Road in the lower sub-basin is delivering fine sediment to the channel via landslide track number 10 [Appendix A]. A 2000 WRP proposal is in place for this site to move the road away from the break in slope and pullback over-steepened fill materials. These works should address this sedimentation concern. As in Devil Creek, the numerous bank failures along the mainstem channel will continue to produce fine sediment until natural re-vegetation occurs (potentially 20 years). Based on the level of turbidity observed during the aerial overview, the surface erosion hazard rating for Dale Creek is considered moderate [Table 3]. Proposed road works at landslide 10 will have a minor effect in reducing sedimentation, but natural recovery will be the only way to reduce the hazard over the long-term.

PHOTO 2. Dale Creek fan showing partial recovery from 1990s debris flow. Note limited recovery on bank failures upstream of the fan.

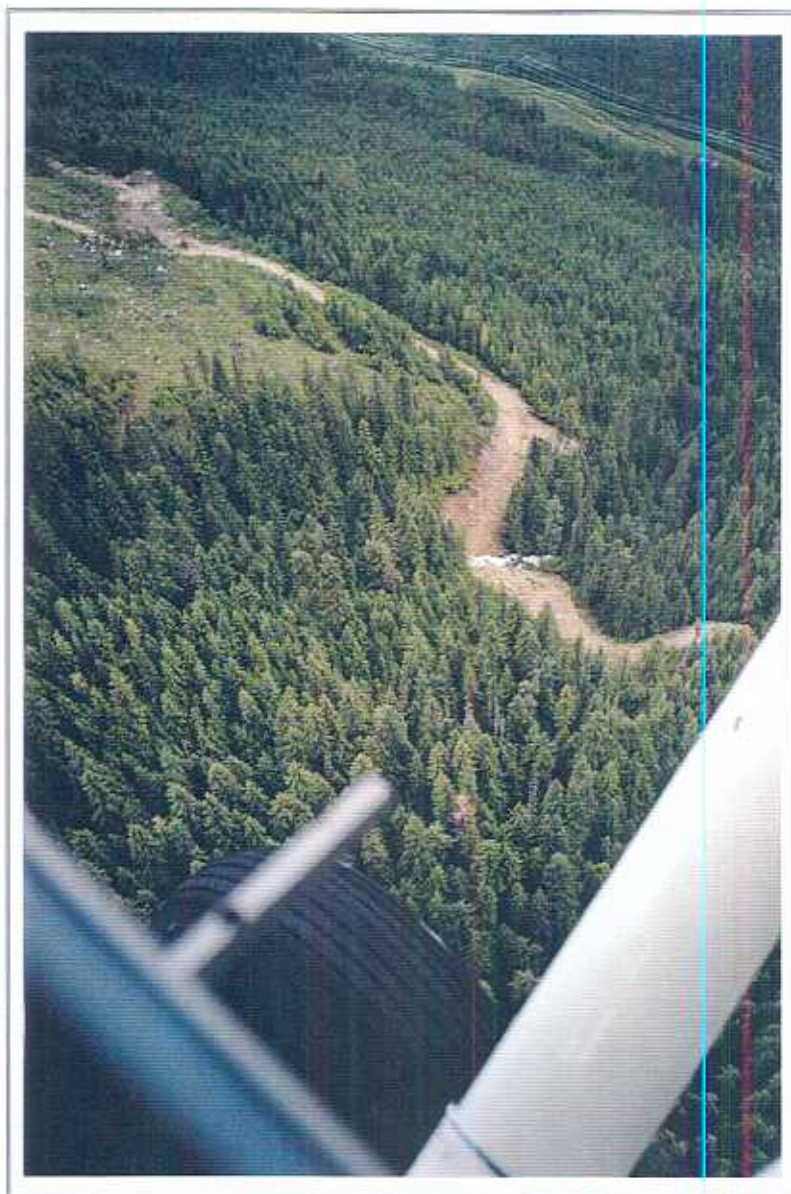
PHOTO 3. Lower road access to opening 226 on the south side of the residual above Wap Lake. The road was re-contoured following the occurrence of landslides 20 and 21 but remains a source of fine sediment to Wap Creek.

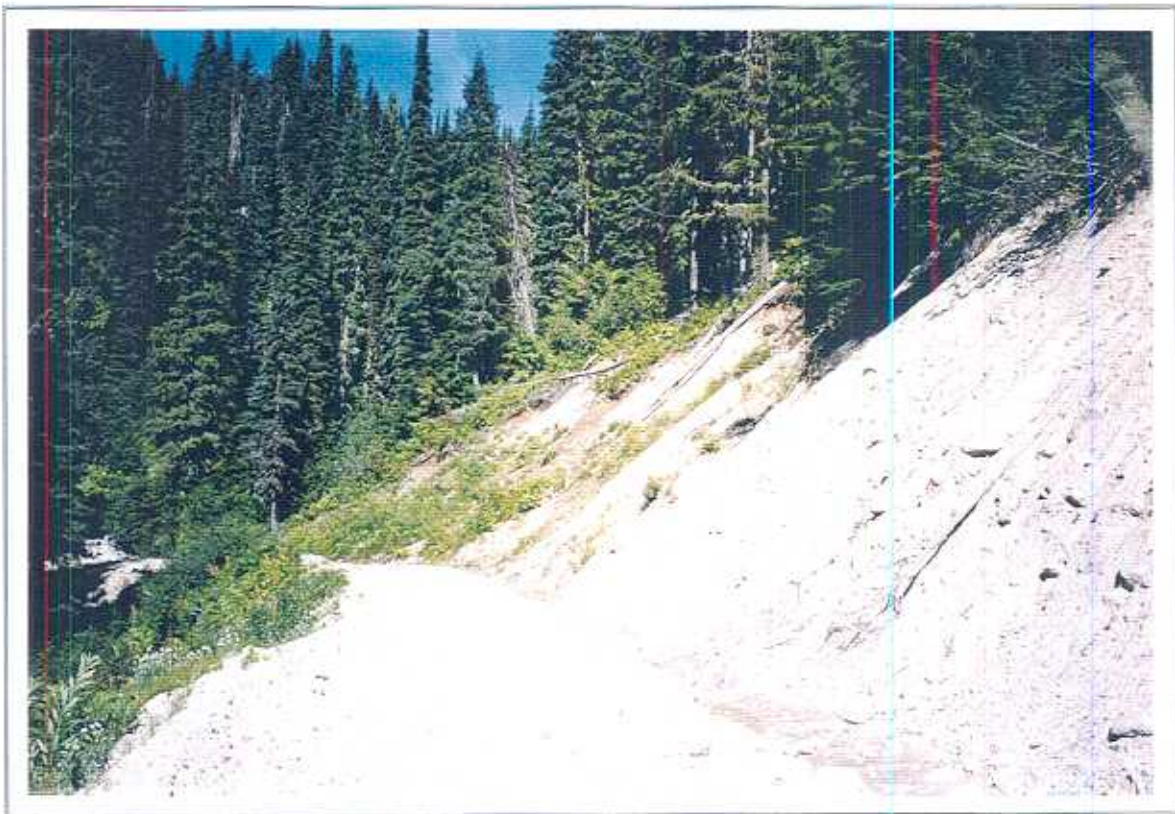
PHOTO 4. Eroding cutslope on the 9019 road before the first crossing on the largest northeast tributary channel in the residual above Wap Lake. Regular slumping with sediment transport through the ditch is causing turbidity in the tributary.

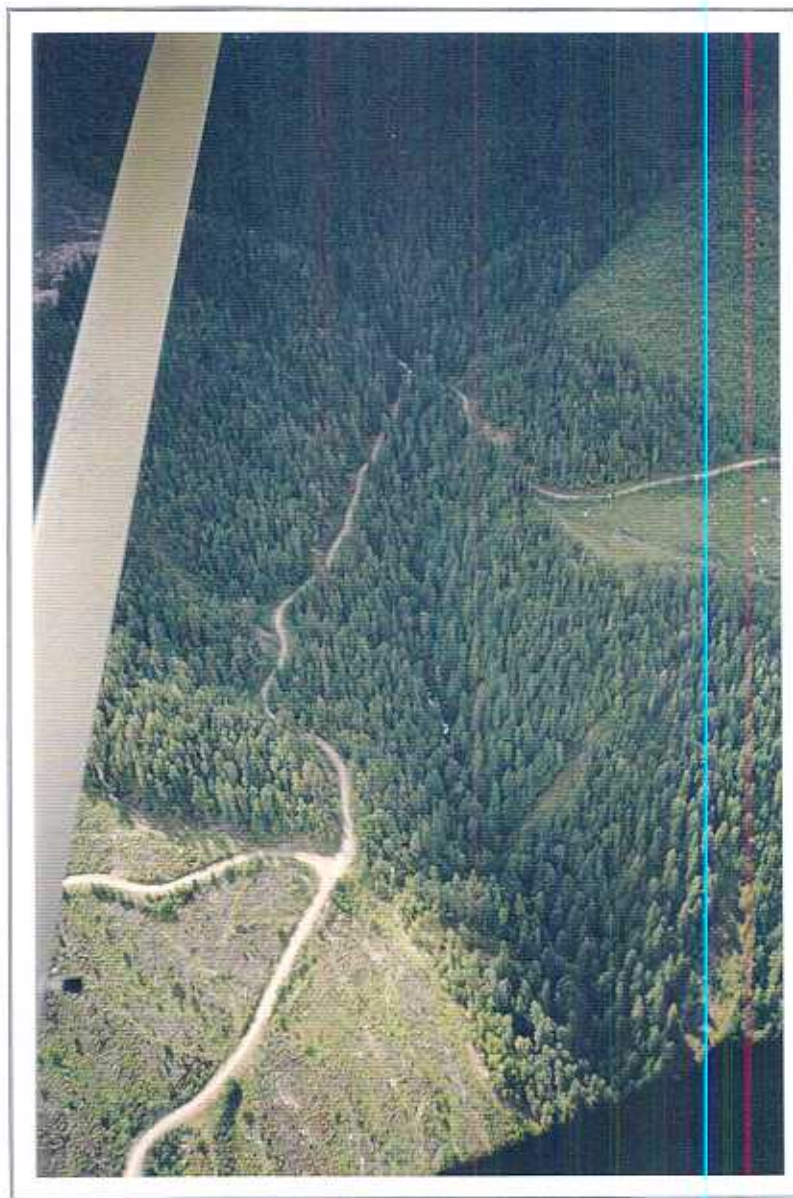
PHOTO 5. Iron Road crossing on Un-named Creek showing three old drainage related landslides into the channel and several road sections with unstable cutslopes.

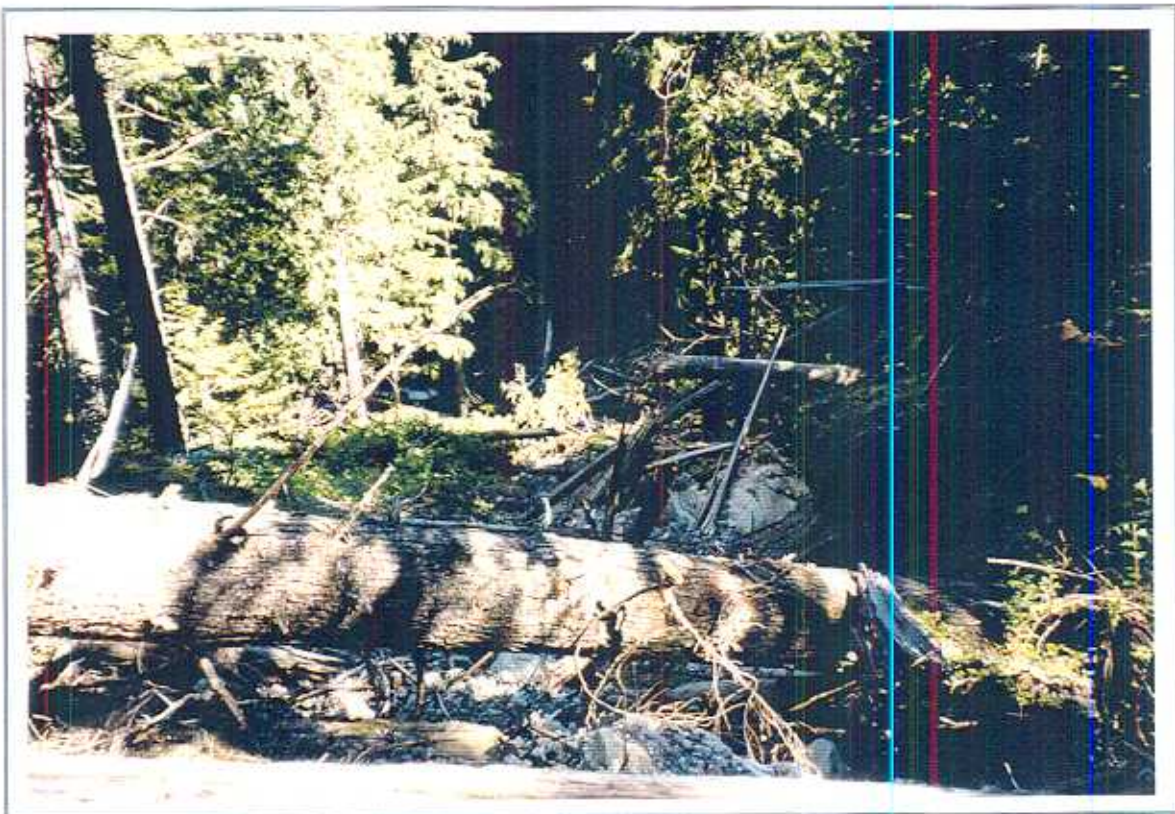
PHOTO 6. Road drainage related landslide into Iron Creek from the IceBox Mainline. No cross-drains are present along the road section above the slide, allowing concentrated drainage to flow onto the steep gully sidewall of Iron Creek.

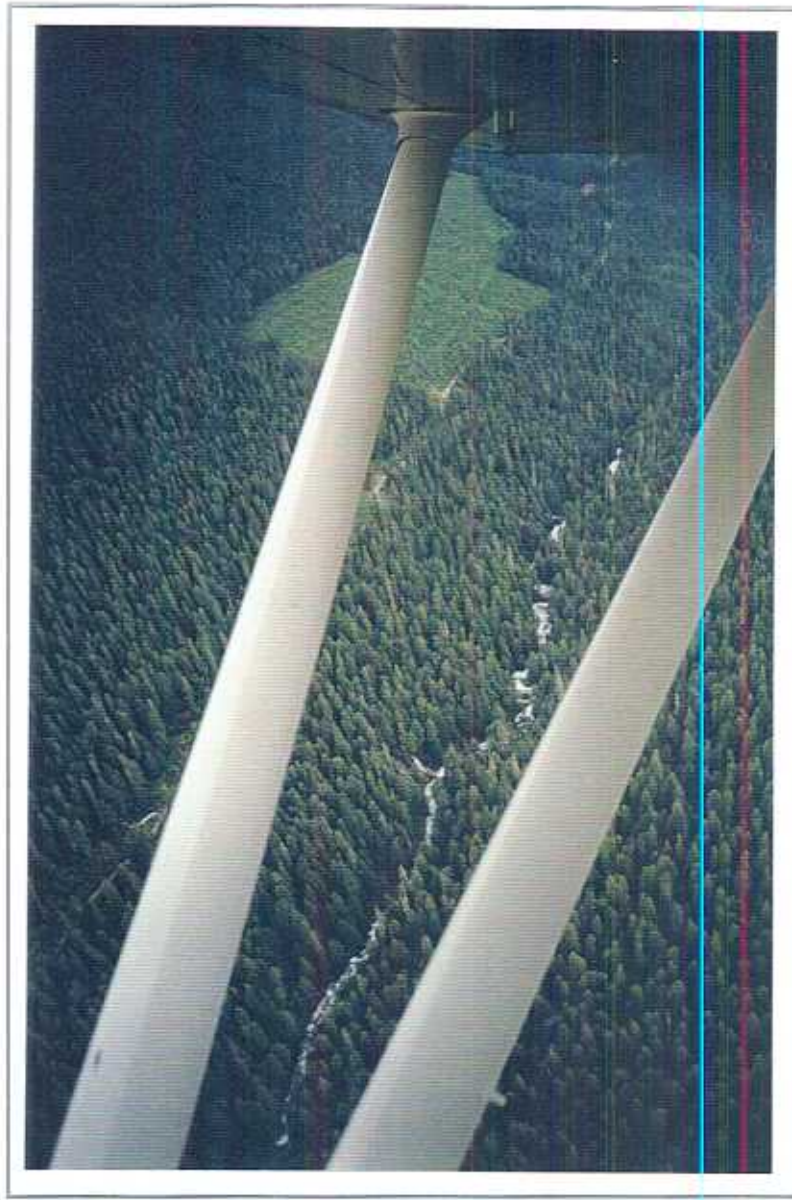
PHOTO 7. Road drainage related bank failures along Derry Creek below the Derry FSR. Note the discharge onto the bank failure shortly after a spring rainfall event.

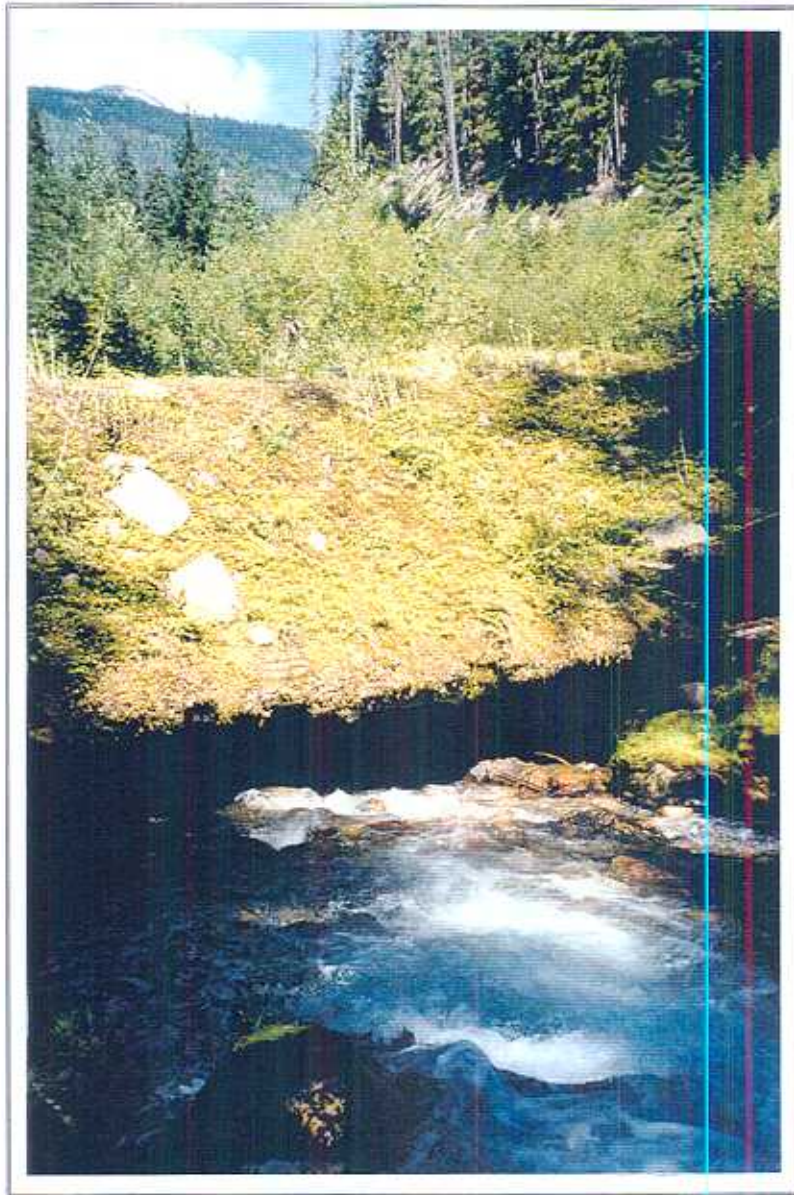
PHOTO 8. Fill loaded onto the wood culvert over Fennell Creek on the Derry FSR. The structure is rotting and may fail into the channel.

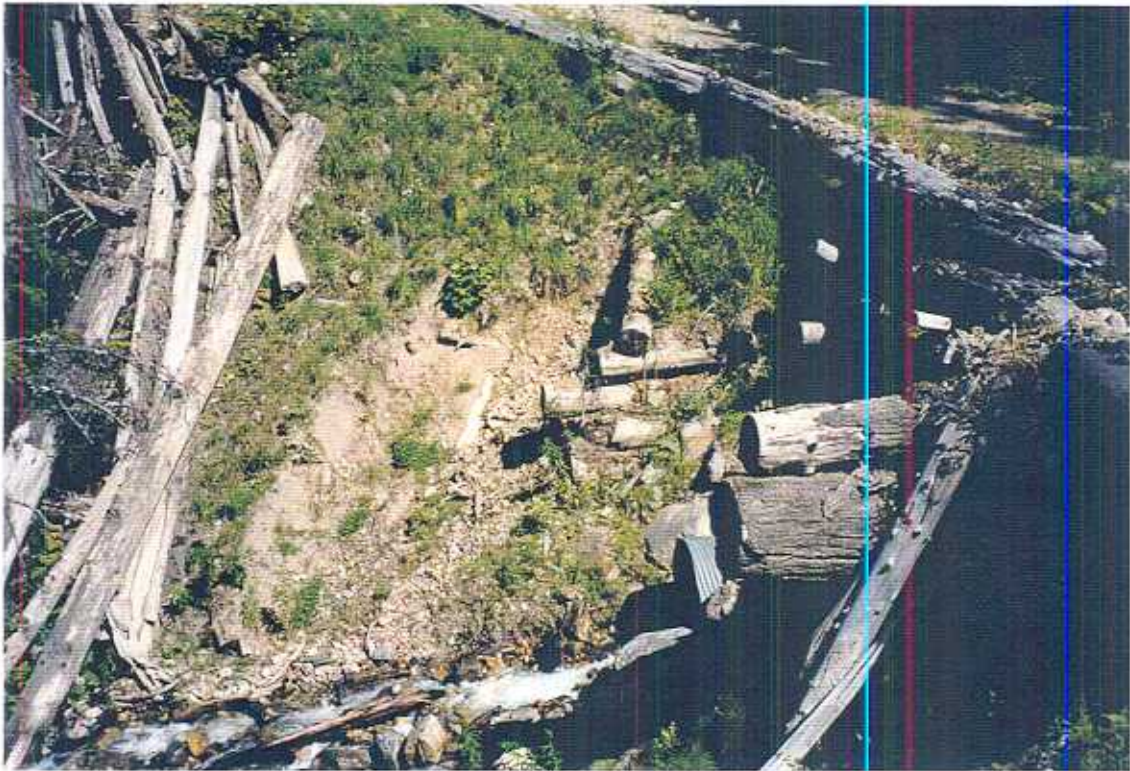
PHOTO 9. Old composite crossing on the 4th tributary beyond Fennell Creek on the Derry FSR. This structure should be removed or upgraded to prevent further sediment and debris input to the tributary channel.

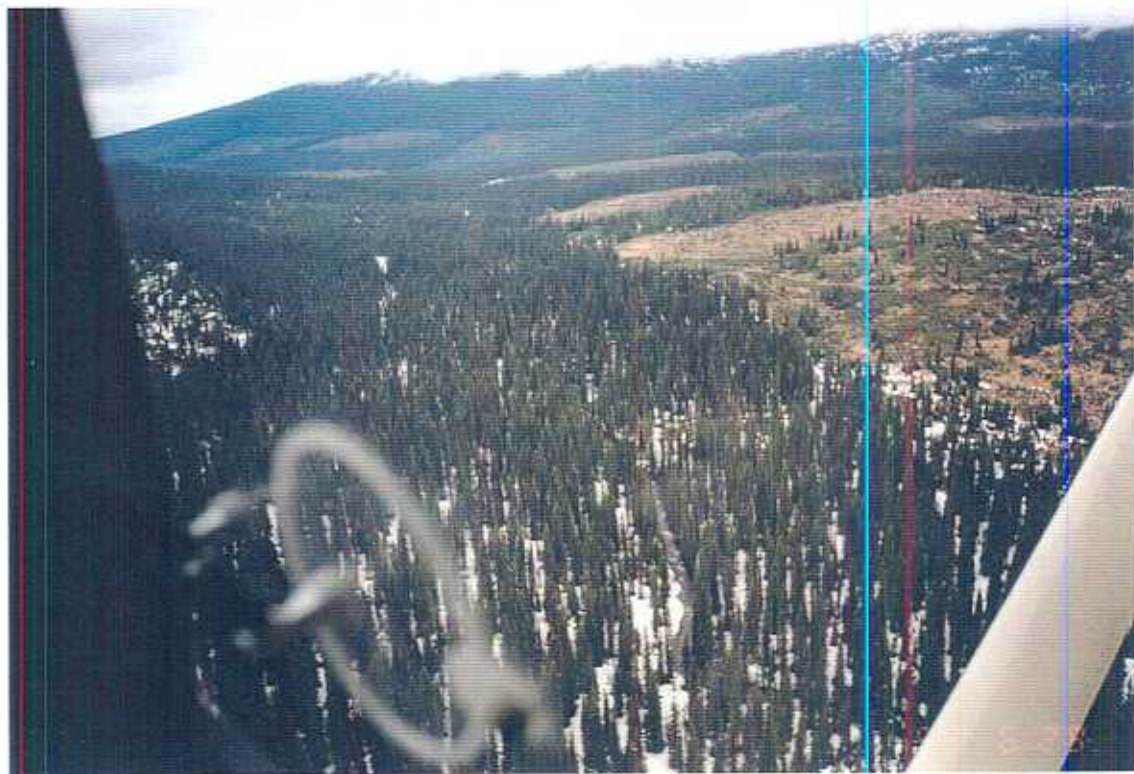
PHOTO 10. Backyard Creek mainstem channel on the plateau above Wap Lake. Note the low rolling terrain dominated by sand and gravel outwash deposits. Channel stability is good on the plateau and no major sediment sources were noted.

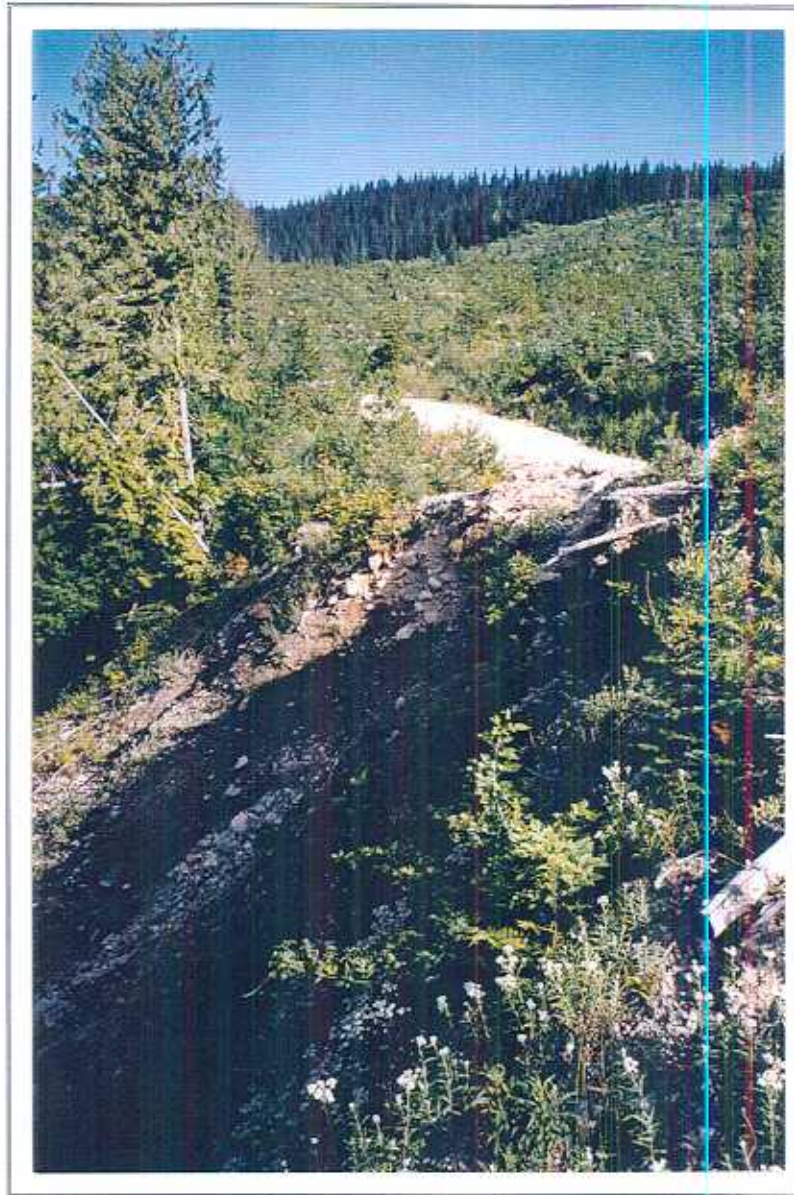
PHOTO 11. Landslide #19 from the 9019 road into the northeast tributary in the residual above Wap Lake. This slide was caused by drainage diversion onto an overloaded fillslope.

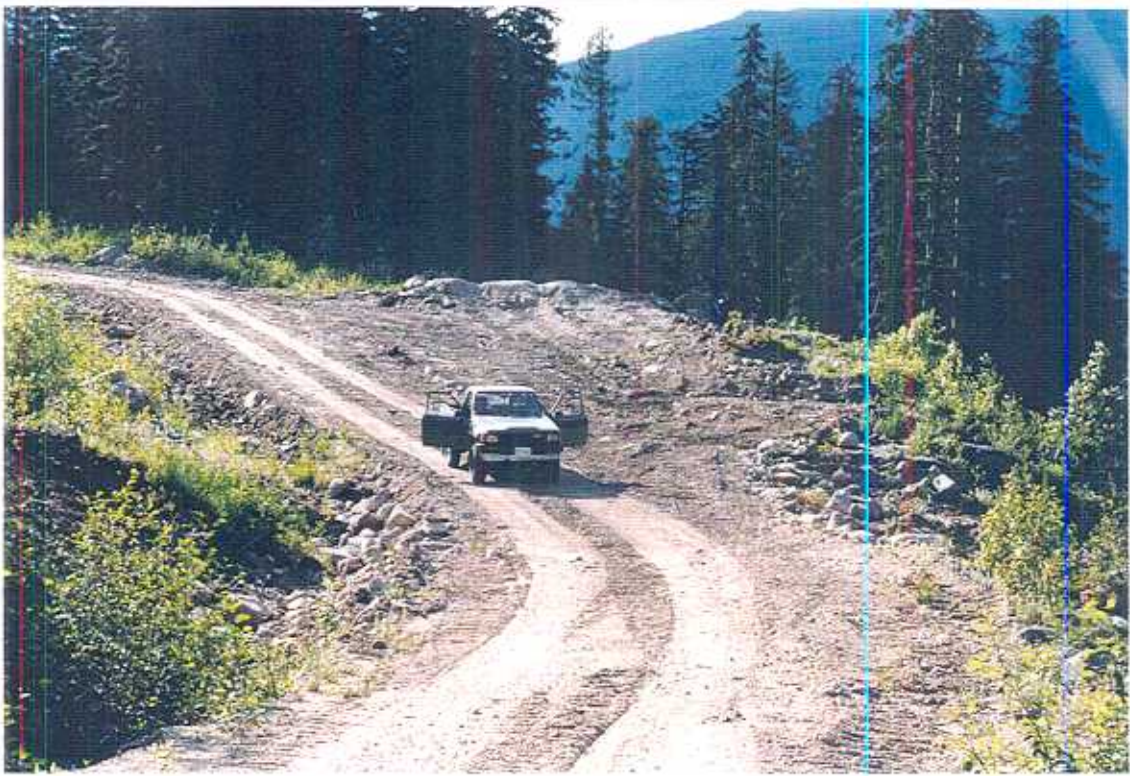
PHOTO 12. Recent fill material piled atop landslide #19. This site continues to be oversteepened which may lead to additional landslides into the tributary channel.

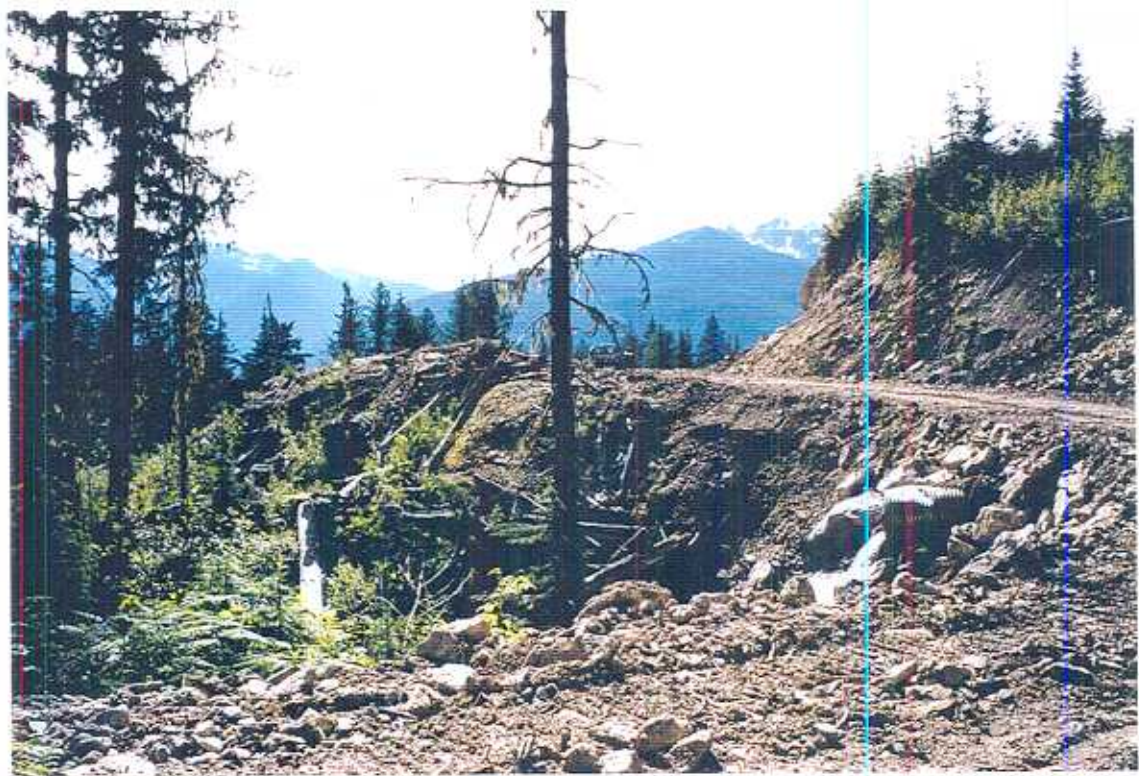
PHOTO 13. Recent road improvement spoils dumped onto an oversteepened fill draining into a small tributary beyond the large northeast tributary crossing on the 9019 road.

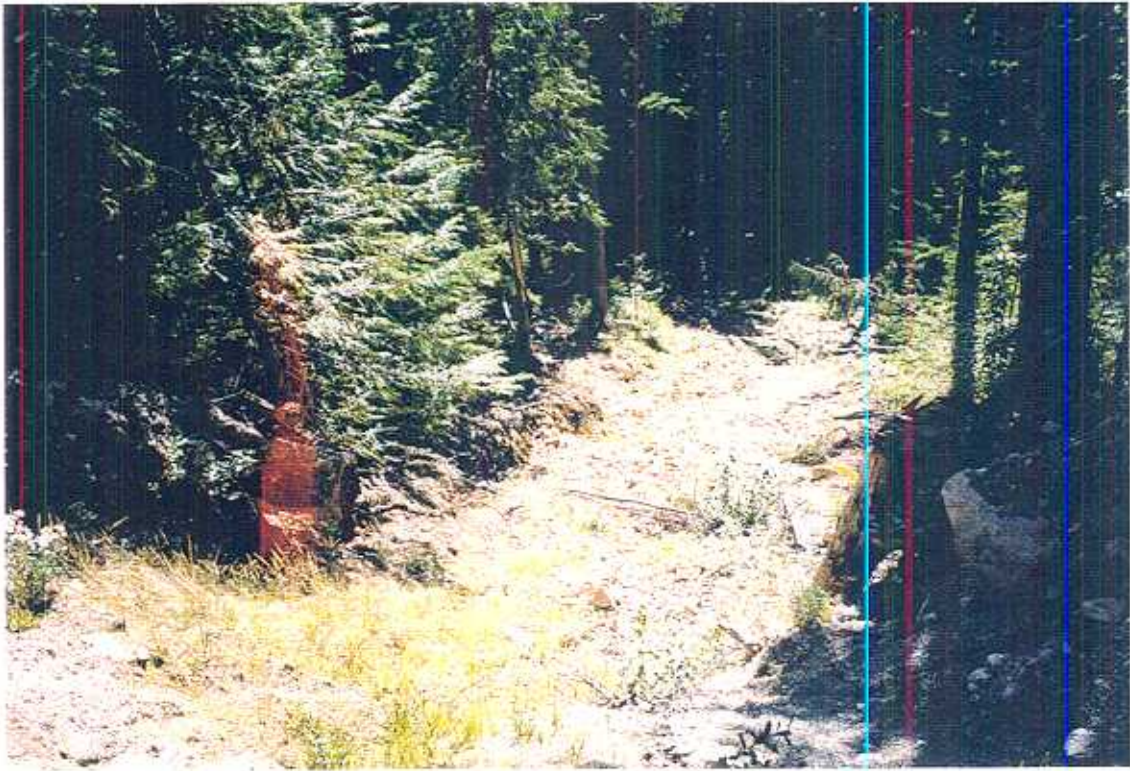
PHOTO 14. Failed crib wall on the 100 road that triggered a landslide into the Wap mainstem channel in the residual above Frog Falls. Similar cribbing structures are present along other portions of the 100 road in the general area.

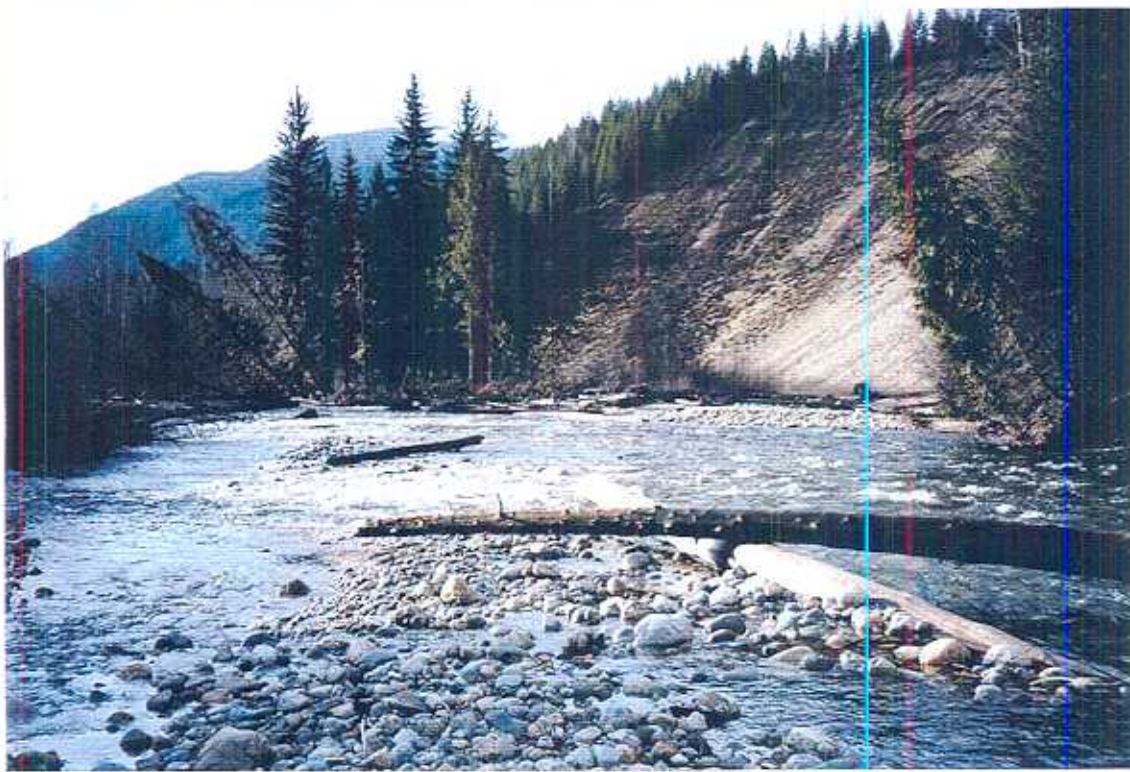
PHOTO 15. The lowermost large bank failure on Wap Creek immediately downstream of the Derry Creek confluence. The majority of flow has been diverted away from this lower failure by aggradation and debris accumulation in the side channel leading to the toe of the slope.

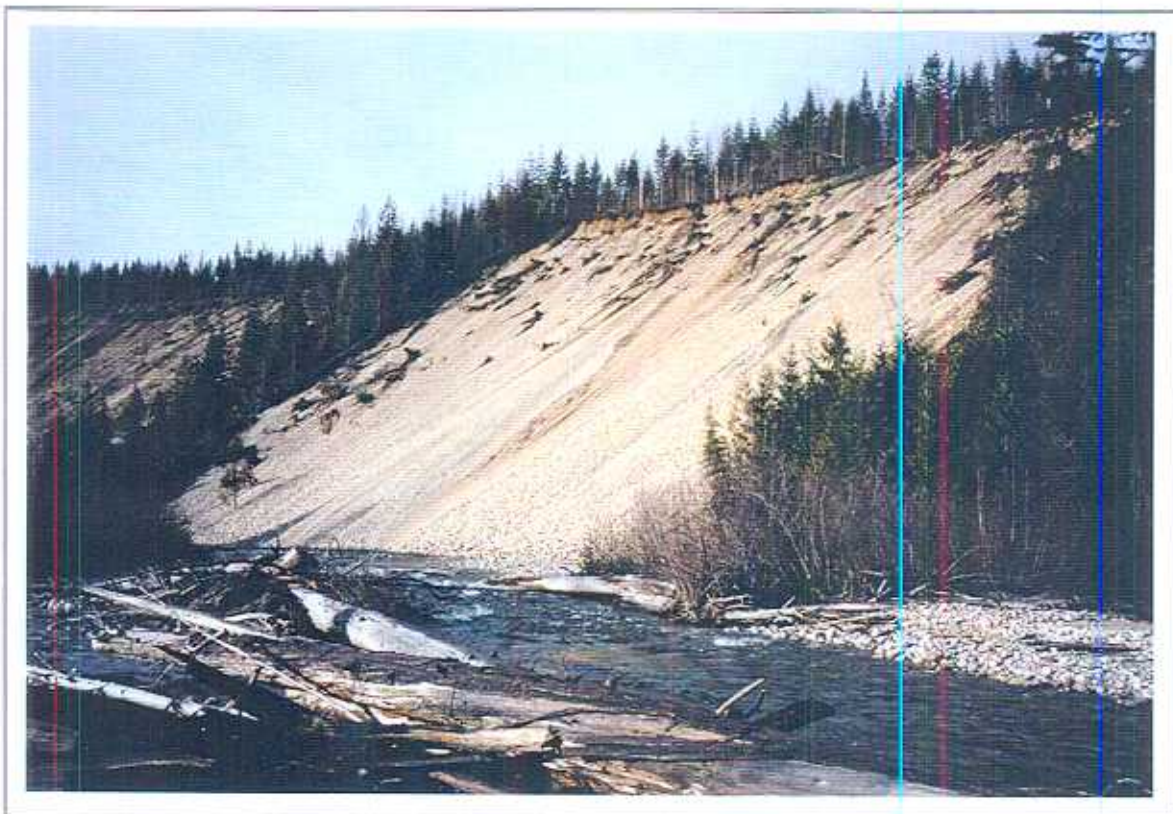
PHOTO 16. The second large bank failure on Wap Creek that is currently contributing sediment to the channel. The dimensions of the two failures are approximately 50 m high and cumulatively 150 to 200 m wide.

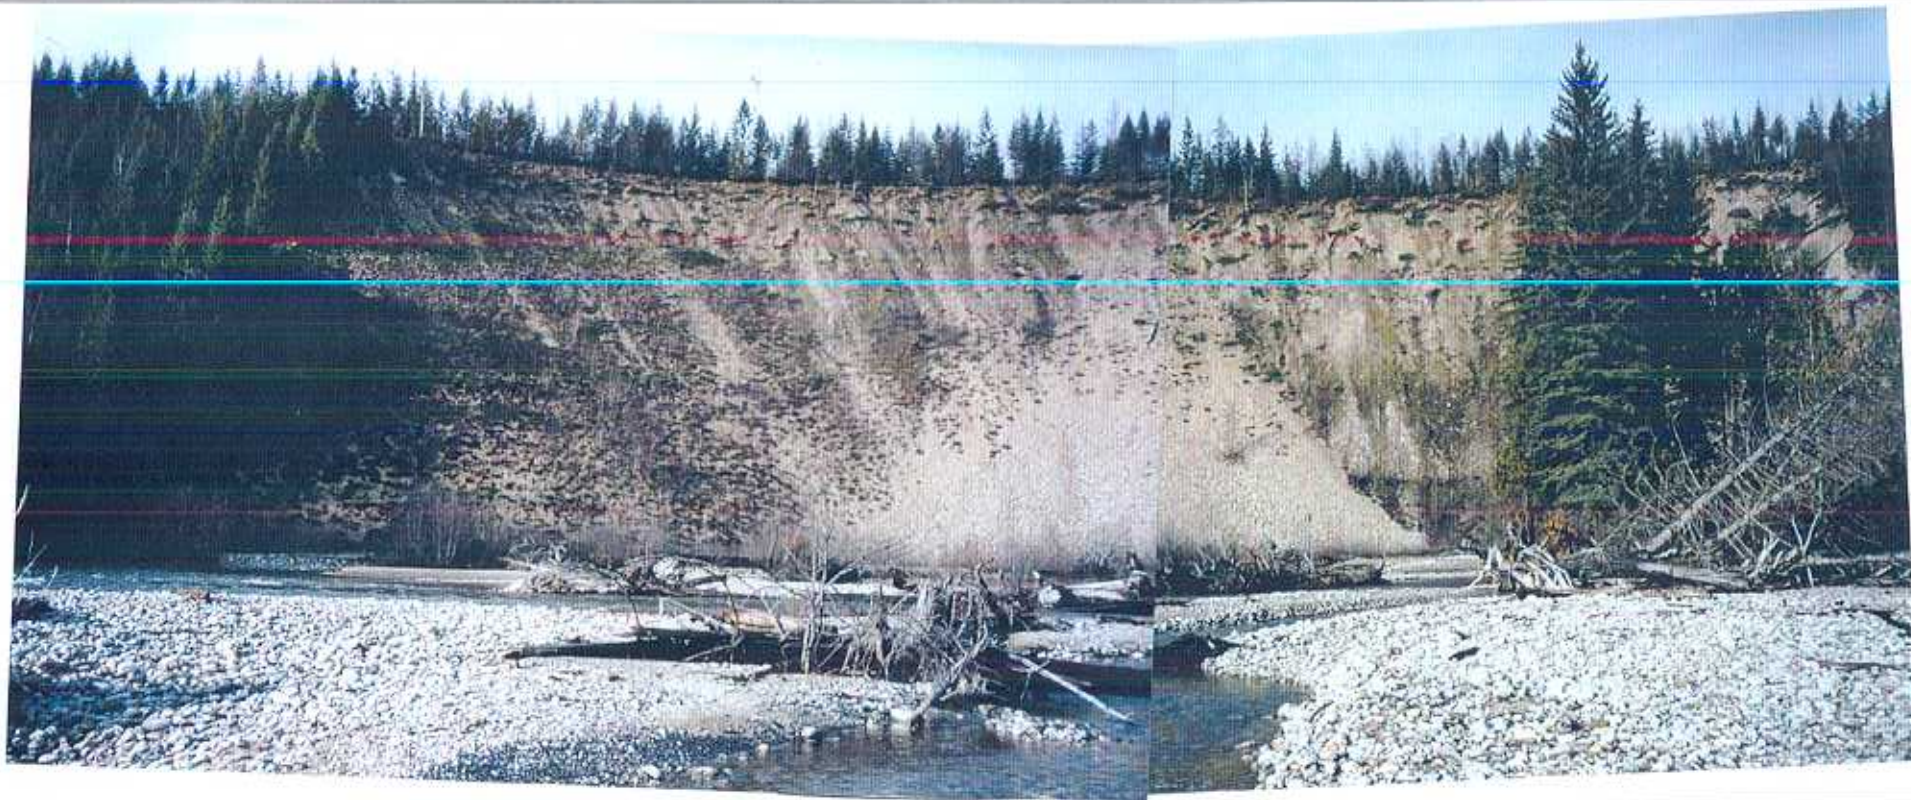
PHOTO 17. View upstream to the lower failure showing the active channel width and partial re-vegetation on the raveling slope.

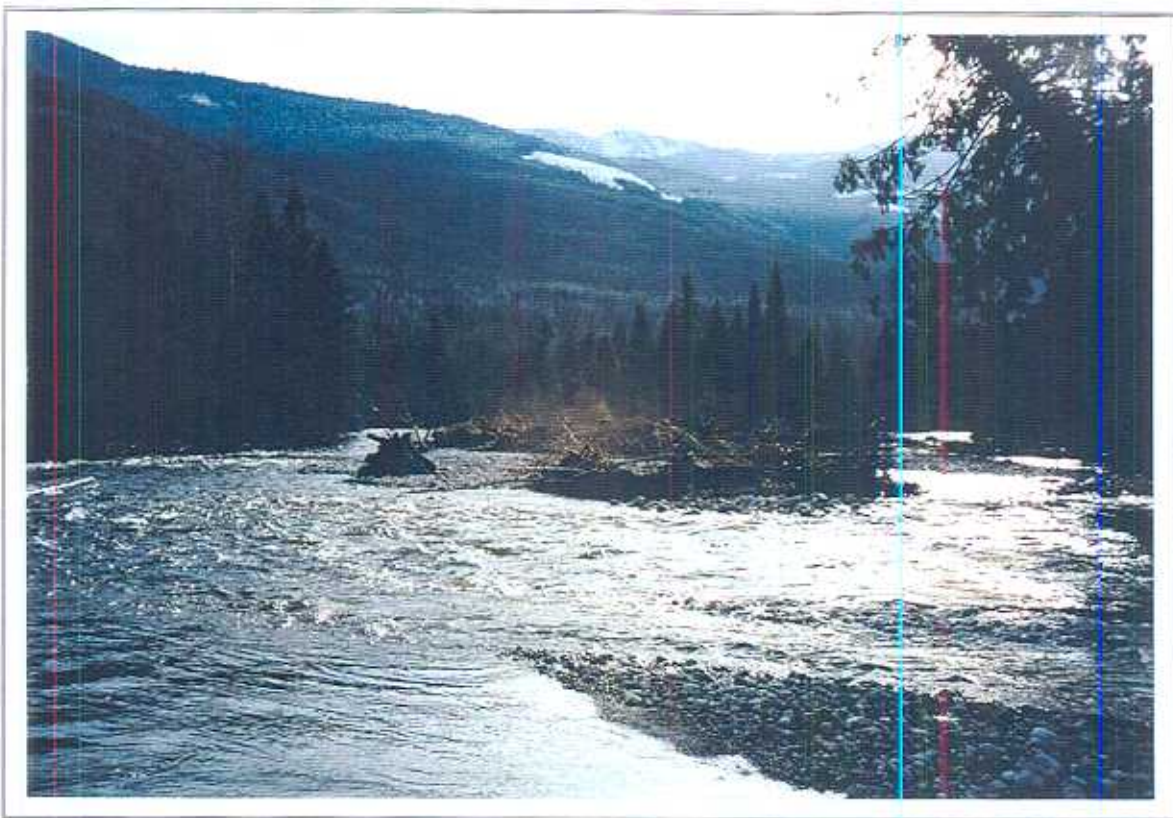
PHOTO 18. Wap mainstem channel downstream of the two large bank failures showing the active channel width and instream debris from the failures and bank erosion.

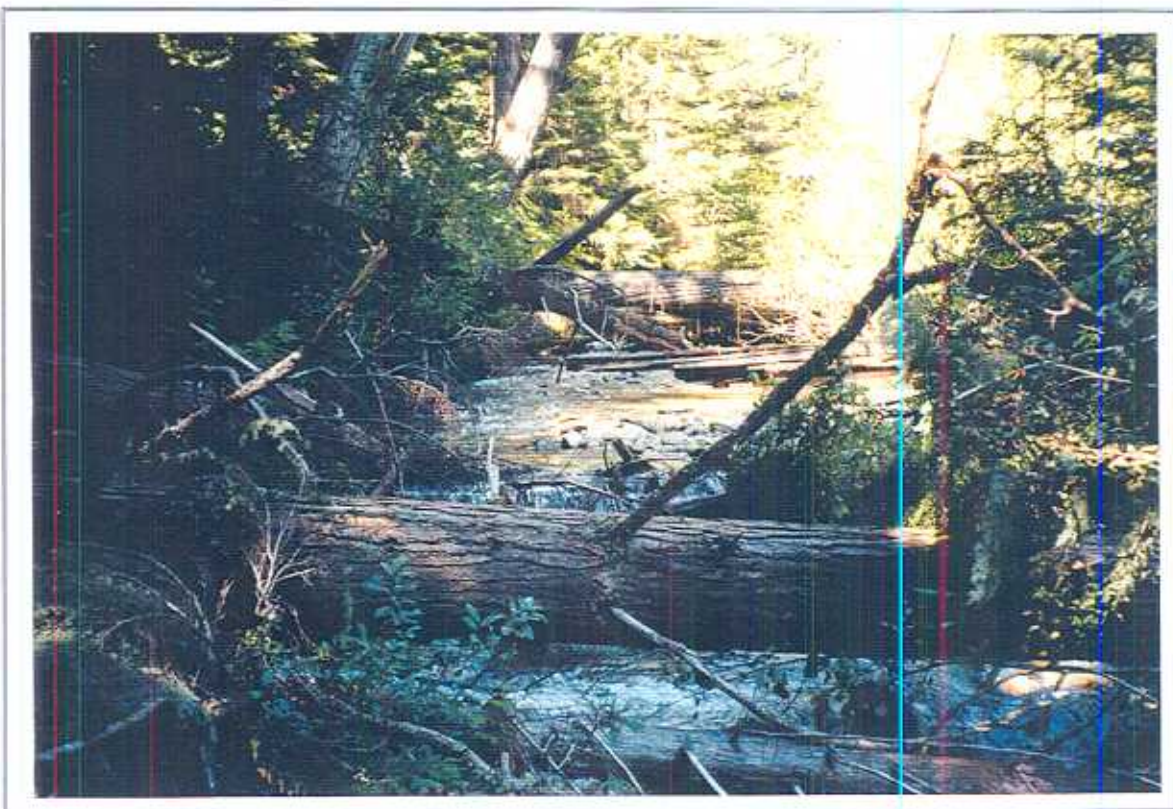
PHOTO 19. Blowdown into reach C4 of Cavanaugh Creek. No major channel obstructions caused by the blowdown were noted.

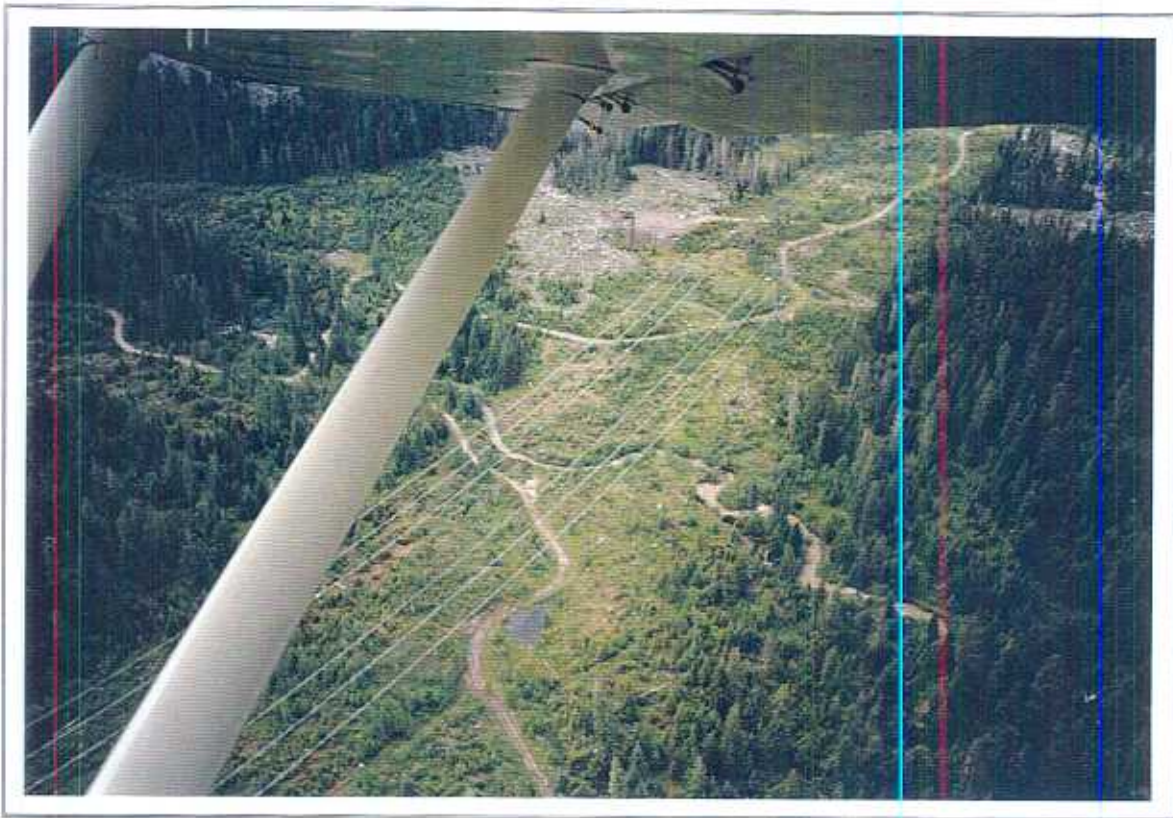
PHOTO 20. Cavanaugh Creek flowing under the BC Hydro transmission line. Some channel widening and bank erosion has occurred through this reach but regeneration of deciduous and coniferous species has limited long-term disturbance.

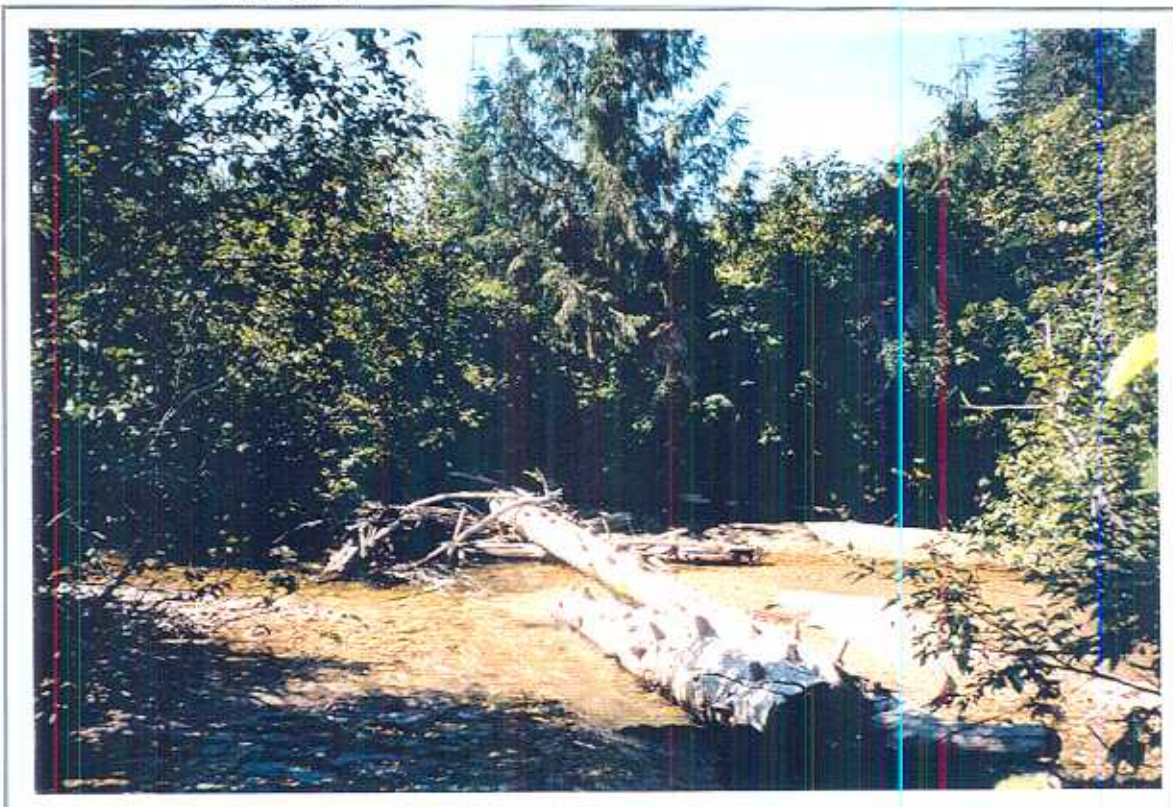
PHOTO 21. Riparian regeneration along Cavanaugh Creek beneath the BC Hydro line. Note old stumps on the banks and instream sediment bars from localized and upstream bank erosion.

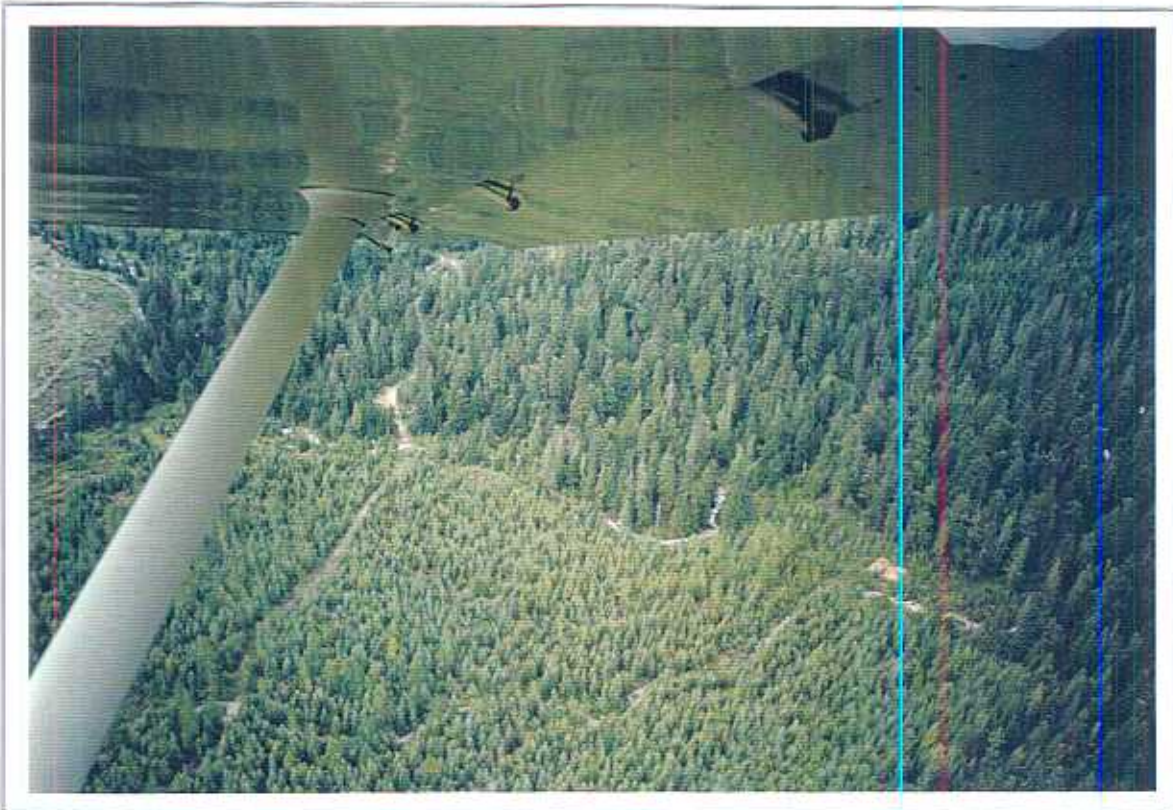
PHOTO 22. Two washed out road crossings on the Ohashi Road through opening 42 in the Cavanaugh Creek sub-basin. The two structures have caused some localized disturbance and should be removed.
