Results of the Interior Watershed Assessment Procedure

WAP CREEK WATERSHED

By
DOBSON ENGINEERING LTD.
#4, 1960 Springfield Road
Kelowna, BC
V1Y 5V7

June 2000

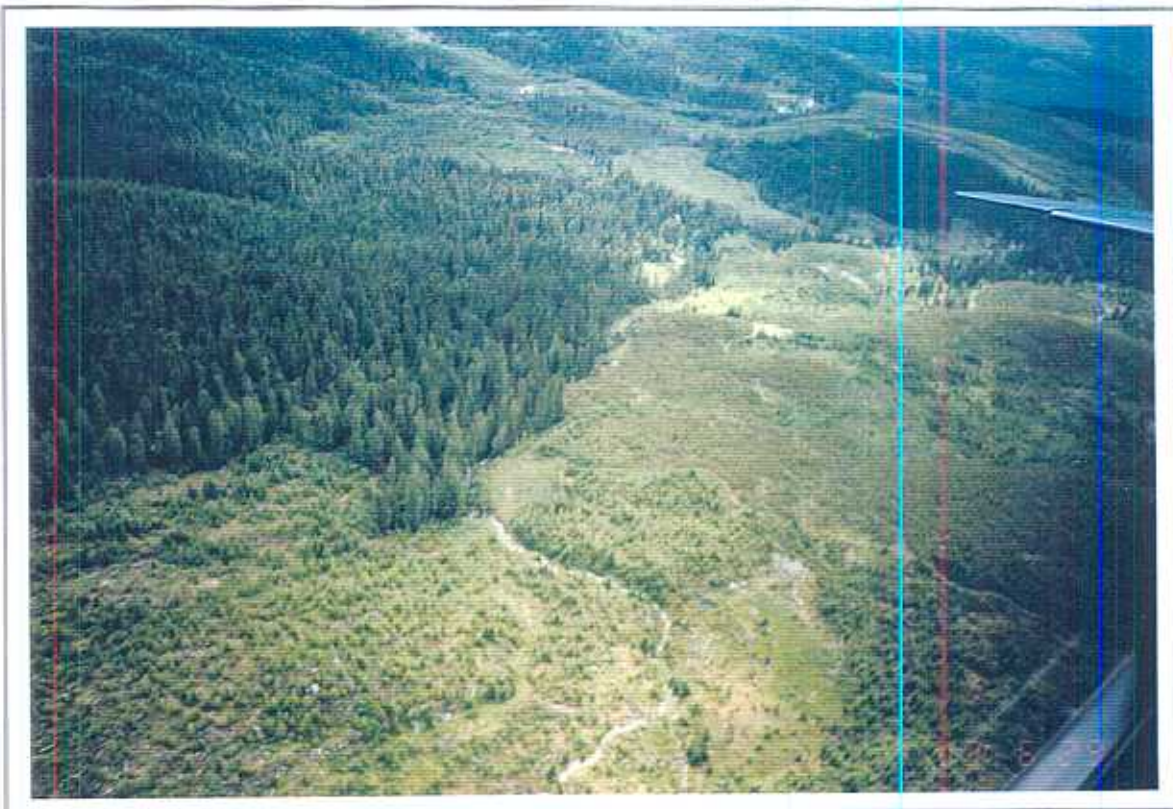
PHOTO 23. Failed road crossing on a trail between openings 41 and 43 in the upper Cavanaugh sub-basin. Bank erosion is occurring at this site which is the uppermost source of turbidity in the system.

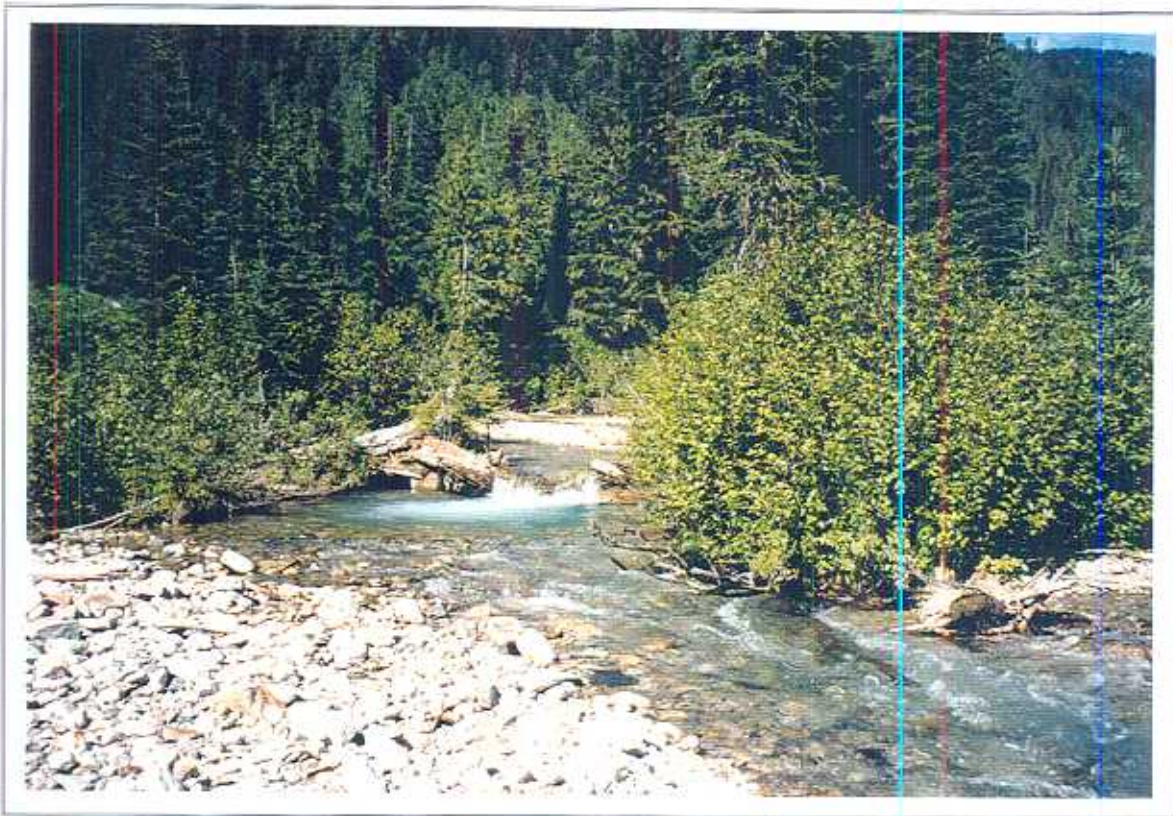
PHOTO 24. Reach D4 of Derry Creek flowing through opening 7. The channel was disturbed by past harvesting in the riparian zone but is recovering with deciduous and coniferous regeneration on the banks.

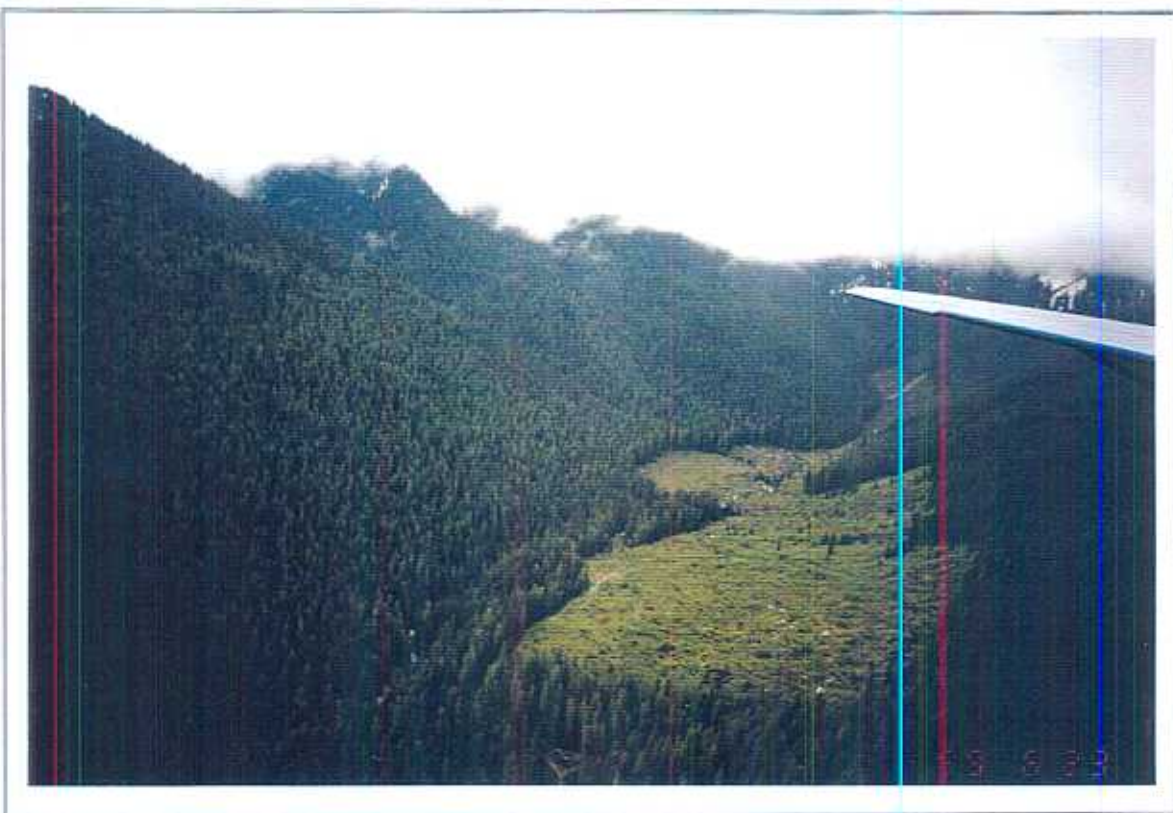
PHOTO 25. Reaches D4 and D5 of Derry Creek showing past riparian harvest, and landslide 15 that did not impact the channel.

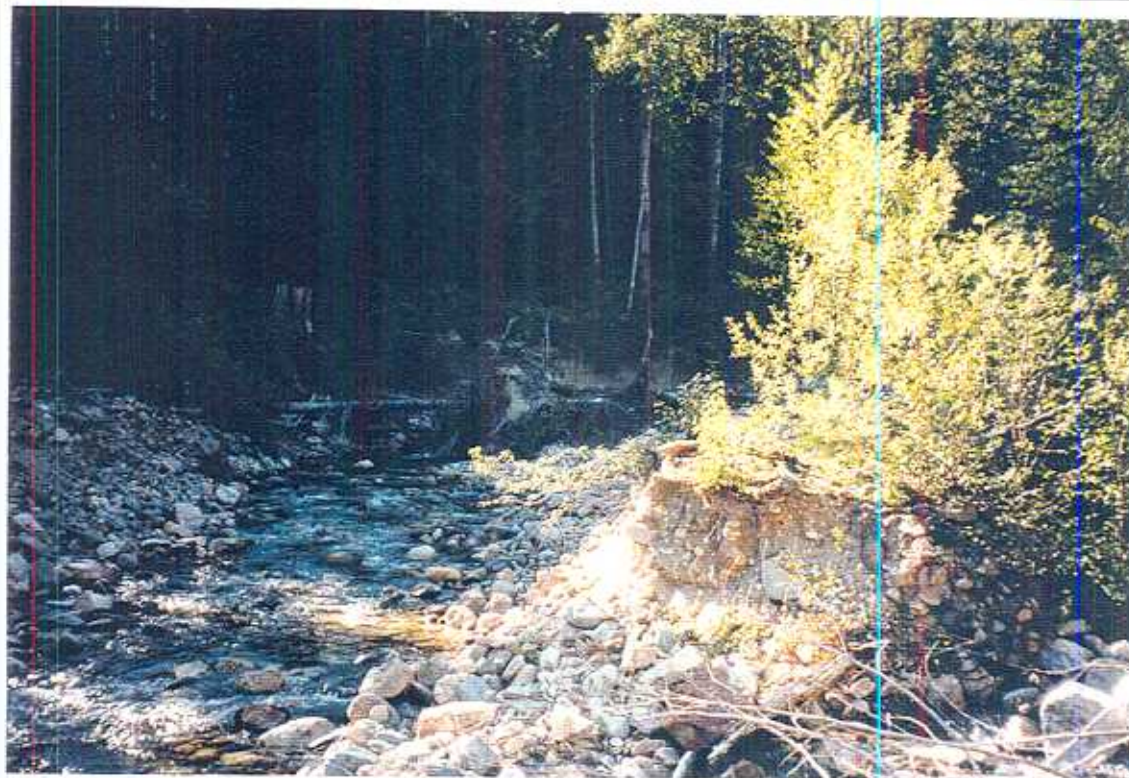
PHOTO 26. Upper Backyard Creek fan showing disturbance that appears to be the result of increased discharge (peak flow) following wildfire and beetle salvage harvesting on the plateau.

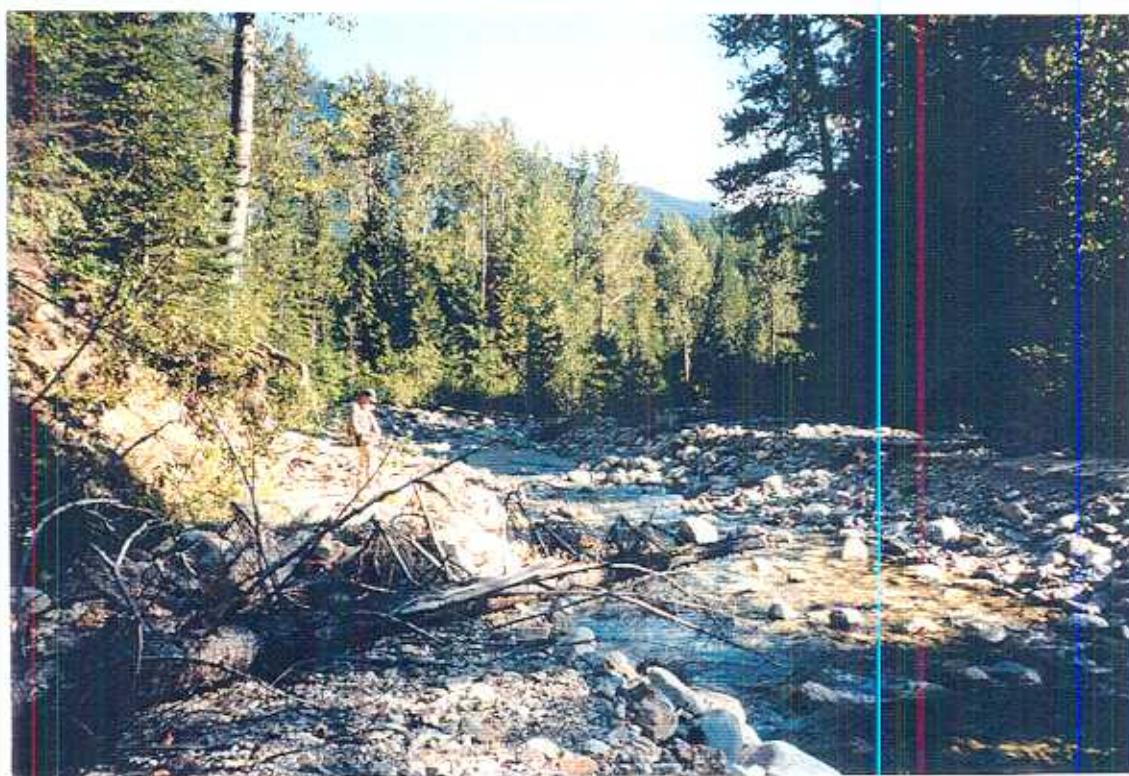
PHOTO 27. Backyard Creek in the mid-fan area showing the active transport of large boulders and ongoing bank erosion and woody debris input.

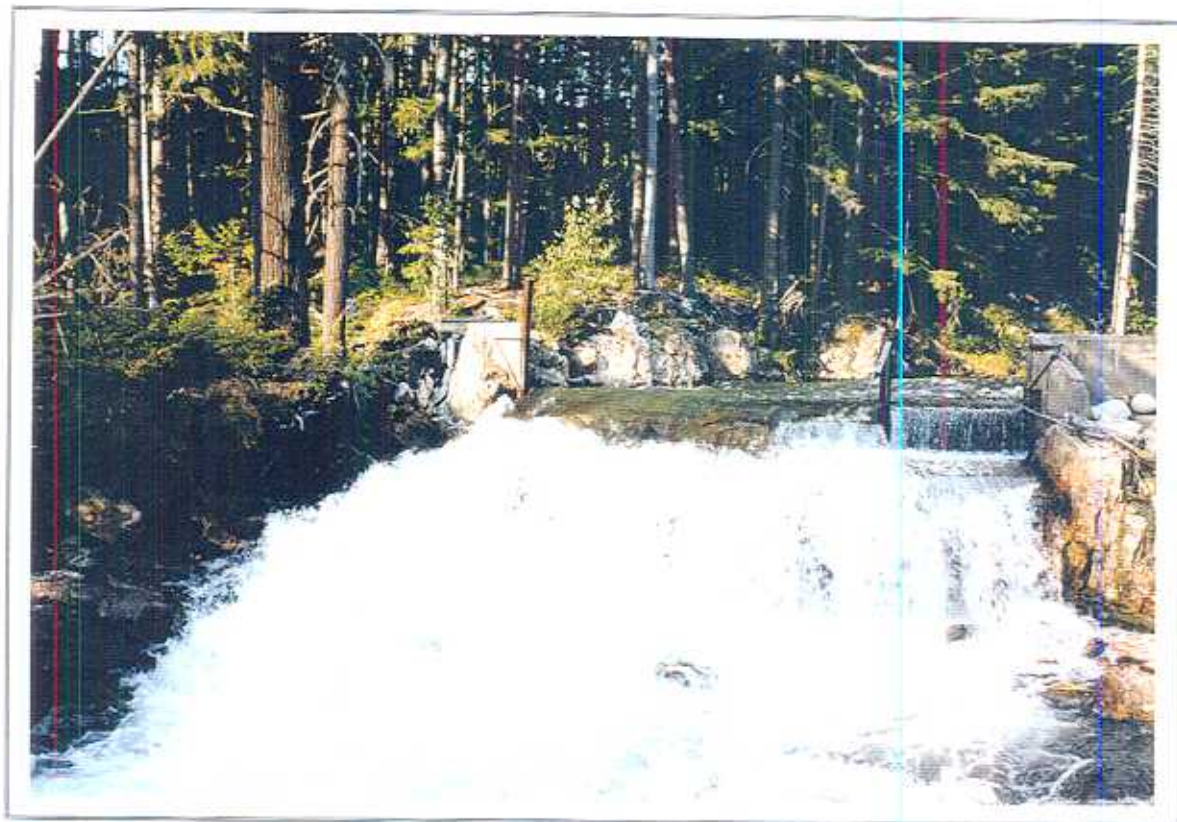
PHOTO 28. The second hydro-electric diversion structure on Wap Creek upstream of Frog Falls. This structure is no longer active but has caused considerable channel disturbance by increasing velocity through the structure and into the alluvial channel downstream.

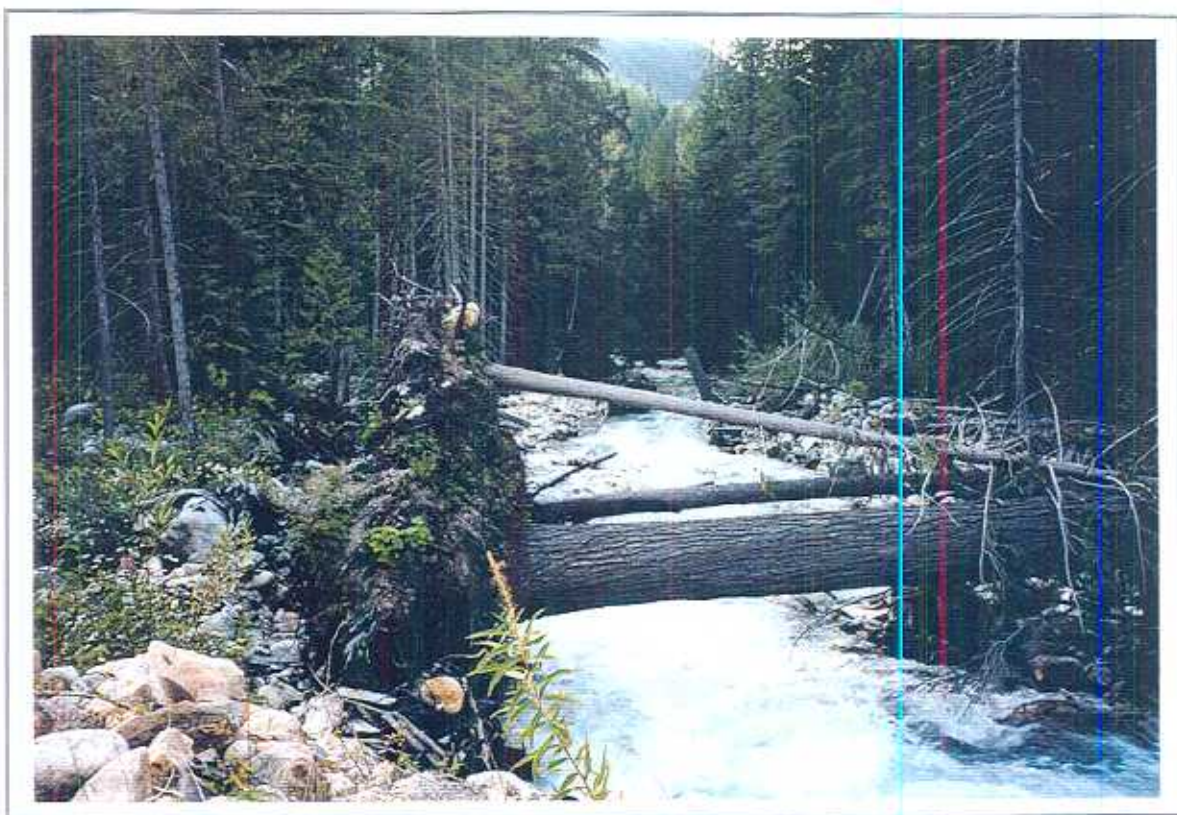
PHOTO 29. Channel disturbance downstream of the second diversion structure.

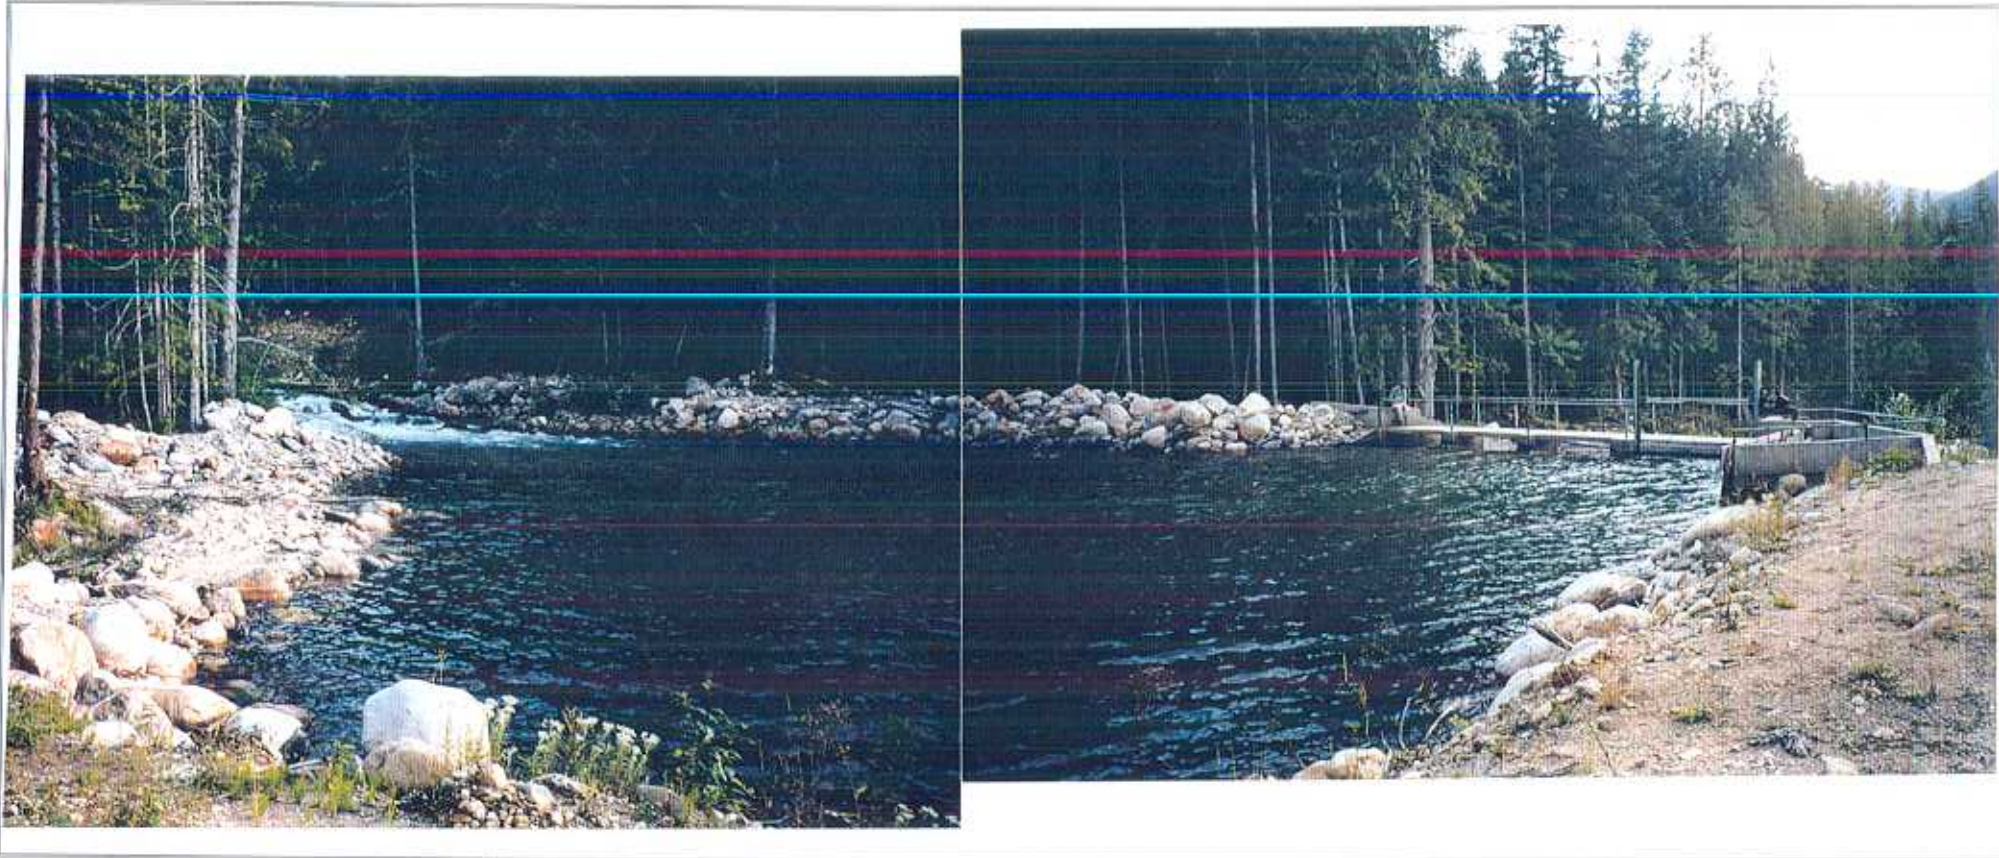
PHOTO 30. The third and uppermost hydro-electric diversion structure at the apex of the alluvial fan upstream of Frog Falls. Note the alluvial fill materials used to contain the small intake pond.

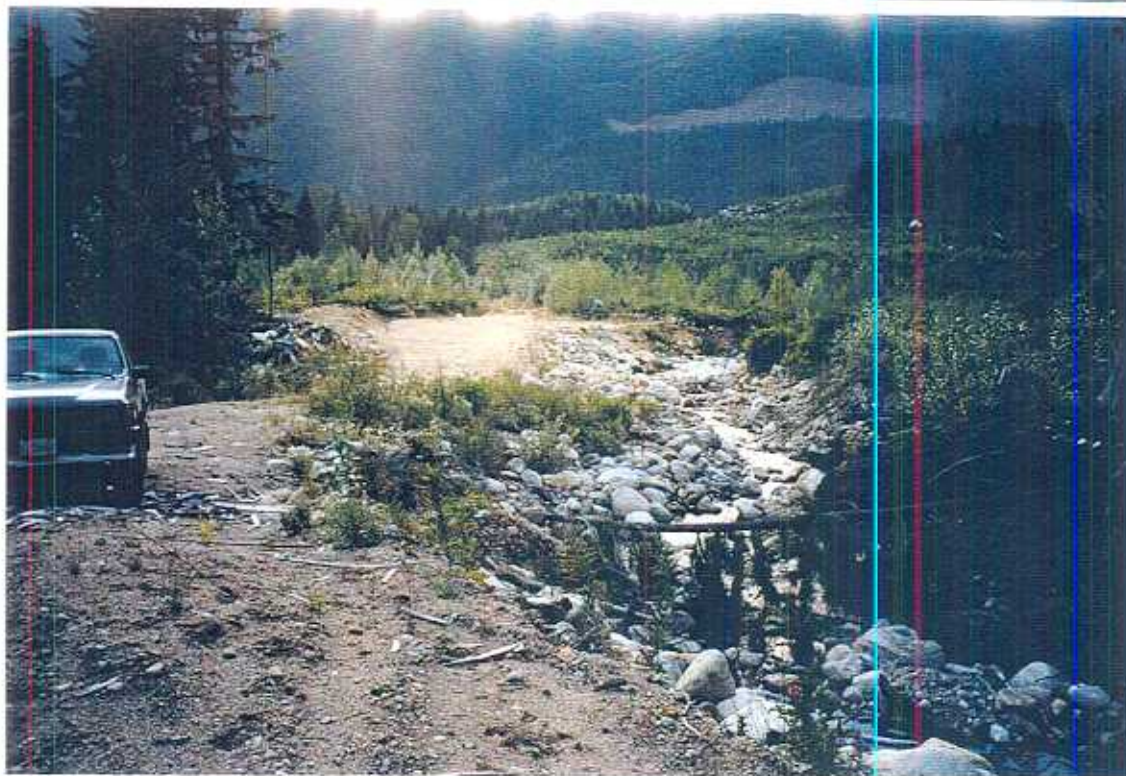
PHOTO 31. New channel formed by the 1997 avulsion around the third diversion structure. Overflow from the dam is reported to be a regular occurrence during periods of frazzle ice formation in the late fall or woody debris accumulation in the spring.

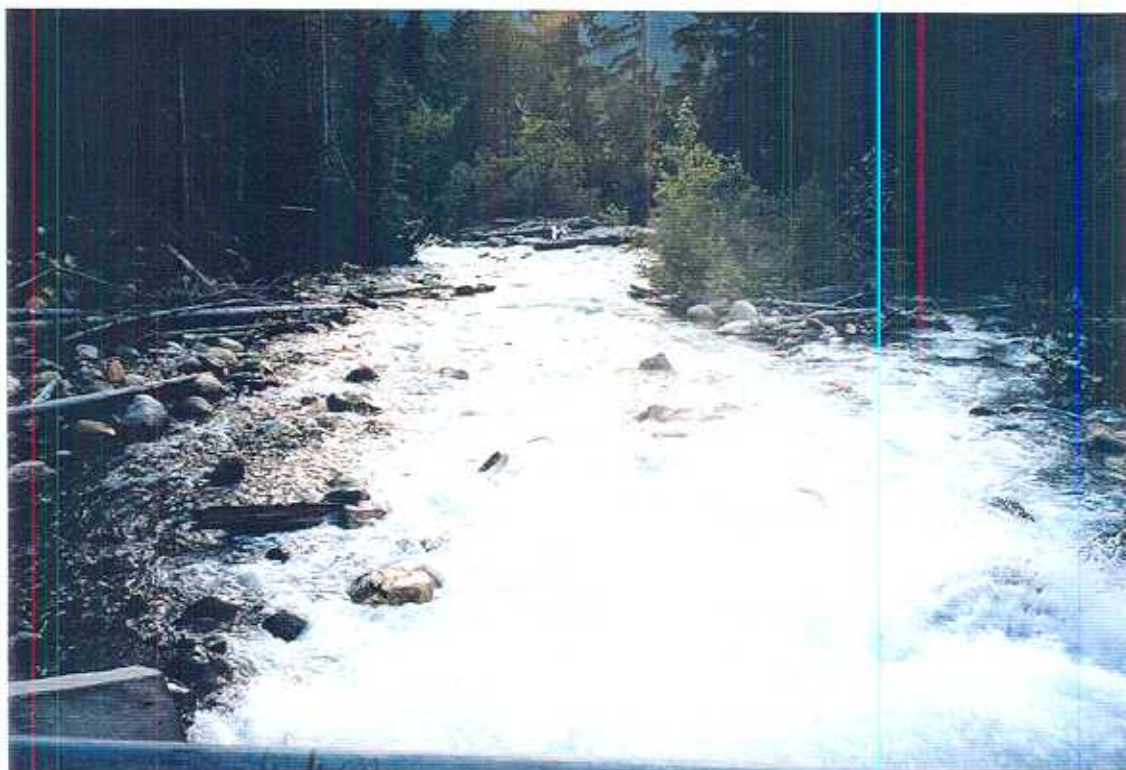
PHOTO 32. Channel disturbance immediately downstream of the outfall from the third diversion structure.

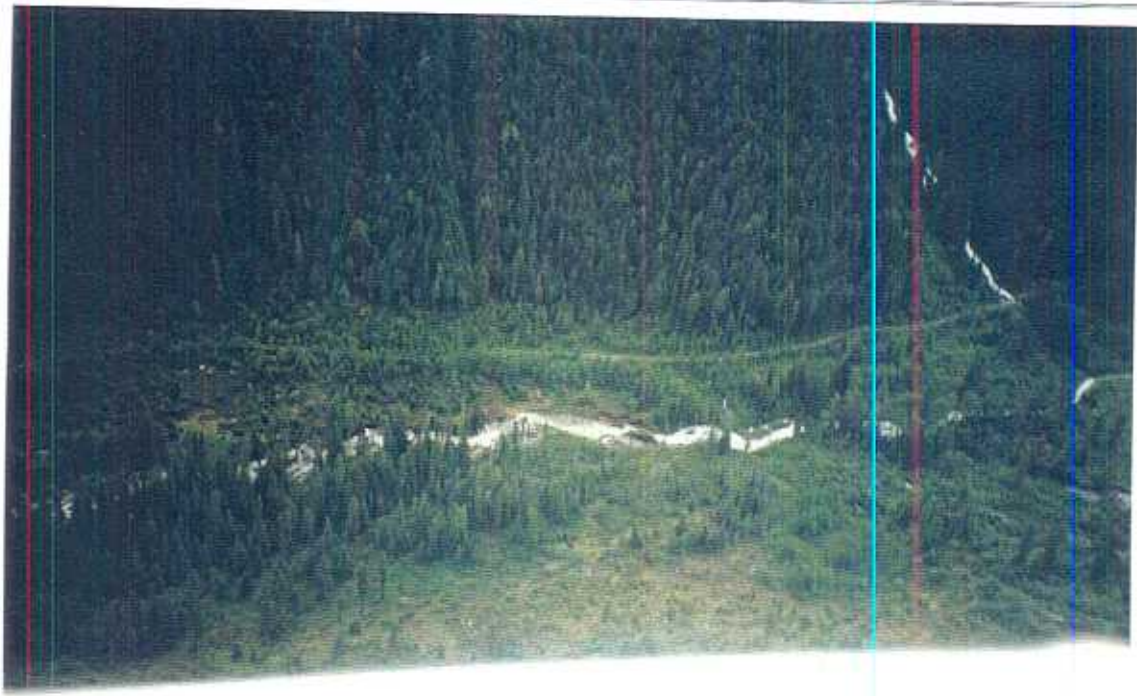
PHOTO 33. Channel disturbance downstream of the old crossing on Upper Wap Creek. Note the eroding cutbank in the centre of the photograph and increased channel width from aggradation downstream of the initial disturbance site.

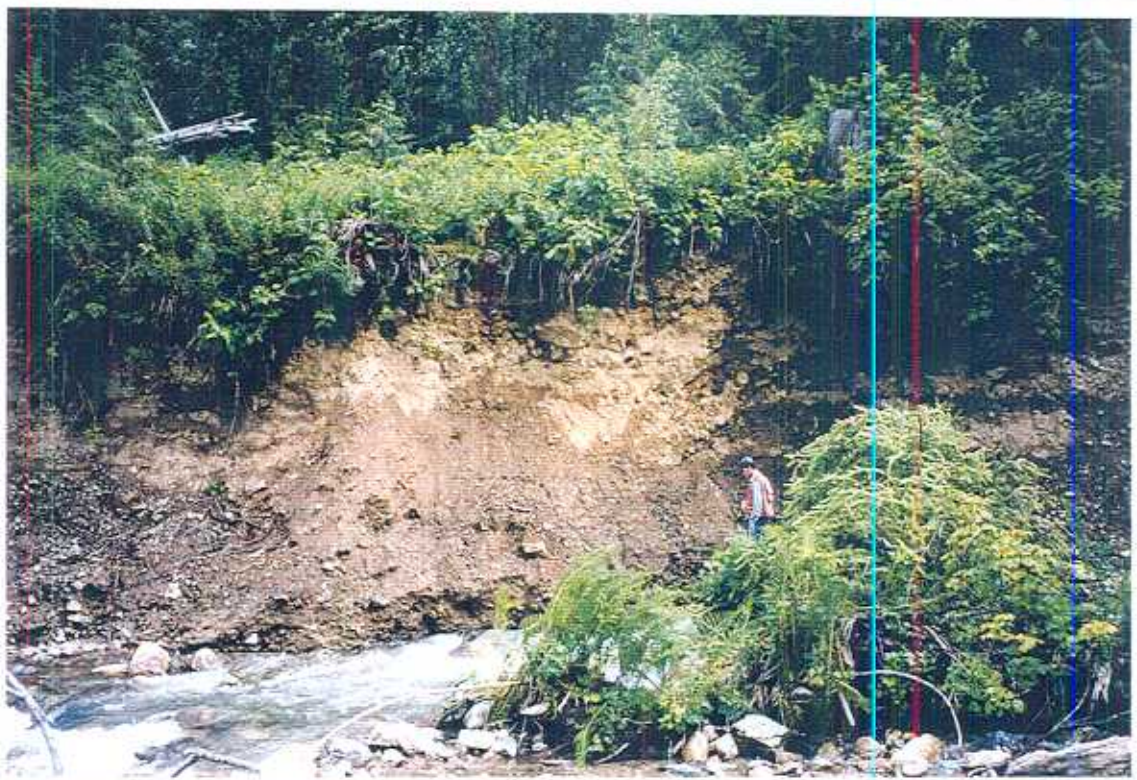
PHOTO 34. View of the compacted glacial till and glacio-fluvial bank noted in photograph 33. This site represents the uppermost source of turbidity in the Wap Creek system.
