Results of the Interior Watershed Assessment Procedure

WAP CREEK WATERSHED

By
DOBSON ENGINEERING LTD.
#4, 1960 Springfield Road
Kelowna, BC
V1Y 5V7

June 2000

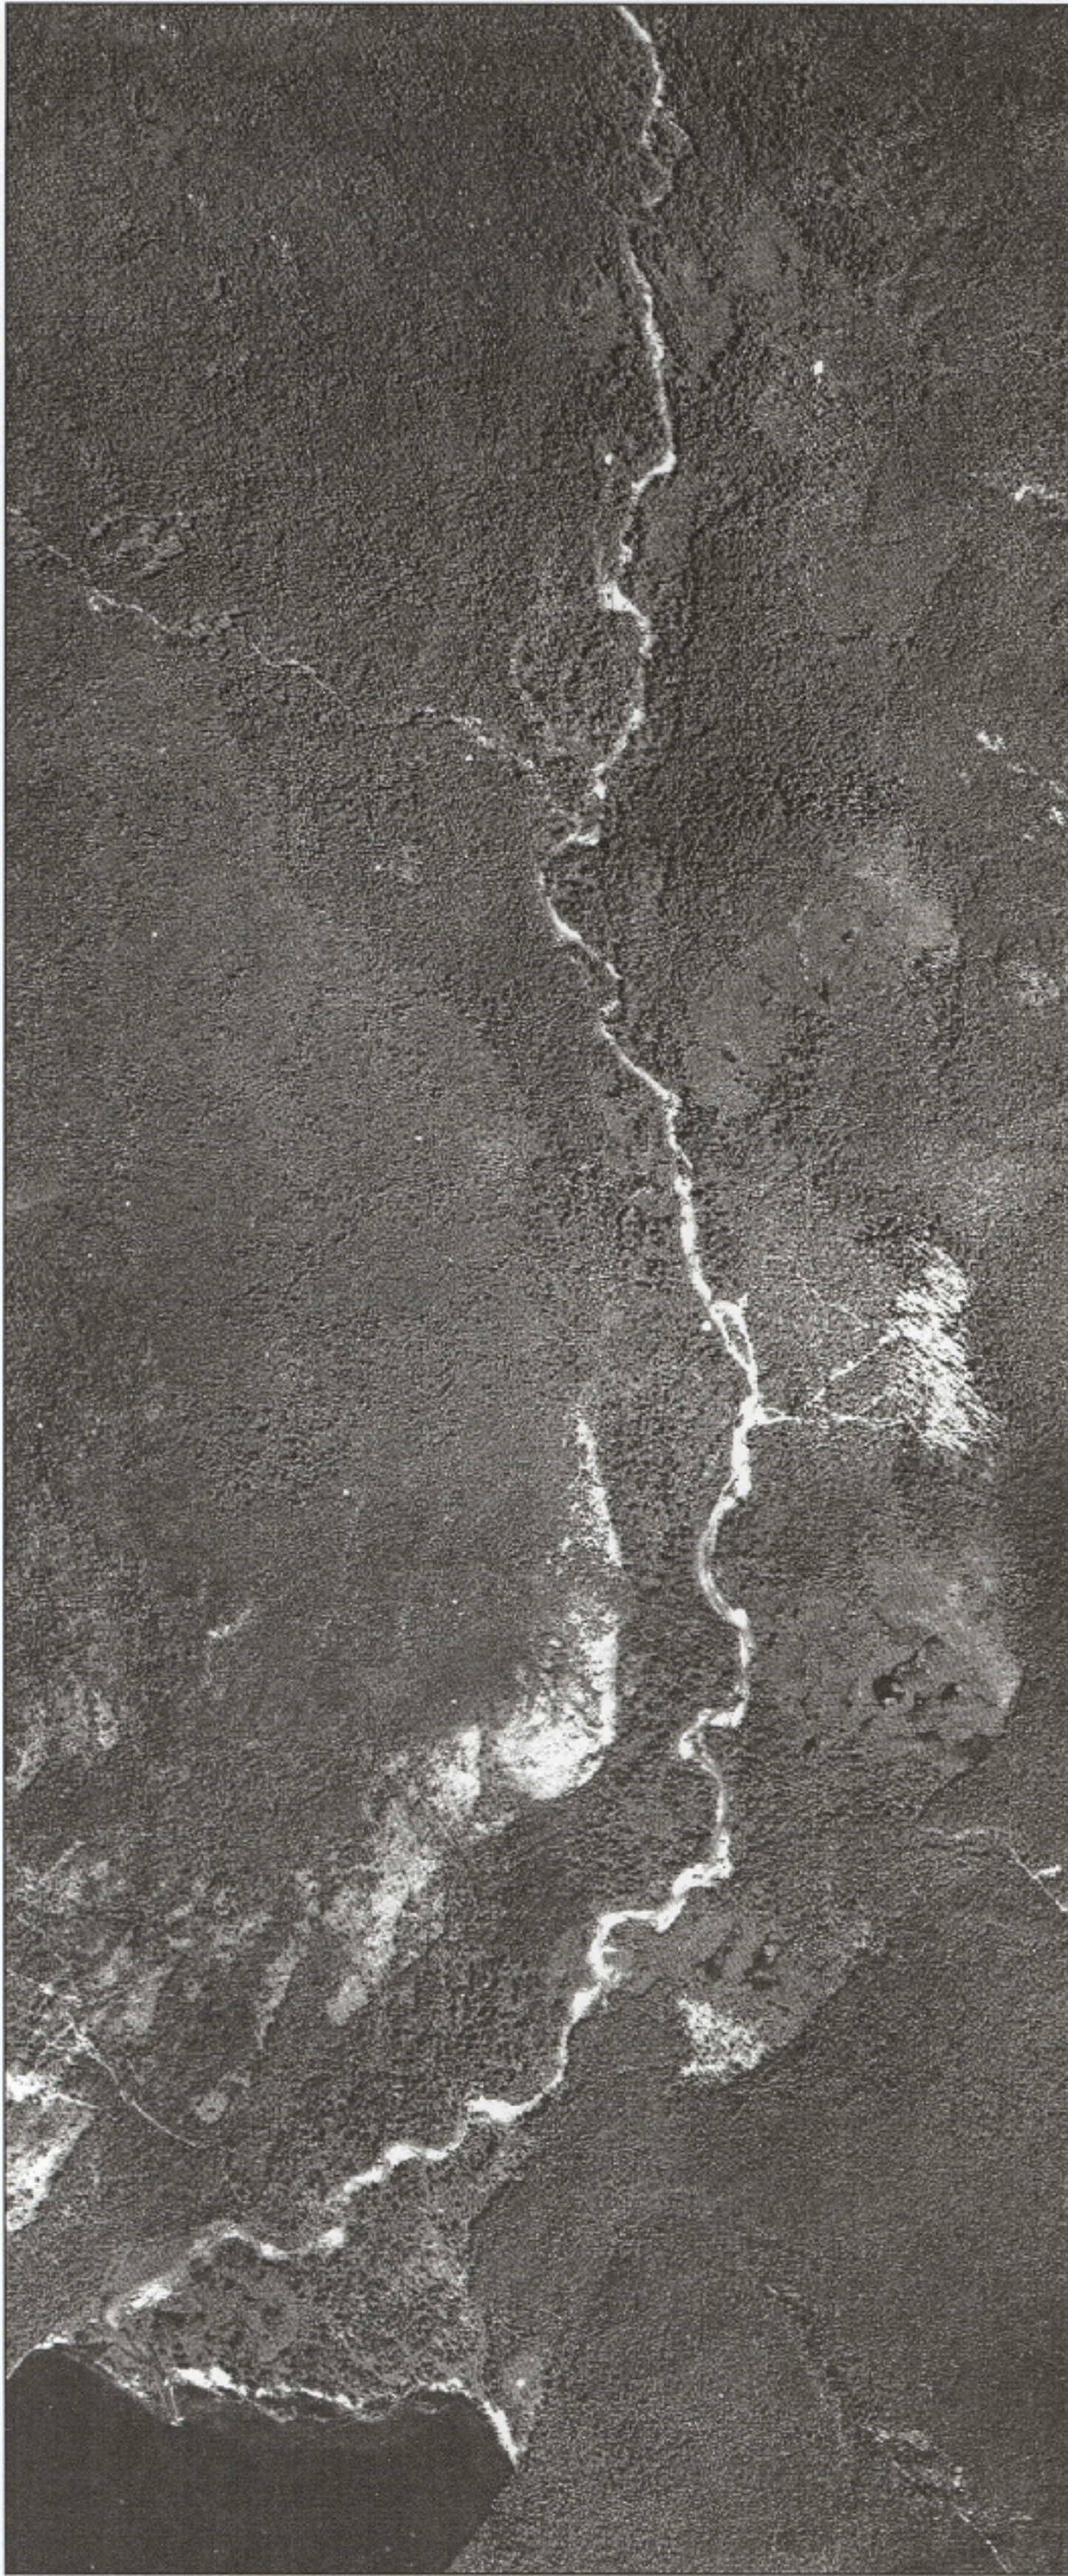
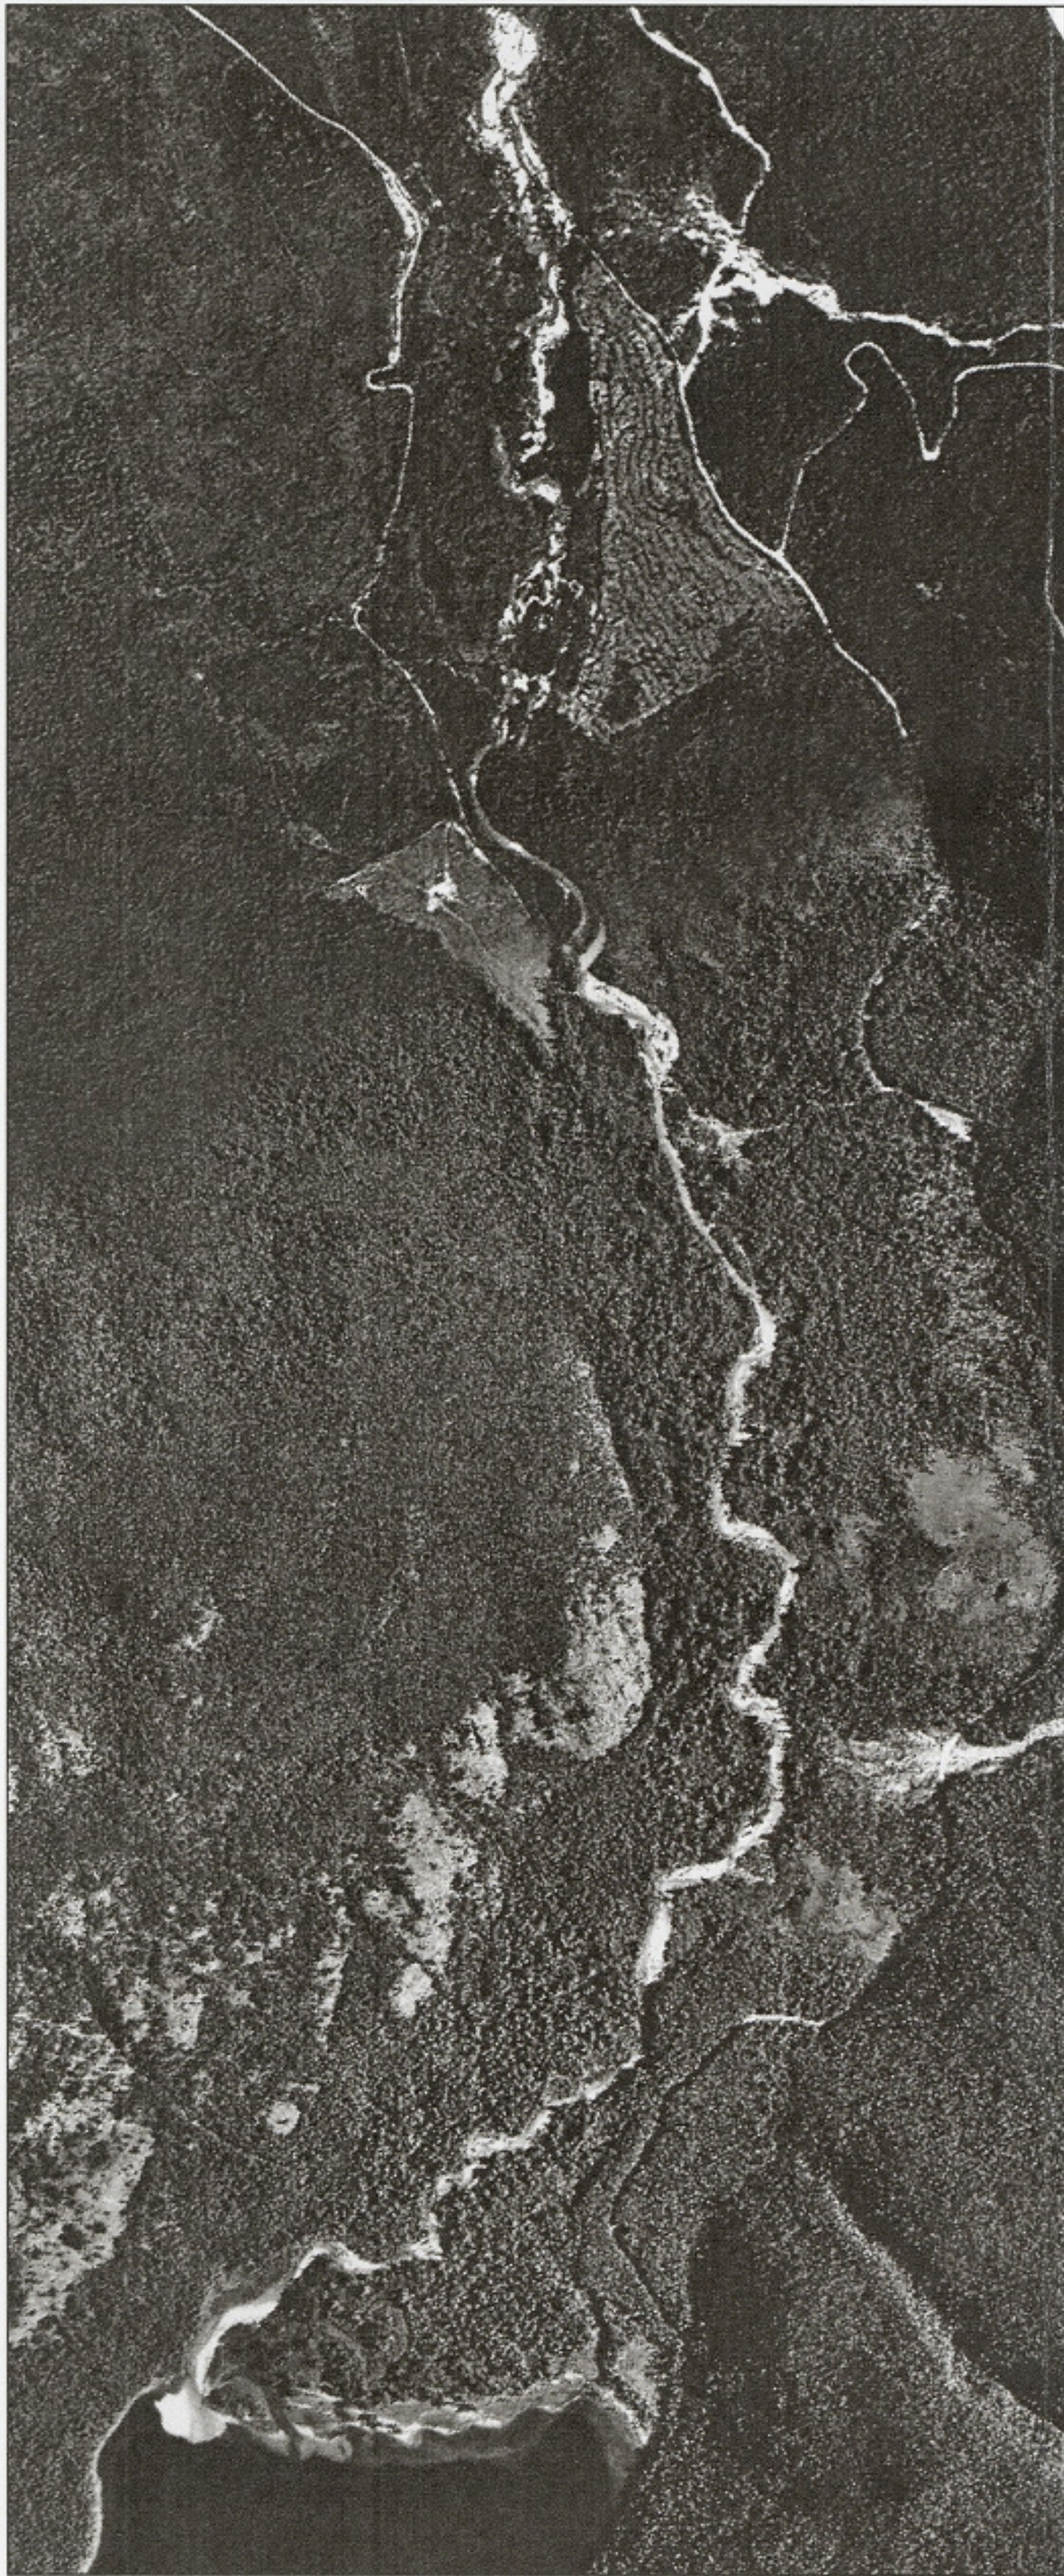
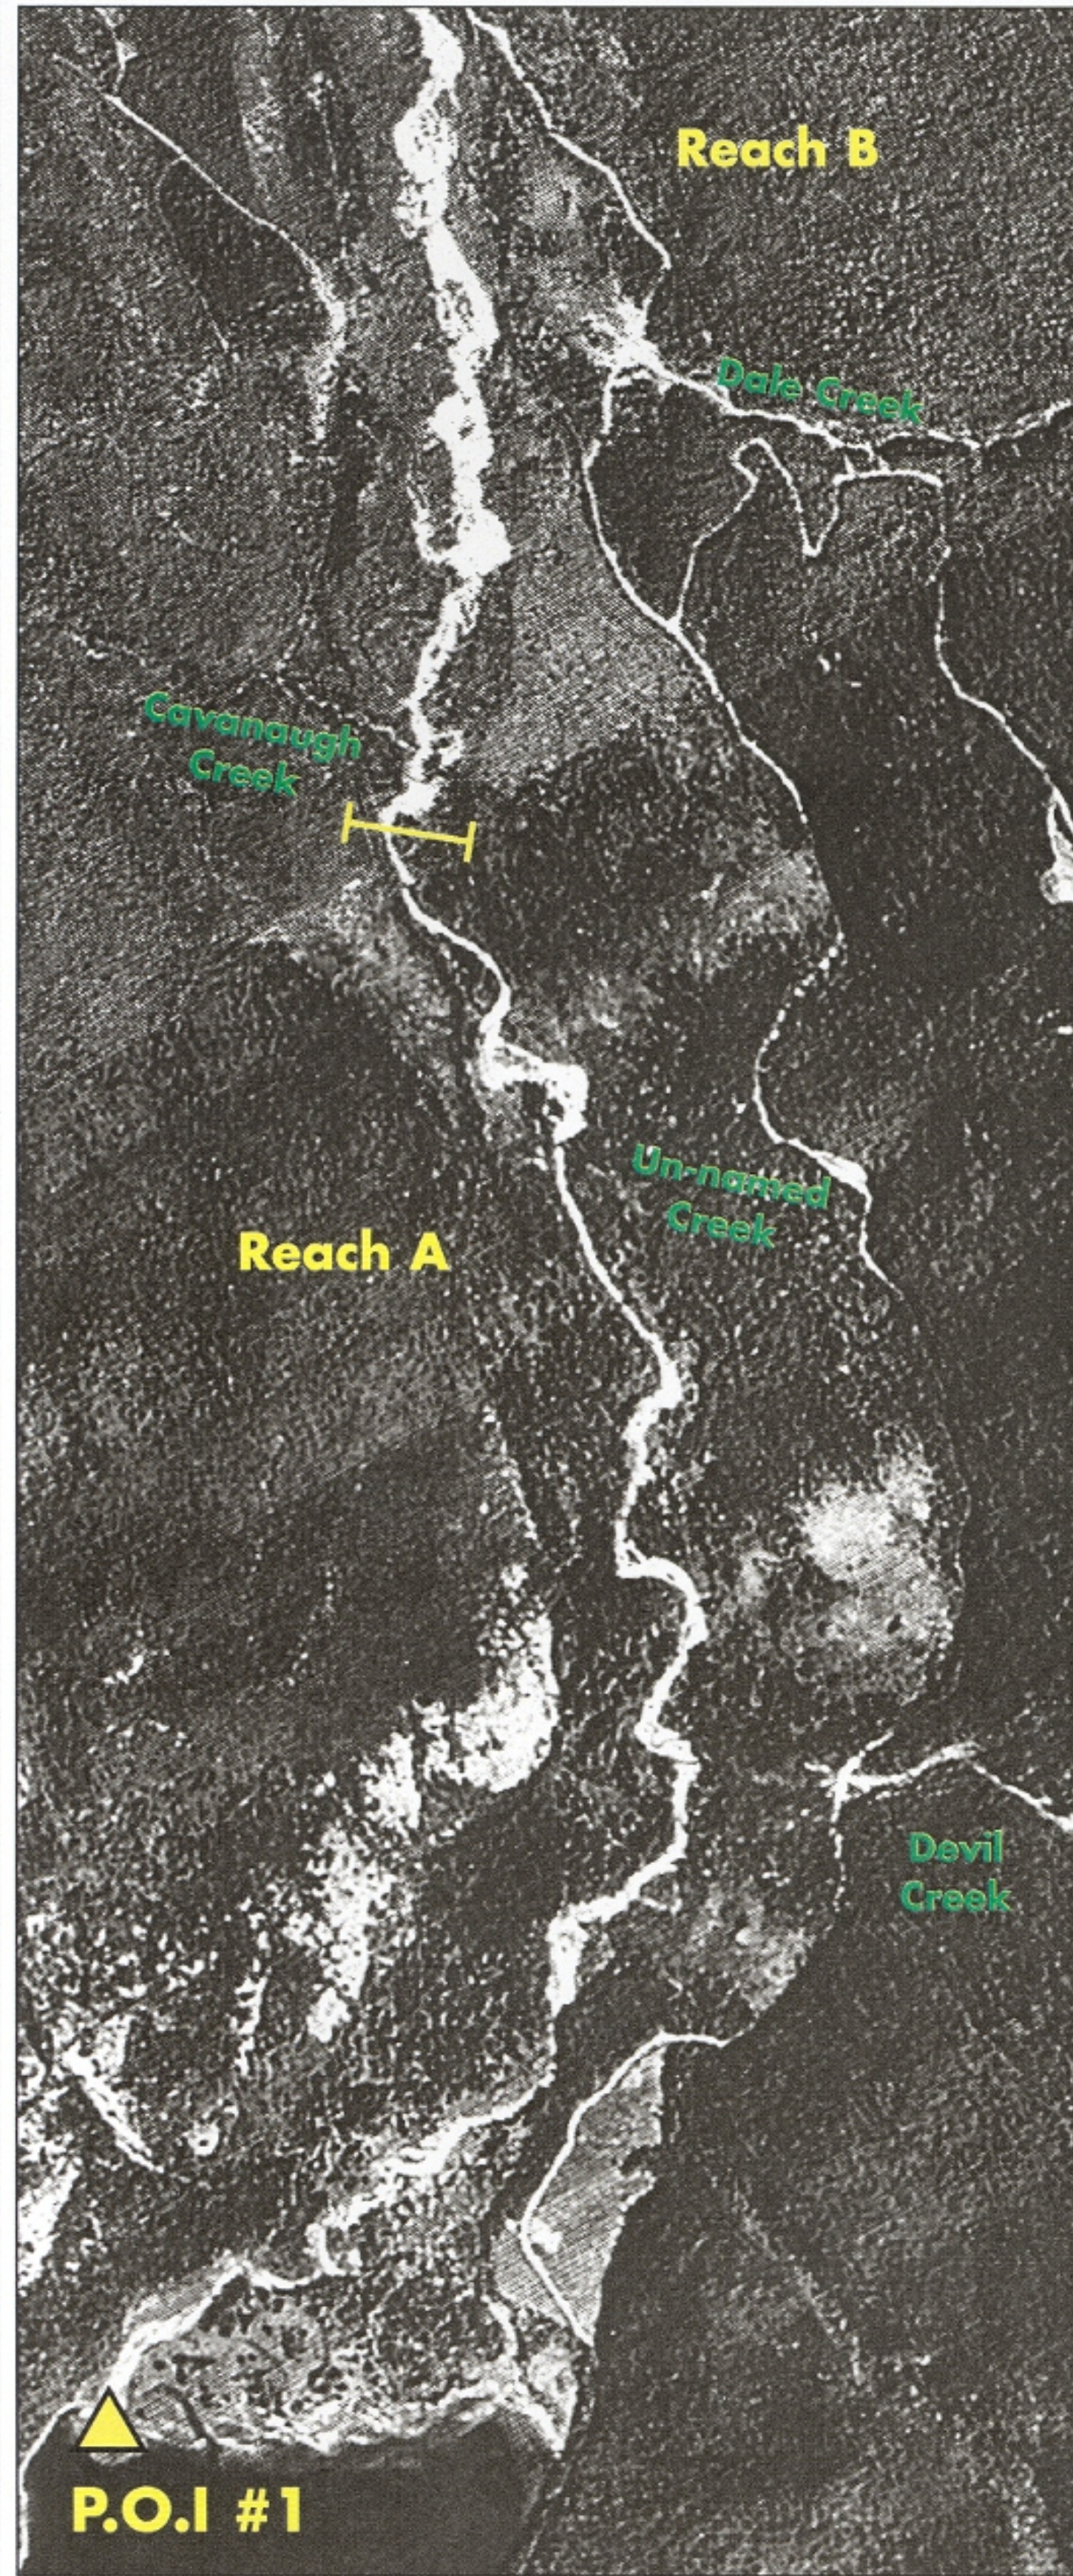
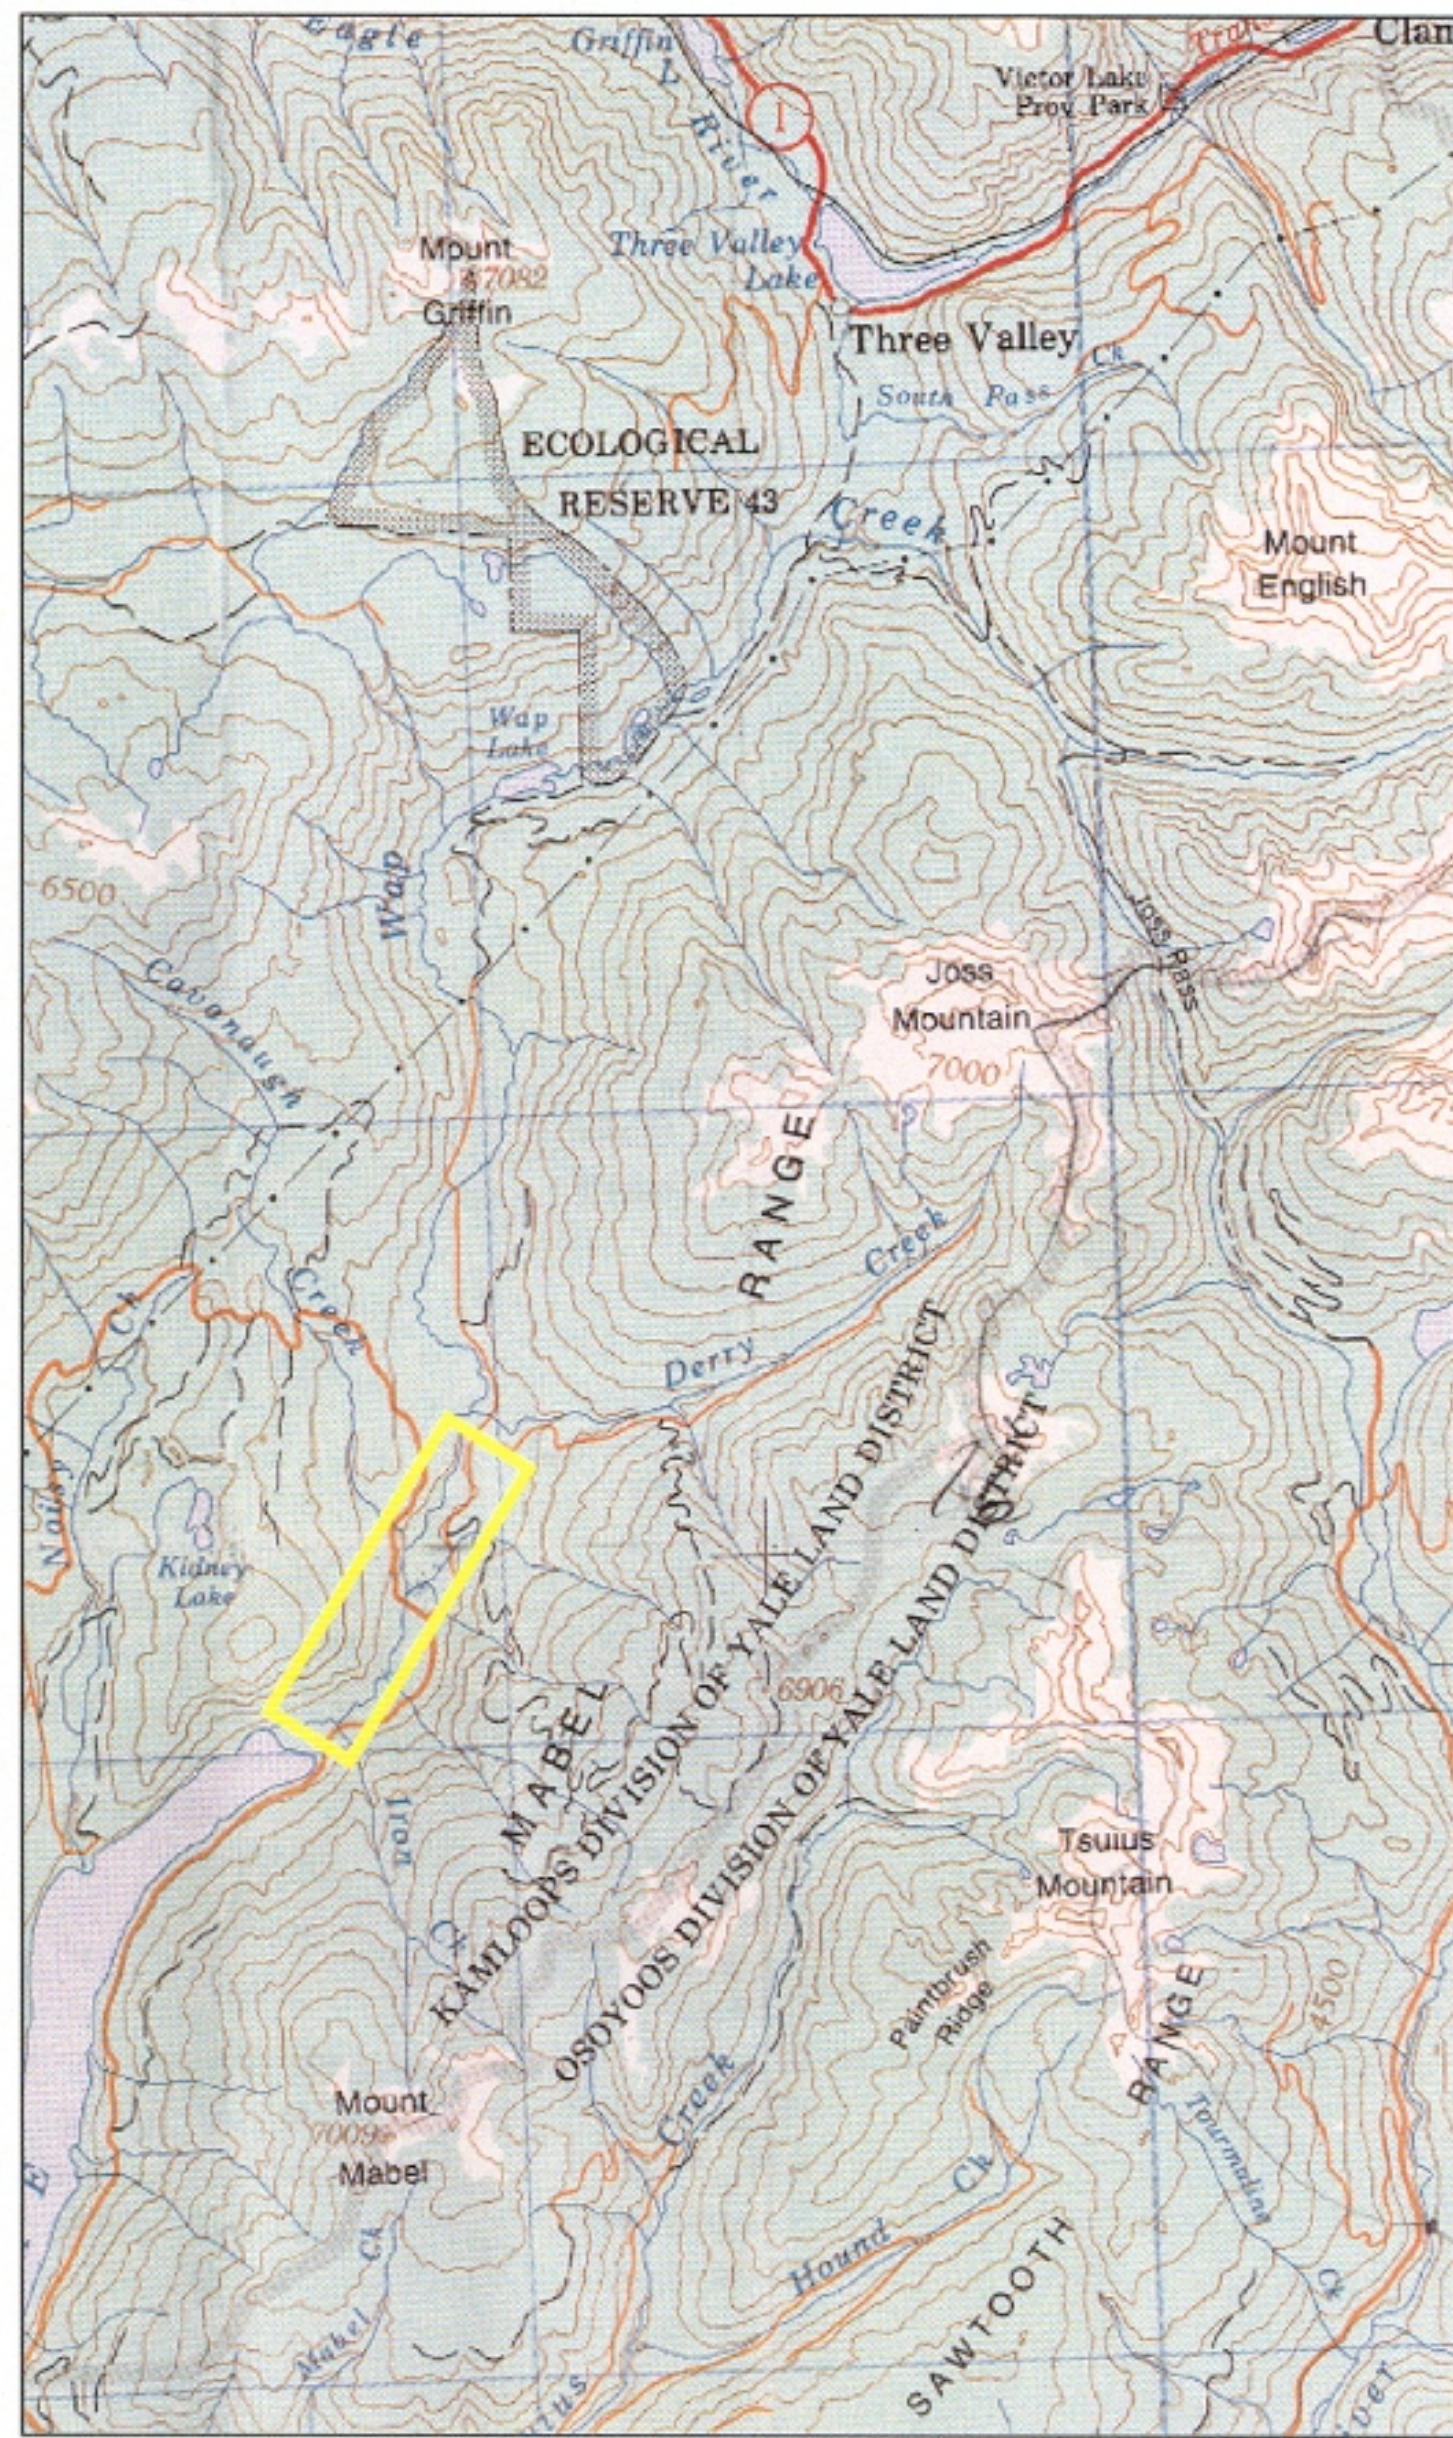
- Lower reaches of the Wap mainstem channel showing natural bar development and some side channels on the alluvial floodplain (1959).
- Significant disturbance is visible in 1984 and 1997 from very high sediment input from upstream bank failures and localized bank erosion. The active channel is up to 400% wider from sediment loading, the channel is straighter and mid channel bars are extensive.
- Much of the lower floodplain was selectively logged prior to 1959. The historic logging is not the cause of disturbance.
- Note the Dale and Devil Creek alluvial fans that dispersed the majority of sediment and debris from the road fill initiated debris flows. A minimal amount of coarse sediment from the debris flows actually reached the Wap mainstem channel.
