Results of the Interior Watershed Assessment Procedure

WAP CREEK WATERSHED

By
DOBSON ENGINEERING LTD.
#4, 1960 Springfield Road
Kelowna, BC
V1Y 5V7

June 2000

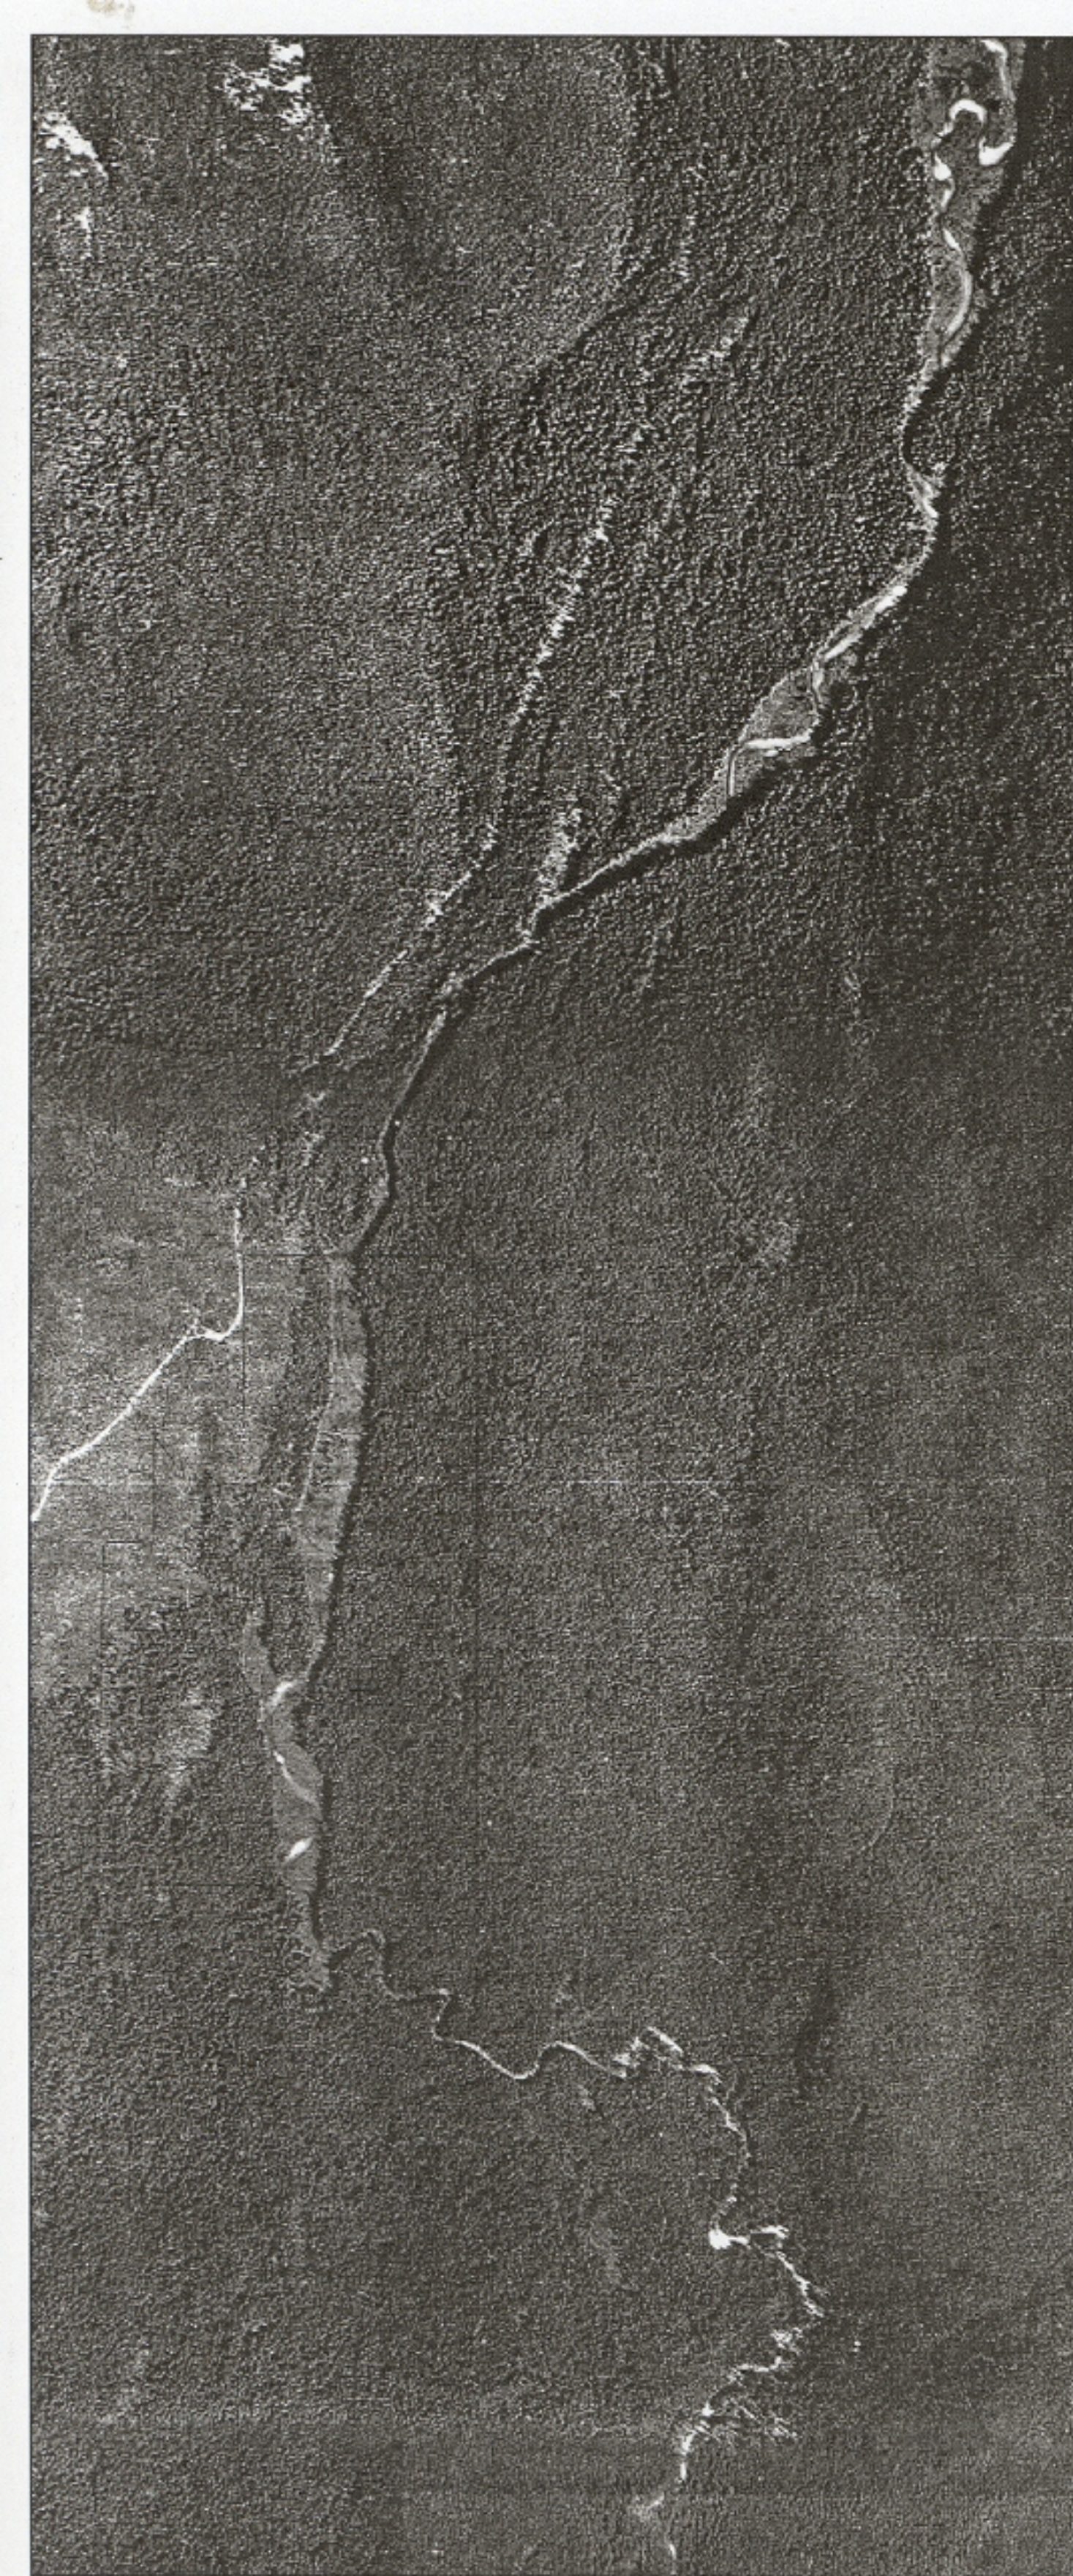
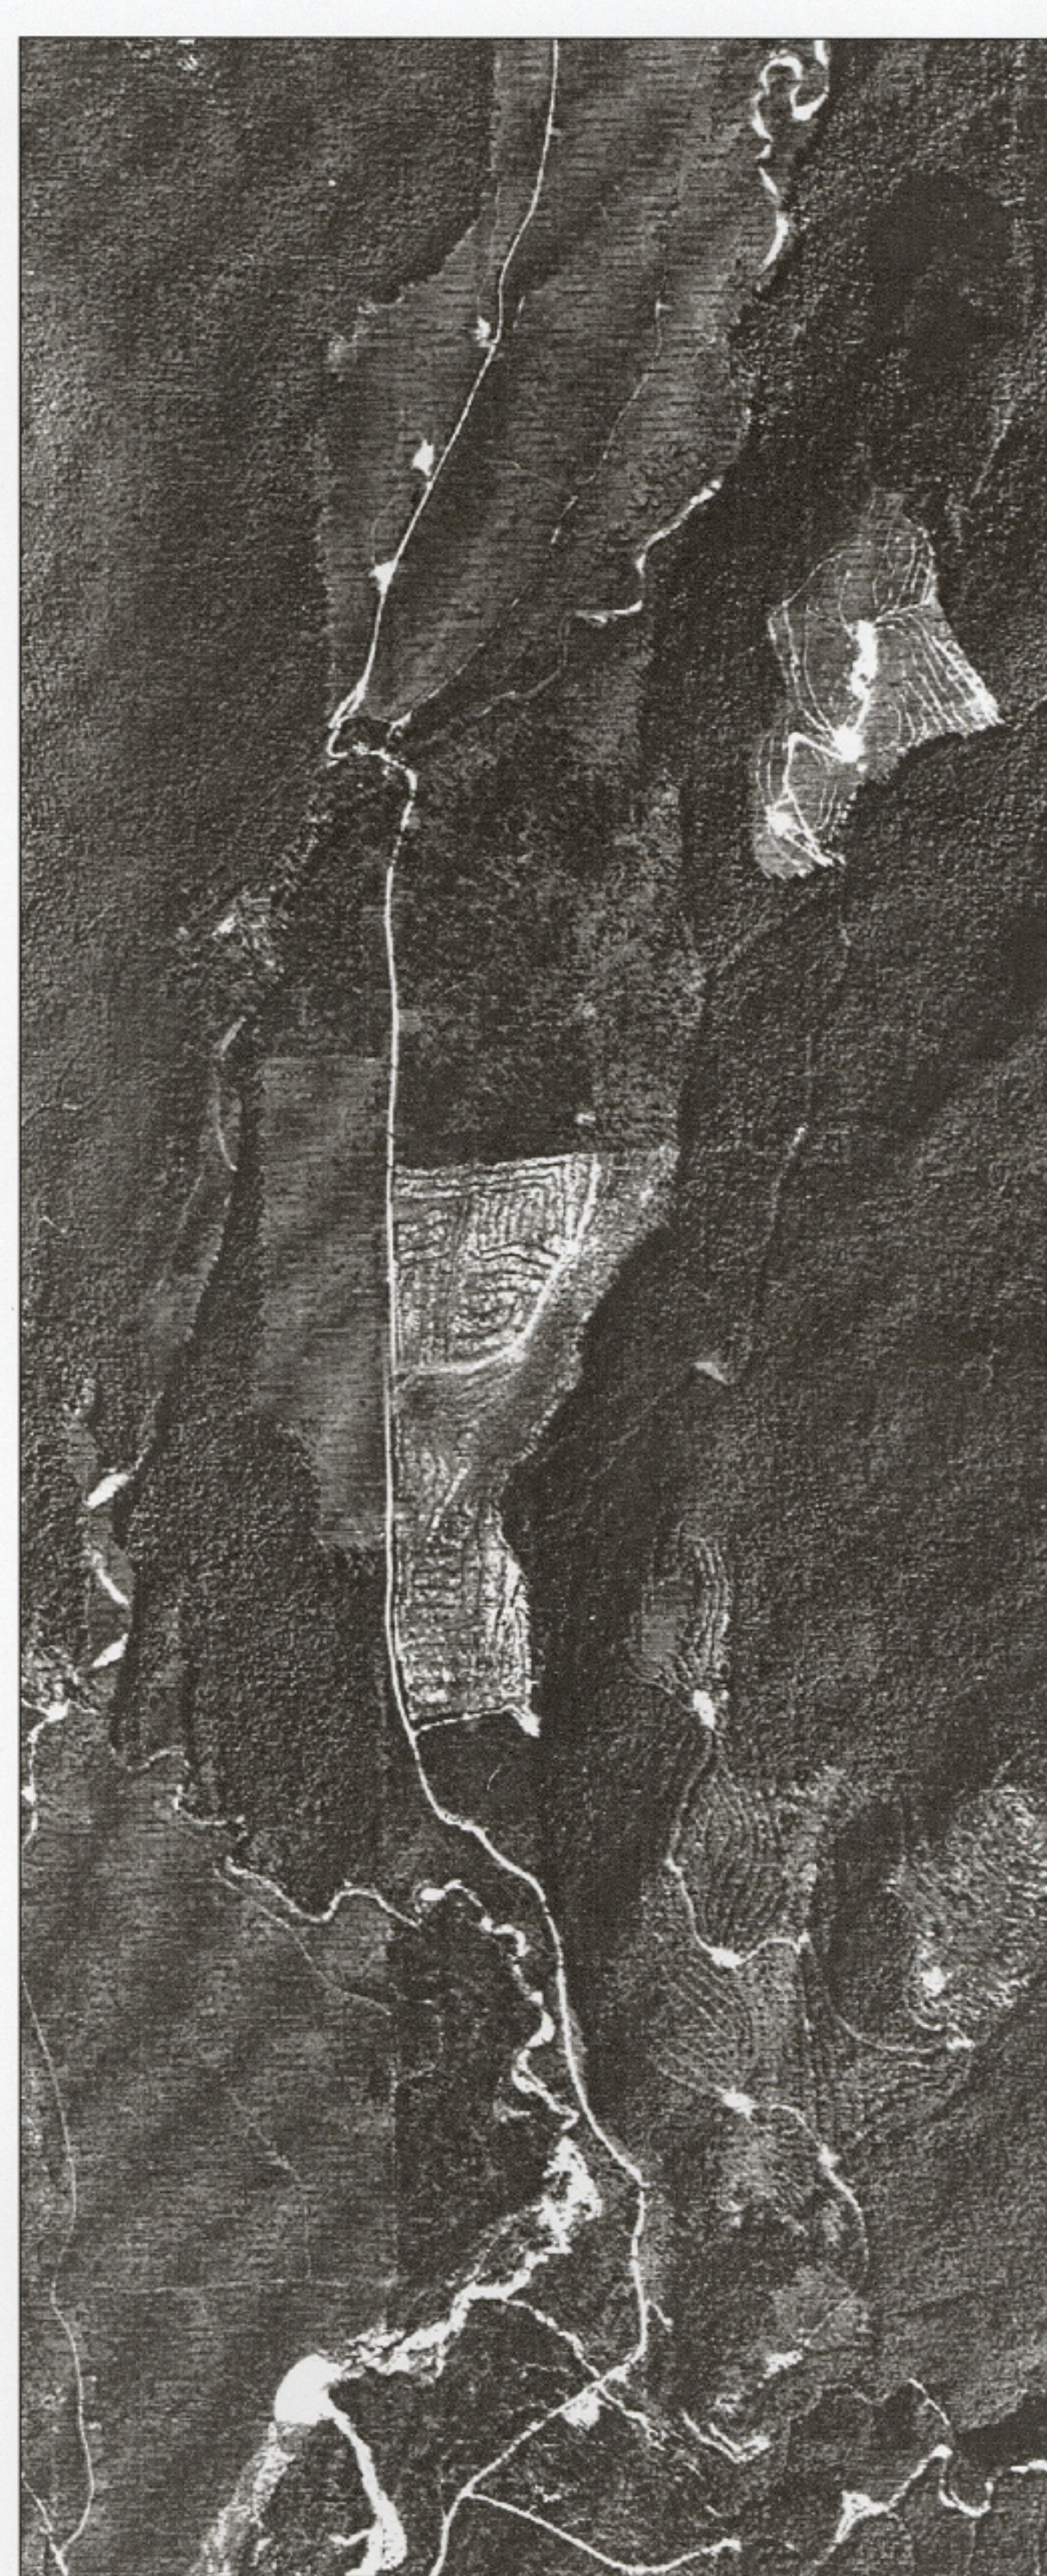
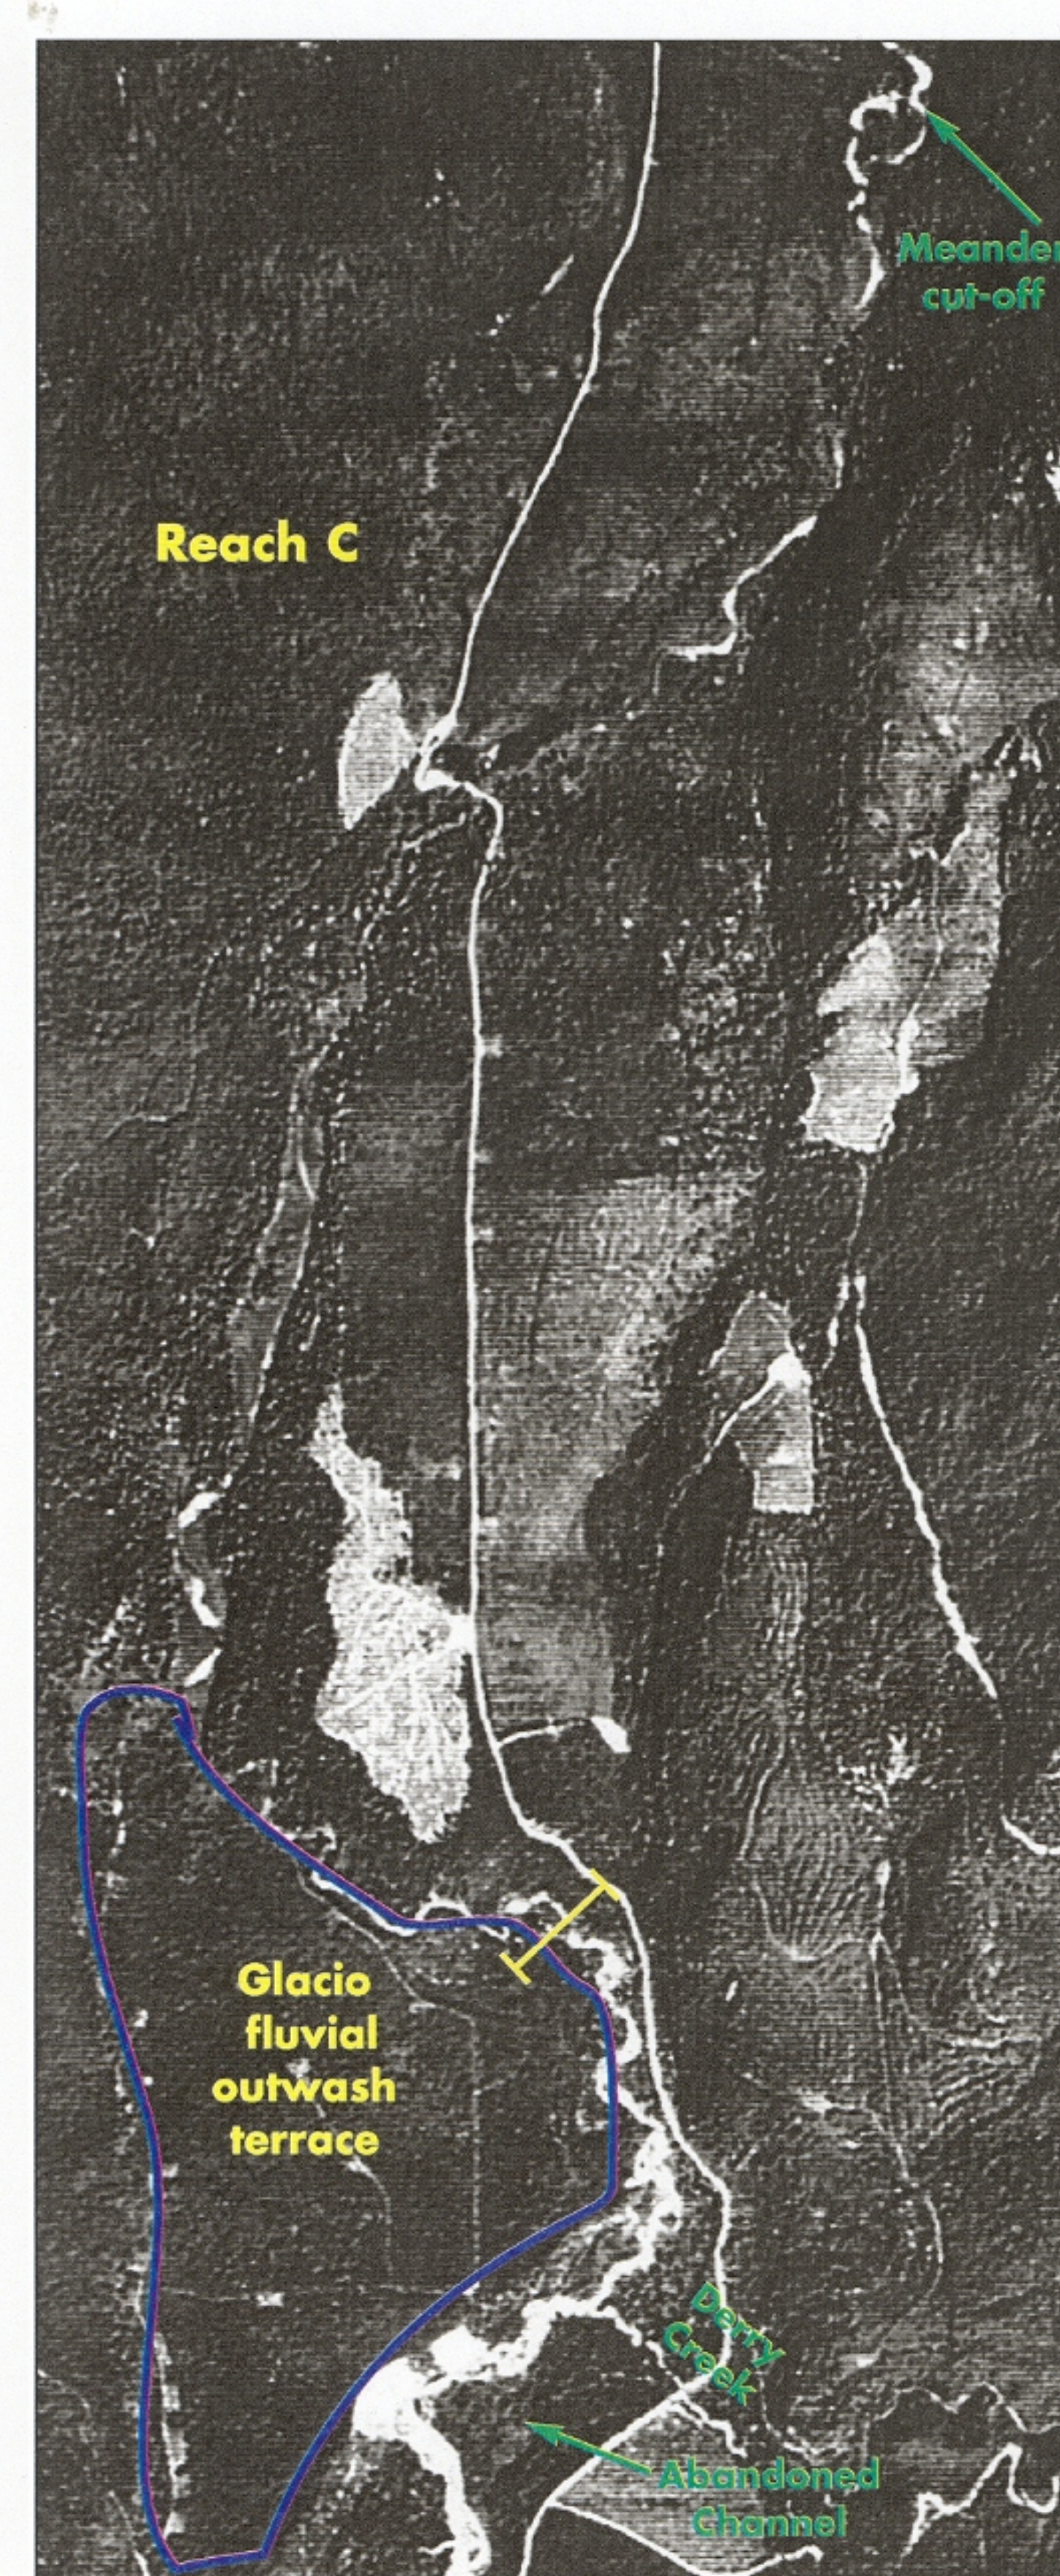
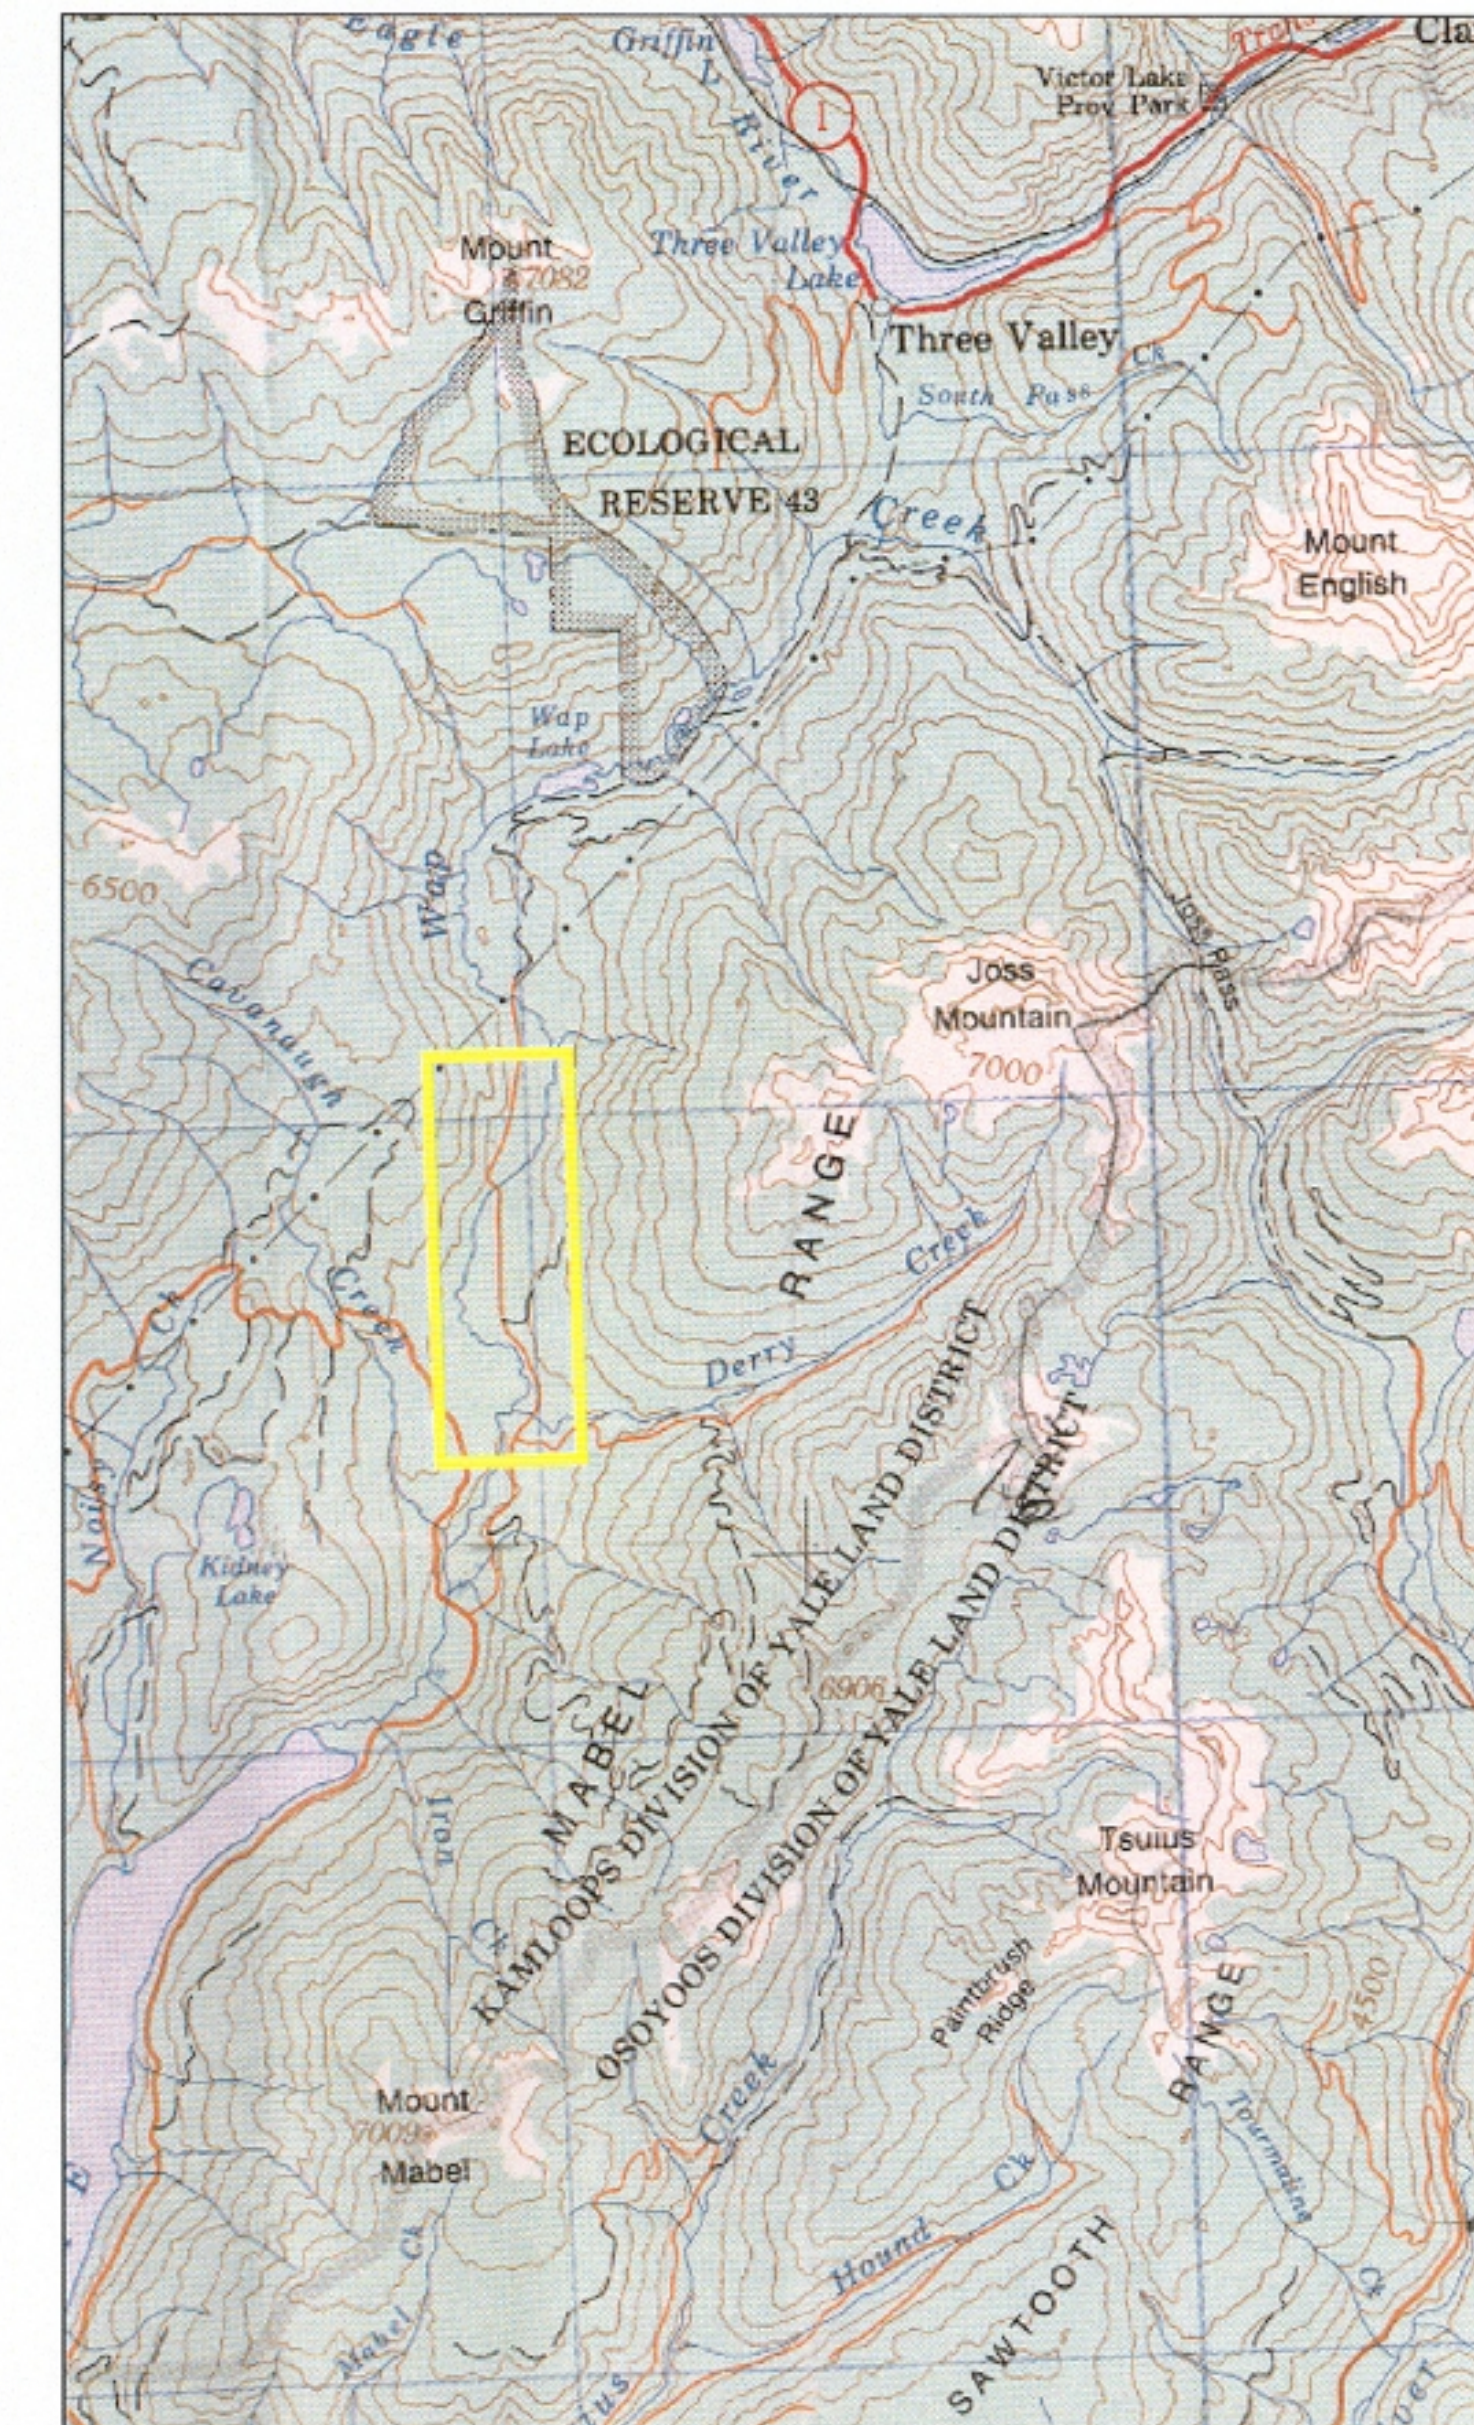
- Upper Reach B and lower Reach C showing the large bank failures that are occurring following harvest of the large block on an historic glacio-fluvial outwash terrace.
- Upstream of the large bank failures some increase in sediment load is visible with bar development and a meander cut-off. The increase in sediment load visible upstream of the bank failures is thought to be from natural tributary input following 1960's wildfires.
- Note evidence of an abandoned channel near the bank failures that could be used to divert flow away from the erodable outwash slope in order to revegetate and stabilize. Mature vegetation on the outwash slope was providing stability in 1959.
- Also note increased sediment load on the Derry Creek fan from upstream road sediment sources and harvesting on the south side of the fan.
