Results of the Interior Watershed Assessment Procedure

WAP CREEK WATERSHED

By
DOBSON ENGINEERING LTD.
#4, 1960 Springfield Road
Kelowna, BC
V1Y 5V7

June 2000

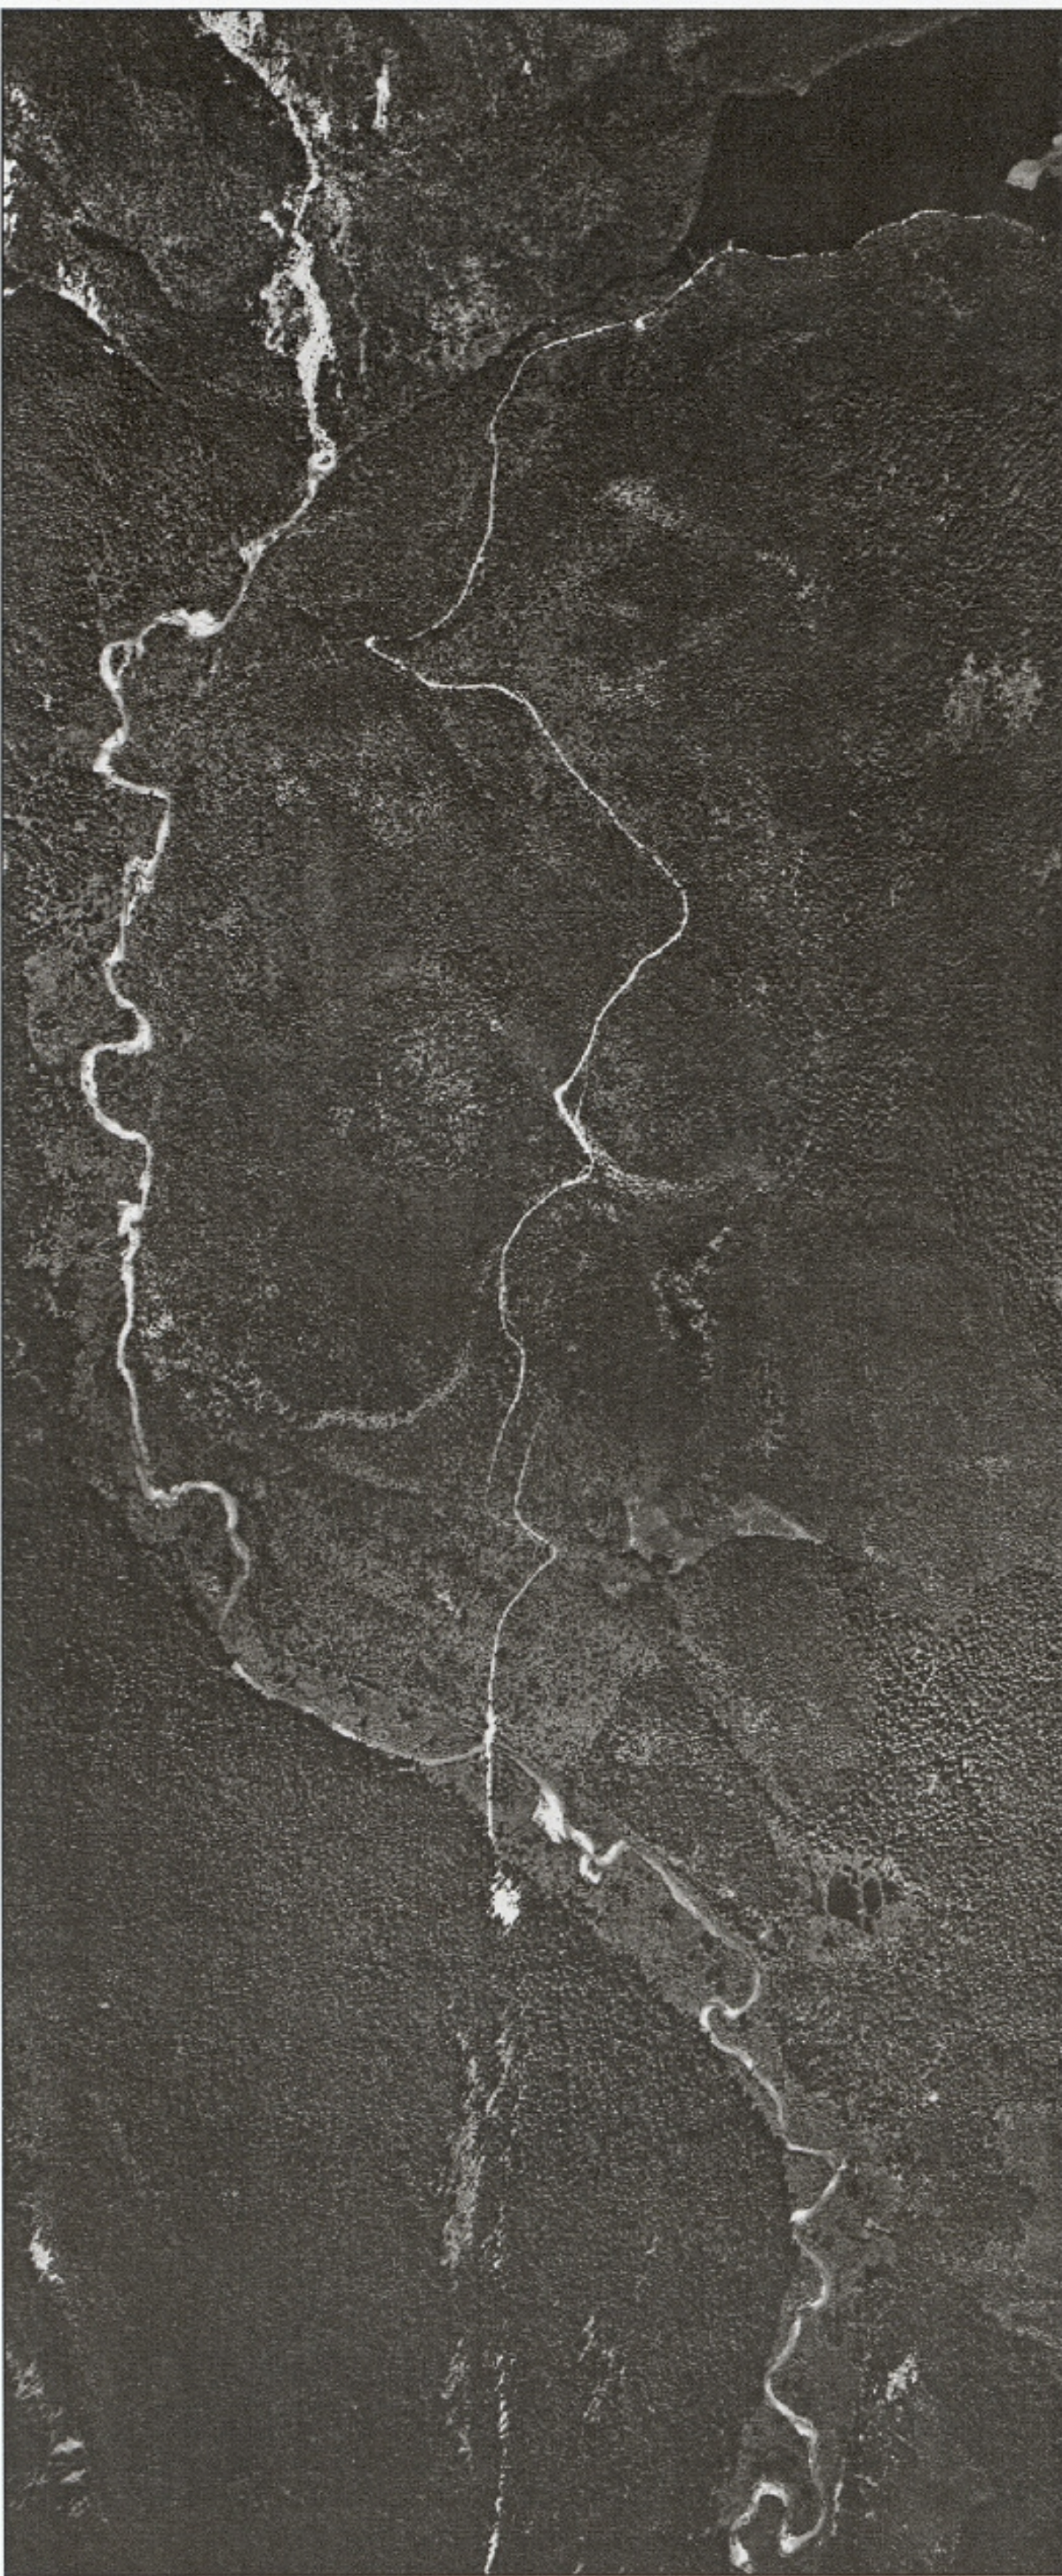
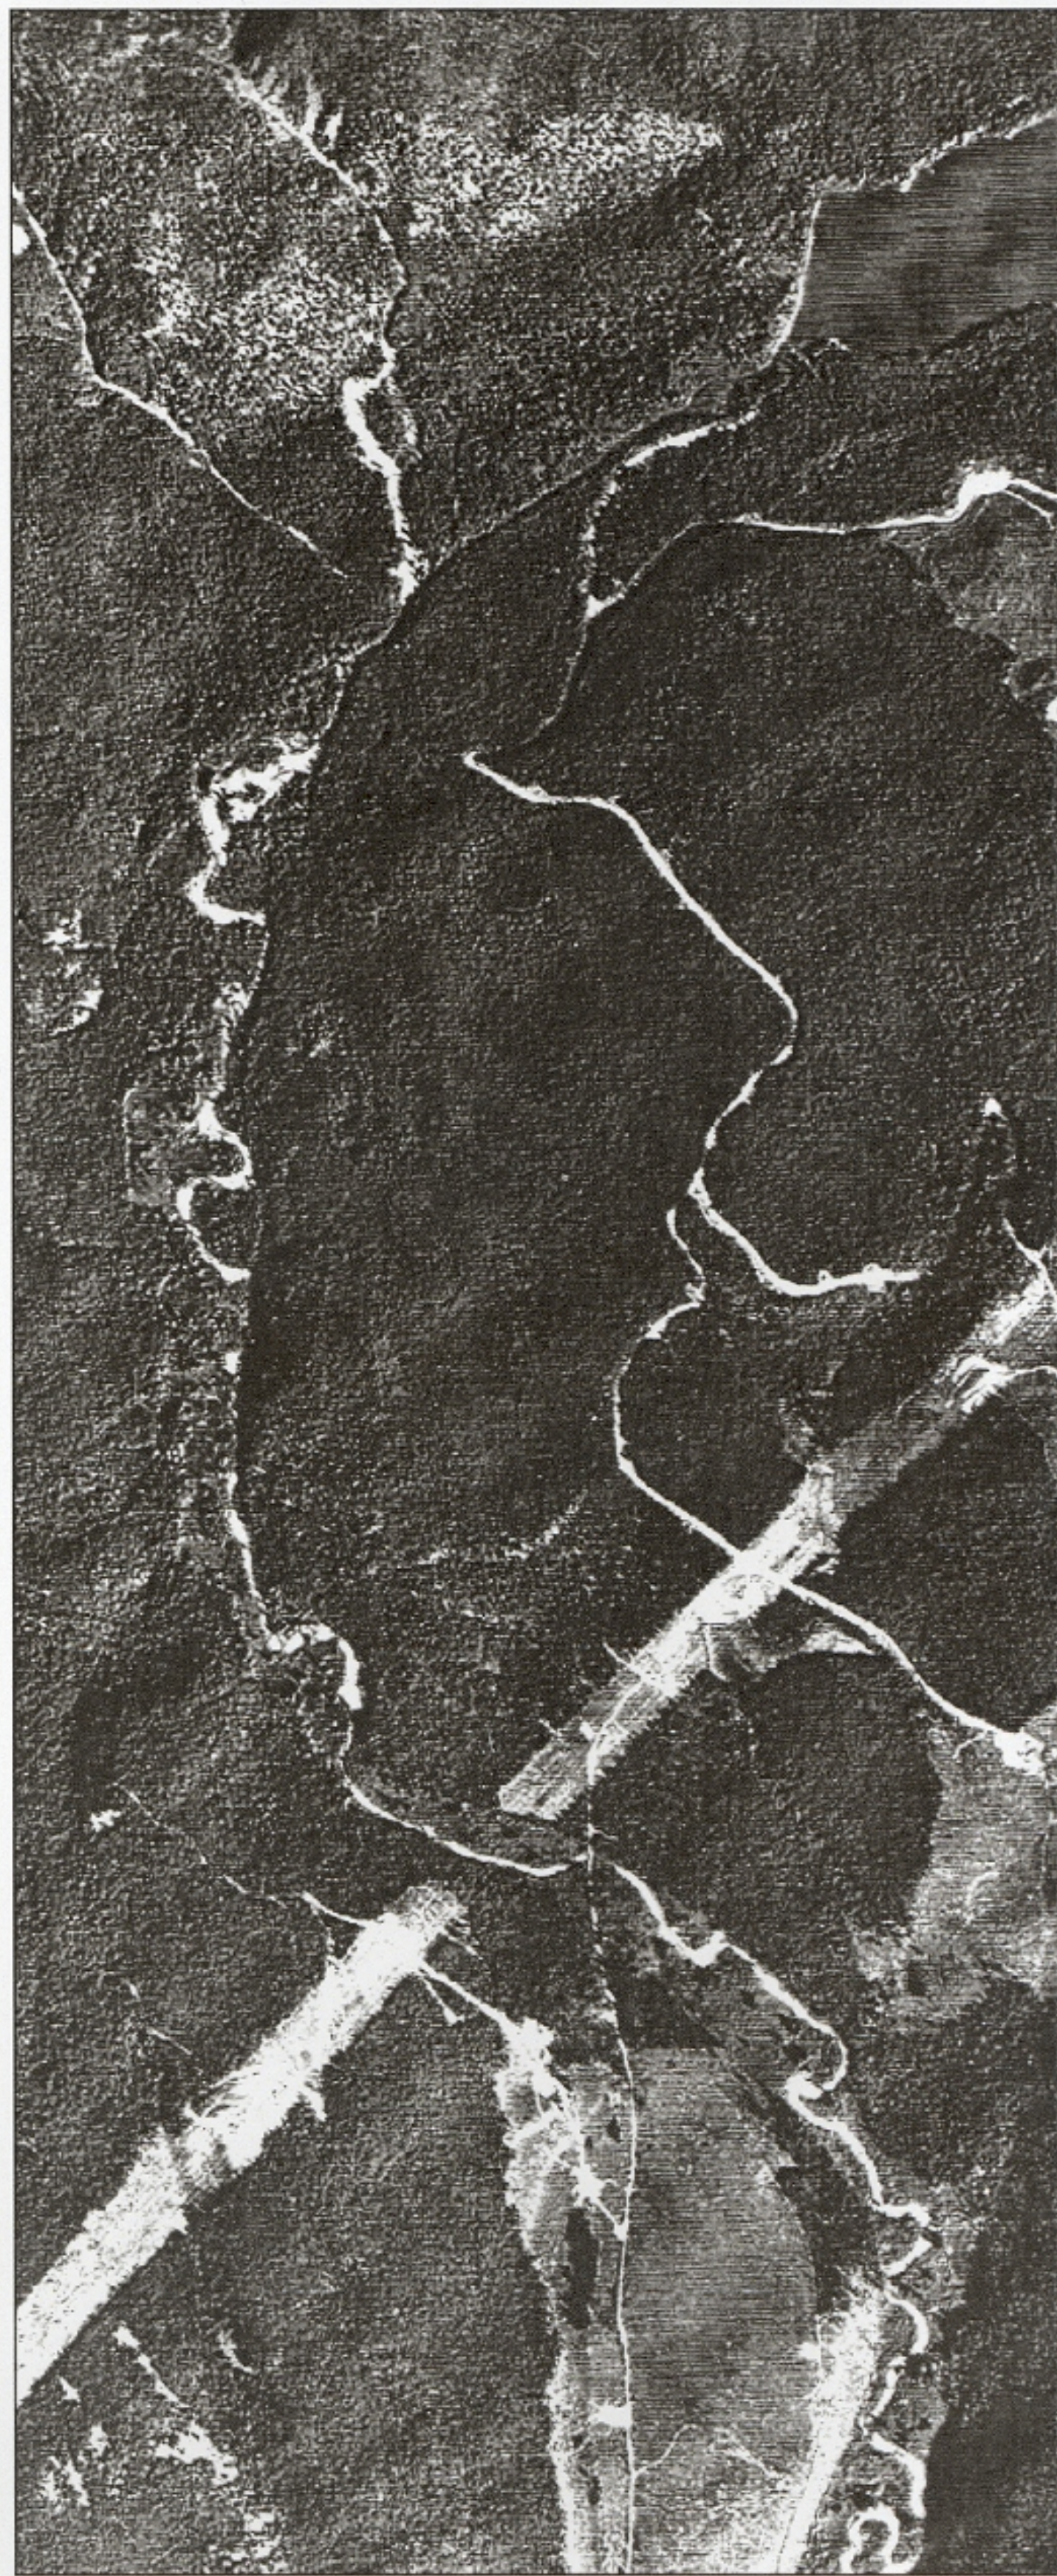
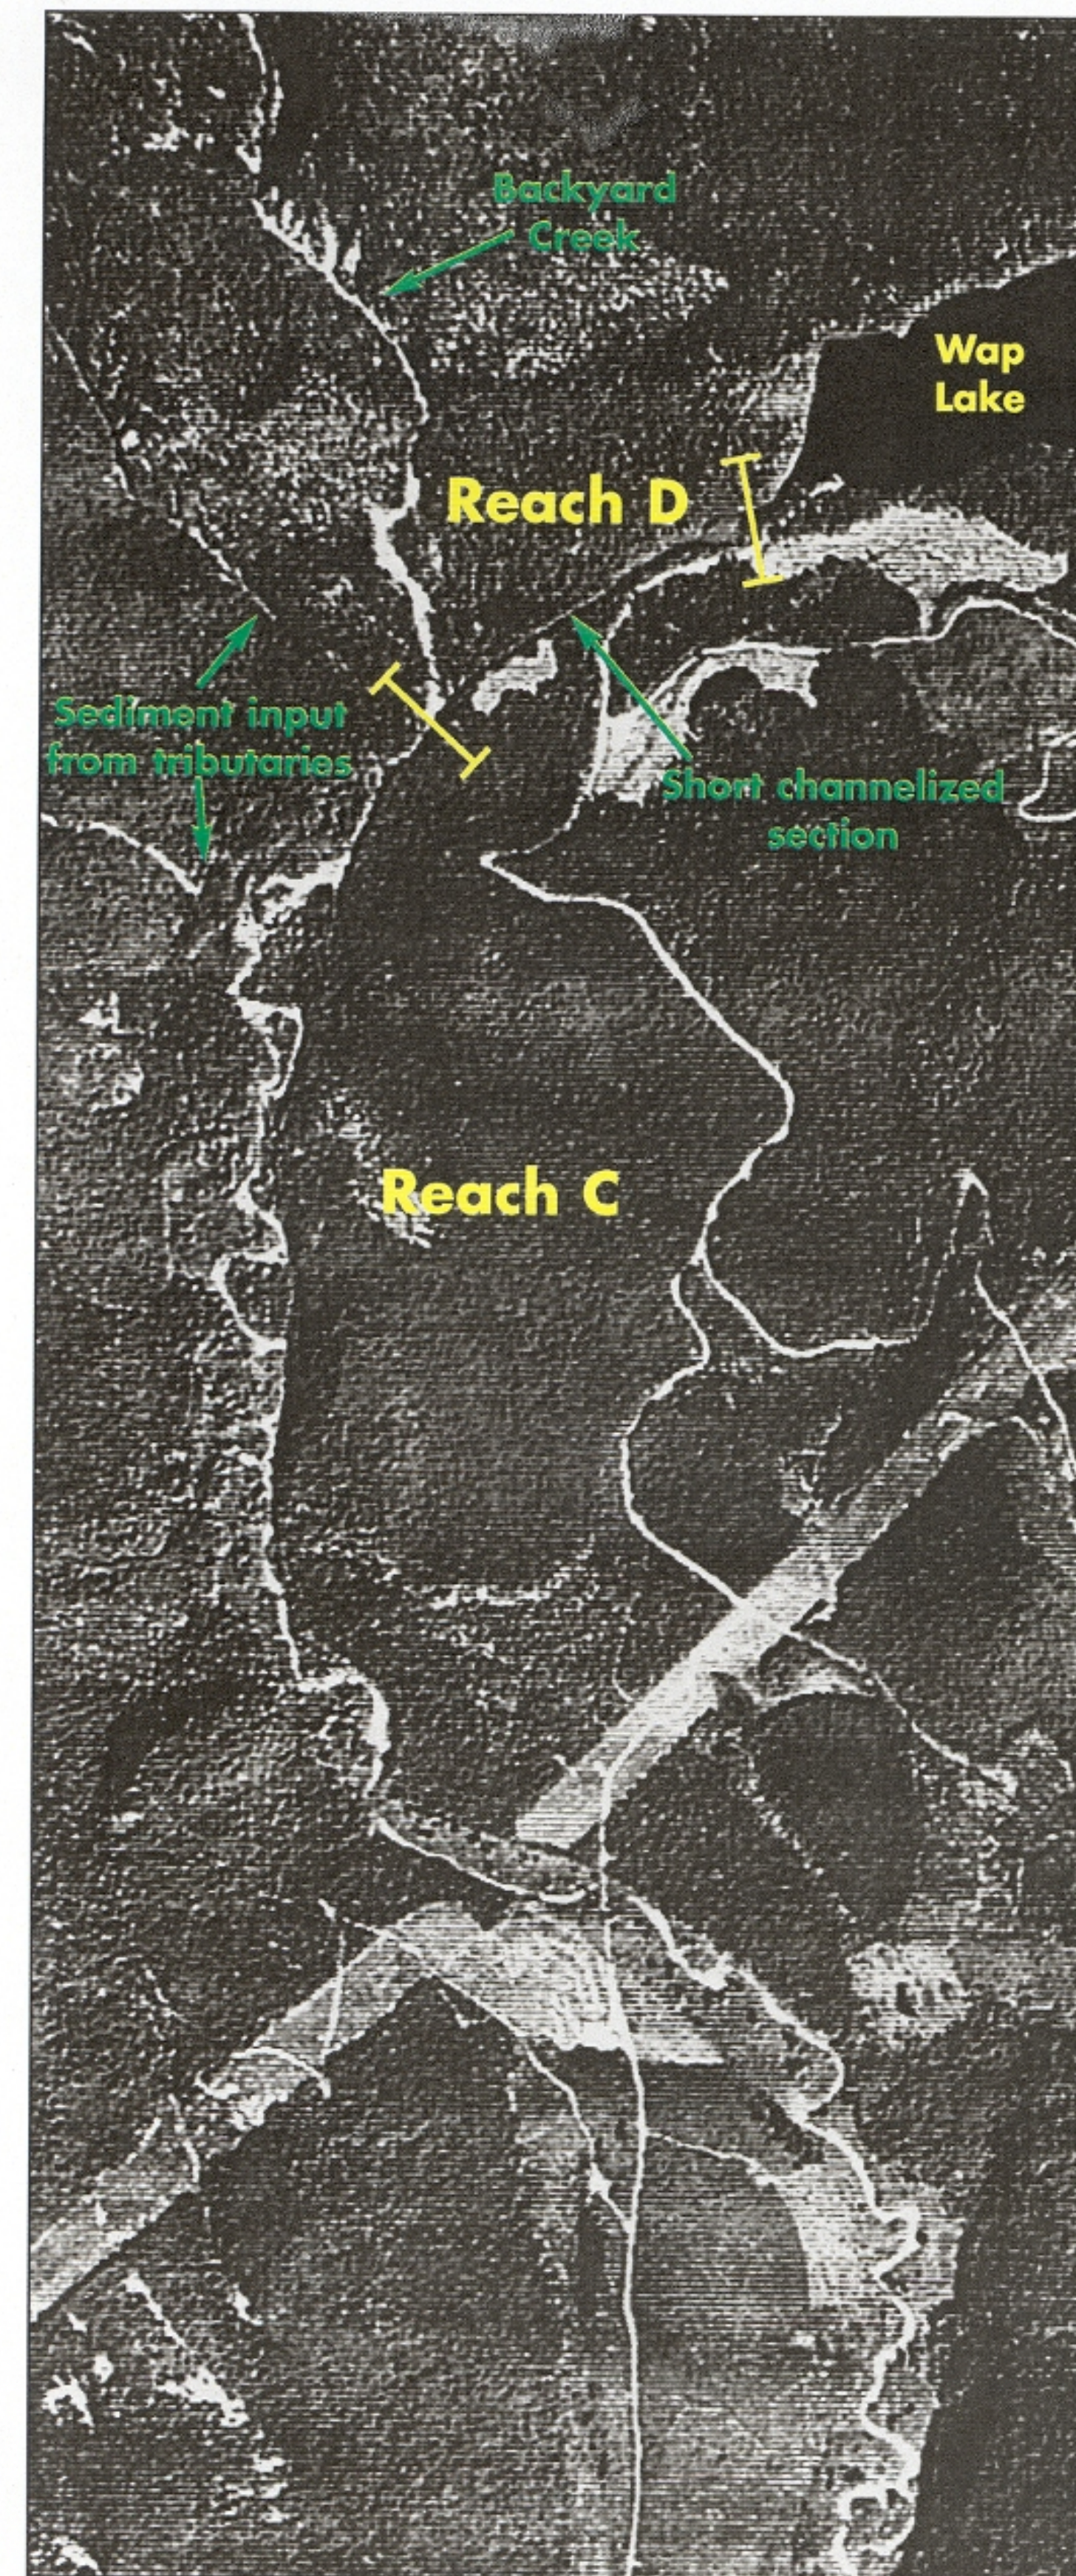
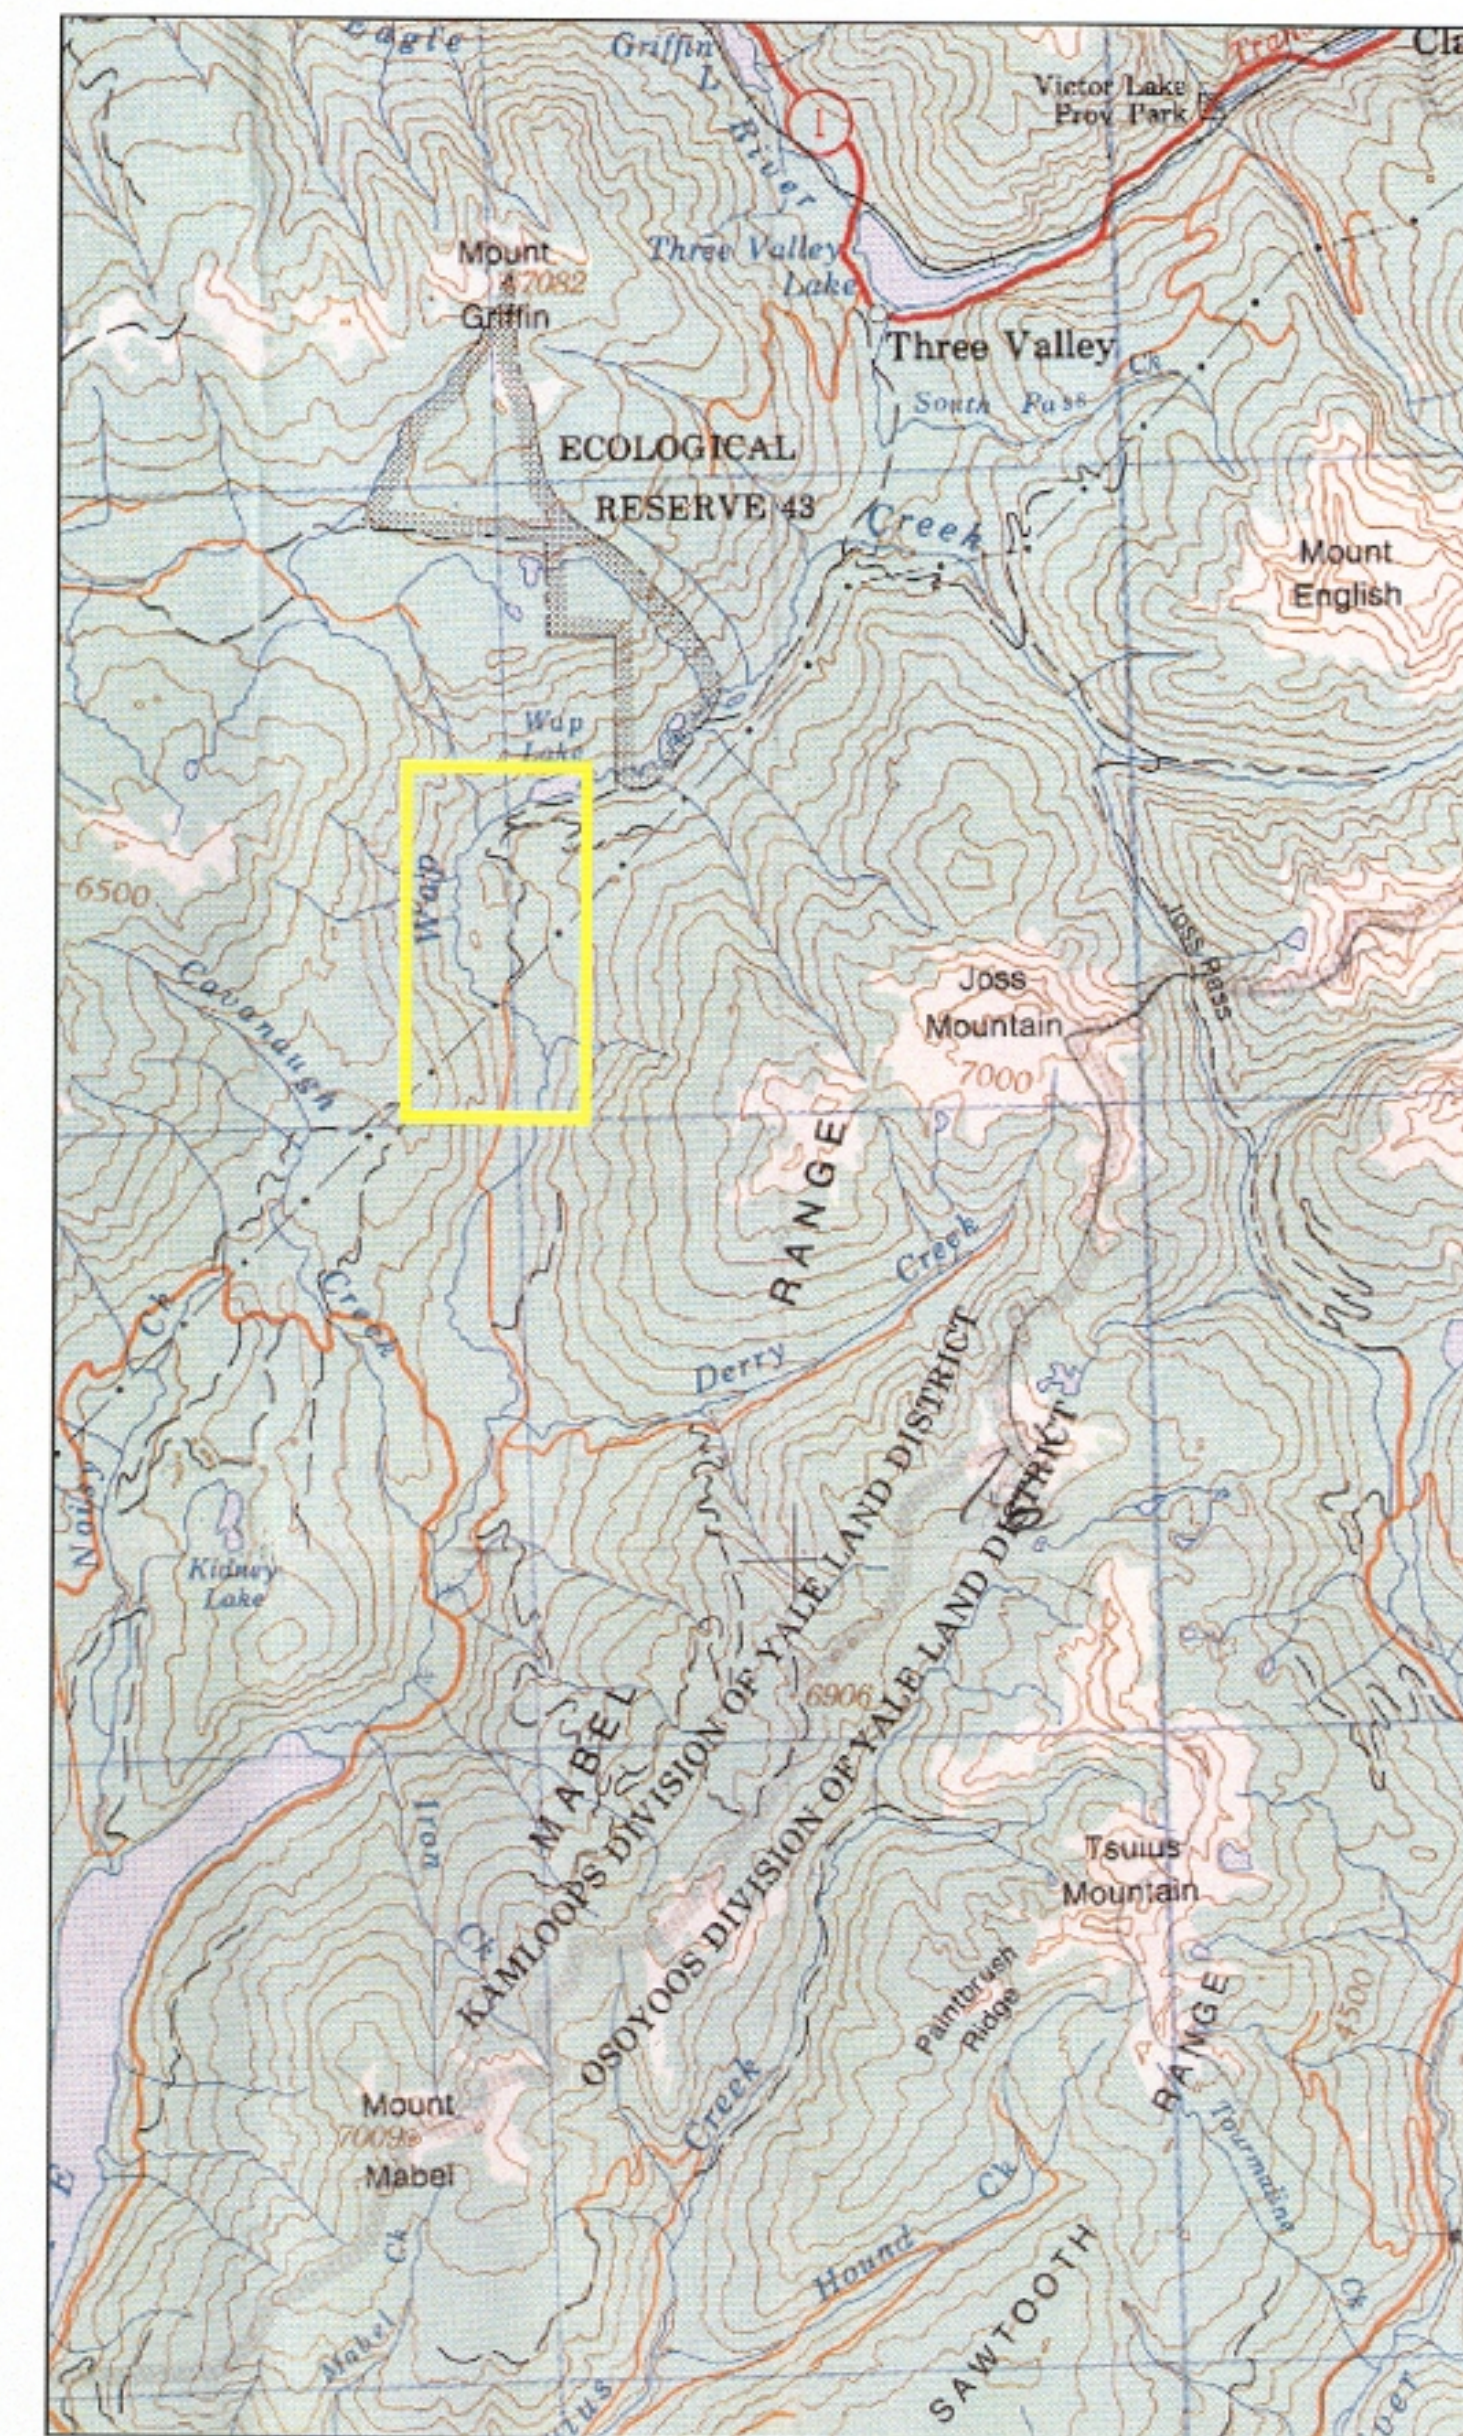
- Upper Reach C and Reach D downstream of Wap Lake. The mainstem channel morphology has remained unchanged with sediment loading from Backyard Creek and other small tributaries along the west and north side of the valley.
- Much of the upper Backyard Creek sub-basin and north valley wall between Wap Lake and the powerline burned between 1960 and 1965. Channel and gully destabilization in the small tributaries and steep reach of Backyard Creek appears to have transported a significant volume of sediment to the Wap mainstem. The two small tributaries and lower Backyard Creek remain unstable but are recovering.
- The transport of sediment in Reach C of Wap Creek is slow based on a very low gradient. Minor aggradation will persist in the channel until the tributaries recover and instream gravel and sand bars revegetate.
