Results of the Interior Watershed Assessment Procedure

WAP CREEK WATERSHED

By
DOBSON ENGINEERING LTD.
#4, 1960 Springfield Road
Kelowna, BC
V1Y 5V7

June 2000

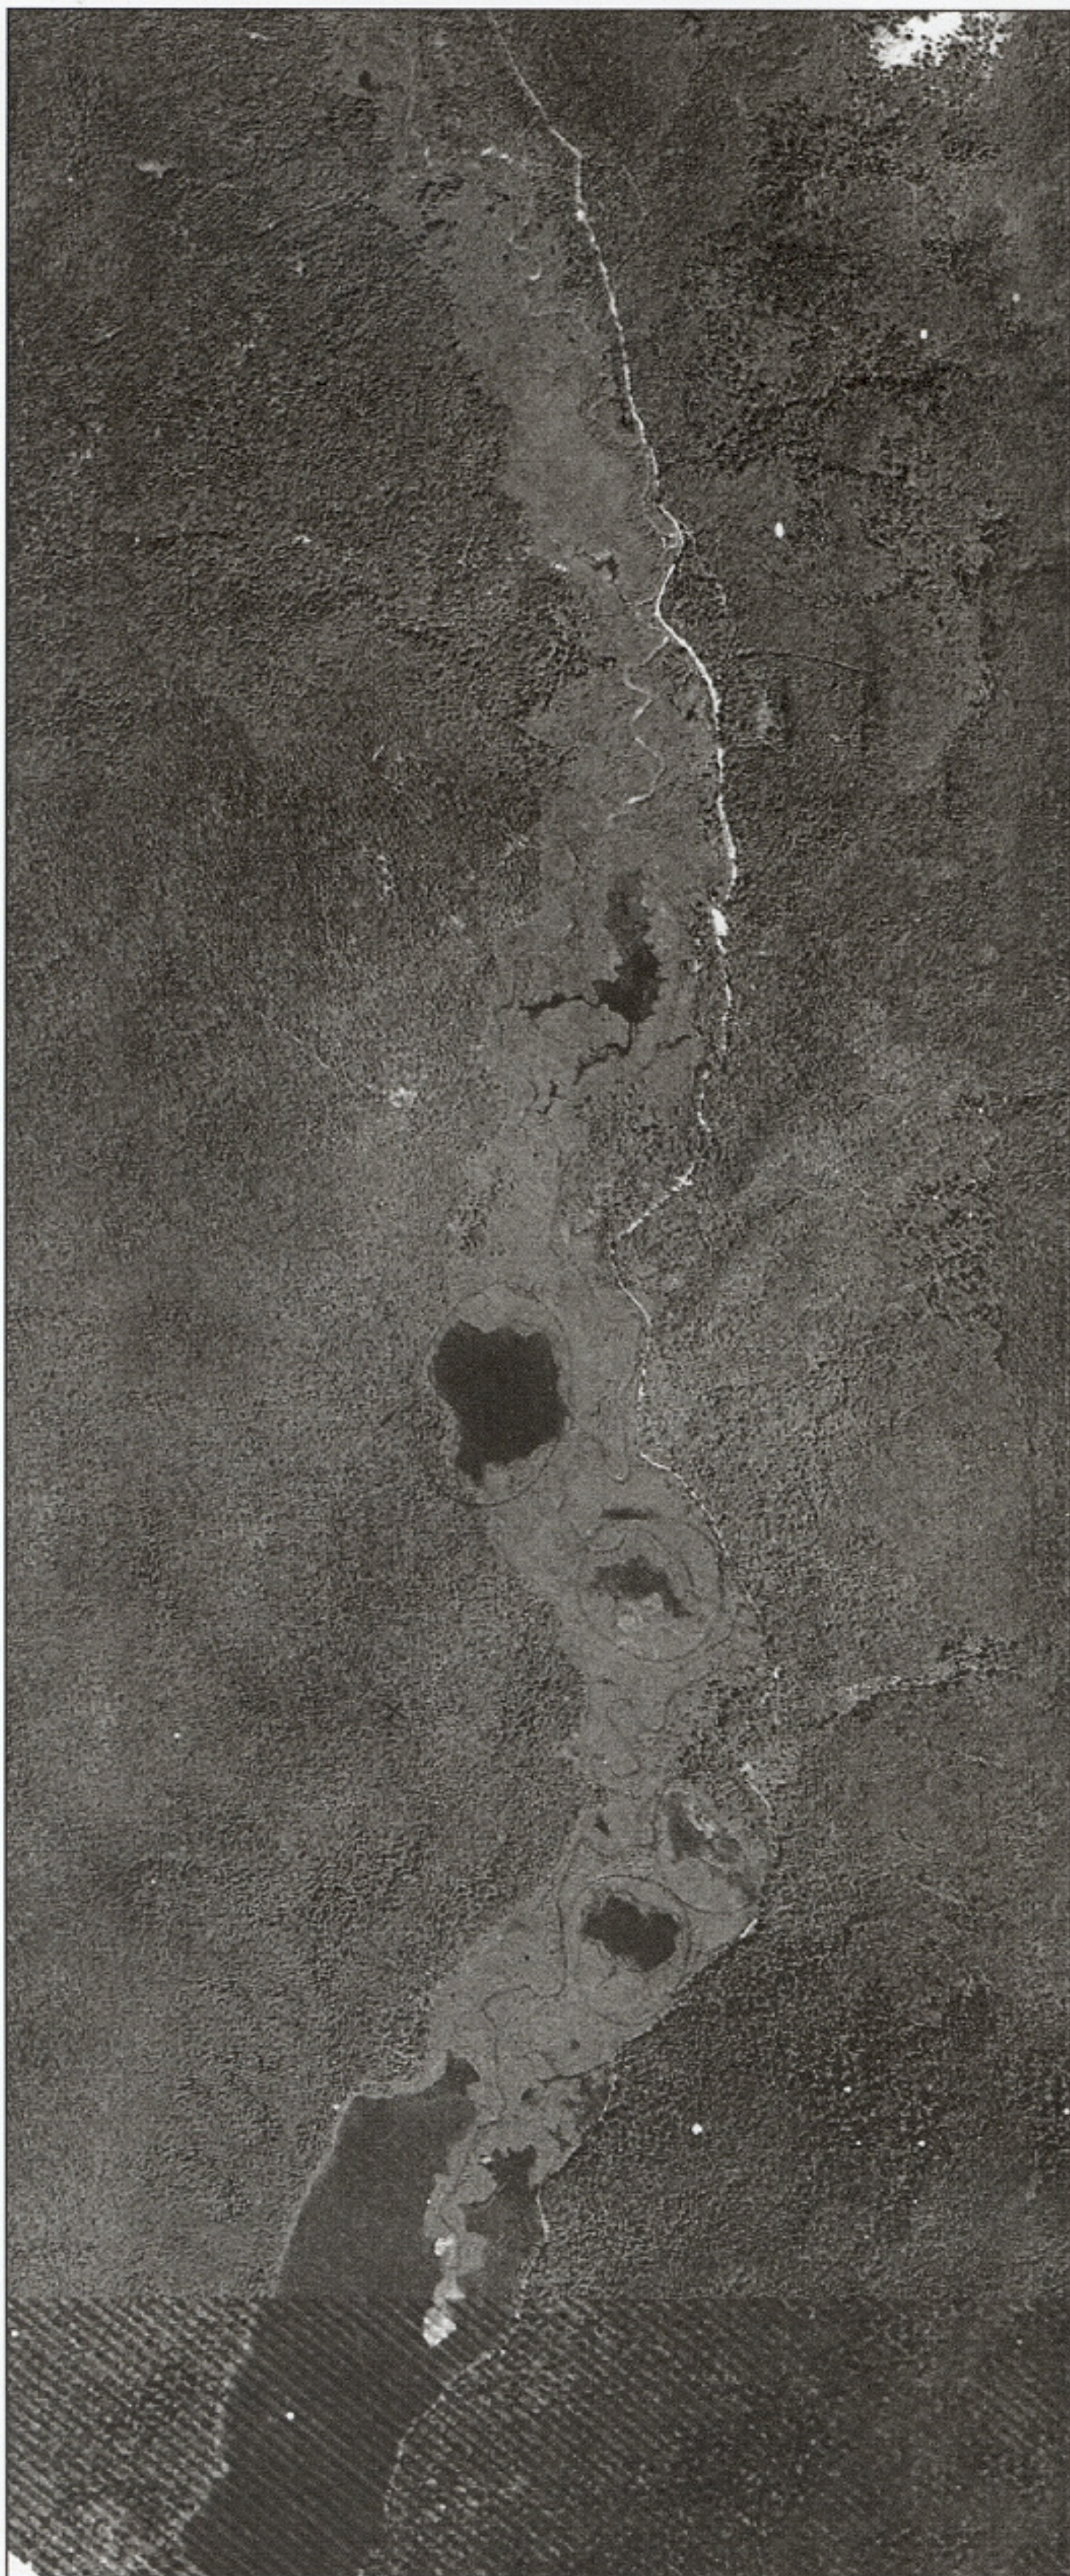
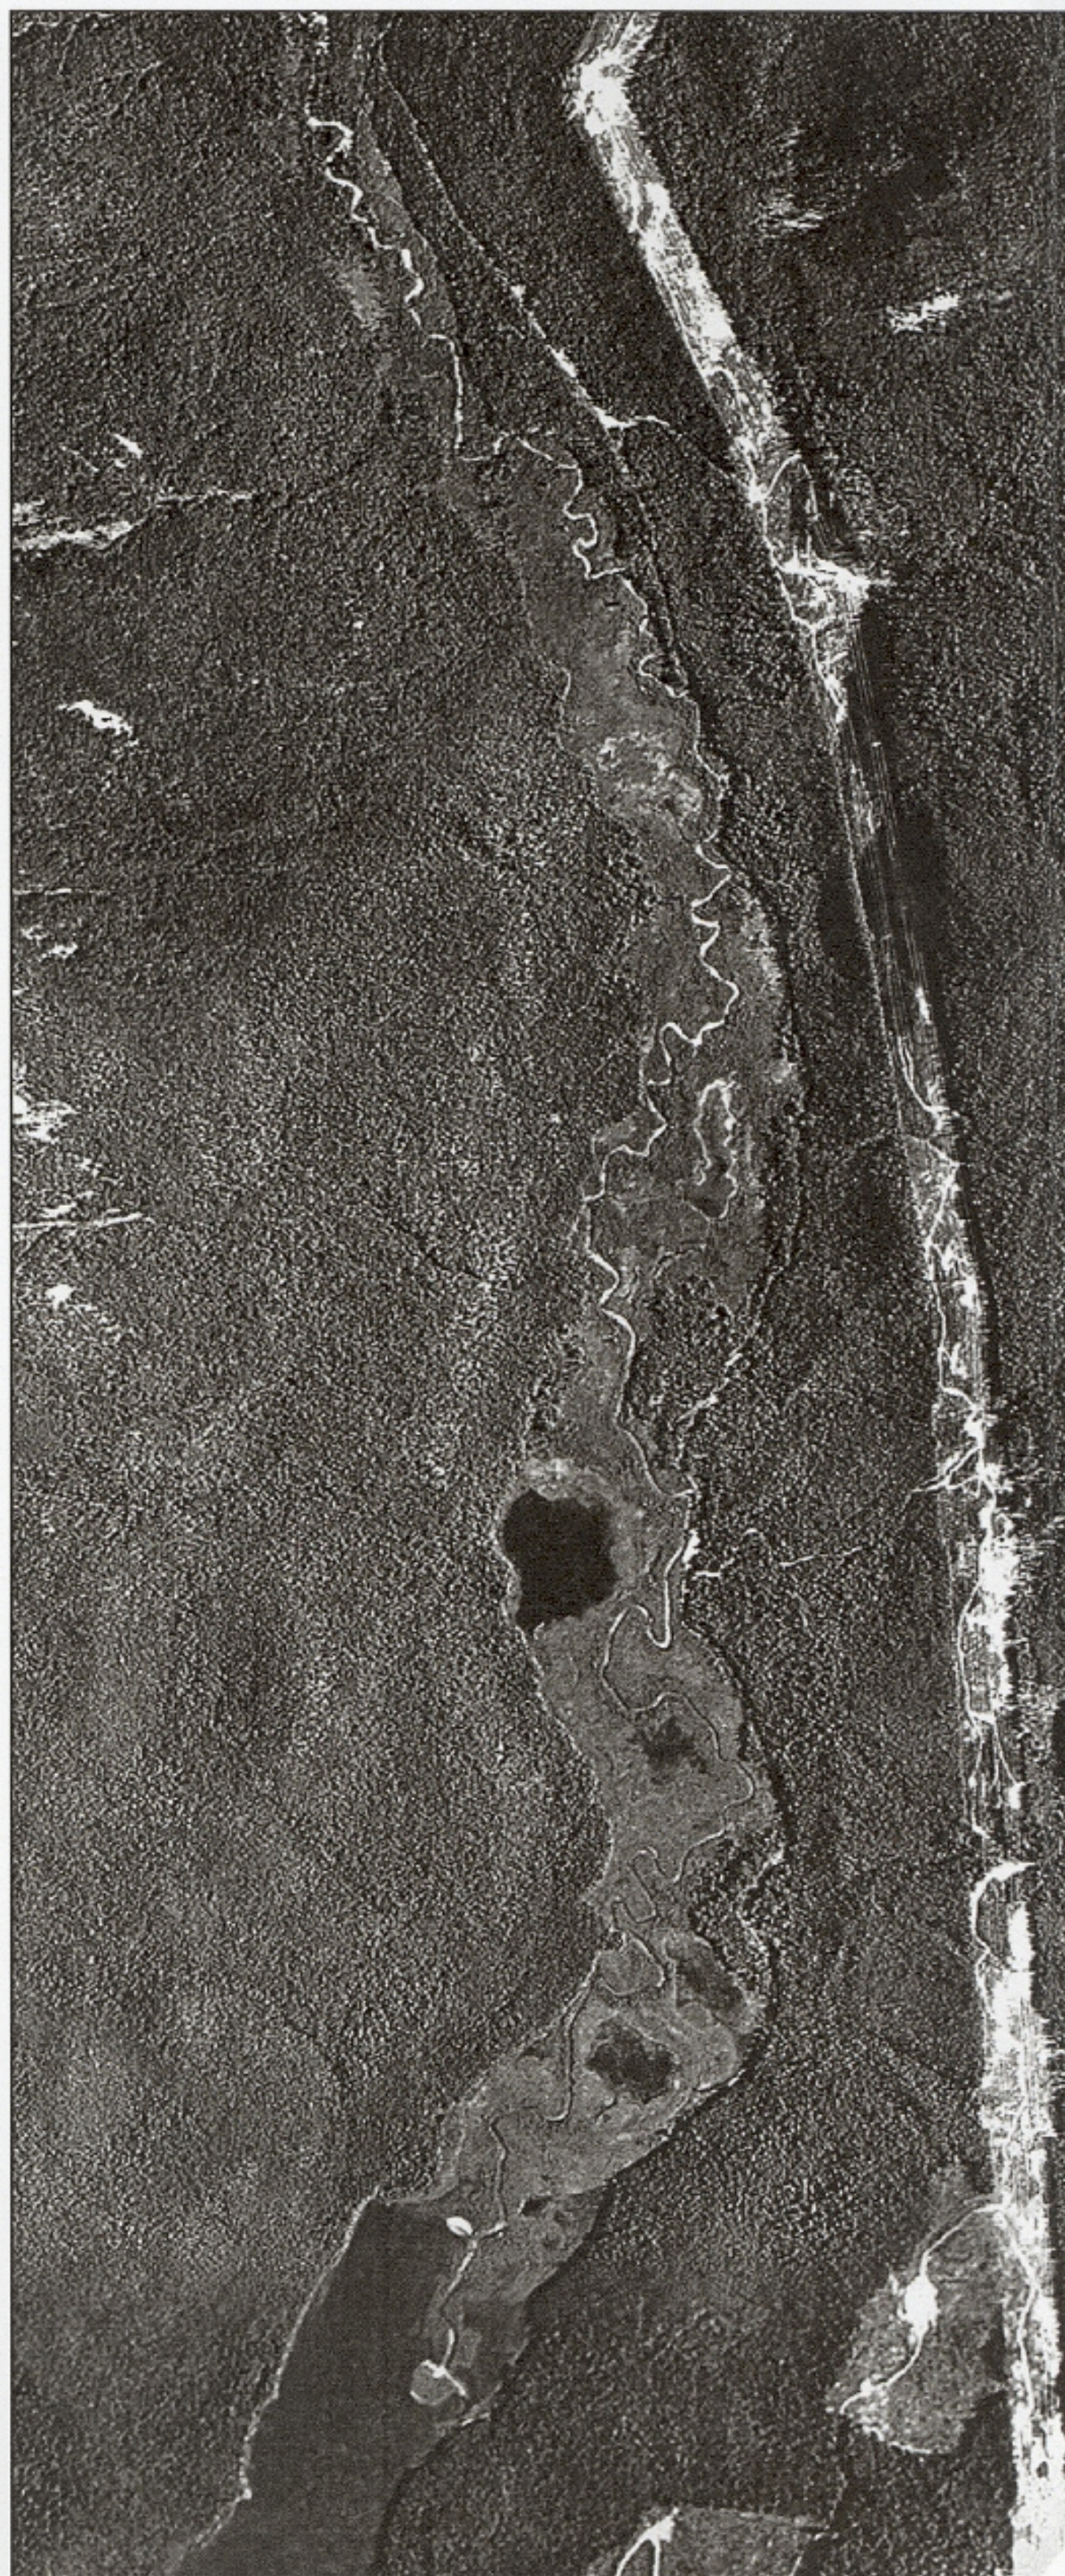
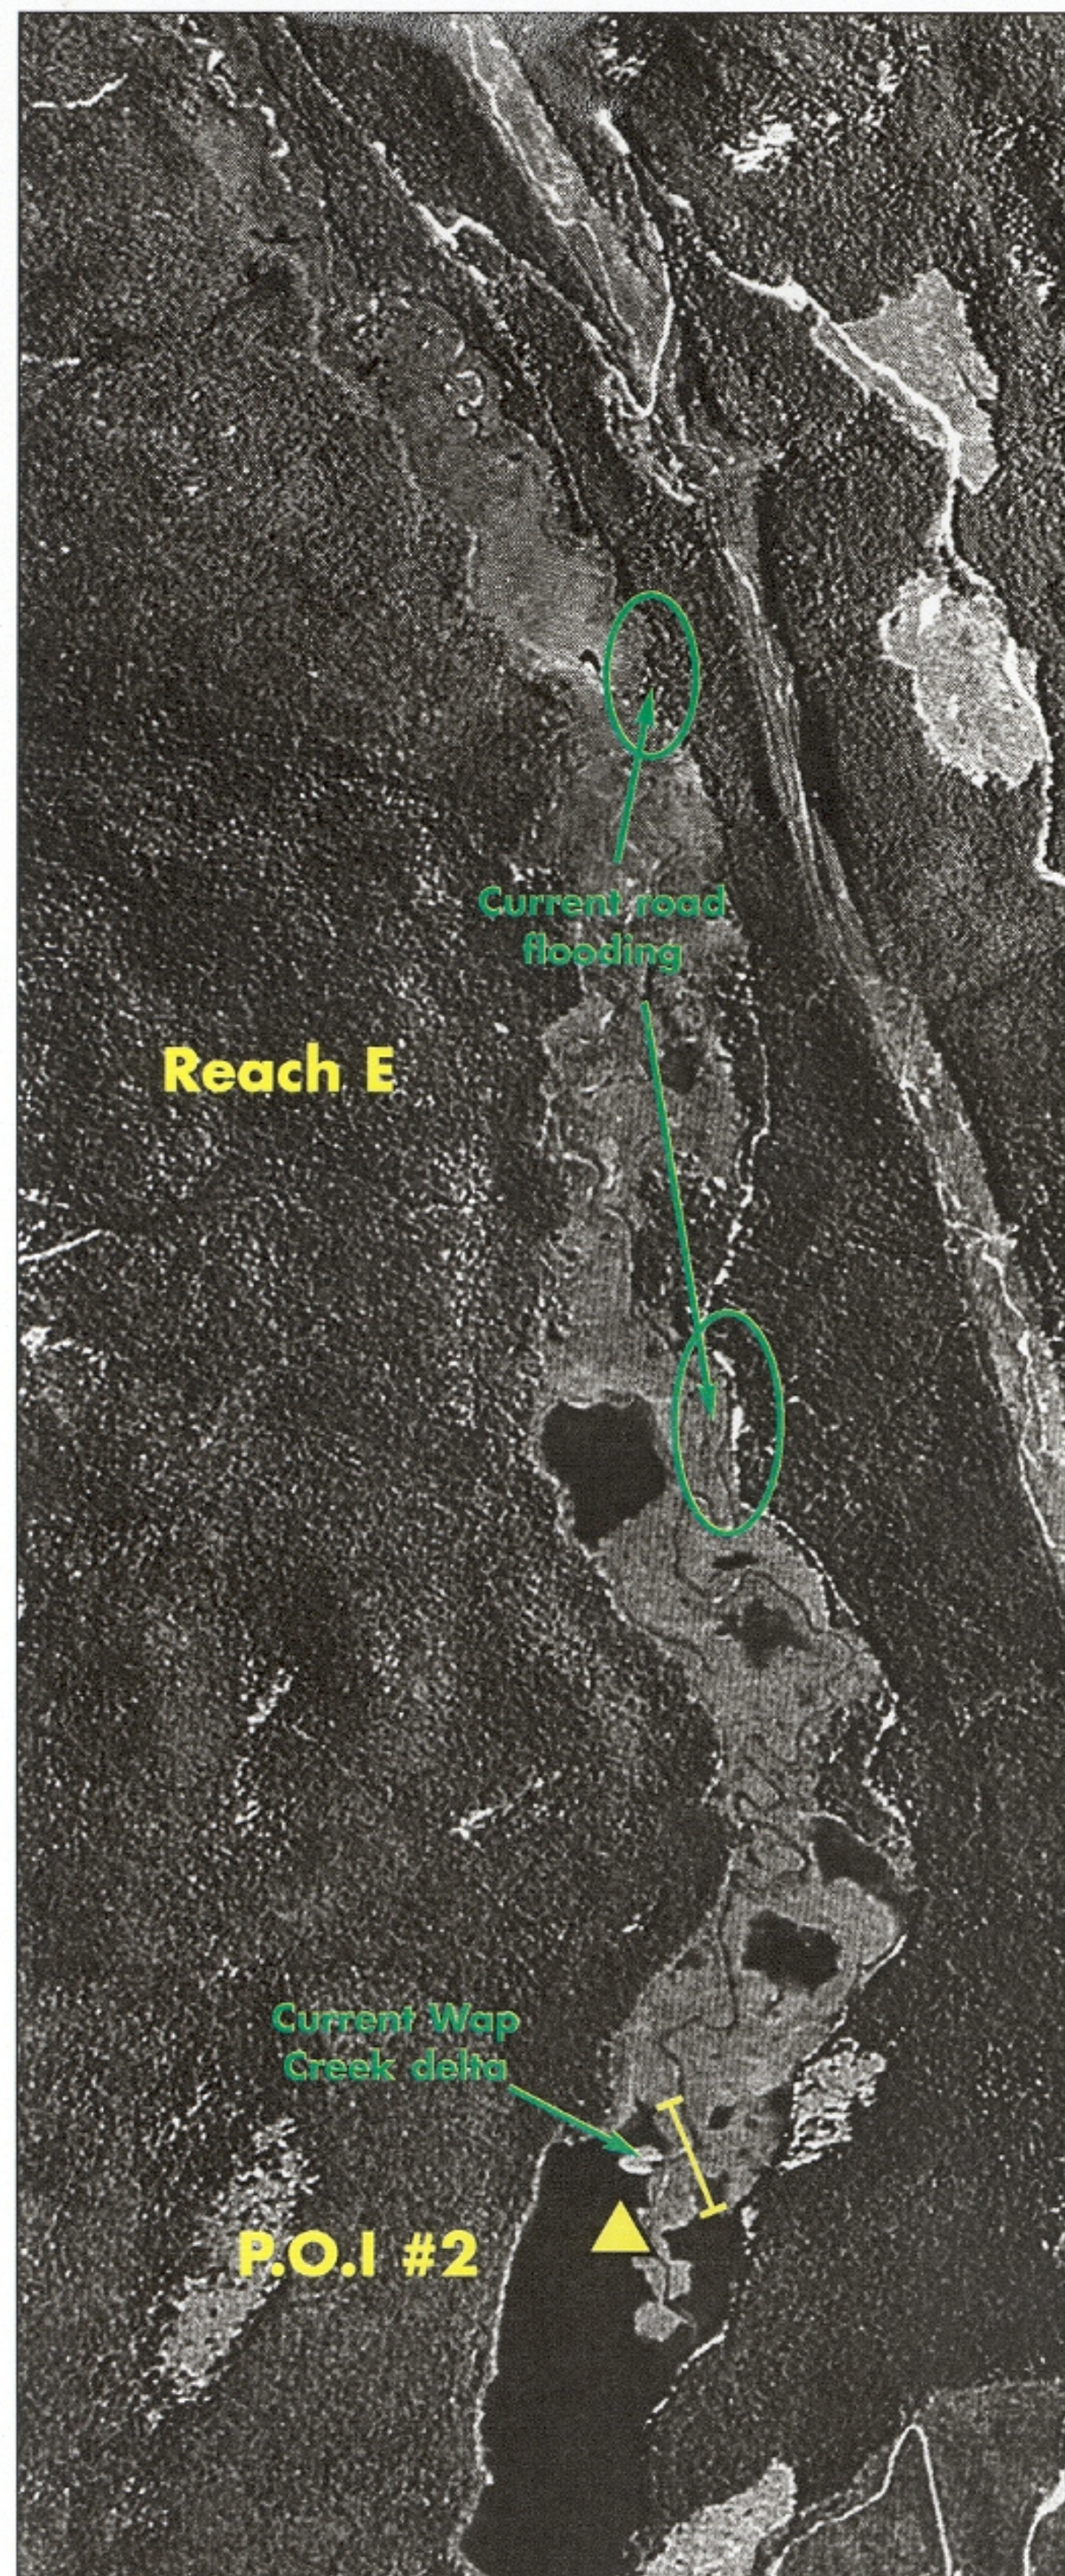
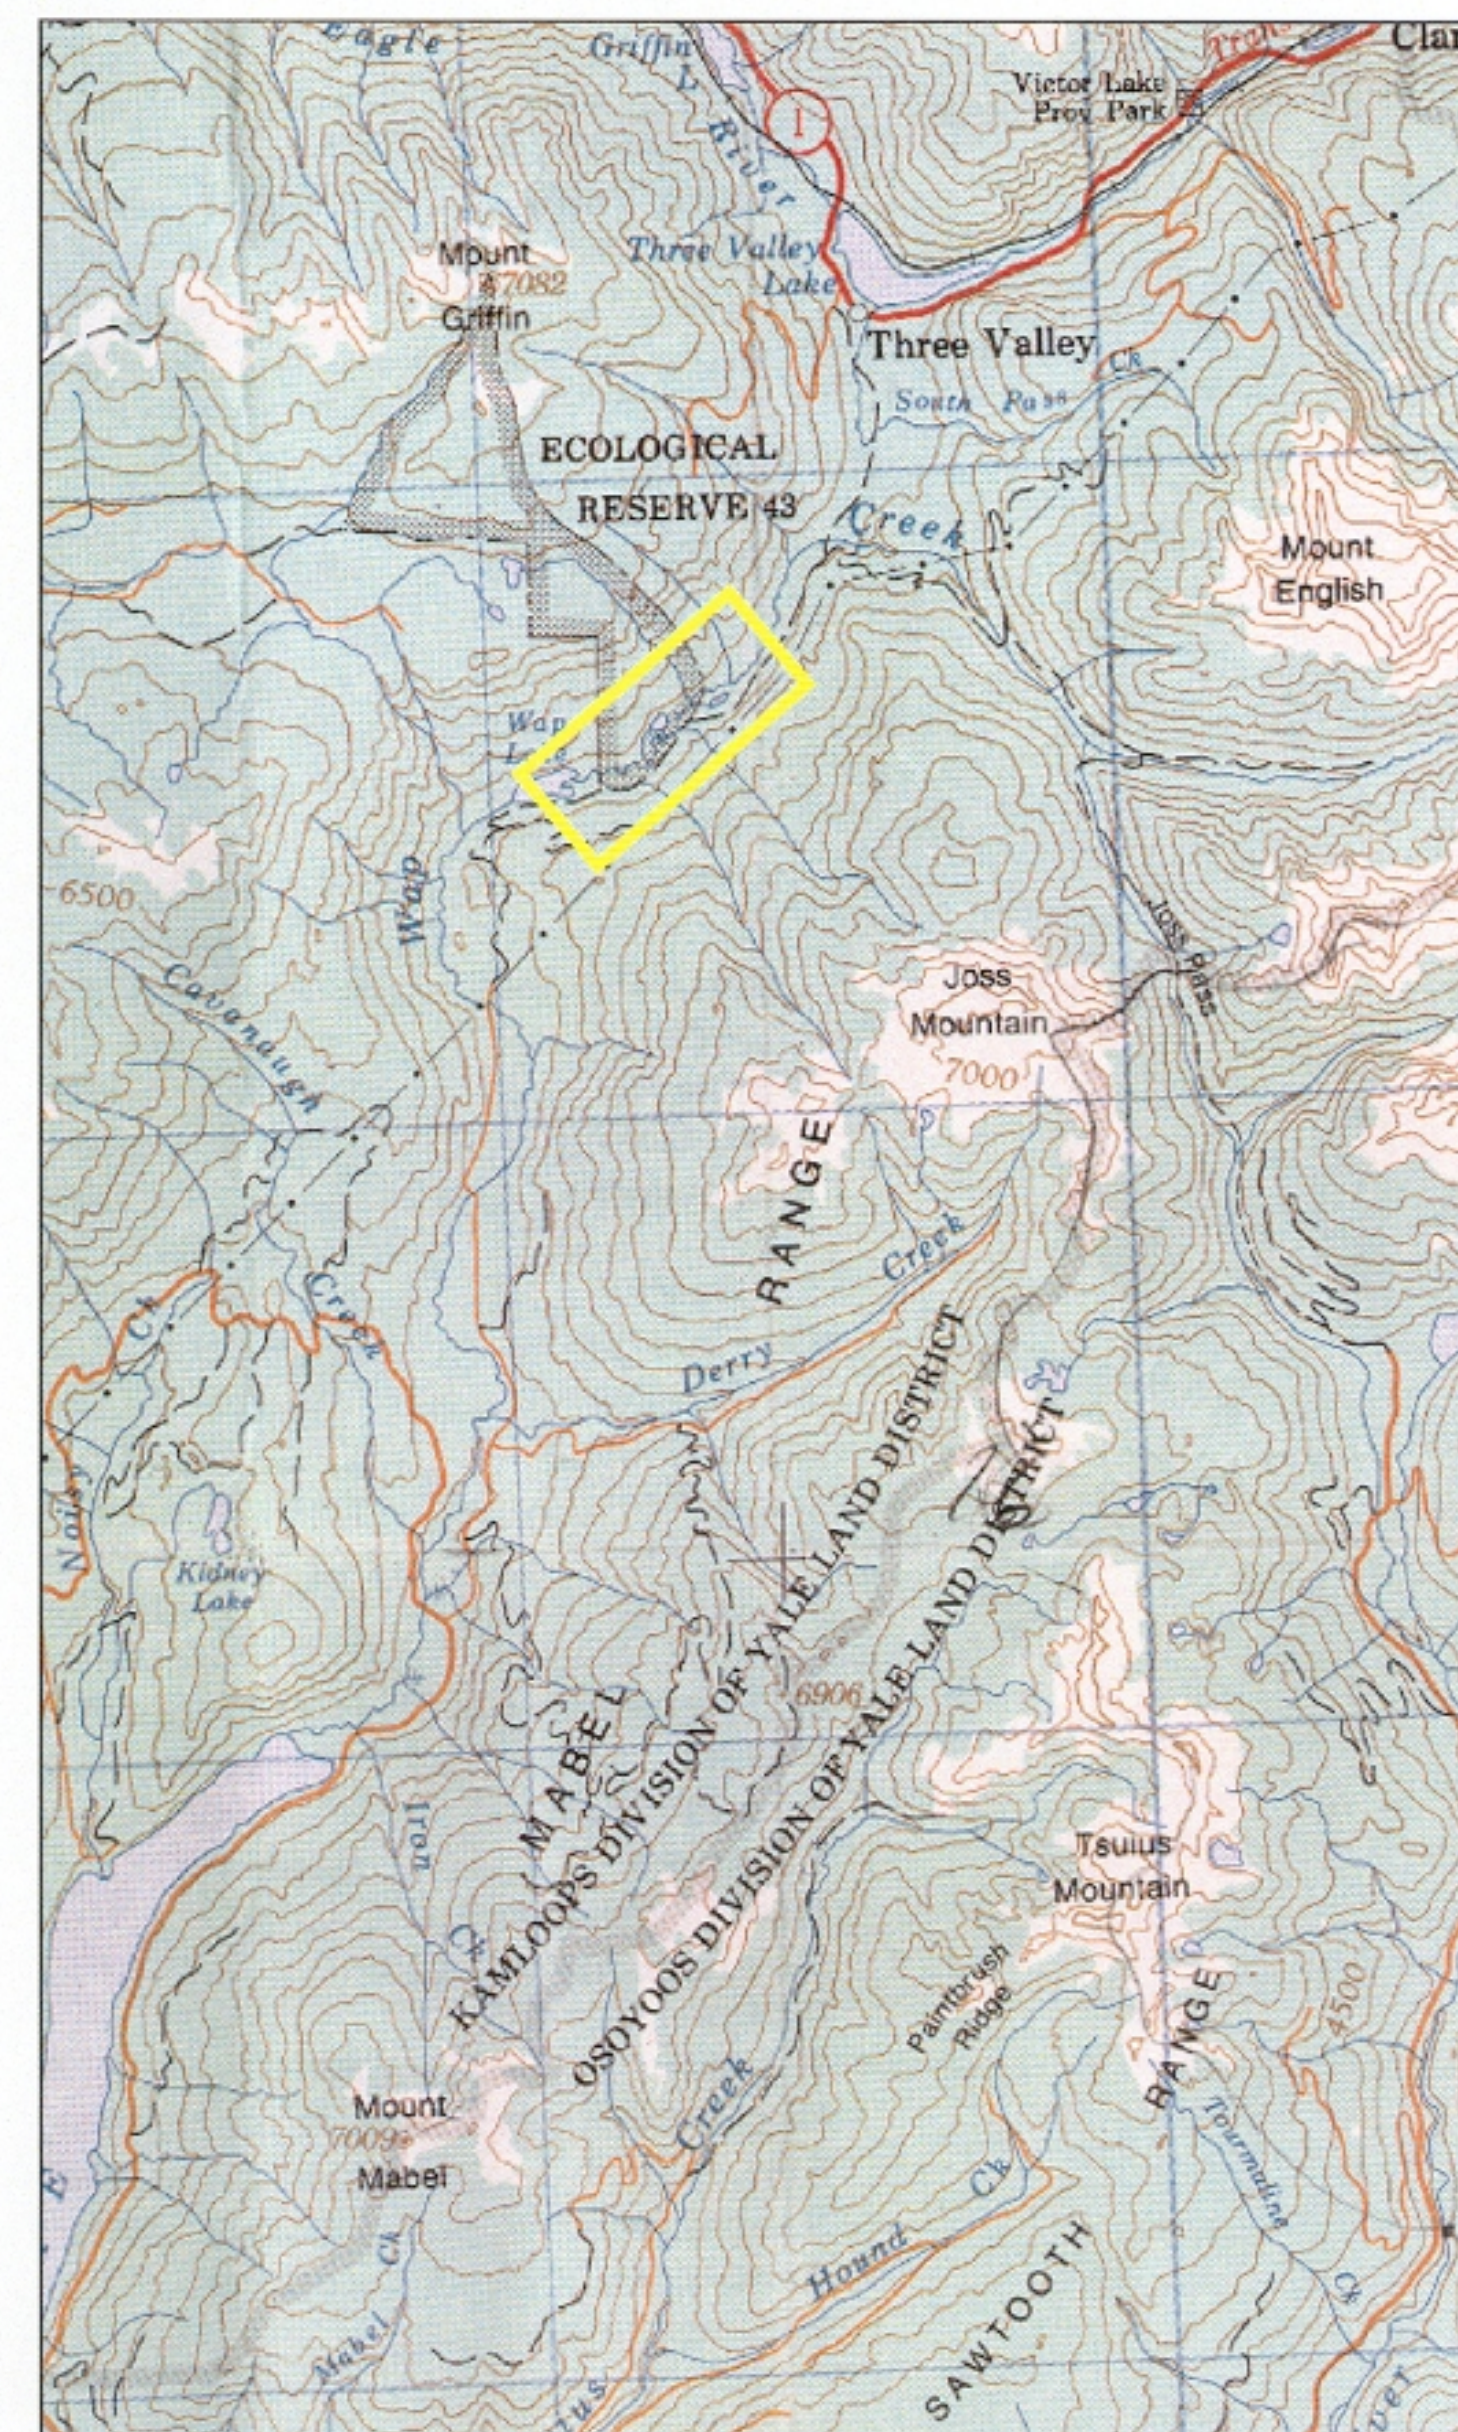
- Reach E and lower Reach F upstream of Wap Lake. An increase in sediment supply has occurred in these reaches from upstream landslides. Lower reach F is a large fan that shows channel widening and lateral movement in response to the increase in sediment load.
- Some visible increase in channel bar area can be attributed to lower discharge in the 1984 and 1997 photos, but channel infilling with sand and small gravel has occurred throughout Reach E to Wap Lake.
- An avulsion did occur on the Wap delta building into Wap Lake between 1959 and 1984. The delta is a “birds foot” type with an elongated central deposition feature and small lateral lobes formed by natural avulsions. The most recent avulsion may have been partly caused by the increase in sediment load. No restoration is required.
