Results of the Interior Watershed Assessment Procedure

WAP CREEK WATERSHED

By
DOBSON ENGINEERING LTD.
#4, 1960 Springfield Road
Kelowna, BC
V1Y 5V7

June 2000

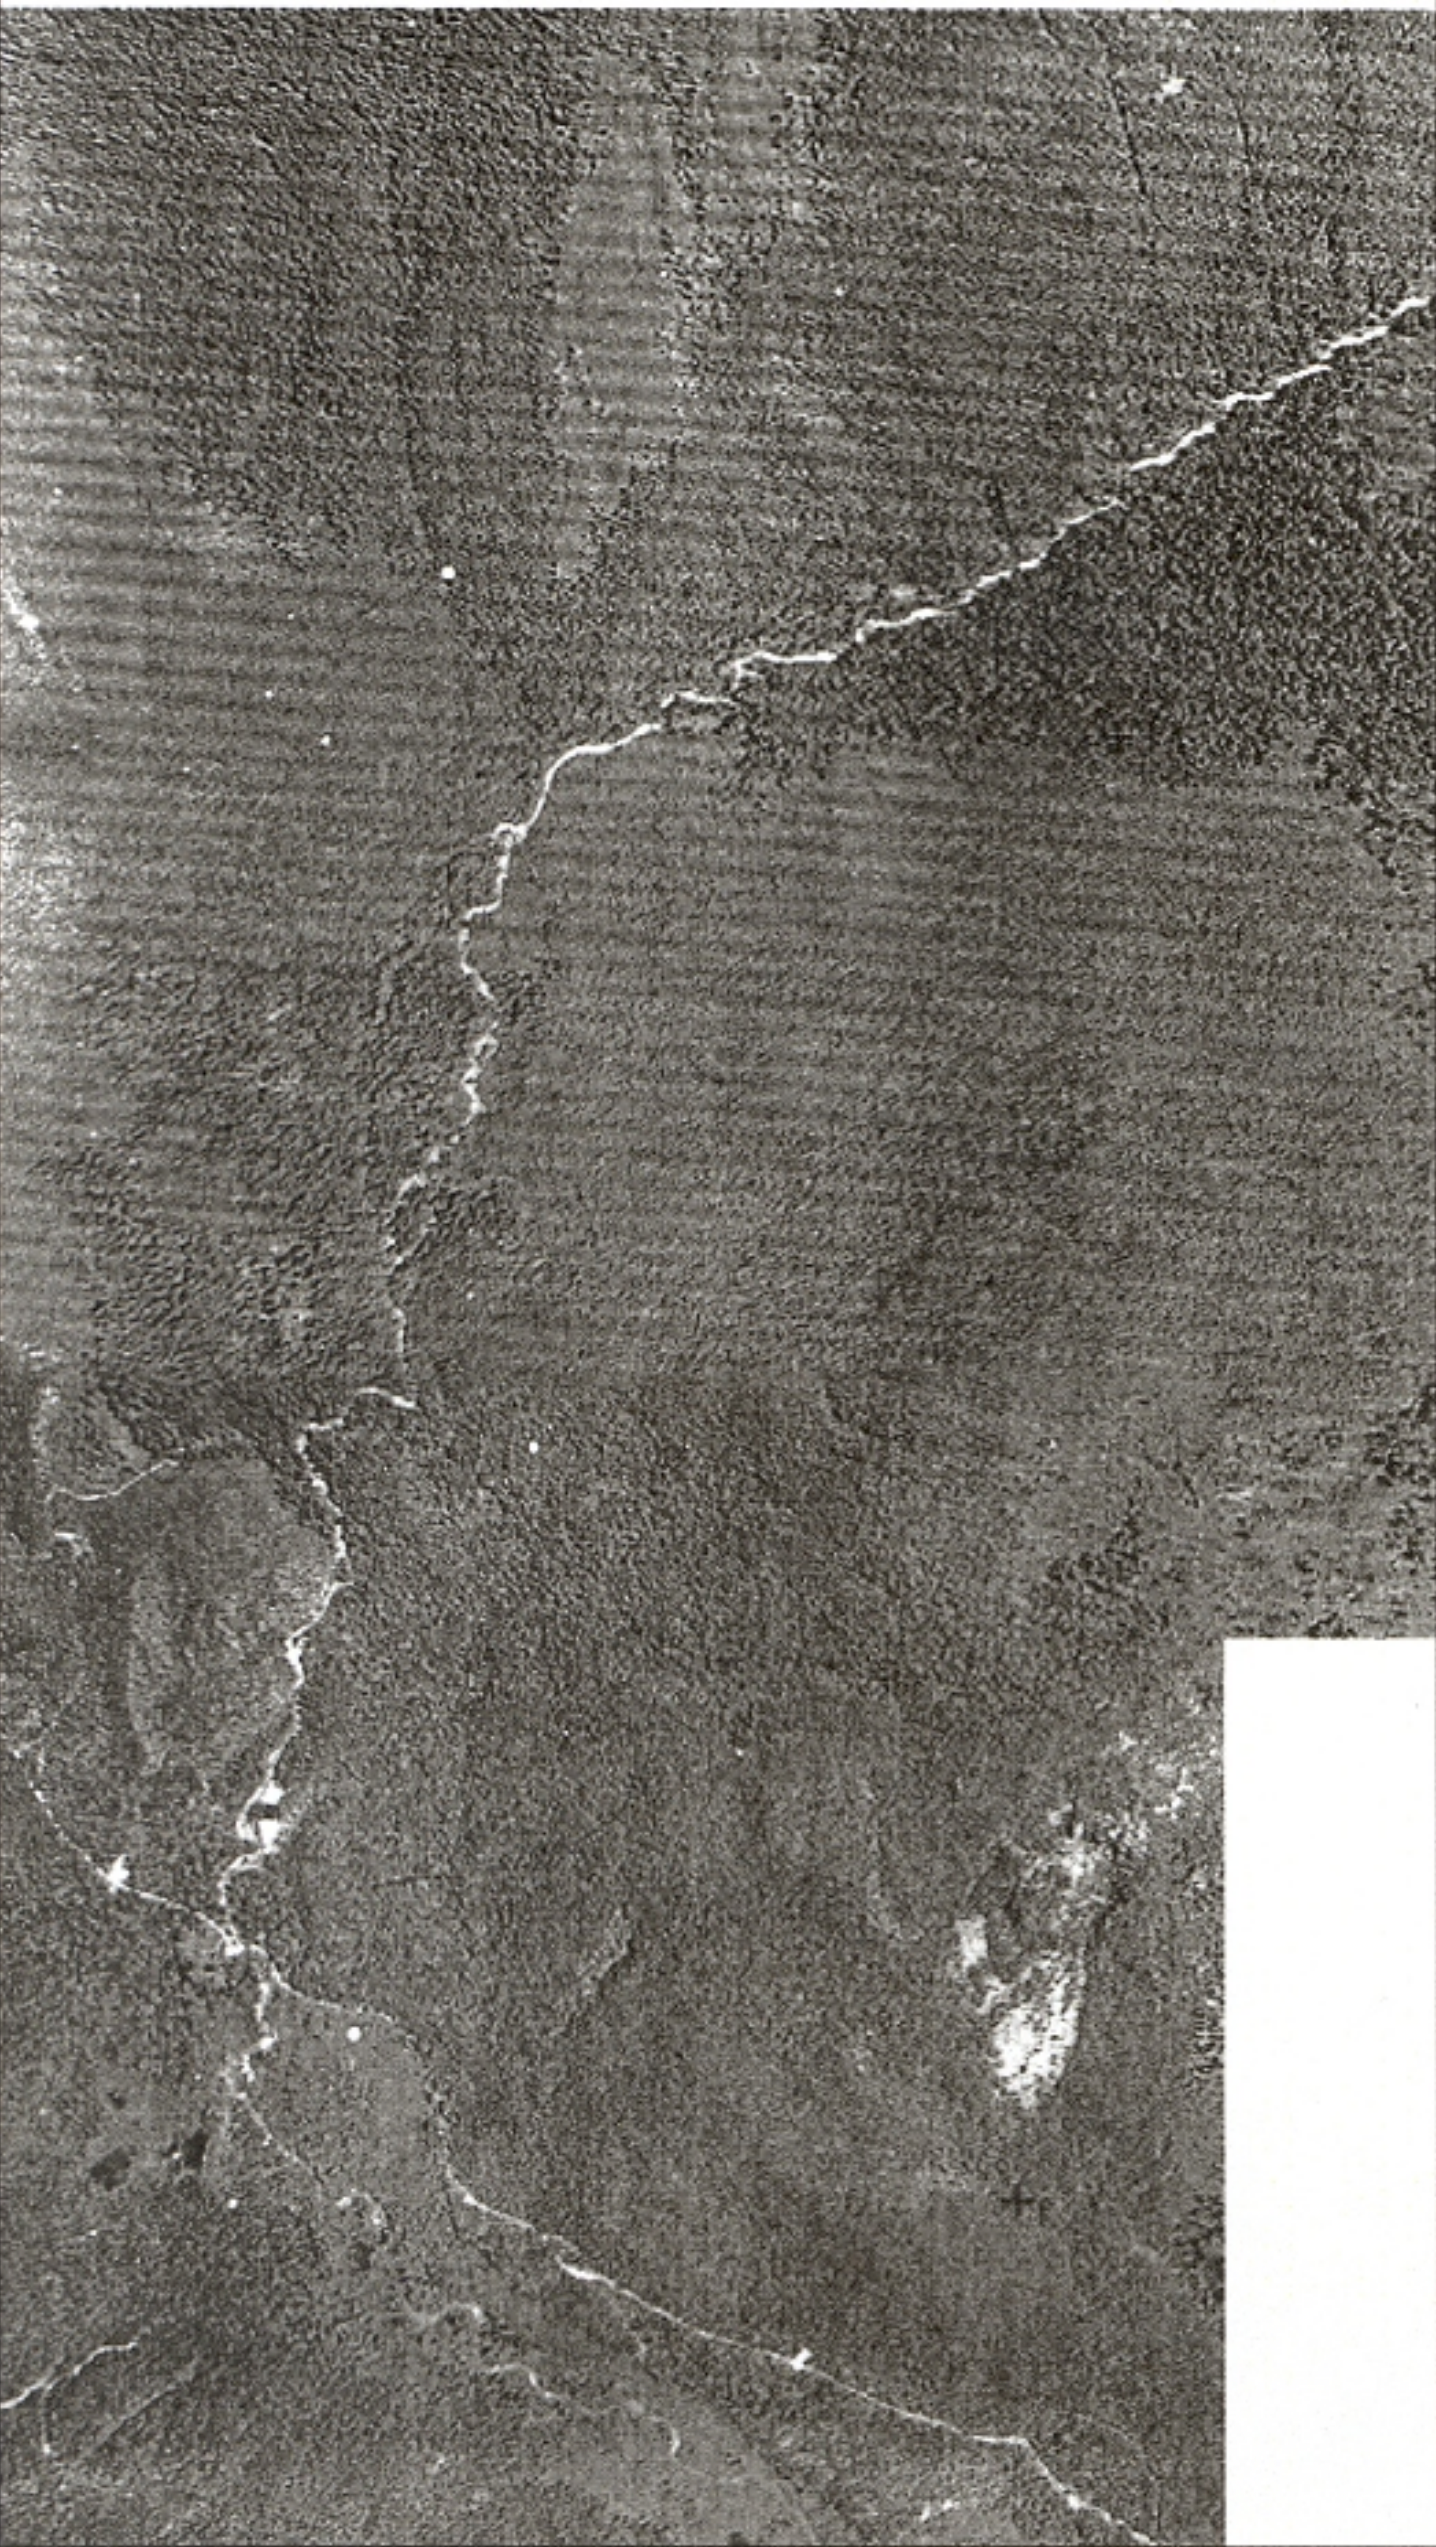
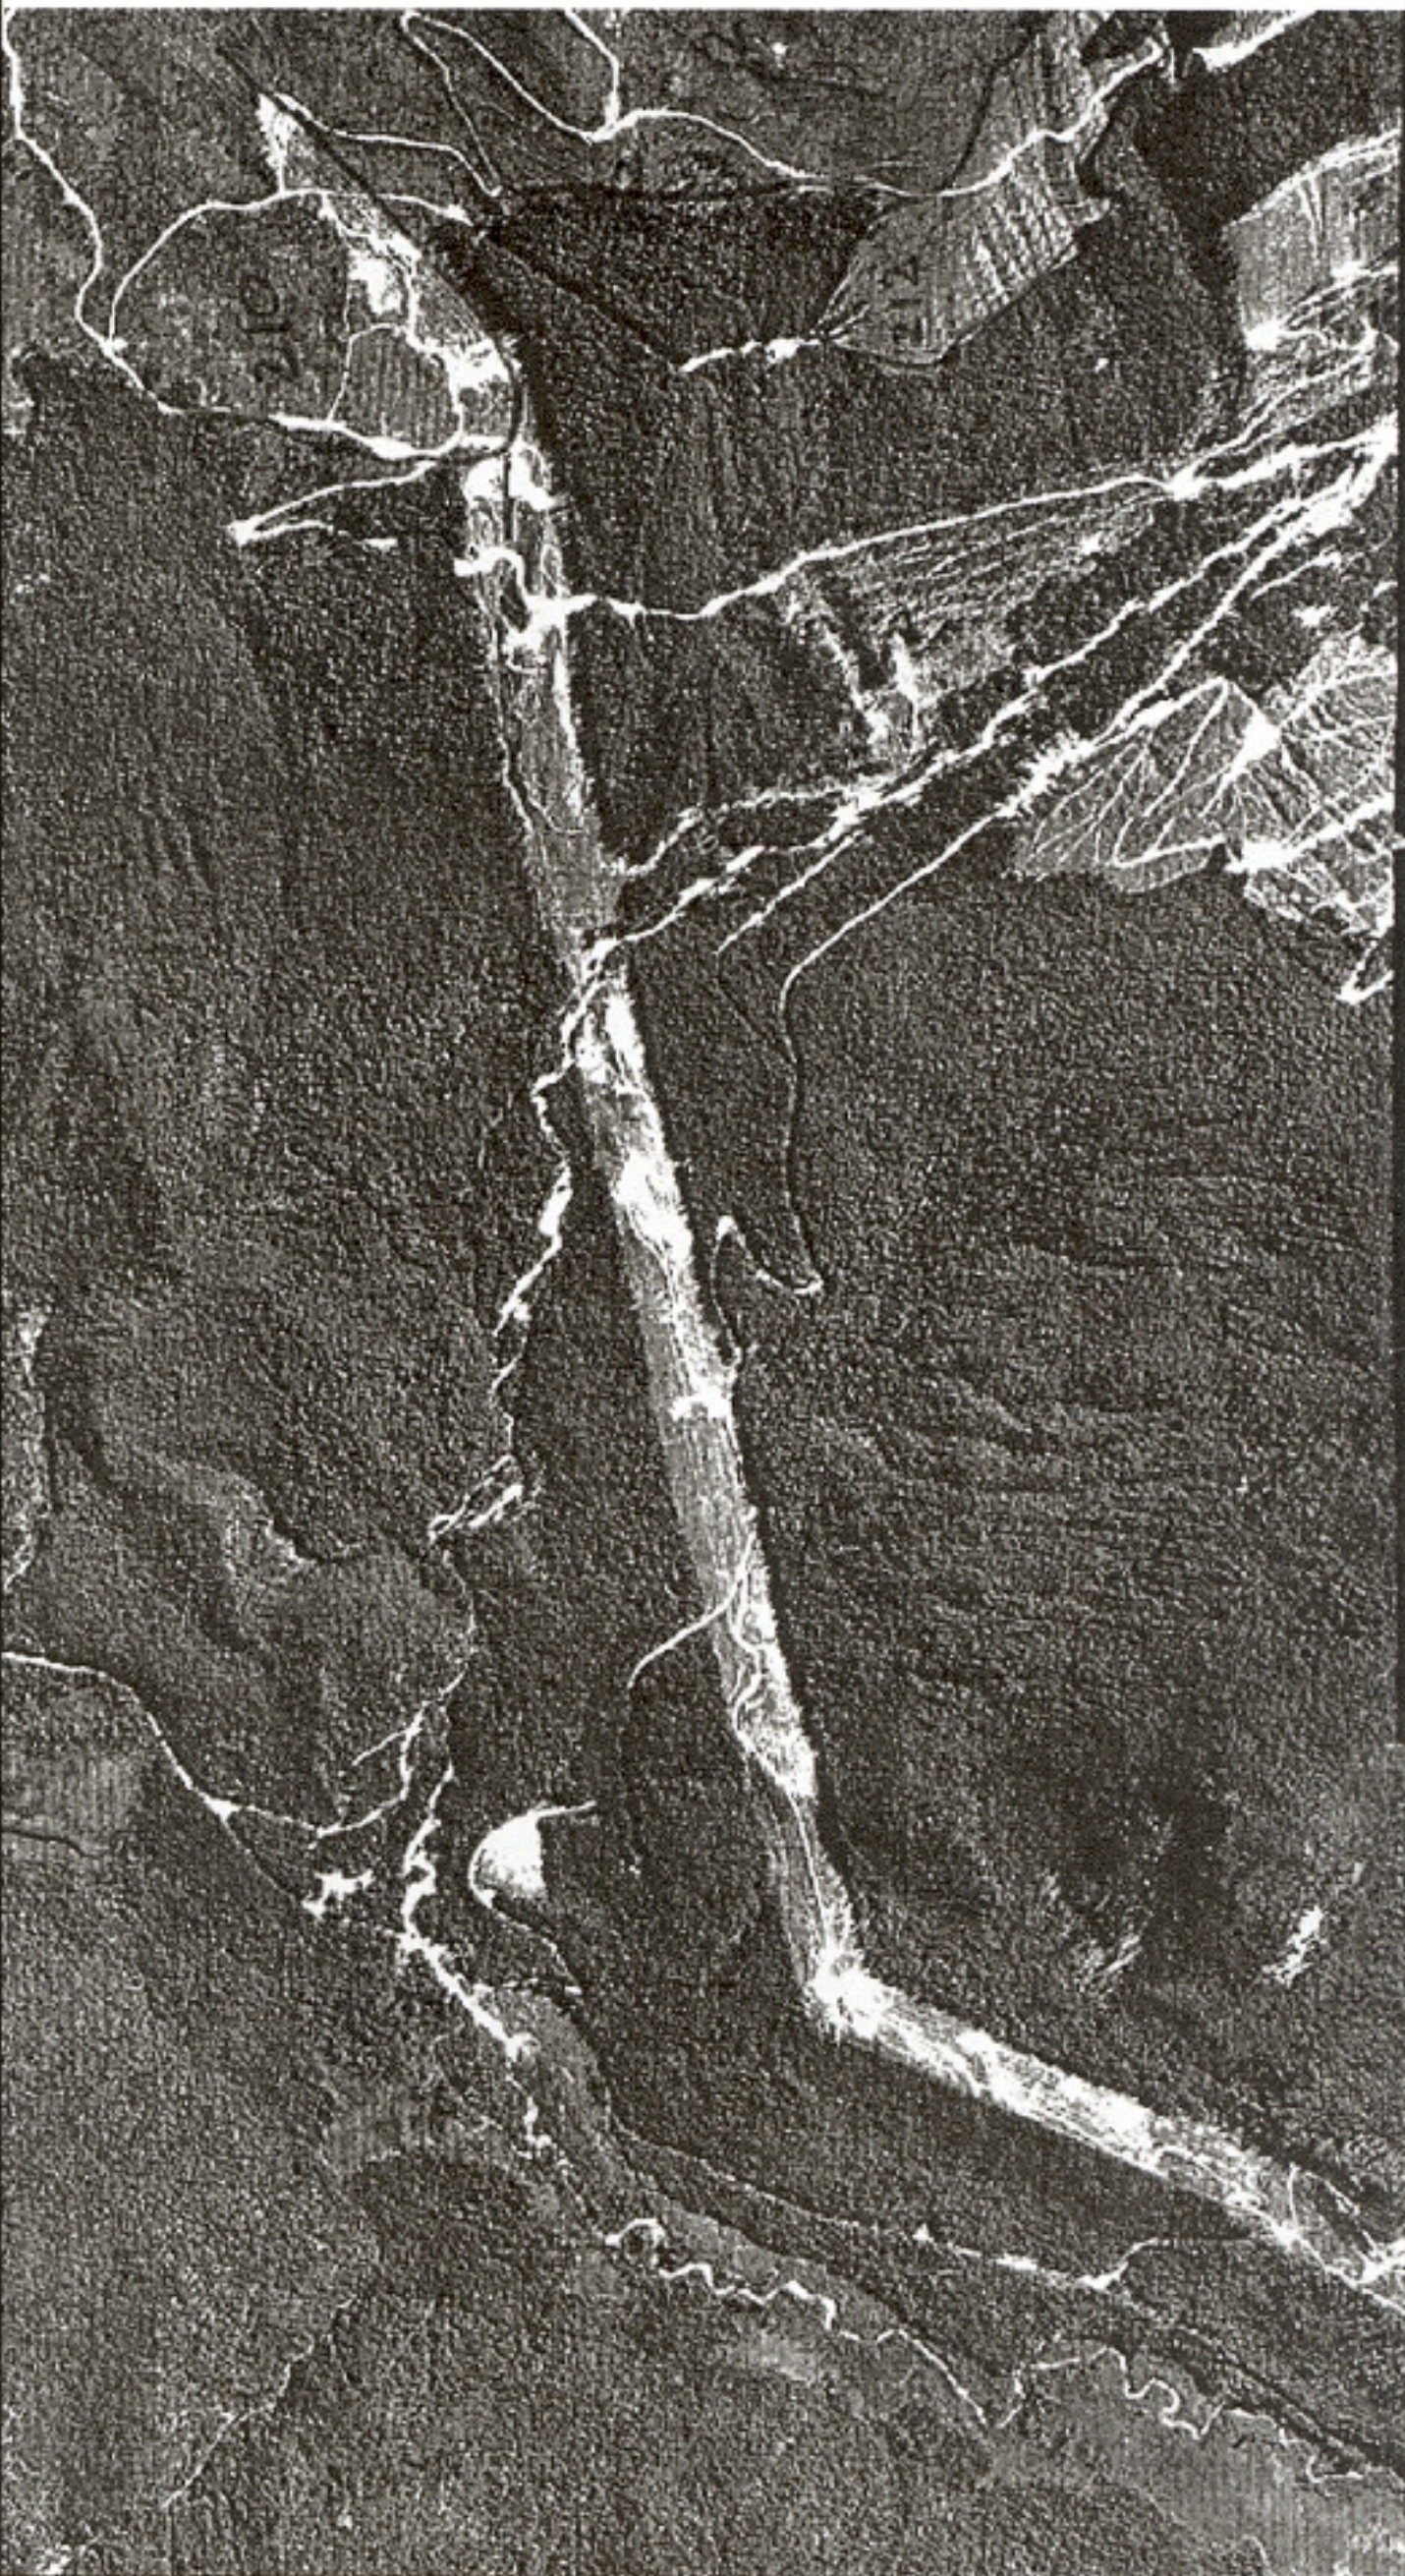
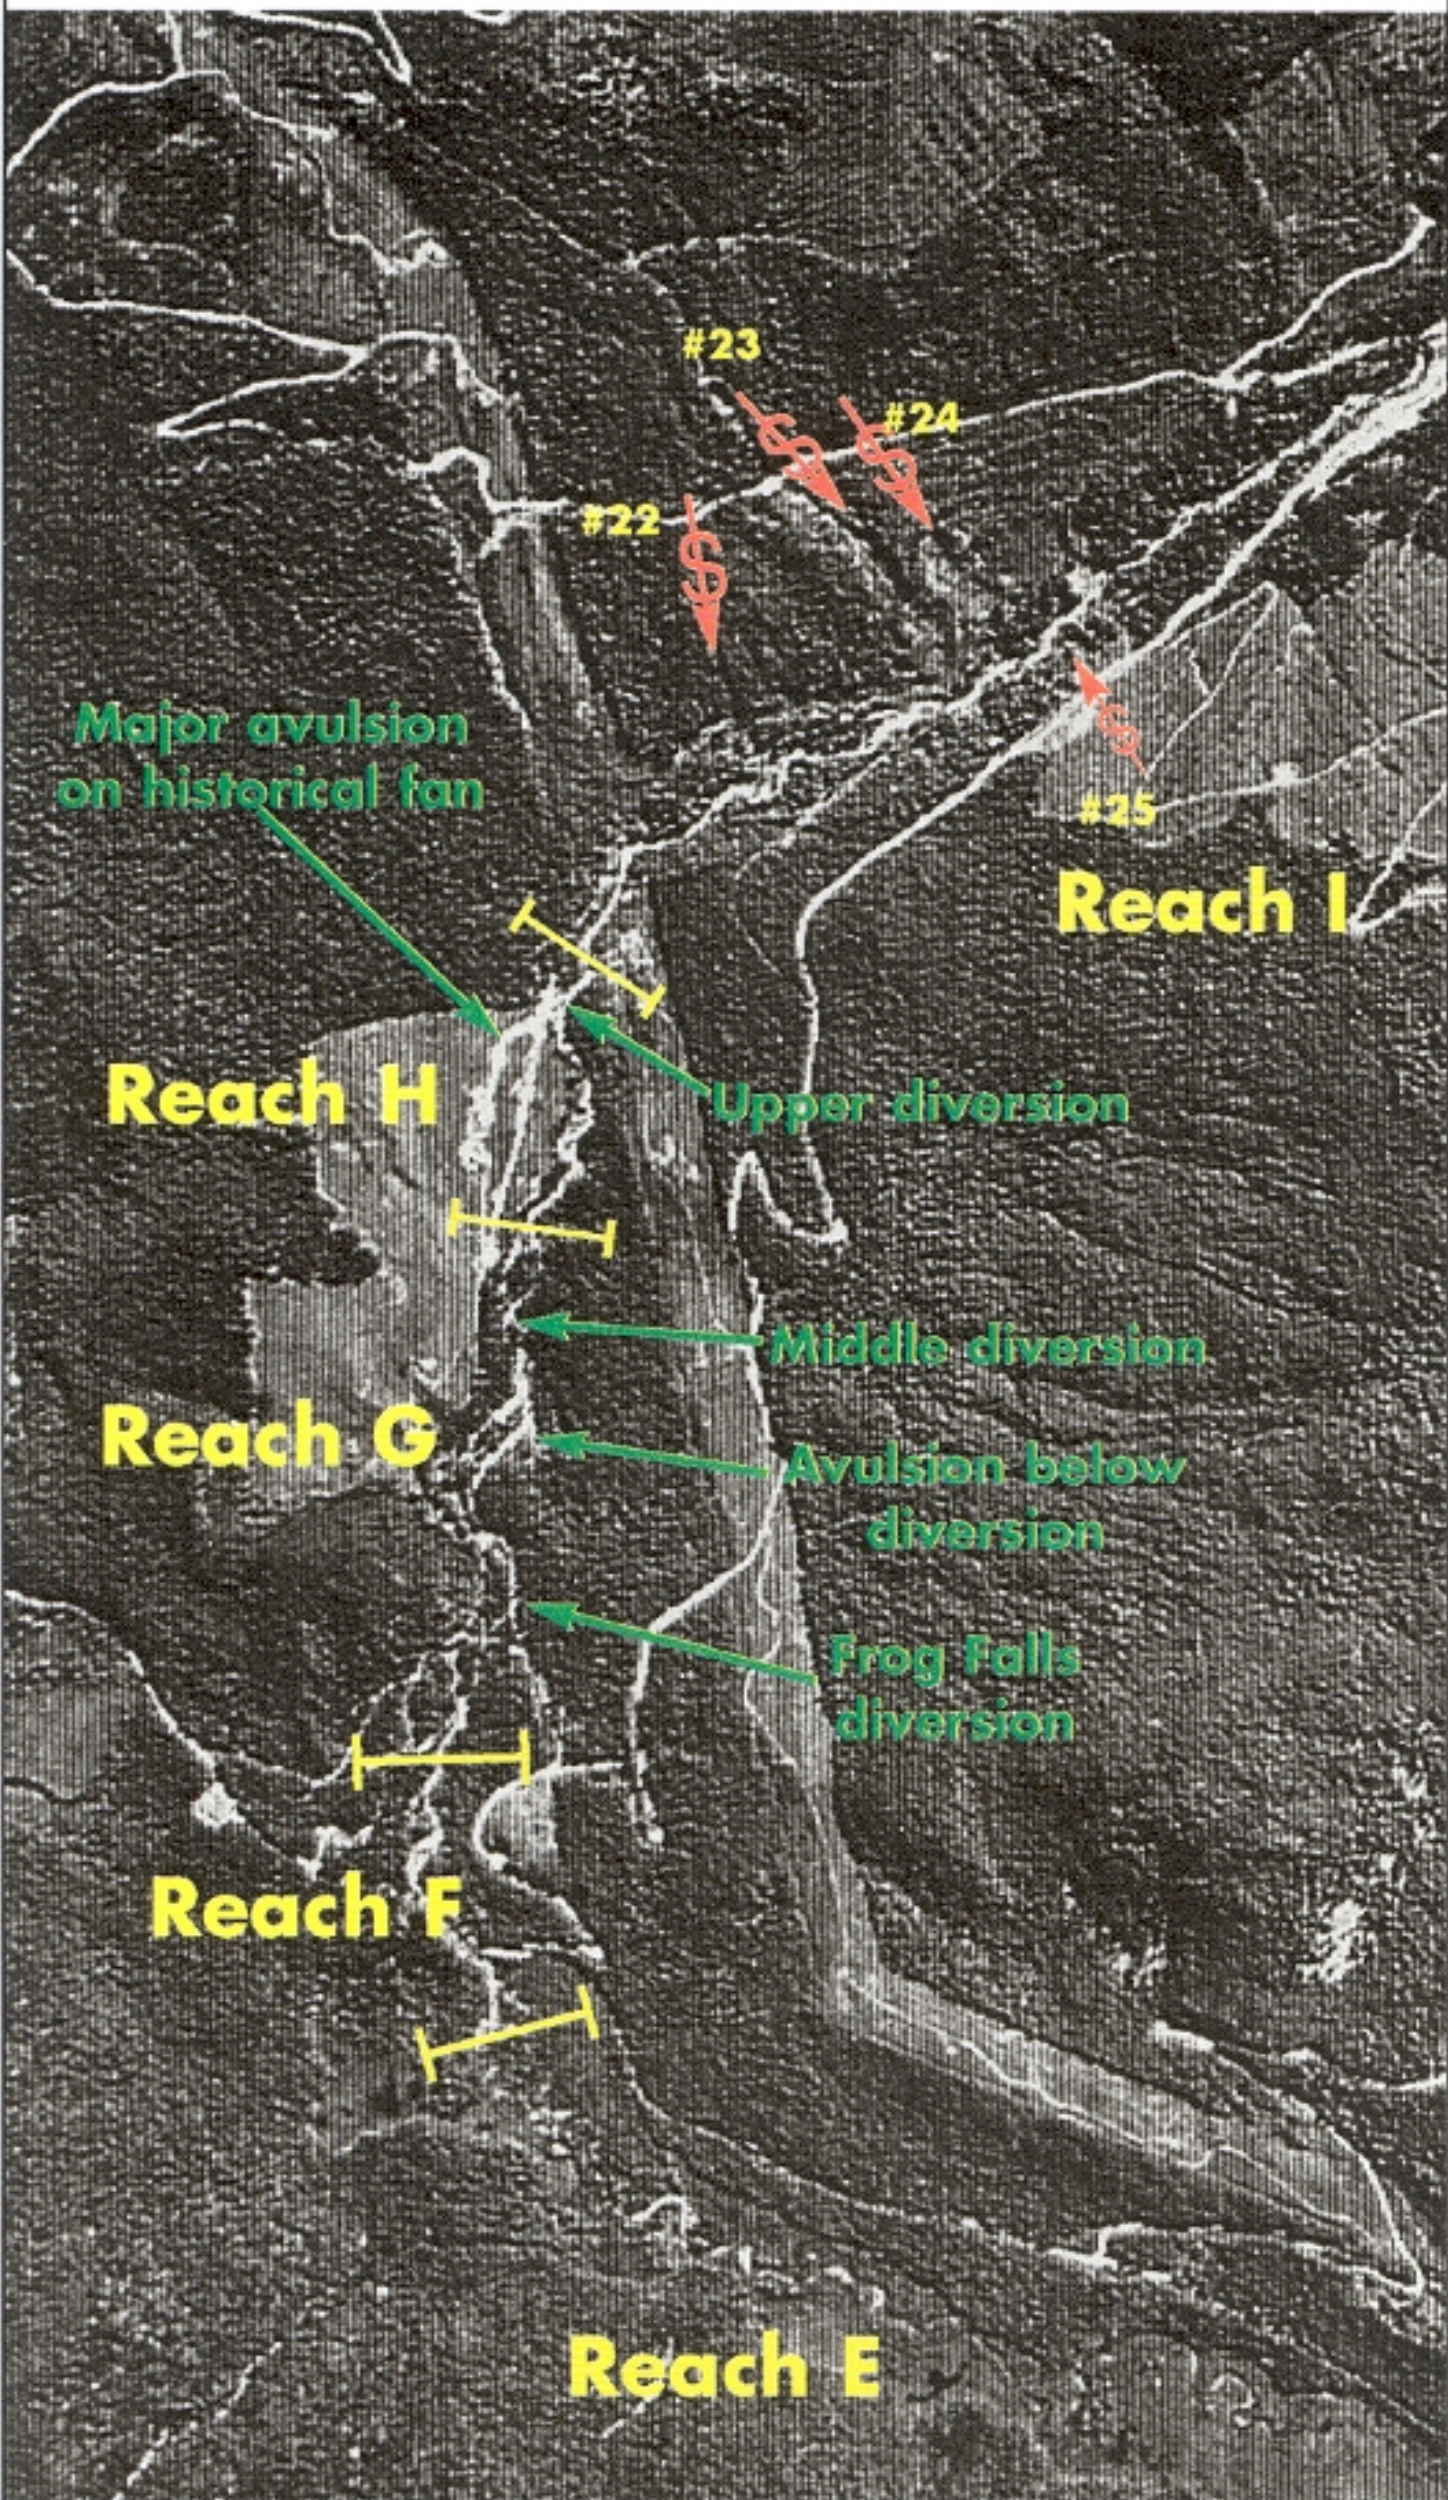
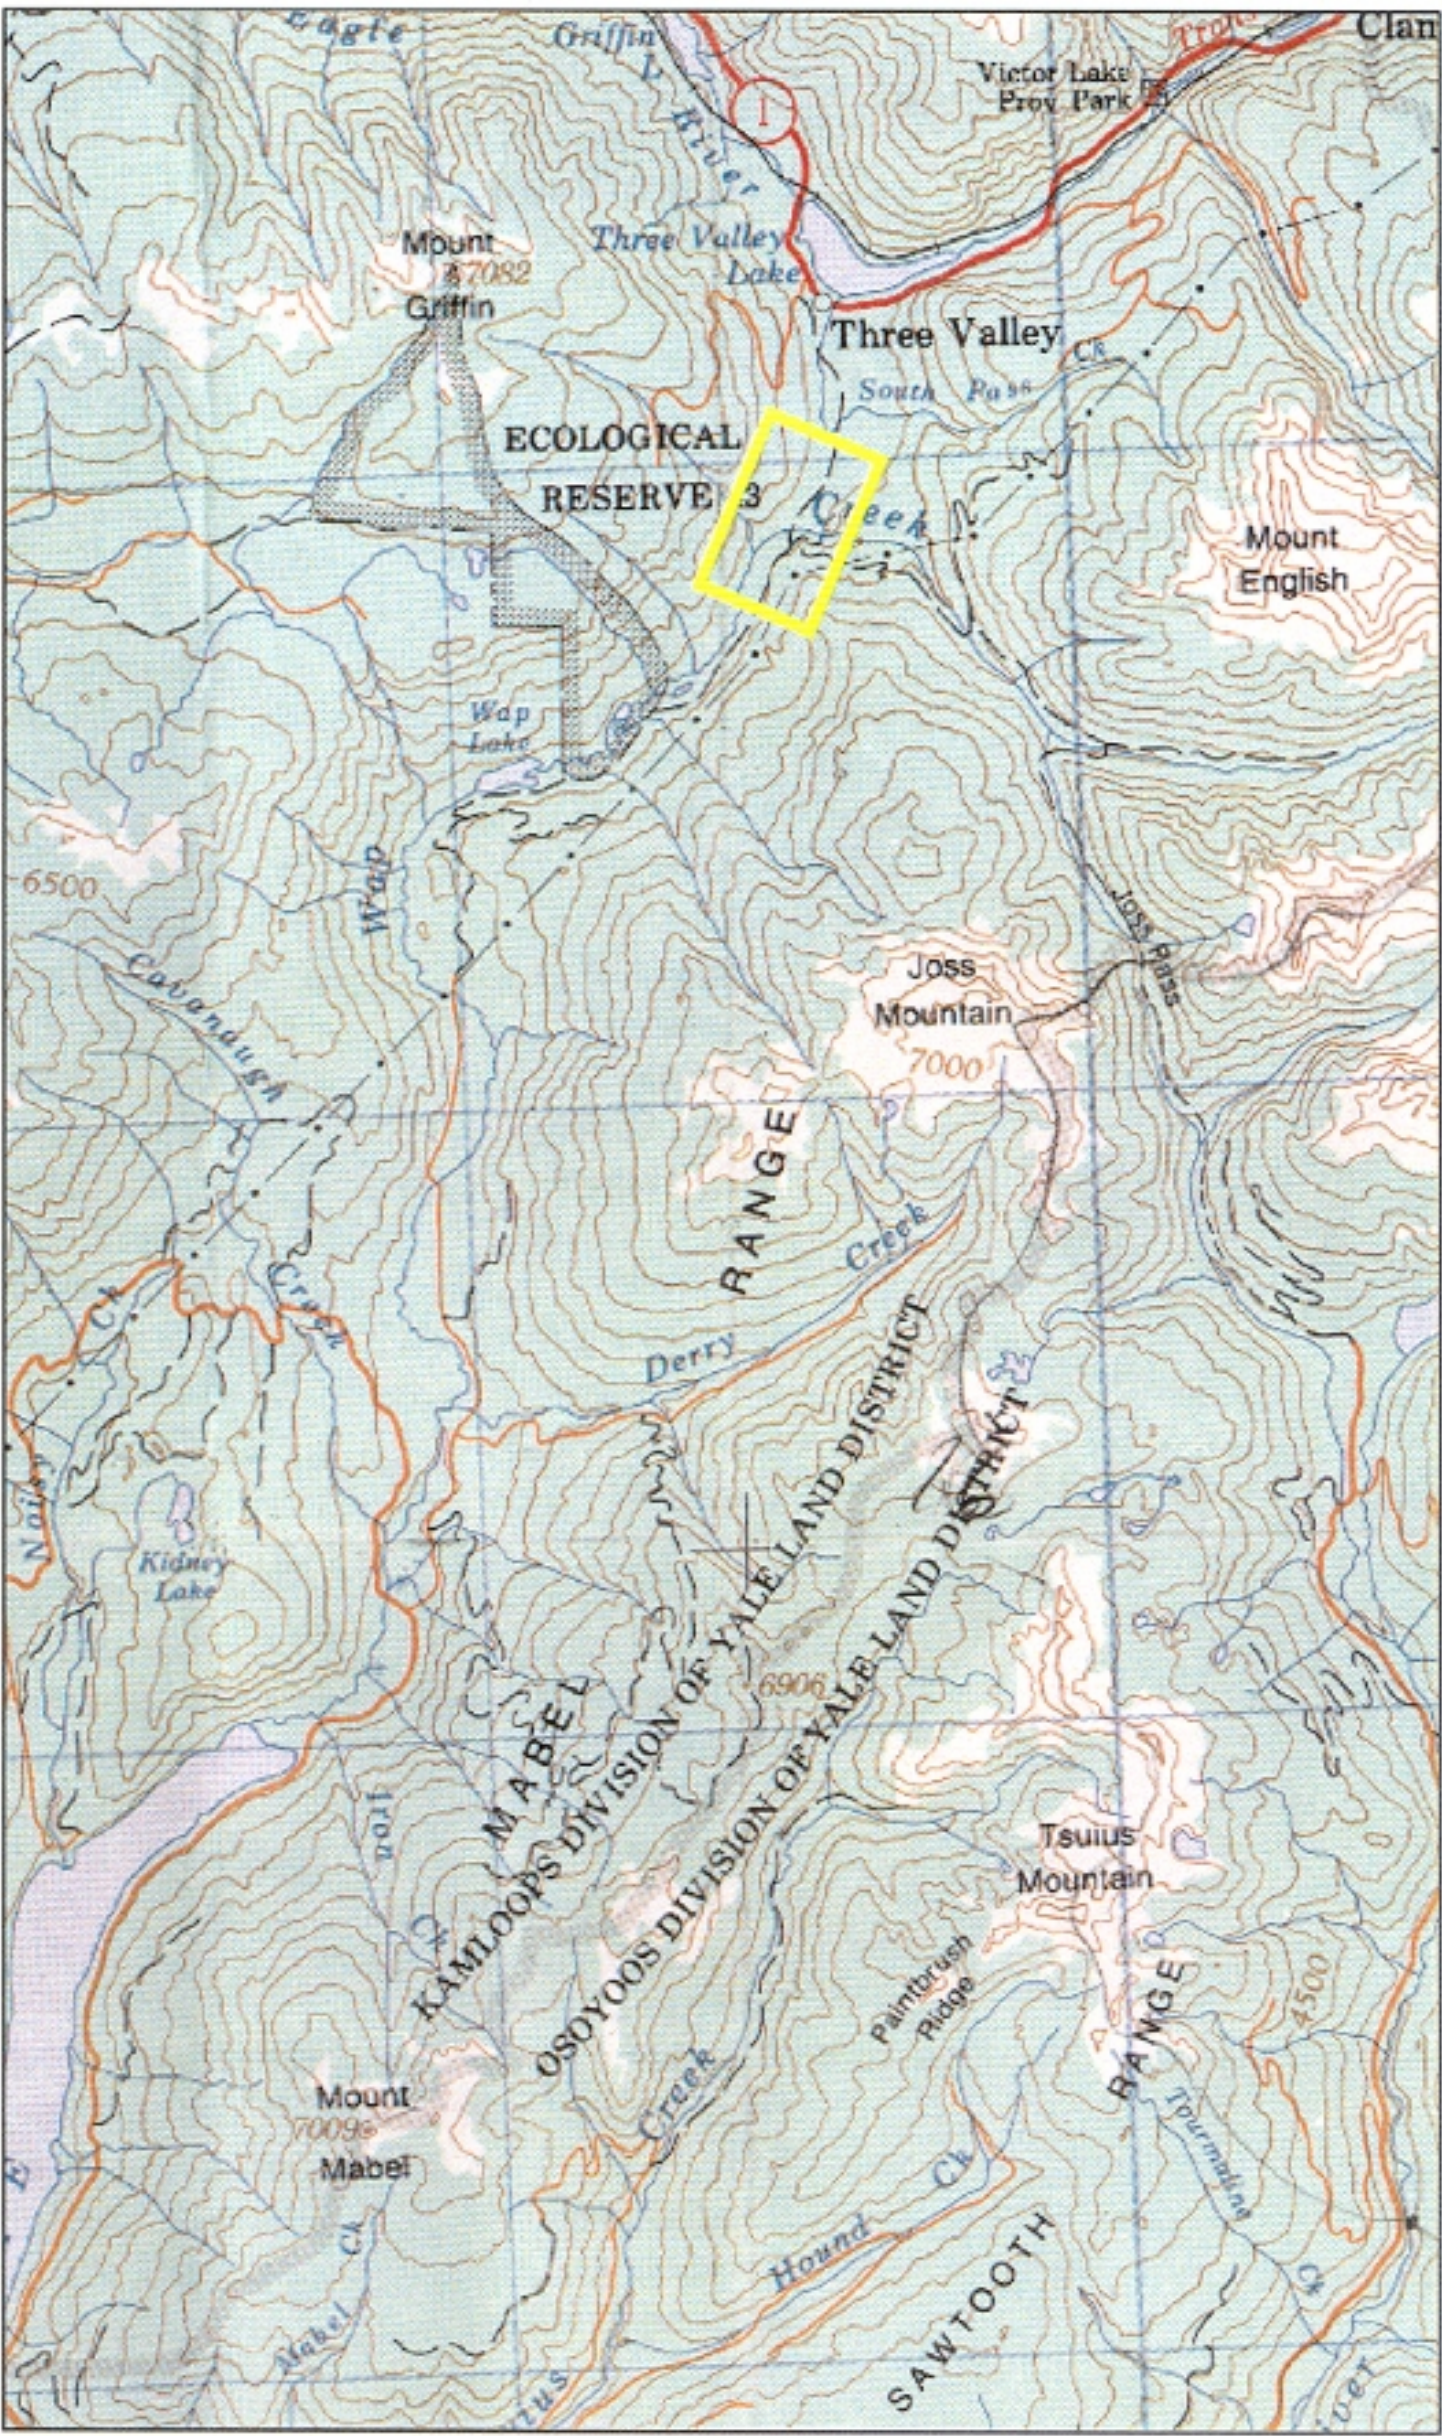
- Upper Reach E, Reaches F, G, H and lower I. The remainder of reach F is shown with disturbance from upstream landslide impact.
- Reach G is a bedrock and boulder controlled reach with limited disturbance. The Frog Falls hydro diversion is located at the top of the falls and has not caused any disturbance. Above the falls an avulsion is visible in 1984 that was reported to be caused by a large flood in 1983. The diversion is not currently active but still constricts flow increasing velocity and stream power.
- Reach H shows a major avulsion between 1984 and 1997 caused by flooding on the upper diversion at the apex of an historic fan.
- Sediment loading from landslides is visible through Reaches E, F, G and H from 1984 to present.
