**An Inventory of Watershed Conditions
Affecting Risks to Fish Habitat
in the
CARIBOO, COTTONWOOD & HORSEFLY
WATERSHEDS**

VOLUME I
Cariboo River Watershed
(Sections 1 to 5 & 6)

Prepared for
CARIBOO REGION INTERAGENCY MANAGEMENT COMMITTEE
Williams Lake, BC

by
CHAPMAN GEOSCIENCE LTD.
Nanaimo, BC
&
DOBSON ENGINEERING LTD.
Kelowna, BC

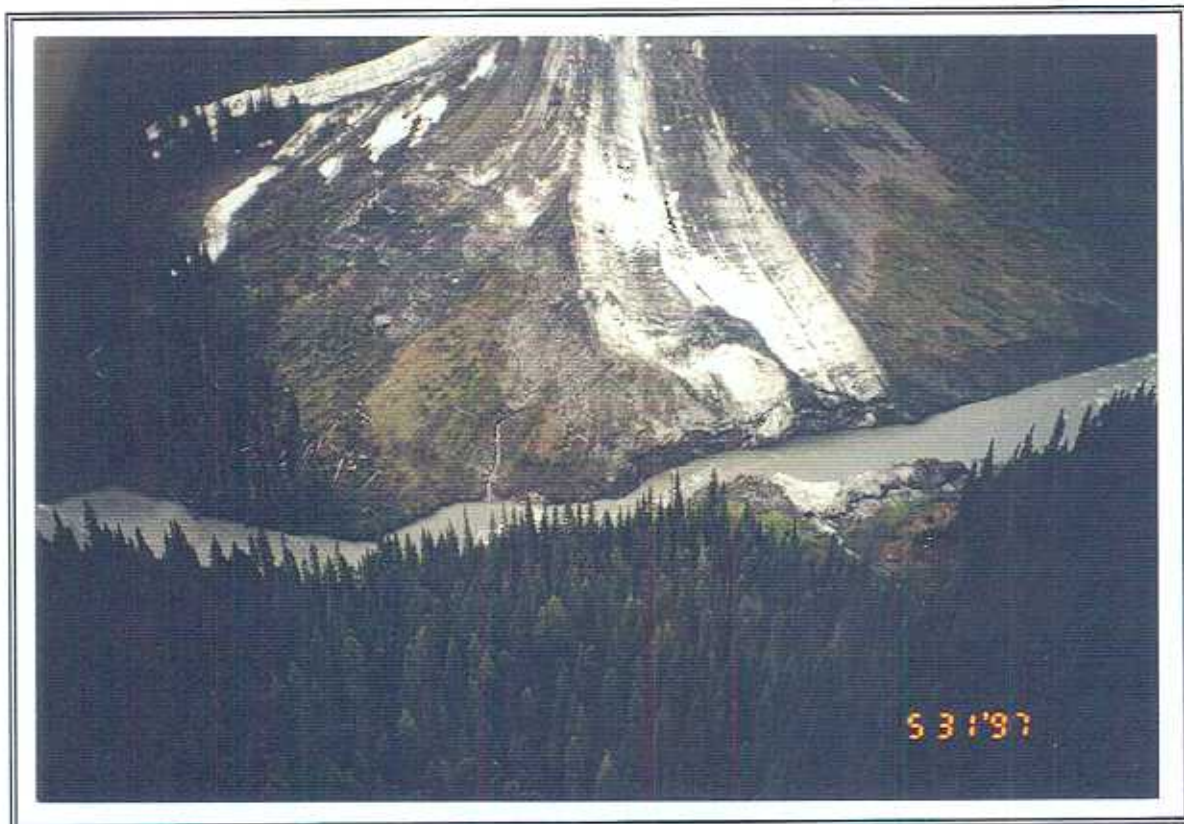
PHOTO C1. Avalanche in upper Cariboo River watershed above Matthew River confluence.

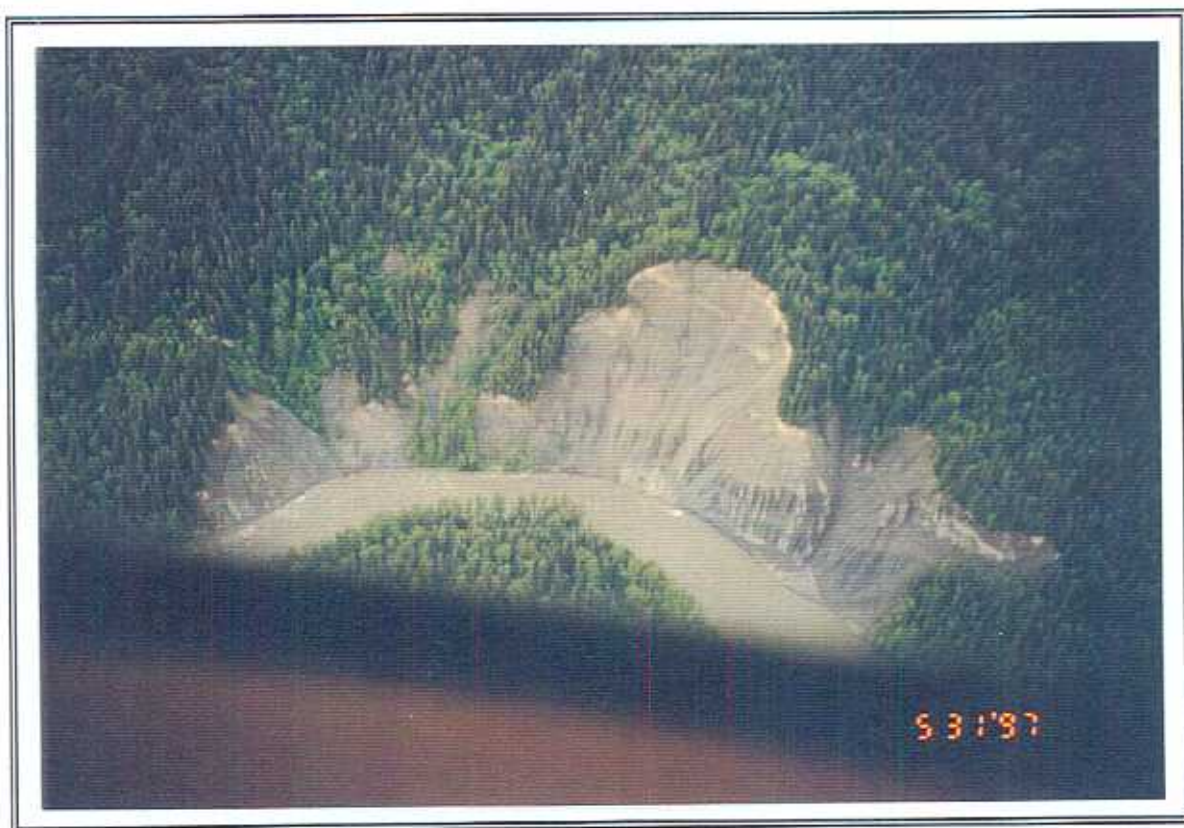
PHOTO C2. Large bank failures in fine textured glacio-fluvial and glacio-lacustrine sediment in lower Cariboo River watershed.

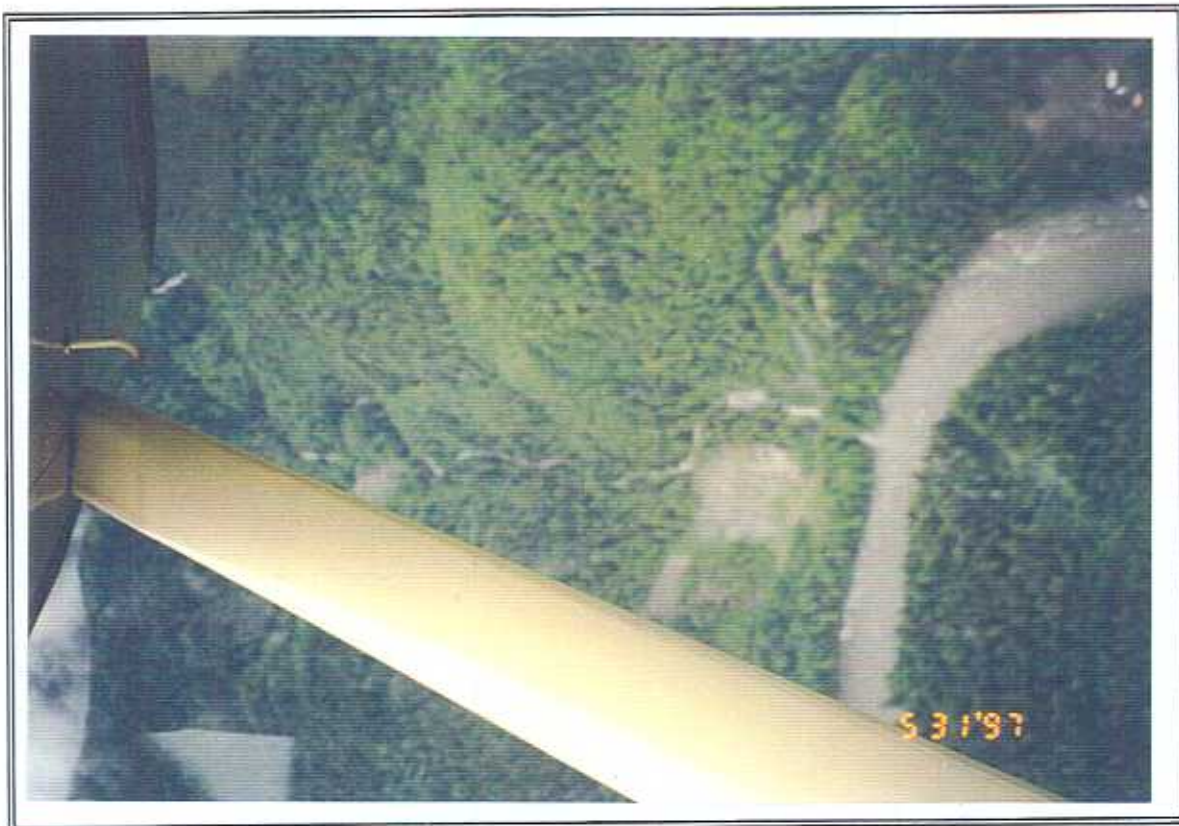
PHOTO SP1. Old placer mining scar at the mouth of Spanish Creek on the Cariboo River [Site S1].

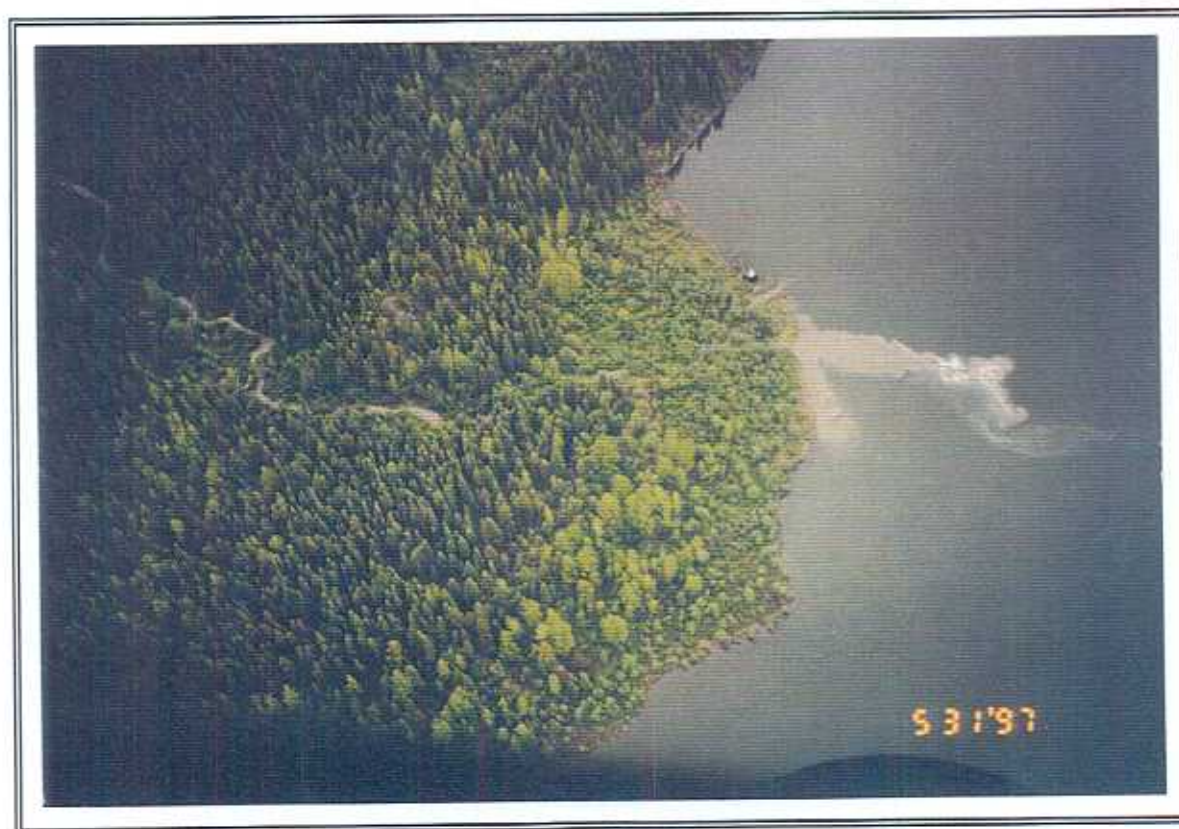
PHOTO SP2. Sediment plume into Spanish Lake from road and ditchline erosion in upper tributary [Site S5].

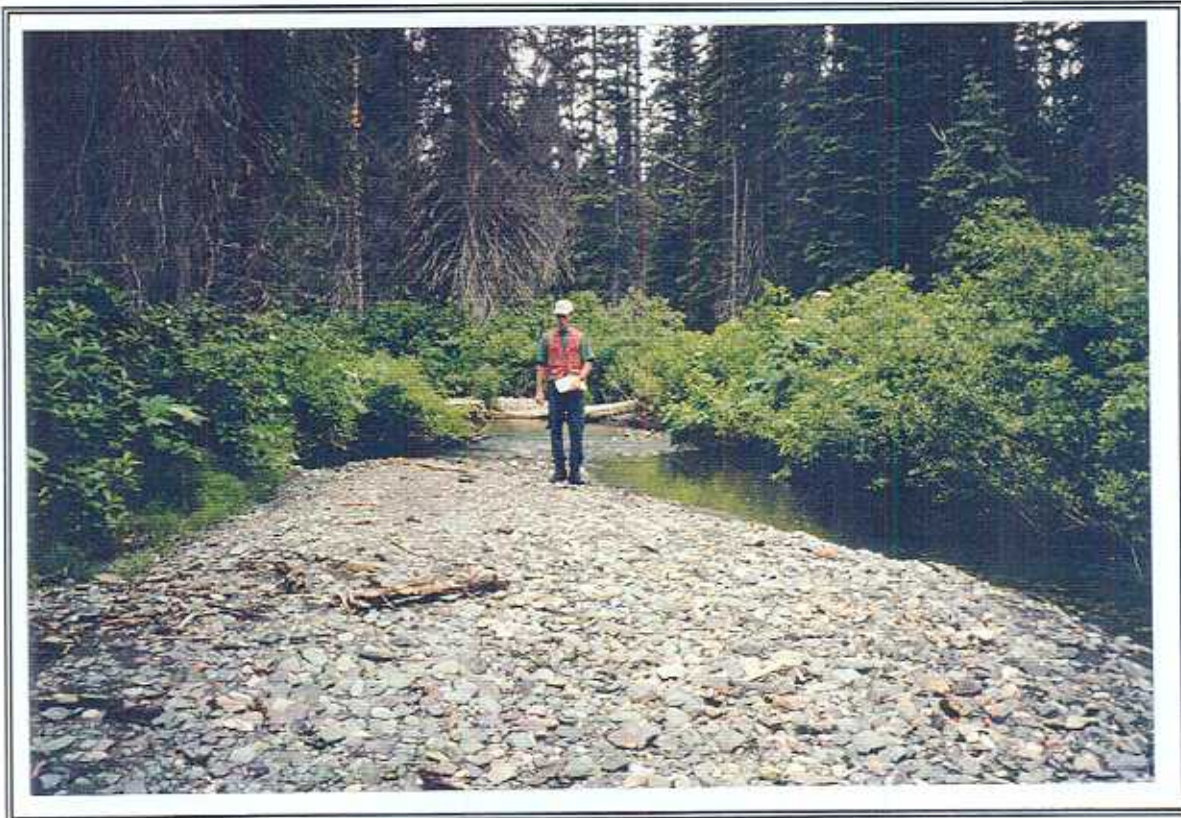
PHOTO SP10. Upper Blackbear Creek showing elevated bar material - downstream [Site S4].

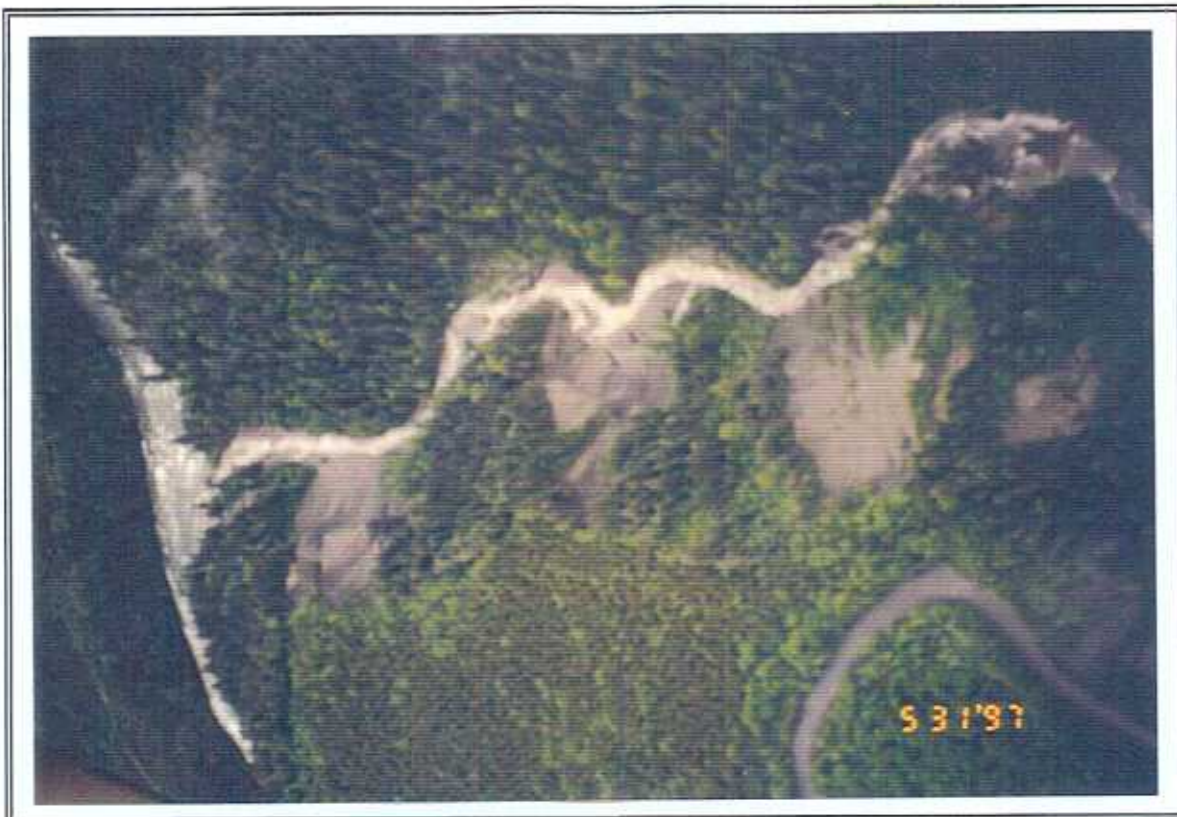
PHOTO S1. Bank failures and placer mining scars on Seller Creek [Site Sel1].

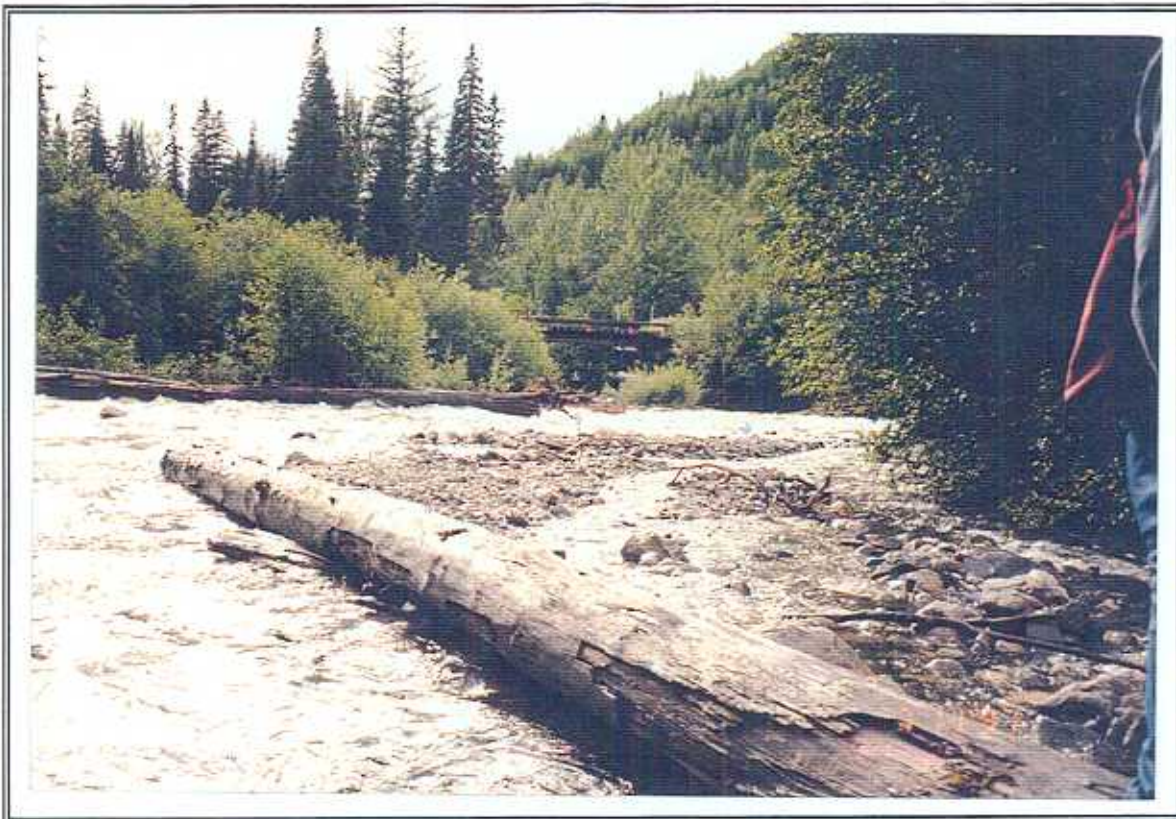
PHOTO S3. Lower Seller Creek showing aggradation from upstream bank failures and landslides - downstream [Site Sel2].

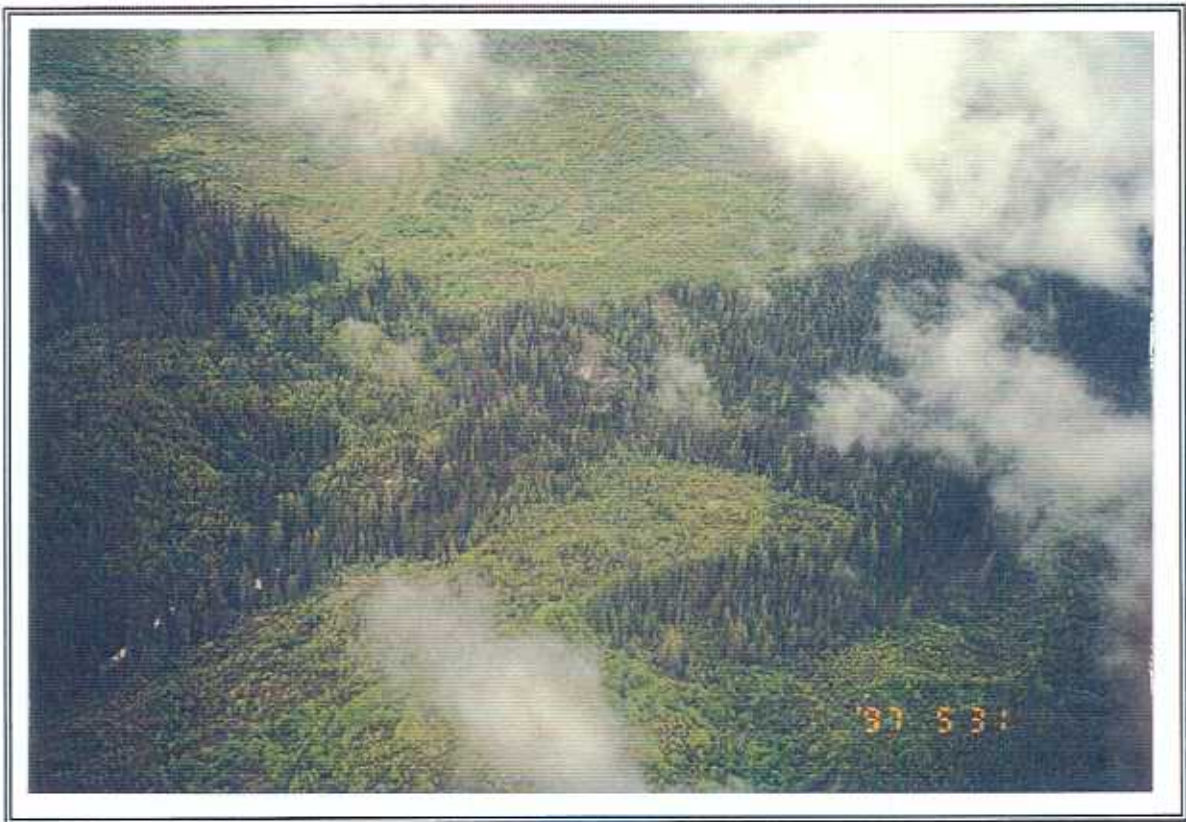
PHOTO R1. Bank failures below old cutblocks in the lower Rollie Creek watershed [Site Rol3].

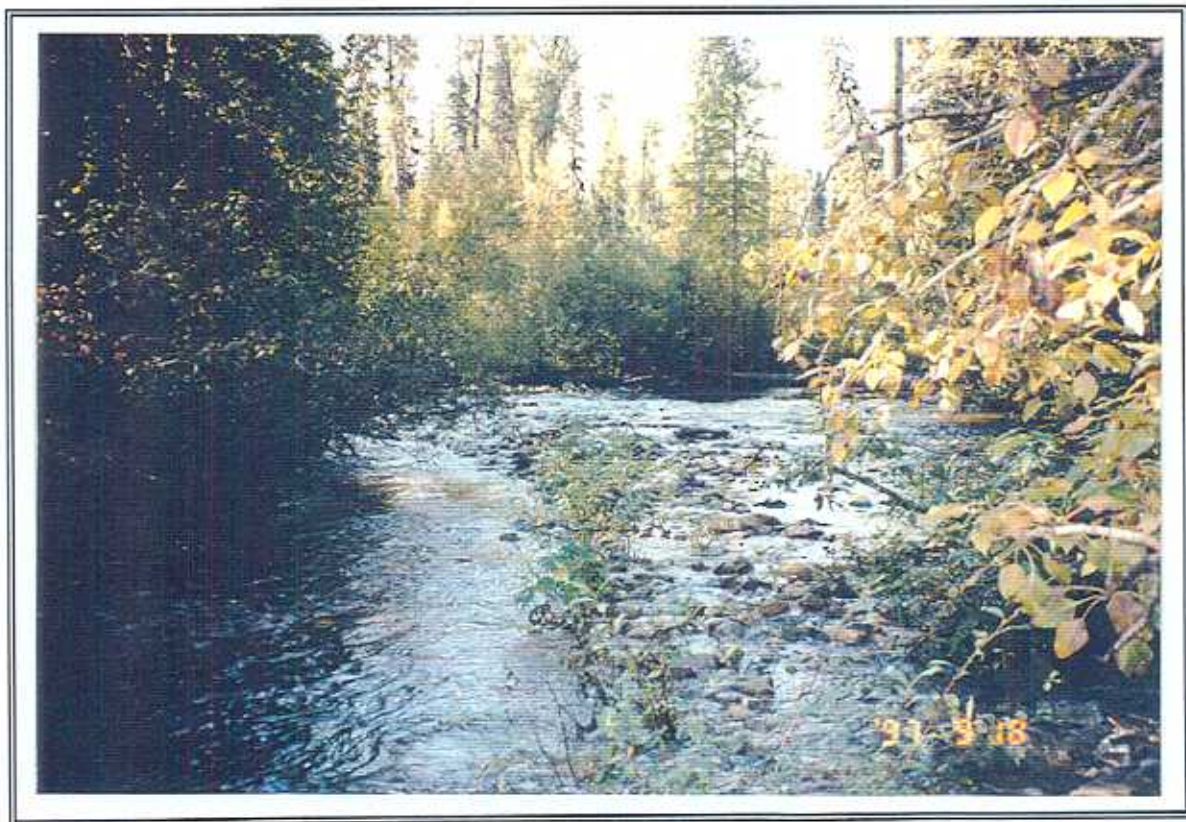
PHOTO R2. Rollie Creek on the alluvial fan showing lateral streamflow over elevated mid-channel bar - upstream [Site Rol2].

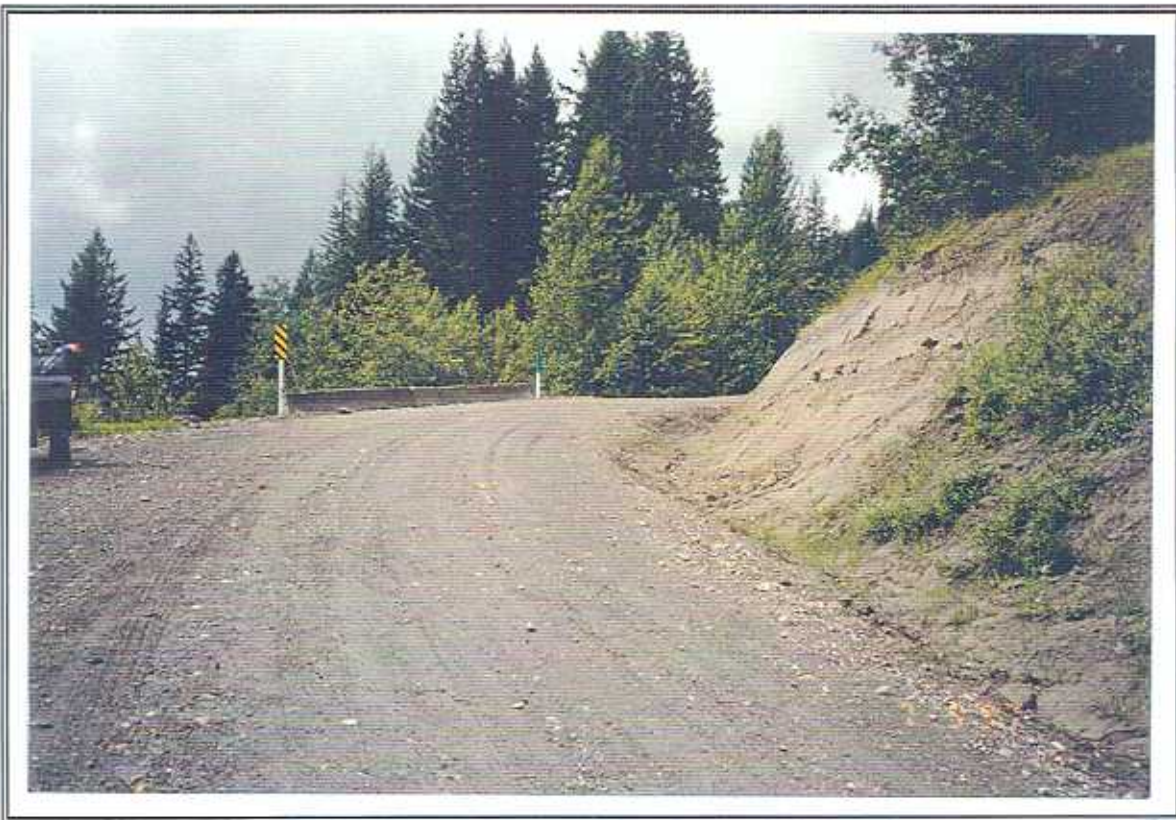
PHOTO R7. Rollie mainline road climbing out of the main Cariboo River valley through fine textured glacio-lacustrine sediments [Site R11].

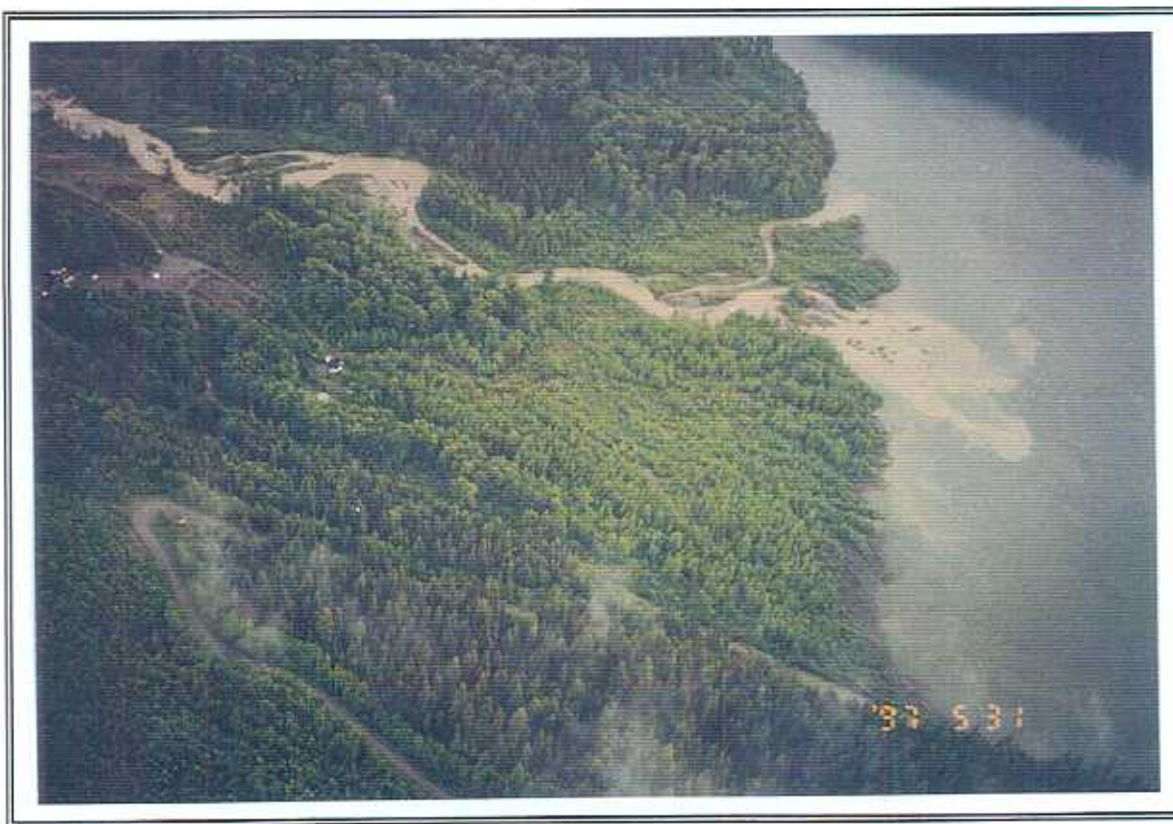
PHOTO K1. Lower Keithley Creek alluvial fan showing multiple channels, aggraded conditions and sediment plume into Cariboo Lake [Site K1].

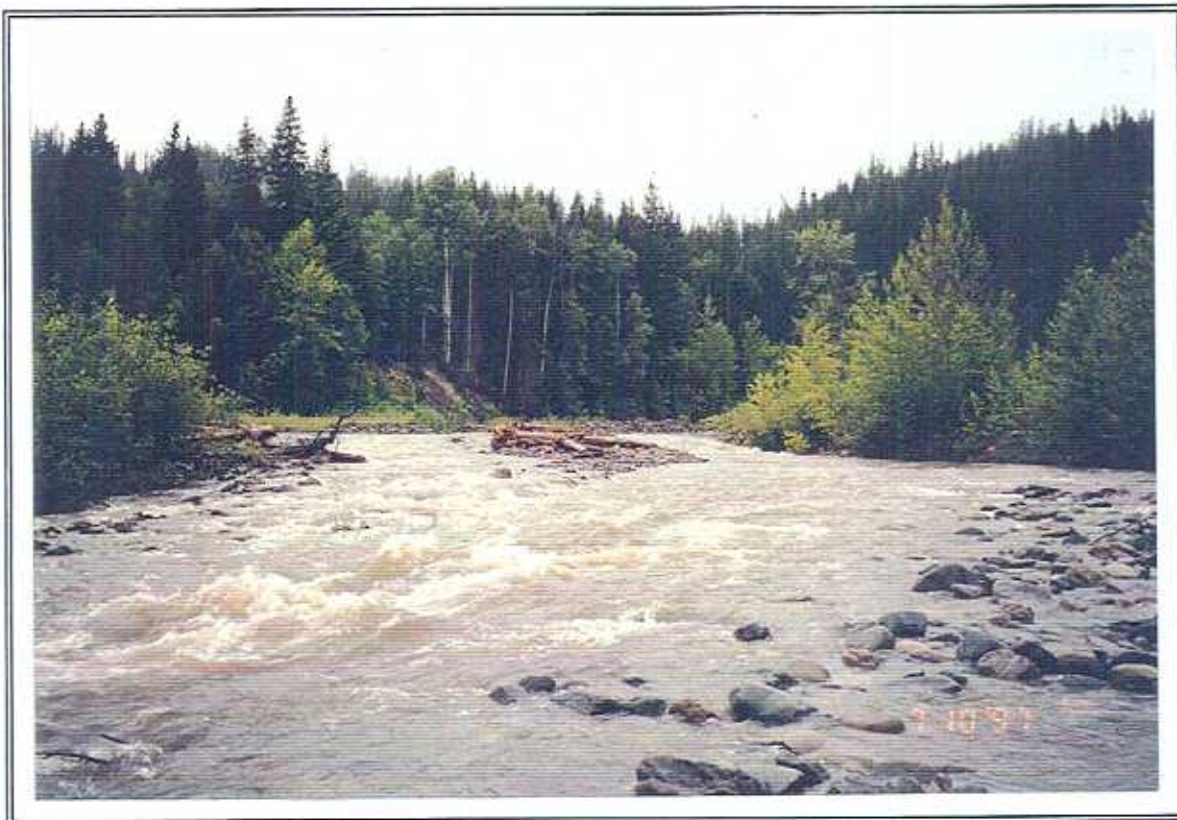
PHOTO K2. Turbid flow in multiple channels on Keithley Creek alluvial fan - upstream [Site K2].

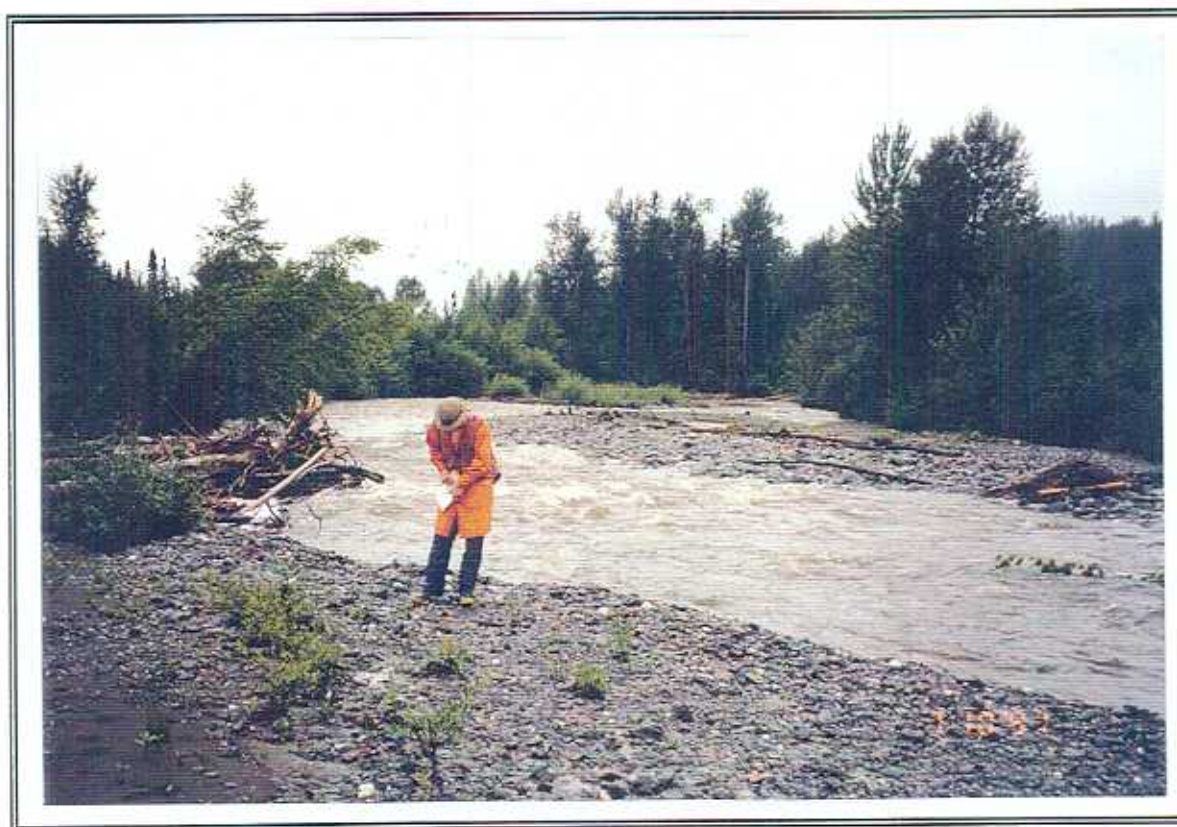
PHOTO K3. Aggraded Keithley Creek channel with fresh large woody debris piles eroded from upstream banks - downstream [Site K2].

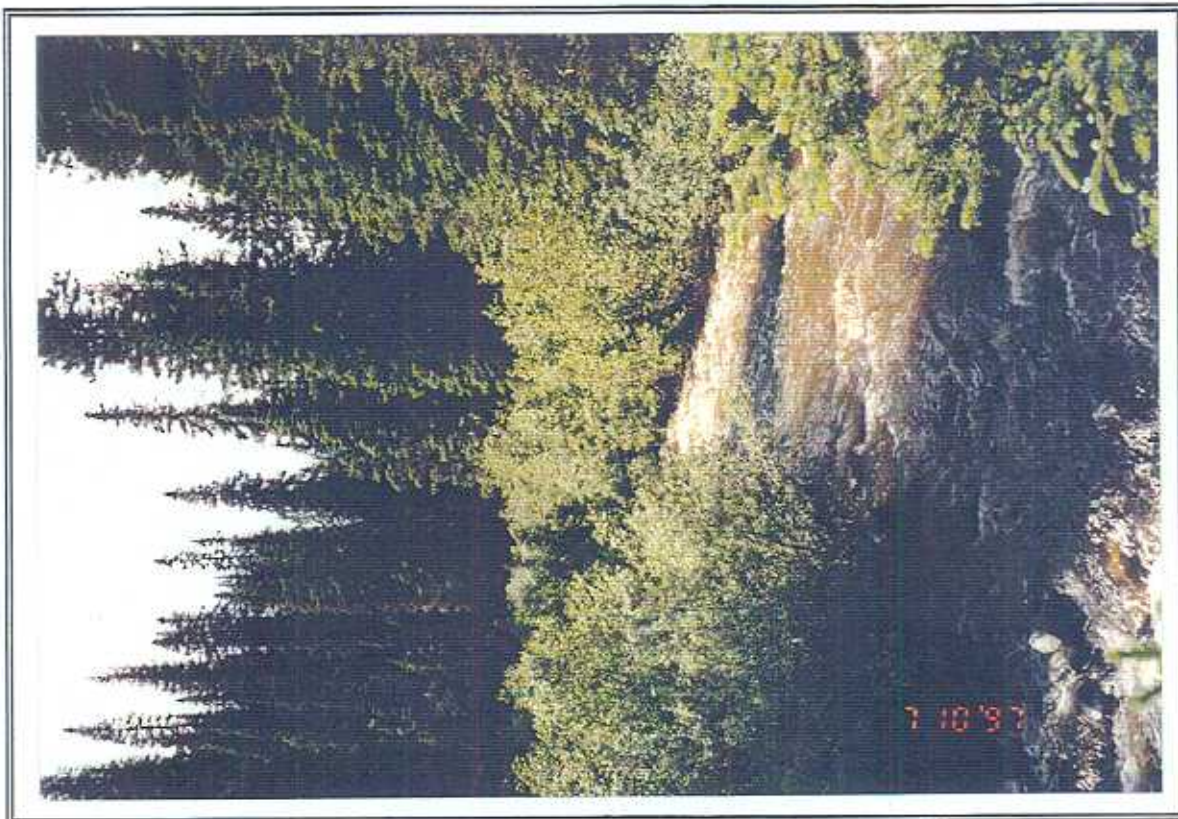
PHOTO K4. Upper Keithley Creek showing high suspended sediment level - upstream [Site K5].

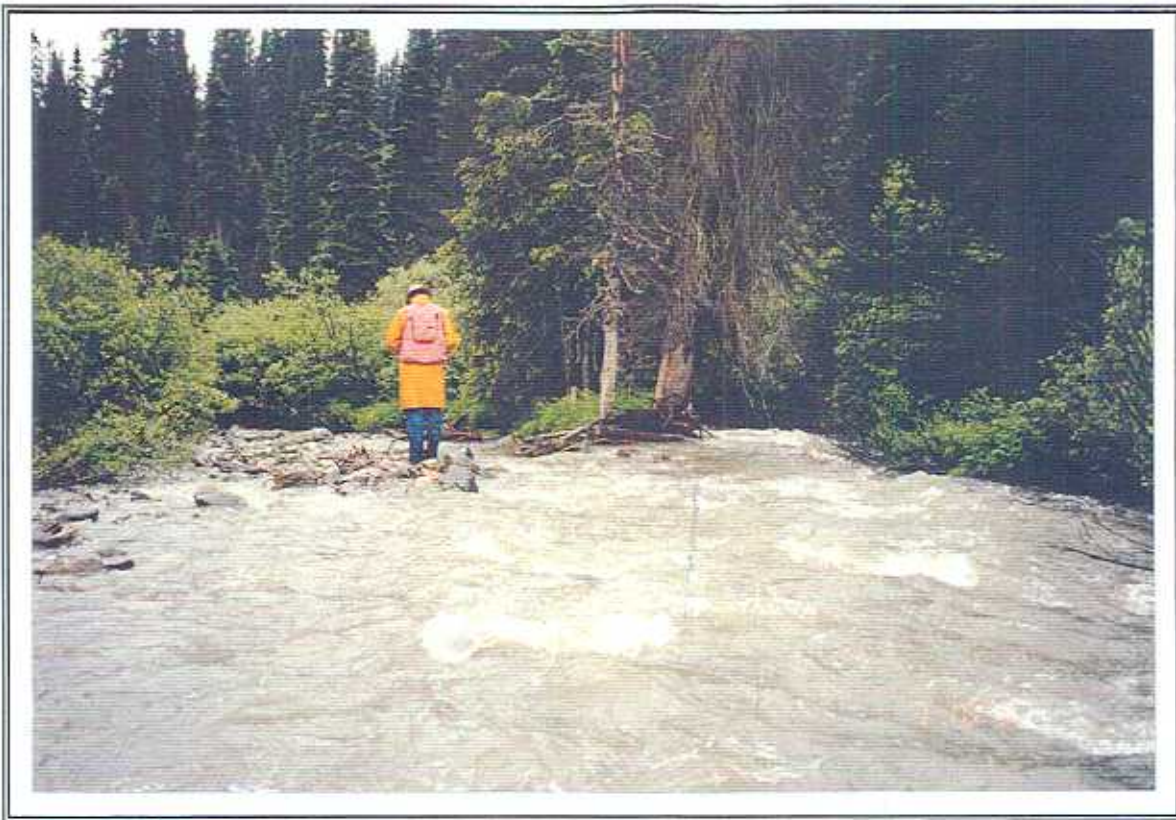
PHOTO K8. Snowshoe Creek below confluence with Little Snowshoe Creek showing aggraded conditions resulting from increased bedload supply and transport - downstream [Site K9].

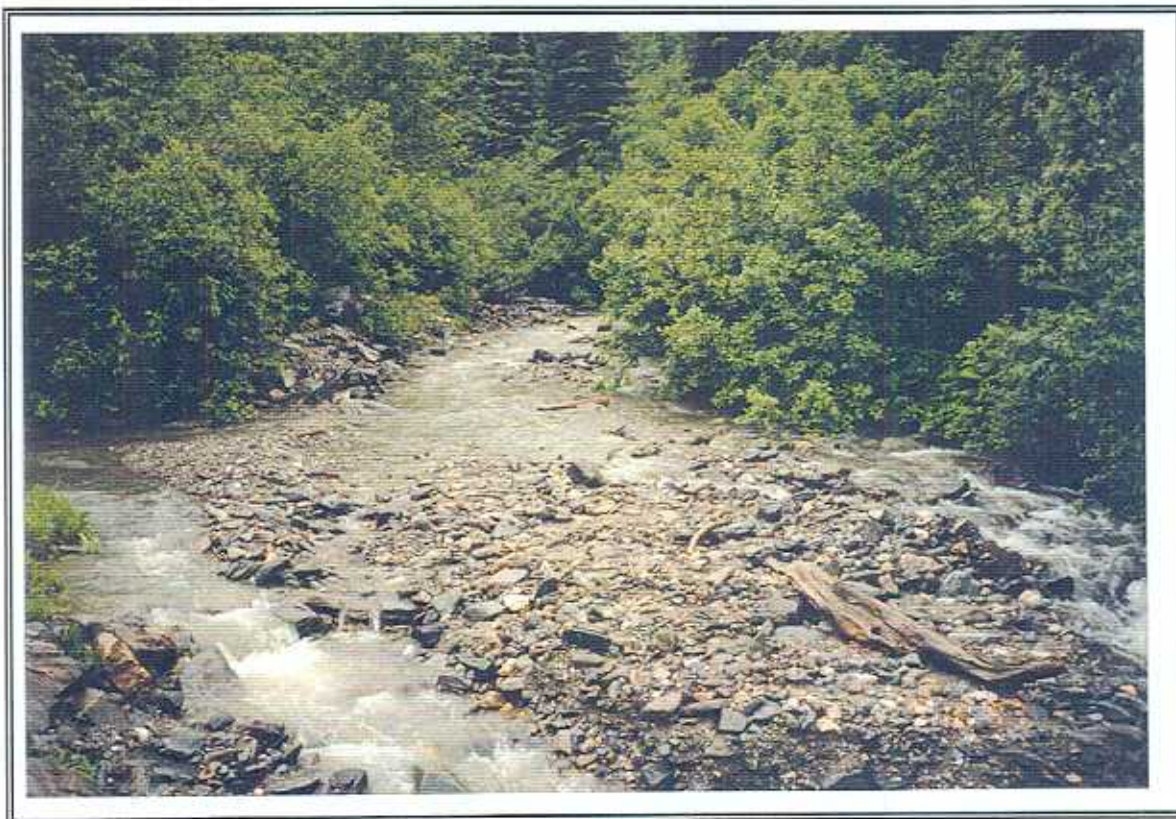
PHOTO K9. Increased bedload in Weaver Creek resulting from channel bank disturbance in upstream placer mines - upstream [at mainline crossing on east side of Keithley Creek].

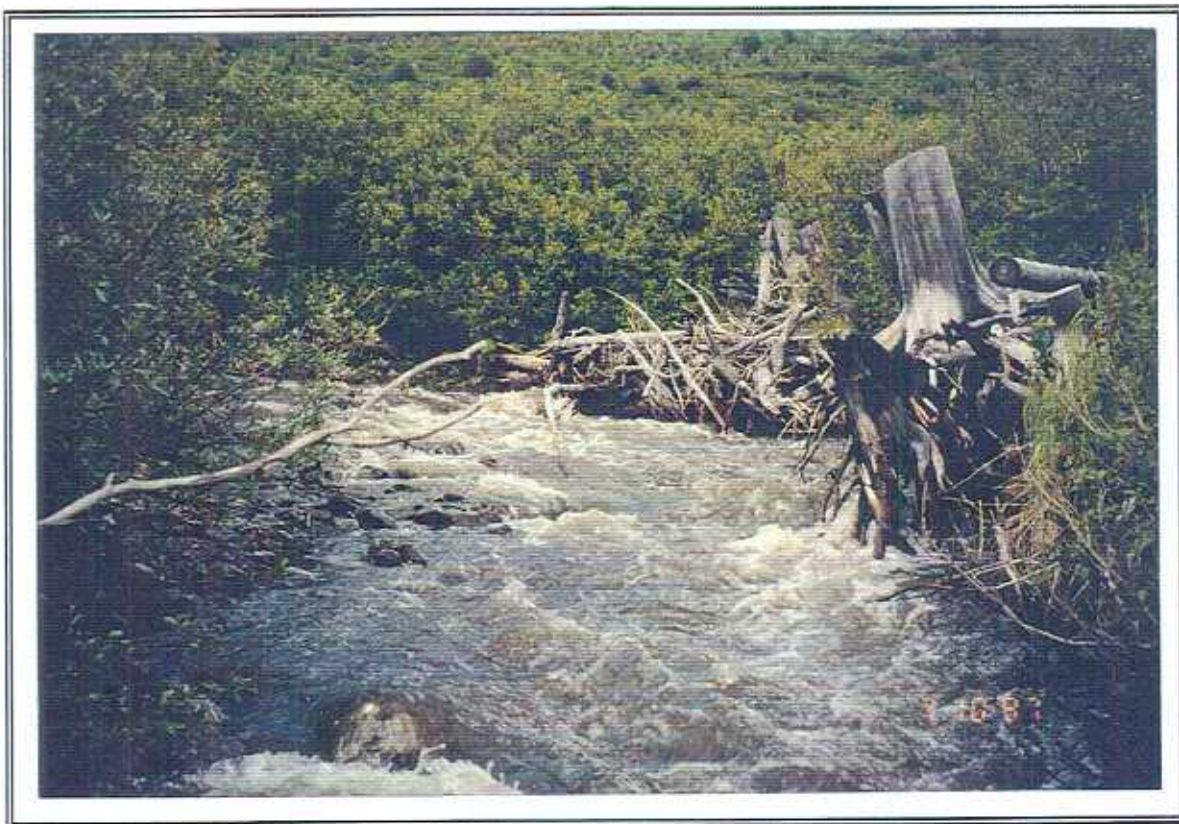
PHOTO K10. Bank erosion resulting from harvesting in the riparian zone on upper Rabbit Creek - upstream [Site K6].

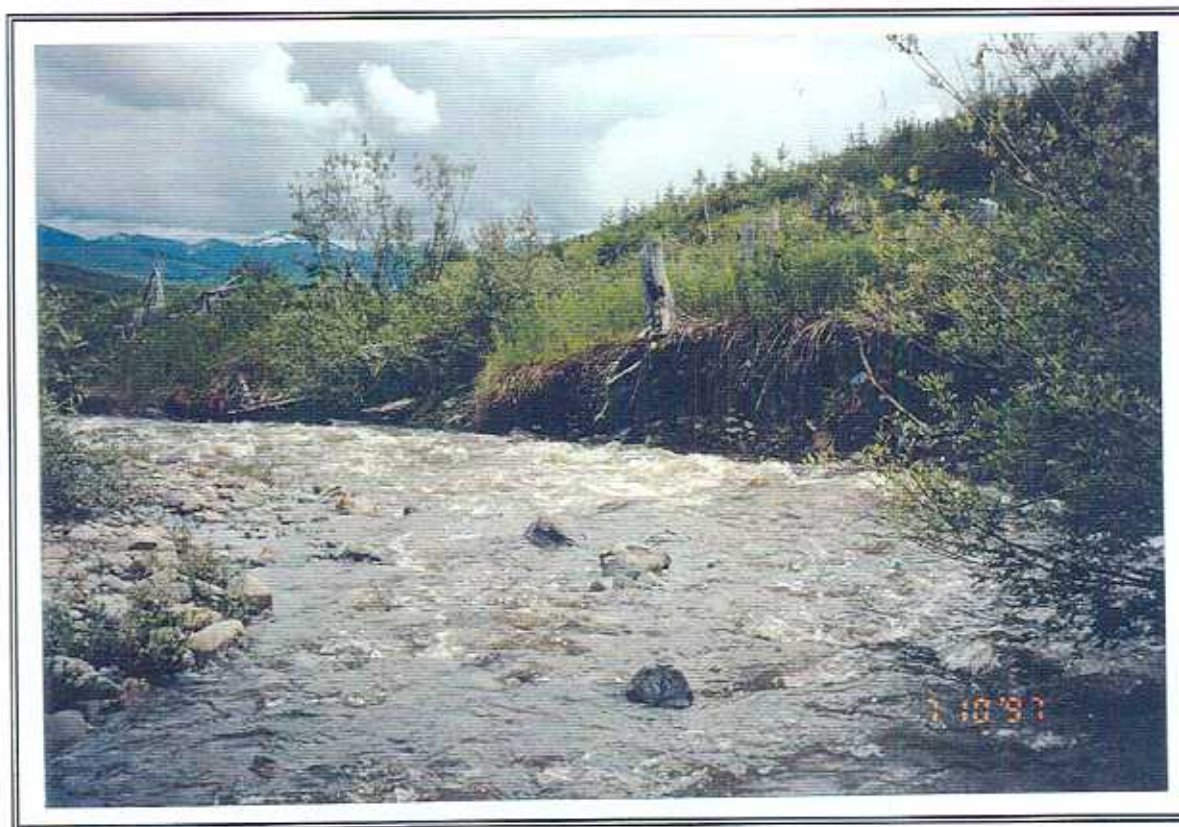
PHOTO K11. Bank erosion on upper Rabbit Creek - downstream [Site K6].

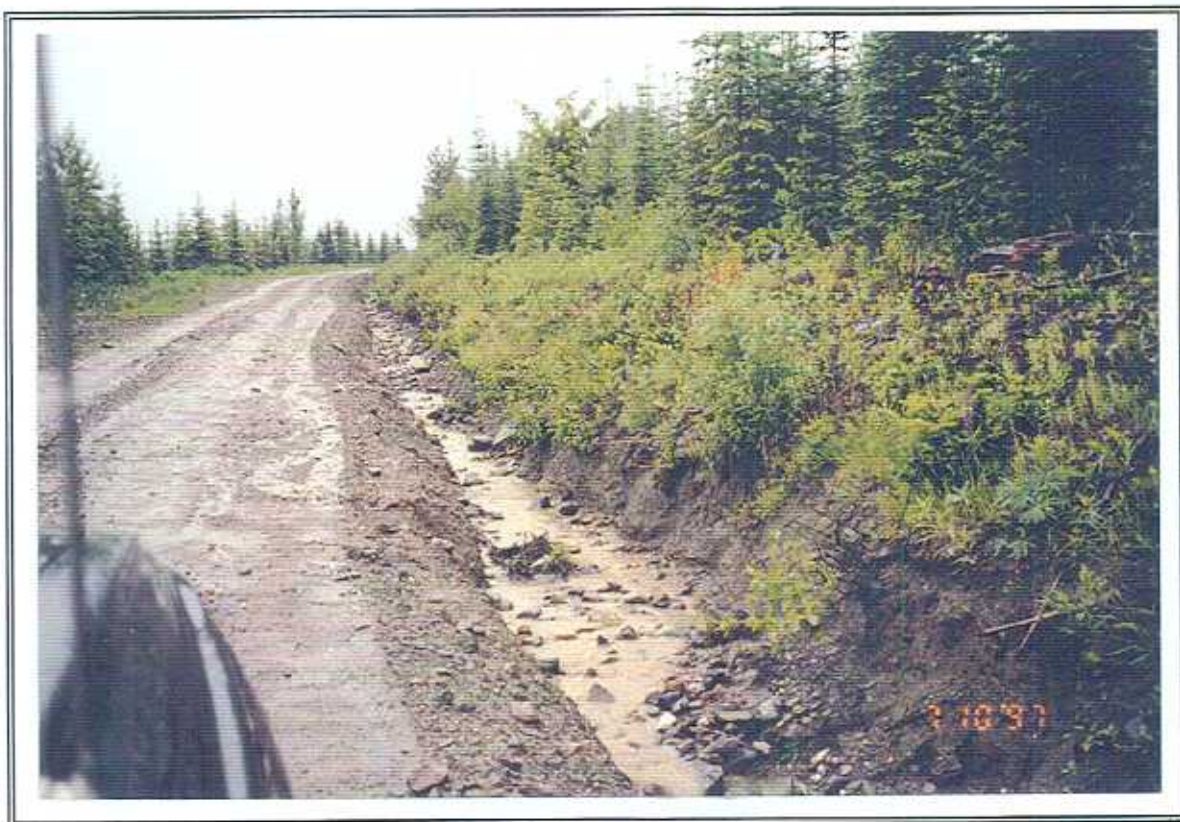
PHOTO K12. Incised ditch line on mainline road leading into upper Snowshoe and Little Snowshoe basins [Site K7].

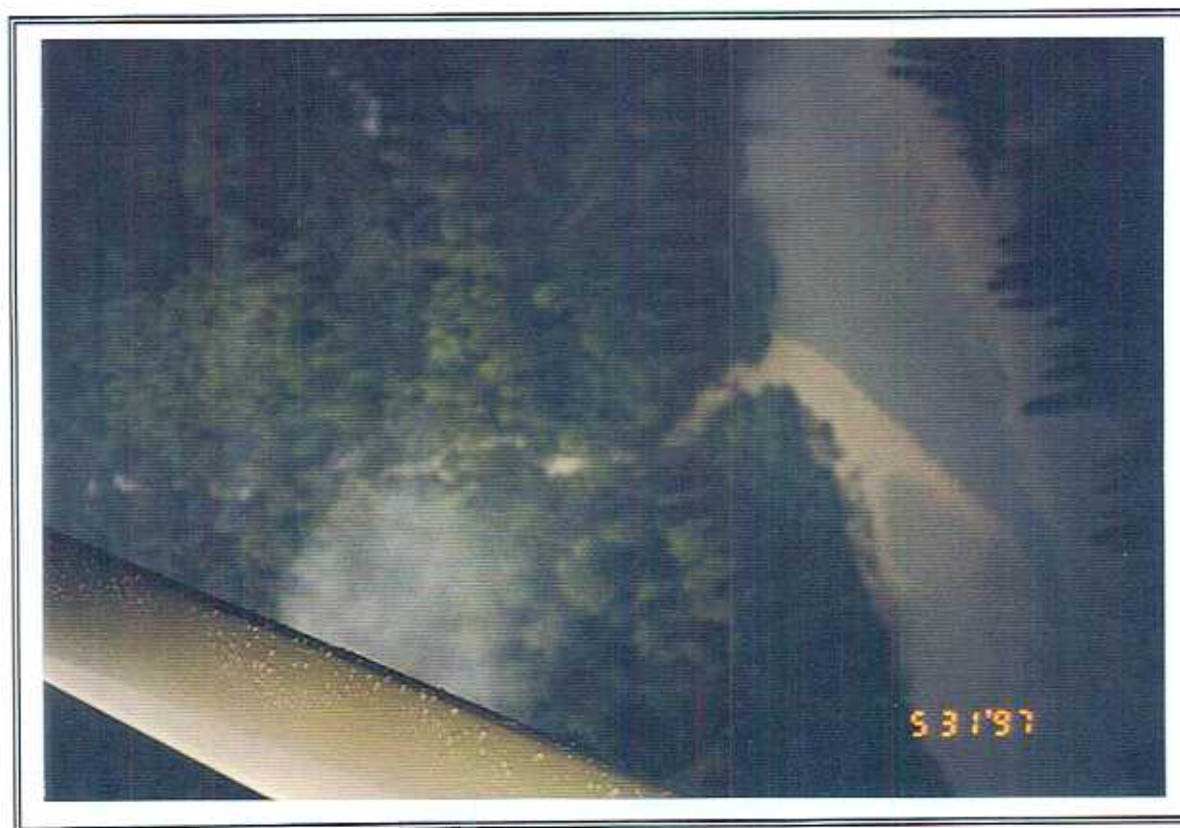
PHOTO H1. Sediment plume from Harveys Creek into Cariboo River during freshet [Site H1].

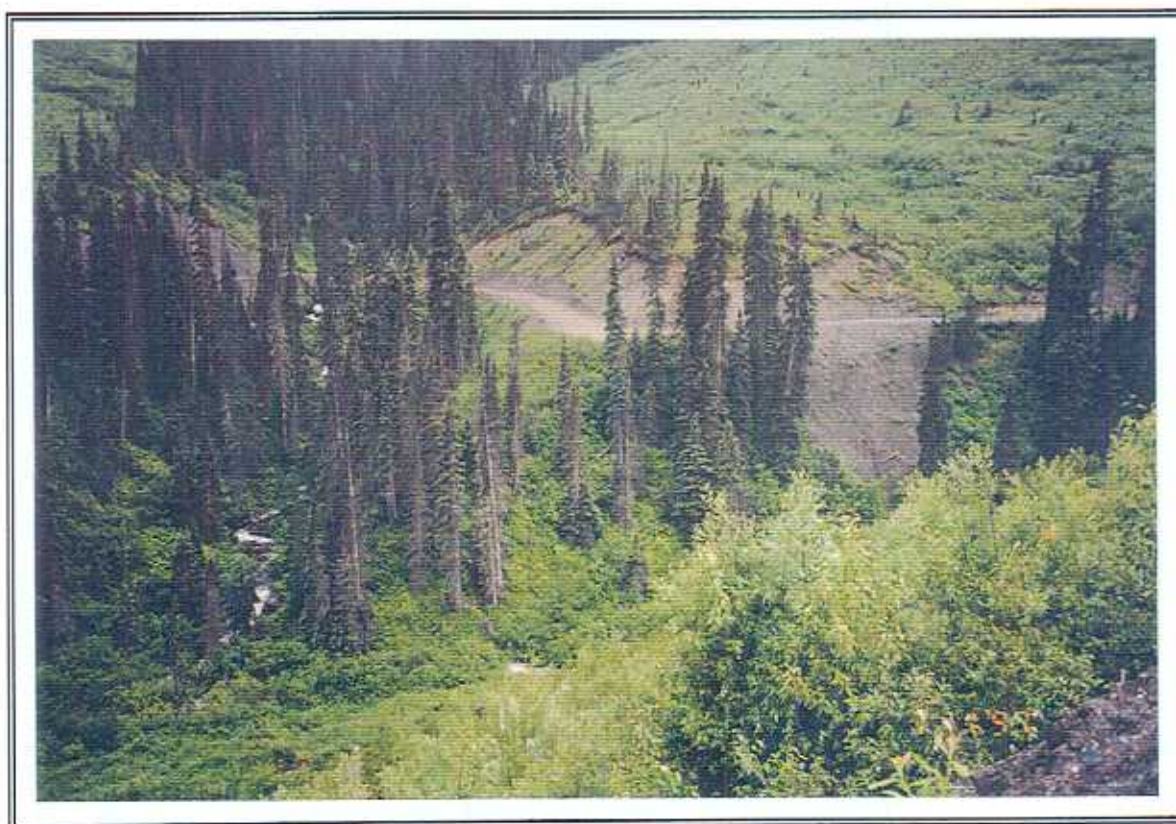
PHOTO H3. Hillslope failure from mainline road into Harveys Creek and exposed soil sites at stream crossing location [Site H2].

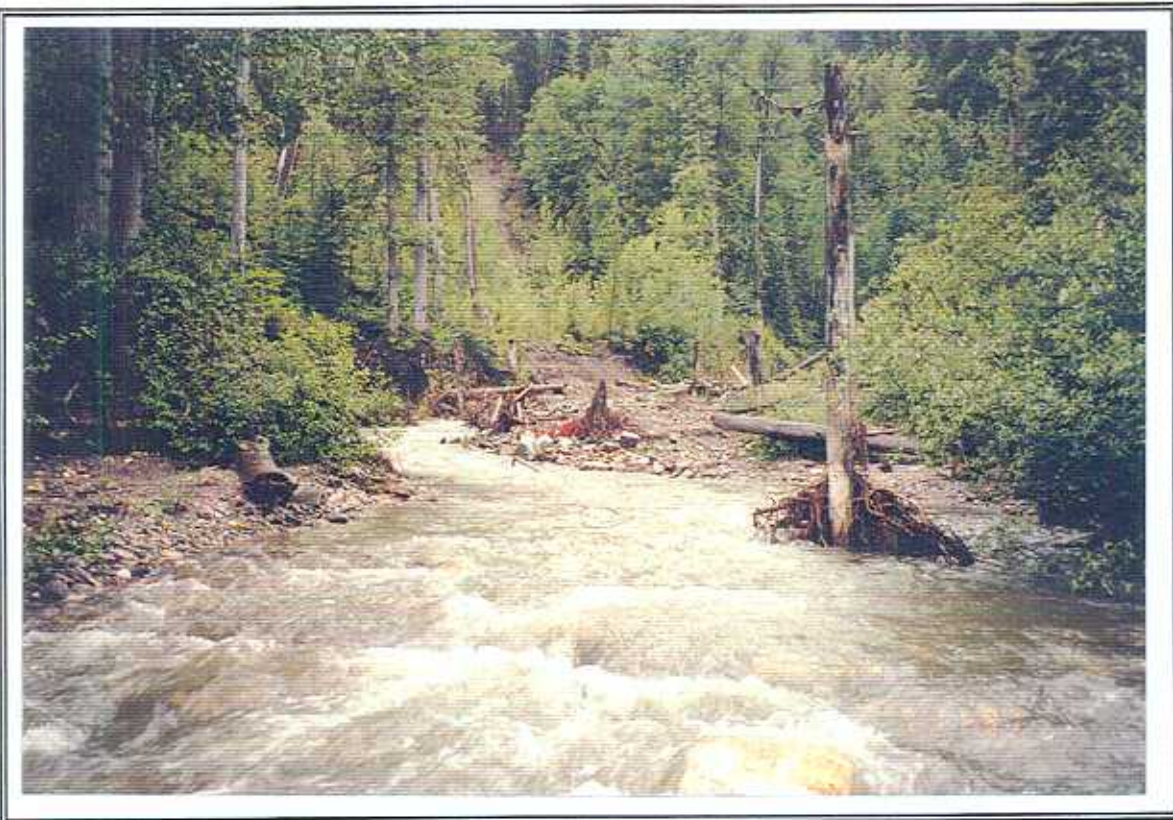
PHOTO H4. Unstable channel on Harveys Creek alluvial fan showing recent widening and aggradation - upstream [Site H1].

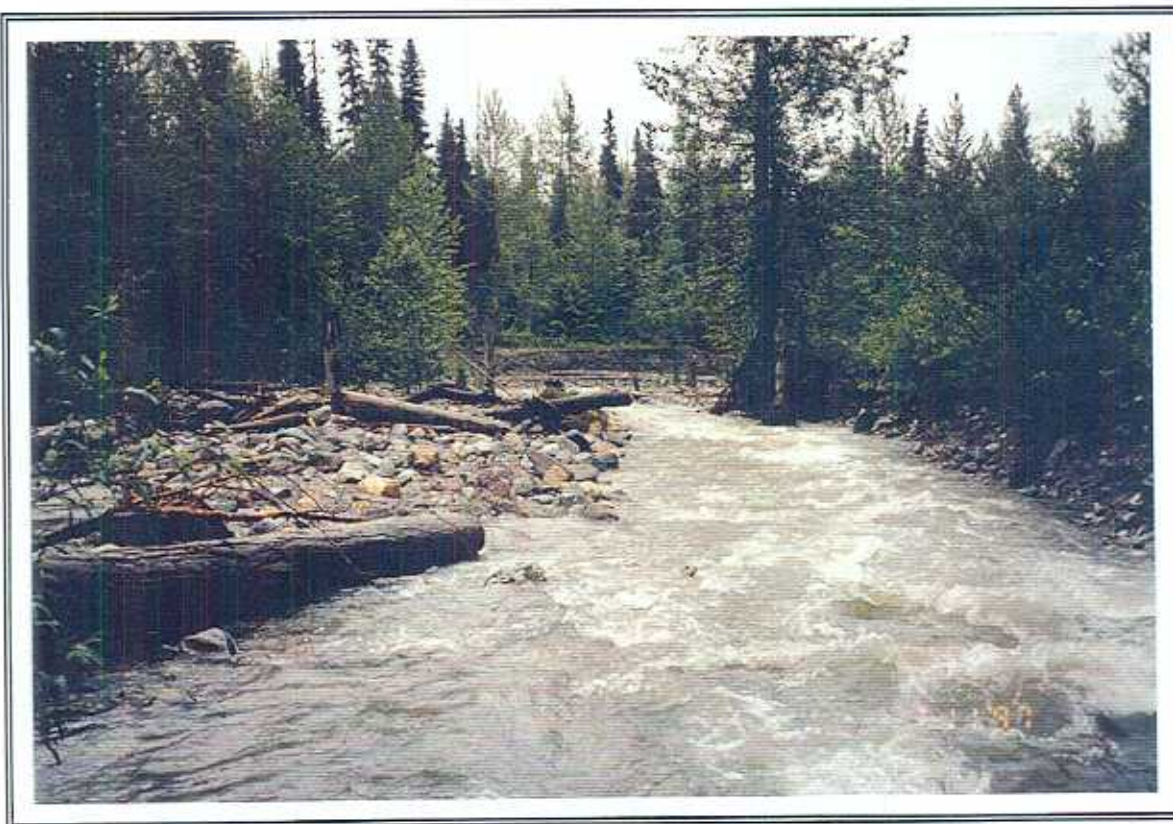
PHOTO H5. Harveys Creek at alluvial fan apex showing recent bank erosion and logging debris in the channel - downstream [Site H1].
