**An Inventory of Watershed Conditions
Affecting Risks to Fish Habitat
in the
CARIBOO, COTTONWOOD & HORSEFLY
WATERSHEDS**

VOLUME I
Cariboo River Watershed
(Sections 1 to 5 & 6)

Prepared for
CARIBOO REGION INTERAGENCY MANAGEMENT COMMITTEE
Williams Lake, BC

by
CHAPMAN GEOSCIENCE LTD.
Nanaimo, BC
&
DOBSON ENGINEERING LTD.
Kelowna, BC

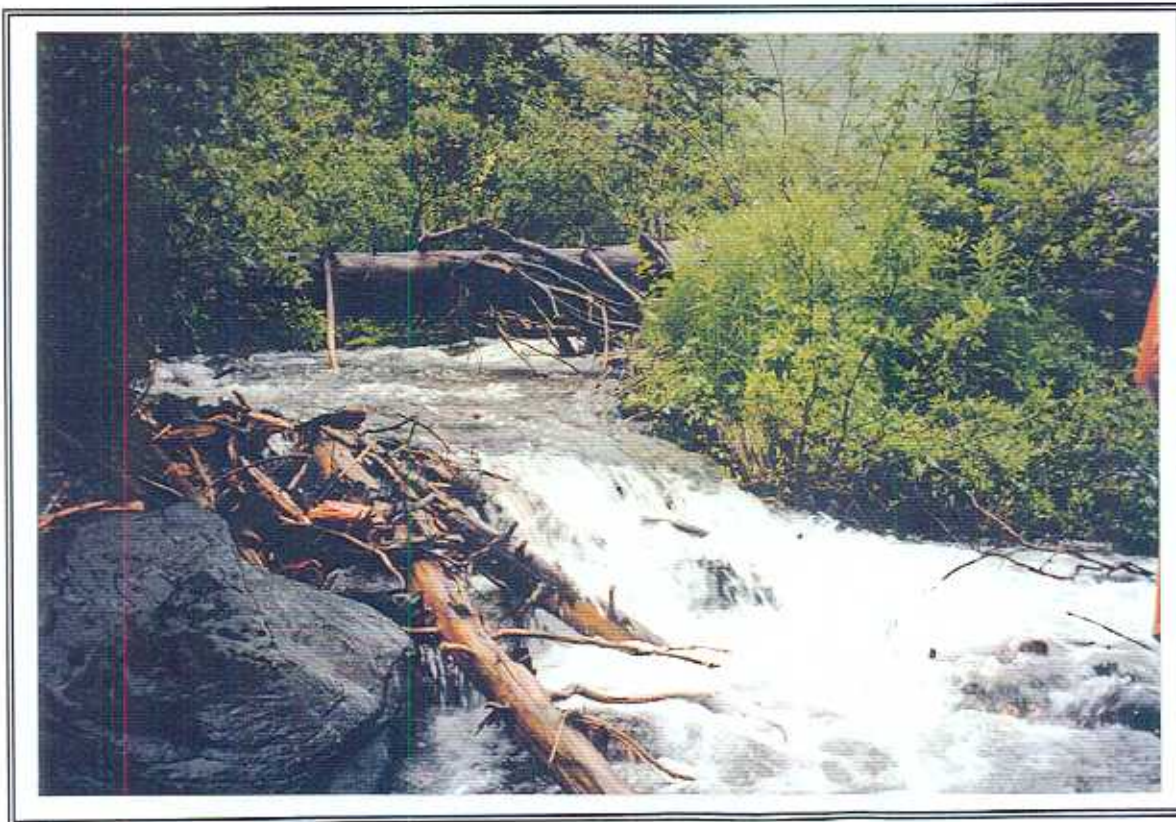
PHOTO H7. Small woody debris accumulations in upper Simlock Creek introduced during pre-FPC harvesting in the riparian zone - upstream [Site H5].

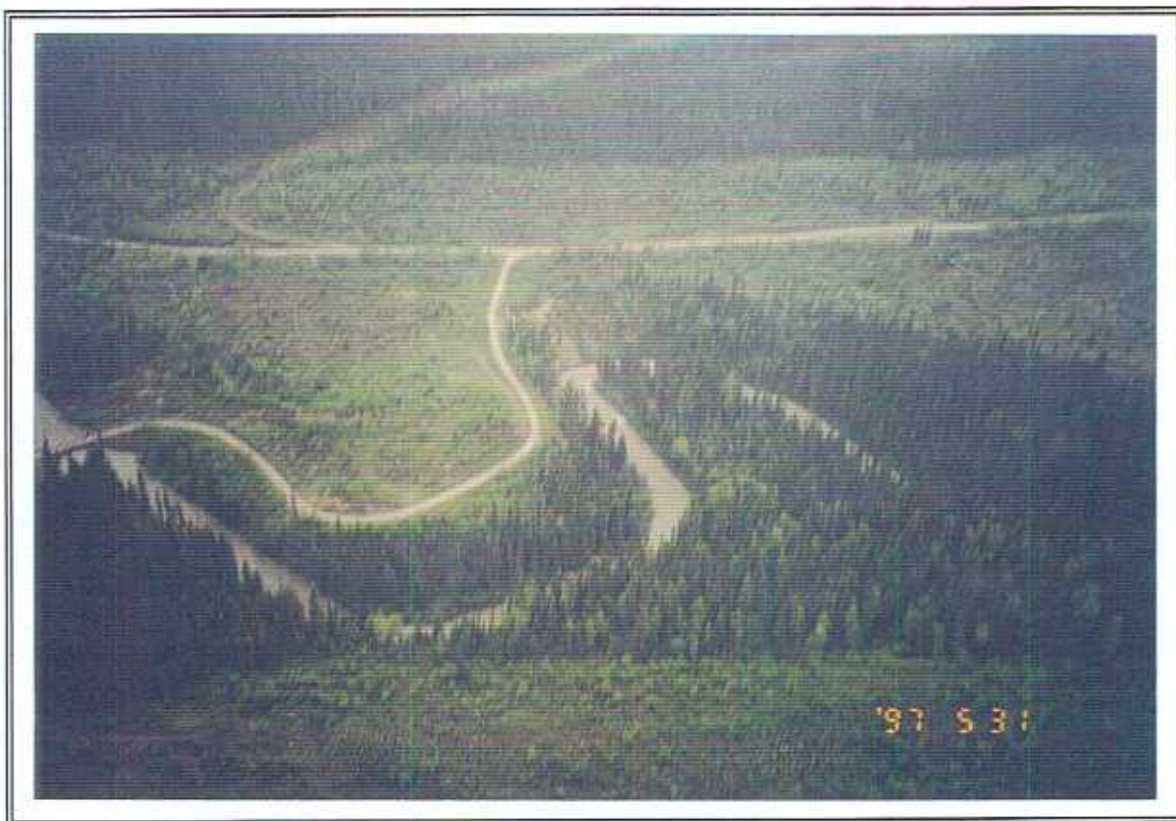
PHOTO L1. Bank failures into lower Little River below harvesting boundary [Site L4].

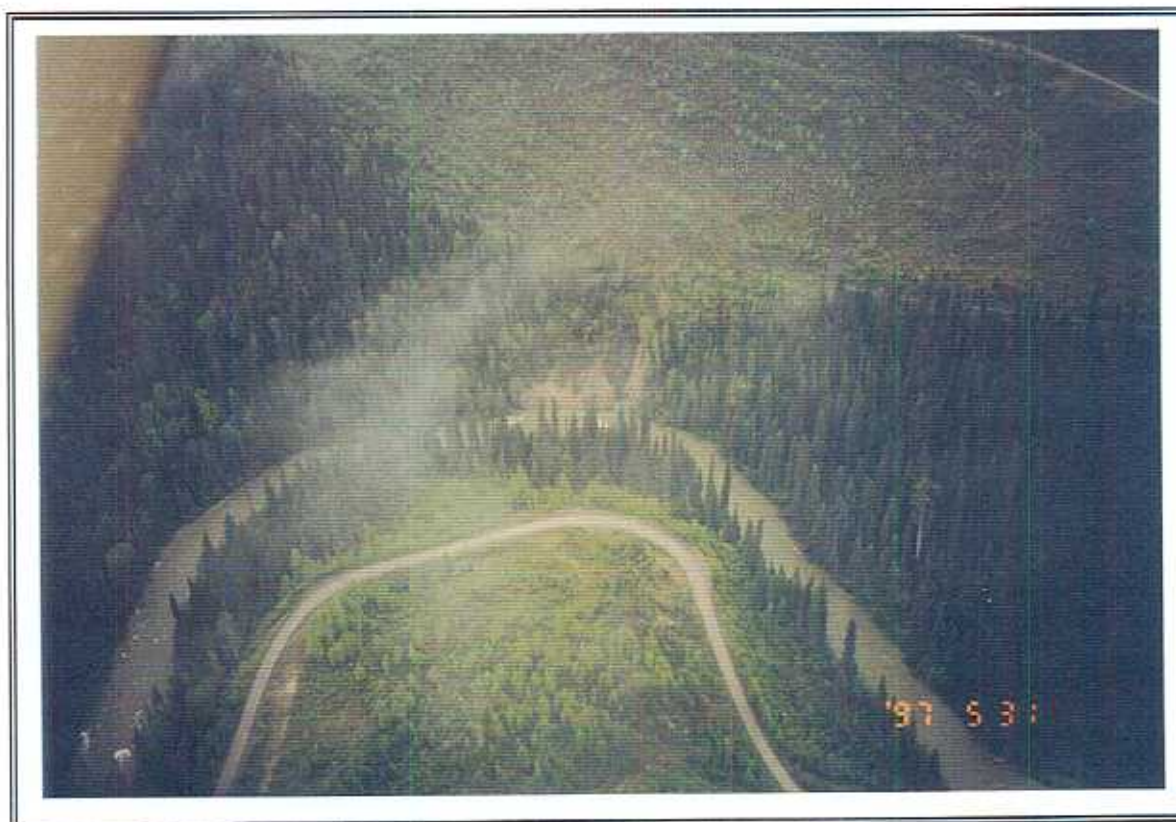
PHOTO L2. Bank failure into lower Little River on outside of meander bend below harvesting boundary [Site L5].

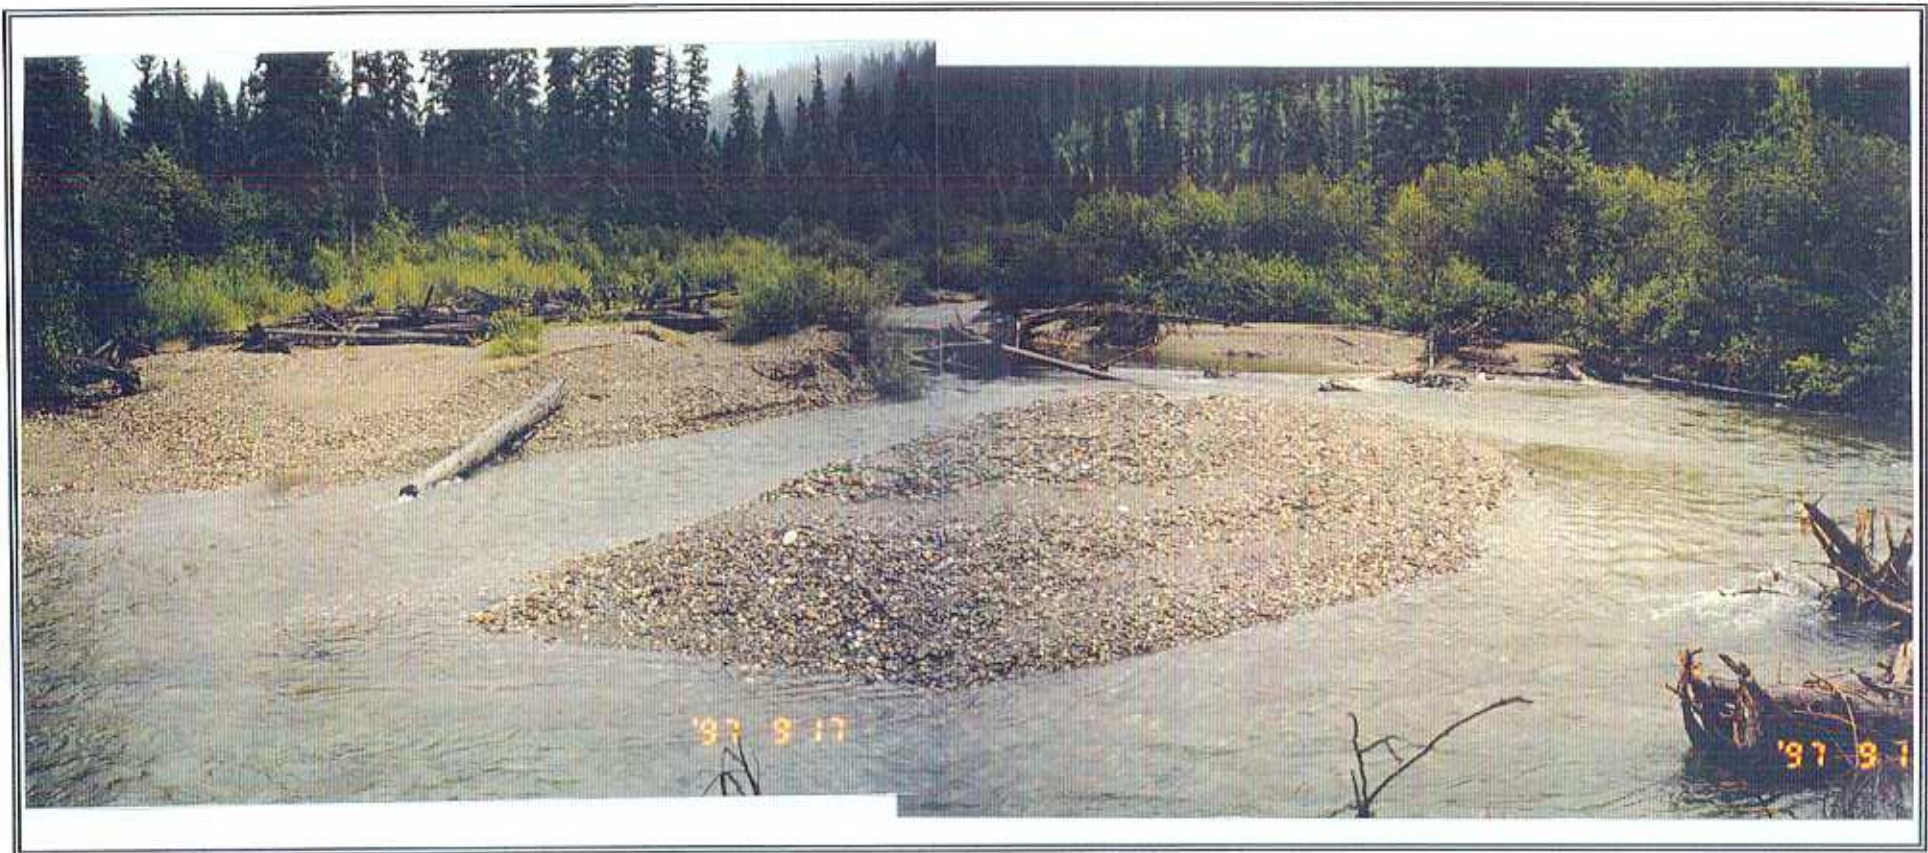
PHOTO L3-4. Lower Little River above alluvial fan showing elevated gravel and sand bar deposits and multiple channels - upstream [Site L2].

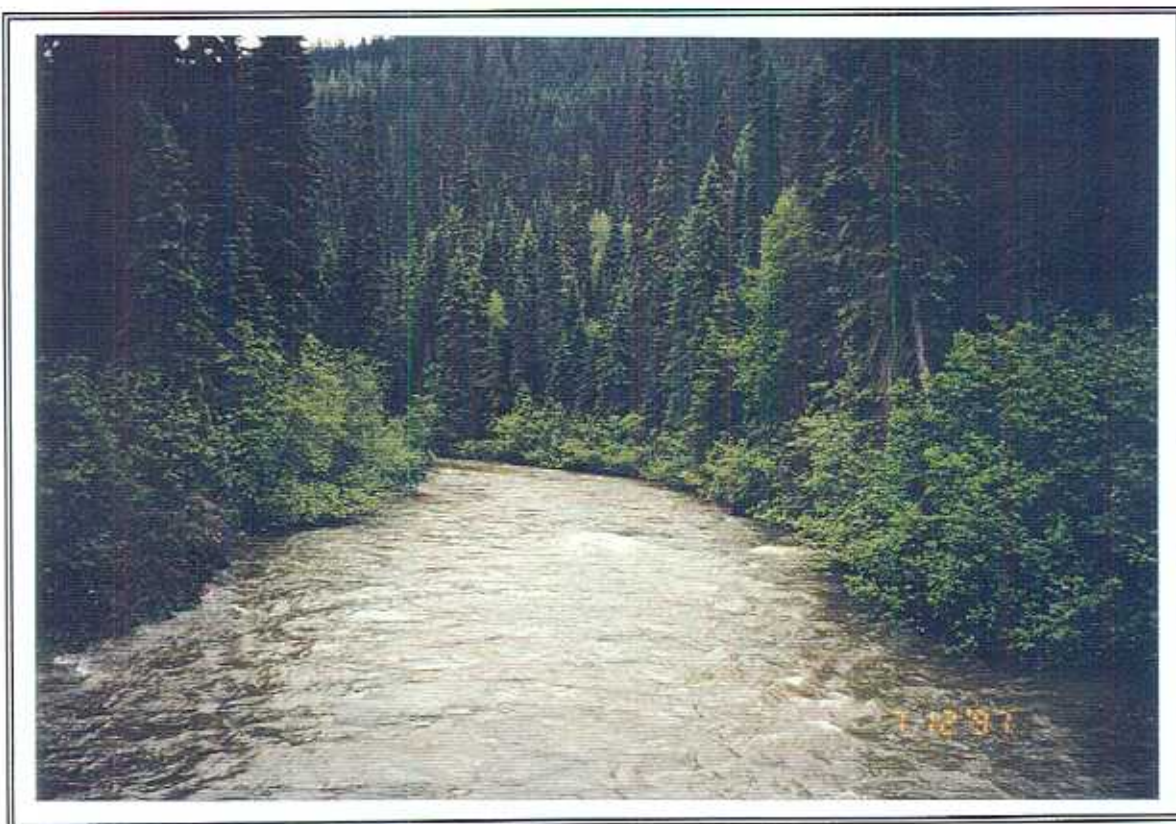
PHOTO L6. Turbid flow during field inventory on Lower Little River - upstream [Site L3].

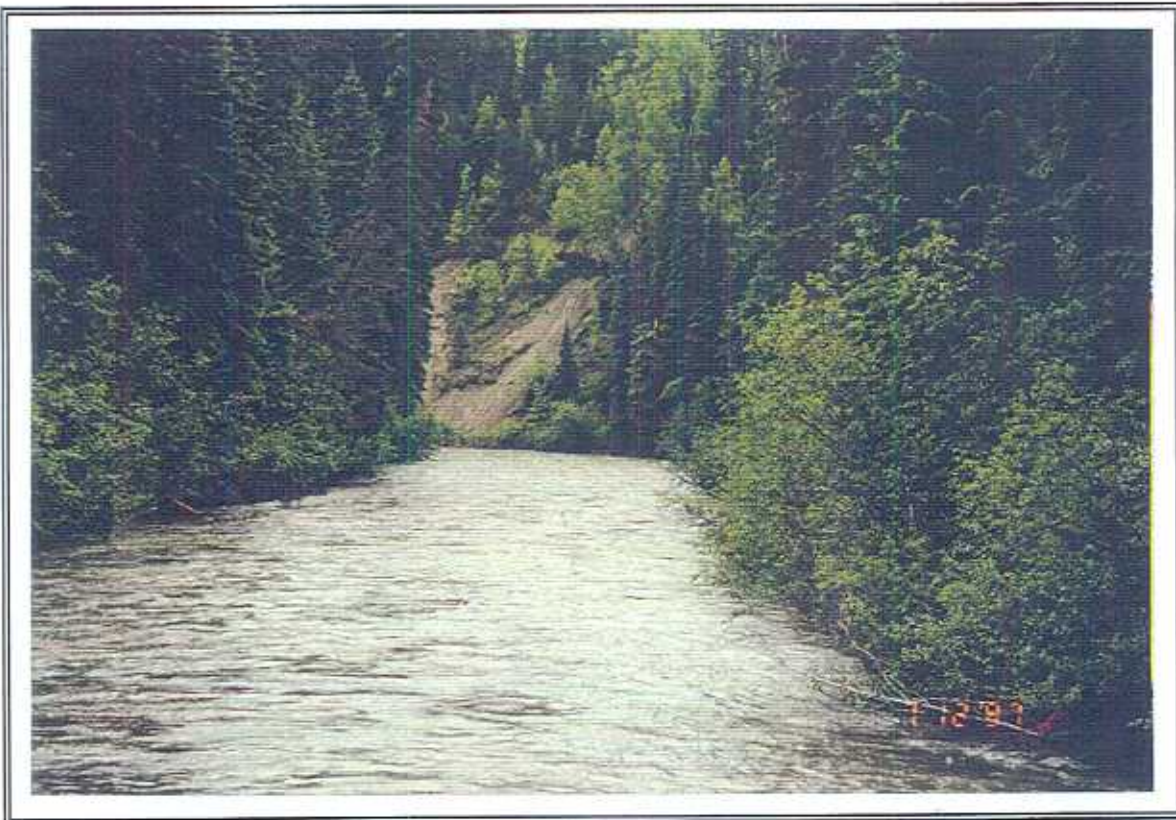
PHOTO L7. Large bank failure below harvesting boundary into lower Little River - downstream [Site L3].

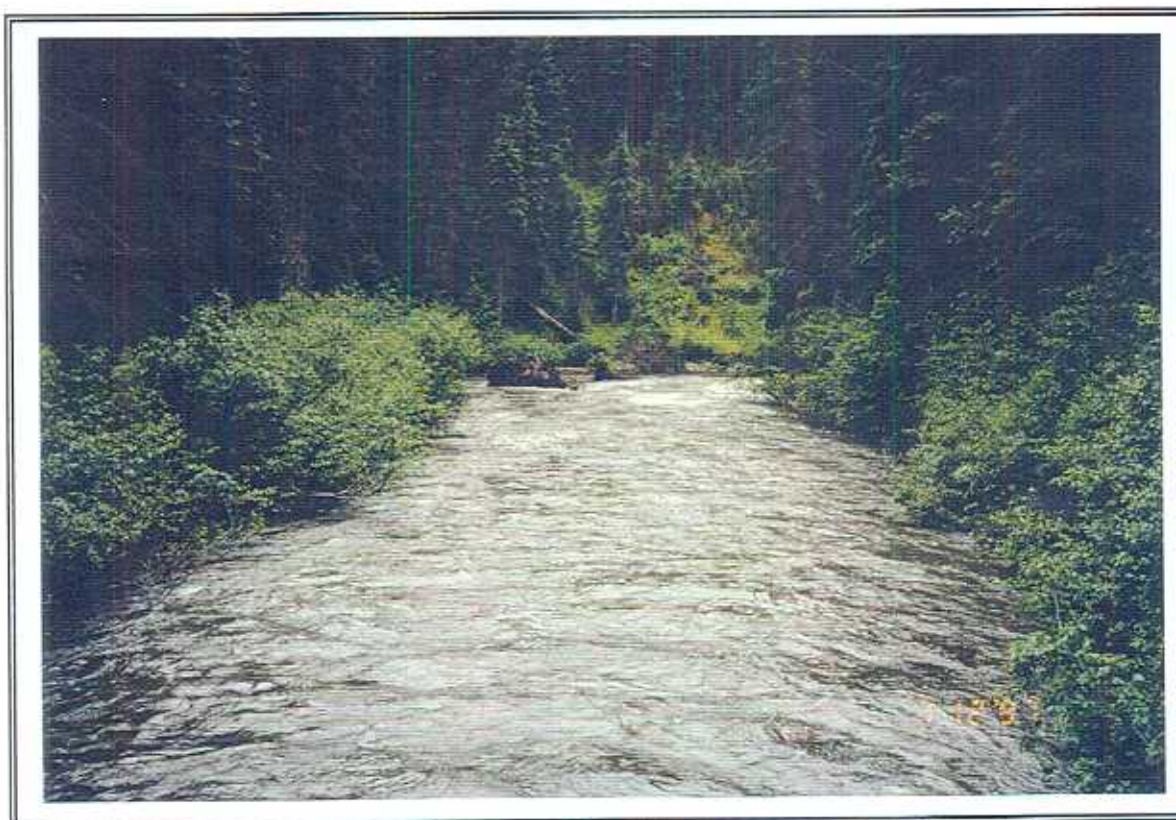
PHOTO L8. Freshly eroded banks and natural large woody debris input to the lower Little River - upstream [Site L6].

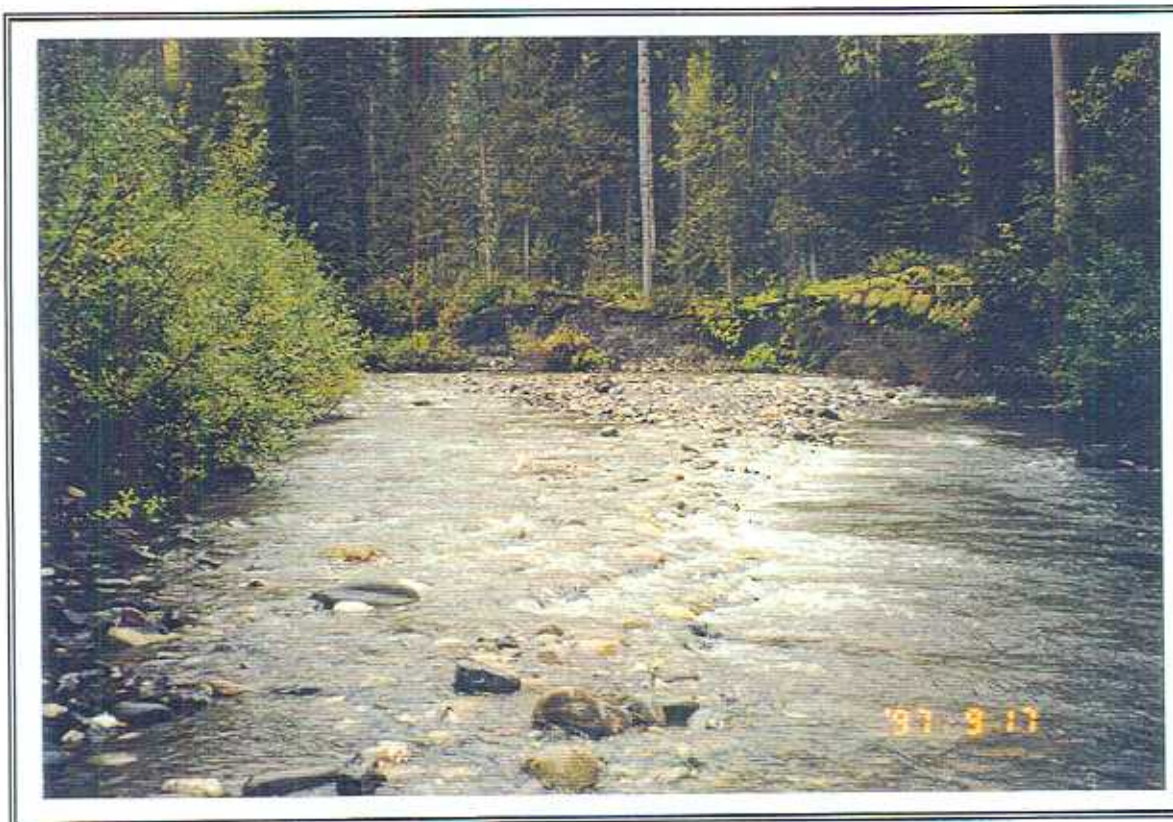
PHOTO CN1. Lower Cunningham Creek on the alluvial fan showing aggradation and bank erosion - upstream [Site C1].

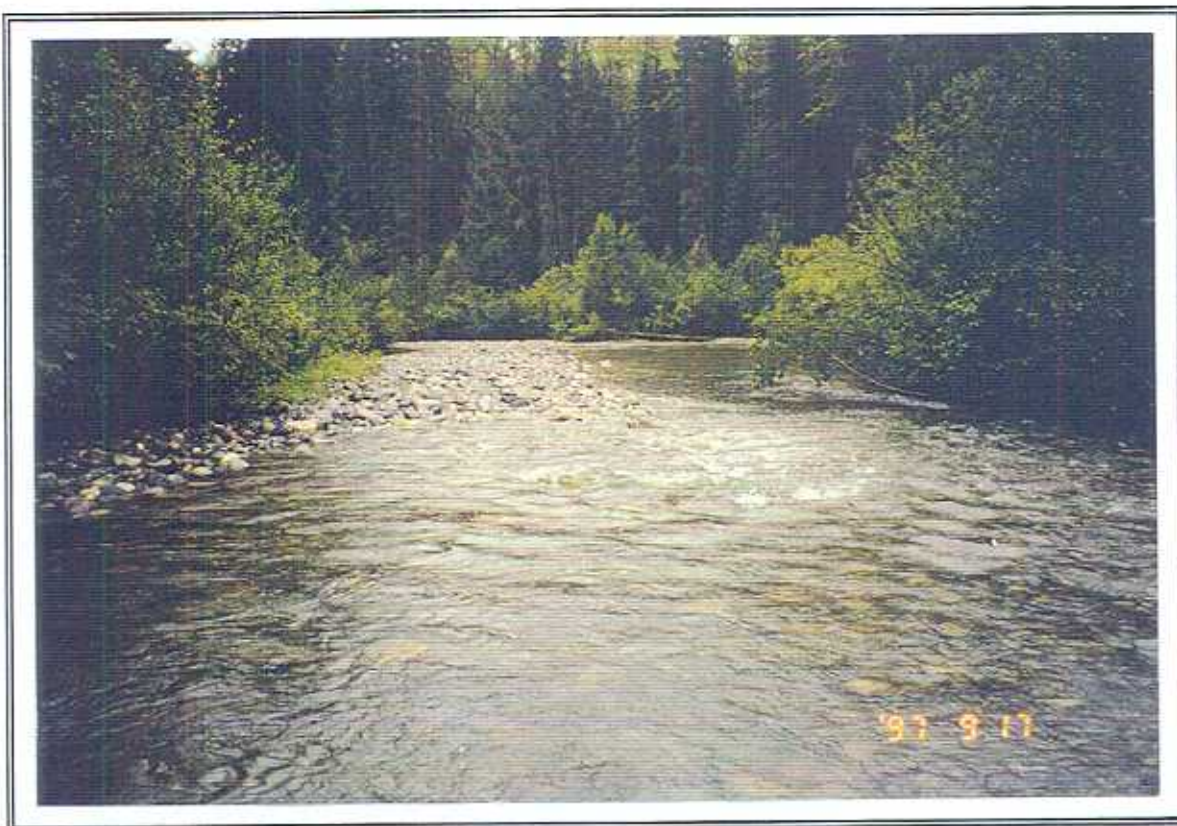
PHOTO CN2. Cunningham Creek on the alluvial fan showing bar formation - downstream [Site C1].

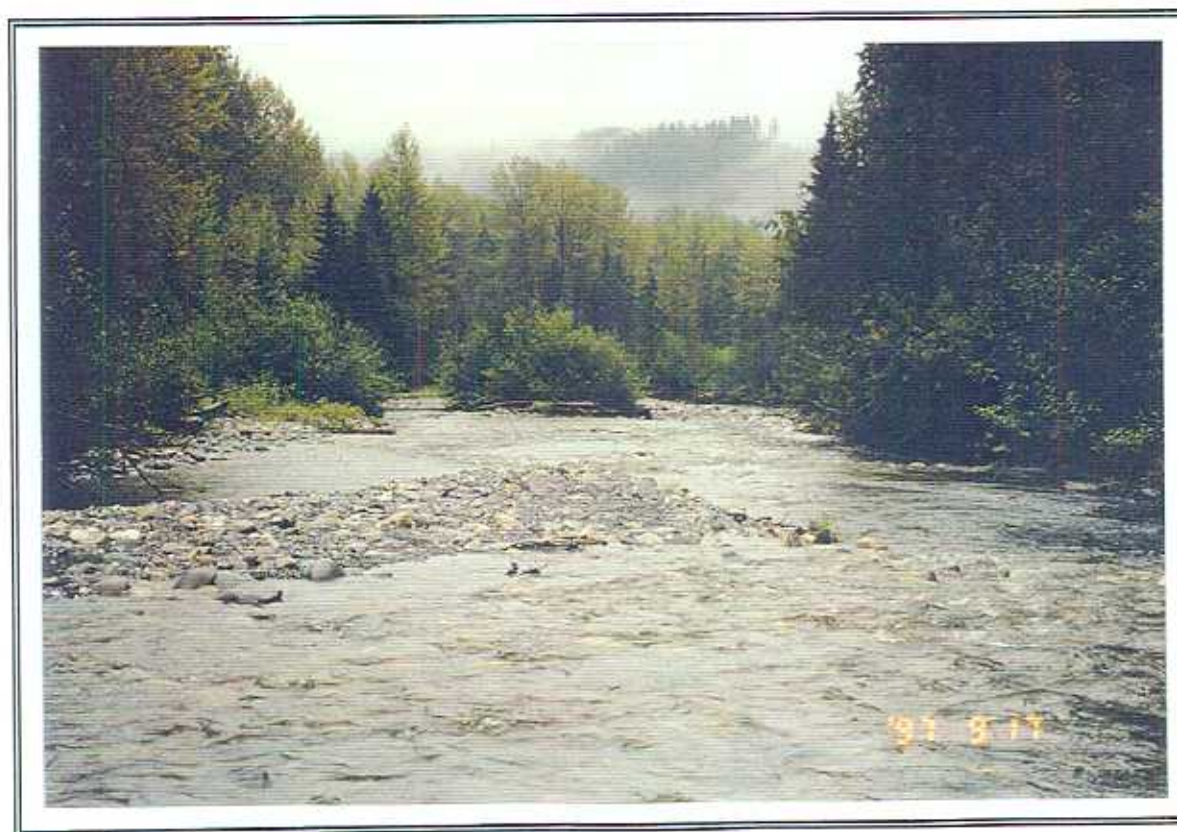
PHOTO CN3. Multiple channels and channel widening on the Cunningham Creek alluvial fan - downstream [Site C1].

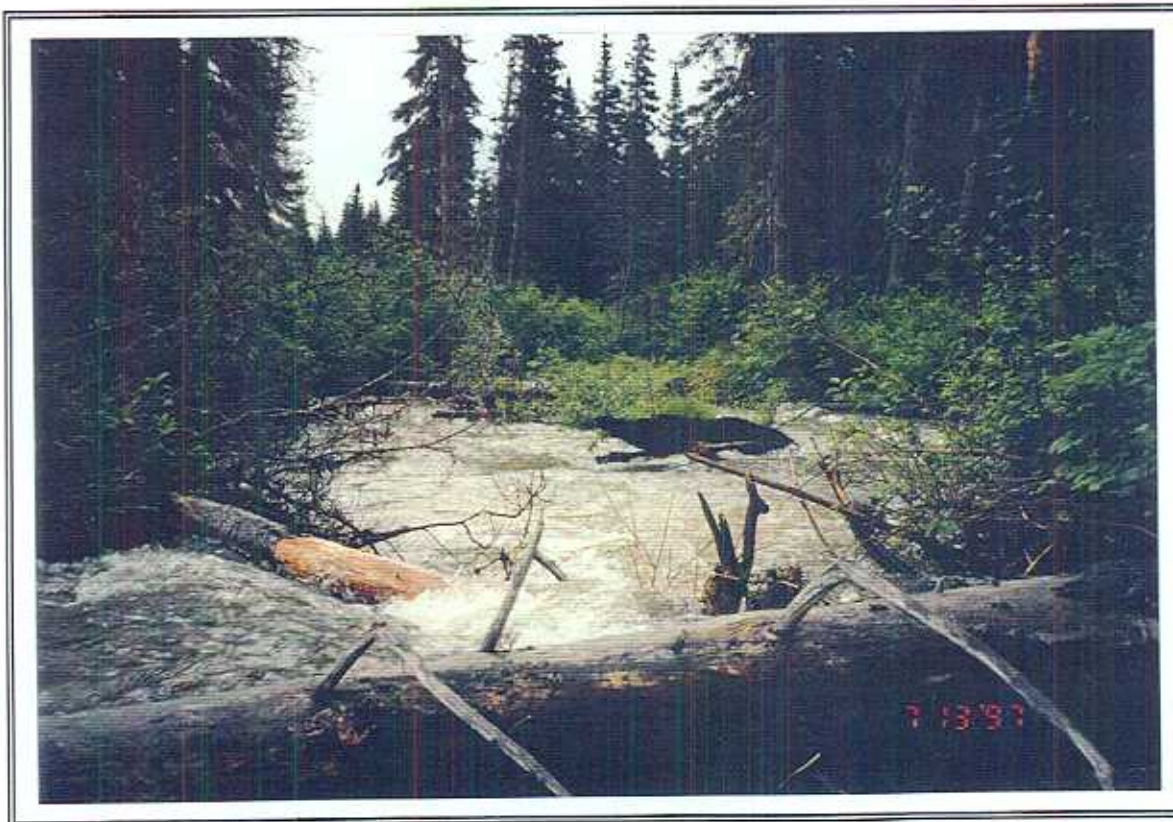
PHOTO CN5. Increased large and small woody debris from pre-FPC harvesting in the riparian zone of Tisdale Creek - downstream [Site C3].

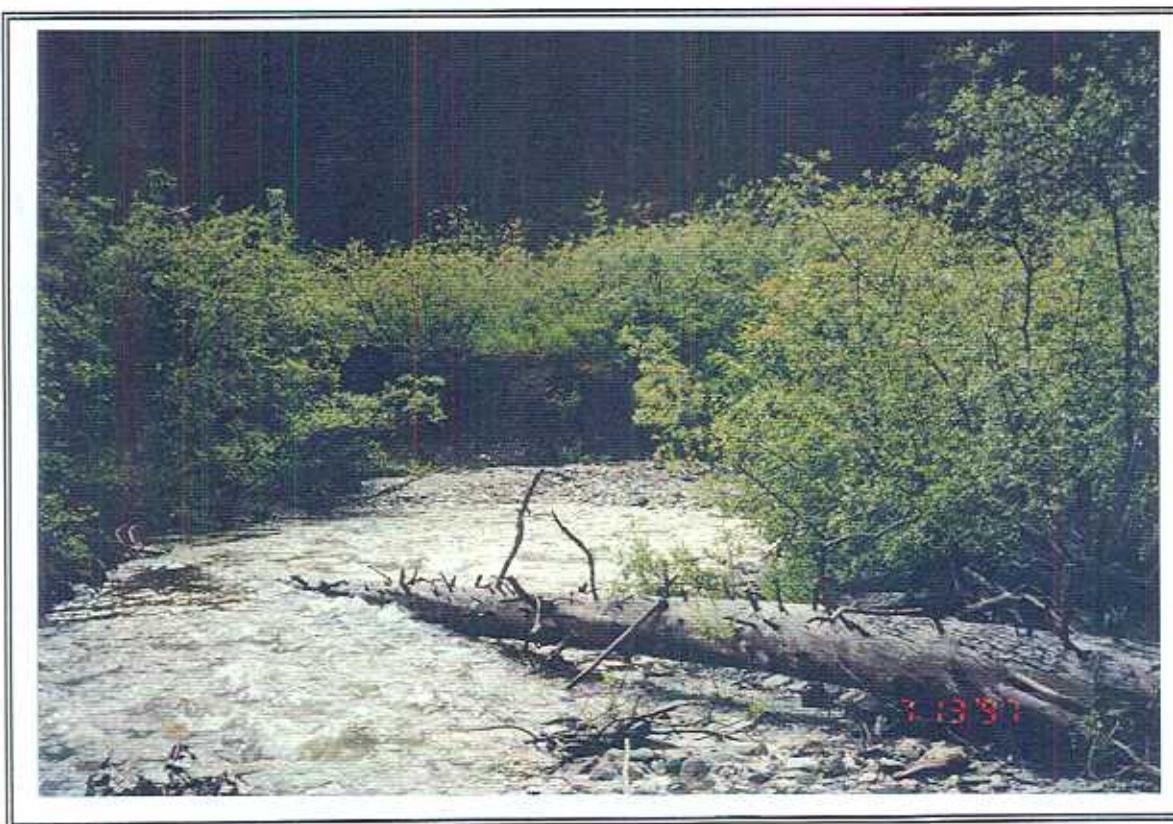
PHOTO CN7. Bank erosion in placer mined floodplain materials in upper Cunninham Creek - downstream [Site C8].

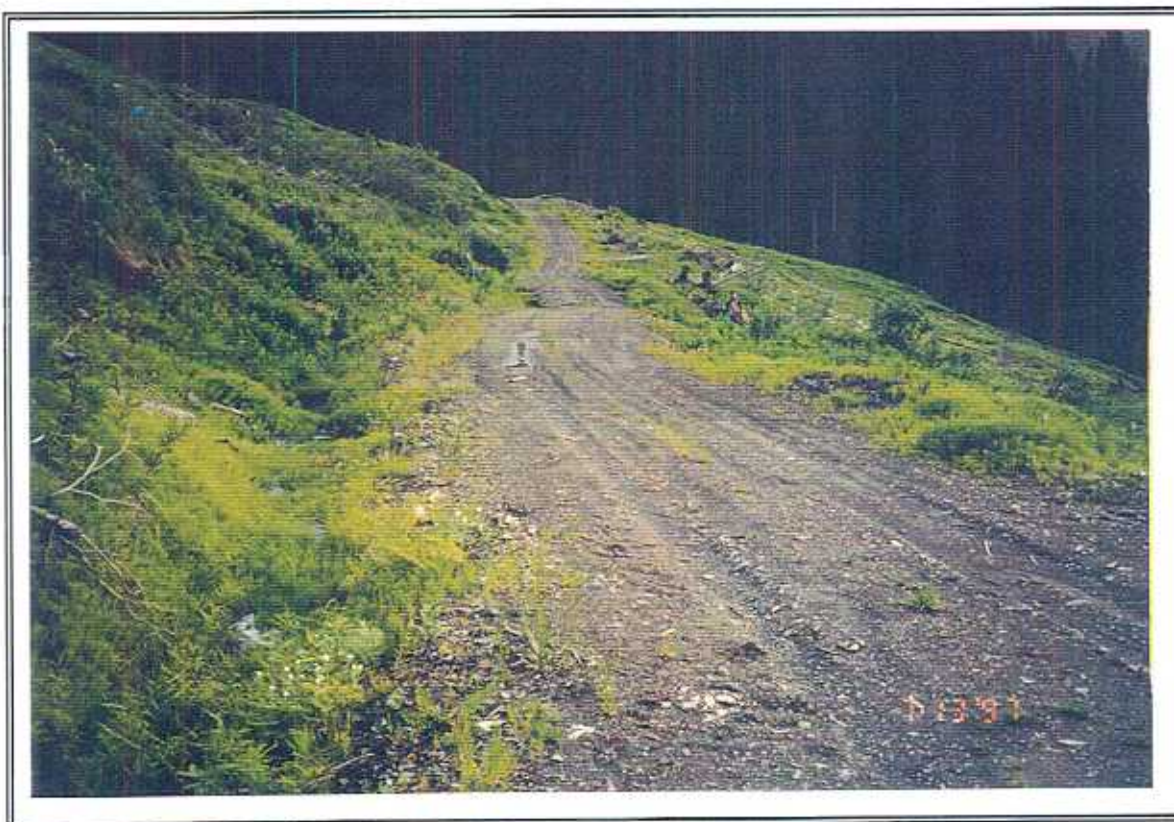
PHOTO CN9. Ruts in fine textured pre-FPC road surface in the middle watershed [Site C4].

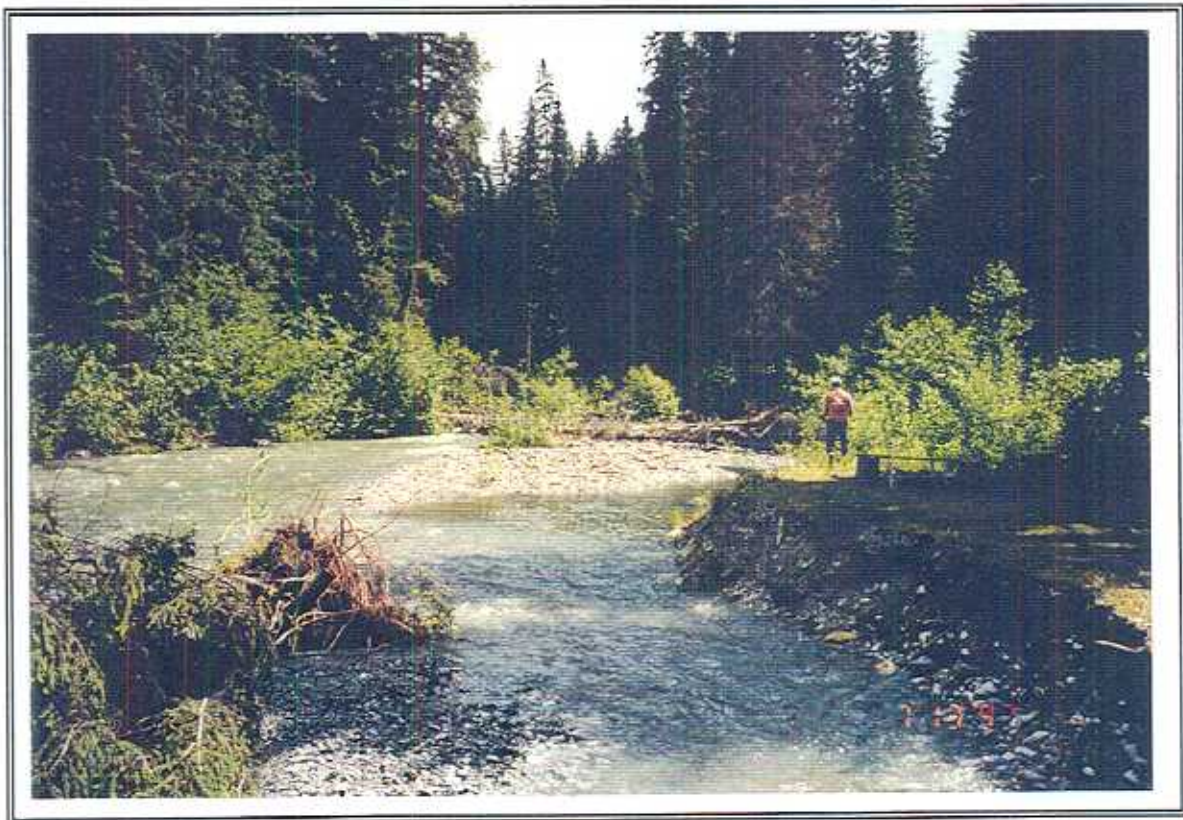
PHOTO KB1. Recent channel disturbance on the Kimball Creek alluvial fan - upstream [Site Kim1].

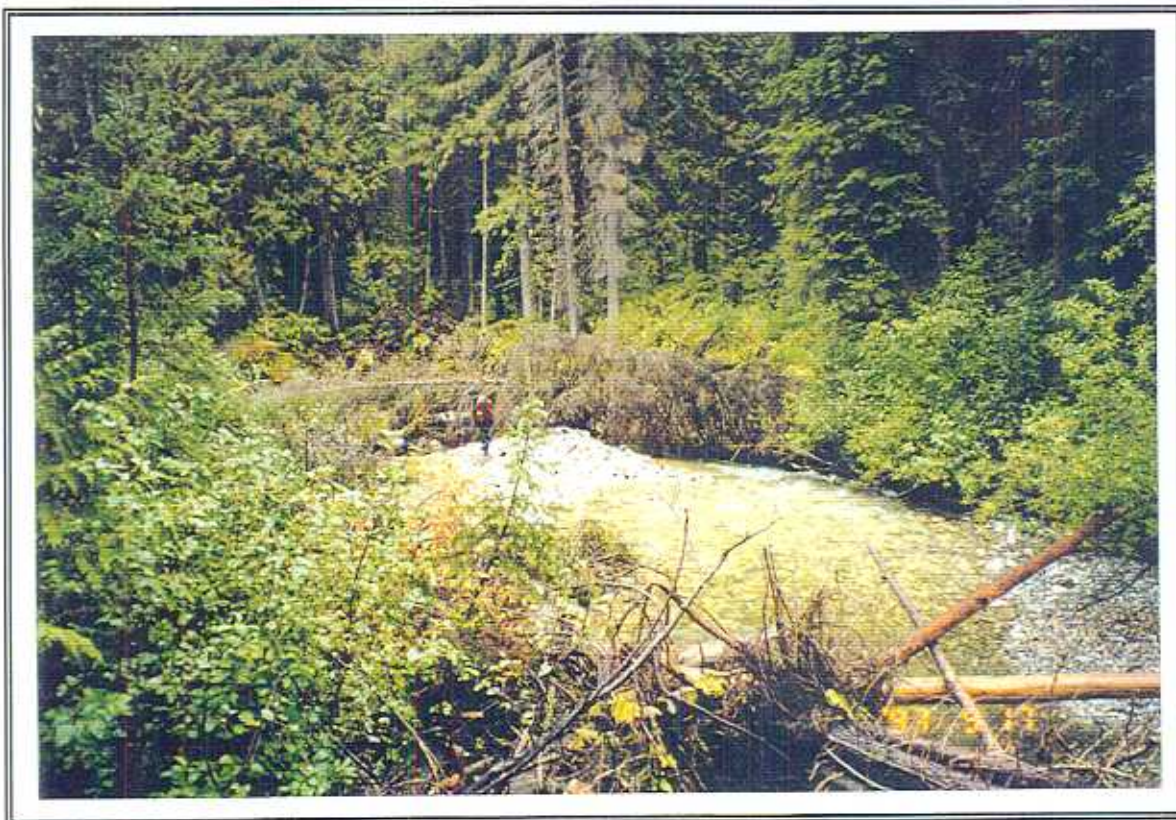
PHOTO KB3. Bank erosion and large increase in woody debris input to lower Kimball Creek [Site Kim1].

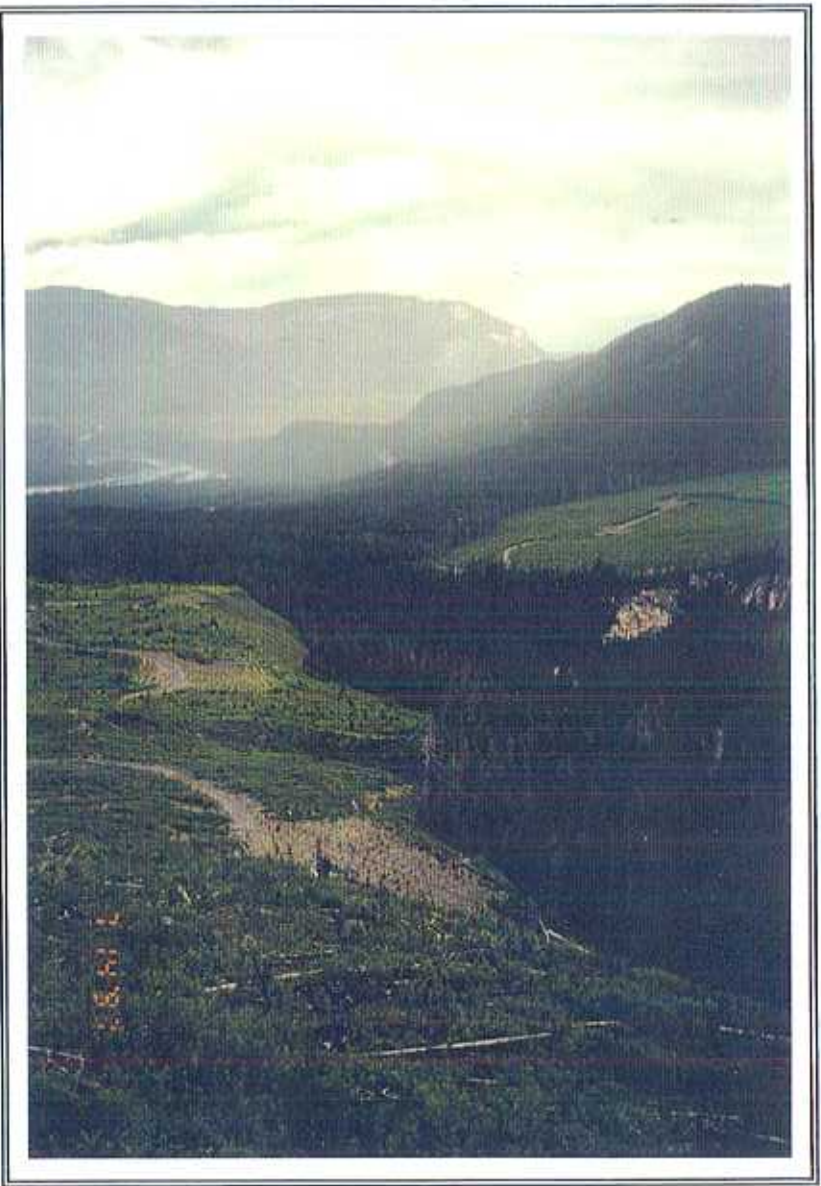
PHOTO KB8. Pre-FPC landings and harvesting to the break in slope above Kimball Creek [Site Kim5].

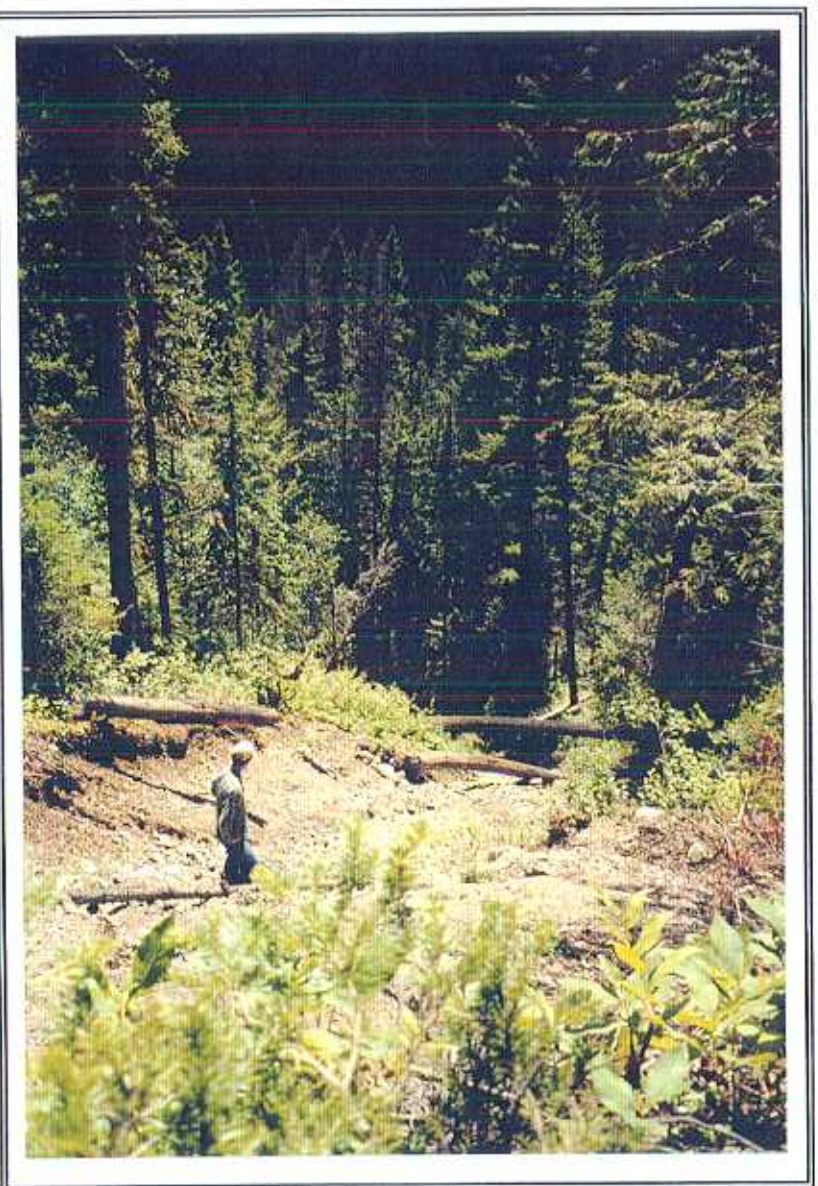
Forest development related landslides were observed in the Kimball Creek and Sellers Creek watersheds. Some failures were the result of the location of cutblocks along the break in slope of large glacio-fluvial outwash deposit along the incised river valley. Some were the result of blowdown, and at least one failure was initiated by ditch line runoff that had been directed onto a steep hillslope.

PHOTO KB9. Landslide initiated by ditchflow concentration and diversion across a landing onto the steep slope above Kimball Creek. Direct sediment delivery to the channel [Site Kim4].

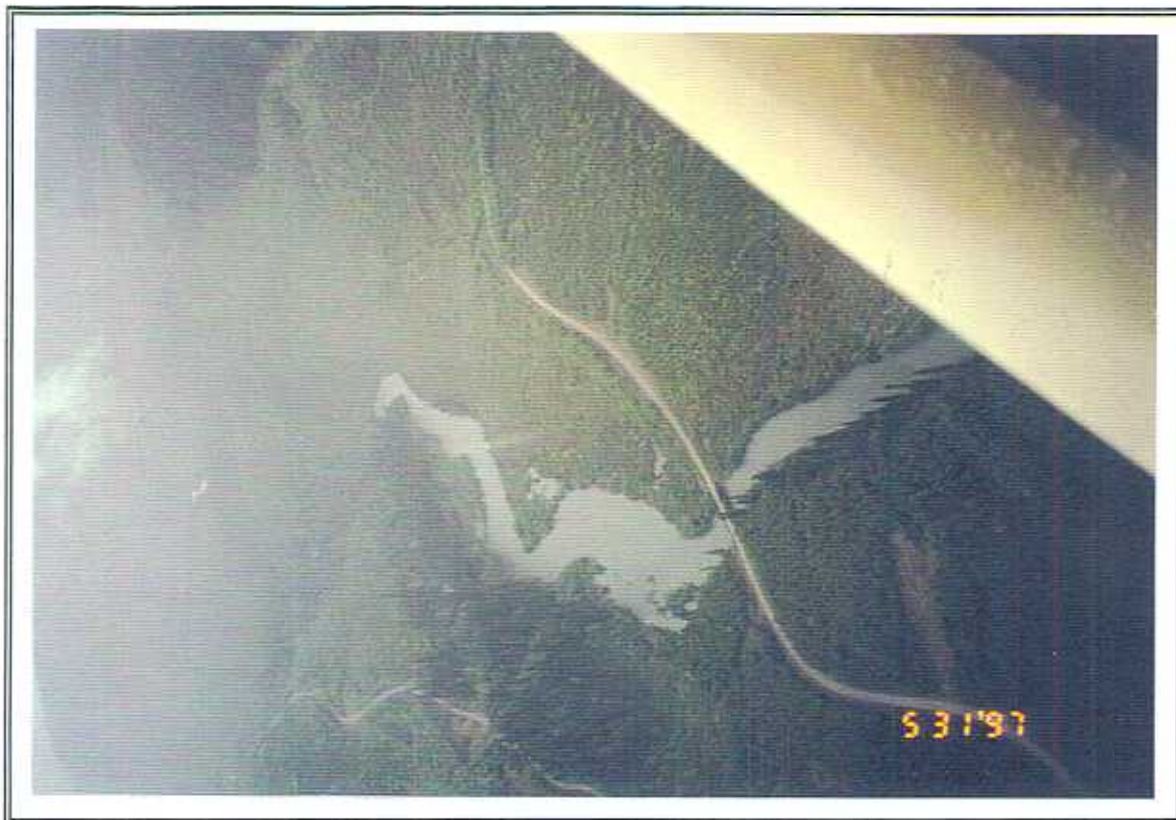
PHOTO M1. Extensive riparian harvesting along the lower mainstem channel of the Matthew River [Site M1].

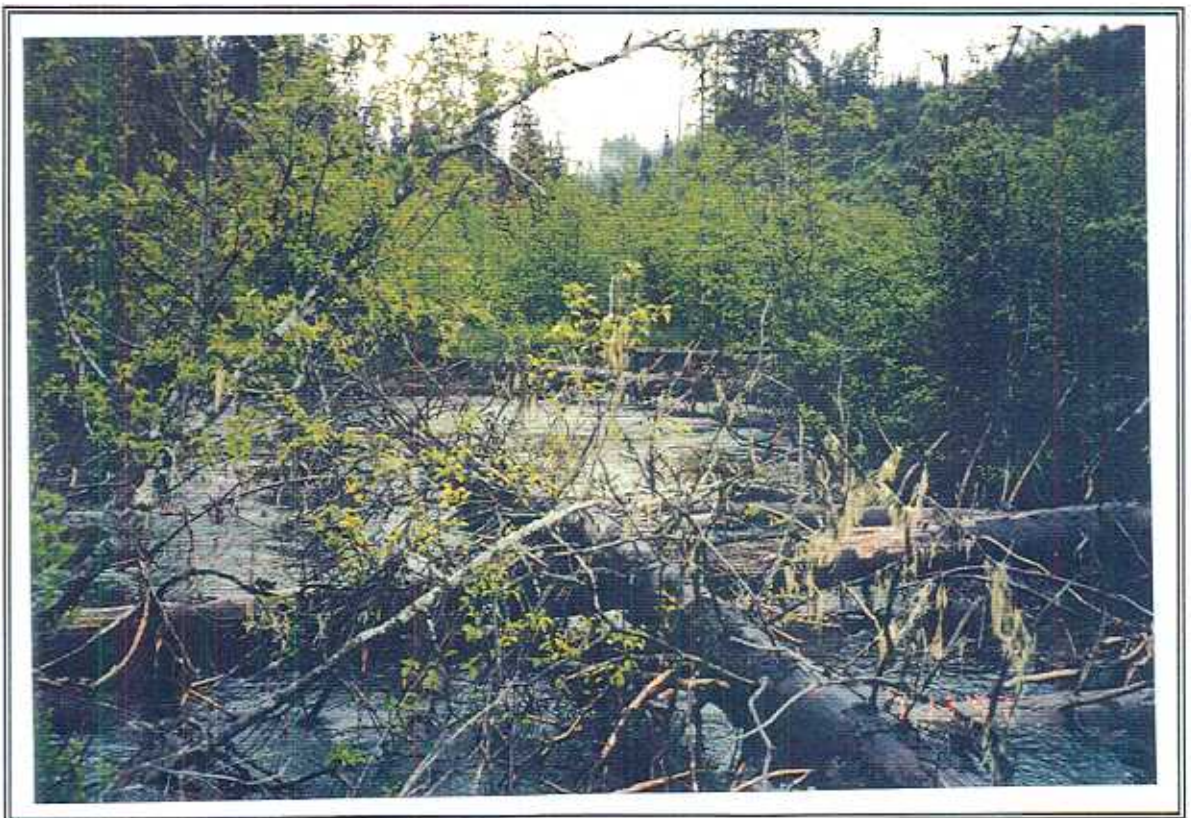
PHOTO M4. Lower Connection Creek with a large woody debris increase from blowdown in the riparian zone - upstream [Site M4].

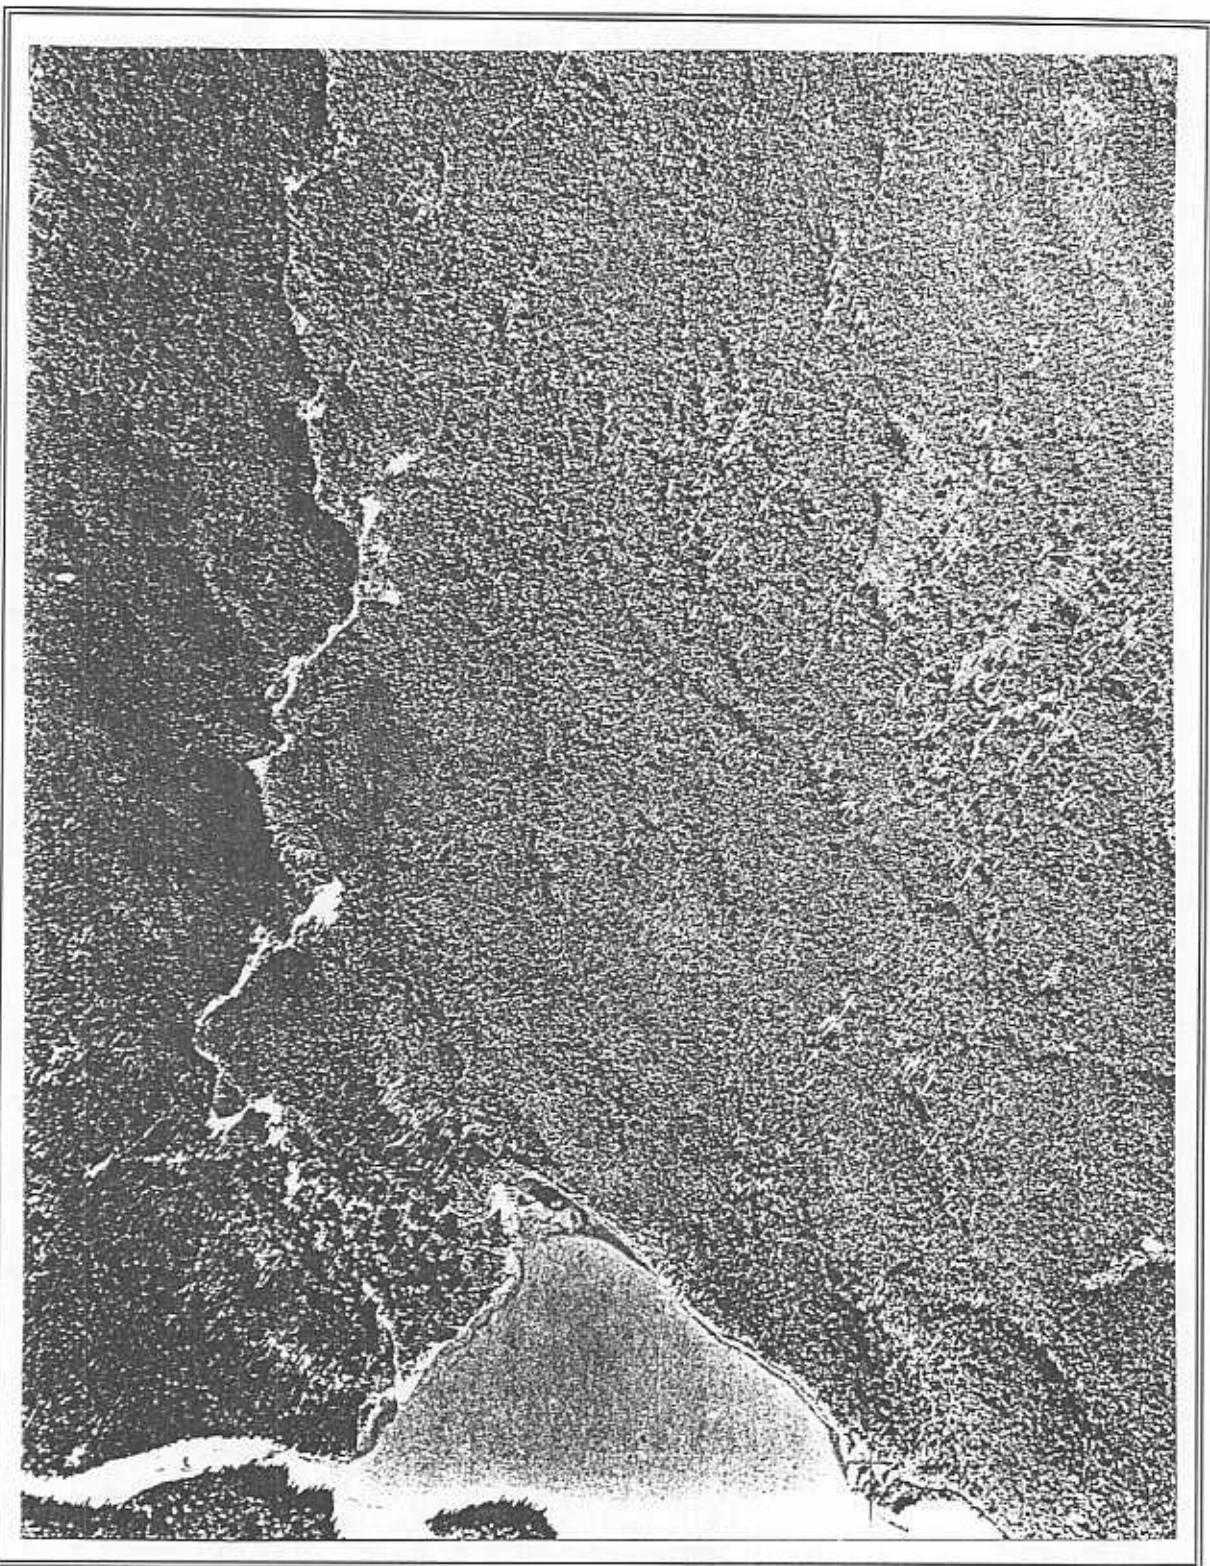
1955 - Lower Rollie Creek and the Rollie Creek alluvial fan showing actively eroding placer mining scars, and channel bar development immediately above the alluvial fan [BC2342:20].
