**An Inventory of Watershed Conditions
Affecting Risks to Fish Habitat
in the
CARIBOO, COTTONWOOD & HORSEFLY
WATERSHEDS**

VOLUME I
Cariboo River Watershed
(Sections 1 to 5 & 6)

Prepared for
CARIBOO REGION INTERAGENCY MANAGEMENT COMMITTEE
Williams Lake, BC

by
CHAPMAN GEOSCIENCE LTD.
Nanaimo, BC
&
DOBSON ENGINEERING LTD.
Kelowna, BC

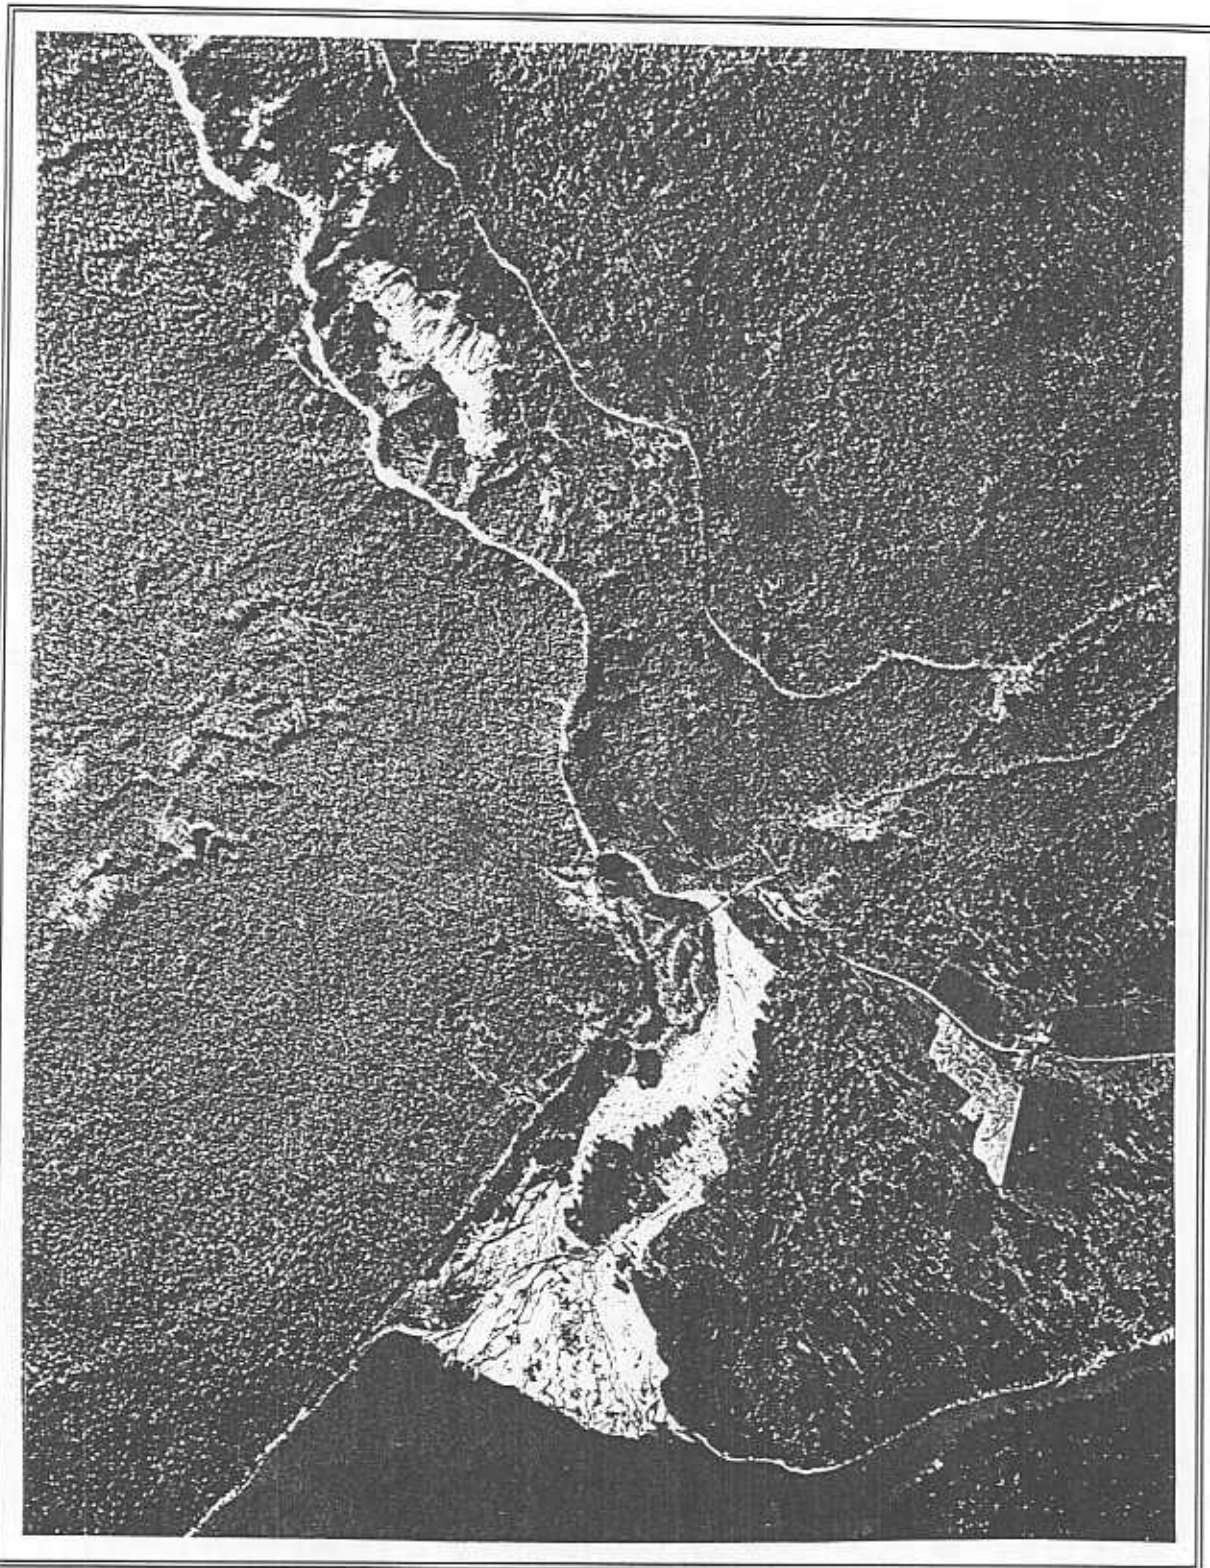
1955 - Extremely active channel on the Keithley Creek alluvial fan with multiple channels and limited riparian vegetation. Large active placer mining site on lower channel upstream of the alluvial fan [BC 2343:67].

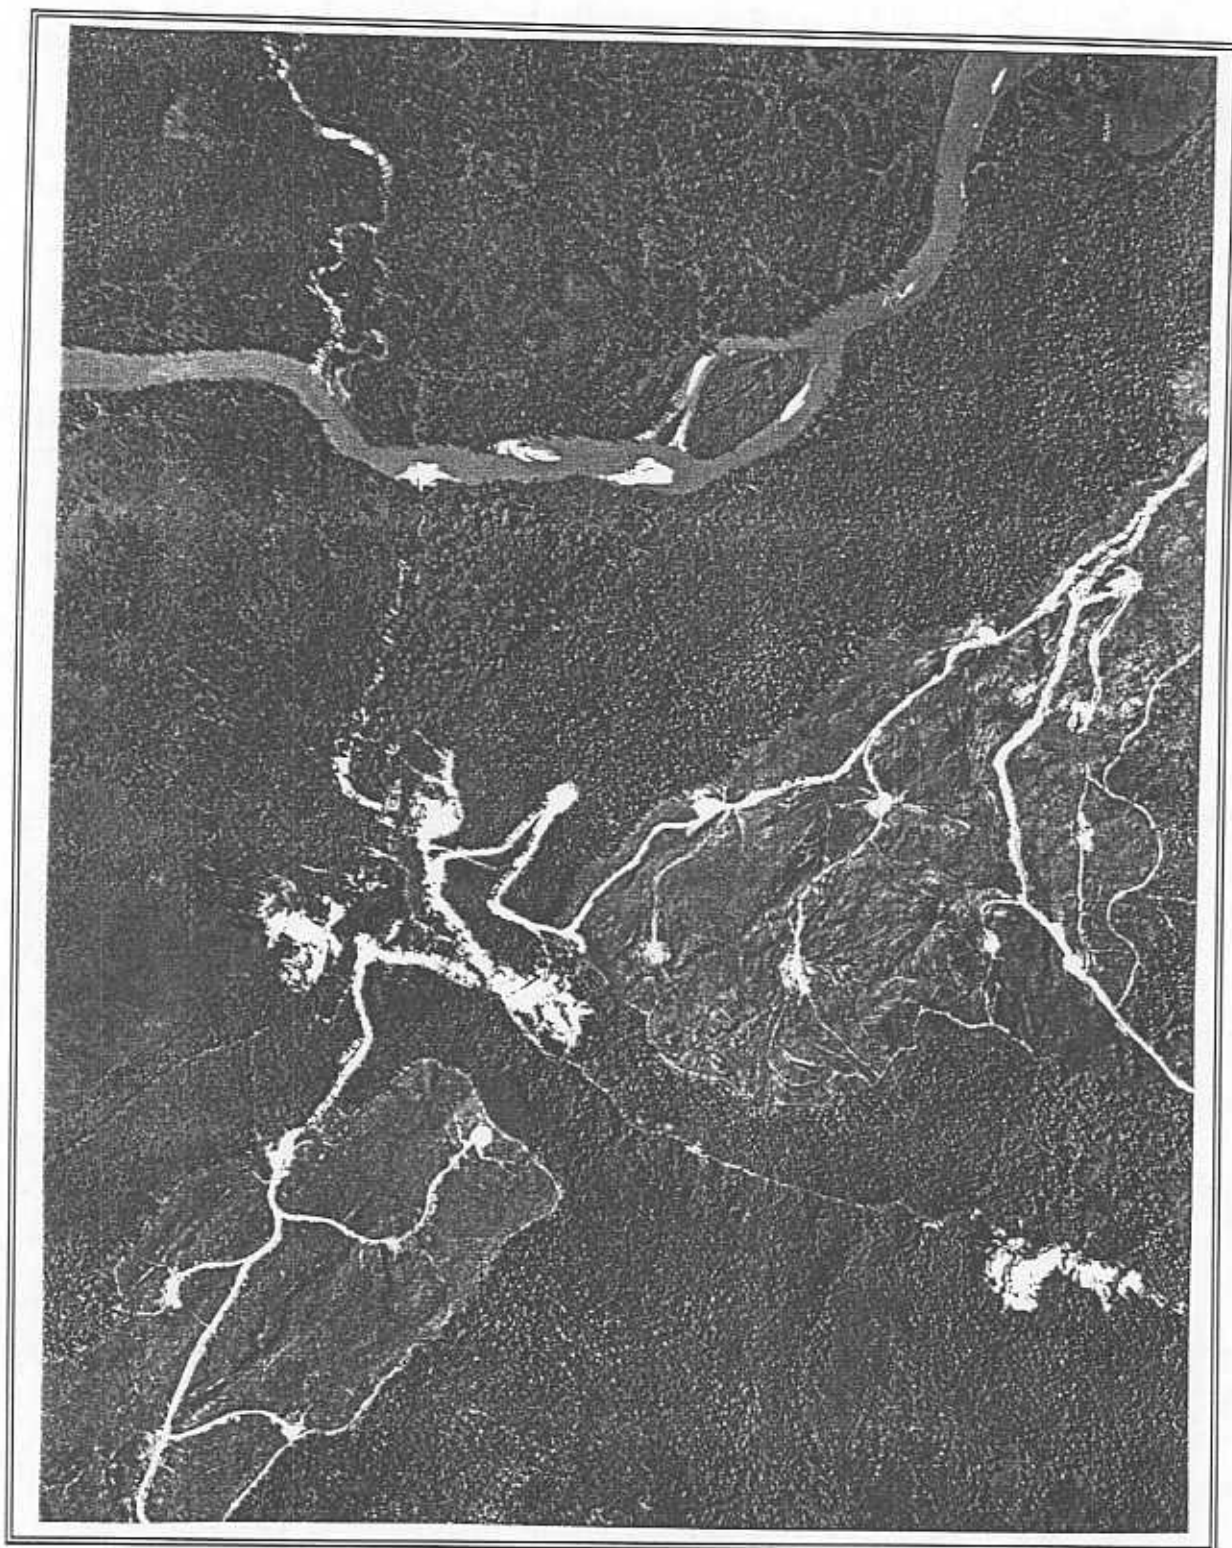
1992 - Harveys Creek lower mainstem channel and alluvial fan. Large placer mining scars and active mines on the steep valley slopes and glacio-fluvial terrace. Pre-FPC forest road constructed in erodible soils. Visible channel disturbance on the alluvial fan [30BCC 91061 No.4].
