**INTERIOR WATERSHED
ASSESSMENT PROCEDURE
for the
CORNING CREEK WATERSHED**

February 2000

A Watershed Restoration Project Funded by Forest Renewal BC.

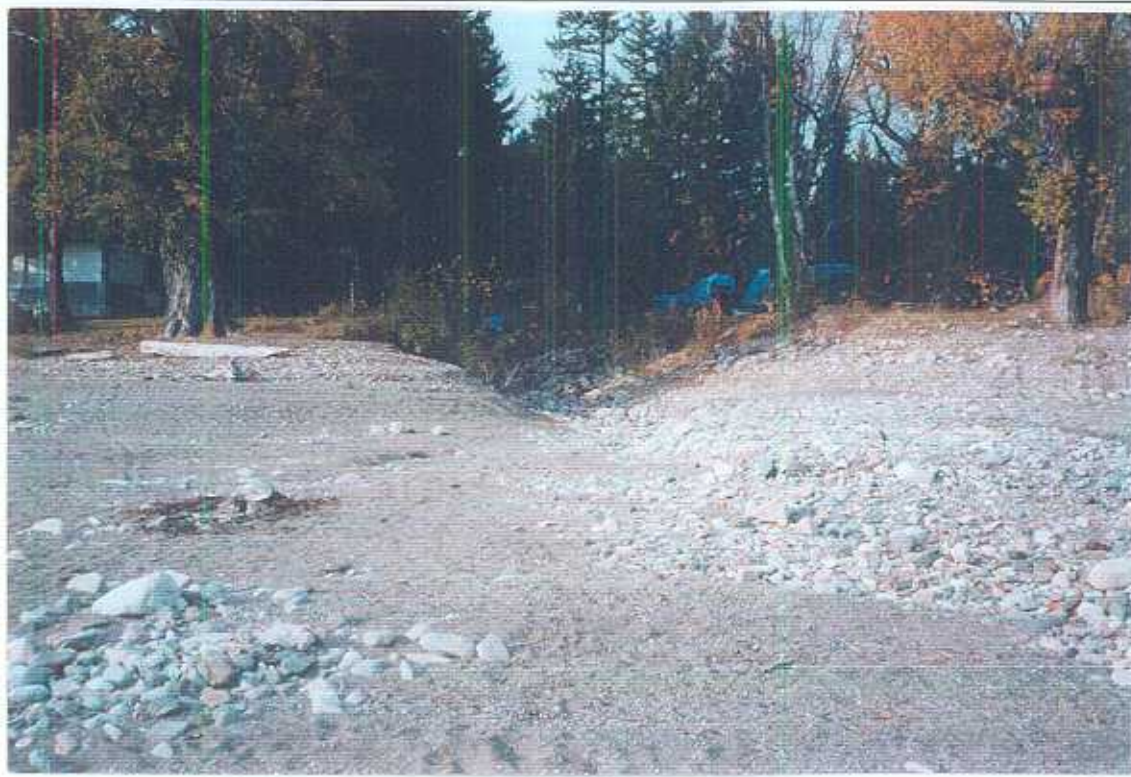
Reach 1 was found to be mostly stable and followed an established, relatively well incised channel (Photos 1 and 2). Large cedars (>60cm dbh) were noted growing on and out of the banks indicating long-term channel stability. Substrates were predominantly cobble and some bedload movement was apparent. Few fines were noted near the mouth of the creek.

Photo Plate 1. Reach 1. Corning Creek at outlet into Shuswap Lake.

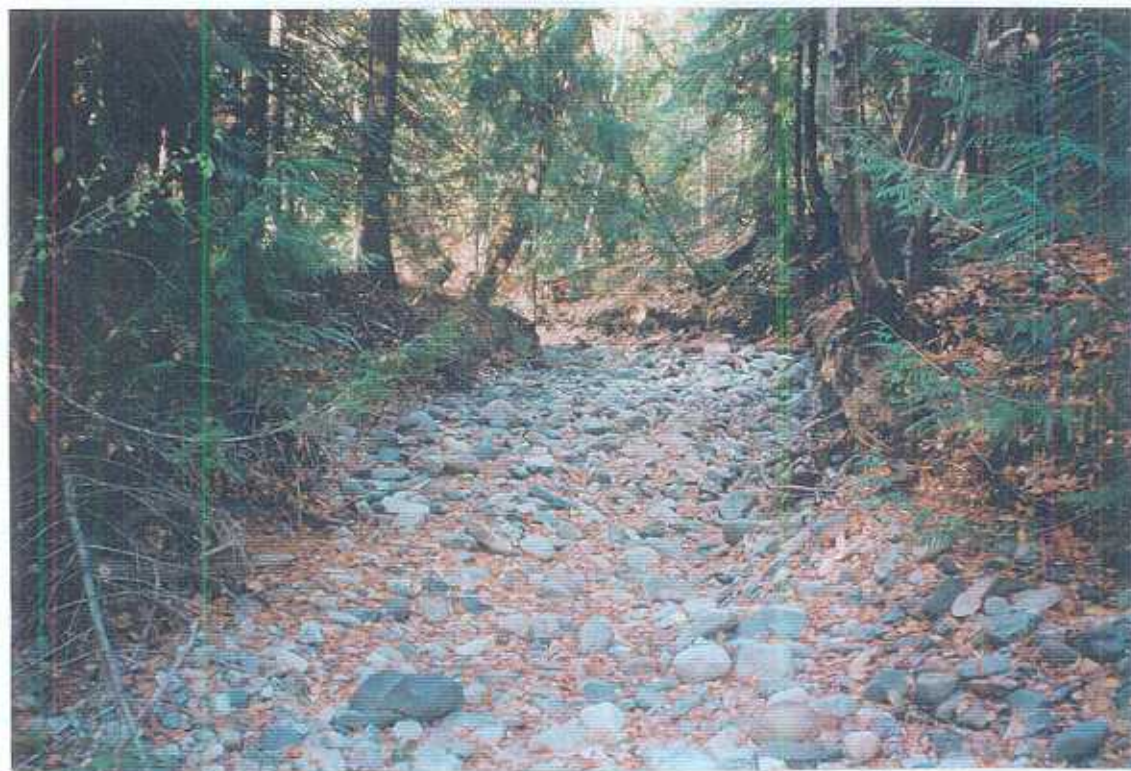
Through much of the reach, the channel appeared deficient of large woody debris (LWD). Some selective cutting and removal of riparian trees had occurred on the adjacent private land, but not enough to substantially affect stream conditions. Instream LWD may have been buried by cobble deposition or mechanically cleared by local landowners at one time. Debris jams and instream LWD serve to check bedload movement in a channel, however excessive debris and/or large jams can also lead to localized deposition, bank erosion and channel avulsions on a fan. Instream LWD is often removed to prevent the latter, at the expense of bedload staging.

Photo Plate 2. Reach 1. Typical channel conditions. Note lack of LWD in creek.

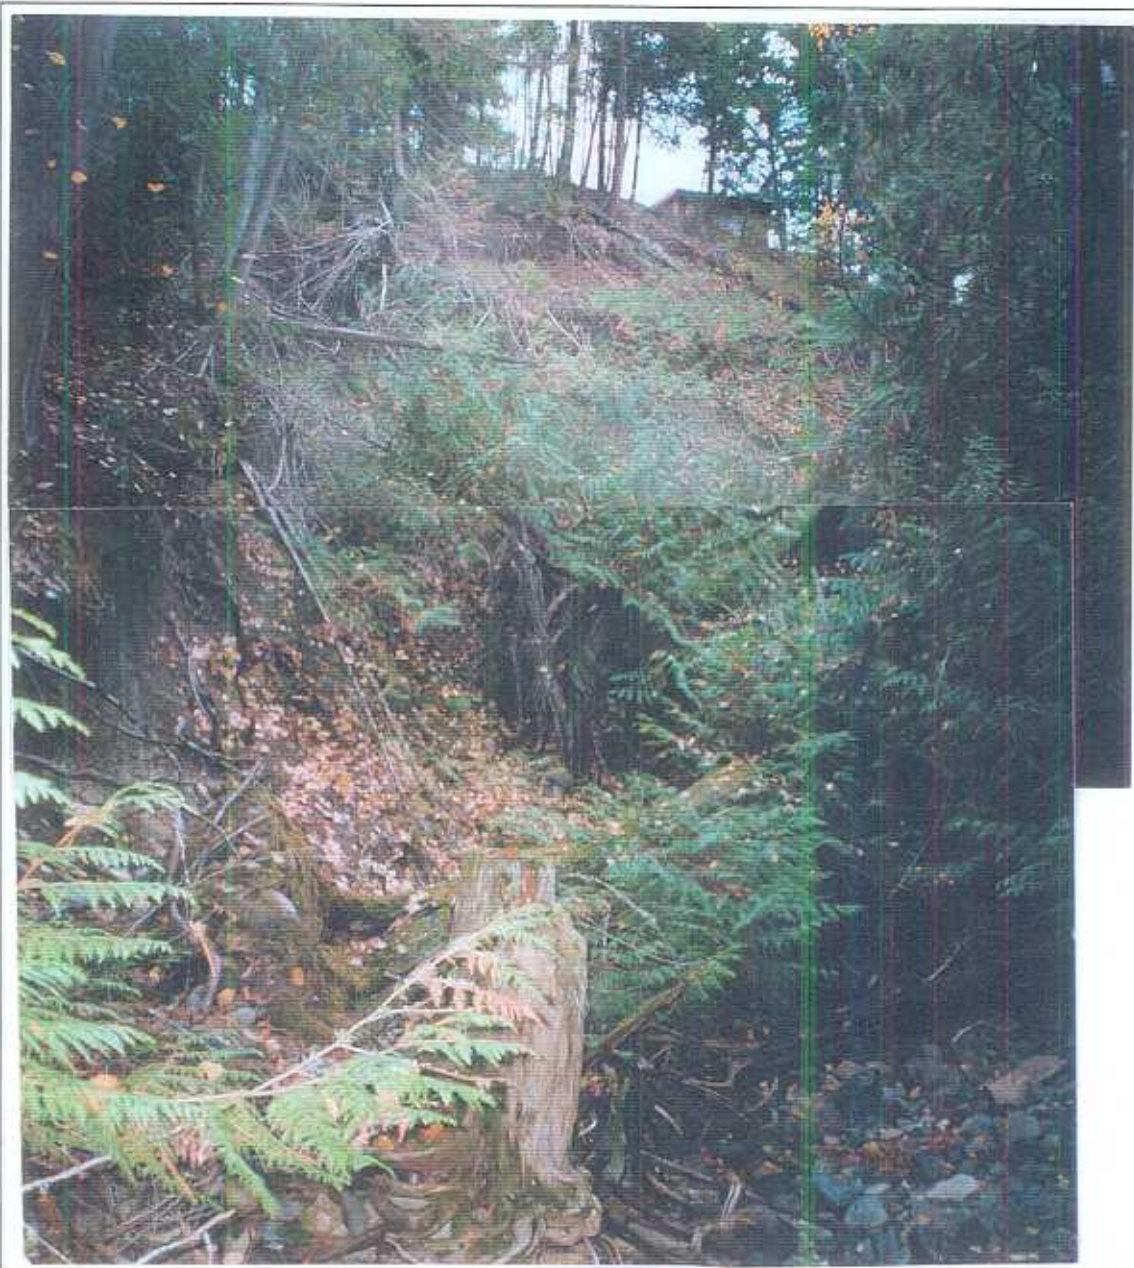
Two old, partially revegetated landslides were noted near the lower end of Reach 2 (Photos 3 and 4) (see EMRA S1, S2 and S3, Silvatech 1999). The landslides are indicated on the map provided in Appendix E. Although failures S1 and S2 were described as separate occurrences in the EMRA, the two are thought to be connected and indicative of a single large slope movement. Continued sediment contributions to the creek from the slides are likely to be minor. There is some potential for failure S1/2 to be reactivated through bank erosion along the toe of the slide. A private building was observed on the bench above the failure and may potentially be affected should the slope continue to regress. The other landslide (S3) is on a cleared slope and may be related to the construction of a private access road to the floodplain, near one of the licensed water intake sites. This slide is buffered from the mainstem creek by an area of brushed floodplain.

Photo Plate 3. Reach 1. Landslide scarp along edge of creek. Note building on top of slope. (S2)

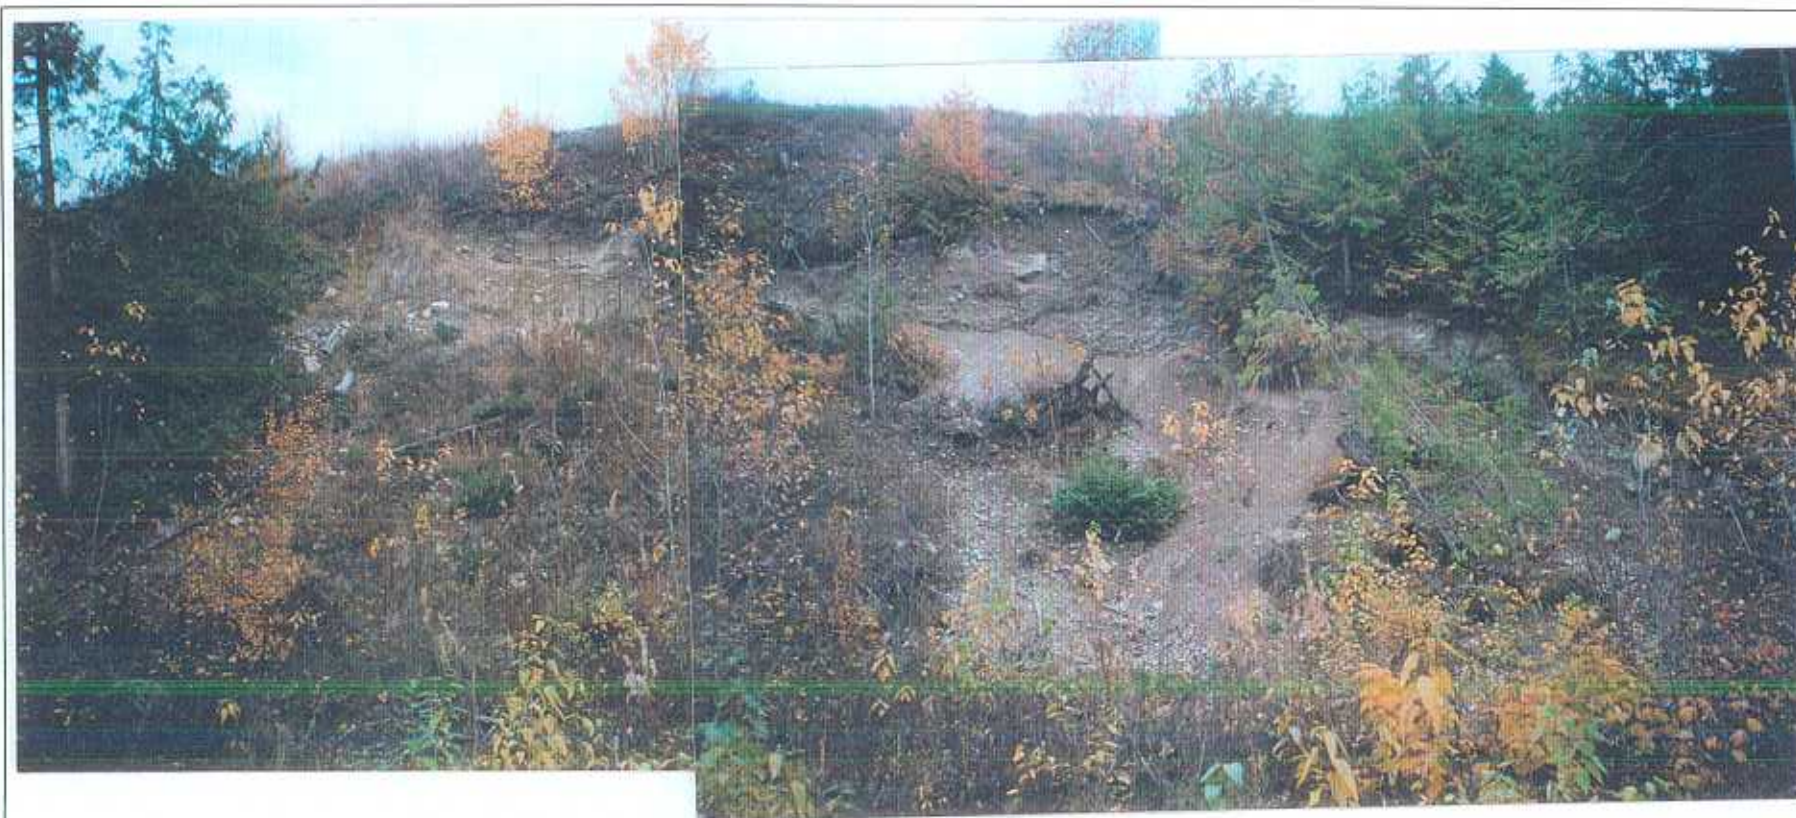
Photo Plate 4. Reach 1. Landslide associated with access road to water intake site. (S3)

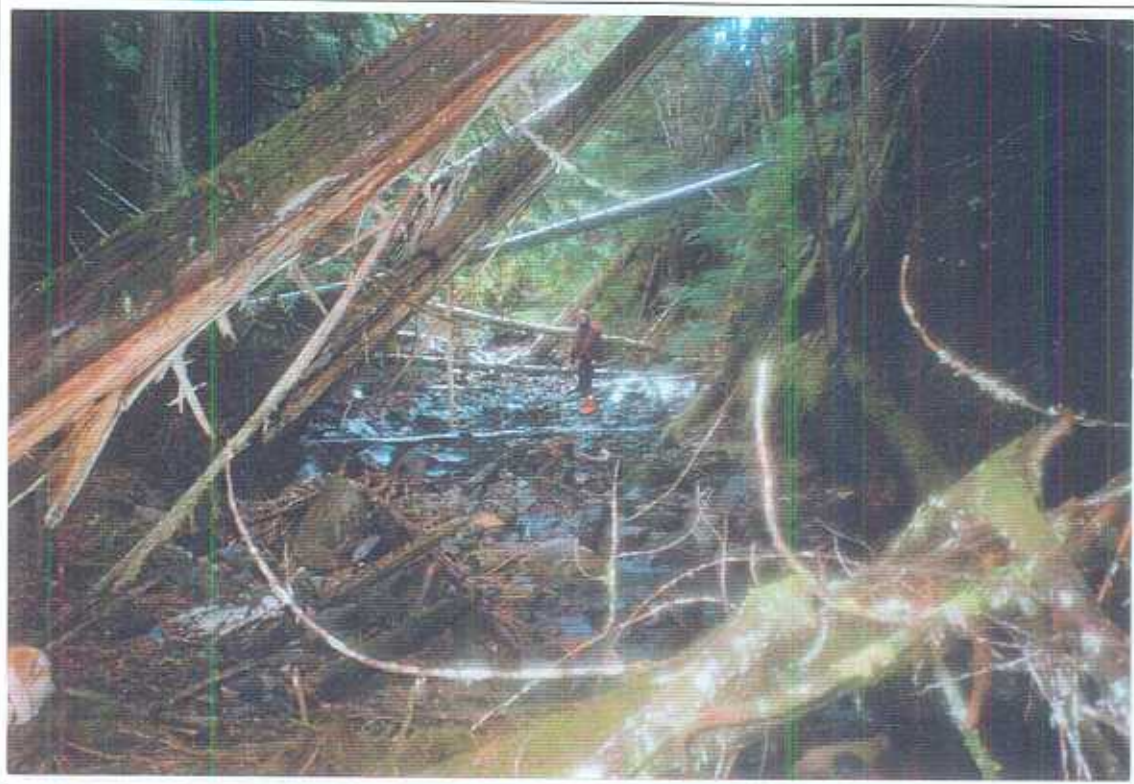
Evidence of recently increased channel activity, such as gravel deposits, debris jams with cobble wedges and bank scour were observed along the mainstem in the vicinity of the confluence (Photos 5, 6 and 7). In some areas, aggradation was sufficient to cause channel dewatering for short sections. Downstream of the confluence conditions improved while upstream the conditions deteriorated. Frequent bedrock controls in the channel and along the banks provided some stability to the channel form.

Photo Plate 5. Reach 3. Aggraded channel sections upstream of confluence with east tributary.

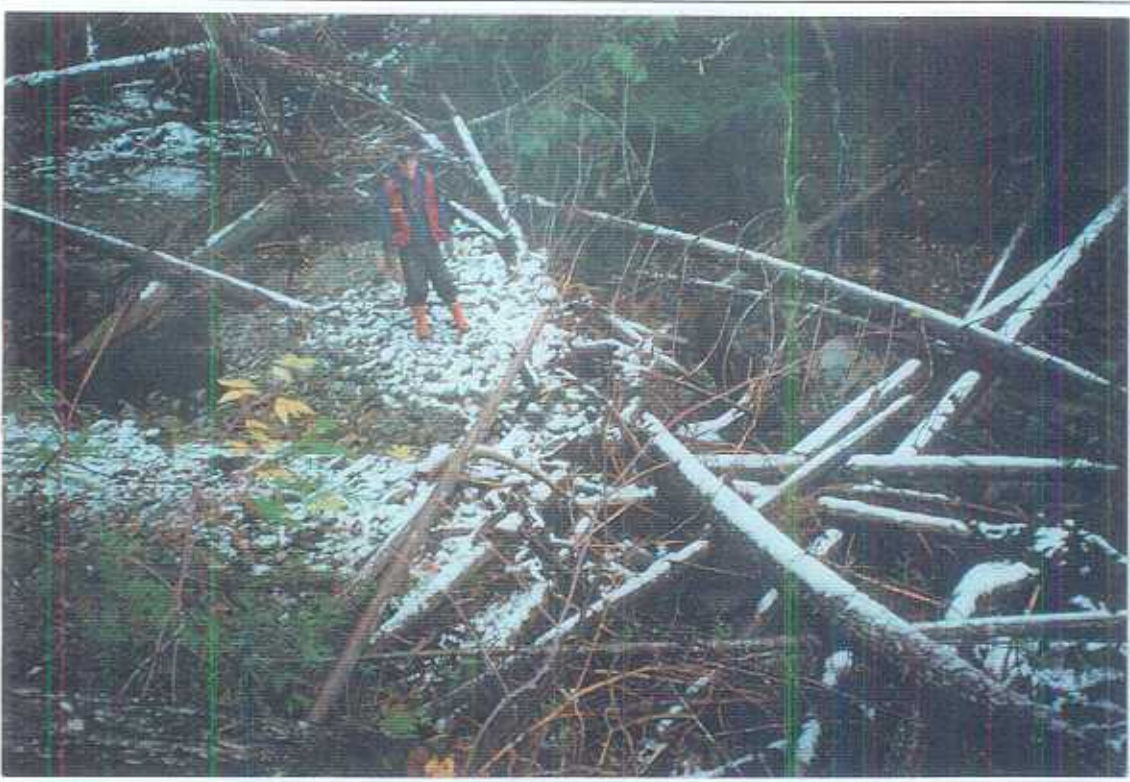
Photo Plate 6. Reach 3. Sediment wedge captured behind debris jam.

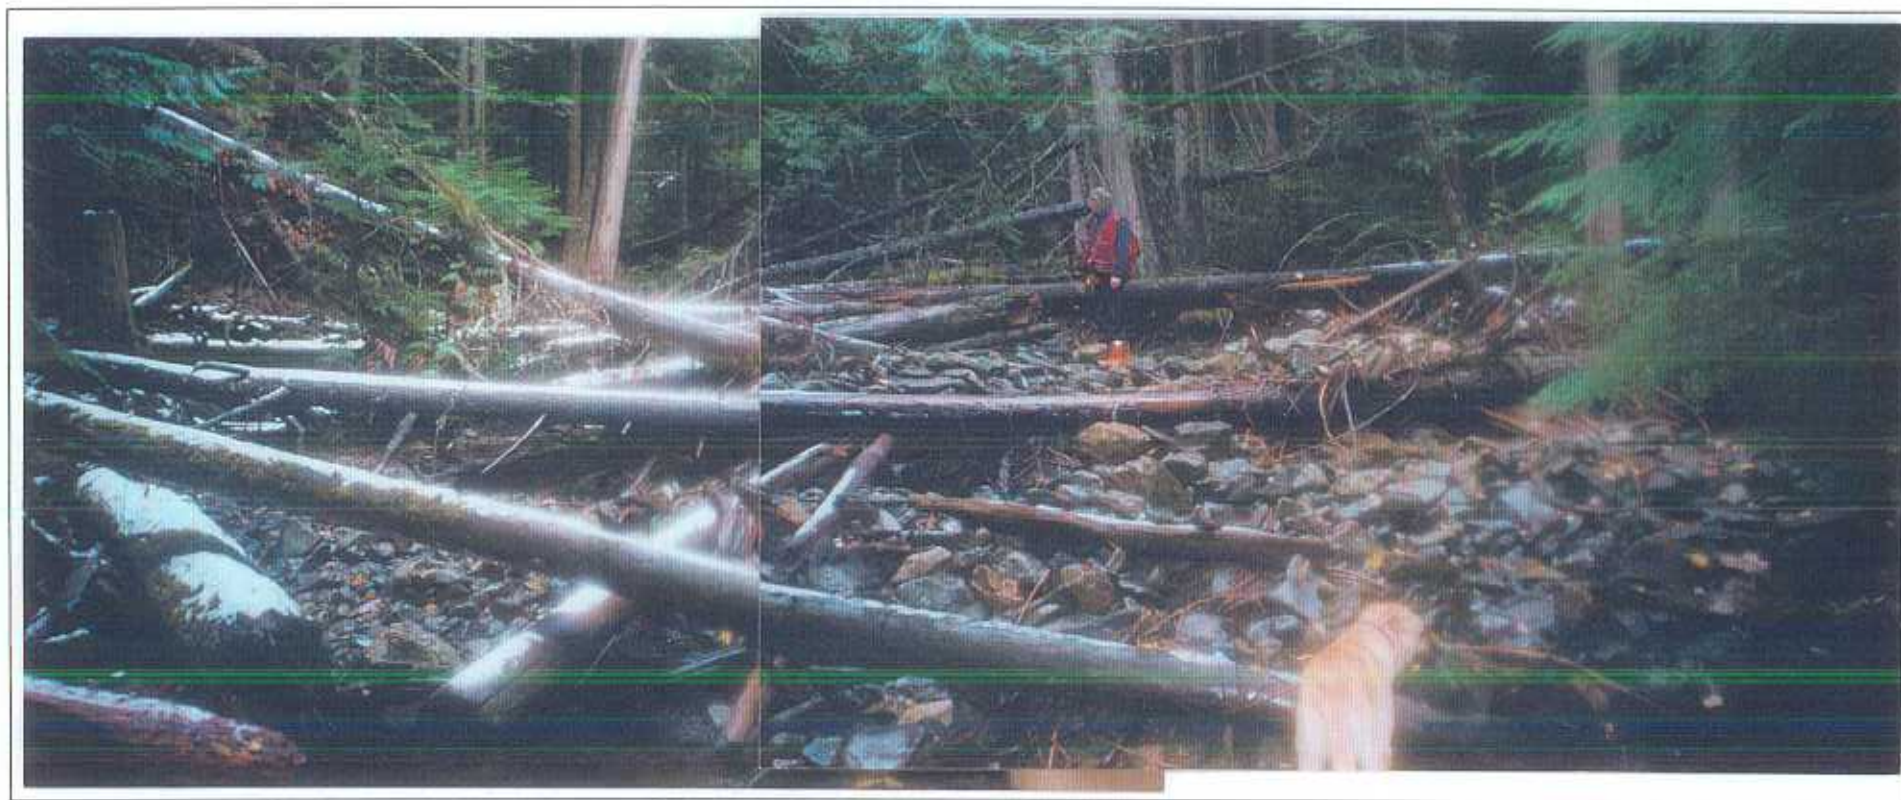
Photo Plate 7. Reach 3. Dewatered section of aggraded channel

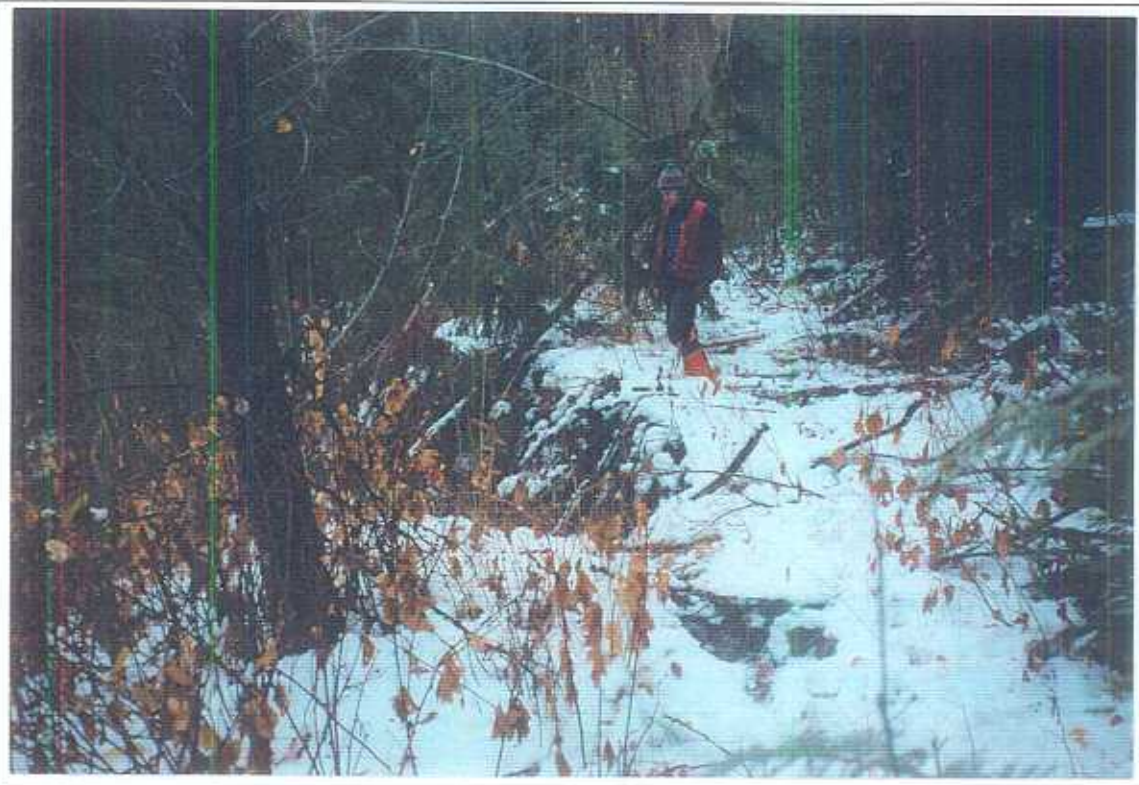
Photo Plate 8. Reach 3. Slope failure (S4) where water has been concentrated along lower edge of block.

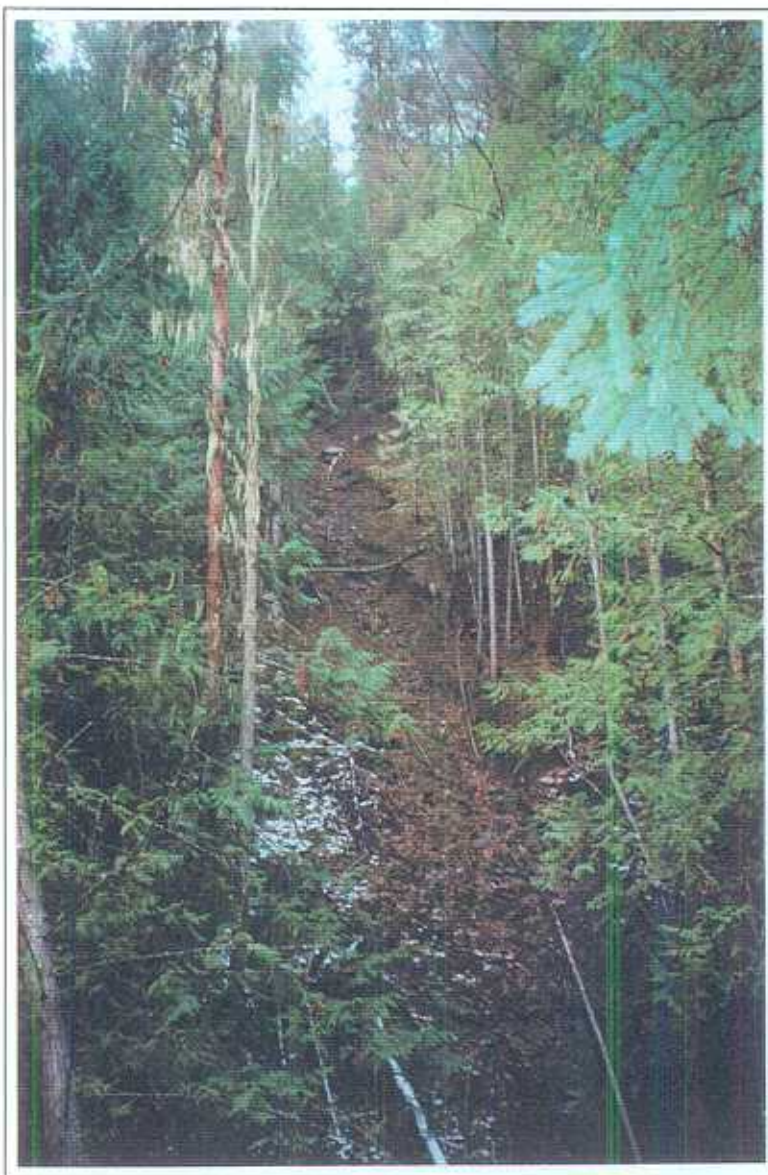
Photo Plate 9. Reach 3. Gully (Failure S5) related to upslope drainage problems. (Note bedrock near lower end.)

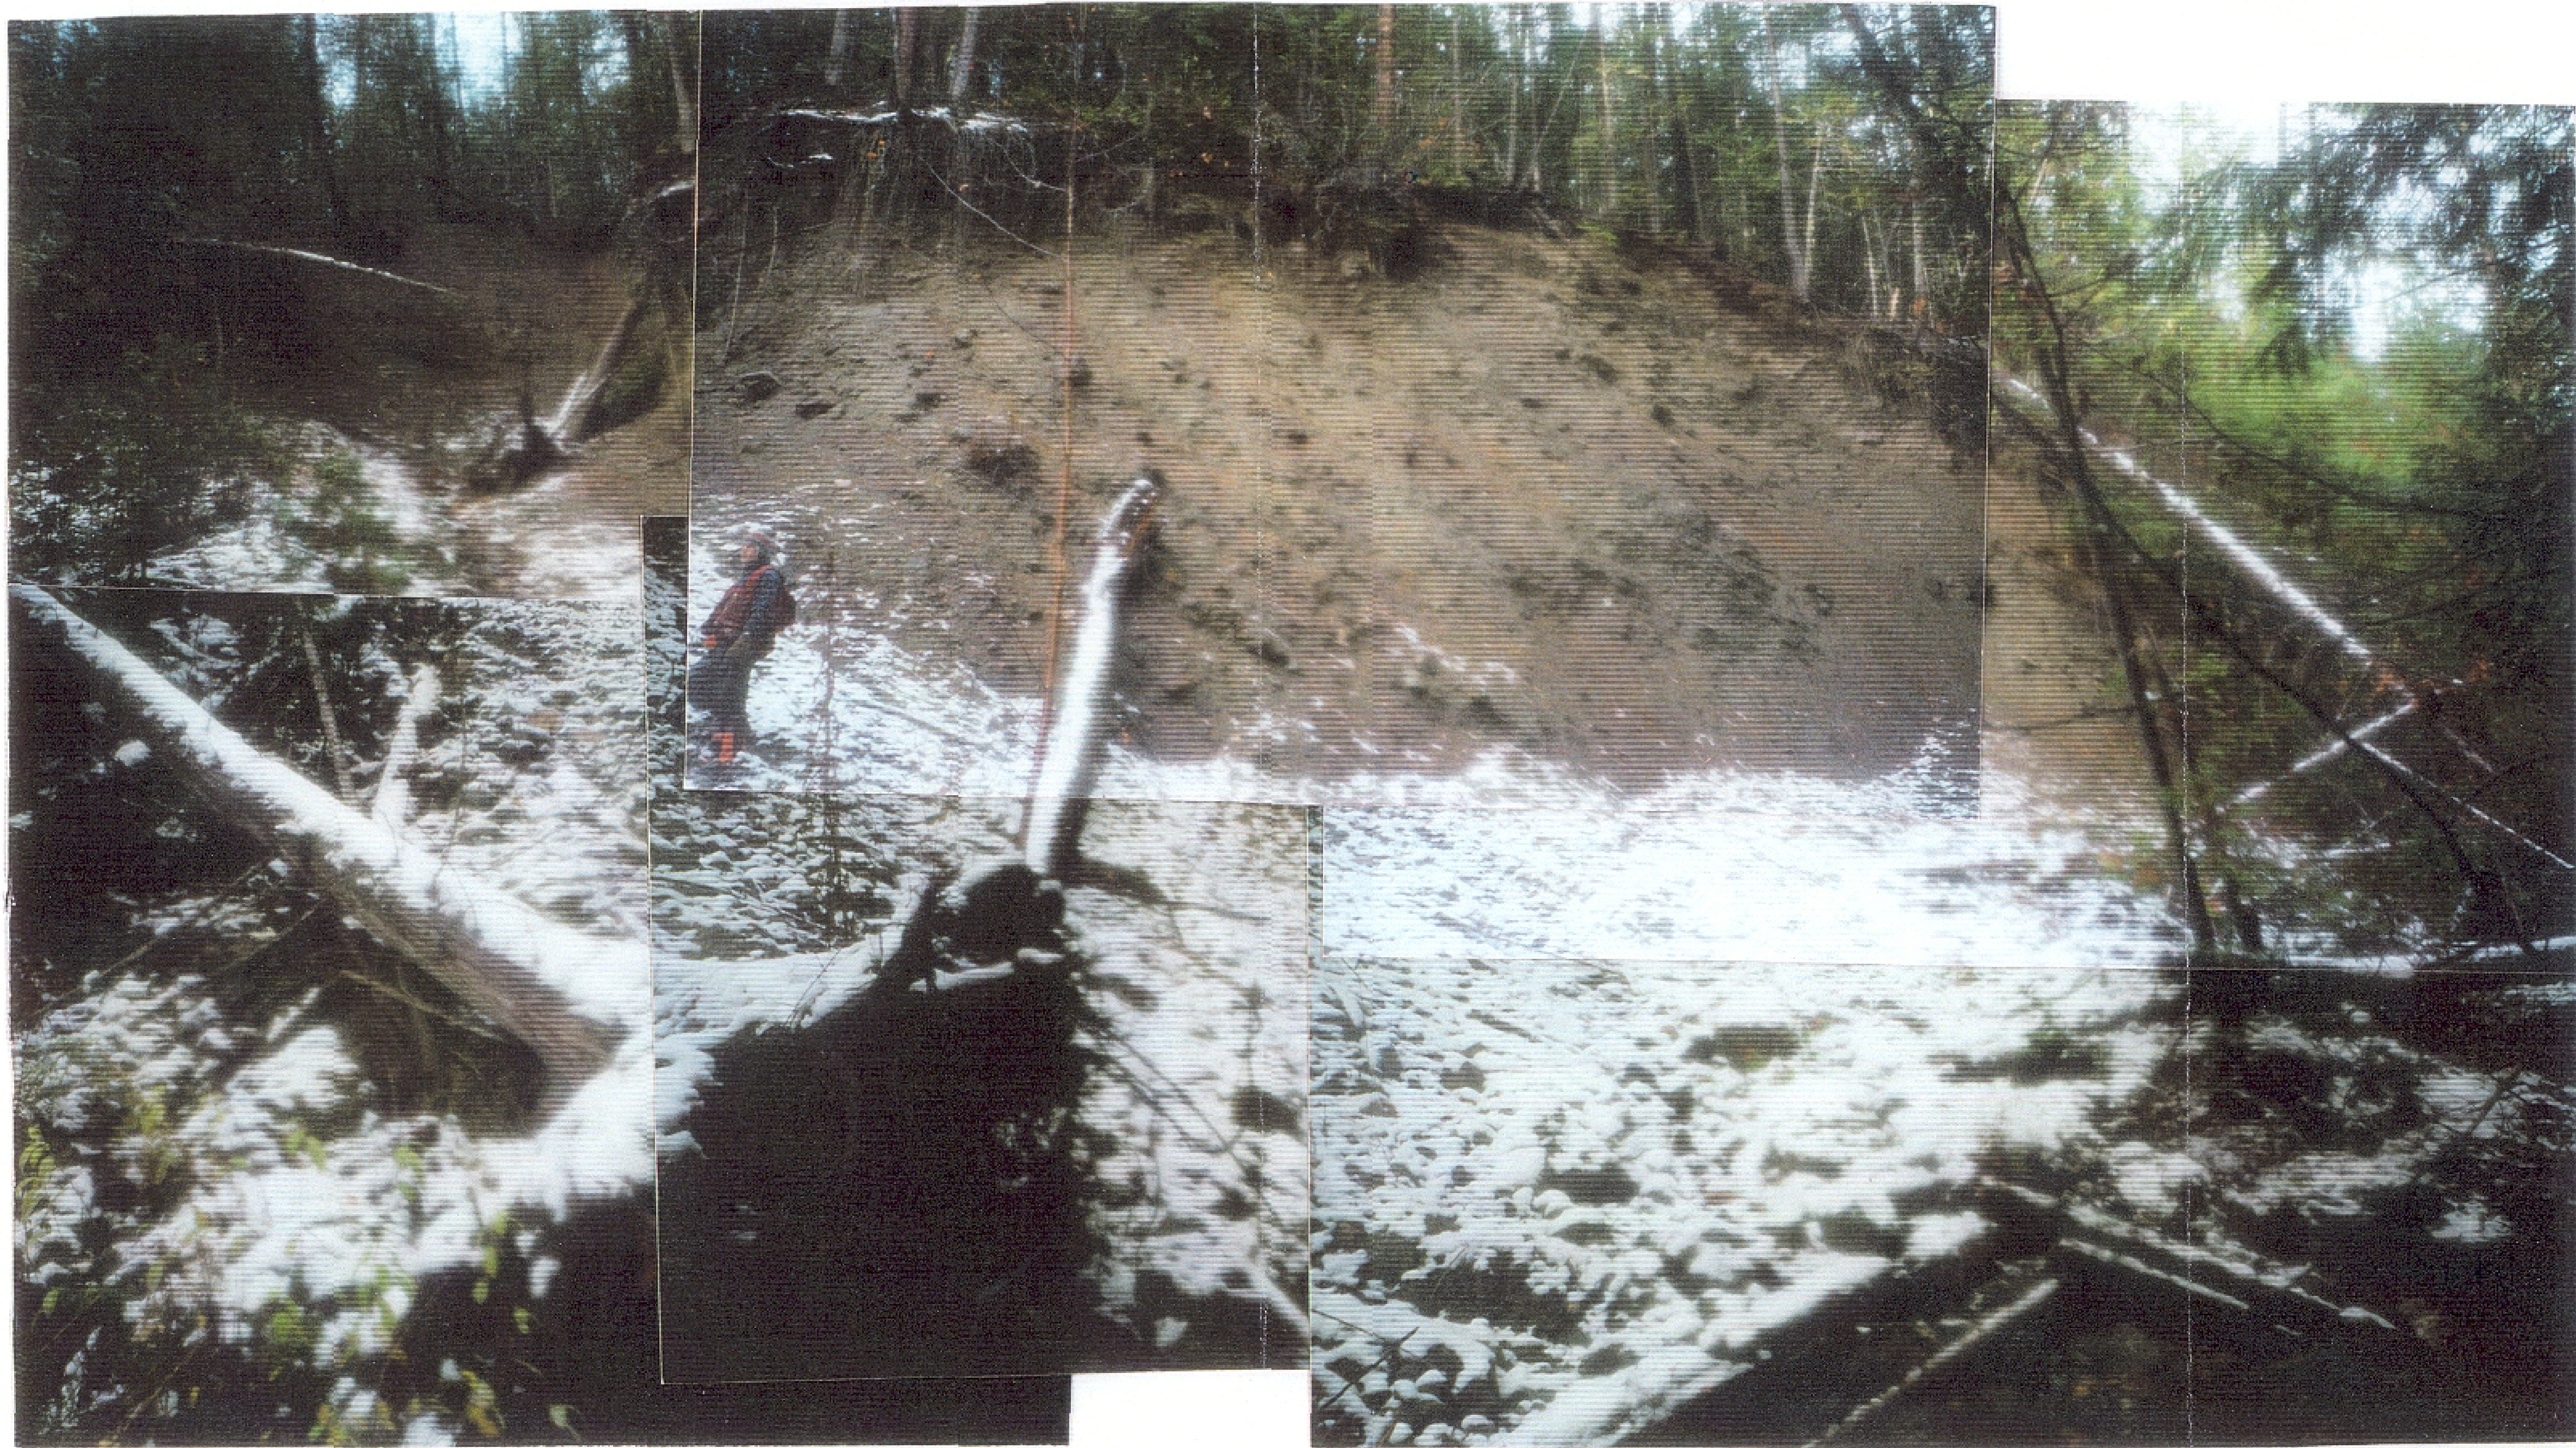
Slope failures S6 and S7 were also inspected as part of the ground survey. These two failures were found to be recently active, enlarged bank failures in relatively deep tills with a high content of fines (Photos 10 and 11). Failure S6 is visible on the 1994 airphotos, however, S7 is not, possibly due to the dense forest canopy. No evidence of upslope issues contributing to either failure was observed and the events were inferred to be natural. Recent activity at the failures may have been the result of toe/bank erosion during the significant discharge event in May 1997, recorded by WSC for

Photo Plate 10. View of failure S6 from stream edge.

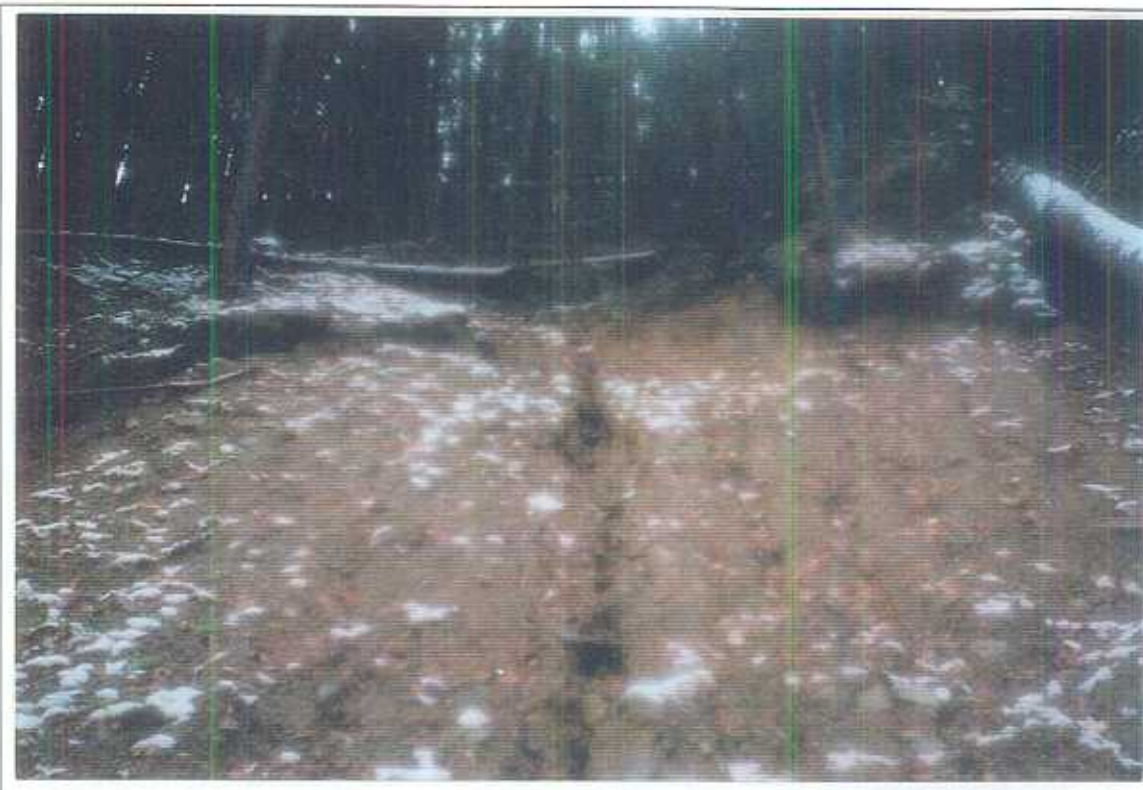
Photo Plate 11. Reach 3. Enlarged bank failure. (S7)

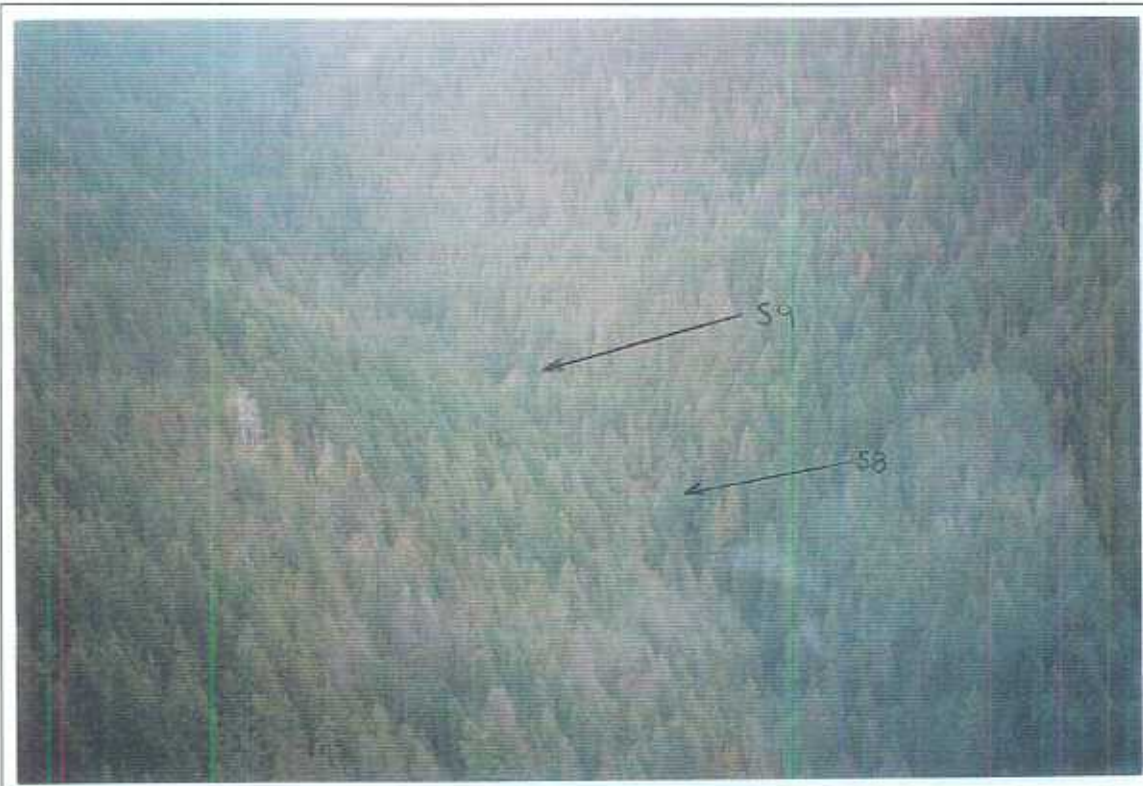
Although not inspected on the ground, failures S8 and S9 also appeared to be recently active enlarged bank failures, similar to S6 and S7 (Photo 12). Indications of both failures are visible on the 1994 aerial photography. The failures are inferred to be natural, although some harvesting occurred upslope. A forested buffer of relatively flat terrain remains between the cutblock and the top of the slope above the failures, reducing the likelihood of a connection. A detailed site inspection is otherwise required to ascertain possible causes of the failures. — yes

Photo Plate 12. Reach 3. Slope failures S8 and S9 photographed from above.

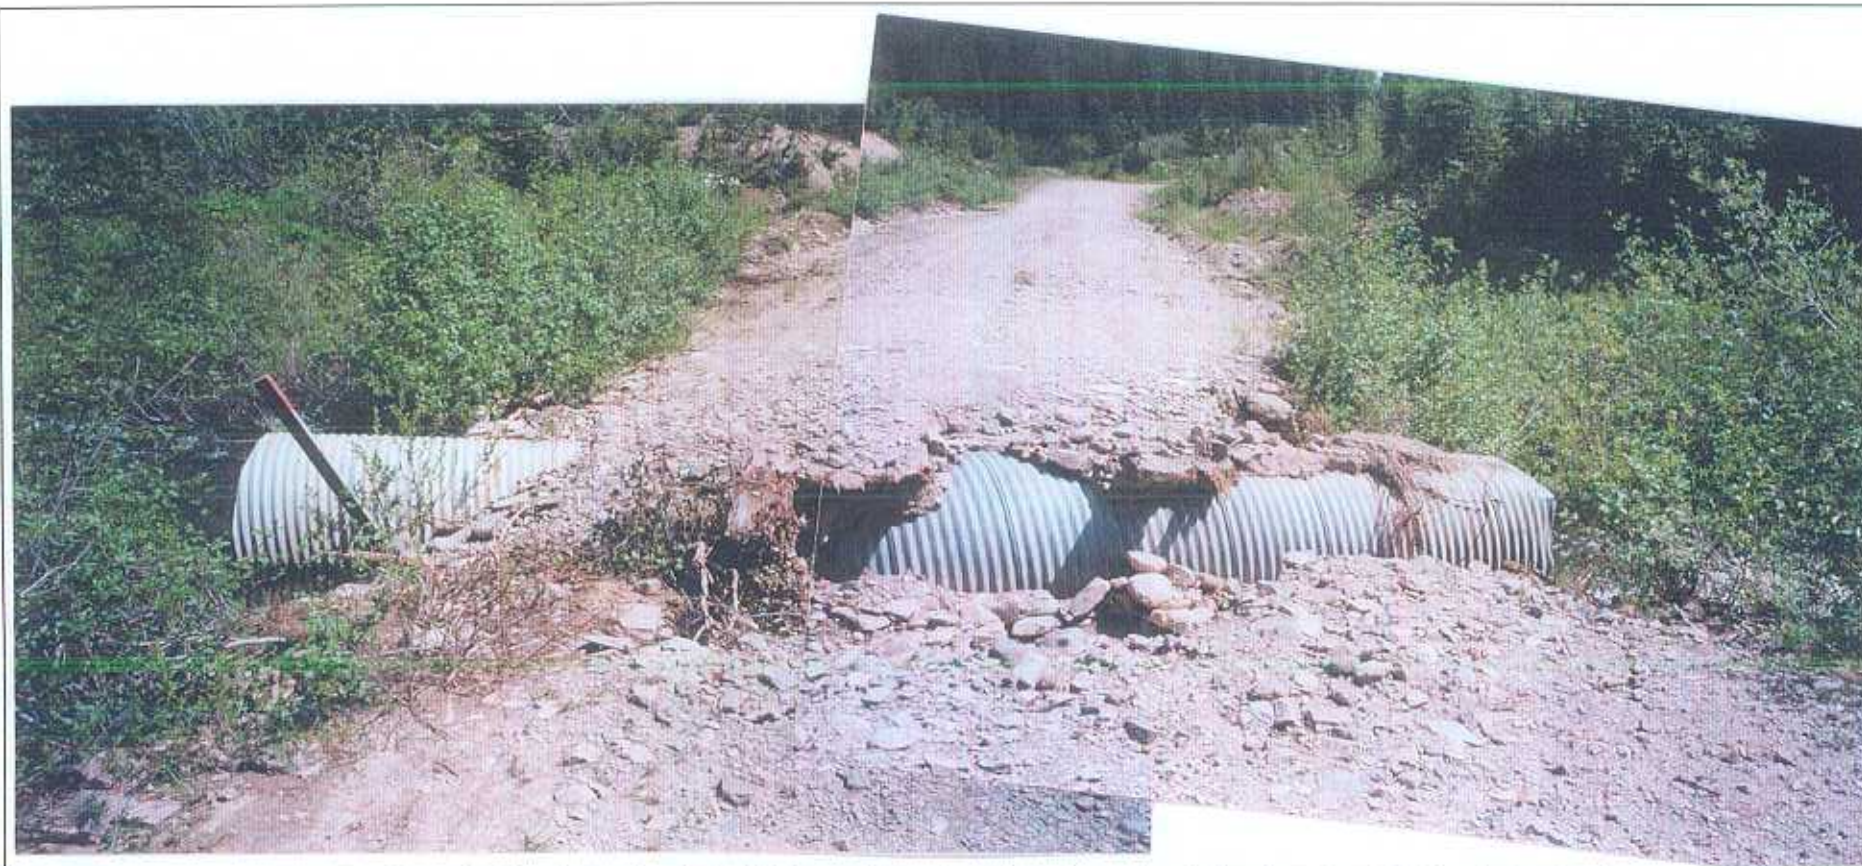
Photo Plate 13. Reach 5. (Site 4). Road washout at 1200 mm diameter culvert crossing following the 1999 freshet. Inadequate cover likely caused the culvert damage shown in photo plate 15.

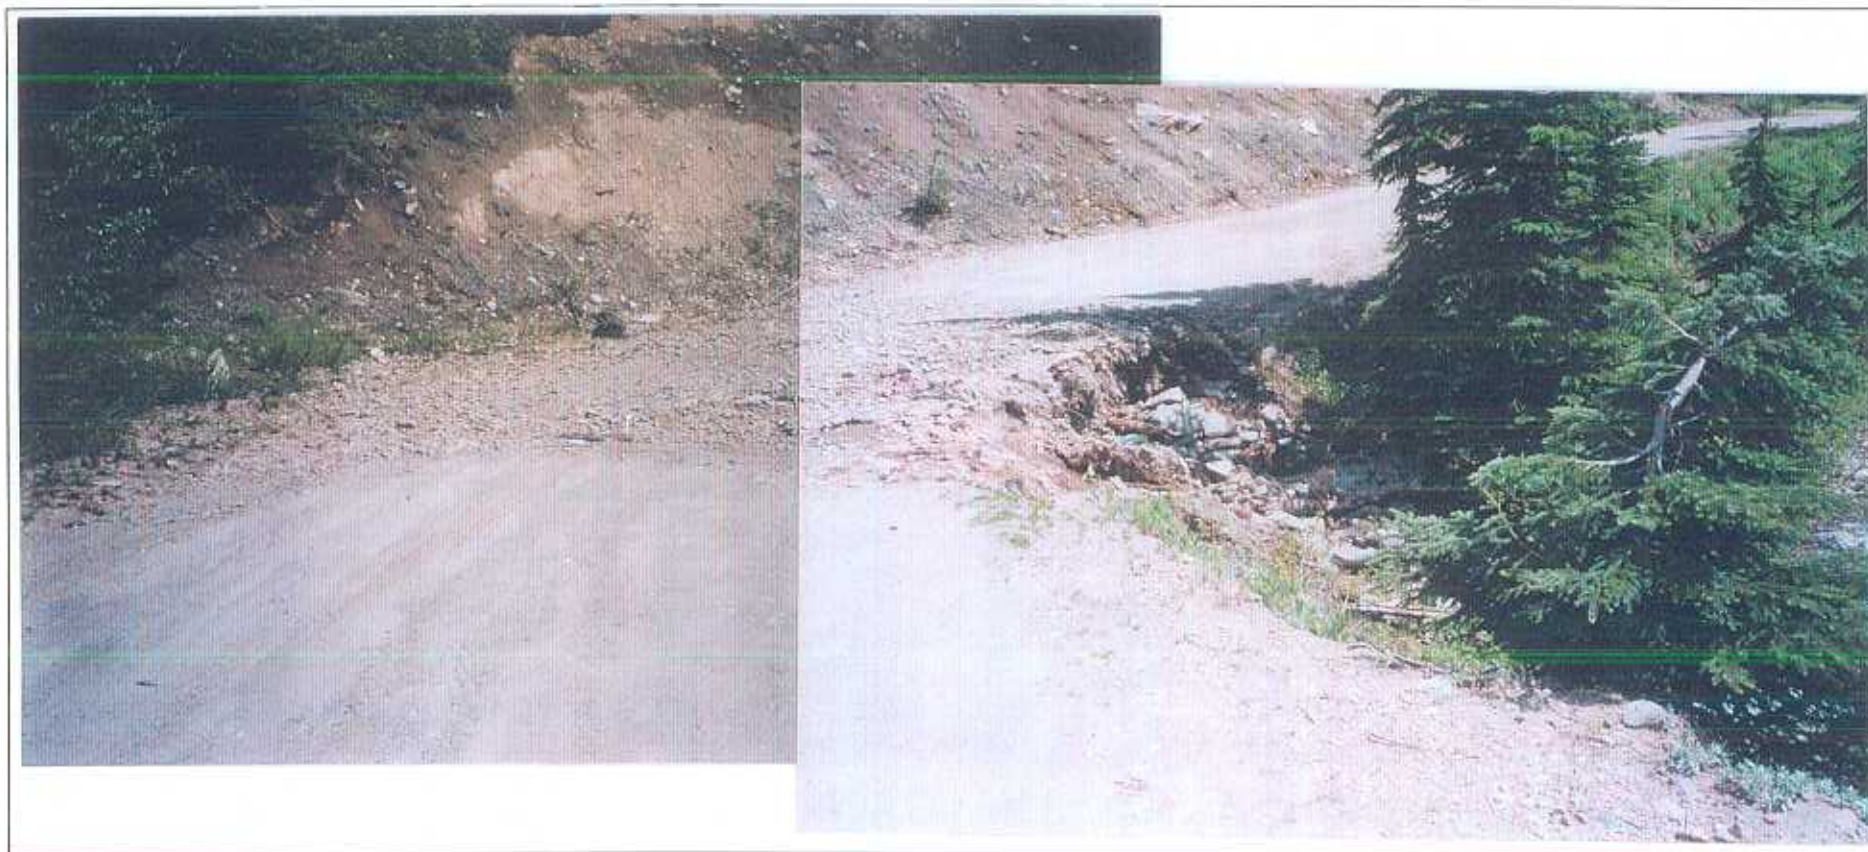
Photo Plate 14. Reach 5. (Site 12) 1200 mm diameter culvert overtopped during 1999 freshet, leaving eroded road surface and fillslope.

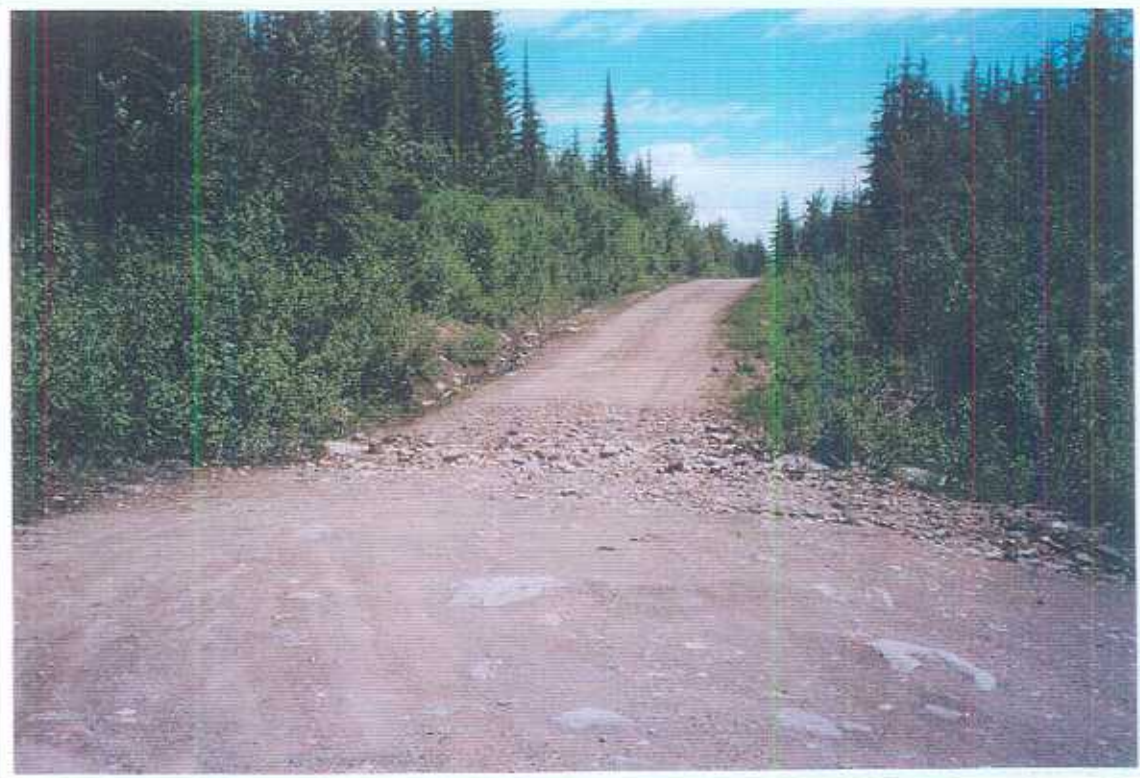
Photo Plate 16. Tributary channel to Reach 3. Evidence of overtopping at 1200 mm diameter culvert crossing. (Site 3)

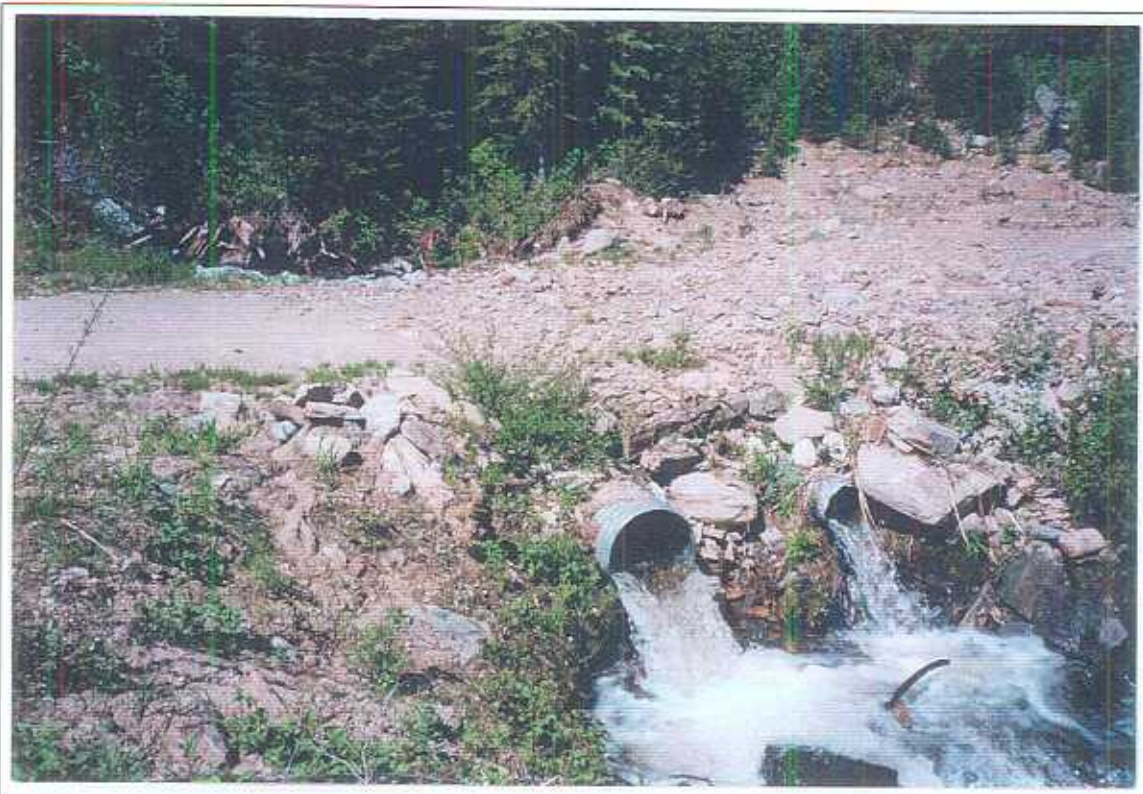
Photo Plate 17. Tributary to Reach 4 (Site 13). Two culverts (600 mm and 300 mm diameter) overtopped in 1999 freshet.

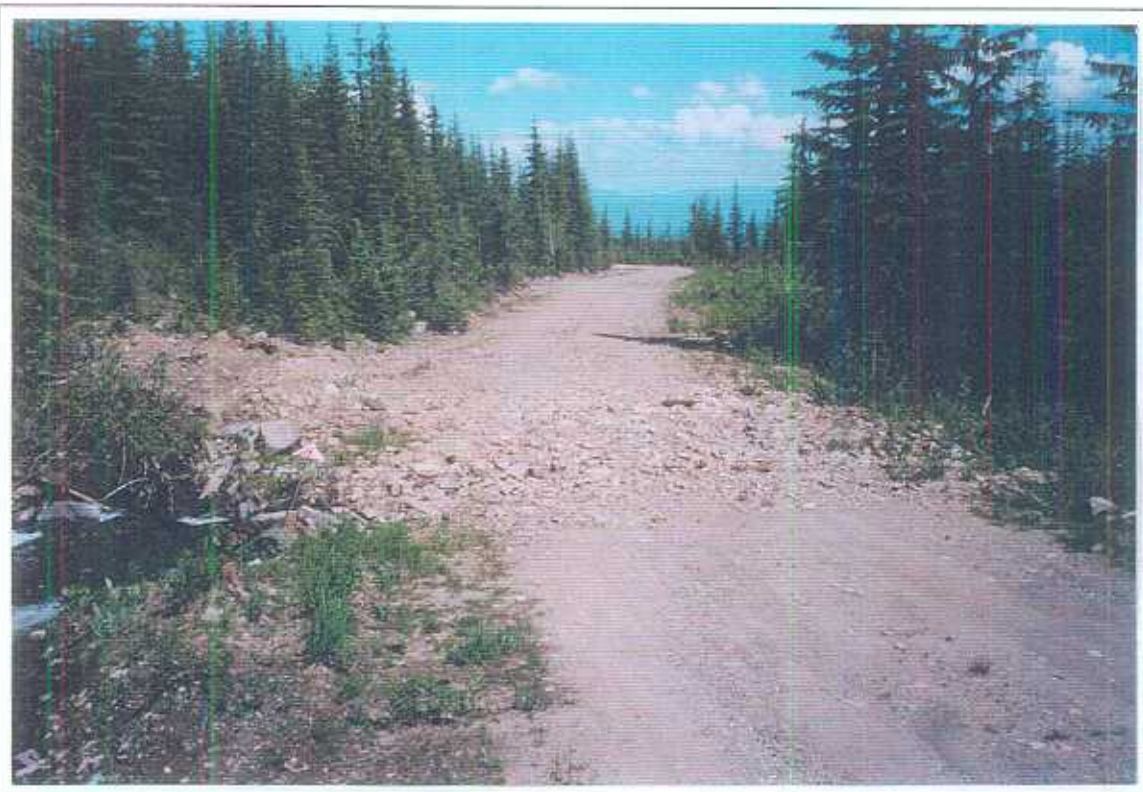
Photo Plate 18. Tributary to Reach 4 (Site 13). Two culverts (600 mm and 300 mm diameter) overtopped in 1999 freshet.
