**INTERIOR WATERSHED
ASSESSMENT PROCEDURE
for the
CORNING CREEK WATERSHED**

February 2000

A Watershed Restoration Project Funded by Forest Renewal BC.

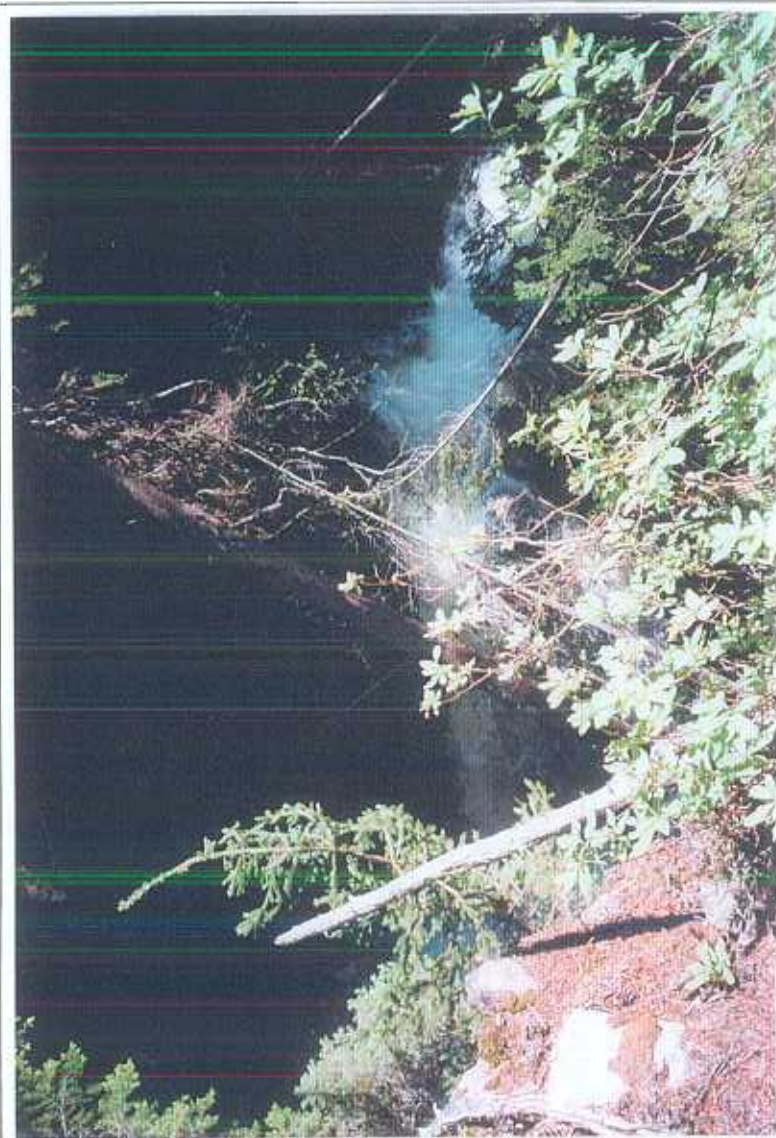
Photo Plate 19. Reach 4. Site 2 mainstem. Bedrock controlled cascade into lower valley.

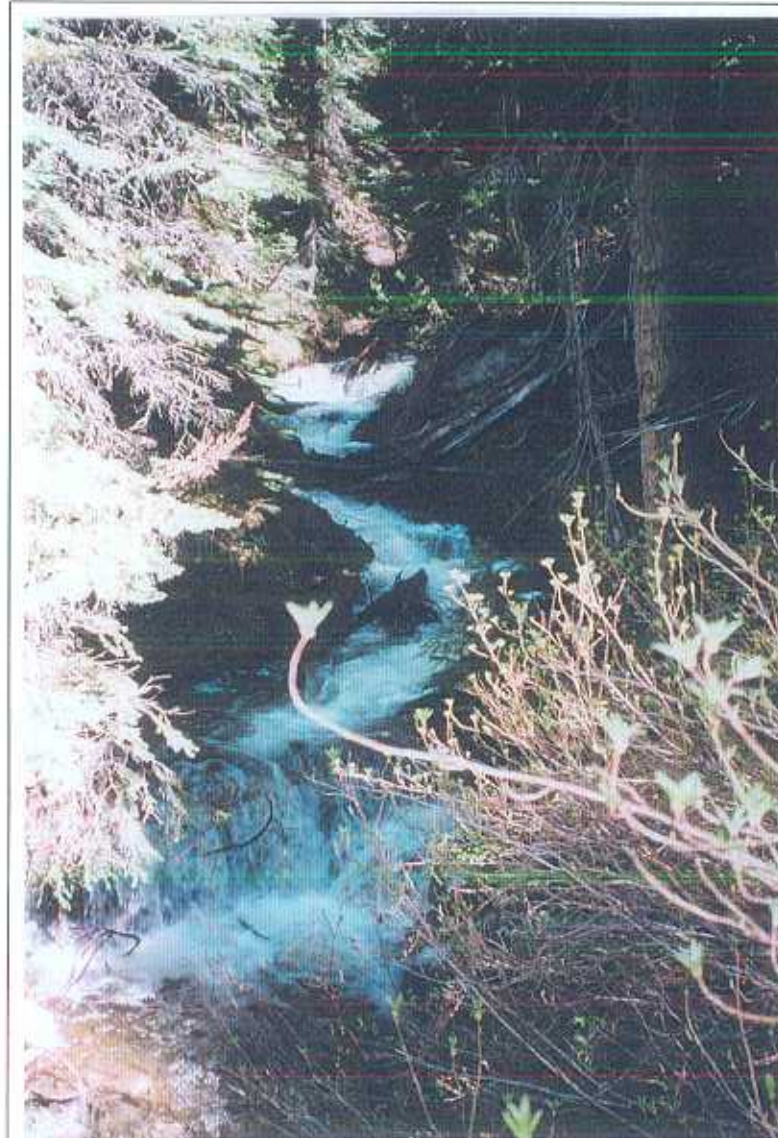
Photo Plate 20. Site 7. West tributary. Bedrock and wood controlled cascade into lower valley.

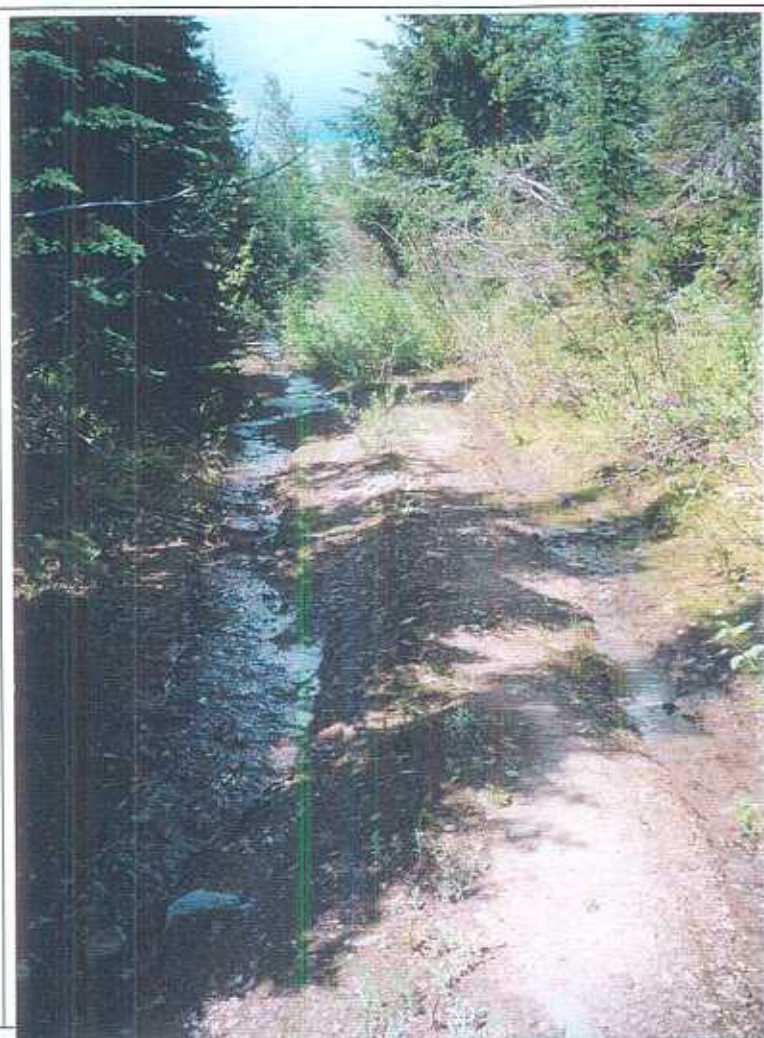
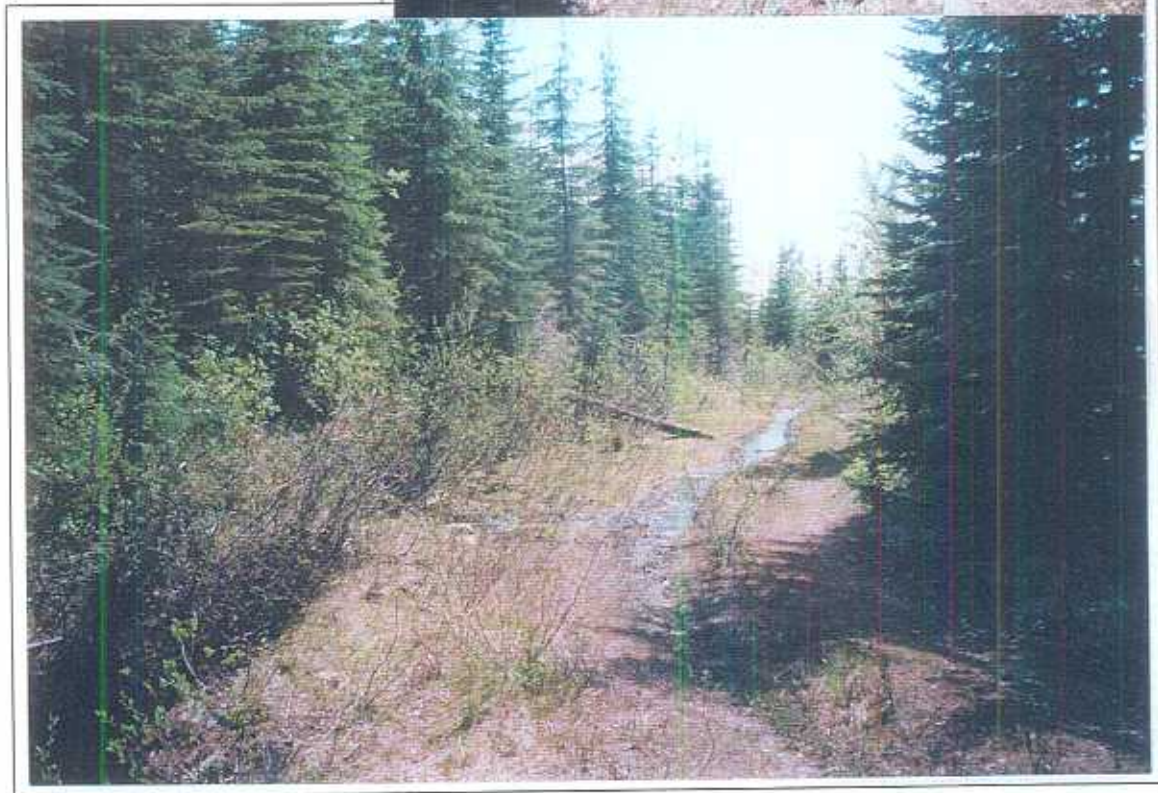
During the inspection of the Upper sub-basin, a diversion of surface drainage along a disused haul road was noted near Site 10 (Photos 21 and 22). The diverted flows eventually returned to a natural watercourse while still on the relatively flat plateau. Although partly self-armoured, the diverted flows will continue to scour the old road surface and generate fine sediments. Natural drainage should be restored in this area.

Photo Plates 21 (upper) and 22 (lower). Reach 5 tributary Site 10. Old disused road intercepting and redirecting drainage several hundred metres across the plateau.

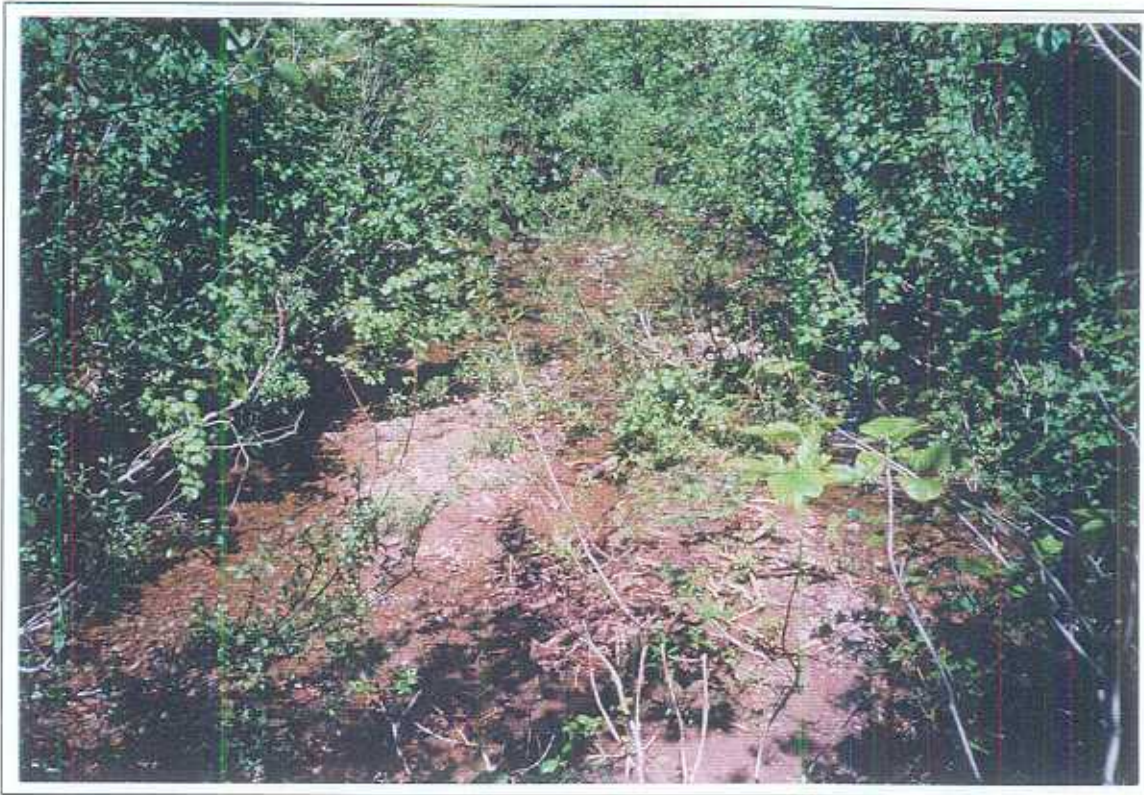
The culvert (1200mm) at Site 6 is probably undersized, as was evidenced by channel aggradation upstream of the crossing (Photo 23). Stored sediments are being re-vegetated with shrubs. Aggradation may eventually further reduce the capacity of the culvert, compounding the situation. The culvert should be removed or replaced with a larger size, or failsafed through road deactivation.

Photo Plate 23. East sub-basin. Site 6. Sand and gravel deposits upstream of the road crossing.

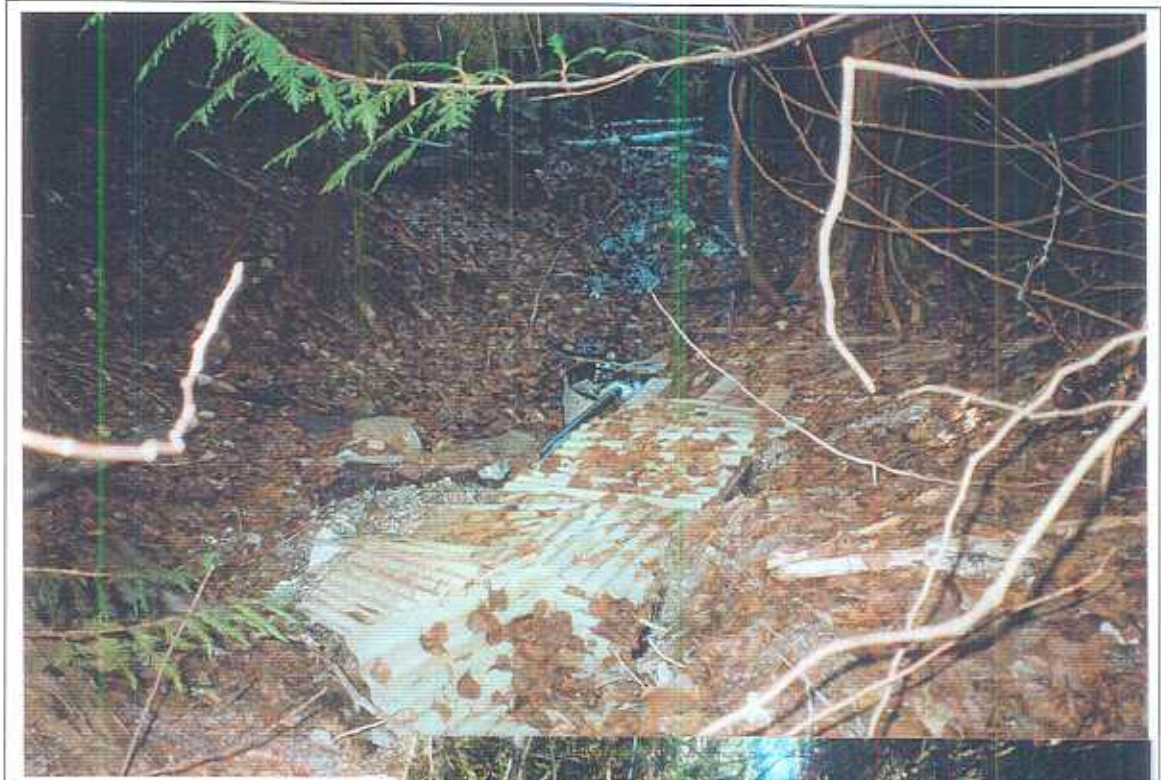
Photo Plate 24 (above). Freeman Brook water intake structures where surface flows emerge.

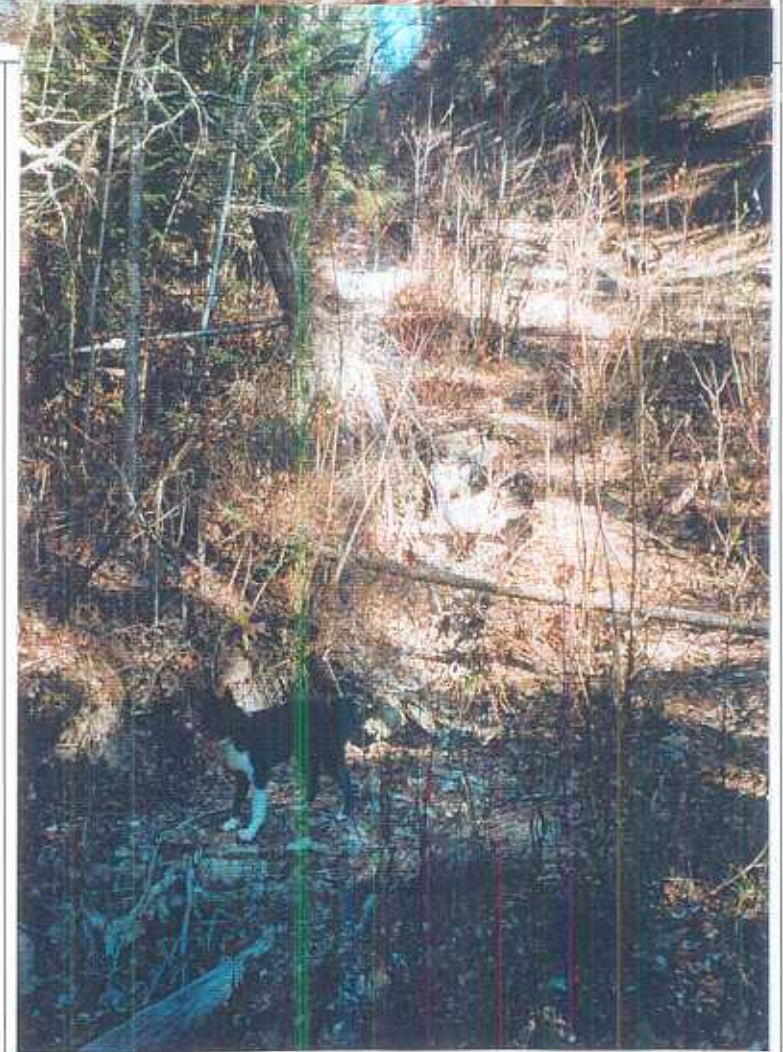
Photo Plate 25 (right). Steep access following Freeman Brook up to storage ponds. Note scoured channel.

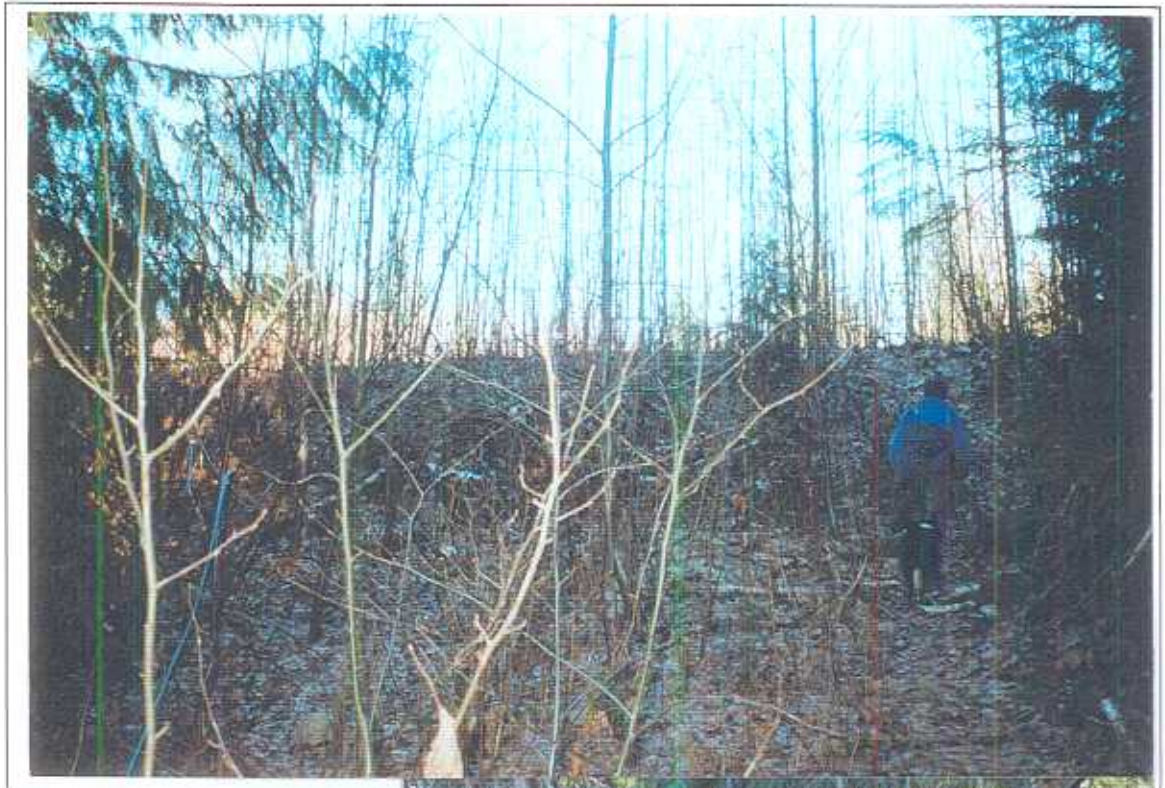
Immediately at the top of the access trail was the first of two storage ponds (Photo 26). A section of corrugated steel culvert was provided as an overflow from the ponds in the direction of Freeman Brook (Photo 27). The main purpose of the culvert appeared to be the protection of the berm from erosion in the event of overflows, preventing a rapid failure of the berm. Regular releases of water from the ponds into Freeman Brook were not apparent. Other than this overflow, no surface water connection was found to exist from the ponds into lower Freeman Brook.

Photo Plate 26 (above). Berm constructed to create storage ponds at the top of Freeman Brook. Note waterlines.

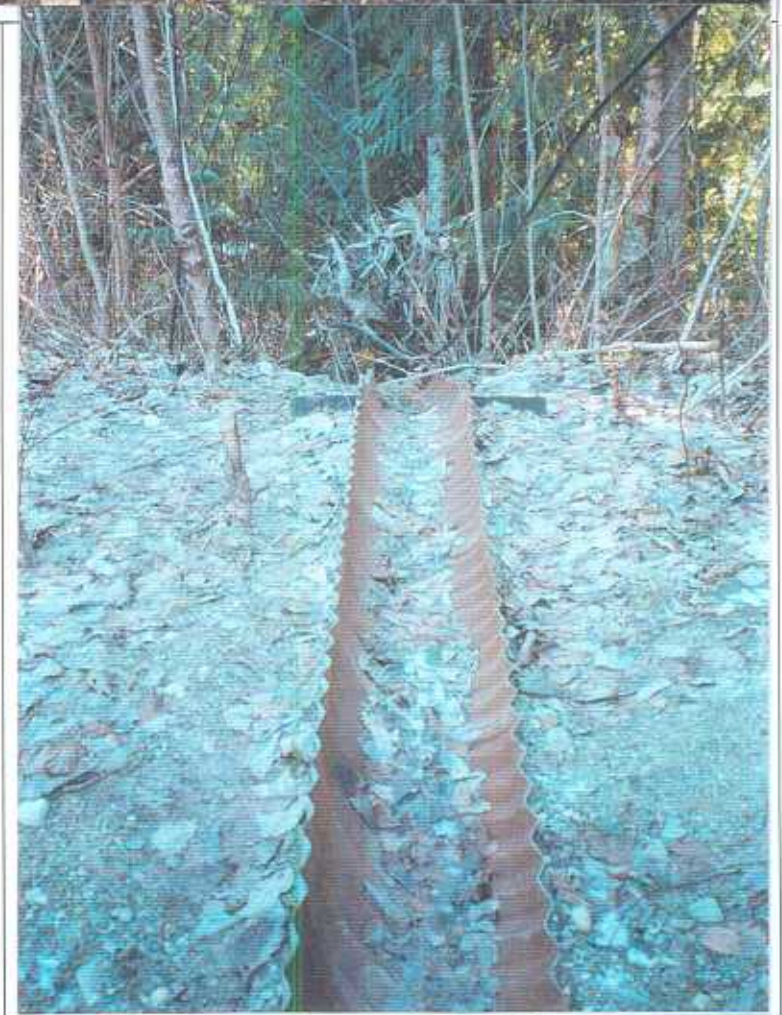
Photo Plate 27 (right). Culvert section used as overflow from ponds into upper Freeman Brook.

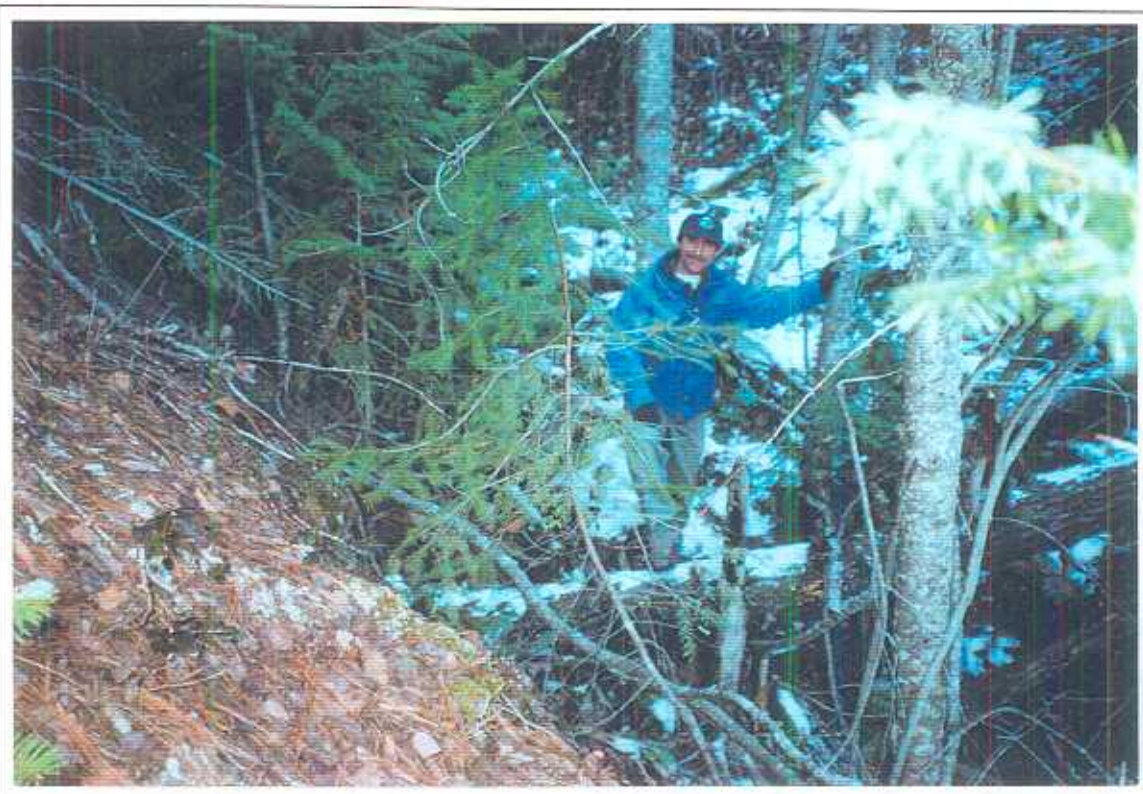
Photo Plate 28. Natural (dry) draw connecting storage ponds to Corning Creek mainstem (unmapped).

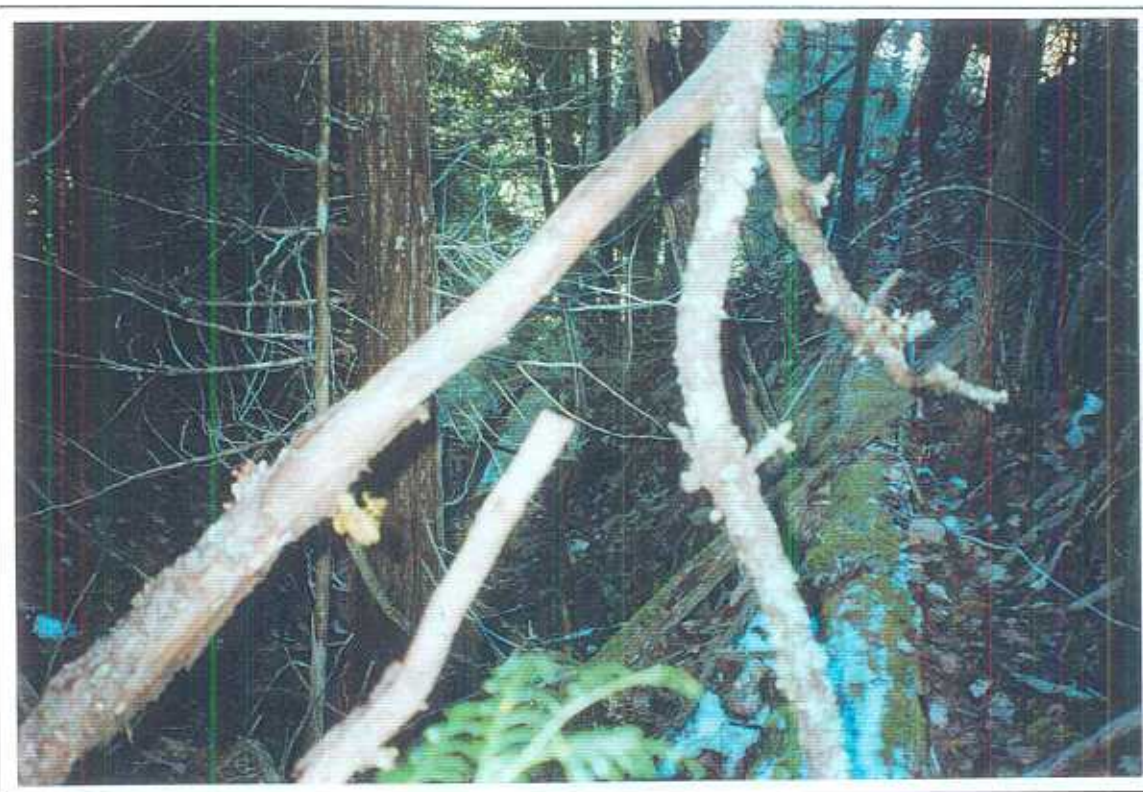
Photo Plate 29. Natural (dry) draw connecting storage ponds to Corning Creek mainstem (unmapped).
