### **WATERSHED RESTORATION PROGRAM**

# **MIDDLE SHUSWAP RIVER WATERSHED STREAM ASSESSMENT**

#### **Project 511.03**

March 28, 1996.

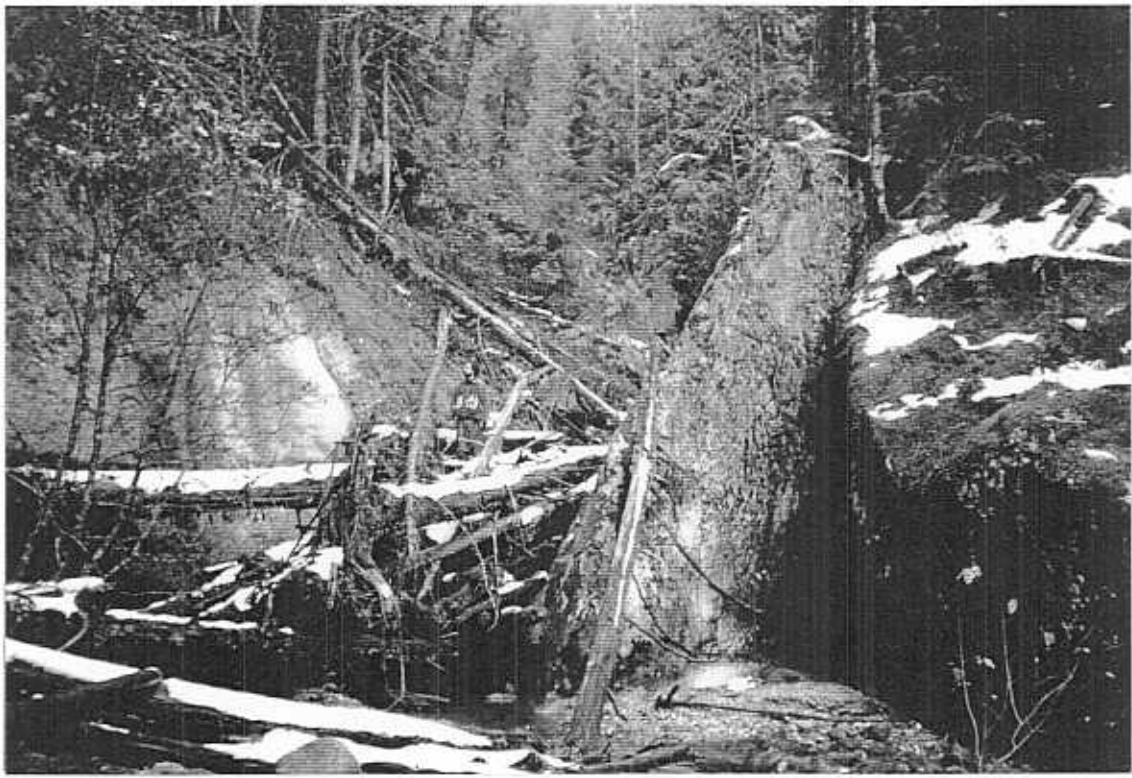
**Photo 1.** Debris jam on the right bank jammed between the boulders and the bank.  
**Stream Name:** Tsuius Creek      **Site #:** 4      **Reach #:** 2  
**Coordinates:** 50°37'19N 118°39'53W      **Code:** Fb/Q•D•N•3

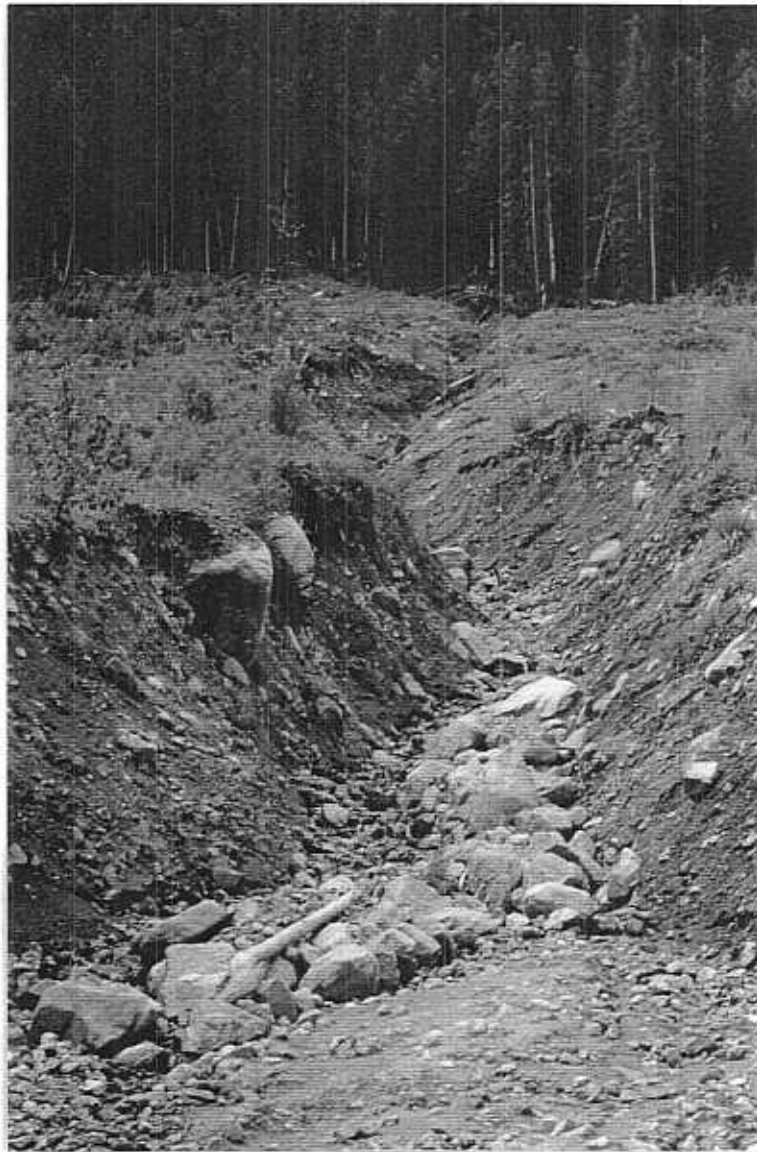
Site #3	Large landslide track. The slide likely pre-dates forest harvest, but harvest and/or road building appears to have re-activated it. Evidence of surface erosion and minor instability. Road over slide track apparently needs frequent repairs.
---------	---

Photo 1. Landslide track at Site #3, Hound Creek, looking upslope from the road.

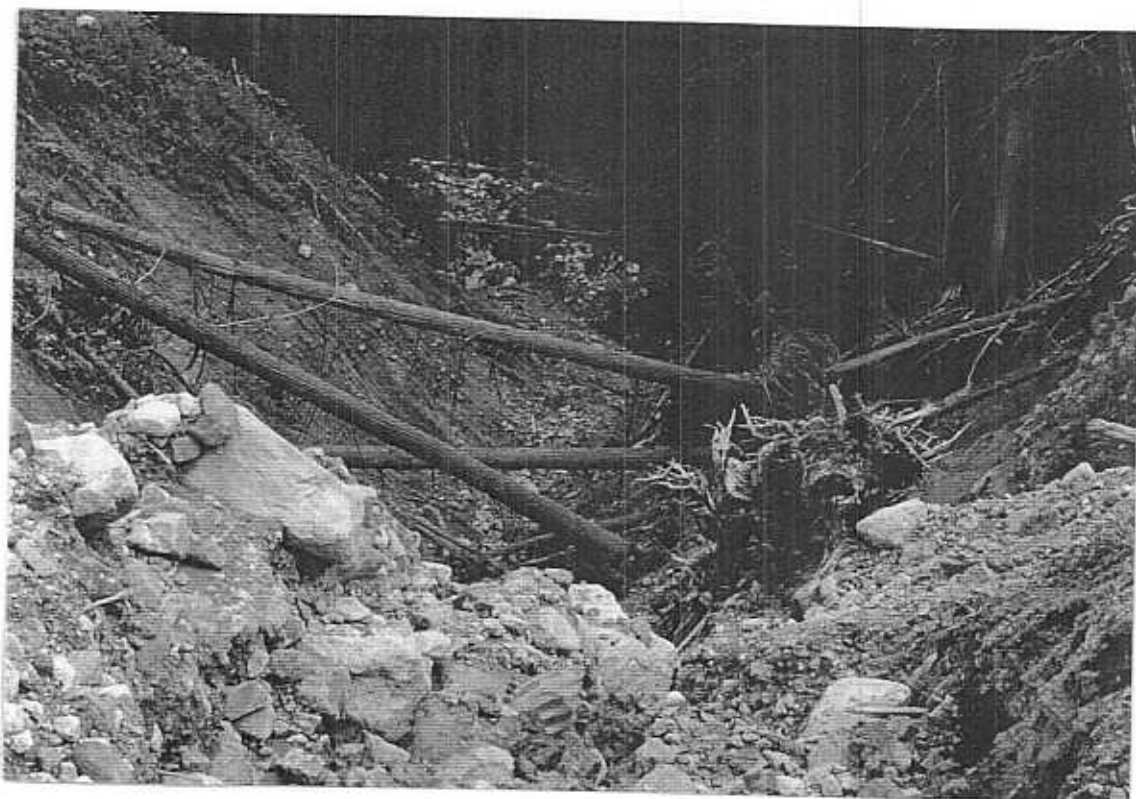
Photo 2. Landslide track looking downslope towards Hound Creek. Note culvert remanants in the foreground.

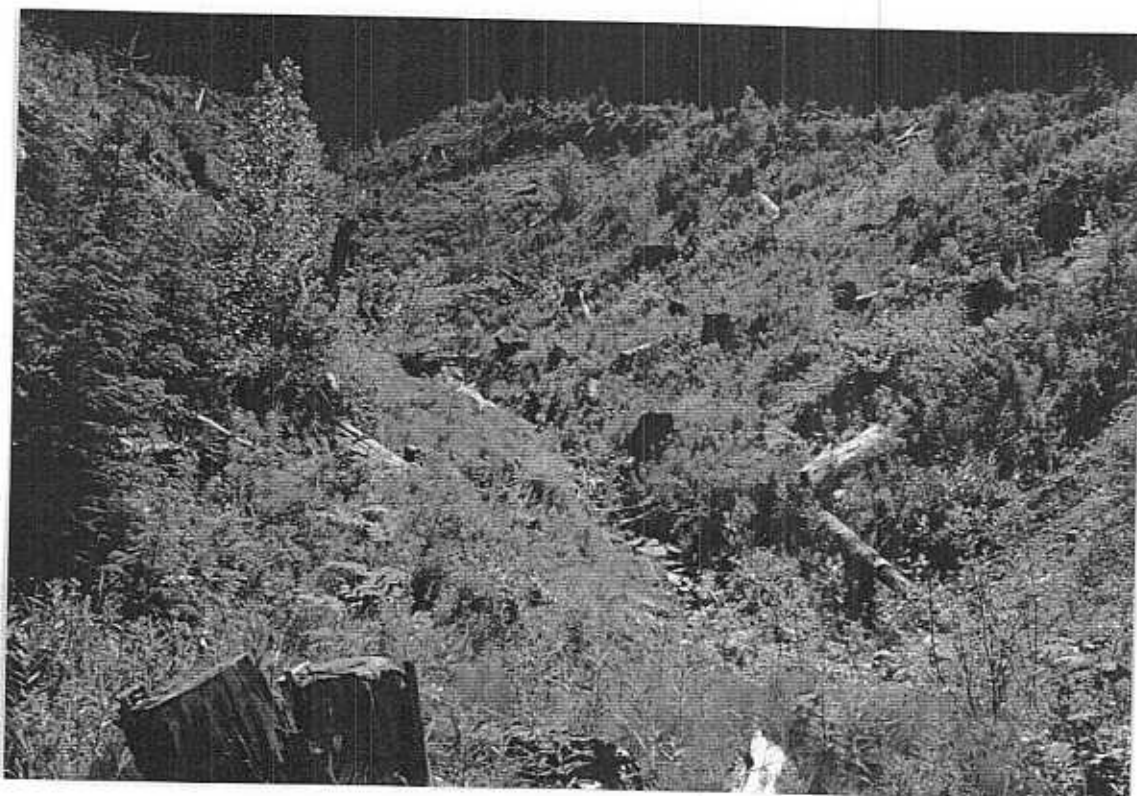
Photo 3. Stable landslide track to the east of one shown in Photos 2 and 3.

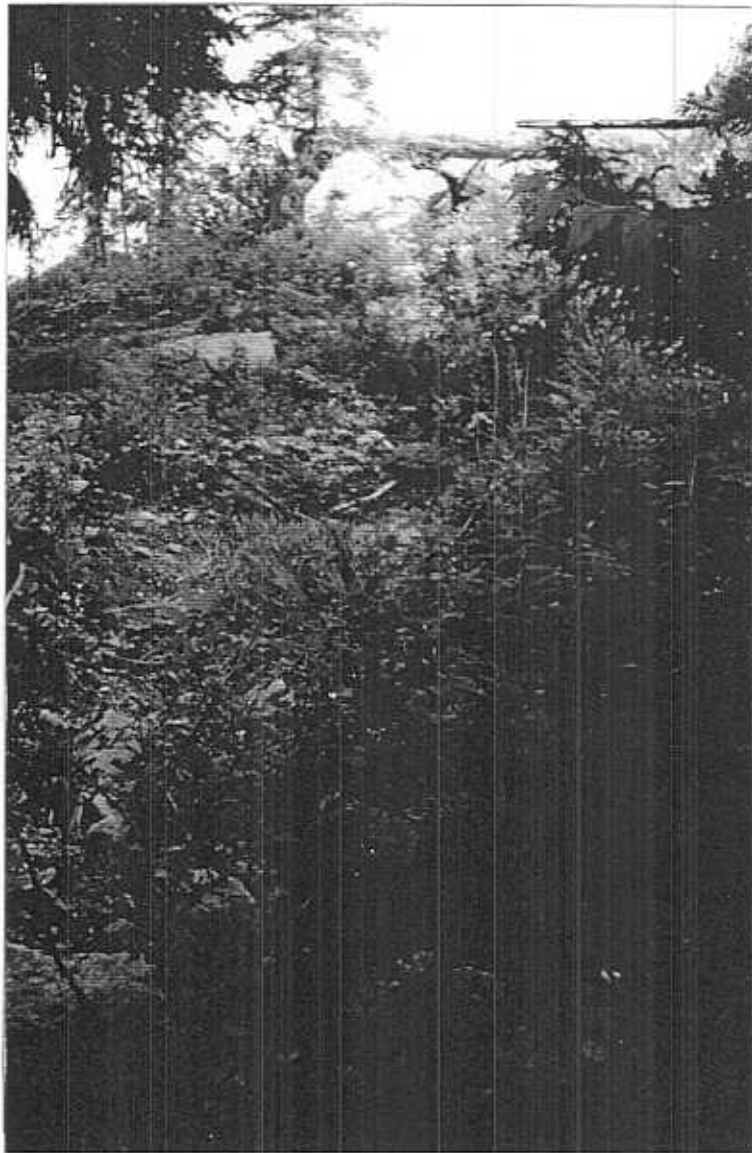
**Photo 1.**

Exposed old road fill-slope with some gravels/boulders reaching the right bank of stream.

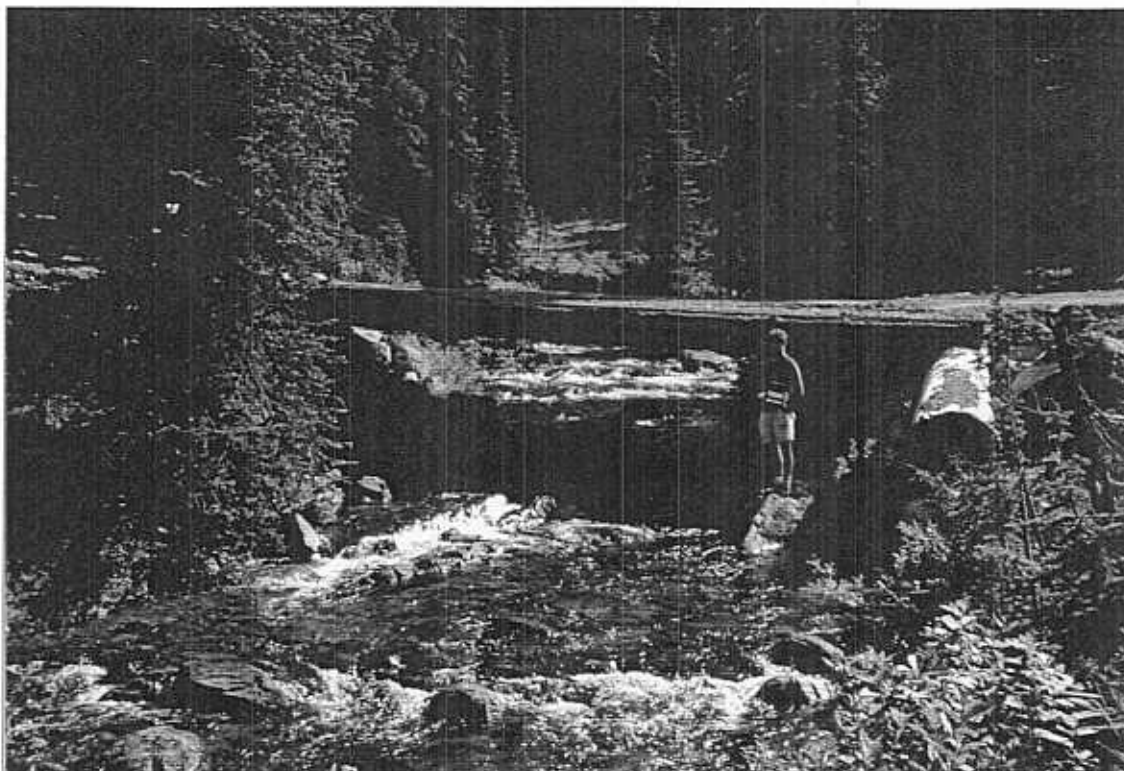
A relatively recent bridge crosses Whip Creek at this site to access cutblocks in the headwaters area of Whip Creek. The bridge is constructed of two old steel flatbed railway cars with wood decks which span across the channel (Photo 2). The bridge deck is in poor condition and there are several holes through the deck where sediment is being transported to the creek. There is a gap in center portion of the bridge, where the two railway cars are joined, that also permits sediment to enter the creek. There has been some erosion of the road surface that has entered the creek along the left bank. The input of fine sediments from the bridge and the adjacent road may affect downstream spawning habitat.

Photo 2. Steel-span (railway cars) bridge with rotting wood deck and erosion of road surface, u/s view.

The bridge should be repaired to meet the standards of the *Forest Practices Code*. As well, the road should be repaired and adjacent exposed soils seeded to minimize erosion.

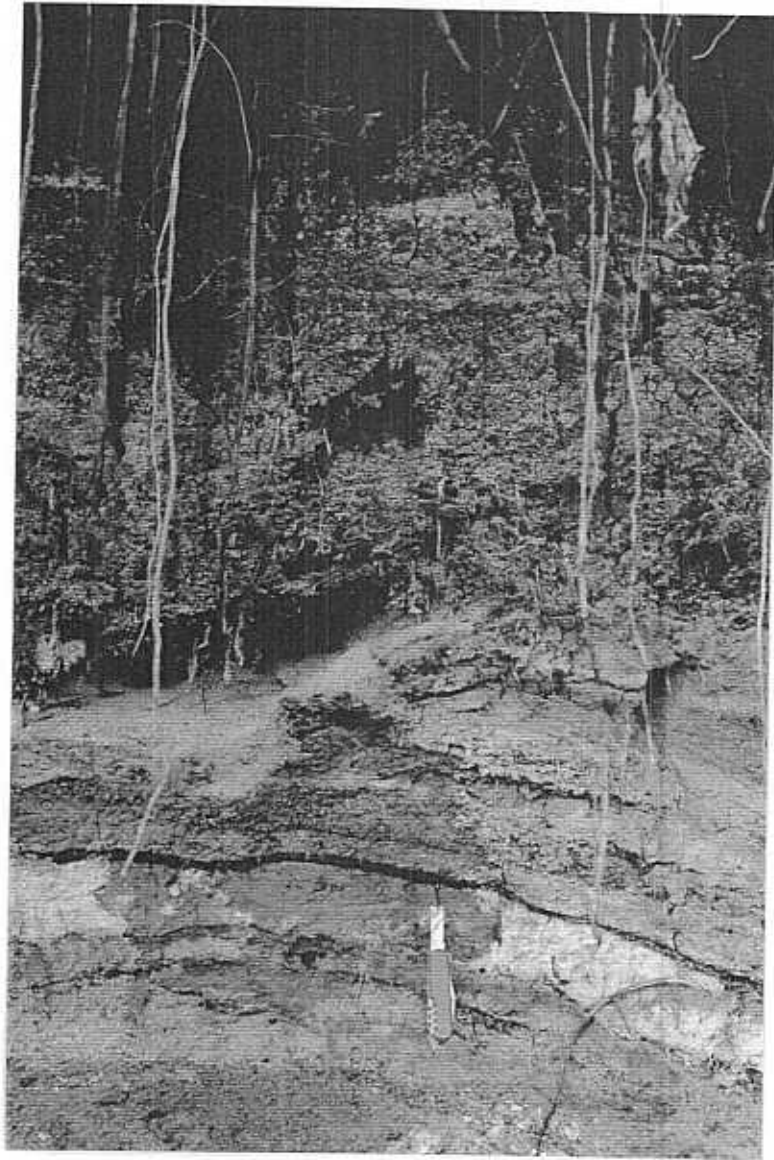
Photo 1. Streambank at Site #4 showing interbedded layers of sand and peat. Note charcoal layers indicating historic fire.

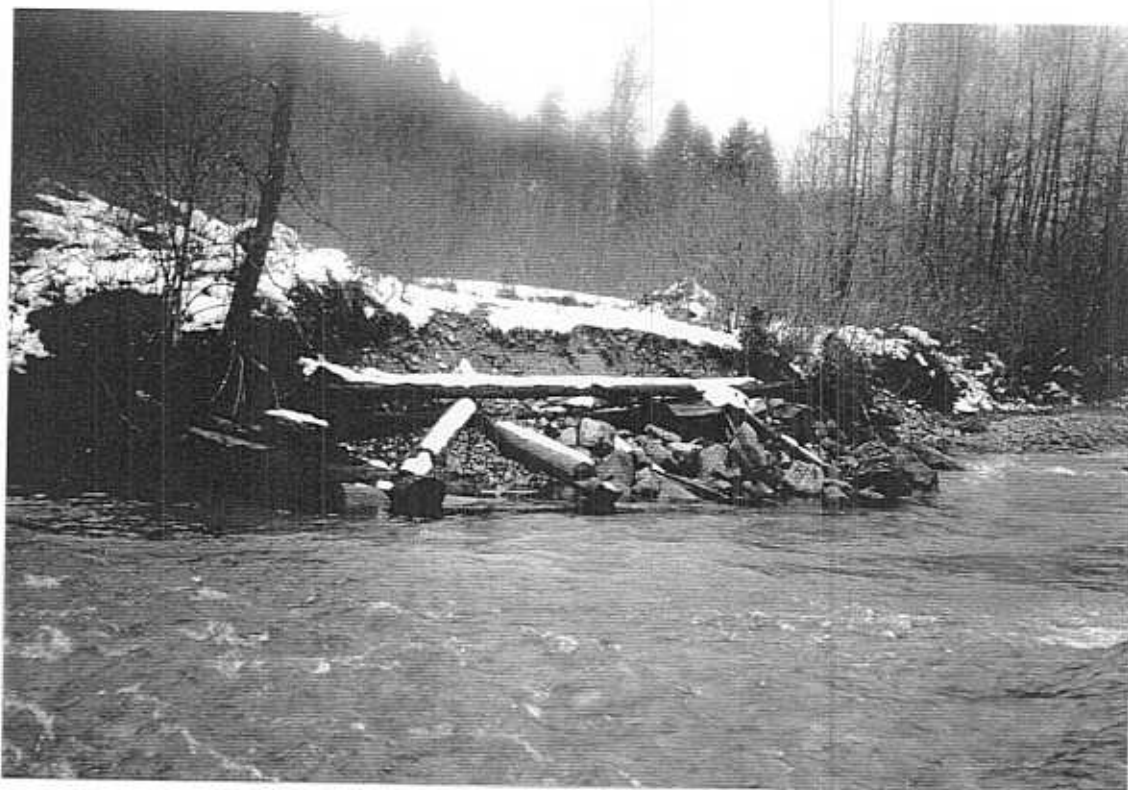
Photo 2. Wap Creek: Washed out bridge abutments at Site #4.

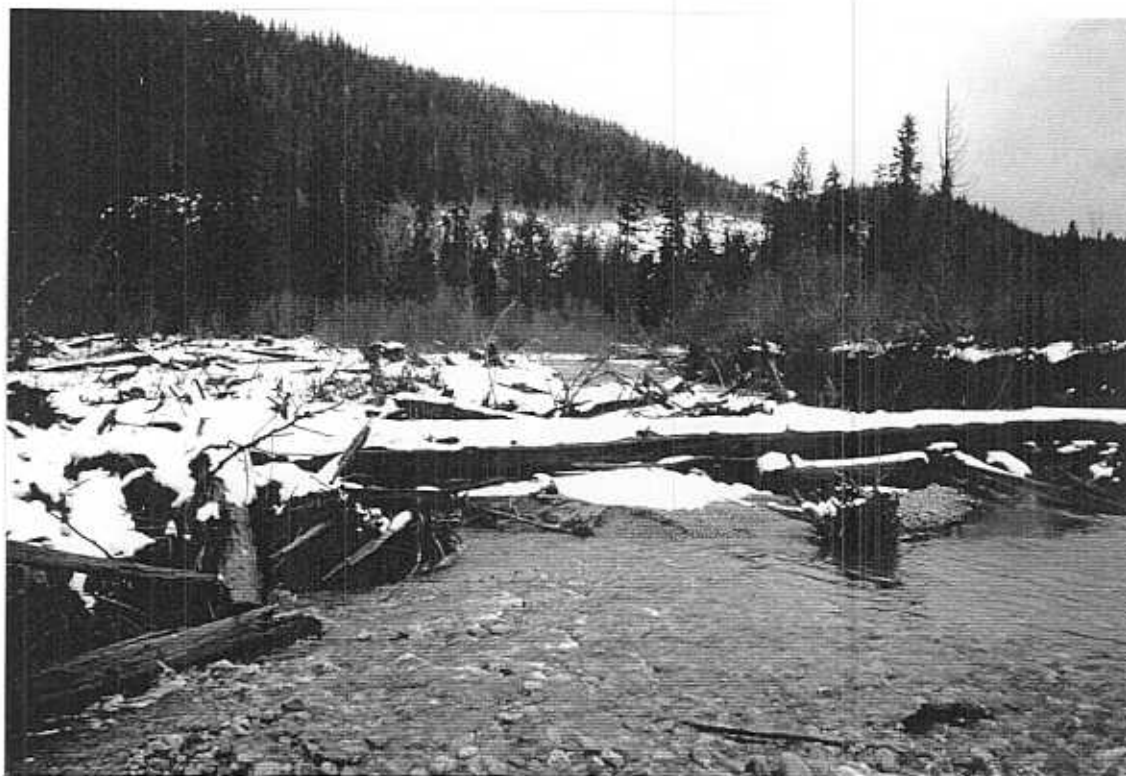
Photo 3. LWD scattered across channel at Wap Creek Site #4. Note eroding bank at right.

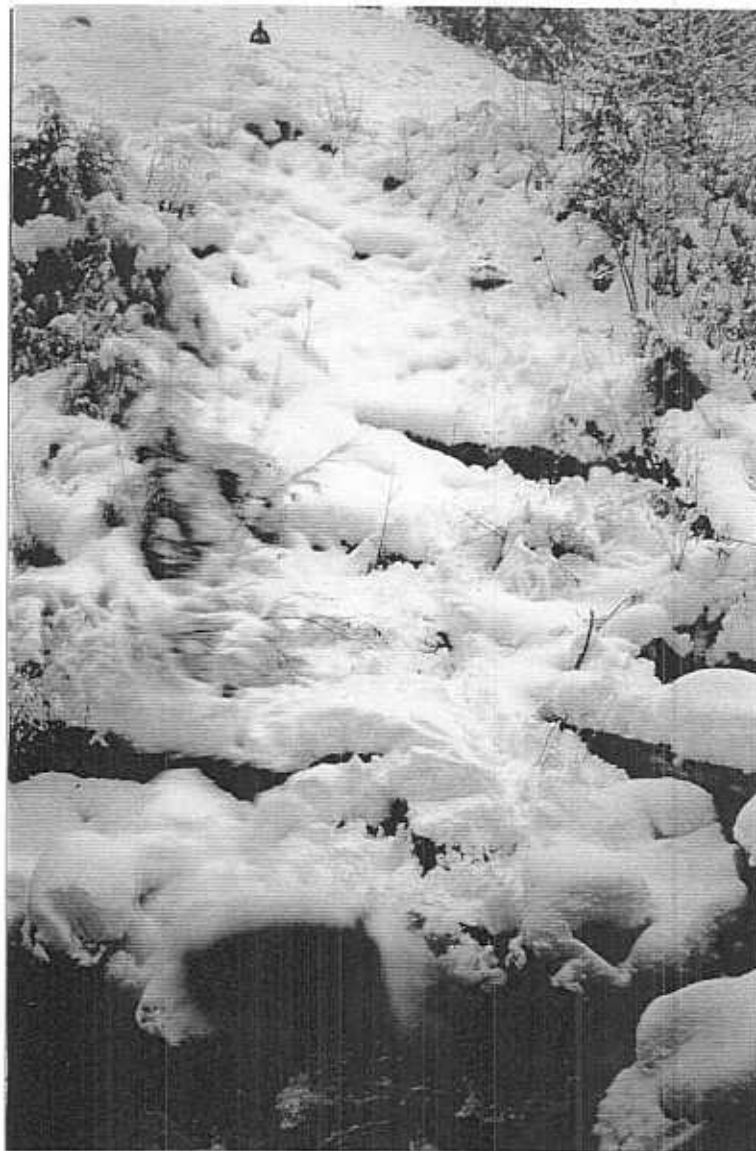
**Photo 4**

Hill slump originating at the road 20 m above the channel on the left bank.

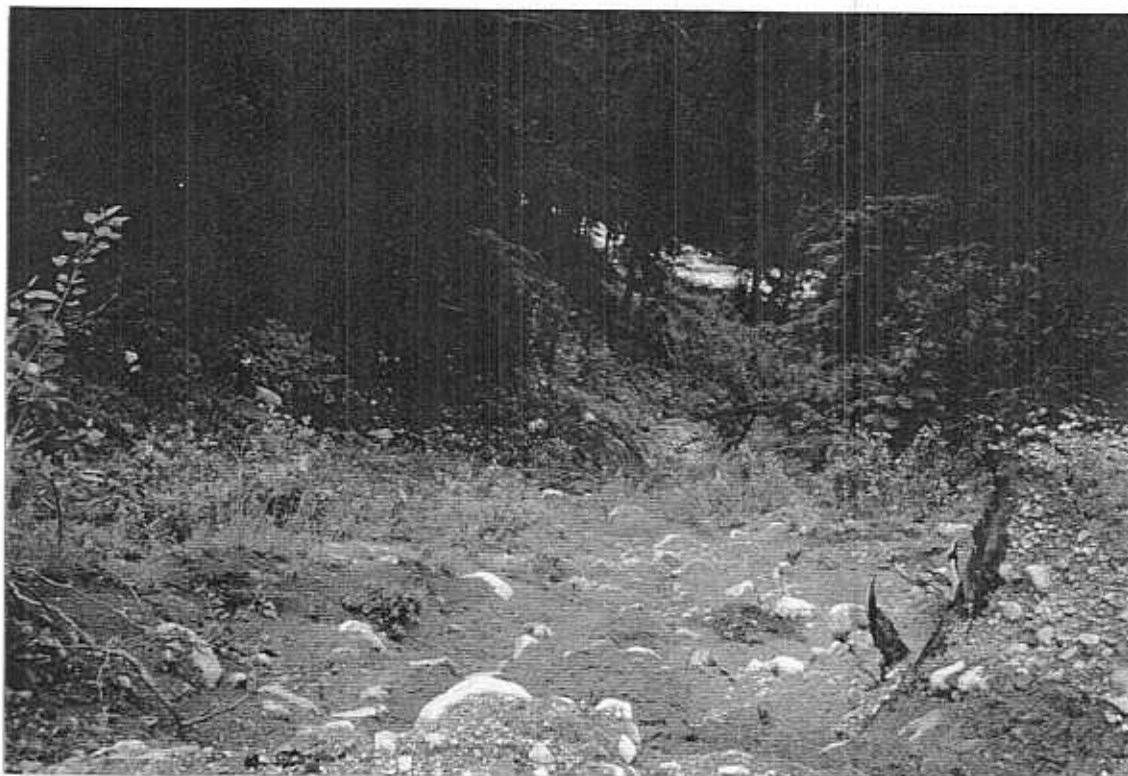
Photo 5

A large debris flow has initiated from the newer forestry road, impacting the right bank of Wap Creek at this site (Photo 5). The debris flow occurred through colluvial surficial materials overlying bedrock on a steep side slope (70-80%). The failure appears to have initiated at the road fill, as there was no evidence of instability in the road bed. The debris flow traveled approximately 100 m downslope before it started to deposit a large fan of debris along the right bank and into the channel (Photo 6). The debris did not appear to impact the left bank, however a lobe of sediment and LWD has been deposited in the channel. The LWD has created some large (1 m) waterfalls which may form a barrier to fish migration. There has been some localized bank erosion and scouring of the channel bed to accommodate flows through the debris. There is potential for good rainbow trout fish habitat at this site, however fish may not be present at this site due to possible barriers downstream at sites #28 and #30. No fish were observed when the site was inspected.

Slide from the road with some active erosion and some regeneration of vegetation.

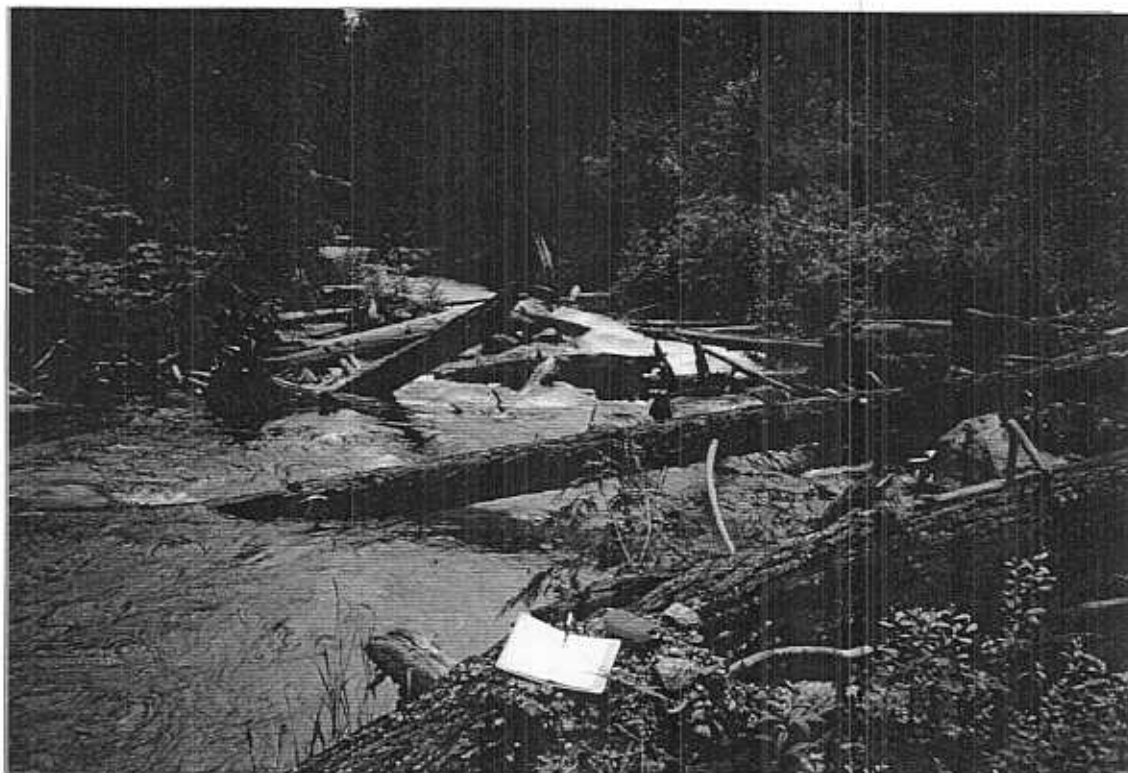
Photo 6

Debris jam at the base of the slide with much of the debris being unstable, d/s view.

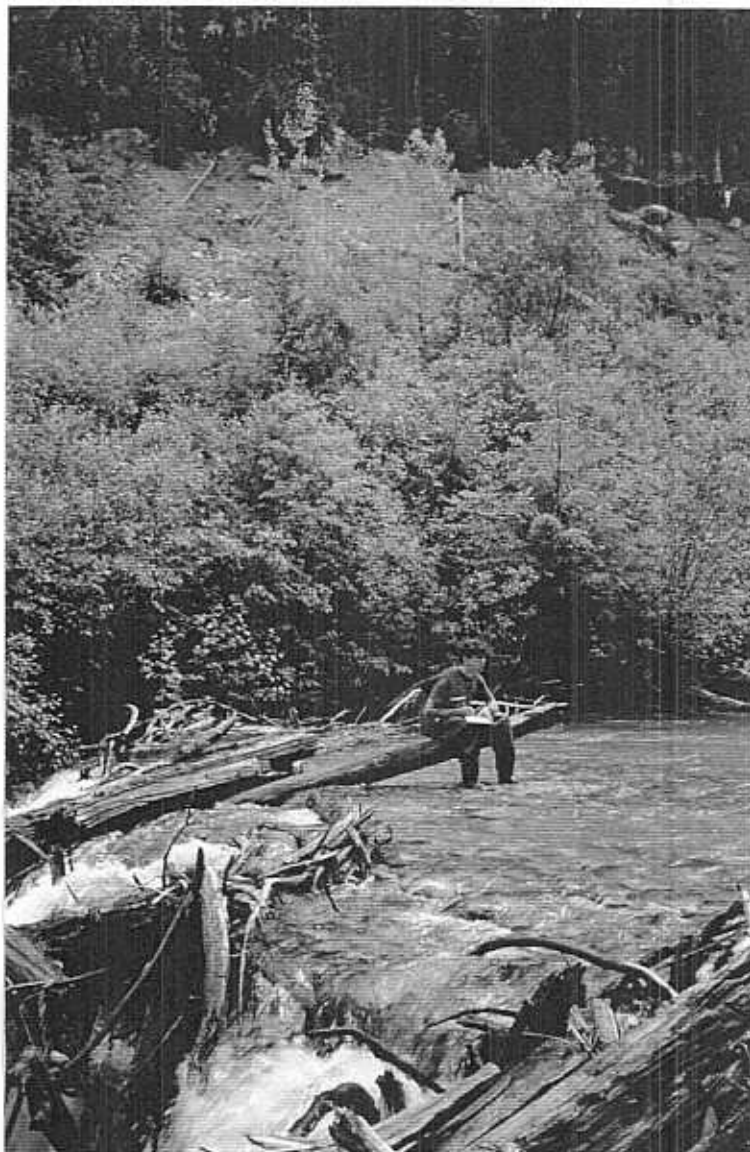
**Photo 7**

Debris jam (2 m high) with accumulation of sediment and channel widened to 20 m.

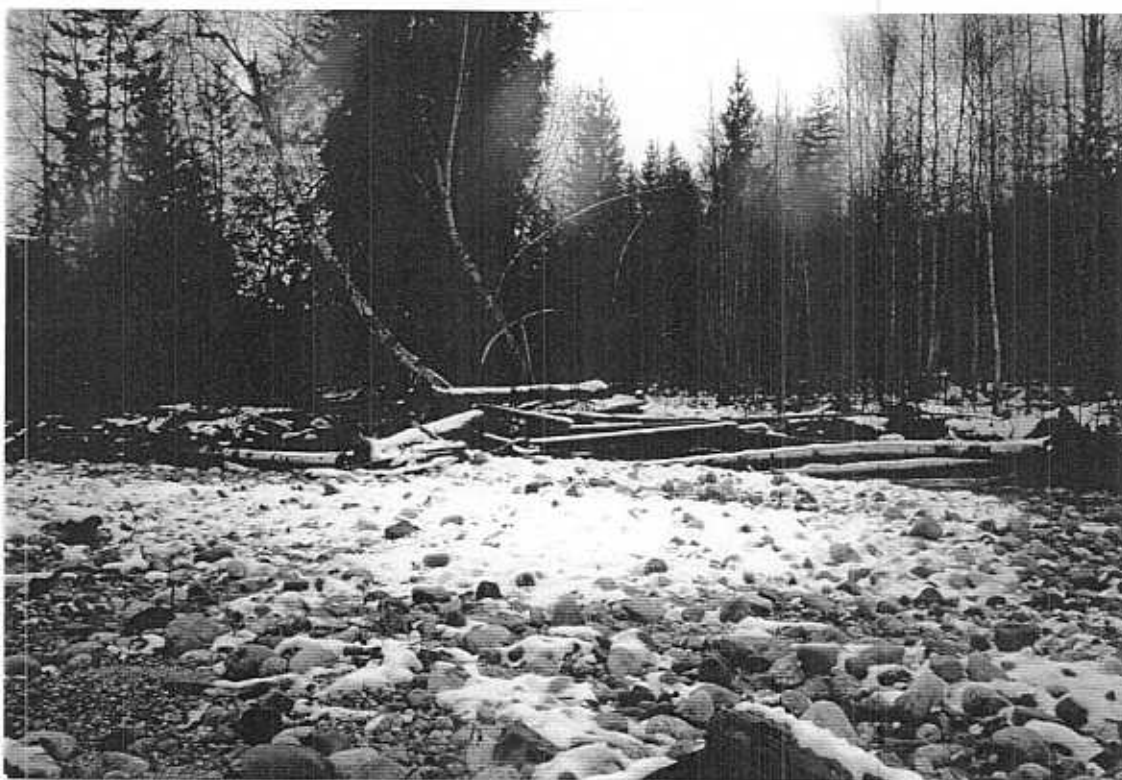
Impacts at Site #3 consist of one large debris jam and a substantial amount of LWD scattered throughout the (Photo 1, Appendix VIII) for a distance of about 400 m. Photo 2 shows the eroding left bank immediately adjacent to the floodplain. Most of the debris appears unstable. The debris piles have apparently caused scouring out of some deep pools and accumulations of gravel and sand deposits.

Photo 1. Kingfisher Creek Site #3: Debris jam (approx 20 m wide).

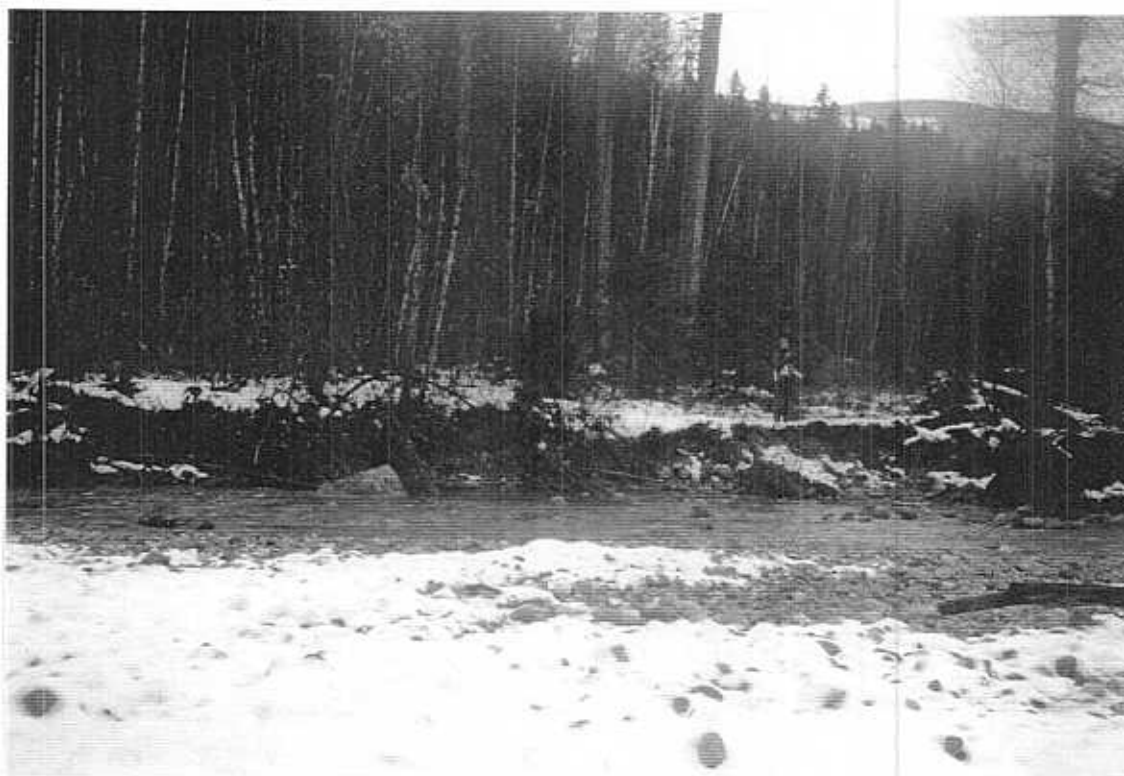
Photo 2. Eroding left bank at Site #3.

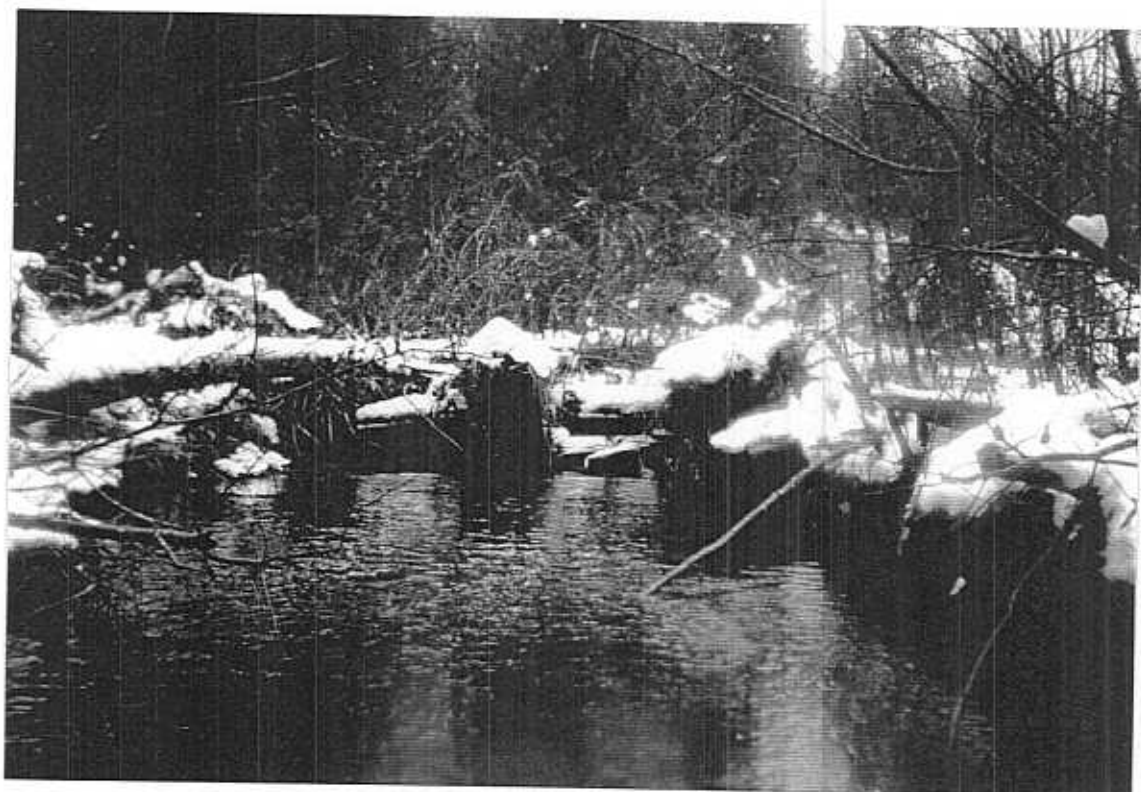
Photo 3. Debris jam at the downstream end of an island, blocking the main channel.

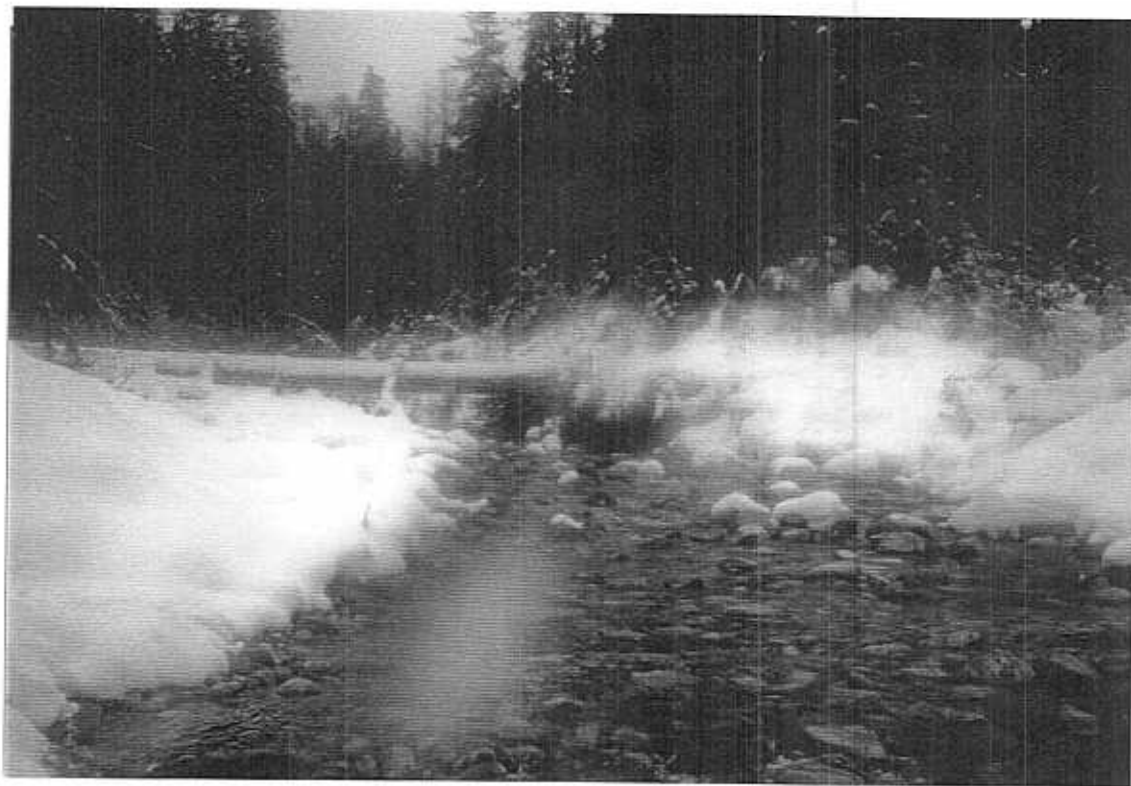
**Photo 4** LWD across the channel 50 m upstream from the bridge crossing, upstream view.  
**Stream Name:** Kingfisher Creek **Site #:** 23 **Reach #:** 5  
**Coordinates:** 50°44'41N 118°44'13W **Code:** Fb/Q•D•N/F•2

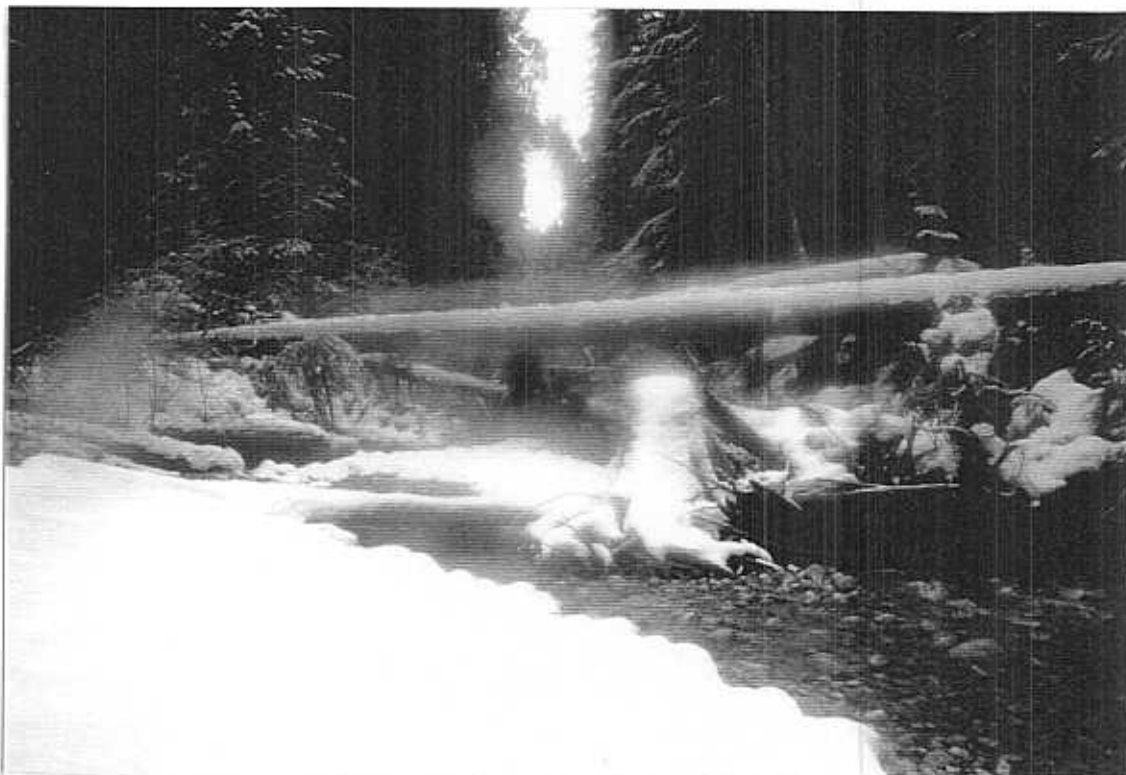
Site #25 was initially assigned an F•2 code from the video. It was visited in the process of trying to access Site #23. The large amount of LWD in the channel (Photo 5) that was of logging origin warranted changing the classification to F•1. These accumulations of LWD have caused large amounts of gravel and cobbles to be deposited upstream of the debris. If the debris mobilizes, a flush of sediment could be released downstream. Some of the debris is natural in origin, probably originating from the eroding banks. The cut block along the left bank has approximately 20 years of regeneration and has a buffer retained along its length.

**Photo 5** LWD at the upstream end of the cutblock with a logged stump in the middle of the channel, downstream view.  
**Stream Name:** Kingfisher Creek **Site #:** 25 **Reach #:** 5  
**Coordinates:** 50°42'62N 118°45'29W **Code:** Fb/Q•D•F•1

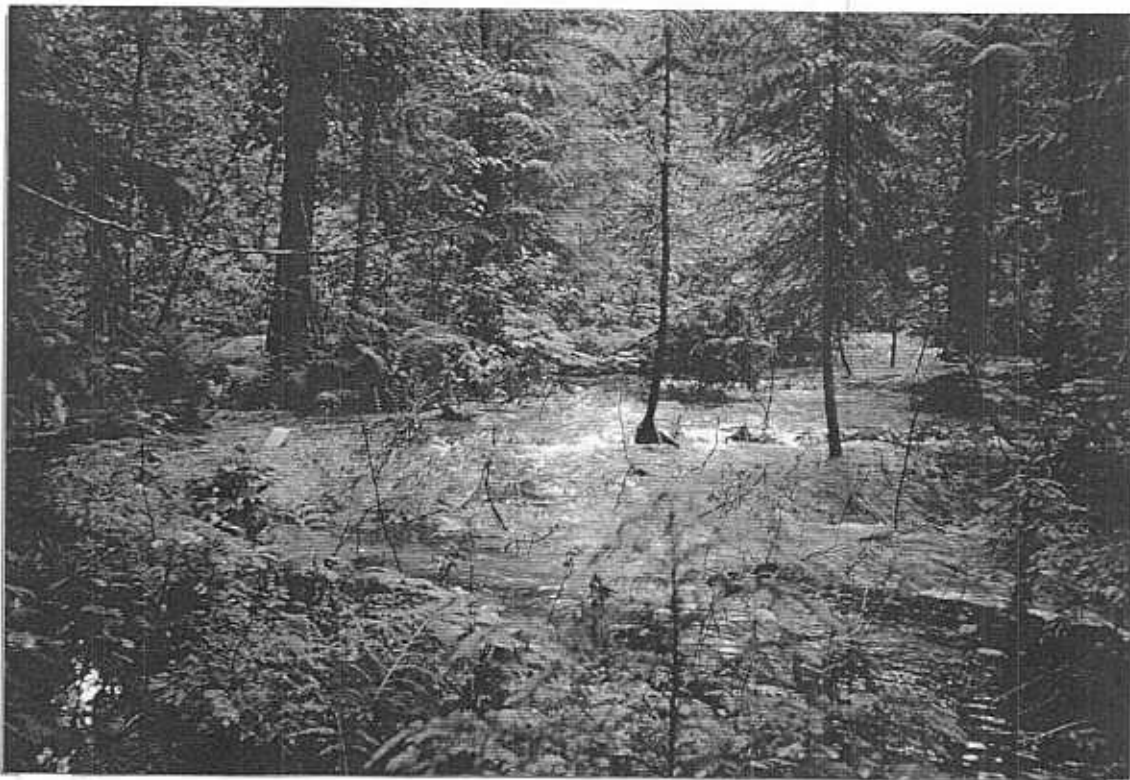
**Photo 6** Stream flowing through the forest as a result of a debris jam u/s, u/s view.  
**Stream Name:** Kingfisher Creek **Site #:** 28 **Reach #:** 5  
**Coordinates:** 50°43.47' 118°45.26' **Code:** Fb/Fs/Q•D•F•1

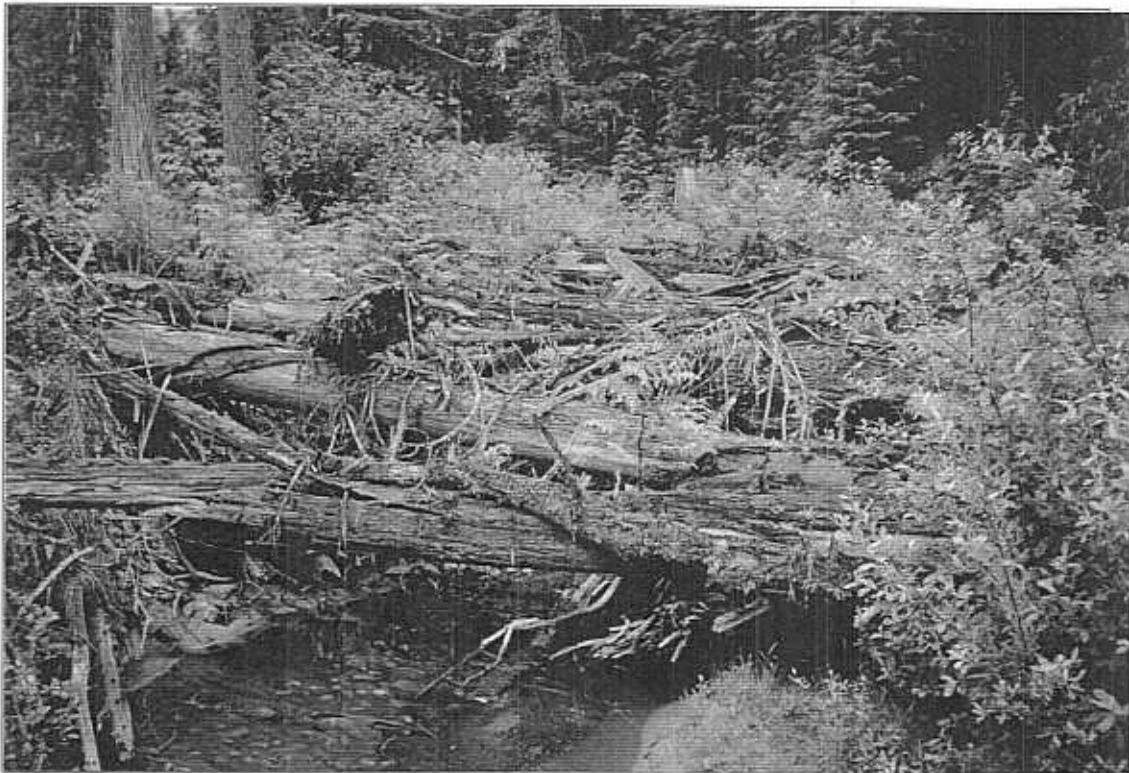
**Photo 7** Substantial LWD blocking a side channel from the left bank of the main channel, u/s view.  
**Stream Name:** Kingfisher Creek **Site #:** 28 **Reach #:** 5  
**Coordinates:** 50°43.47' 118°45.26' **Code:** Fb/Fs/Q•D•F•1

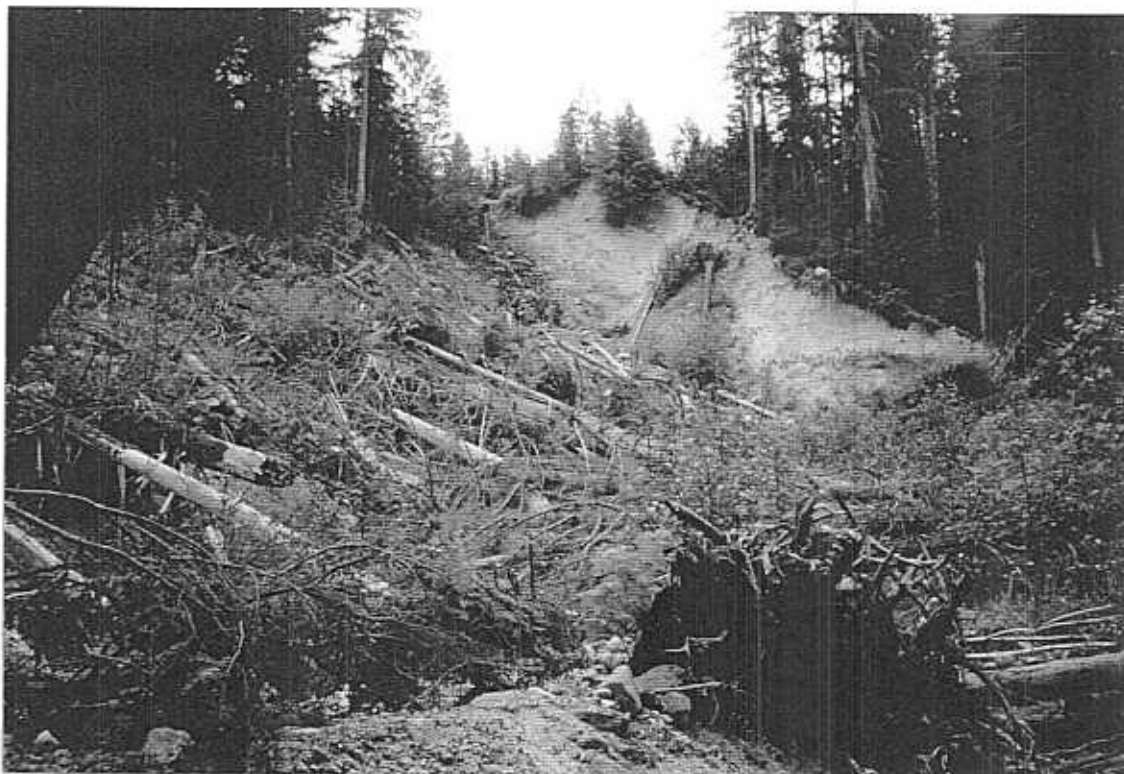
**Photo 1.** Debris and exposed bank associated with the slide at the culvert outlet, view from base of slide.  
**Stream Name:** Cooke Creek      **Site #:** 8      **Reach #:** 2  
**Coordinates:** 49°45.23'      119°20.19'      **Code:** Fb/Fs/Q•C•F•1

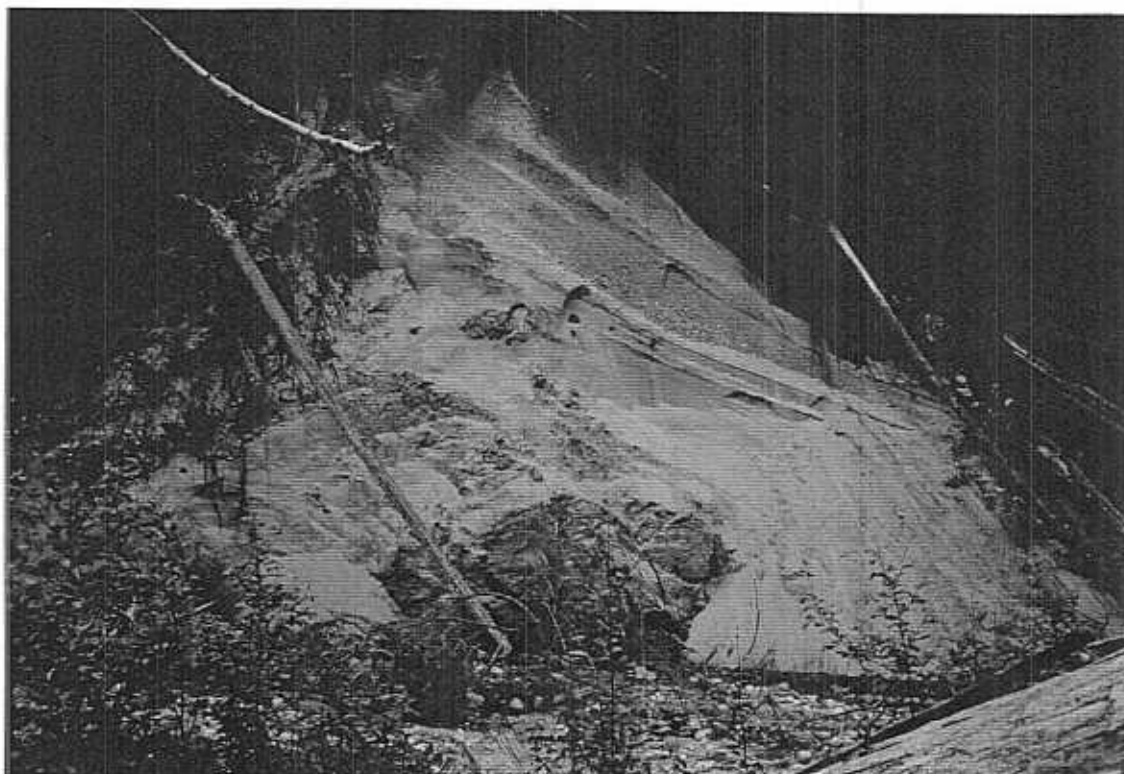
**Photo 2.** Actively eroding deposit (fines/gravels) at the base of the slide, approx. 30 m from the stream.  
**Stream Name:** Cooke Creek      **Site #:** 8      **Reach #:** 2  
**Coordinates:** 49°45.10'      119°20.20'      **Code:** Fb/Fs/Q•C•F•1

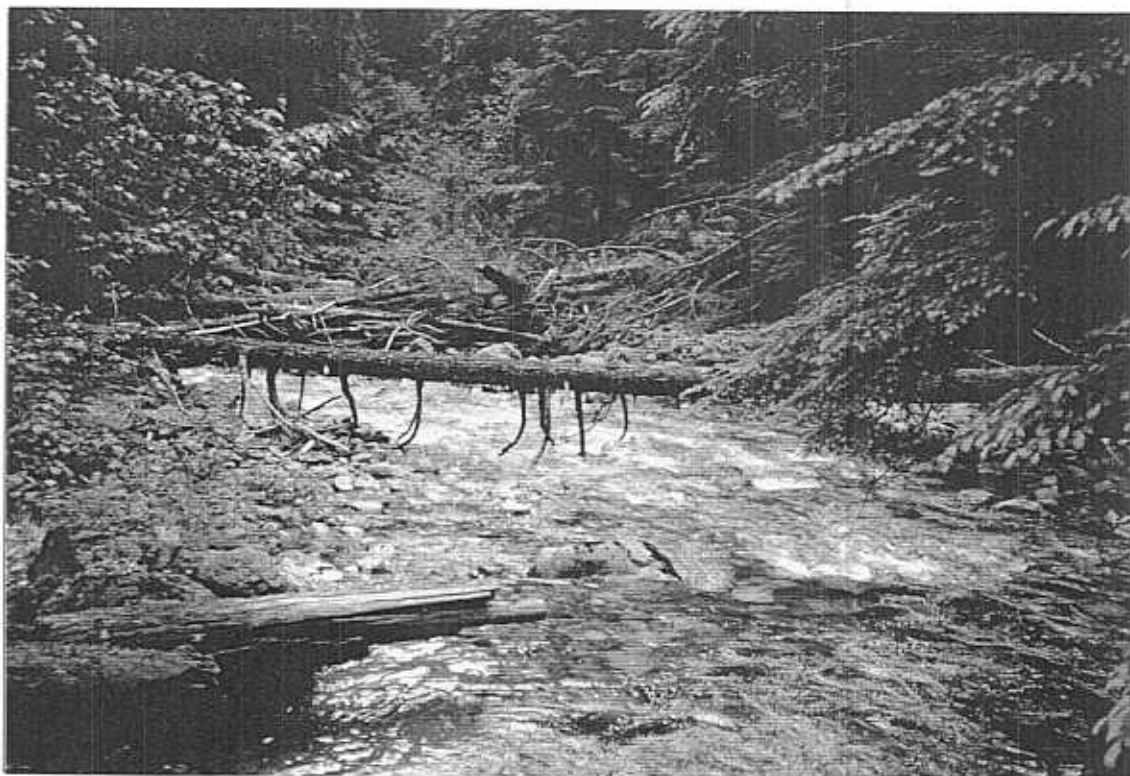
**Photo 3.** Debris jam on the right bank approximately 50 m d/s from the slide, d/s view.

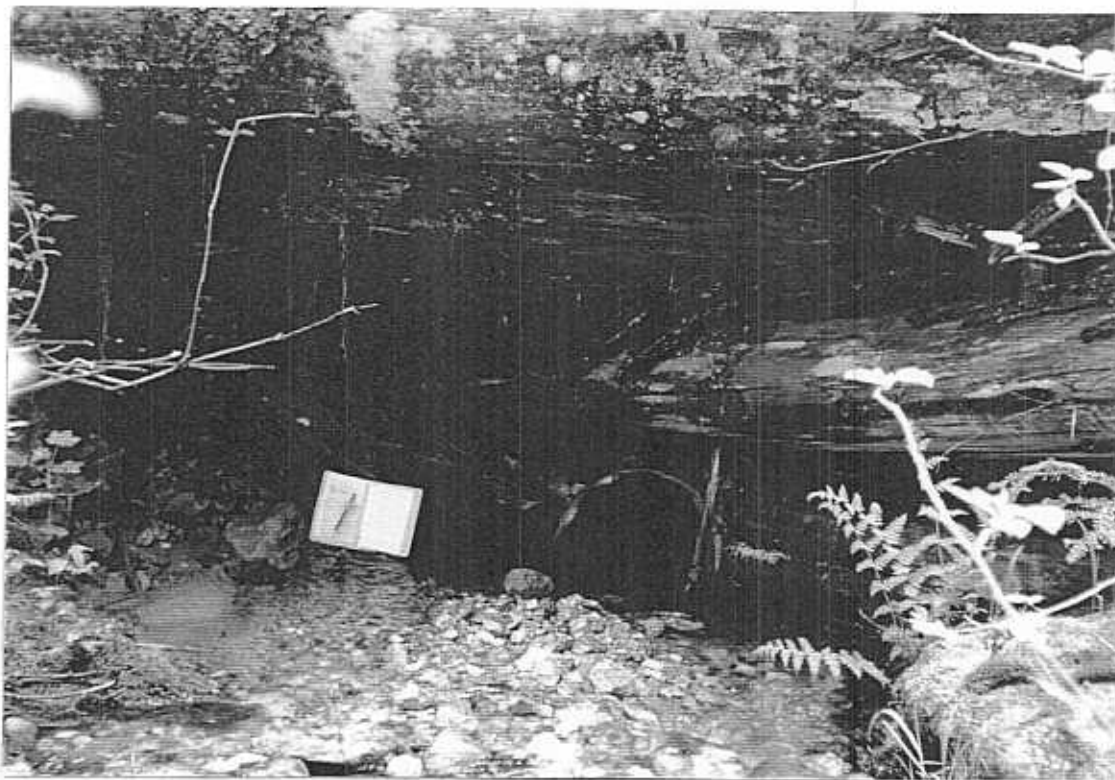
**Photo 1.** Culvert inlet with overlaying rotting wood and accumulation of gravel, d/s view.  
 Stream Name: Brash Creek Site #: 12 Reach #: 2  
 Coordinates: 49°45.23' 119°20.19' Code: Fs/Q•C•F•1
