### **WATERSHED RESTORATION PROGRAM**

# **MIDDLE SHUSWAP RIVER WATERSHED STREAM ASSESSMENT**

#### **Project 511.03**

March 28, 1996.

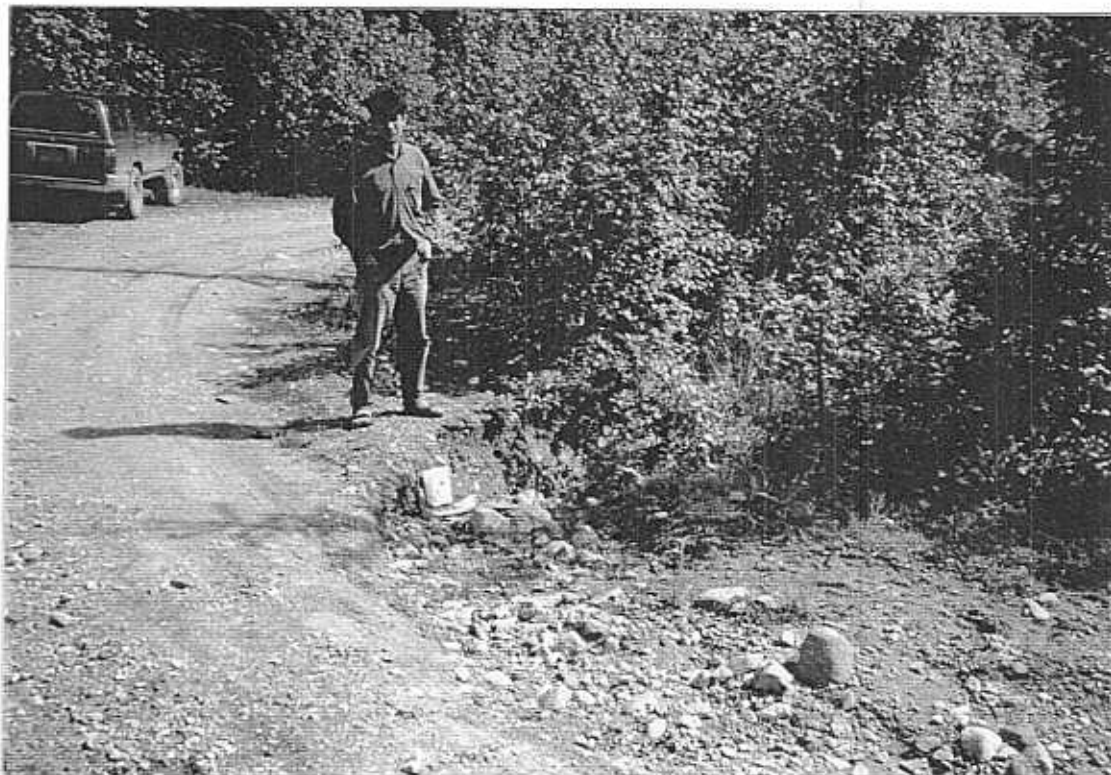
**Photo 2.** Erosion of the road surface adjacent to the d/s end of the culvert, d/s view.  
 Stream Name: Brash Creek Site #: 12 Reach #: 2  
 Coordinates: 49°45.10' 119°20.20' Code: Fs/Q•C•F•1

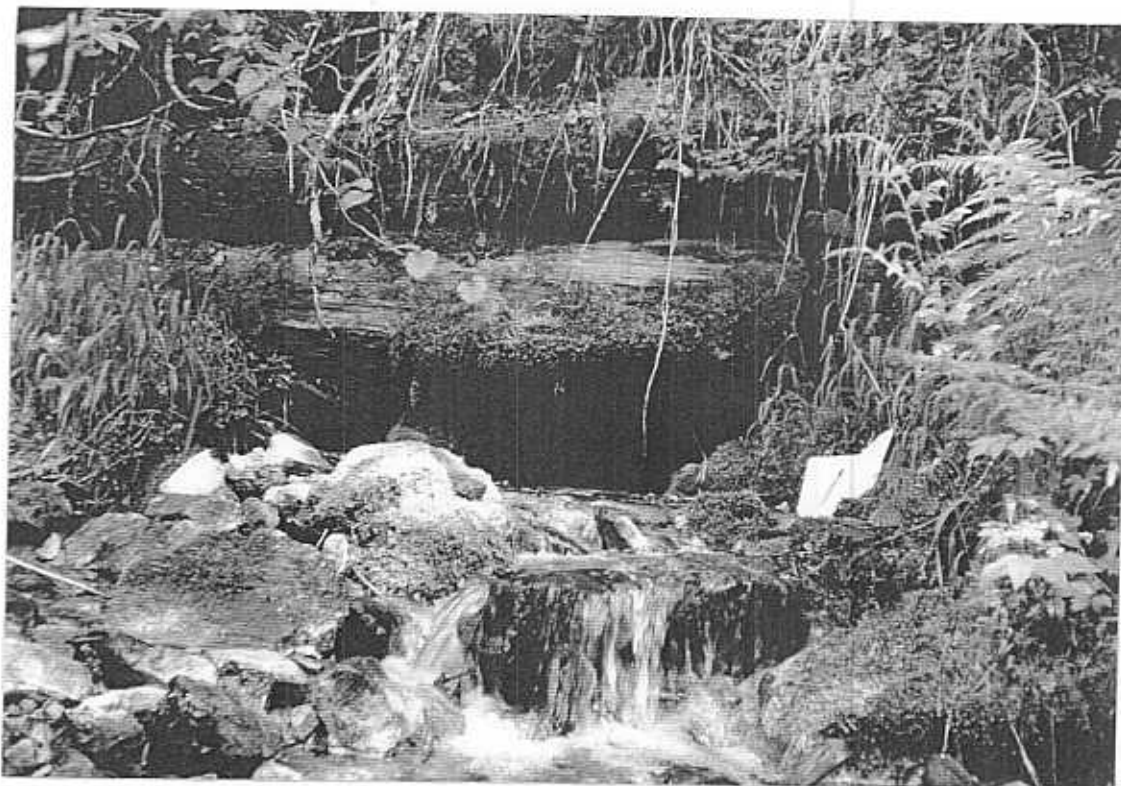
**Photo 3.** Culvert outlet with overlaying logs and restrictions on stream width and peak flow, u/s view.  
 Stream Name: Brash Creek Site #: 13 Reach #: 2  
 Coordinates: 49°45.23' 119°20.19' Code: Fs/Q•C•F•1

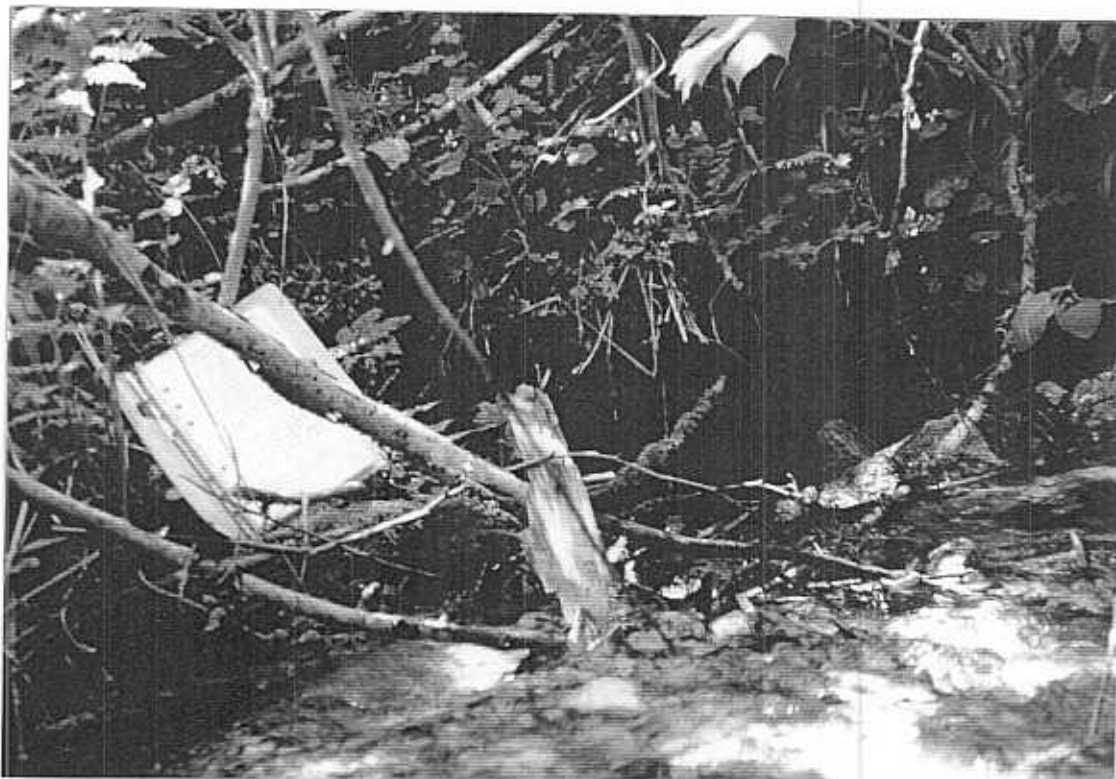
**Photo 4.** Restricted flow and partial blockage of the culvert inlet, d/s view.  
 Stream Name: Brash Creek Site #: 13 Reach #: 2  
 Coordinates: 49°45.10' 119°20.20' Code: Fs/Q•C•F•1
