**FINAL REPORT**

**WATERSHED ASSESSMENT:  
SITKUM, BOURKE, AND  
CLAYTON CREEKS**

**Project 039-04.02**

**November 2000**

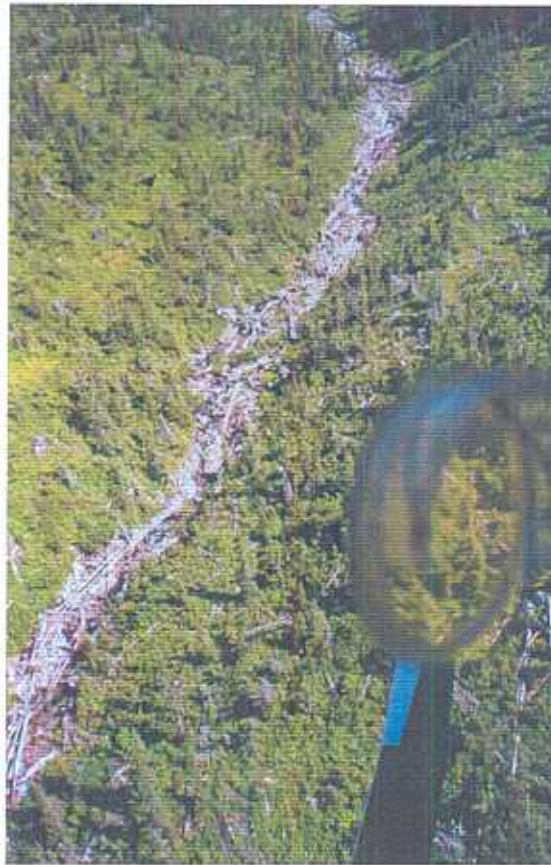
Steep terrain within the watershed has a high potential to deliver sediment and debris to the channel network, as evidenced by the amount of woody debris in the mainstem of Sitkum Creek derived from avalanche activity (Plate 5). A relatively high percentage of the terrain within the watershed has been identified as potentially unstable by Banting Engineering Ltd. (1996). Blocks and roads in these areas have experienced stability problems in the past, and proposed development must consider these factors in their layout and design. Specific recommendations for future development are given in Section 5.3.

Plate 5: Sitkum Creek Macro-reach I east. Step-pool channel with heavy debris loading from avalanche activity.  
Date: 02-Aug-2000                      Photograph 2-19

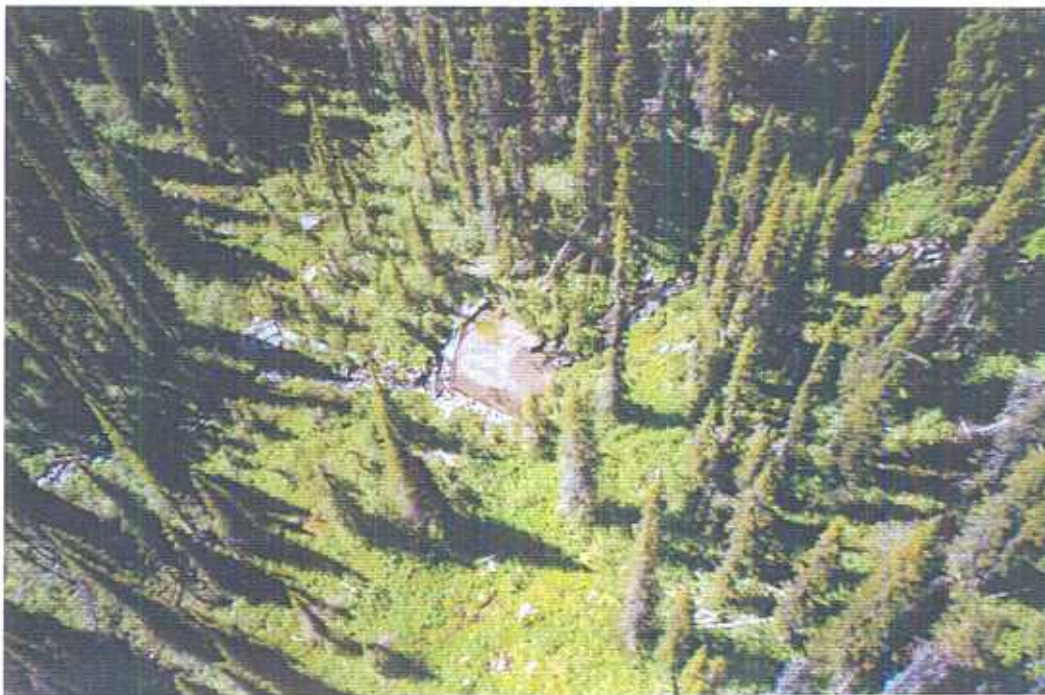
Plate 6: Sitkum Creek Macro-reach I west. Sediment accumulation at wooden weir.  
Date: 02-Aug-2000                      Photograph 2-25

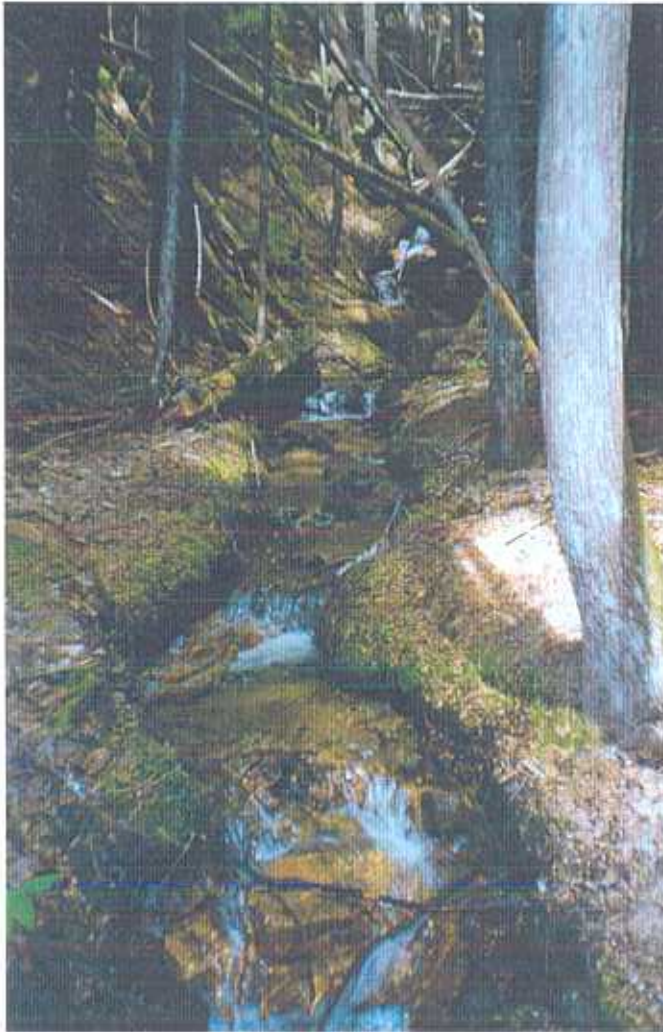
Plate 7: Bourke Creek Reach 3. Step-pool channel below toe of Slide B2. Note sand deposited on channel banks.  
Date: 04-Aug-2000      Photograph 5-15

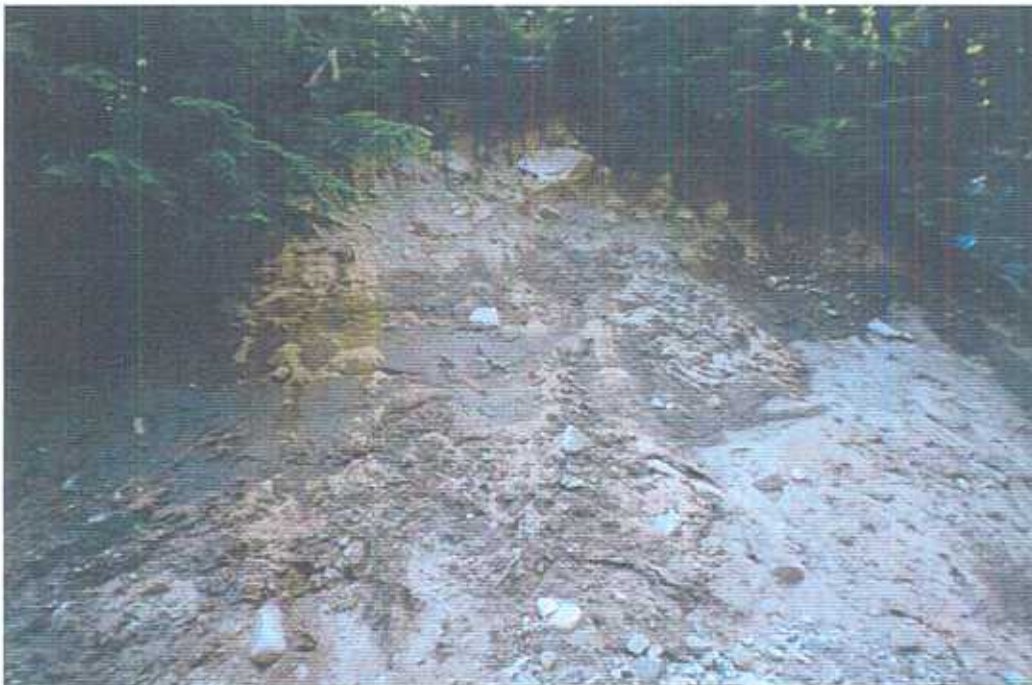
Plate 10: Road cutslope approximately 200 m upgrade of the Sitkum Creek road crossing. The seepage zone between sandy till and fine-grained glaciofluvial deposits is evident.

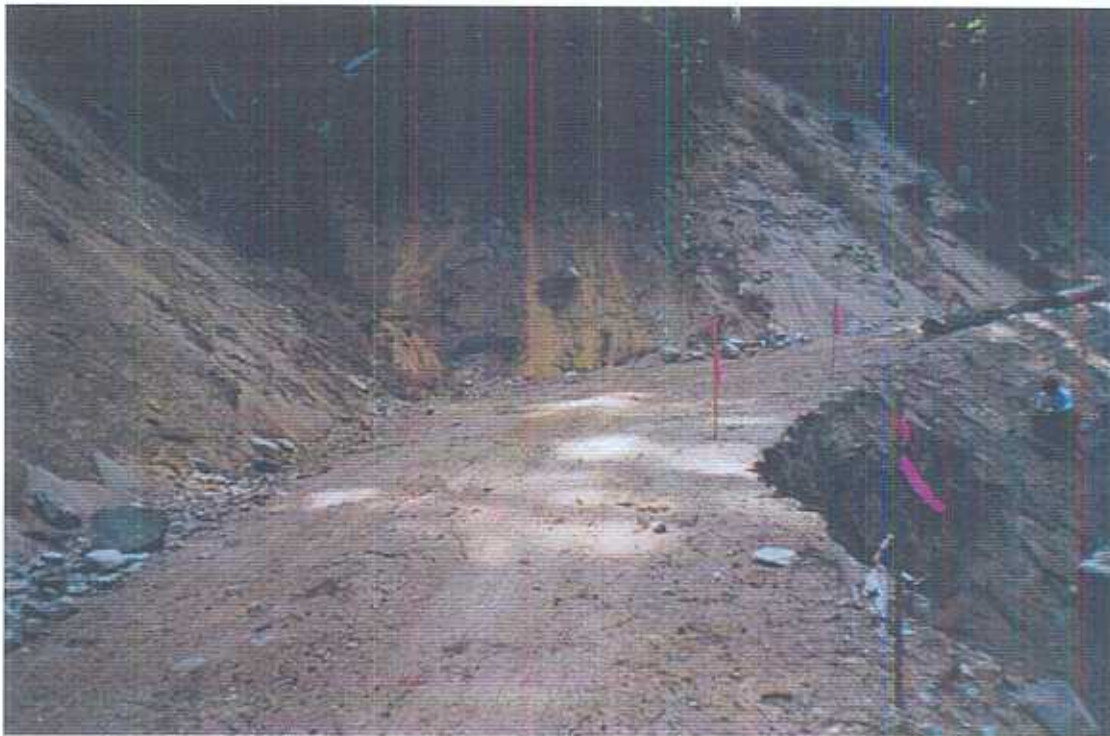
- at 8.75 km the road surface has failed (slide S13), leaving a 2-3 m high headscarp in the fillslope (Plate 11);
- at 9.35 km the cutslope has failed resulting in difficult 4x4 passage;

Plate 11: Road fillslope failure (S13) at gully crossing of Sitkum Creek FSR at 8.75 km. Note 2-3 m vertical headscarp at right.  
 Date: 02-Aug-2000                      Photograph 4-15

- from 8.3 km to 8.8 km the ditches and culverts require frequent cleaning to remove sands derived from the cutslope (this includes slide S12);
- at 8.75 km (slide S13) the road surface requires repair including reconstruction of the fillslope (Plate 11);

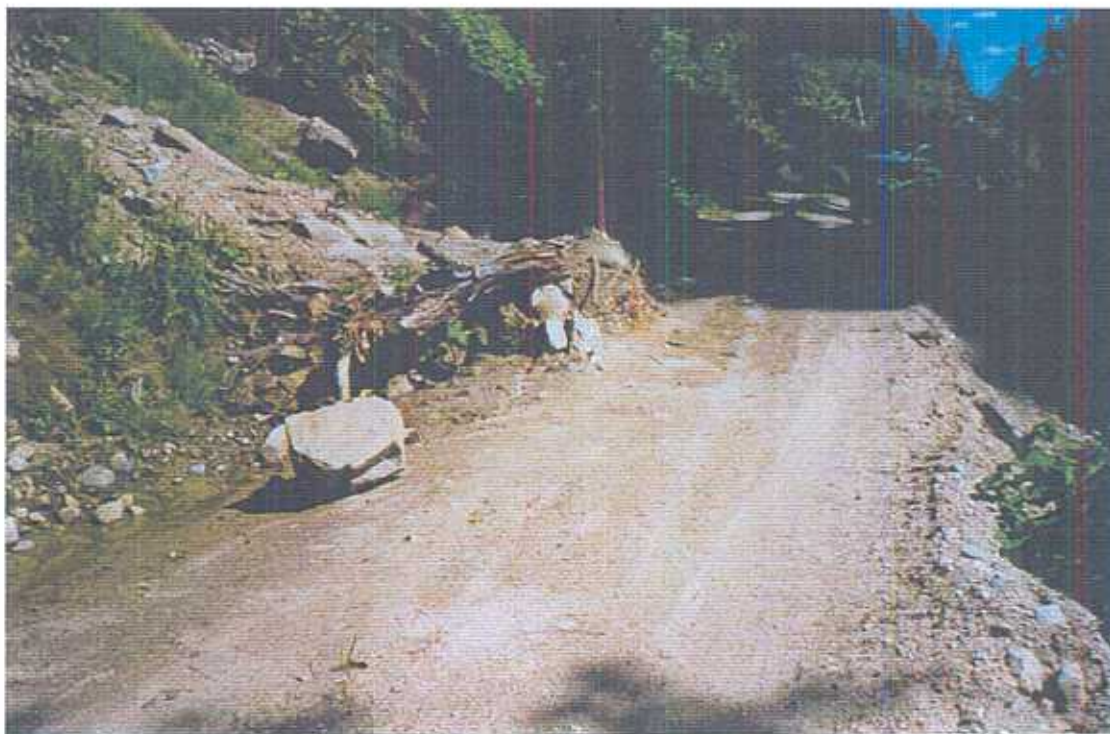
Plate 12: Cutslope slump at 8.13 km along Sitkum Creek FSR. Marked with stake as "#1" in the field.  
 Date: 02-Aug-2000                      Photograph 4-8

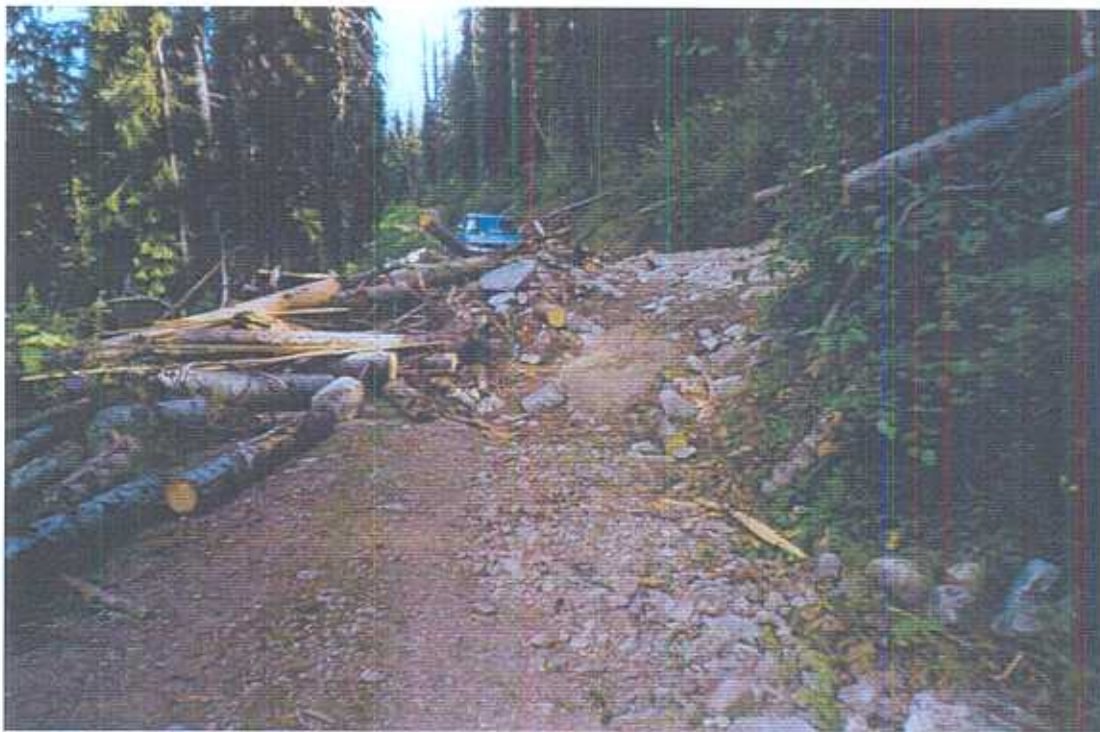
Plate 13: Debris flow (S15) track crosses the Sitkum Creek FSR at 11.5 km,  
resulting in 4x4 passage.

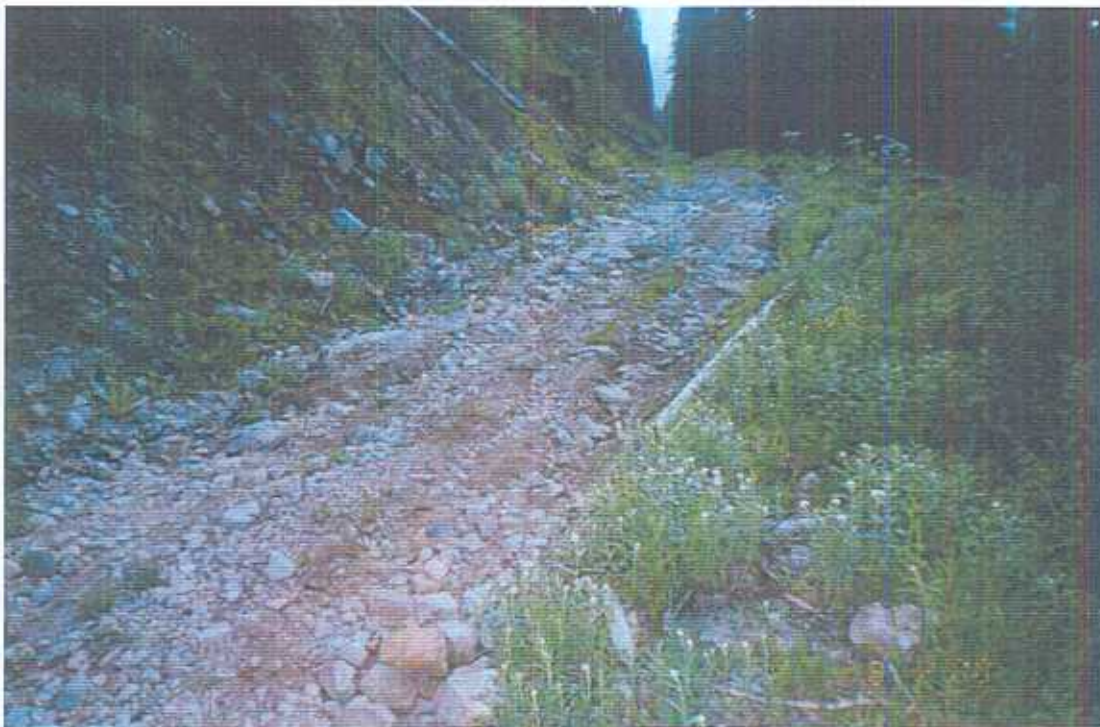
Plate 14: Rutted road surface at 12.1 km along Sitkum Creek FSR.

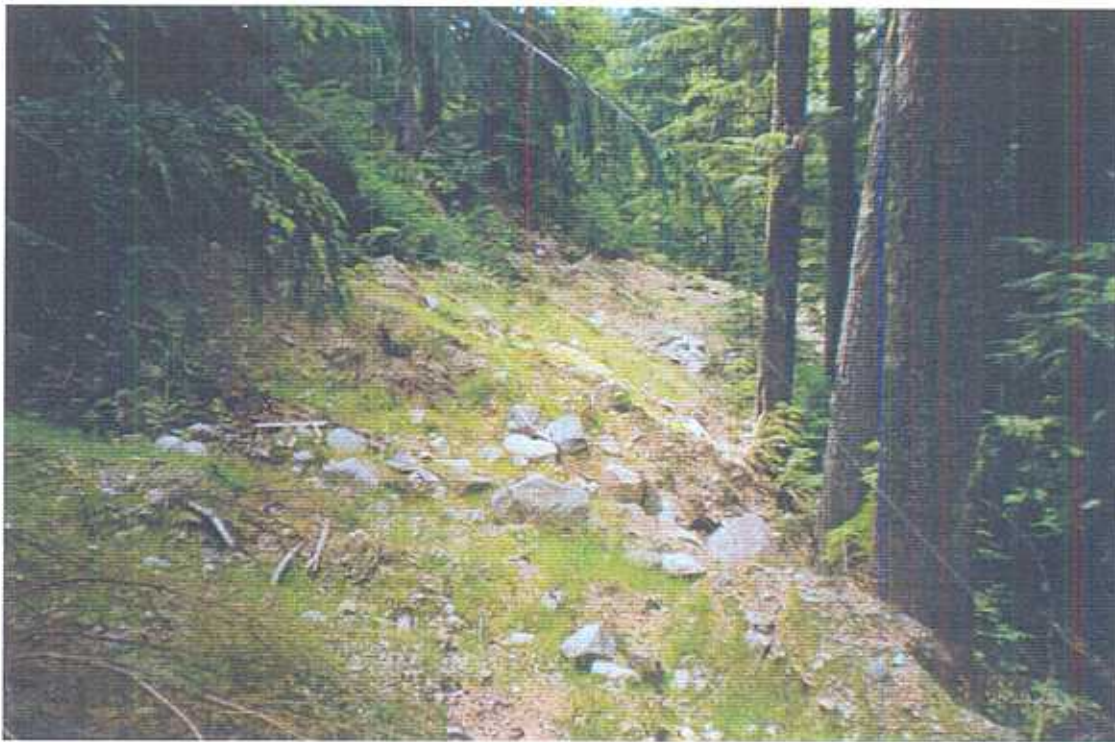
Plate 15: Typical view of Old Sitkum Creek road, with full pullback deactivation.  
 Date: 03-Aug-2000                      Photograph 4-32

In October 1999, the "Old Sitkum Creek Road" (Road 1.0) was permanently deactivated (Plate 15). The deactivation included approximately 1.3 km of moderate pullback of unstable fill, installation of cross-ditches and restoring natural drainage patterns within gullies and draws. The inspection in August 2000 confirmed that the pullback is functioning well and the seeding is establishing on about 40% of the area. However, some additional restoration work is recommended. The following is considered to have the highest priority:

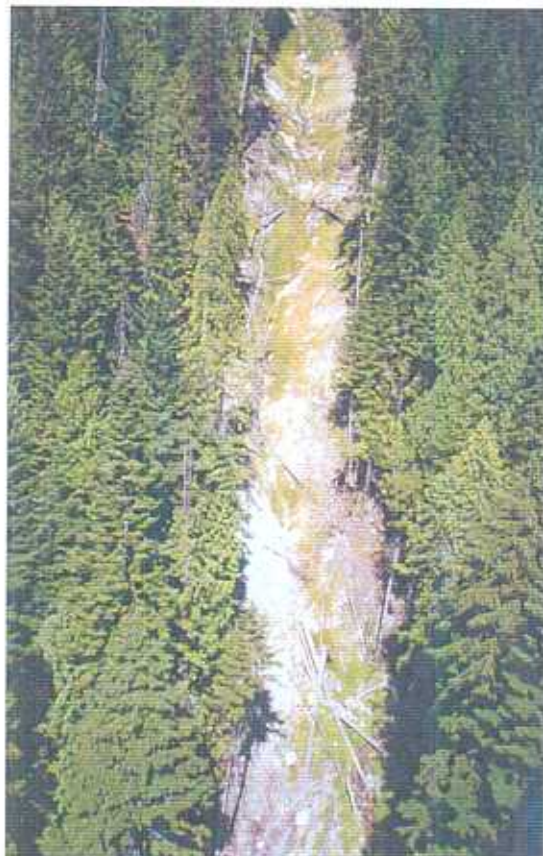
The seeding is taking well, with approximately 50-60% of the slide area vegetated (Plates 17 and 18). However some additional seed would be beneficial, especially at the lowest end of the runout zone where no seed has established. Recommendations for work are discussed further in Section 4.0.

Plate 17: Bourke Slide (B2) just upslope of Bourke Creek in Reach 5.  
Date: 02-Aug-2000      Photograph 3-15

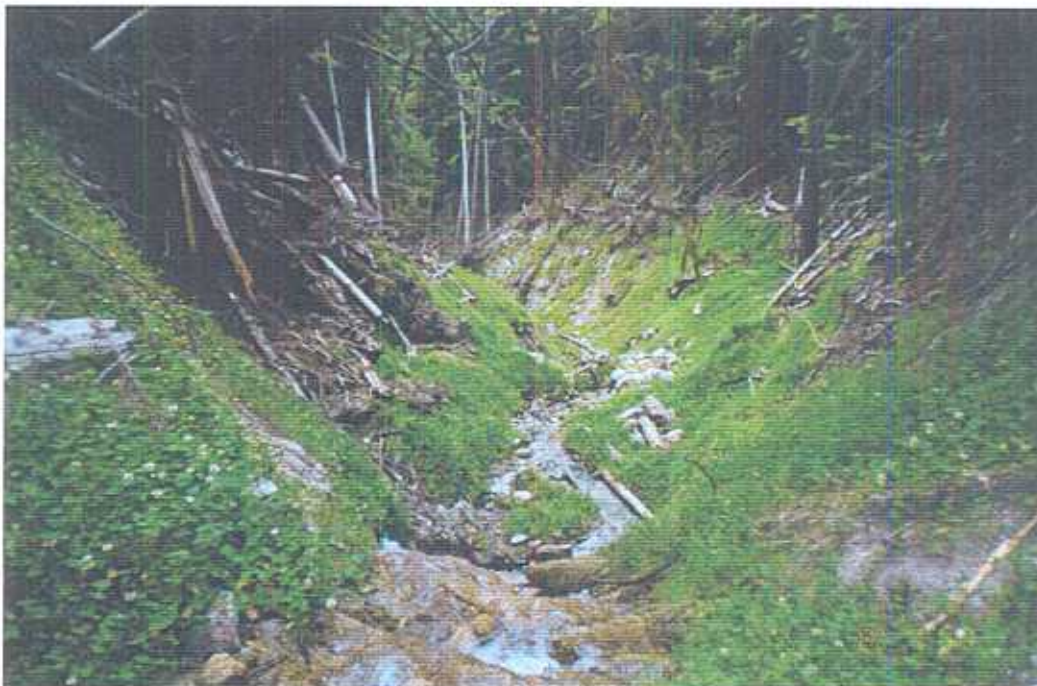
even within the Bourke Slide (B2), which extremely disturbed Reach 5 of Bourke Creek (Plate 18). The sensitivity of each creek ranges from slight to high, generally increasing with decreasing elevation. Constructive efforts on the Sitkum Creek fan have improved the stability of the channel and reduced the risk of damage during high flow events.

Plate 18: Bourke Slide (B2) runout zone with well-established grass and clover  
seed. Reach 5 of Bourke Creek.  
Date: 04-Aug-2000      Photograph 5-20

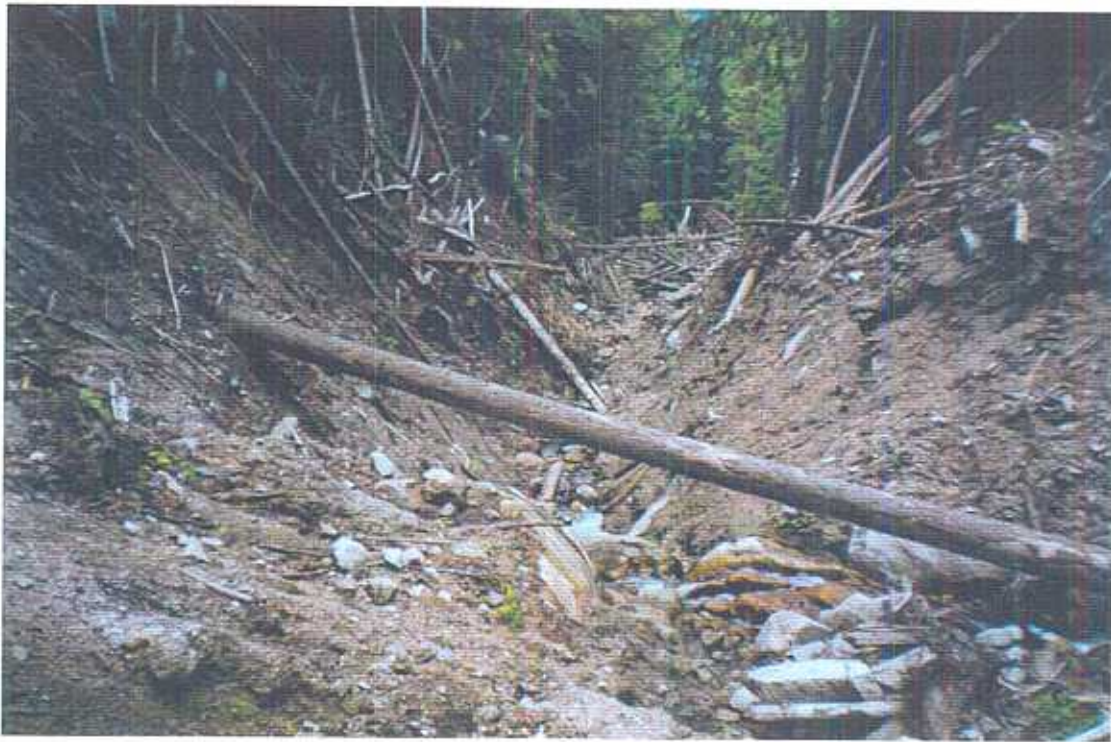
Sediment and debris from the Bourke Creek landslide (B2) in April 1999 has accumulated in Reach 5 of Bourke Creek (at approximately 810 m elevation) in the form of a large stable plug of sediment and debris (Plate 19). Pullback of the remaining fill at the initiating switchback (SB-4) and hydroseeding of the slide track were completed in 1999. The slide track and debris plug were re-examined on foot in August 2000. Some additional prescriptions are recommended to increase the stability of the slide track and lessen the effect on downstream water quality:

Plate 19: Bourke Slide (B2) at lower end of runout zone, looking down towards debris jam at toe. No seed has established here. Reach 5 of Bourke Creek.  
 Date: 04-Aug-2000                      Photograph 5-18

- Reseeding the slide face and runout track in the patches that have not established well. The area is 50-60% established with grass and clover, however approximately 0.17 ha of area remains exposed, largely at the bottom of the slide, immediately upstream of the sediment plug (Plates 18 and 19);
- Channeling the flow through the debris plug to a single channel. The creek currently branches around the plug, and is seeping through material undergoing organic decay. This process has increased the concentration of iron-loving bacteria in the water, likely through a combined increase in available carbon and water temperature. The decomposing bacteria remain in the water down to the community intake, resulting in an unpleasant odour associated with the water (Plate 20).

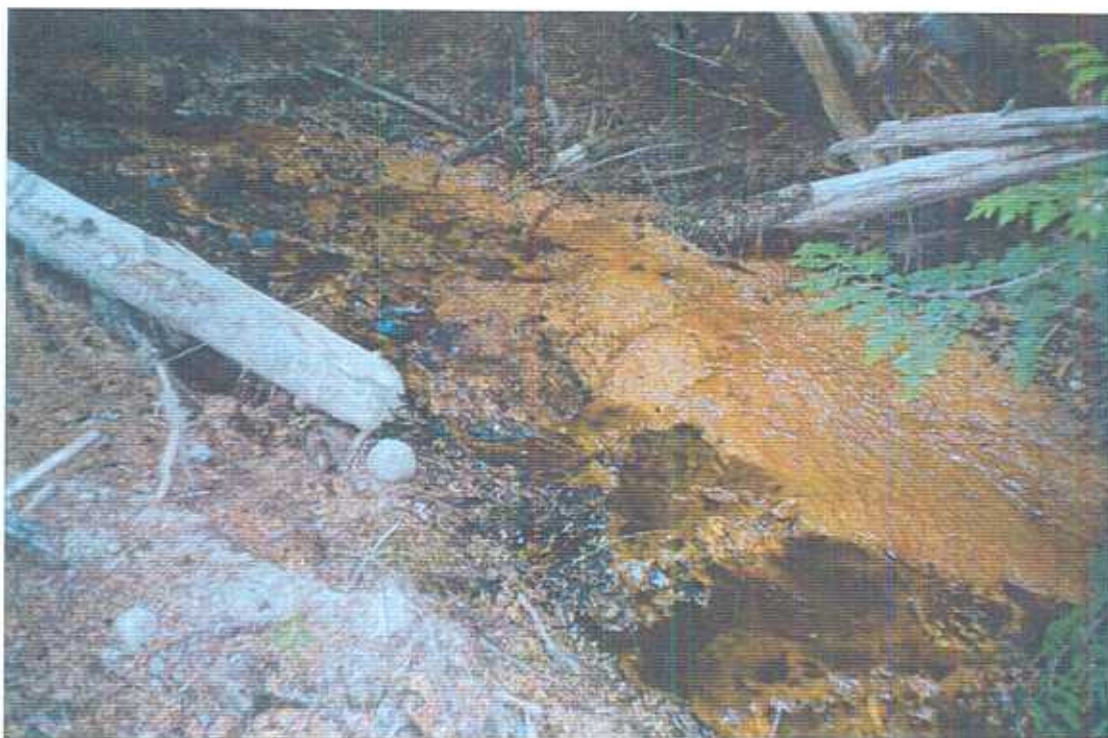
The field investigation of slide B2 included an assessment of the slide headscarp, runout zone, and toe. The sediment and debris lobe at the slide toe is stable, and will not likely ever be moved by hydrologic processes, although it will likely continue to produce sand-sized and finer sediment to the channel for several years. The flow splits into many small distributaries through the sediment lobe, and one branch running around to the right bank is transporting decayed organic sediments from within the lobe, and a smelly rusty coating lines the channel (Plate 20). This has reportedly caused

Plate 20: Organic decayed material in side channel around the Bourke Slide debris jam. Channeling the flow through the jam may reduce this buildup.  
 Date: 04-Aug-2000                      Photograph 5-11

- B2 (Section 4.4) to reduce the addition of decaying organic material to the water (Plate 20);
