**Monashee-Railroad Creeks
Sediment Source Survey and
Access Management Plan**

This report presents the results of a Sediment Source Survey and Access Management Map prepared for the Monashee-Railroad Creek watershed located 11 km southeast of the community of Cherryville, BC.

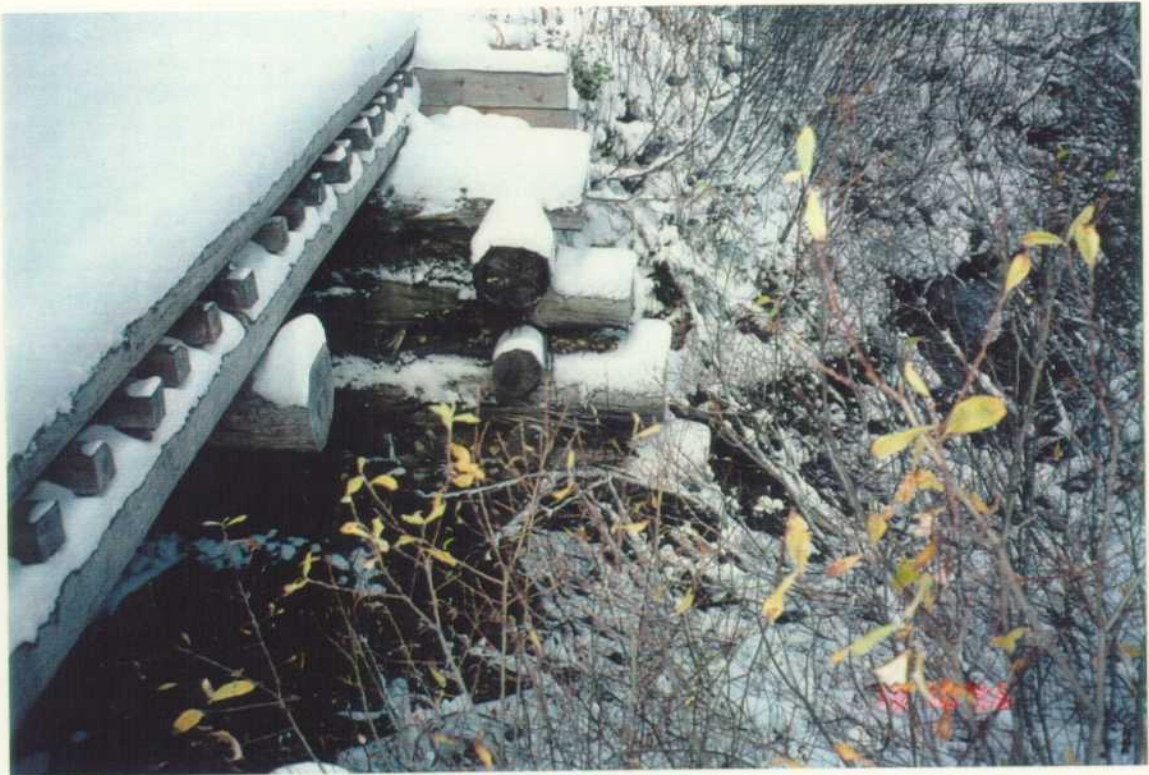
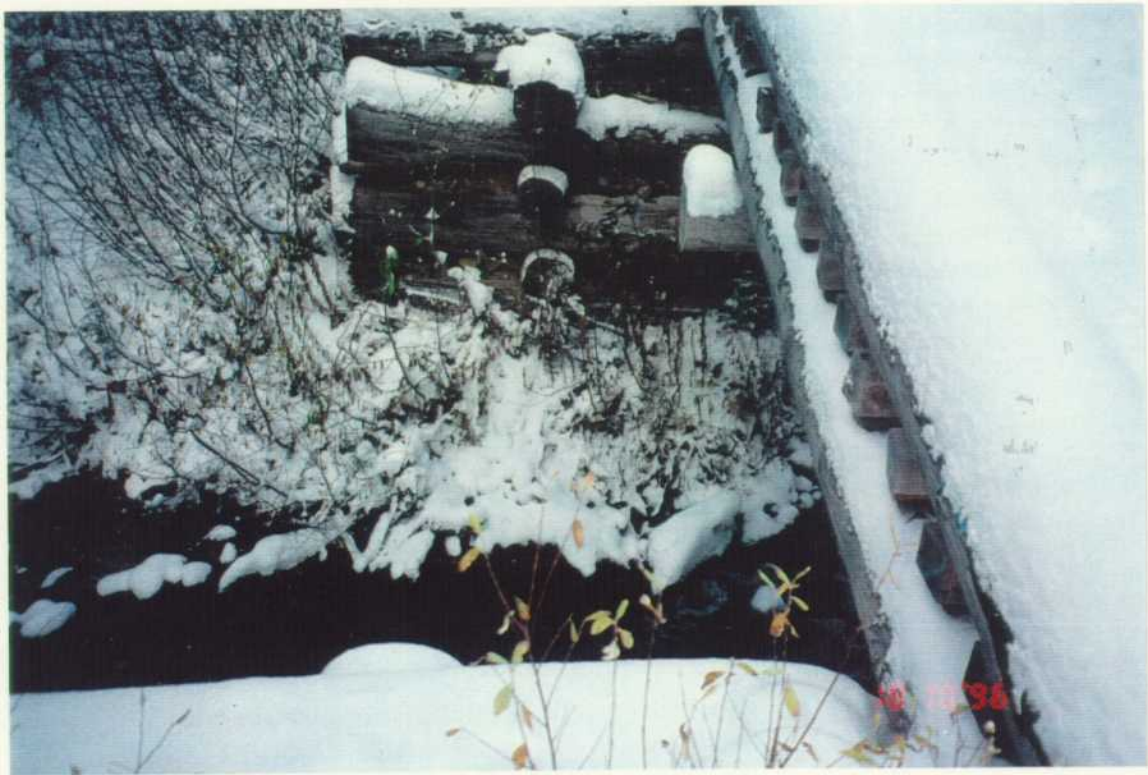
Site 1810

Consequence description:
 Bridge could possibly collapse under any heavy loads. Continued scour at abutments could lead to failure.

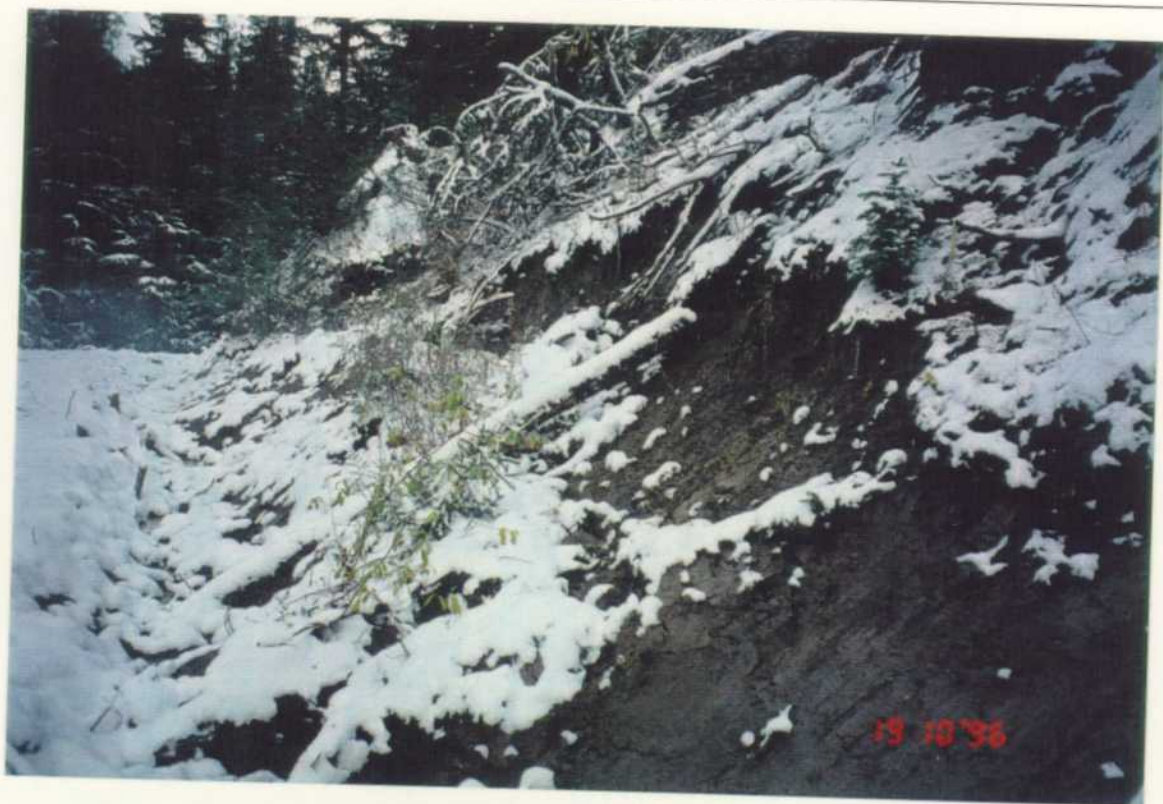
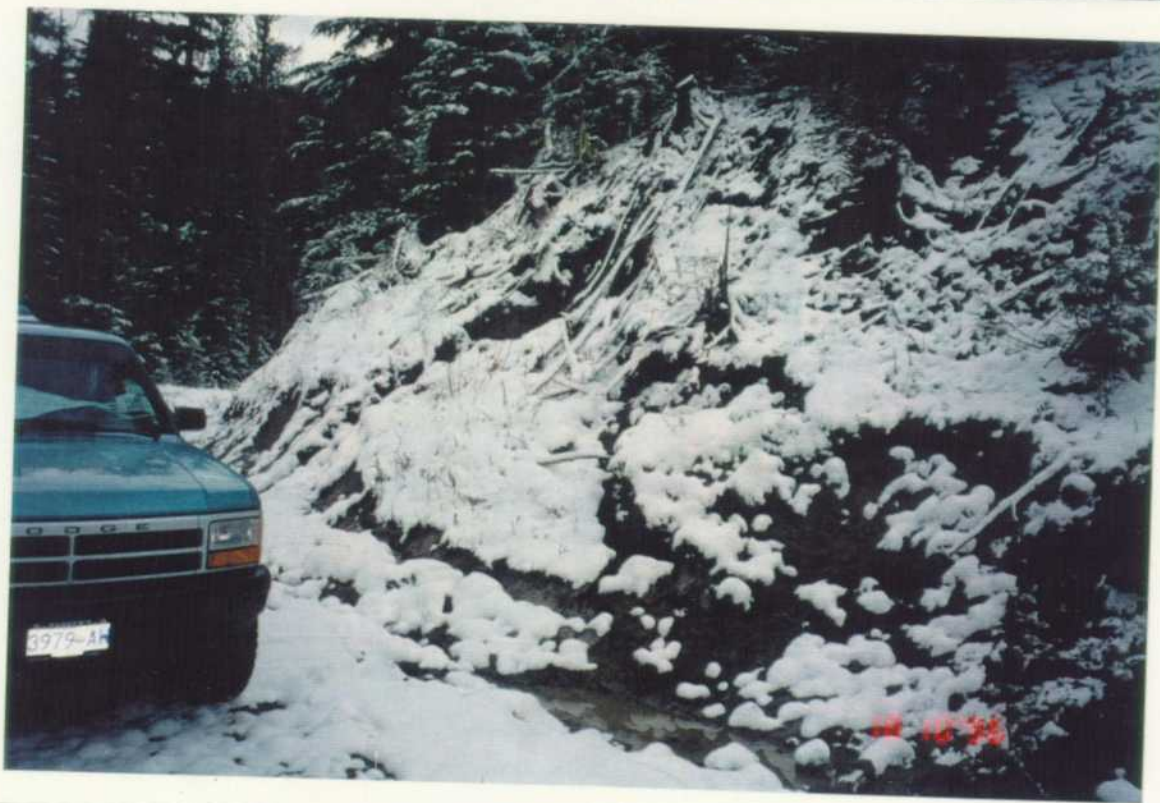
Site 1812

Consequence description: <input type="text" value="Debris will impede ditch water flow."/>	
Comments: <input type="text" value="Bare slope with fine materials, ditch requires work. 100m of ditching and reseeding, to be continued to bridge. Road has been temporarily deactivated."/>	
Risk assessment and Level II requirements: Hazard rating: (H,M,L) <input type="text" value="L"/> Consequence rating: (H,M,L) <input type="text" value="L"/> Risk rating: (VH,H,M,L) <input type="text" value="L"/> Watershed priority: (H,M,L,N) <input type="text" value="L"/>	
Prescription: <input type="text" value="Reseed bare slope and reditch. Road should be regraded during regular maintenance."/>	
Prescription estimate (no level II req): <input type="text" value="\$ 1000"/> Length of road requiring deactivation or rehabilitation: <input type="text" value="N/A"/> Area of hillslope requiring rehabilitation (ha.): <input type="text" value="0.01"/> Access <input type="checkbox"/> Lowbed <input type="checkbox"/> 2WD <input checked="" type="checkbox"/> 4WD <input type="checkbox"/> ATV <input type="checkbox"/> Trail	Level II required: <input type="checkbox"/> Yes <input checked="" type="checkbox"/> No <input type="checkbox"/> If yes go to table 5
