**LEMPRIERE and
MANTEAU CREEK
Watershed Assessments**

Prepared by:

Integrated Woods Services Ltd.
1425 Hugh Allan Drive
Kamloops, BC
V1S 1J3

May, 2001

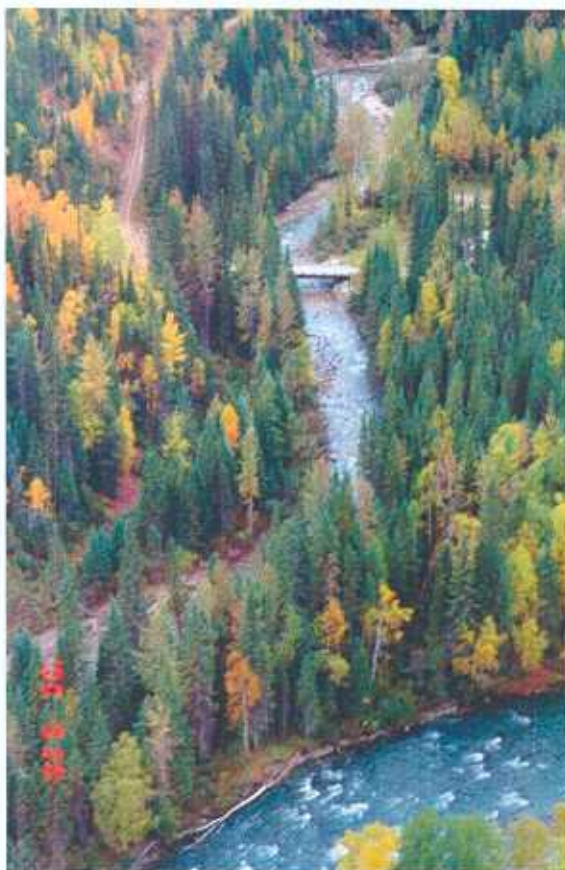
Large woody debris (LWD) does not occur frequently in the channel in this stream reach. The majority of the LWD is clumped in a debris jam approximately 50 m upstream of the North Thompson River. Only a few logs with saw-cut ends were observed in the debris jam. The composition and age of riparian vegetation varies along the stream reach. Alder (*Alnus* sp.) forms dense cover immediately adjacent to the channel in some locales, while mixed or conifer dominated riparian buffers are common (see photo 1).

Photo 1: Lempriere Creek (reach 1) – Sinuous plan form with rapid dominated morphology. Conifer or mixed riparian forest adjacent to channel. SS #2 in background on outside of bend.

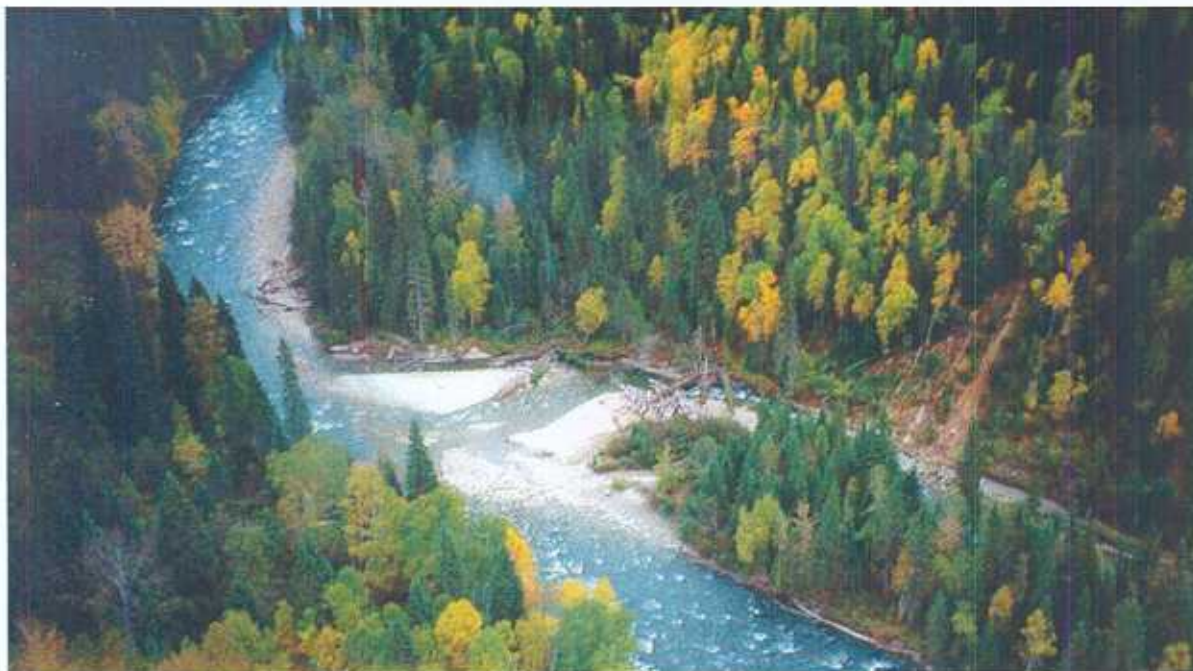
Disturbance levels are moderate for approximately 100 m upstream of the confluence with the North Thompson River. Elevated mid-channel sediment bars, channel braiding and a debris jam were noted in this stream segment (see photo 2). Disturbance indicators noted in other segments of this reach included bank erosion, pool in-filling, extended riffles or cascades, LWD frequency and LWD distribution. Upstream of the moderately disturbed segment, disturbance levels (both aggradation and degradation) are generally low (see photo 3). Characteristics of cascade-pool morphology become evident in the upper stream reach (see photo 4).

Photo 2: Lempriere Creek (reach 1) – Mid-channel sediment bars, channel braiding and LWD jam at confluence with N. Thompson River. SS #1 coupled to channel on right bank.

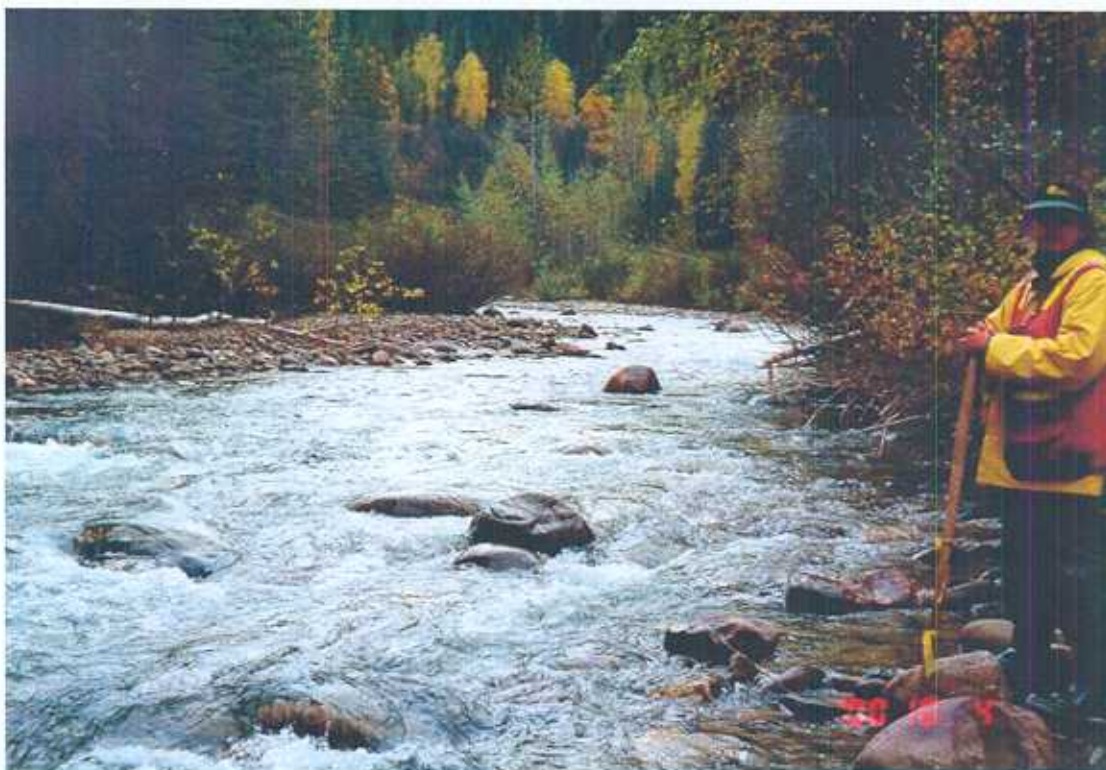
Photo 3: Lempriere Creek (reach 1) – Low level of channel disturbance in mid-reach. Dense alder adjacent to channel in some segments.

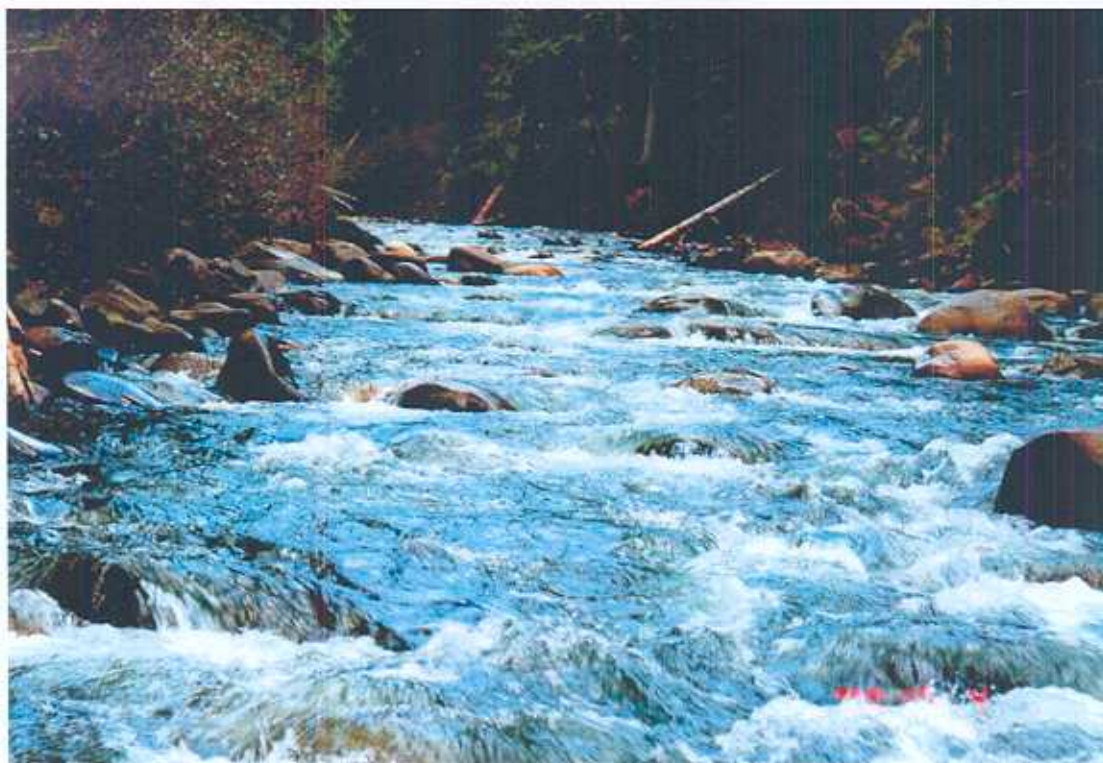
Photo 4: Lempriere Creek (reach 1) – Cascade-pool morphology in upper reach.

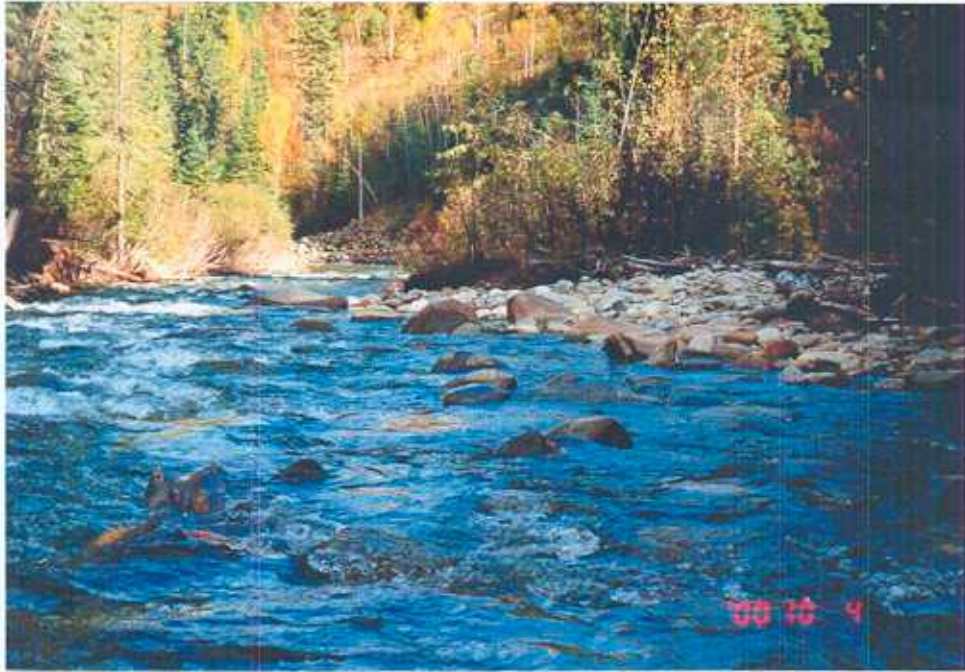
Photo 5: Lempriere Creek (reach 1) – Left channel now carries majority of flow.

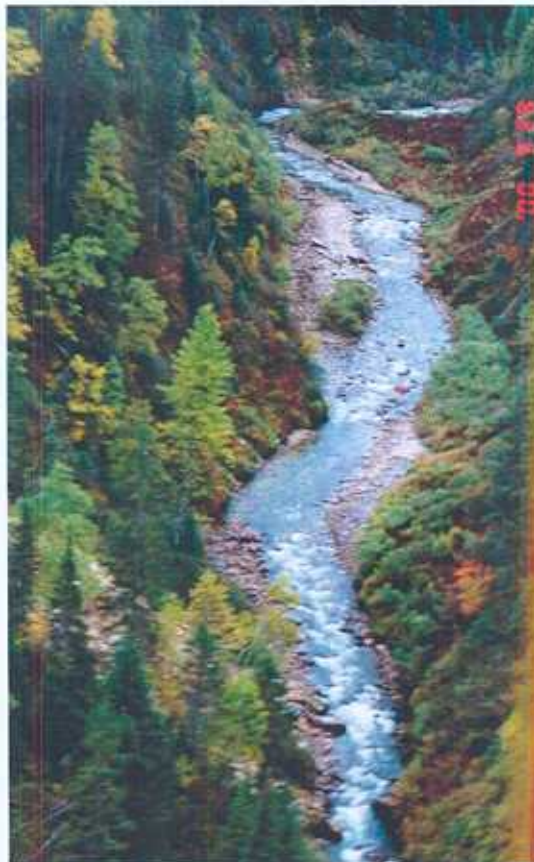
Photo 6: Lempriere Creek (reach 2) – Stable cascade-pool morphology with coupled valley sidewalls. Mass wasting event coupled to channel in foreground.

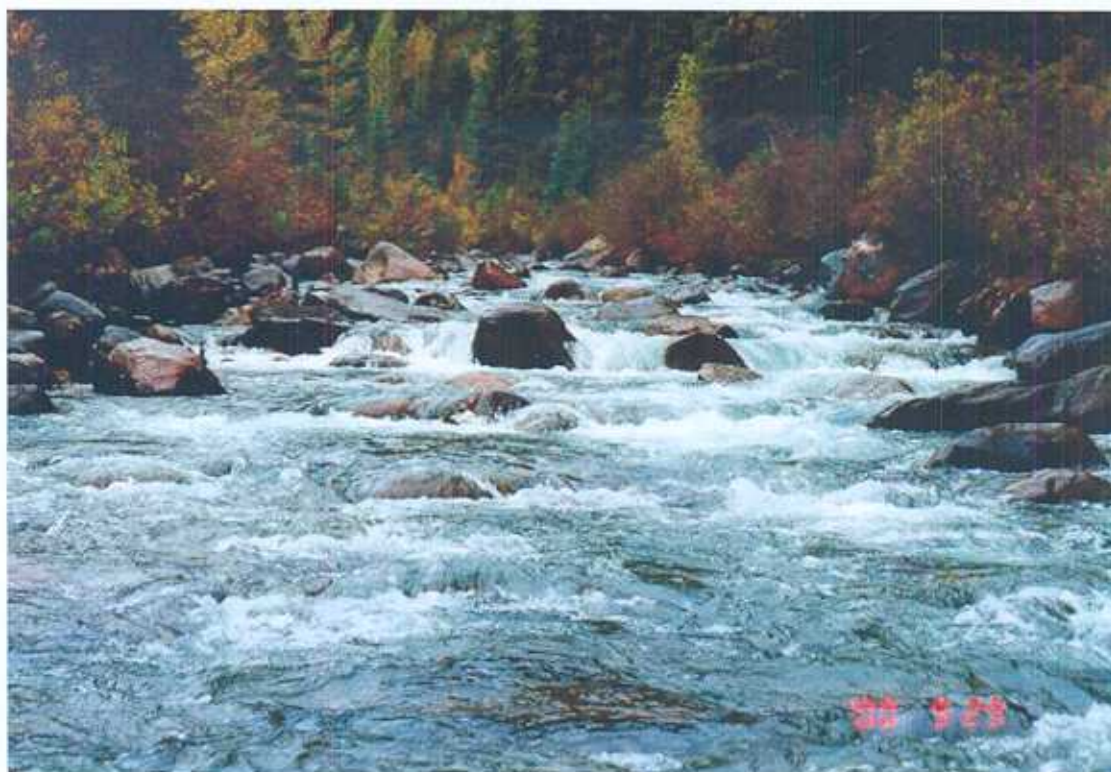
Boulder and cobble were the predominant stream bank materials observed within the assessed segment (see photo 7). These larger clasts form a surface layer on the banks, with smaller calibres occurring beneath the surface layer. Cobble and boulder are the predominant textures present in the surface layer of the stream bed (visual estimate). Boulders frequently have a "b" axis measurement greater than 80 centimetres (cm).

Photo 7: Lempriere Creek (reach 2) – Stable cascade-pool morphology. Note boulder and cobble bank materials and dense riparian shrub layer.

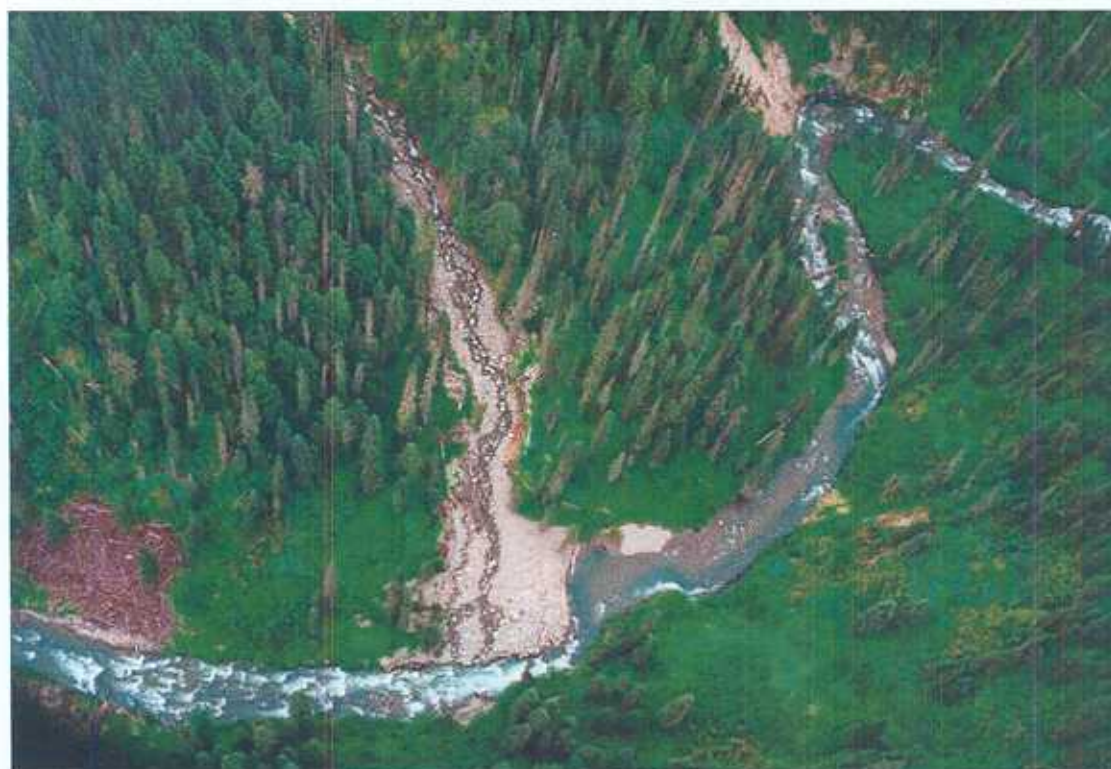
Photo 8: Lempriere Creek (reach 2) – Mouth of unnamed tributary affected by slide 27 and resultant debris torrent. SS #4 is located just upstream of the confluence.

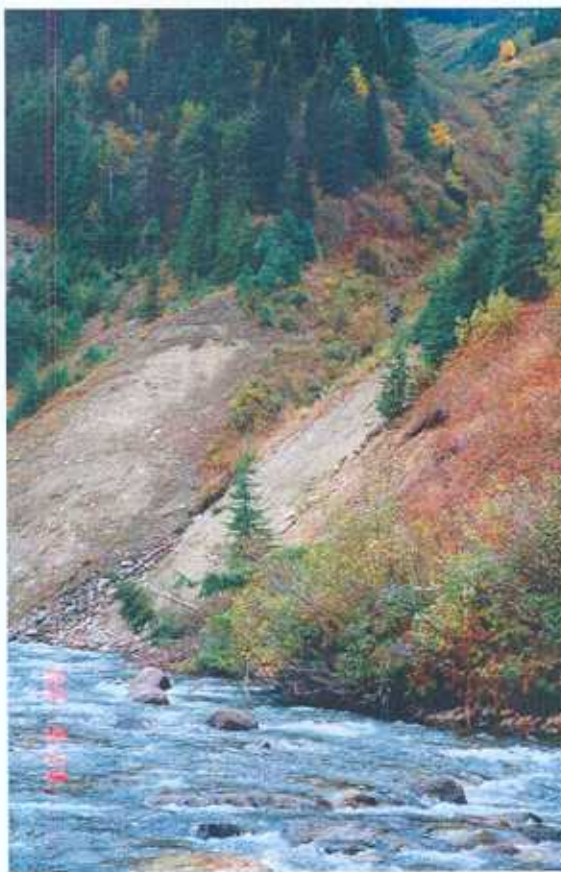
Photo 9: Lempriere Creek (reach 2) – SS #5 at toe of avalanche track in upper reach.

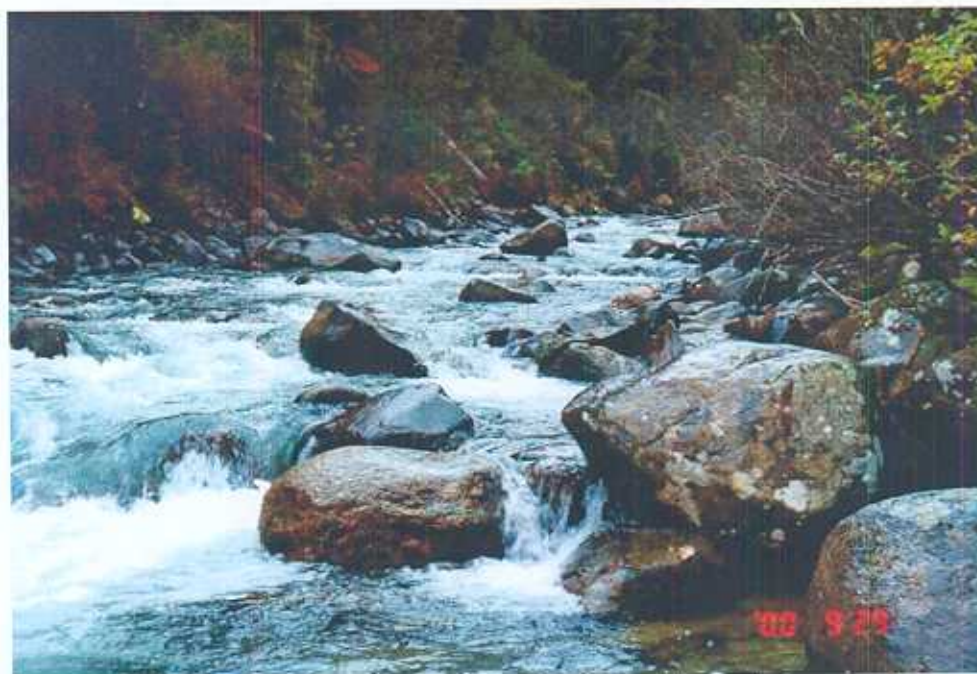
Disturbance levels are low throughout the assessed segment of reach 2 (see photo 10). The disturbance indicators observed during the field assessment included disturbed stone lines and LWD orientation. Disturbance indicators observed during the helicopter overview flight included widening of the channel in depositional areas, eroding banks, channel braiding and LWD jams. The frequency of these indicators is relatively low and disturbance levels are considered low (see photo 11). The channel appeared to be stable throughout much of the stream reach. Channel widening, extensive bars and braiding were observed adjacent to and between four avalanche tracks that are in close proximity to one another in the middle of the reach. These avalanche tracks and disturbance indicators are also apparent on the pre-development aerial photographs (1966). Extensive road-related slope failures (Roads 1300 and 1300.04) coupled to an unnamed¹⁴ tributary to Lempriere Creek (see photos 12 & 13) have resulted in an increased sediment supply to both stream channels. A sediment fan now exists at the confluence of this tributary and Lempriere Creek (see photo 8).

Photo 10: Lempriere Creek (reach 2) – Stable cascade-pool morphology and stream banks.

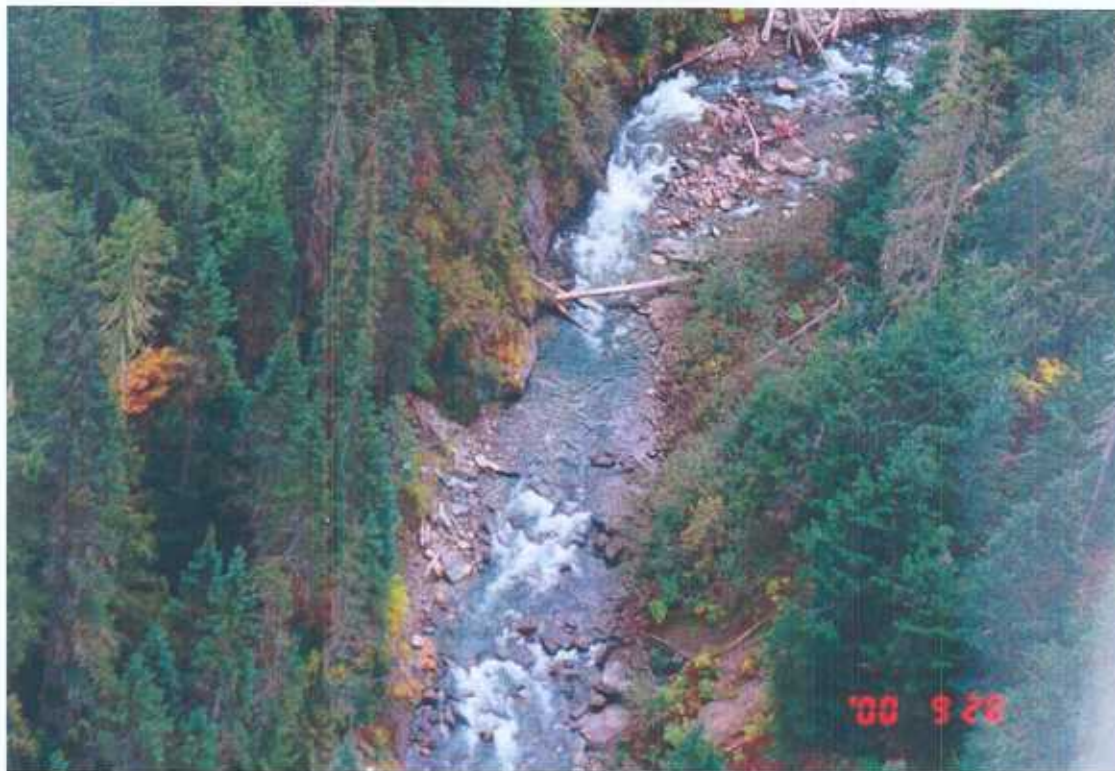
Photo 11: Lempriere Creek (reach 2) – Low level of disturbance. Disturbance indicators in this channel segment are mid-channel deposits and LWD orientation.

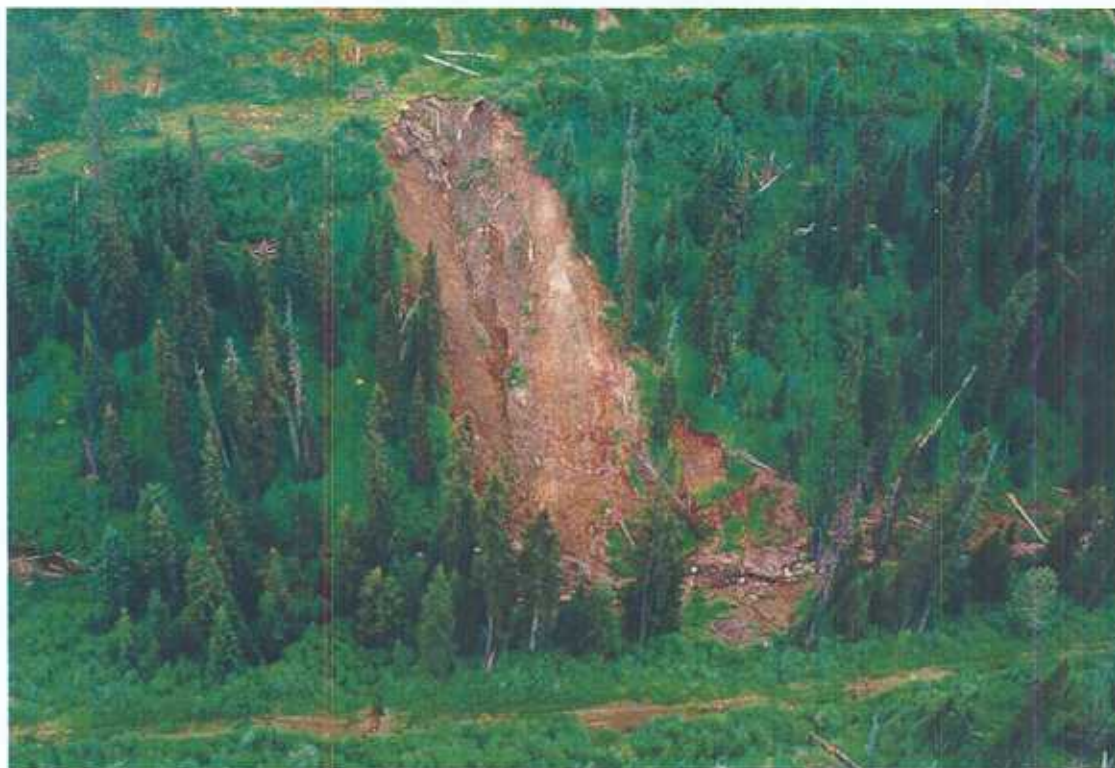
Photo 12: Slide #27 on tributary to Lempriere Creek. Initiation point for debris torrent down the stream. See photos 8 and 13 for effects further downstream on this tributary.

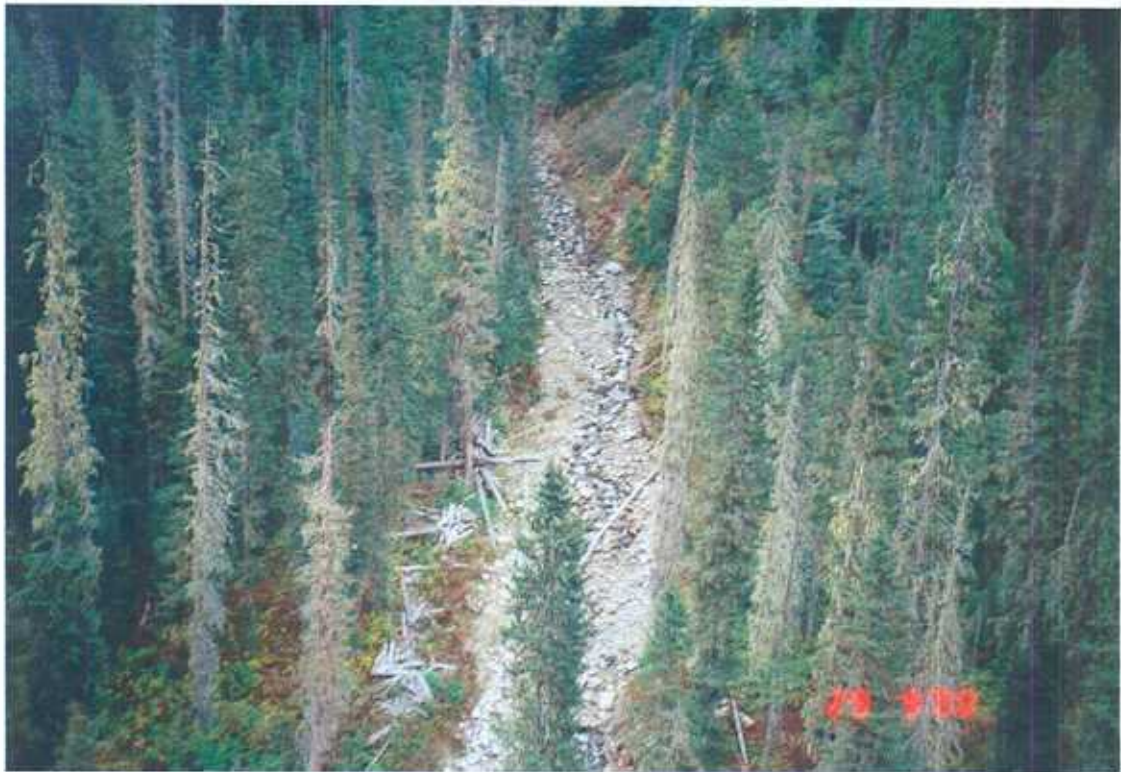
Photo 13: Tributary to Lempriere Creek. Torrented segment of stream between 1300 Road and Lempriere Creek. Initiation point was slide #27.

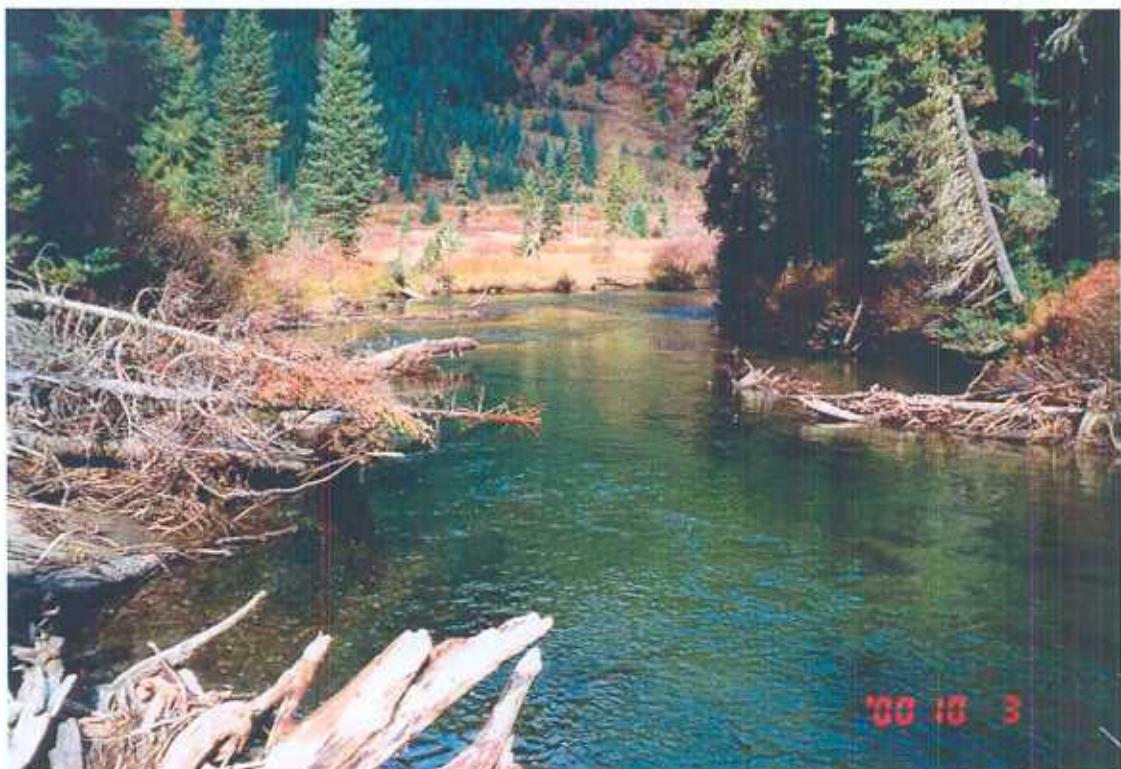
Photo 14: Lempriere Creek (reach 3) – Stable riffle-pool morphology with low degree of entrenchment.

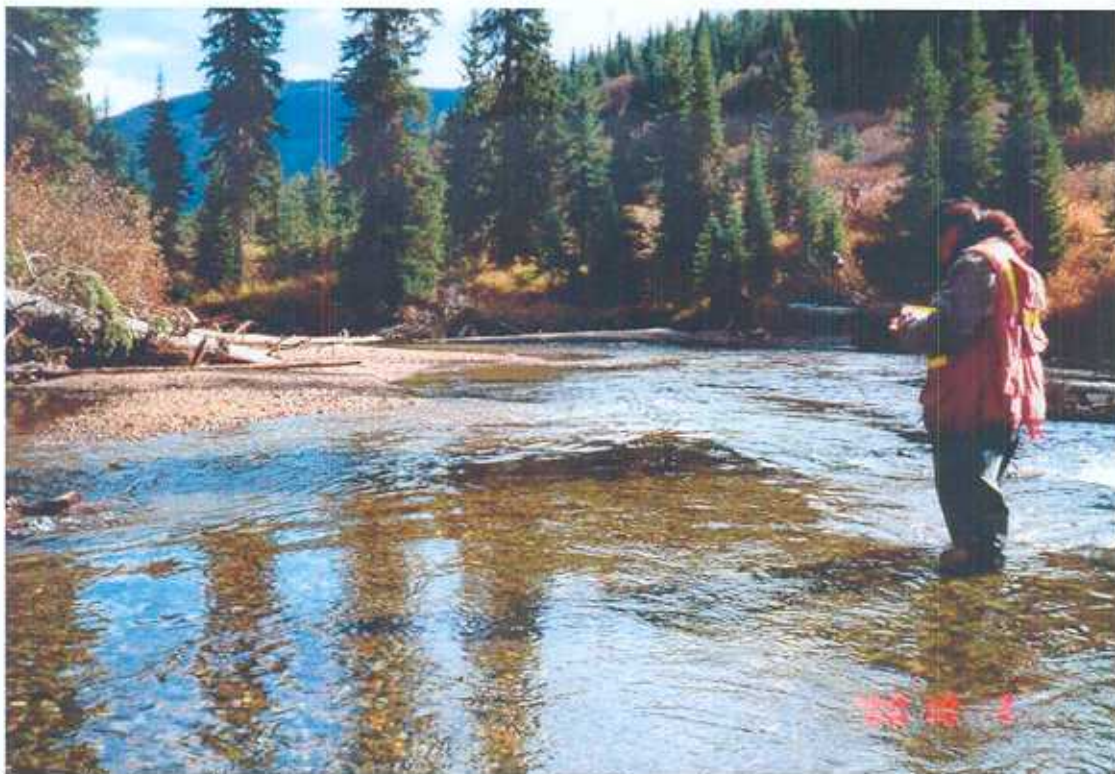
Photo 15: Lempriere Creek (reach 3) – Stable riffle-pool morphology with gravel and sand dominated stream bed.

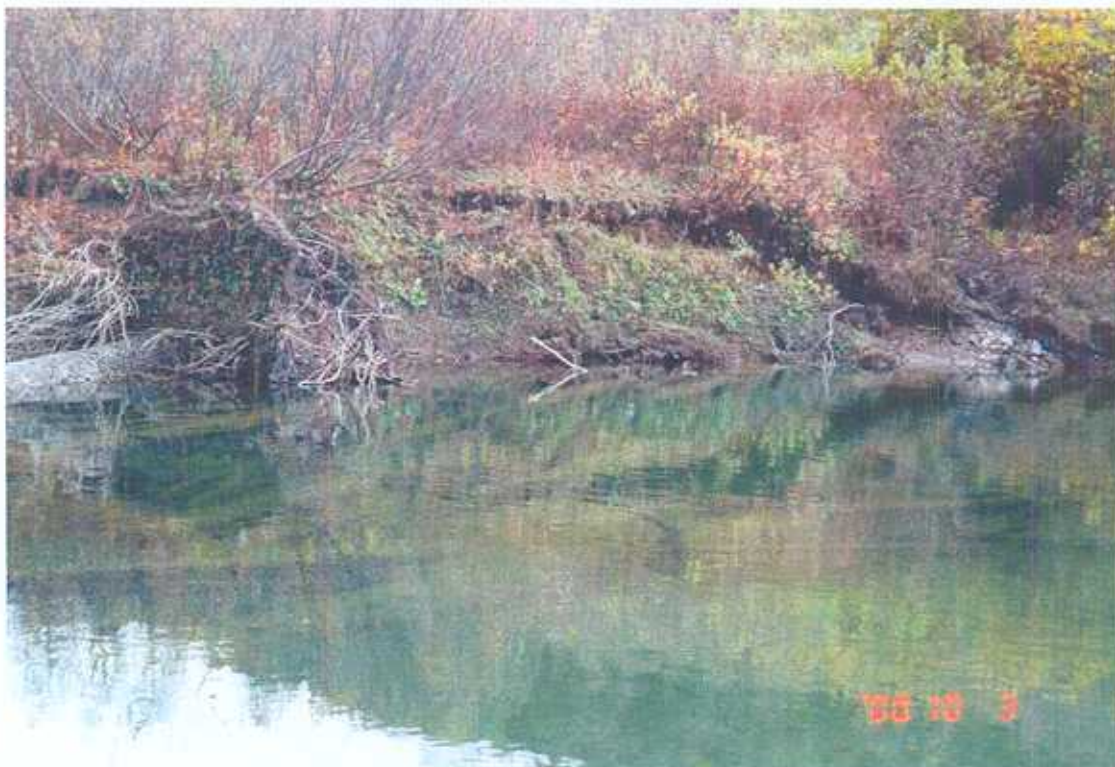
erosion noted (see photo 16). Stable channel conditions were also observed in this reach during the helicopter overview flight (see photo 17). This stream reach was assessed as having a moderate to high sensitivity to stream bank disturbance or changes in water, sediment and/or debris supply.

Photo 16: Lempriere Creek (reach 3) – Example of eroding banks comprised predominantly of fine sand.

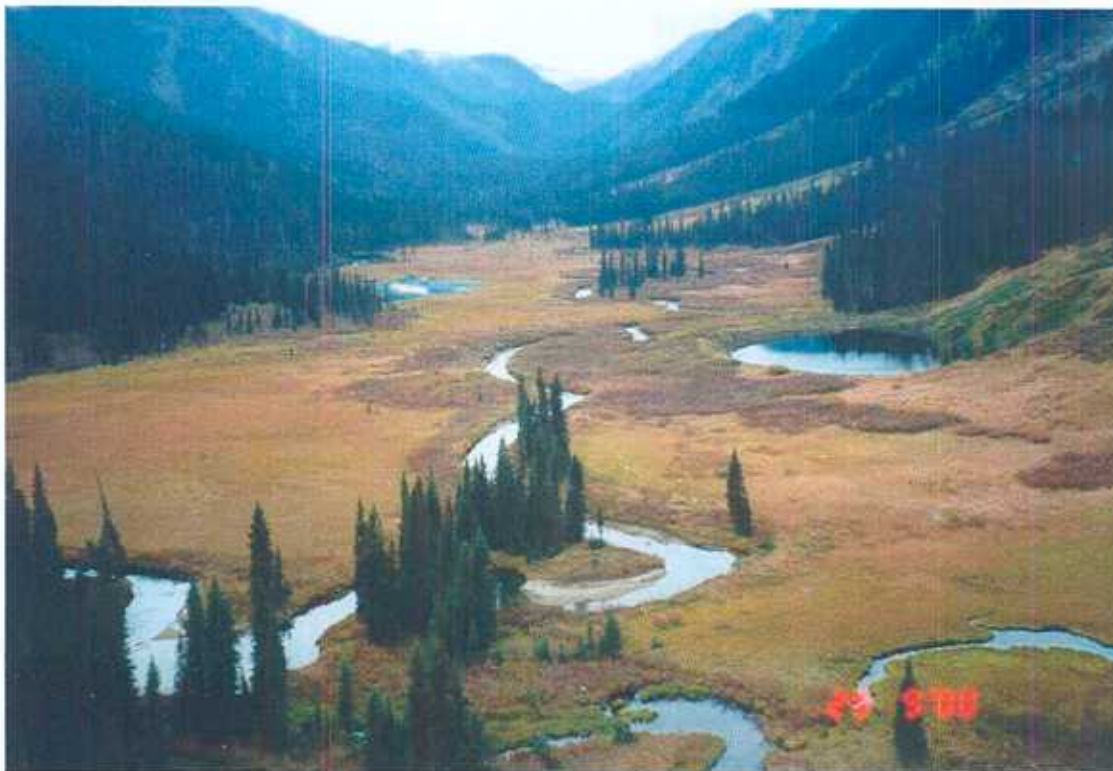
Photo 17: Lempriere Creek (reach 3) – Stable riffle-pool morphology with decoupled valley sidewalls, low degree of entrenchment and variable riparian vegetation.

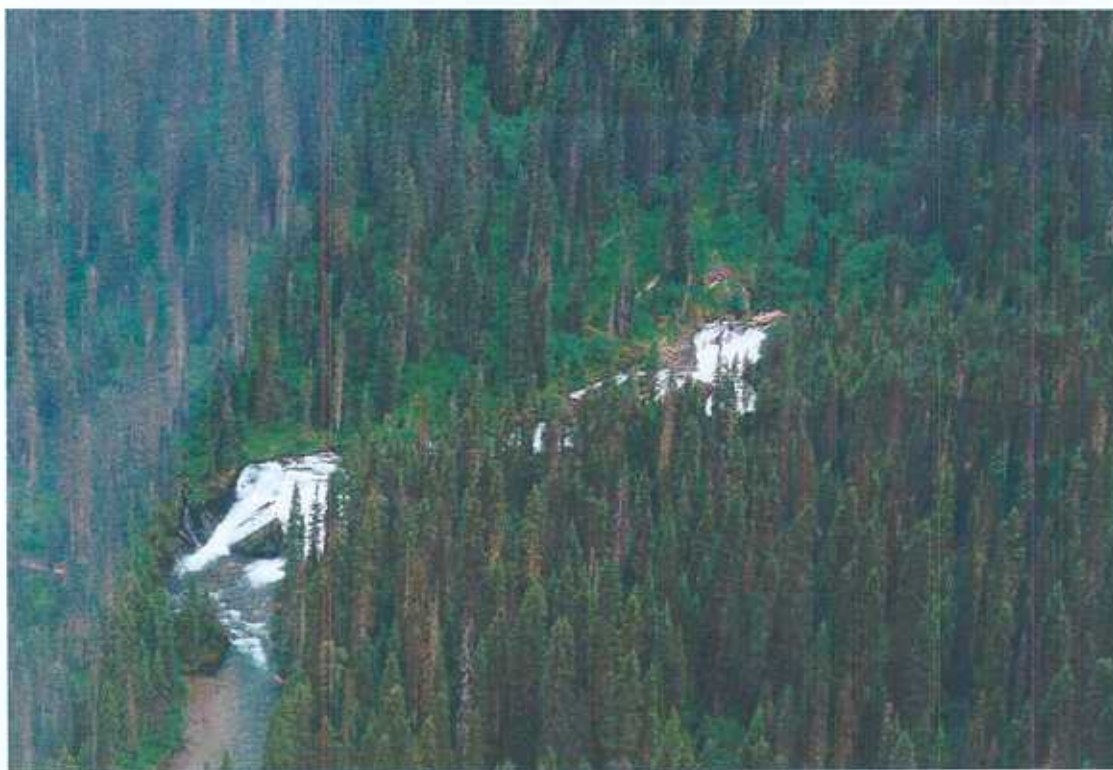
Photo 18: Lempriere Creek (reach 4) – Series of cascades/waterfalls, upstream of existing forest development in watershed.

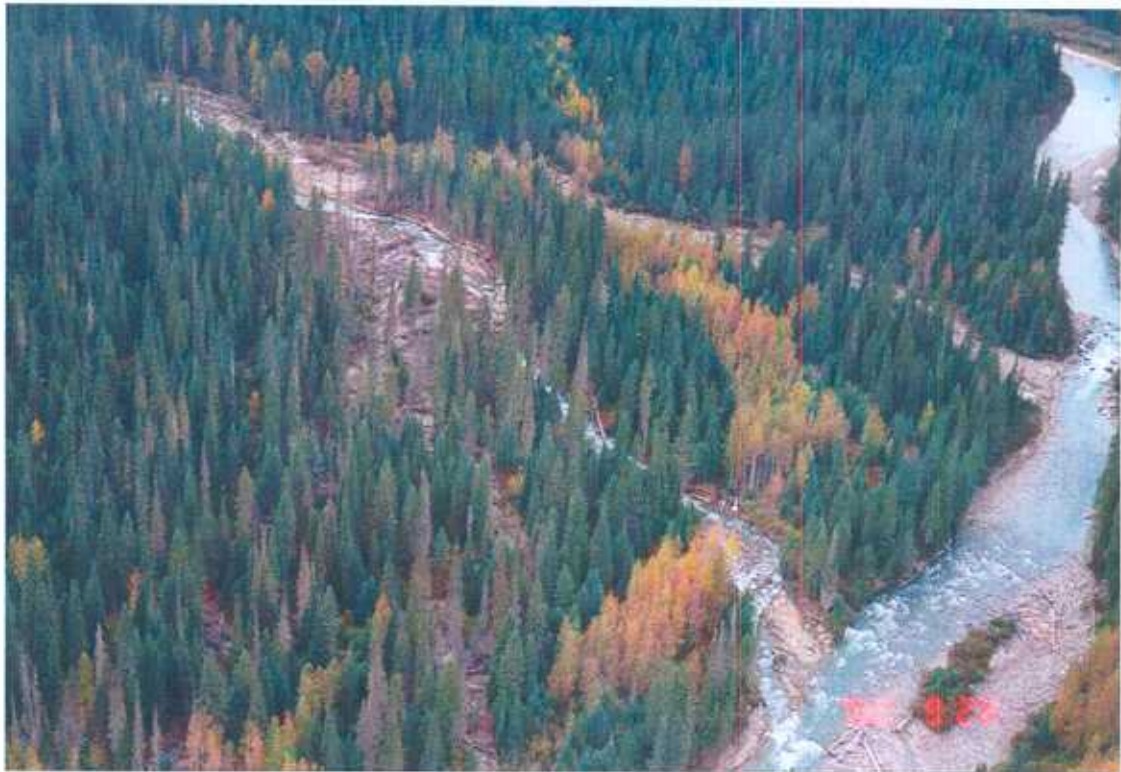
Photo 19: Manteau Creek (reach 1) – Multi-channel form on alluvial fan, with avulsed channel in background. Riparian buffers were left at time of harvest.

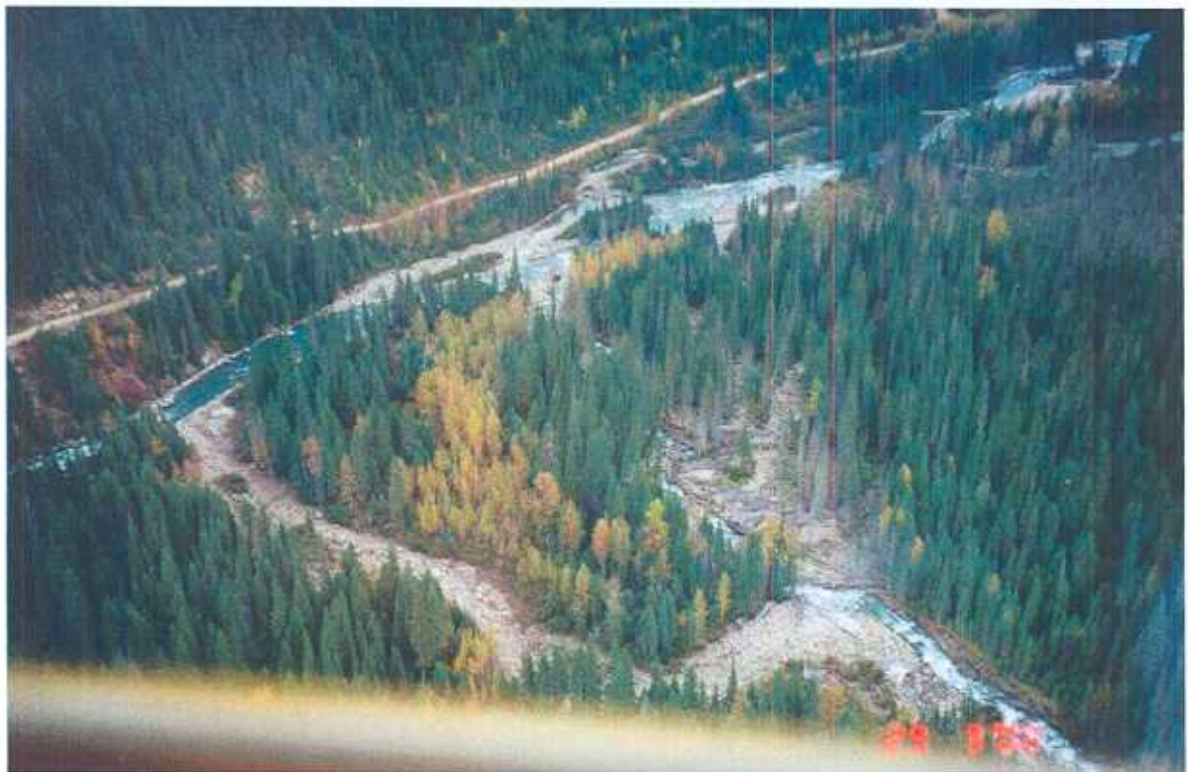
Photo 20: Manteau Creek (reach 1) – Avulsed channel to left side of photo was the original channel.

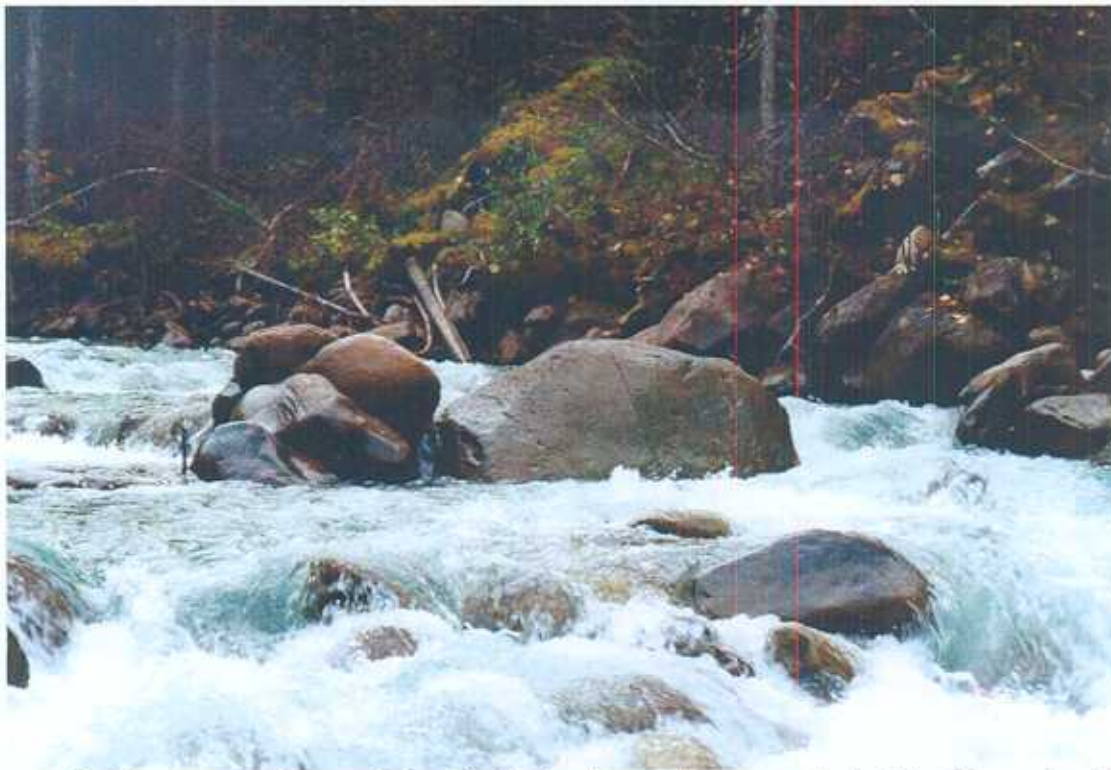
Photo 21: Manteau Creek (reach 2) – Stable bank materials comprised of boulder and cobble.

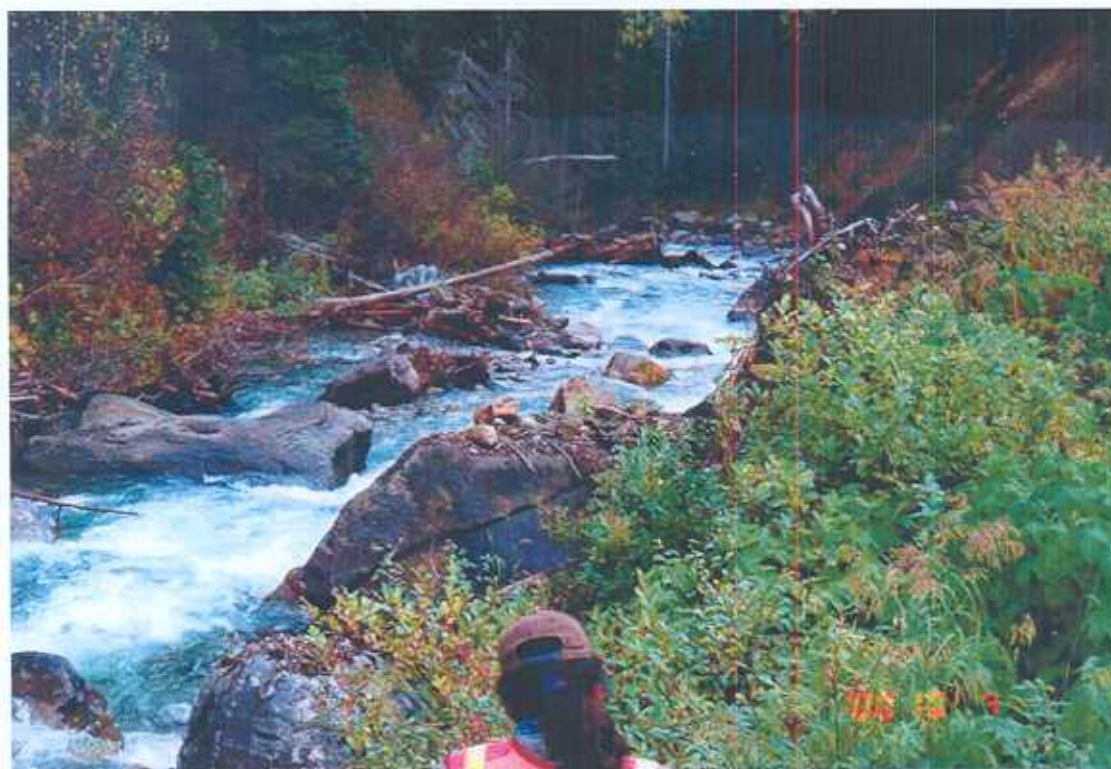
Photo 22: Manteau Creek (reach 2) – LWD clumped into small jams on channel margins downstream of avalanche track. Example of pulse disturbance event.

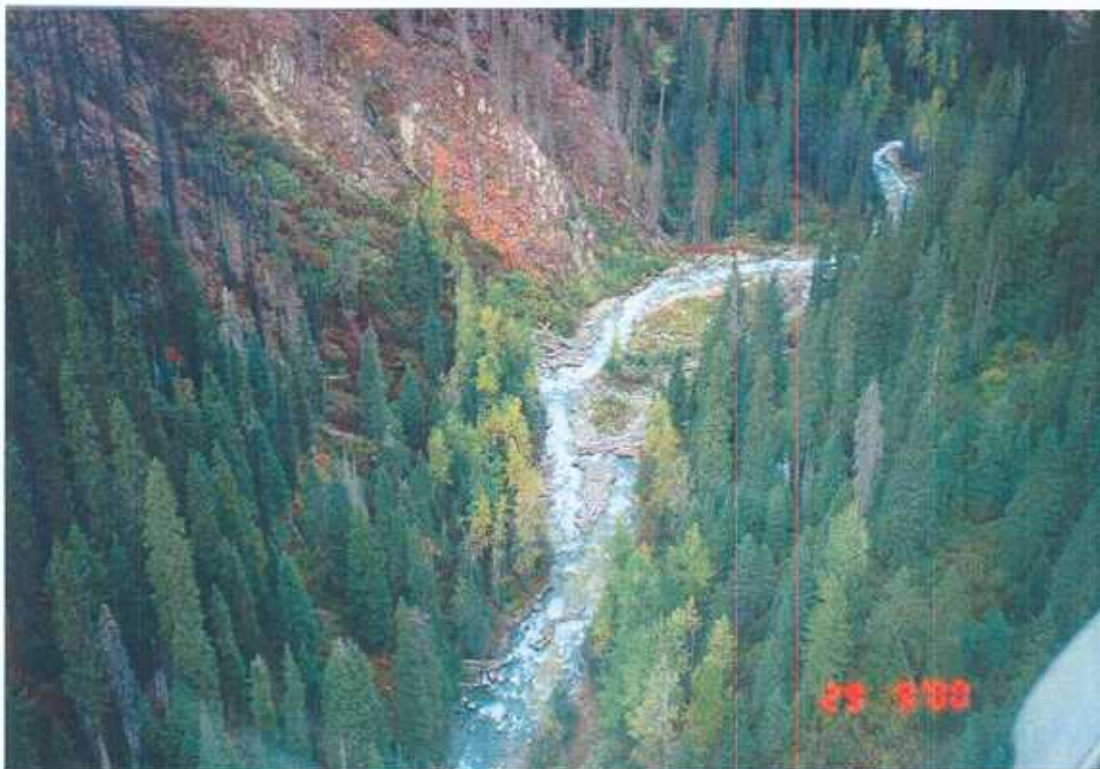
Photo 23: Manteau Creek (reach 2) – Wildfire (1998) came close to left bank of channel. Riparian areas were generally not affected by the wildfire.

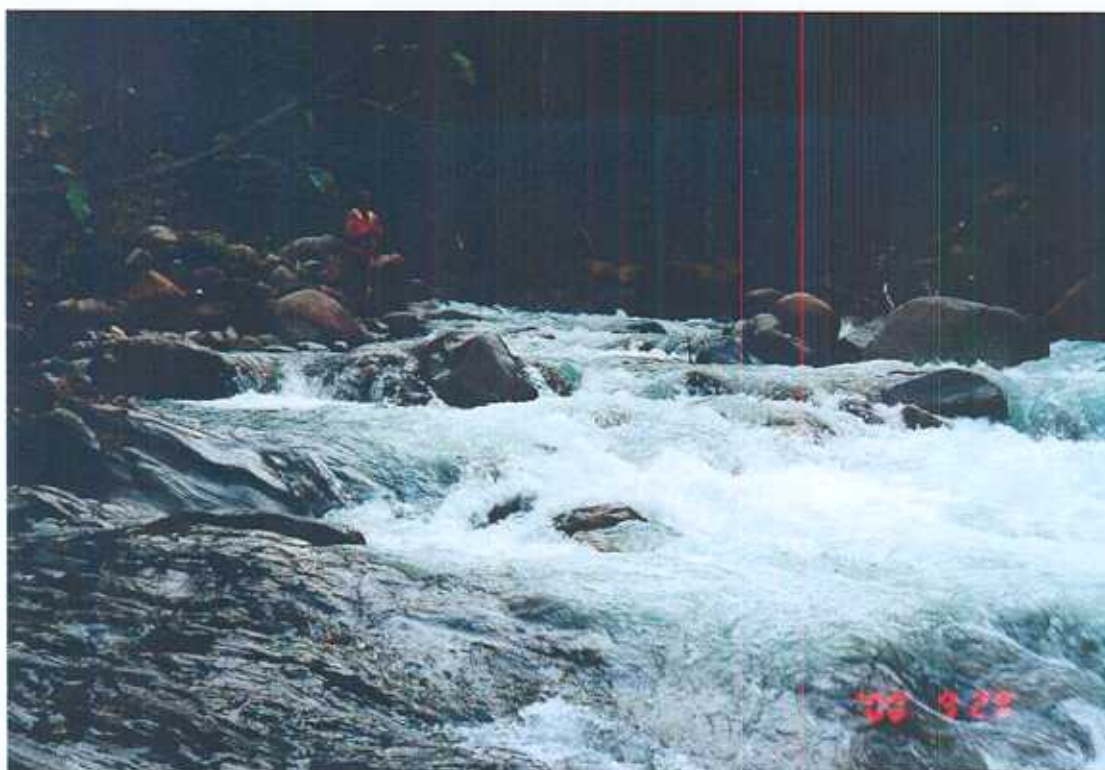
Photo 24: Manteau Creek (reach 2) – Low level of disturbance with stable stream banks.

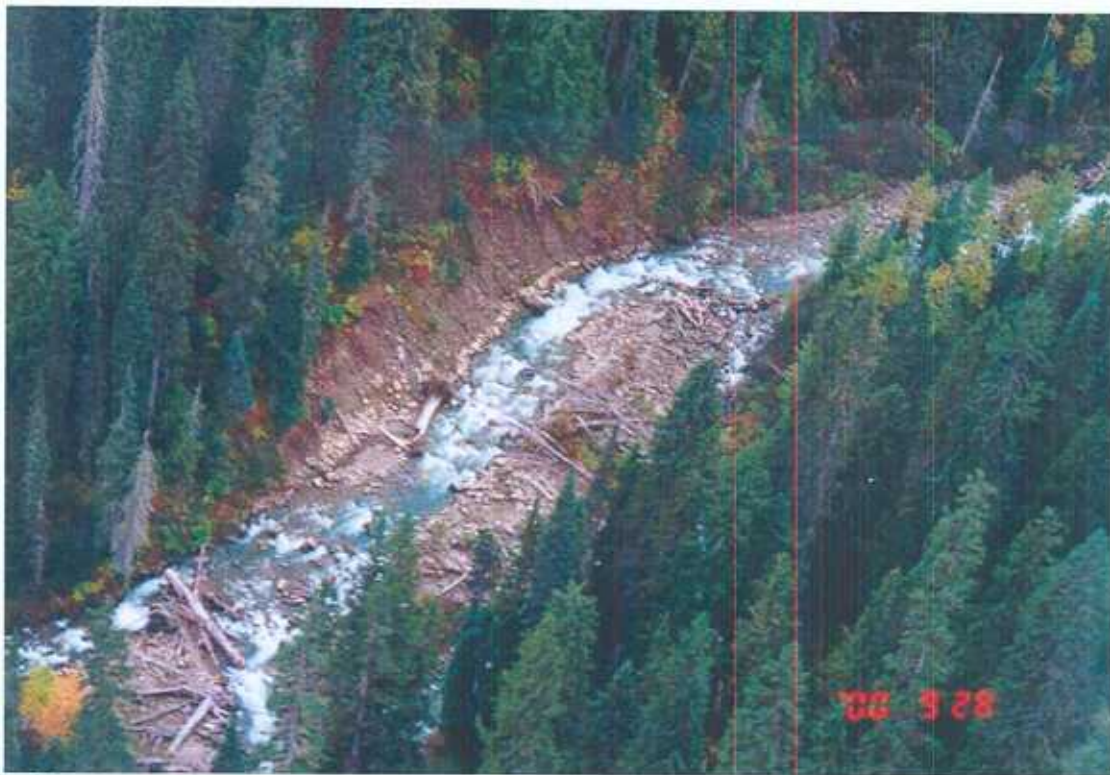
Photo 25: Manteau Creek (reach 2) – Example of bank erosion, mid-channel deposits and channel braiding in the middle of the reach.

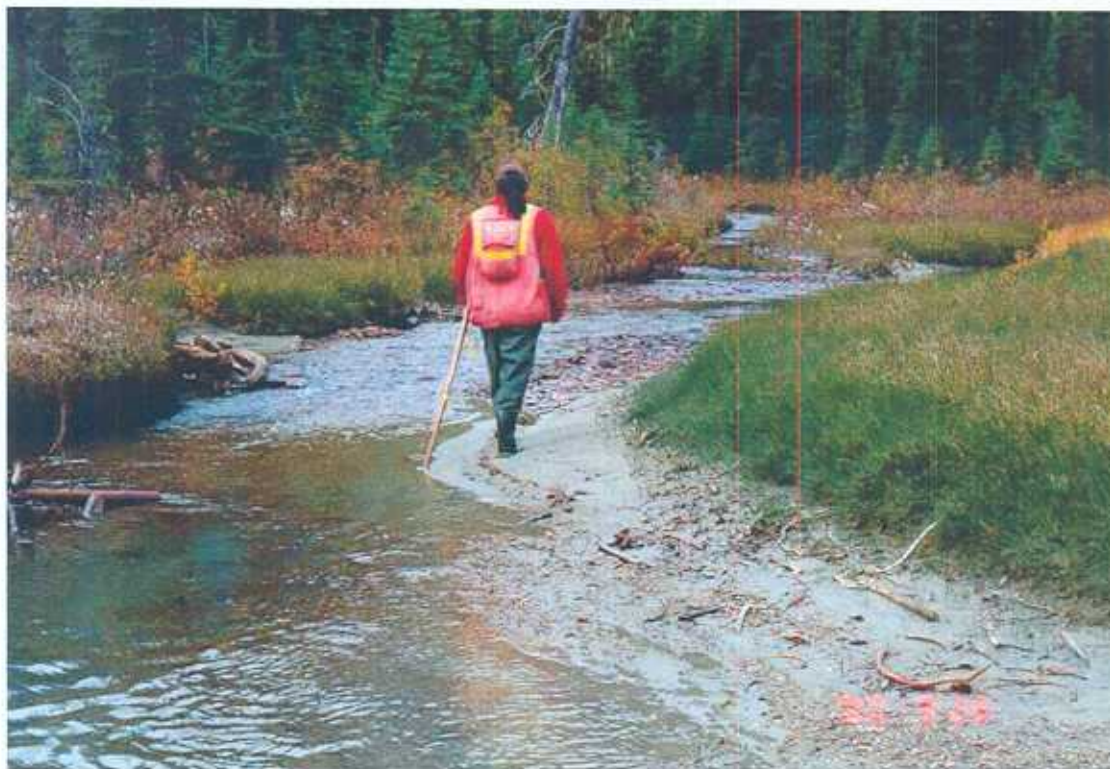
Photo 26: Manteau Creek (reach 4b) – Example of distributary channel at confluence with mainstem channel. Low gradient channel with stable stream banks.
