**LEMPRIERE and
MANTEAU CREEK
Watershed Assessments**

Prepared by:

Integrated Woods Services Ltd.
1425 Hugh Allan Drive
Kamloops, BC
V1S 1J3

May, 2001

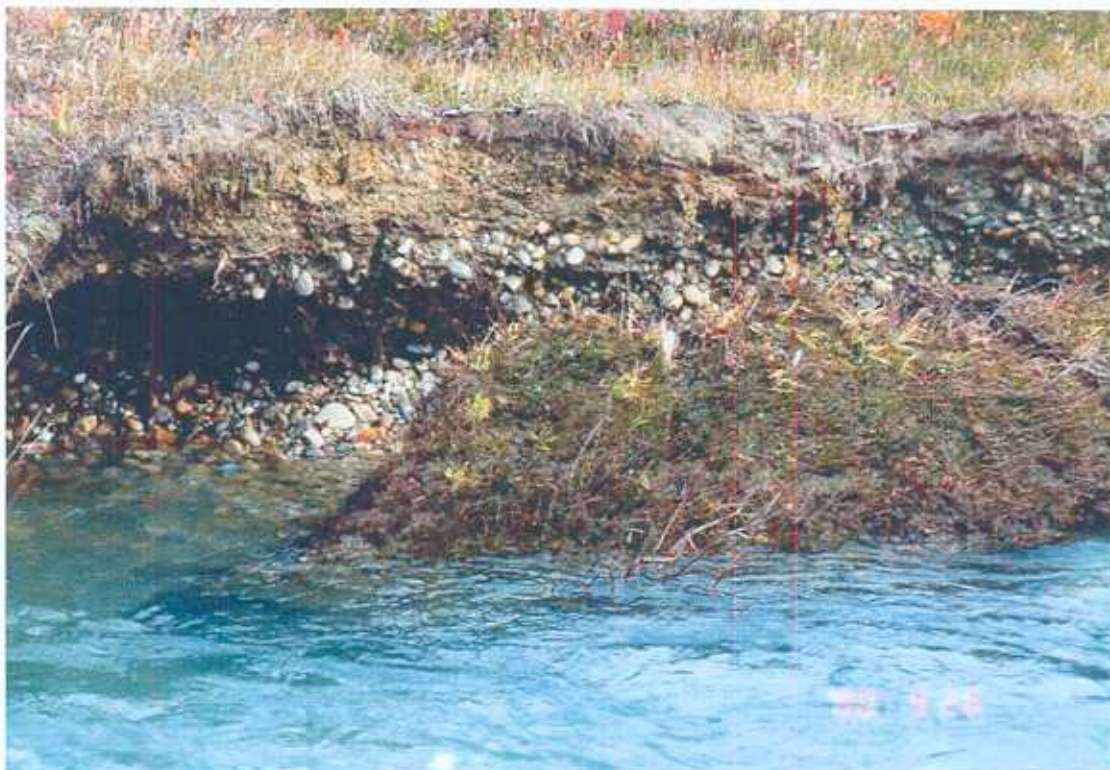
Photo 27: Manteau Creek (reach 4b) – Stratified bank material (sand/gravel over gravel/cobble) near the toe of the alluvial fan.

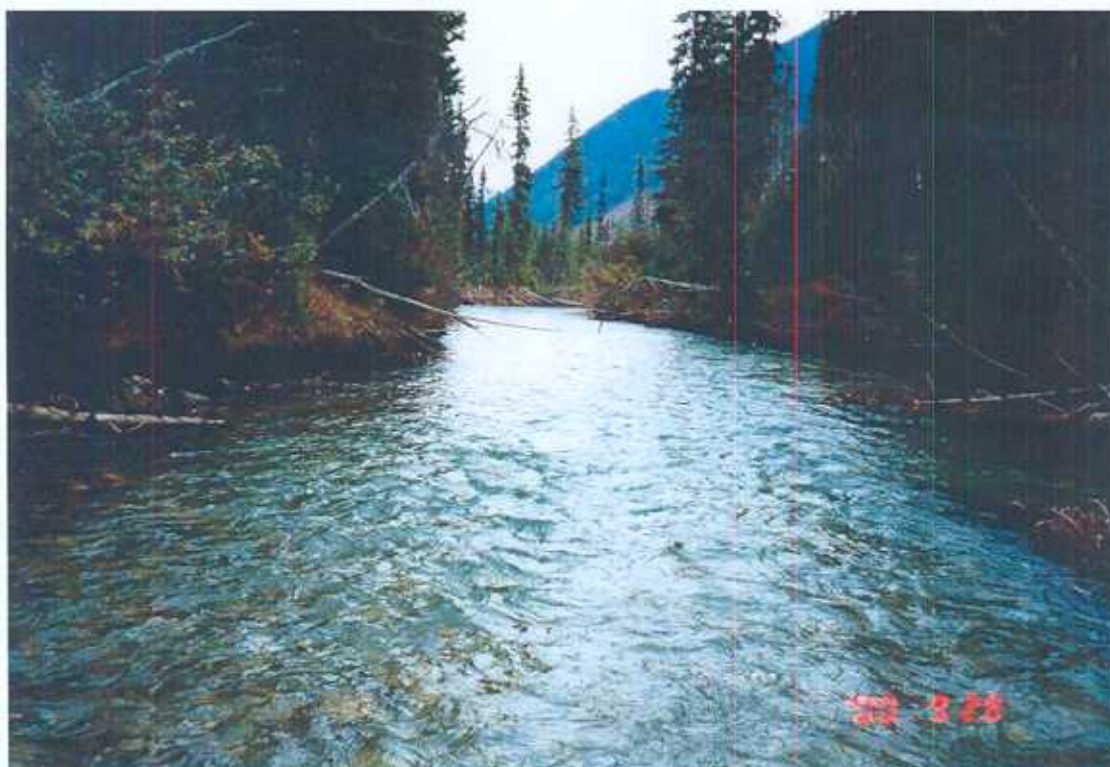
Within the assessed stream segments, stream bank materials and bank stability vary with location. Near the toe of the alluvial fan, stream bank materials are stratified into a layer of sand and gravel overlying a layer of gravel and small cobble (see photo 27). Downstream of the east fork of Manteau Creek, fine sand is the predominant bank material and the stream banks are generally well vegetated and stable (see photo 28). Localized bank erosion was noted in conjunction with sediment deposition. Riparian areas are mostly identified as swamp or non-productive forest, though mature coniferous forest occurs adjacent to the upper reach (see photo 28).

Photo 28: Manteau Creek (reach 4b) – Stable riffle-pool morphology and stream banks.

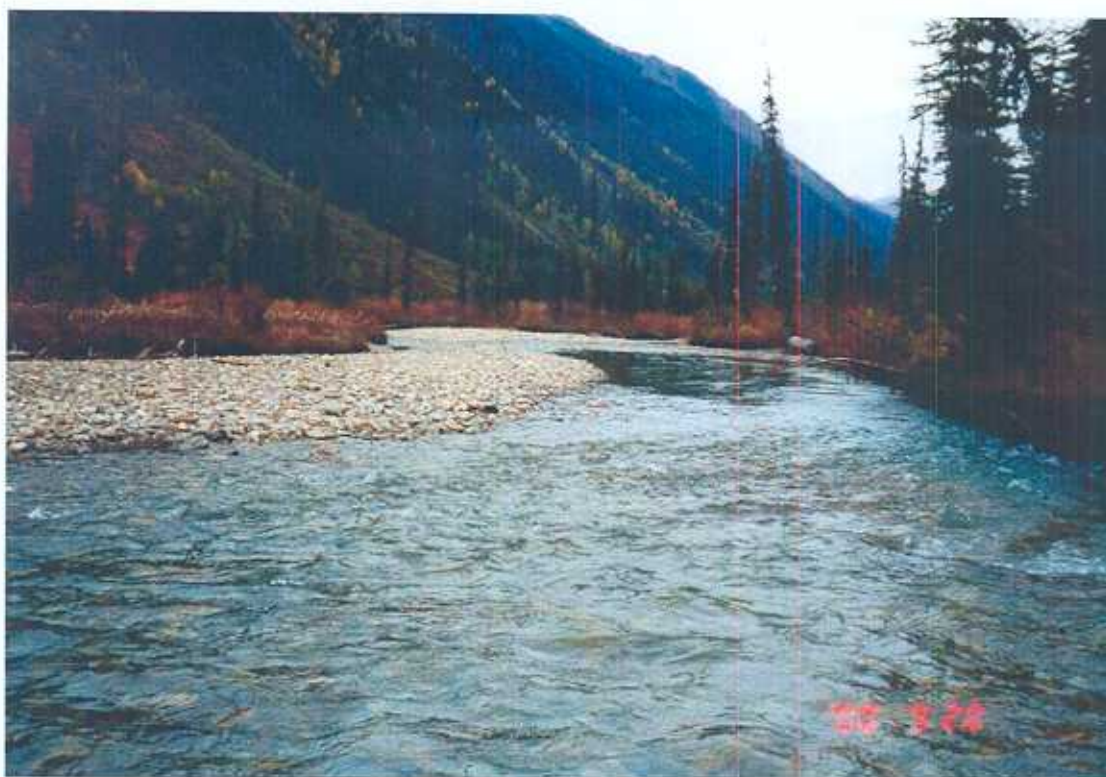
Low levels of channel disturbance were observed in this reach (see photo 29 & 30). Disturbance indicators noted within the reach included extensive lateral bars, mid-channel bars, LWD frequency and LWD orientation. Upstream of the confluence of the east and west forks of Manteau Creek, increased levels of bank erosion and overbank sediment deposition were observed (see photo 31). This reach is considered to be moderately to highly sensitive to changes in the processes controlling channel morphology.

Photo 29: Manteau Creek (reach 4b) – Riffle-pool morphology with low level of disturbance. Extensive lateral bars are characteristic in segments of this reach.

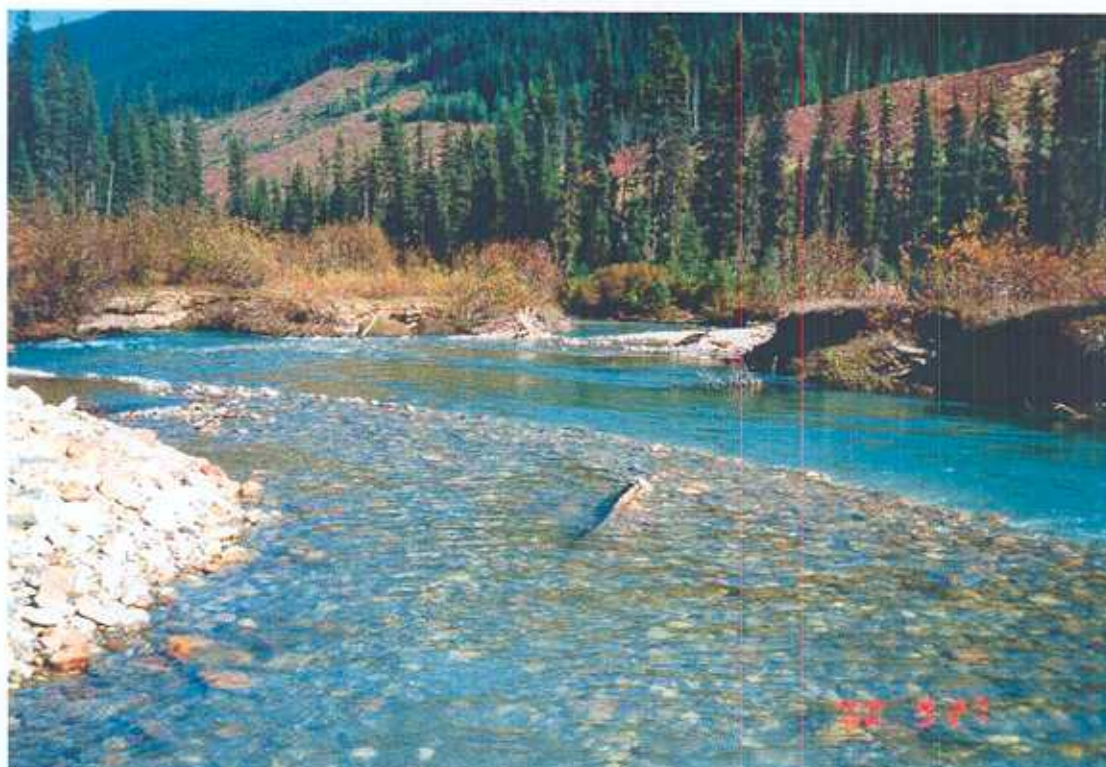
Photo 30: Manteau Creek (reach 4b) – Riffle-pool morphology at confluence of east and west forks. Note erosion occurring on both stream banks.

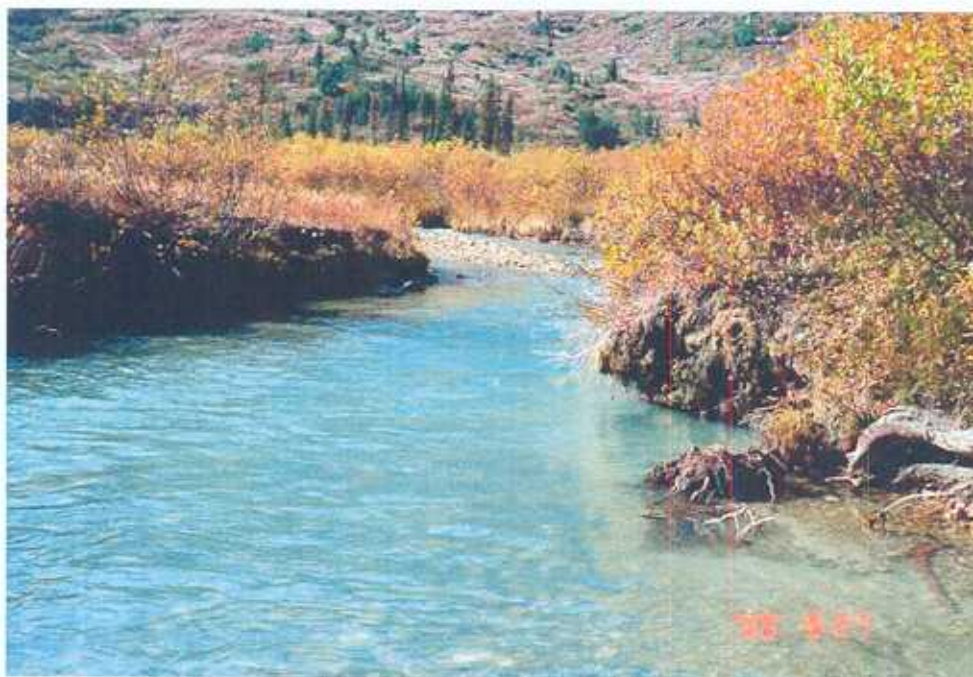
Photo 31: Manteau Creek (reach 4b) – Mid-channel deposition and bank erosion, upstream of the confluence with the East Fork of Manteau.

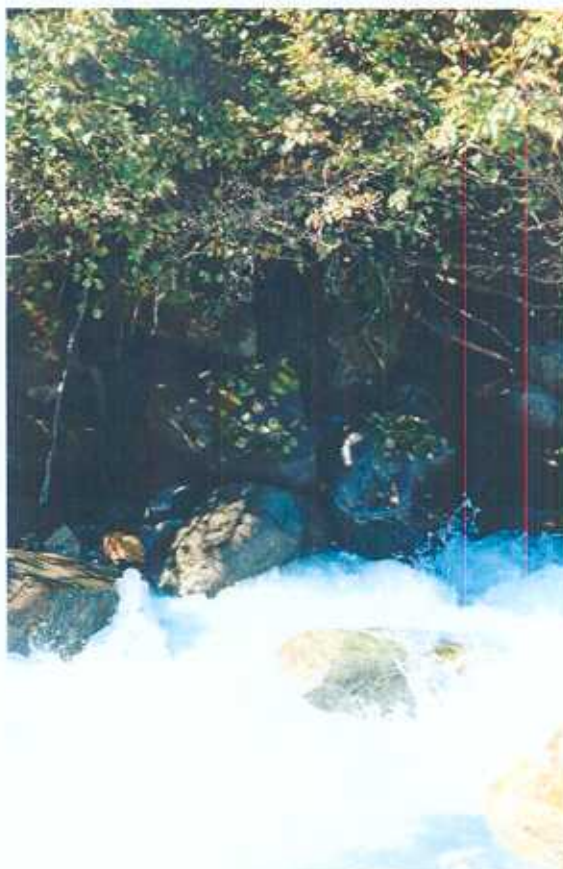
Photo32: Manteau Creek (reach 4c) – Stable bank comprised of boulder and cobble in upper portion of reach (near apex of alluvial fan).

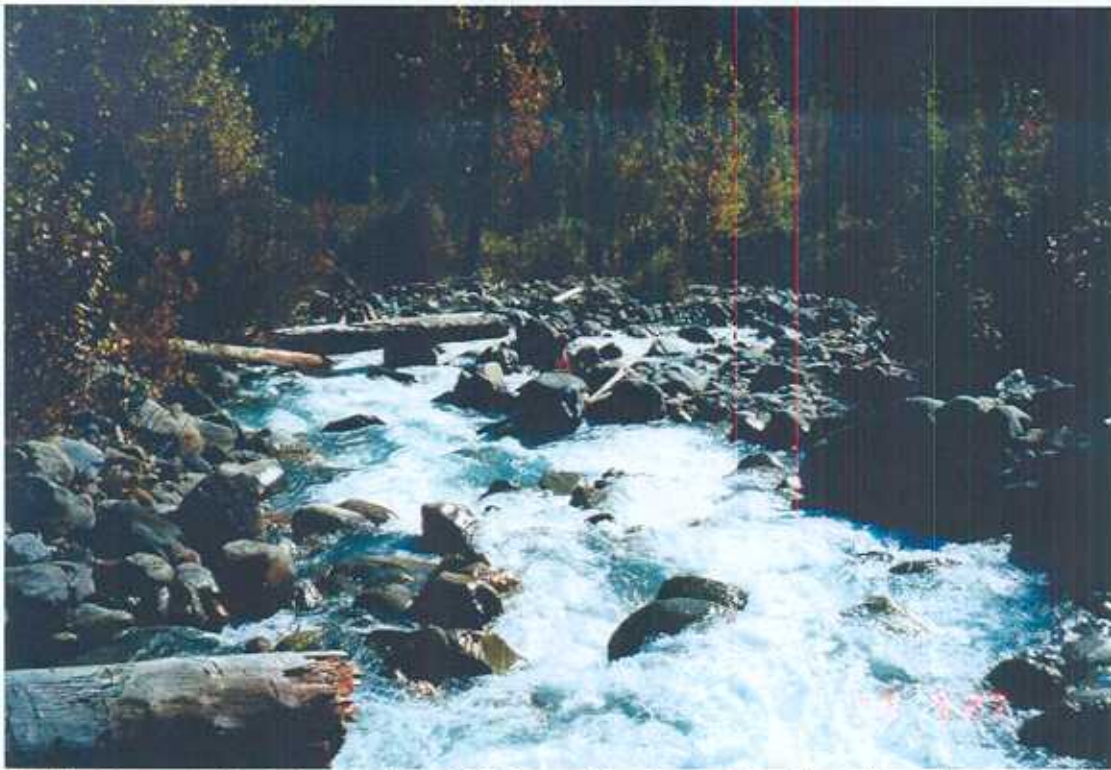
Photo 33: Manteau Creek (reach 4c) – Moderate disturbance level in mid-reach on alluvial fan. Disturbance indicators include avulsions, mid-channel deposits and braiding.

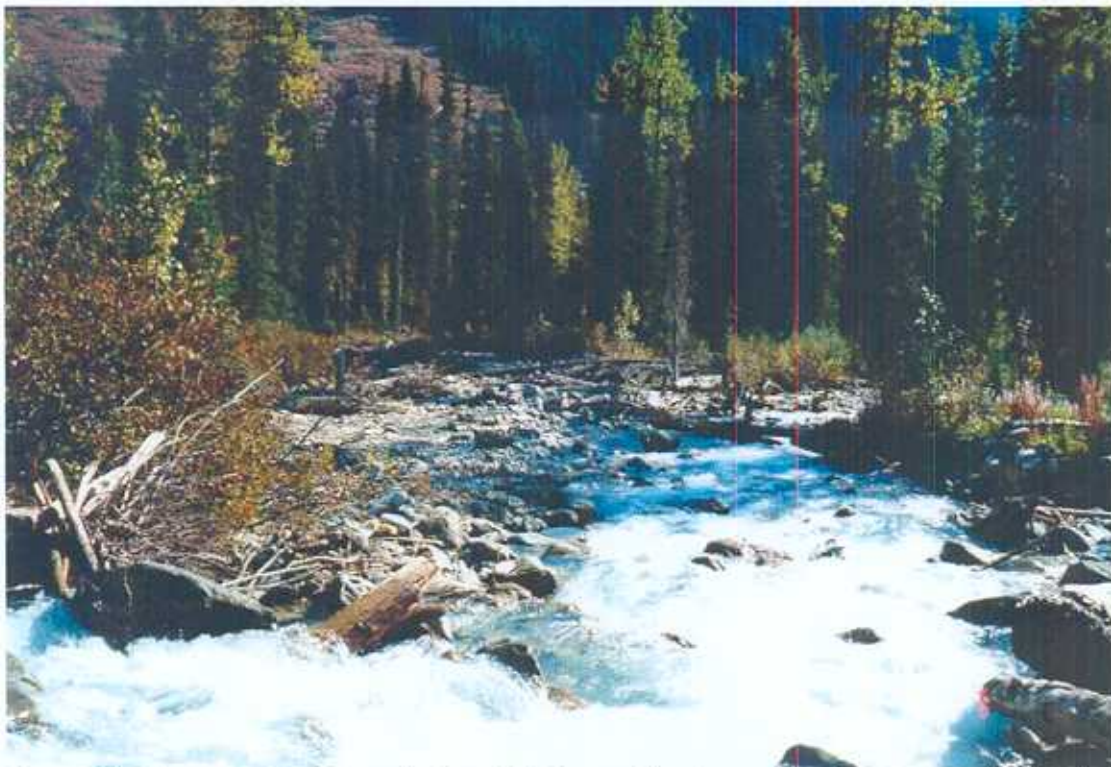
Photo 34: Manteau Creek (reach 4c) – Moderate disturbance level on lower alluvial fan. Disturbance indicators include avulsions, mid-channel deposits and braiding.

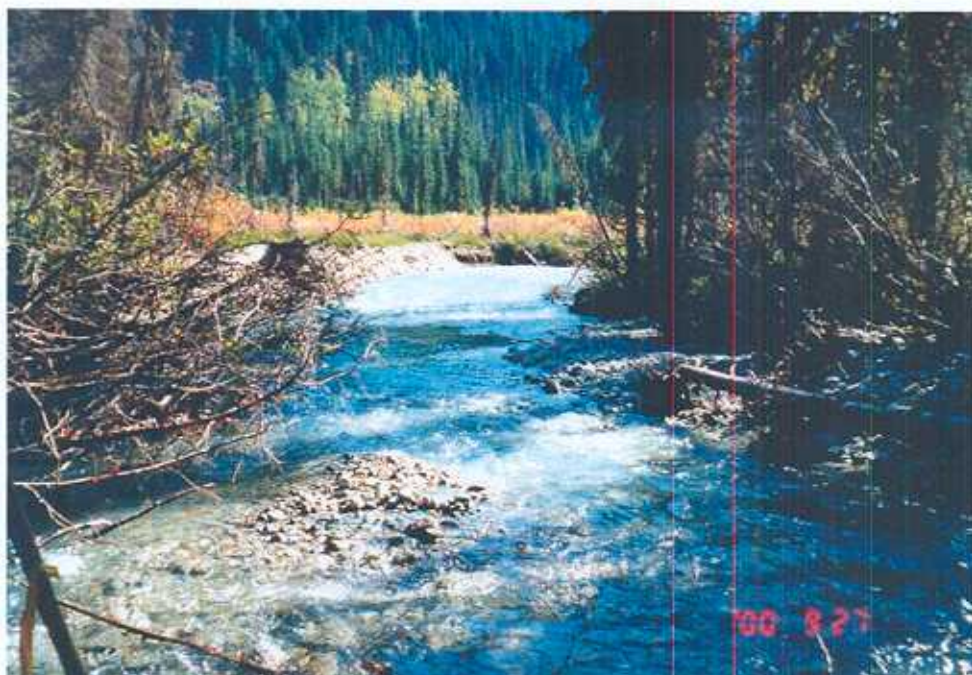
Upstream of the confluence of the east and west forks of Manteau Creek, disturbance levels are mostly moderate. Disturbance indicators noted in this channel segment included numerous avulsions, bank erosion, mid-channel sediment deposition, channel braiding and sediment deposition into riparian areas (see photos 33 & 34). Disturbance levels generally decrease from moderate to low in the lower stream reach (see photo 35).

Photo 35: Manteau Creek (reach 4c) – Reduced channel disturbance near toe of alluvial fan.

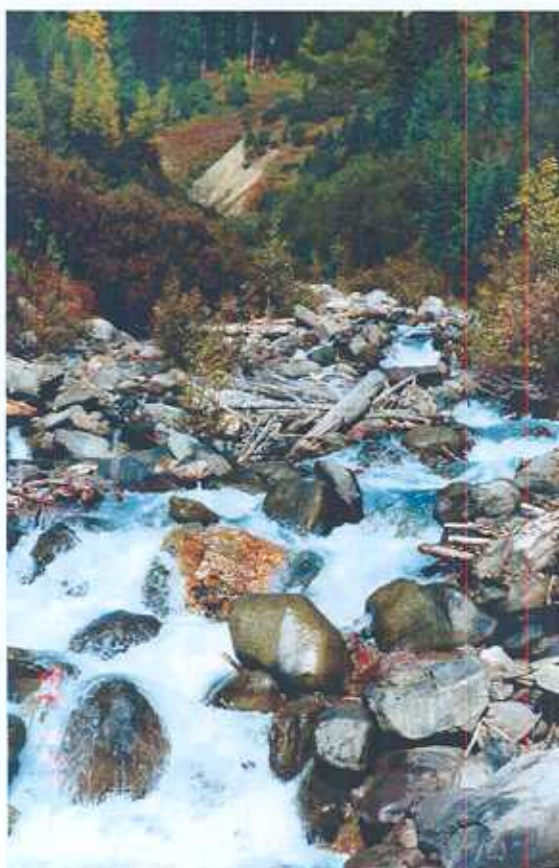
Photo 36: Manteau Creek (reach 4c/5) – Disturbed channel segment with SS #3 in background.

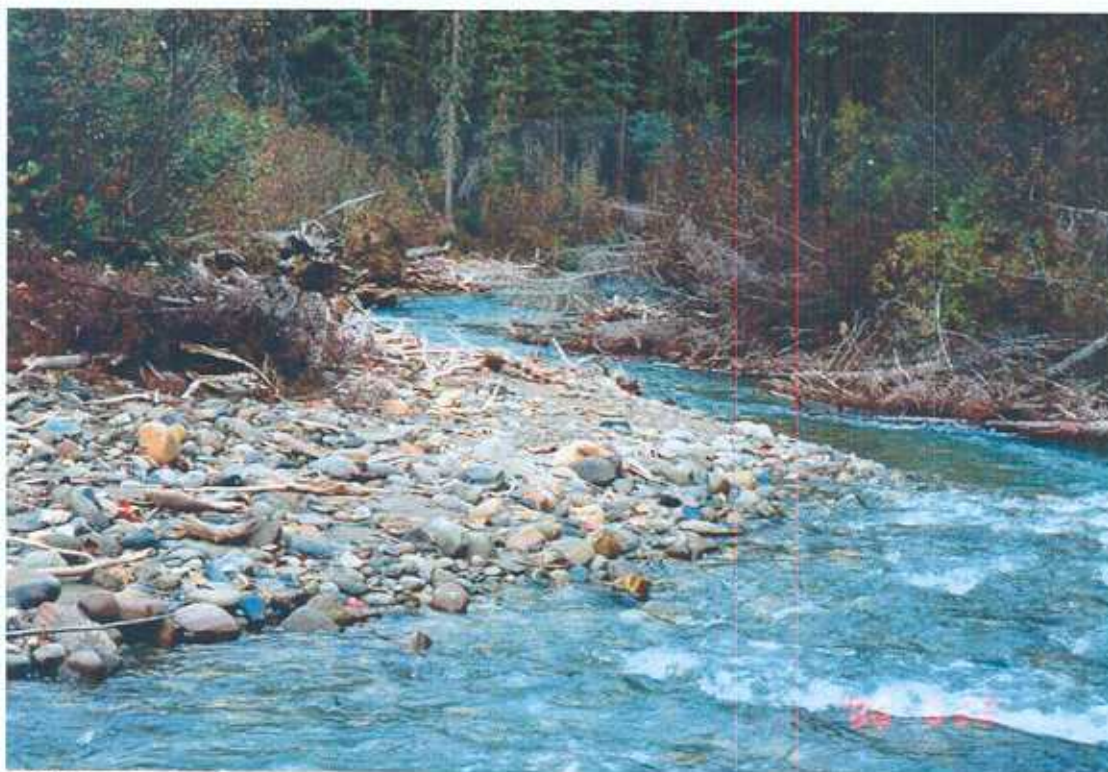
Disturbance levels throughout the reach are generally low (see photo 37) but observed disturbance indicators included extended riffles, infrequent elevated mid-channel deposition and LWD orientation. Channel disturbance has occurred downstream of the Road 1211 bridge, where a berm has been constructed adjacent to the channel (see photo 38). The berm appears to have been constructed to protect the road prism at the west end of the bridge. The berm has been breached for approximately 1.5 m at the upstream end and water can now flow between the berm and the road. Overall, disturbance levels in this reach are low and the channel is considered to be moderately sensitive to changes in the supply of water, sediment and/or LWD. While this fork of Manteau

Photo 37: East Fork of Manteau (reach 1) – Riffle-pool morphology with low level of disturbance.

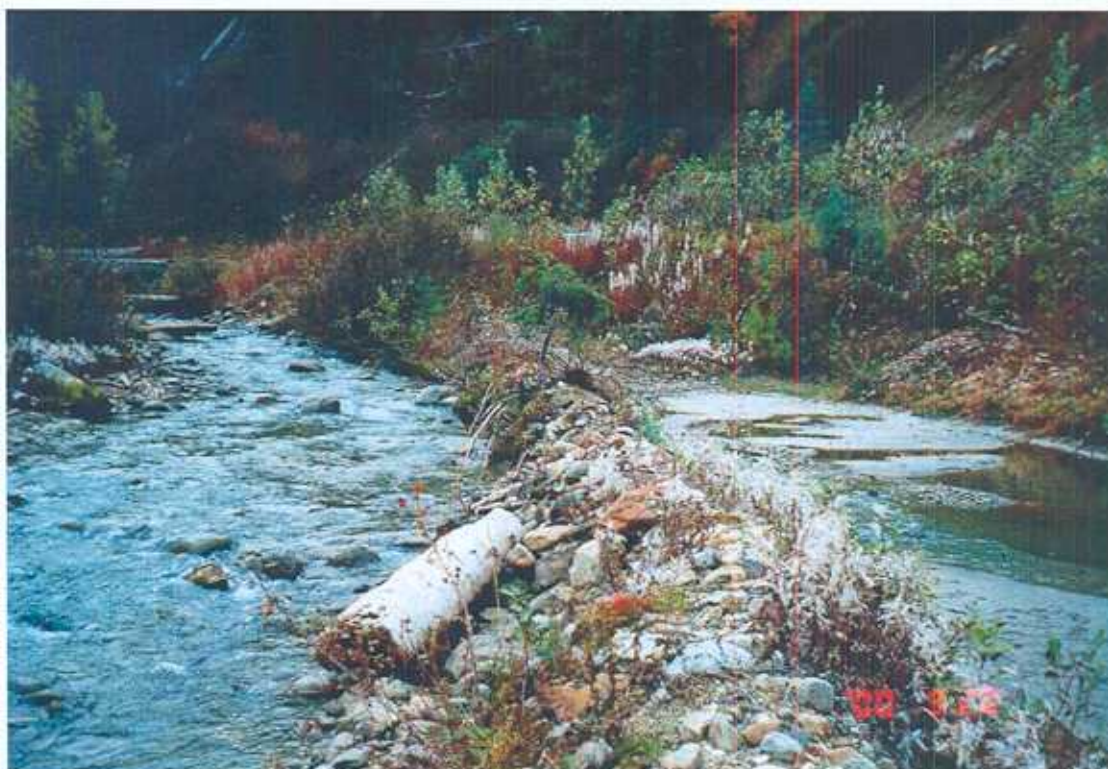
Photo 38: East Fork of Manteau (reach 1) – Berm constructed to protect road prism adjacent to bridge on Road 1211.

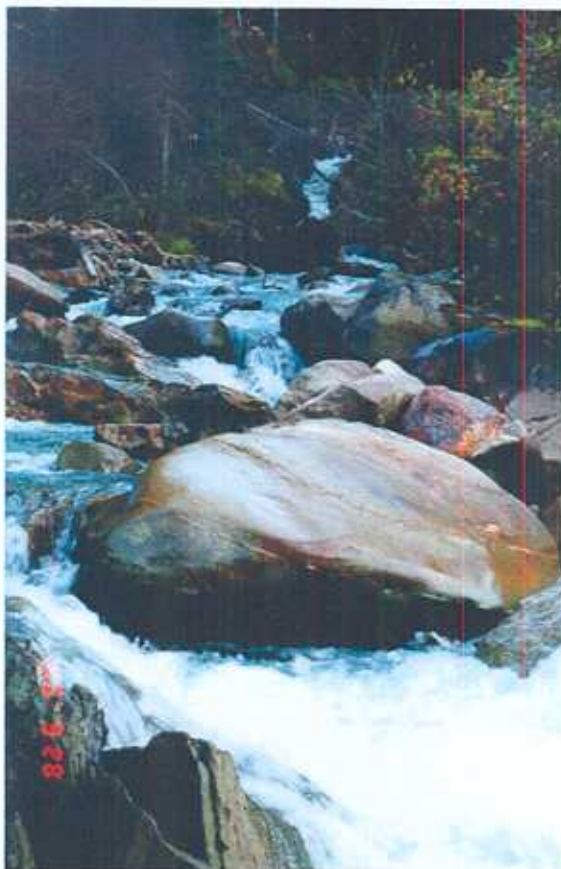
Photo 39: East Fork of Manteau (reach 2) – Stable step-pool morphology.

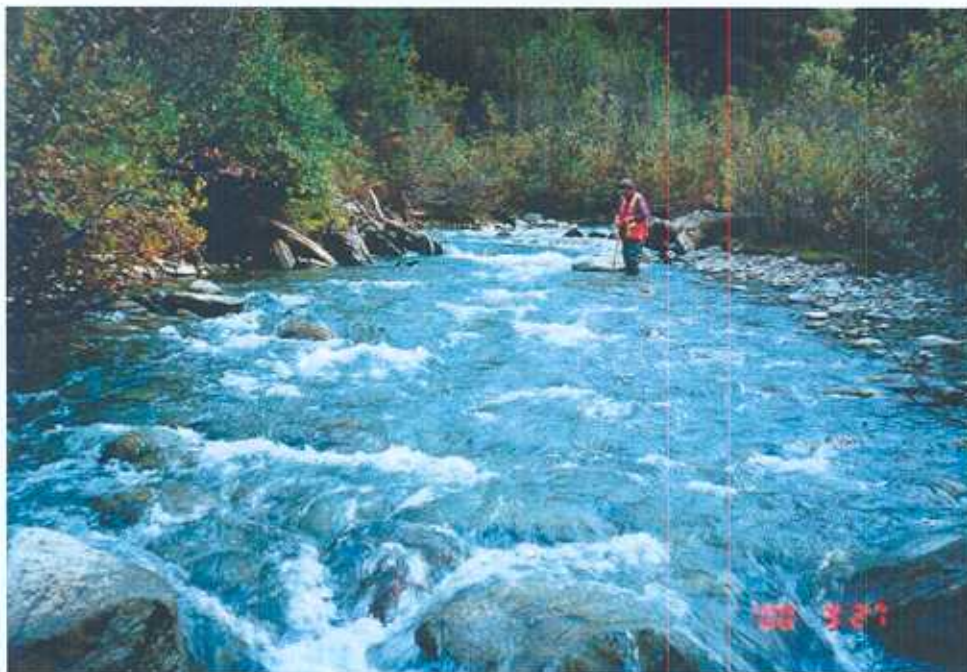
Photo 40: East Fork of Manteau (reach 3) – Stable cascade-pool morphology. Low frequency of LWD with function generally only on channel margins.

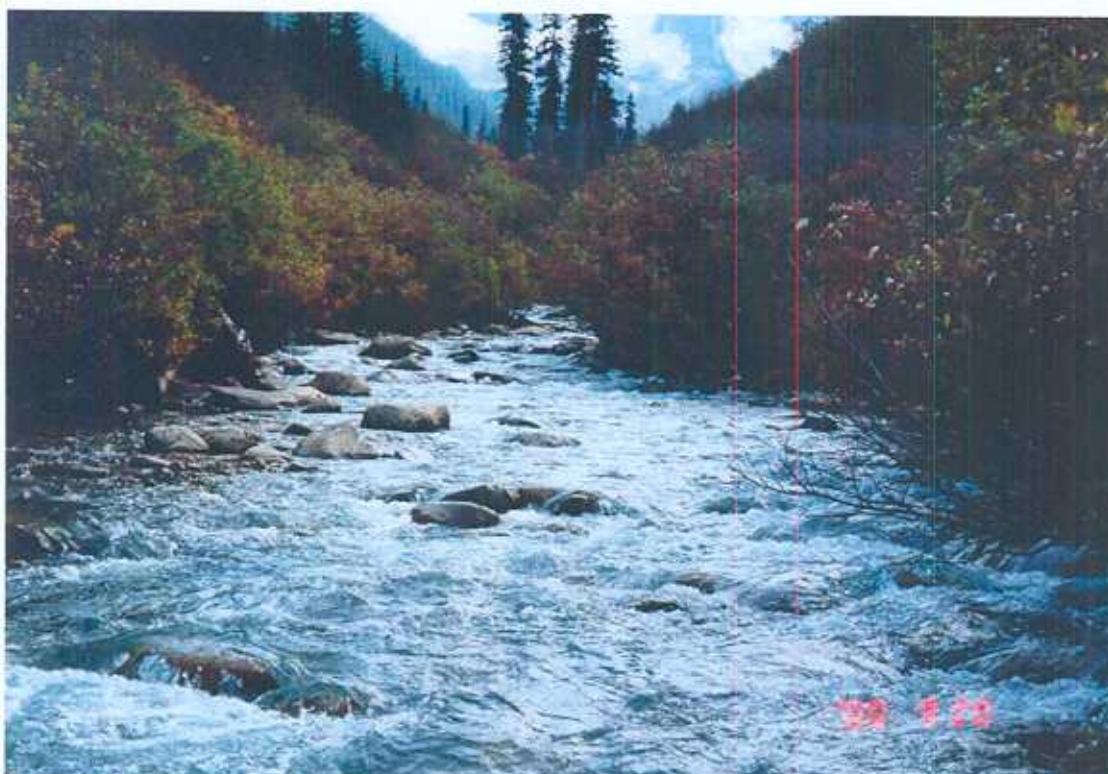
Photo 41: East Fork of Manteau (reach 3) – Stable cascade-pool morphology. Dense shrub layer occurs adjacent to much of the reach.

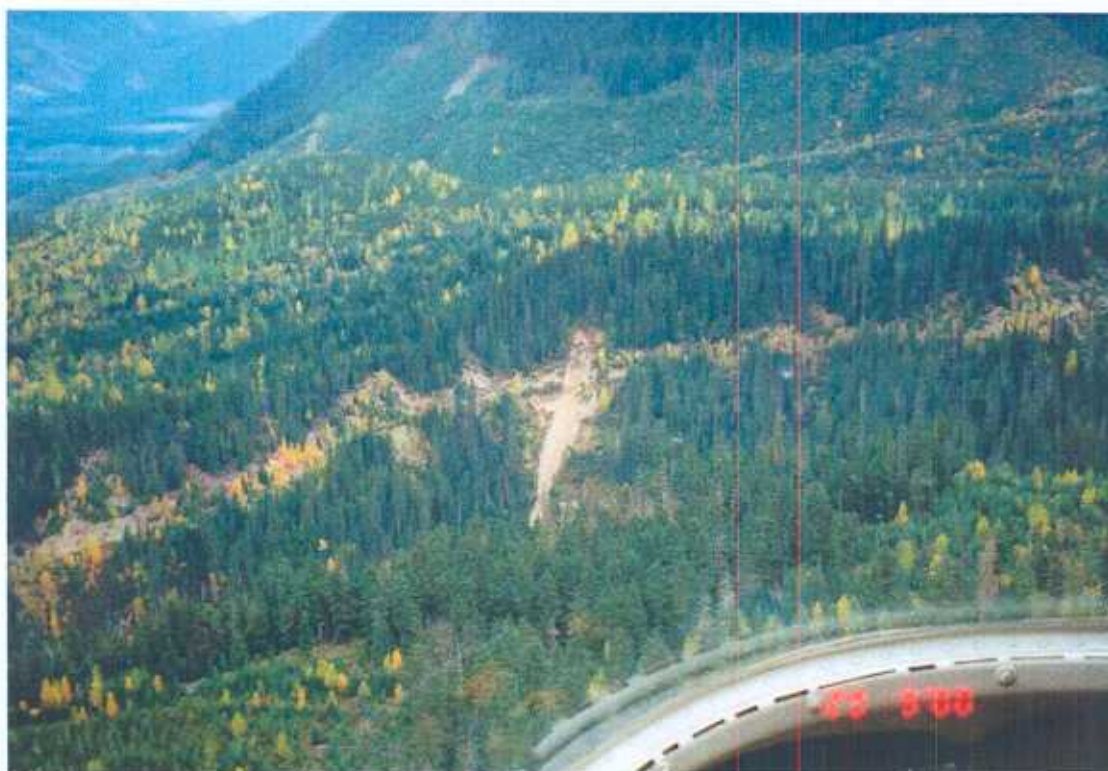
Photo 42: Lempriere watershed – Priority Site “A”, slide “b”. Road was built through class V terrain in the late 1960’s.

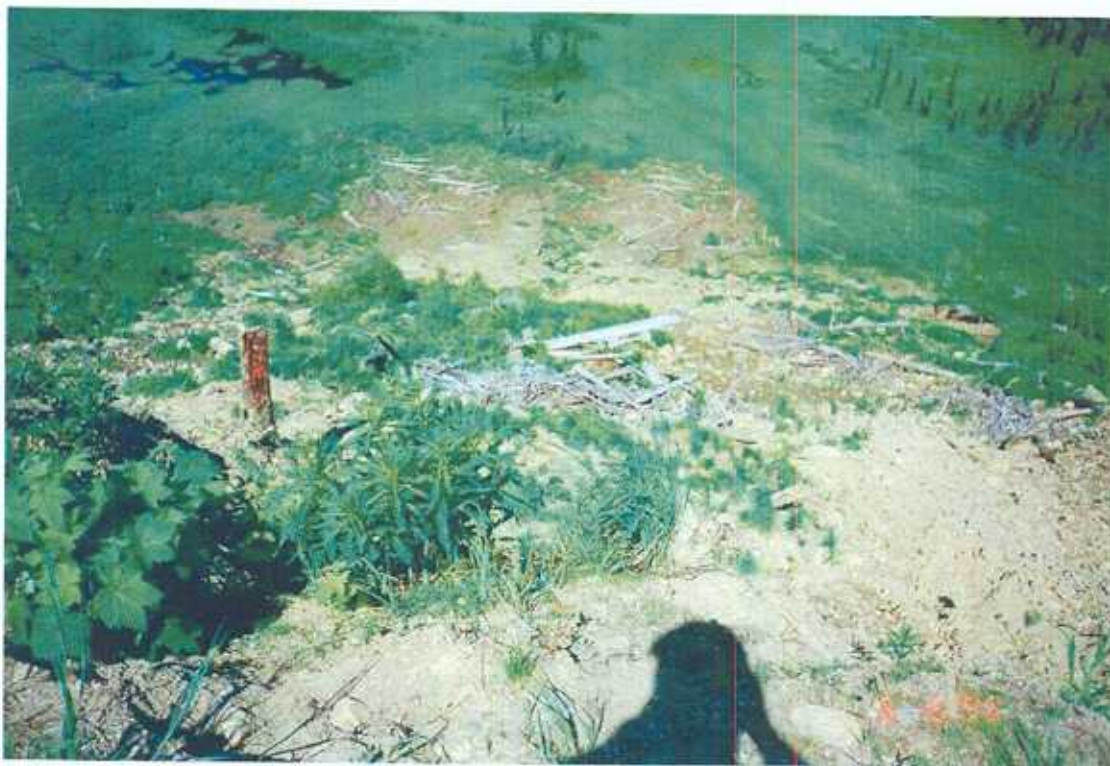
Photo 43: Manteau watershed – Priority site 16, slide 10 on Road 1200.

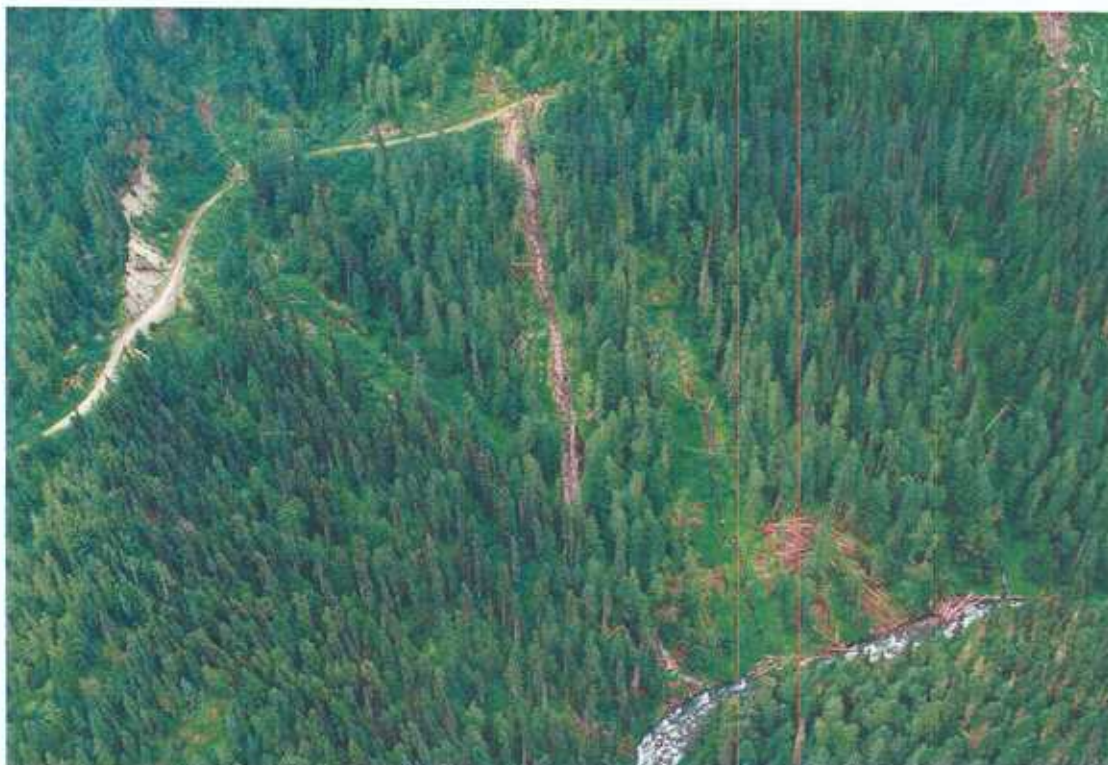
Photo 44: Lempriere watershed – Priority site 10, slide 25 on Road 1300.

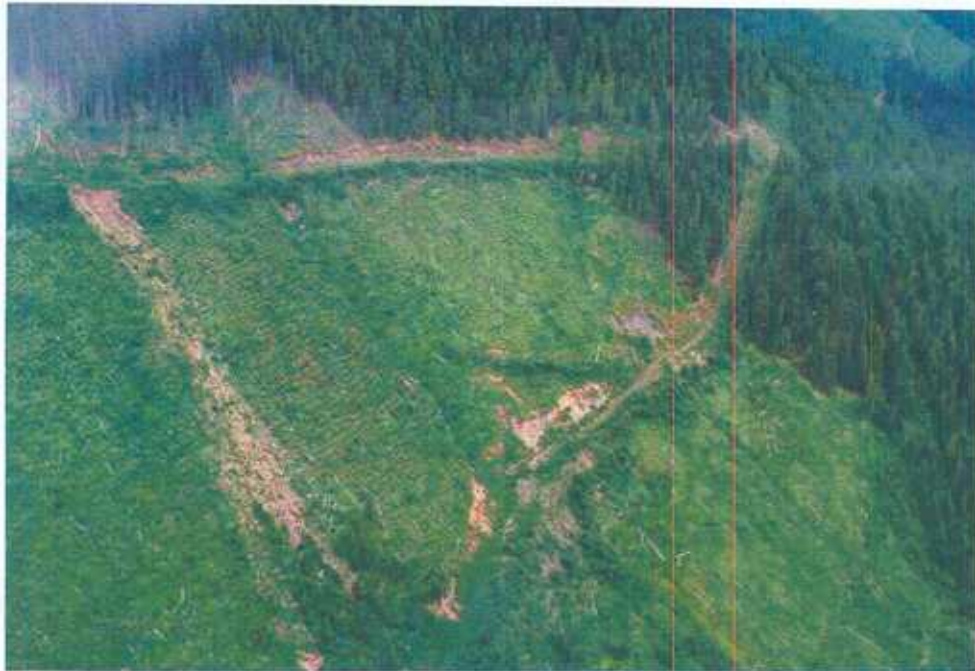
Photo 45: Lempriere watershed – Unnumbered slide initiated at Road 1303.02. Located within opening 18, polygon 167.

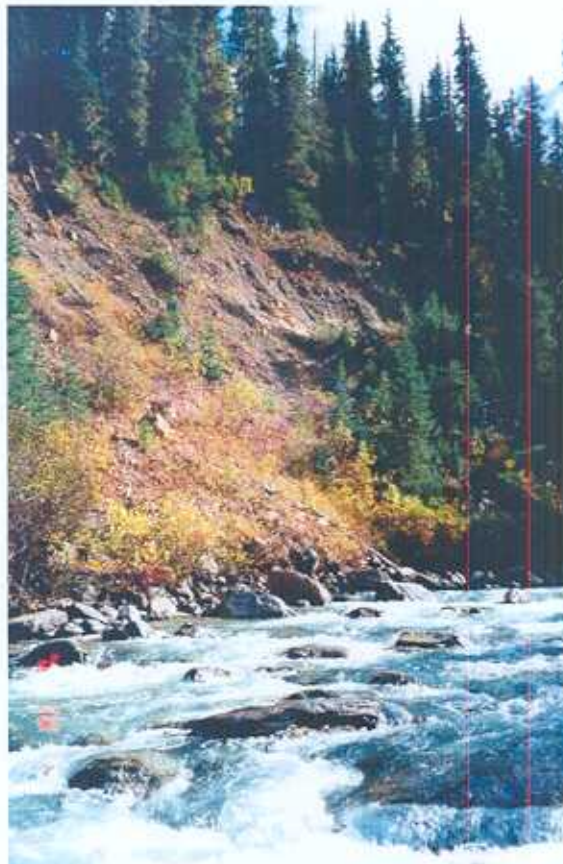
Three large, natural sediment sources coupled to the stream channel were identified in the Manteau watershed (see Table 8). Two sediment sources (SS#1 and #2) were observed in the field downstream of the reach 2-3 break (see photo 46). The third sediment source is coupled to reach 5 at the toe of a large avalanche track. The effects of the third sediment source are discussed further in section 6.3 (Manteau Creek - reach 5).

Photo 46: Manteau Creek (reach 2) – Natural sediment source (SS #2) with partial revegetation.
