Fish Passage Culvert Assessment
for Cahilty Creek Watershed
FIA Project # 4602004

Weyerhaeuser Company Ltd.

ARC Environmental Ltd.
1326 McGill Road
Kamloops, B.C., Canada
V2C 6N6

November 24th, 2006

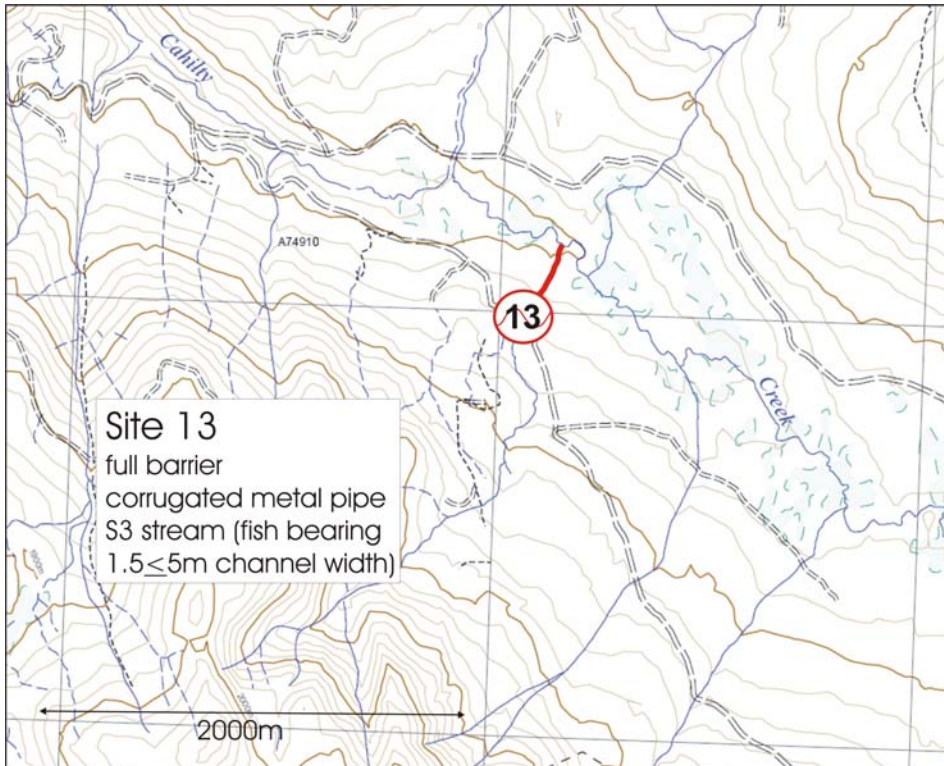
Figure 3: Site 13

Watershed mapping indicates the culvert located approximately 350 m upstream from the confluence with Cahilty Creek limits access to approximately 1.6km of upstream habitat. The natural falls located 1.6km upstream of the culvert is an identified barrier to further fish passage upstream (ARC Environmental Ltd. 2000).

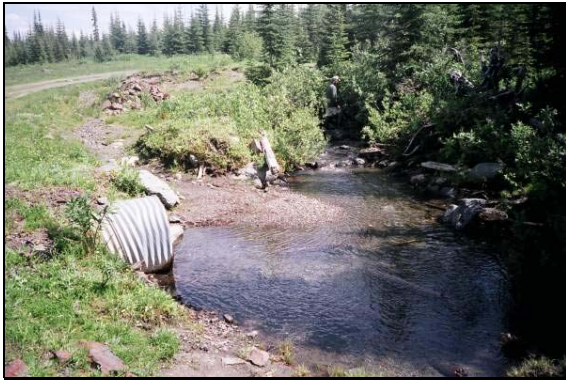
Photograph 1 – Site 13 Inlet Upstream View (Roll 1:9)

Several parameters indicate that the culvert is a barrier to all rainbow trout age-classes throughout the year, the most pivotal ones being the outfall drop (jump height), and the plunge pool depth:outfall drop ratio. The culvert outfall drop of 0.78m in combination with the plunge pool depth of 0.5m does not provide the required 1.25 plunge pool depth:outfall drop ratio required for rainbow trout of any age-class to make the jump up into the culvert. Additionally the jump height of 0.78m is greater than jumping capability of juvenile rainbow trout, regardless of pool depth.

The culvert wetted width (0.5 m) was only 23% of the creek wetted width (2.13 m), and consequently the culvert water velocity (1.5 m/s) was approximately 4 times the velocity measured in the creek (0.38 m/s). Culvert water velocity was greater than the burst speed of juvenile rainbow trout $\leq 125\text{mm FL}$ (i.e. maximum burst speed 1.1m/s), preventing their upstream passage through the culvert. At the time of the assessment (June 27 2006), discharge may have been near historical low flows suggesting that culvert water velocities may regularly be beyond the swimming capabilities of juvenile rainbow trout. In addition, the culvert slope of 5% exceeds the recommended 1% slope recommended for non-baffled culverts <24m long (Parker 2000). As well the culvert water depth recorded was less than the recommended 15cm depth for upstream passage of adult rainbow trout (Parker 2000).

Although the culvert is a barrier to fish passage, it did not appear to require maintenance nor did it contribute to downstream sedimentation. Photographs 1 – 4 present the upstream and downstream view at both ends of the culvert. The results of the culvert assessment are provided in Table 1.

Barrier Evaluation:	
Barrier	Full
Barrier Type	Jump height of 78 cm is greater than jumping capability of juvenile rainbow trout. Culvert pool depth of 50cm is less than 1.25times the culvert outfall depth of 78cm and so fish of all age classes can not make the jump up into the culvert. Culvert slope of 5% is greater than the recommended 1% for culverts without baffles and less than 24m in length. Culvert diameter is 38% of channel width increasing velocity through the culvert. Culvert water velocity in low flow period at 1.50m/s (more than 3 times channel velocity of 0.38m/s) and is greater than the burst speed of both juvenile class sizes. Culvert water depth of 9cm is below the recommended 15cm for adult upstream passage.

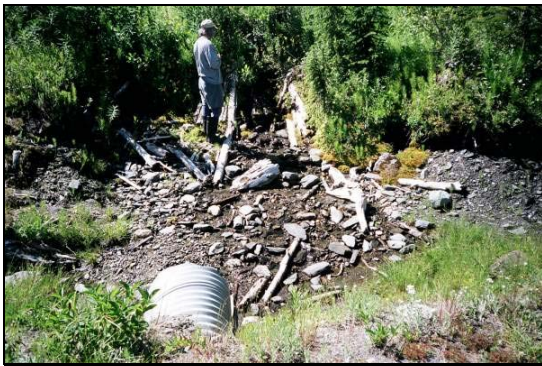
Photograph 5 – Site 32 Inlet Upstream View (Roll 5 Photo 25)

The culvert at this site was determined to be a partial barrier that may allow passage of some age classes of rainbow trout at some times of the year. The culvert water velocity at the time of the assessment was 0.50m/s, more than 4 times the average channel velocity of 0.09m/s, and greater than the burst speed of juvenile rainbow trout <50mm FL. And the culvert water depth of 9cm was below the recommended 15cm for adult rainbow trout upstream passage. In addition, the culvert slope of 3.2% is greater than the recommended 1% for culverts without baffles and less than 24m in length (Parker 2000). However, the culvert plunge pool depth of 31cm is greater than 1.25 times the culvert outfall drop of 18cm and therefore juvenile to adult rainbow trout are able to access the culvert (Parker 2000). However, the vertical ditch wall immediately upstream of the culvert inlet is a full barrier to fish passage. Therefore the culvert acts presents a partial barrier to a short (<250m) and limited amount of habitat, which is likely not accessible due to the vertical ditch wall immediately upstream of the culvert.

Photographs 5 – 8 show the upstream and downstream views of the culvert inlet and outlet. The field worker is standing at the base of the vertical ditch wall immediately upstream of the culvert inlet in Photograph 5.

velocity and water depth mean that in low flow, only larger juveniles are able to pass the culvert. However, although the culvert is a partial barrier the vertical ditch wall immediately upstream of the culvert's inlet is a full barrier to all age-classes of RB at all times of the year.
