HYDROGEOLOGIC EVALUATION
IN REGARD TO DISPOSAL OF WASTEWATER AND STORM WATER
ON A PROPOSED SUBDIVISION AT 8611 GAGLARDI STREET
IN THE DISTRICT OF MISSION
(District of Mission Subdivision Application 90-07)

PACIFIC HYDROLOGY CONSULTANTS LTD.
204 - 1929 West Broadway
VANCOUVER, B. C. V6J 1Z3

SEPTEMBER 10, 1990

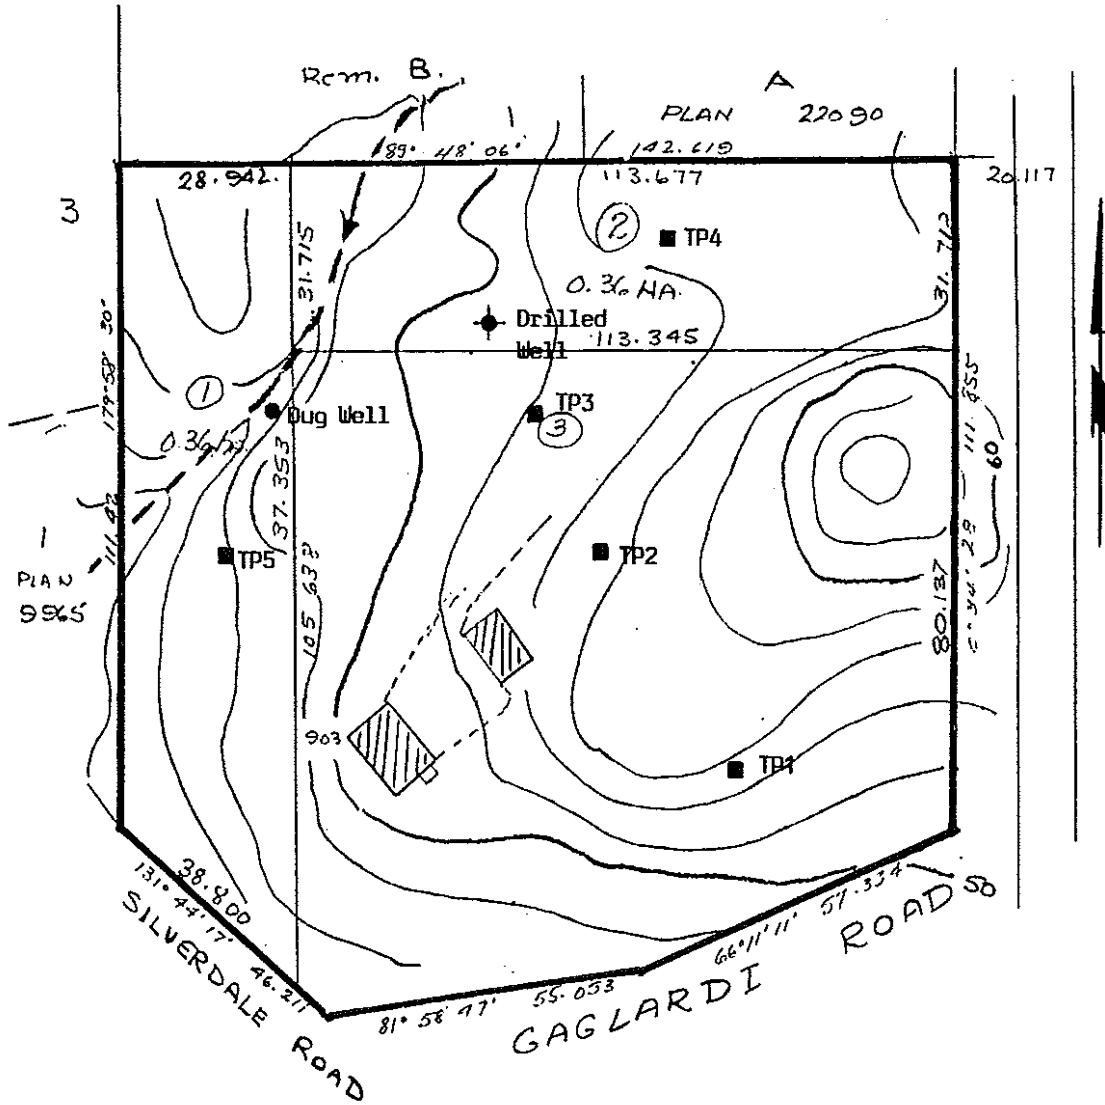
FIGURE 2

A small excavator was used to dig five test pits on the subject Property at the approximate (unsurveyed) locations shown on Figure 2 in Appendix A. The descriptions of sediments exposed in the pits are contained in Appendix B. Four of the pits reached weathered bedrock consisting of loose angular sandstone rubble. All of the holes were completely dry and none showed any mottling or other signs that the near-surface sediments are subject to saturation. A static water level of 7.6 m (25 ft) below ground surface is recorded on the driller's log for the drilled well located on the southwestern part of proposed Lot 2; the driller's log also gives an overburden thickness of 3 m (10 ft). Based on conditions shown in the test pits, it seems likely that part of the three metres of surficial sediments includes weathered sandstone rubble.

TEST PIT LOCATIONS ON PROPOSED MANZER
SUBDIVISION AT 8611 GAGLARDI STREET
