SUITABILITY OF HYDROGEOLOGICAL CONDITIONS
FOR SUBDIVISION OF A PARCEL OF LAND AT 8590 CEDAR VALLEY ROAD
OPPOSITE EGGLESTONE AVENUE IN THE DISTRICT OF MISSION

PACIFIC HYDROLOGY CONSULTANTS LTD.

JANUARY 8, 1990

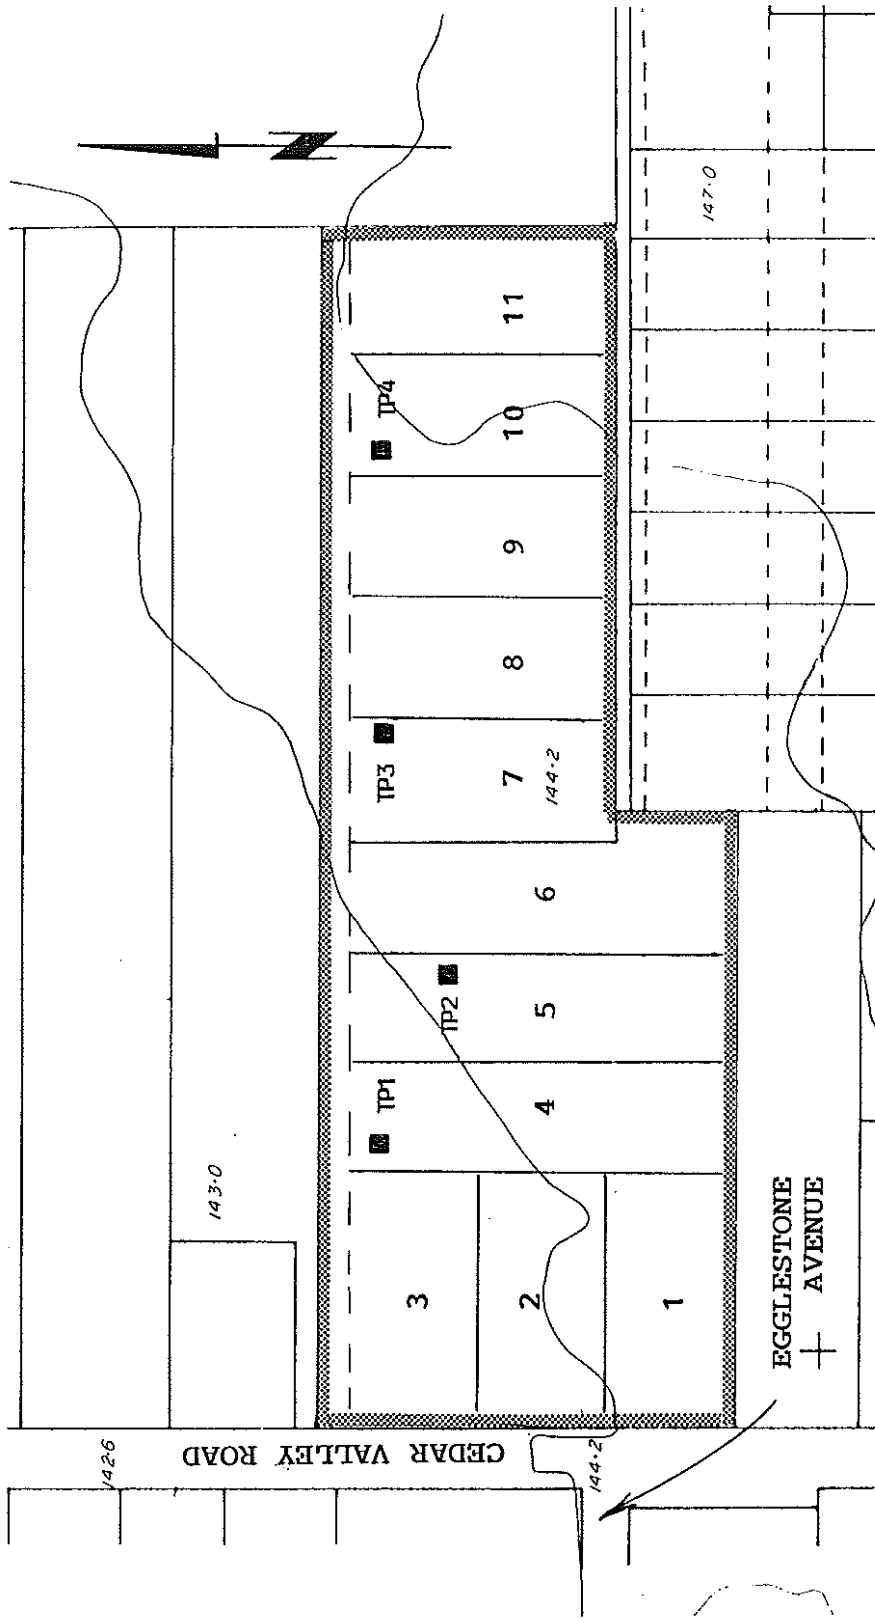
FIGURE 2

The sediments exposed in the four test pits generally confirm that conditions are as shown on GSC Map 1485A of the surficial geology. However, all of the pits showed very fine-grained eolian sediments, usually called loess, at surface; the loess varied in thickness from two metres in Pit 1 on proposed Lot 4 to three metres in Pit 4 on proposed Lot 10. In all pits, the sediment underlying the loess was a clean grey sand of medium grain size, probably a floodplain deposit of proglacial streams. The contact between the loess and the sand was generally sharp and distinct; however, thin beds of sand were observed to be present within the loess about one-half metre above the main contact. The grain size of the loess is approximately at the border between sand and silt; the average grain size is probably about 0.05 mm.

Prominent rusty mottling was observed in the loess in all pits, indicating that the loess has been repeatedly saturated, probably on an annual basis. It was certainly saturated at the time of this investigation.

The test pit logs are attached in Appendix B. The approximate (unsurveyed) locations of the test pits are shown on Figure 2 in Appendix A.

TEST PIT LOCATIONS ON PROPOSED SUBDIVISION AT 8590 CEDAR VALLEY ROAD
IN THE DISTRICT OF MISSION
