SUITABILITY OF CONDITIONS FOR ONSITE WASTEWATER DISPOSAL  
FOR A PROPOSED GOLF COURSE CLUBHOUSE  
NEAR THE TRANS-CANADA HIGHWAY TURNOFF TO AGASSIZ

Prepared for  
BRIDAL FALLS GOLF AND COUNTRY CLUB  
18593 58th Avenue  
SURREY, B.C. V3S 1M3

Prepared by  
PACIFIC HYDROLOGY CONSULTANTS LTD.  
204 - 1929 West Broadway  
VANCOUVER, B.C. V6J 1Z3

February 26, 1992

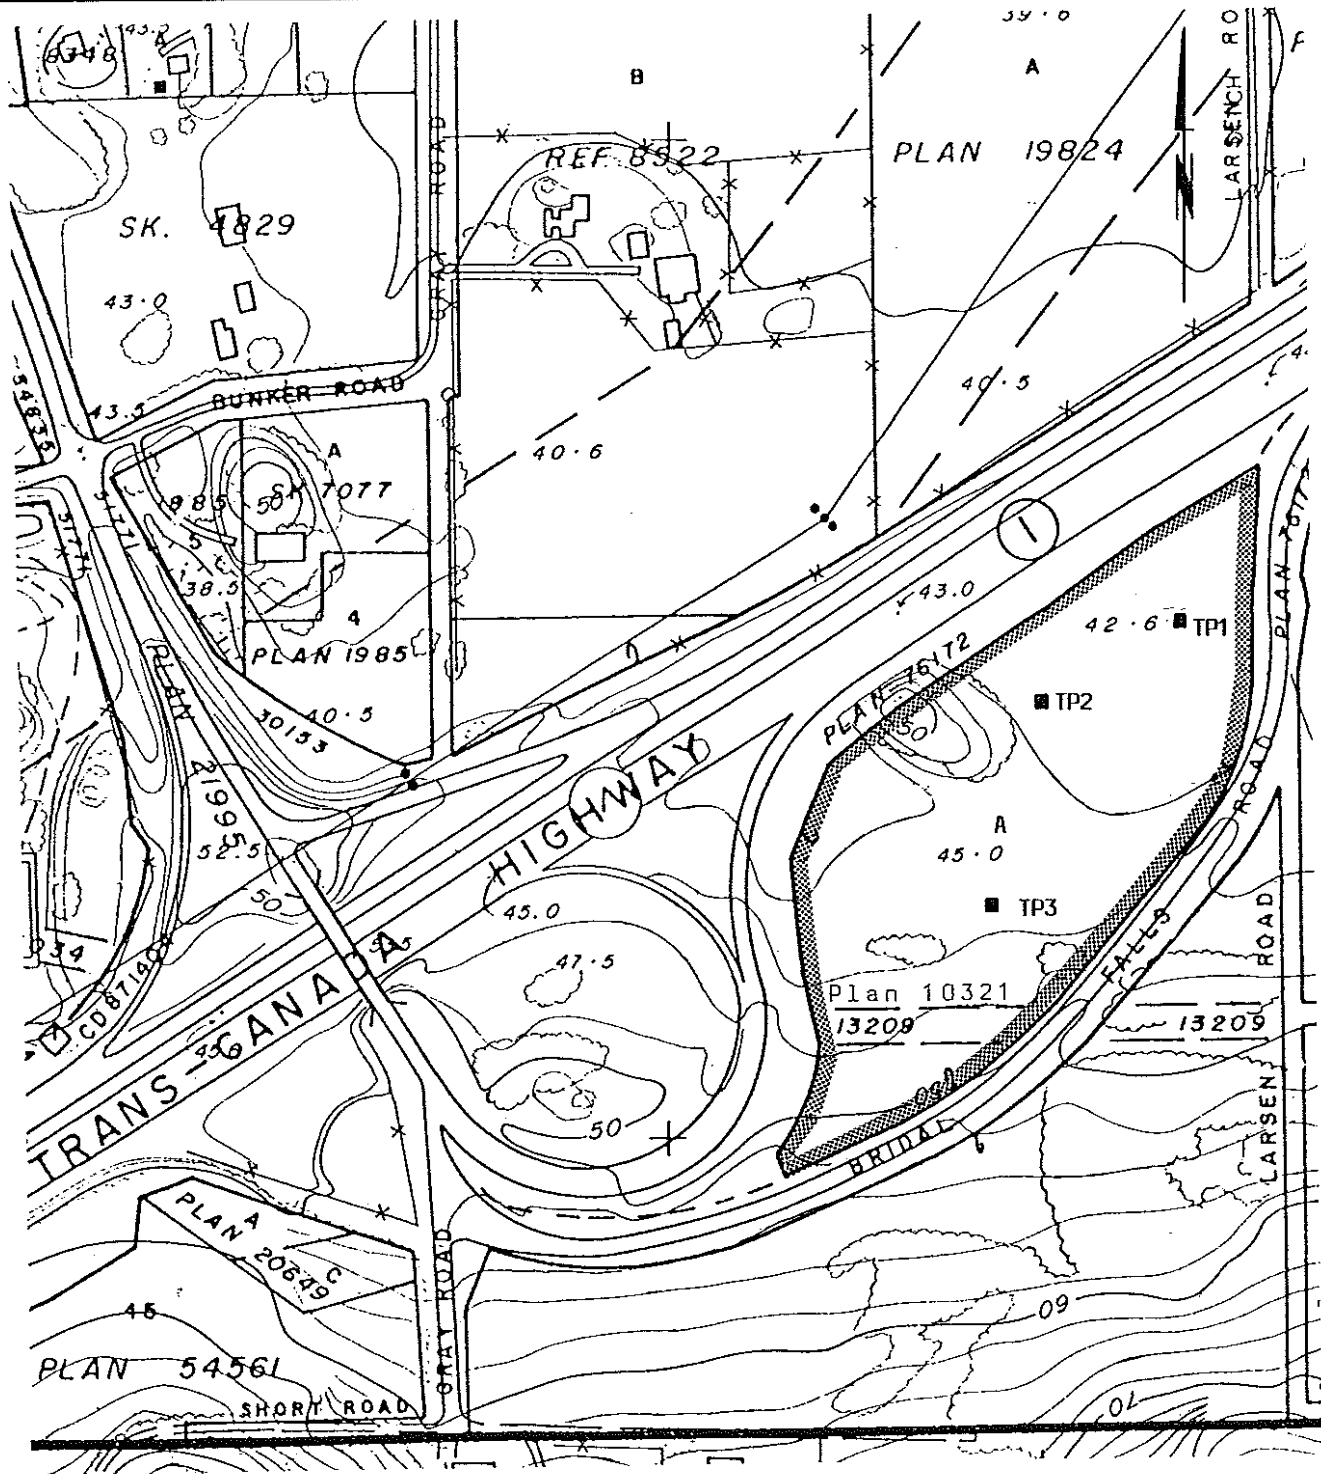
FIGURE 1

The location of the subject Property and the approximate locations of the test pits dug during the field investigation are shown on Figure 1 attached in Appendix A.

Test Pit No. 3 which, as shown on Figure 1, is located in the south-central part of the subject Property, was dug through thin gravelly soil into a varicoloured mixture of silt, fine sand and gravelly sand to a depth of 1.55 m (5.1 ft), with broken pieces of wood (probably roots) to the bottom.

In general, conditions for construction and operation of conventional wastewater disposal fields on the proposed Golf Course Site are quite good, except at the northeast end of the Property where the sediments are finer and where, in the lowest part of the area, the water table is less than one metre below surface.

Wastewater disposal facilities could be located on the part of the subject Property near Test Pit No. 1 but a non-standard field design would be required. However, conditions in the area of Test Pits No. 2 and No. 3 are quite suitable for onsite wastewater disposal using conventional facilities.

TEST PIT LOCATIONS ON PROPOSED  
BRIDAL FALLS GOLF COURSE PROPERTY
