Re: Groundwater - D.L. 117, Nanoose District

TO ACCOMPANY REPORT ON  
**GROUNDWATER CONDITIONS**  
 D.L. 117 NANOOSE DISTRICT

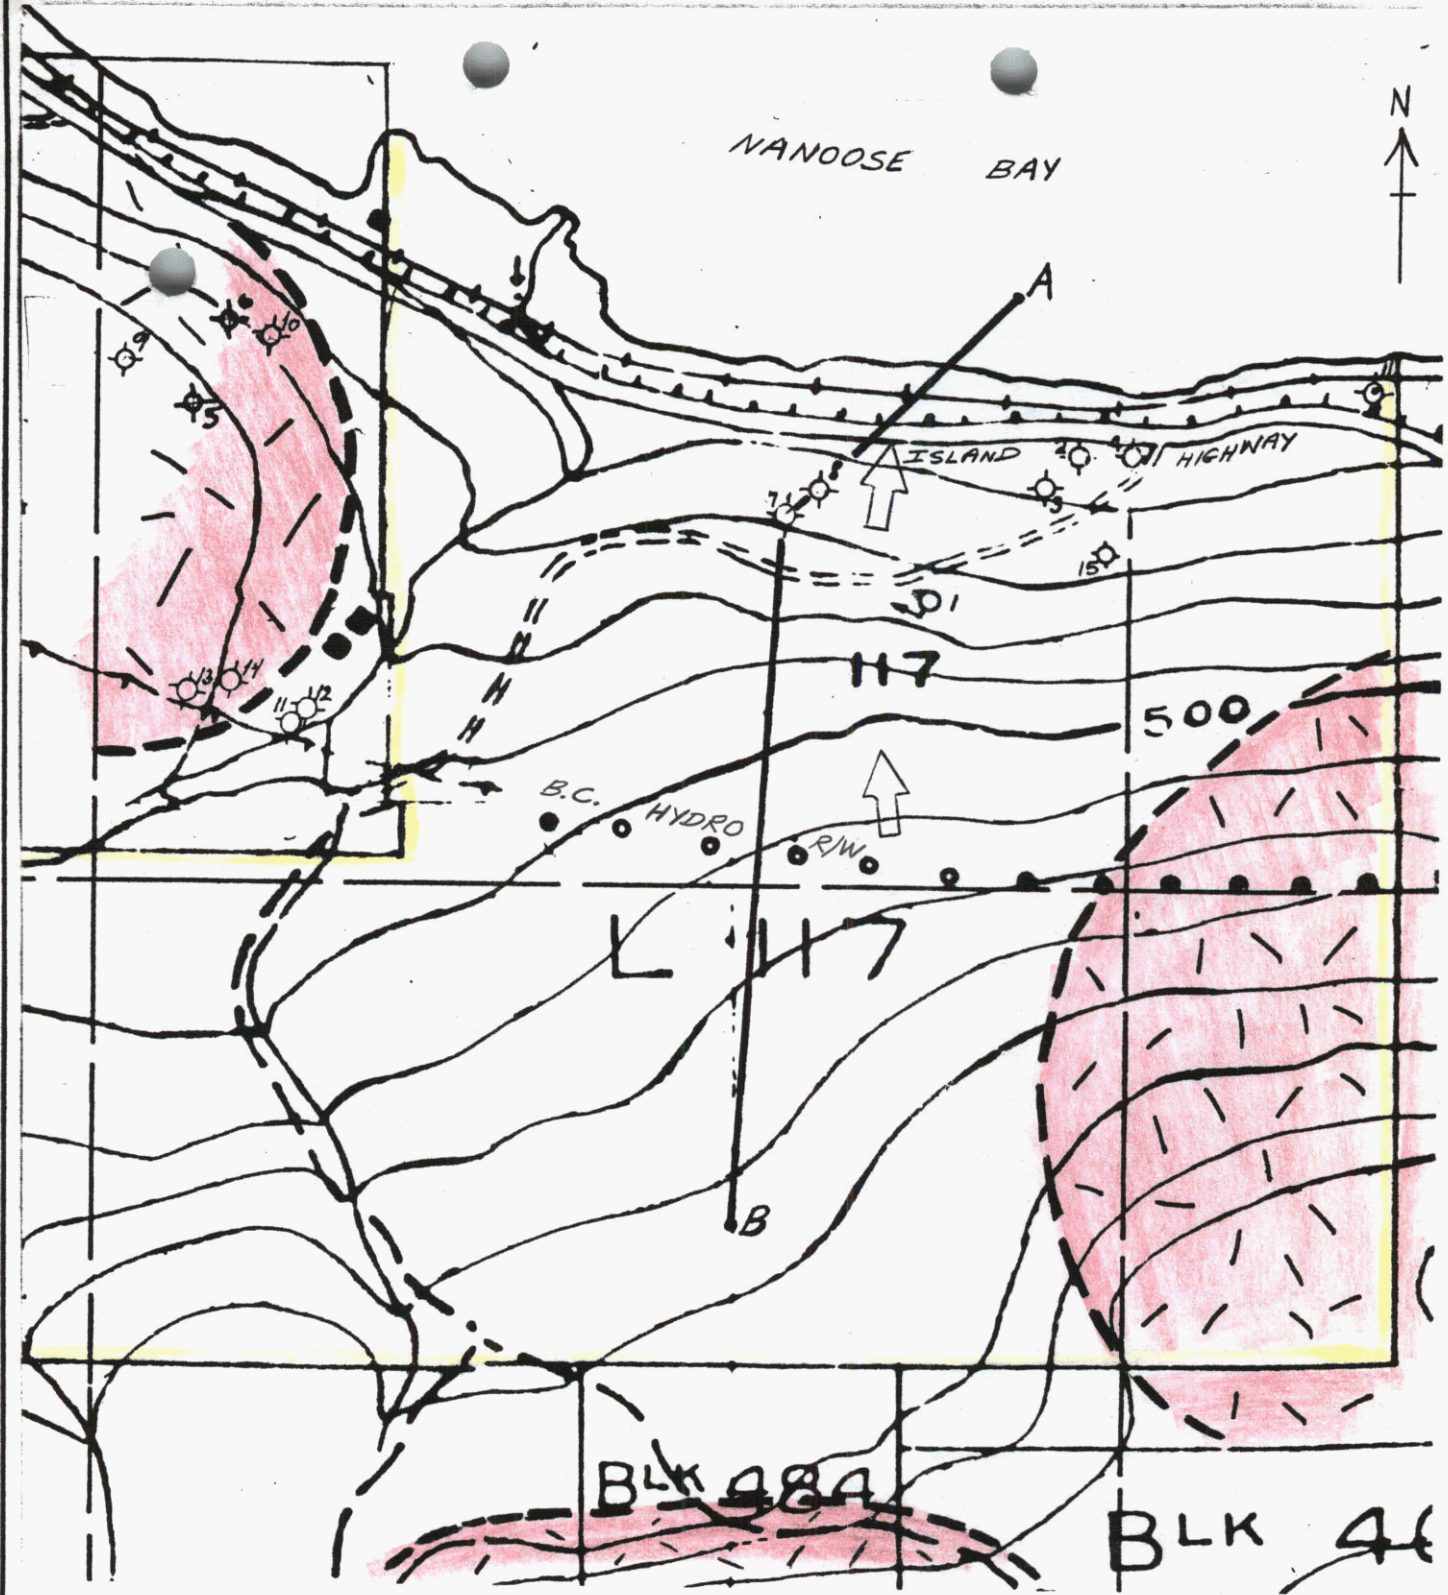
\_\_\_\_\_ APK ENGINEER  
 FILE No. 92 F, FB DWG No. FIG 1

Available geologic mapping (Fyles, 1963) and Halstead (1963) indicates that the greater portion of D.L. 117 is underlain by a marine veneer complex generally less than 5 feet in thickness and comprised of varied stony gravel, gravel, sand, silt, clay and stony loam overlying bedrock. Below the 200 foot elevation these deposits overlie ground moraine deposits of till with lenses of gravel, sand and silt and deposits of sand and gravel of the Quadra Sediments (Fyles, 1963). Wells completed close to the Island Highway (Figure 1) indicate the unconsolidated deposits are up to 200 feet in thickness at this locality. Available terrain analysis mapping (Ministry of Environment) indicates the greater portion of D.L. 117 to be underlain by sandy colluvial and sandy morainal deposits. Below the 400 foot elevation, gravelly and sandy marine and morainal deposits are indicated. Examination of air photographs covering D.L. 117 indicates that the unconsolidated deposits occurring upslope of the B.C. Hydro right-of-way could be relatively thick (several tens of feet) except along the southeastern boundary of D.L. 117 where bedrock is exposed (Figure 1).

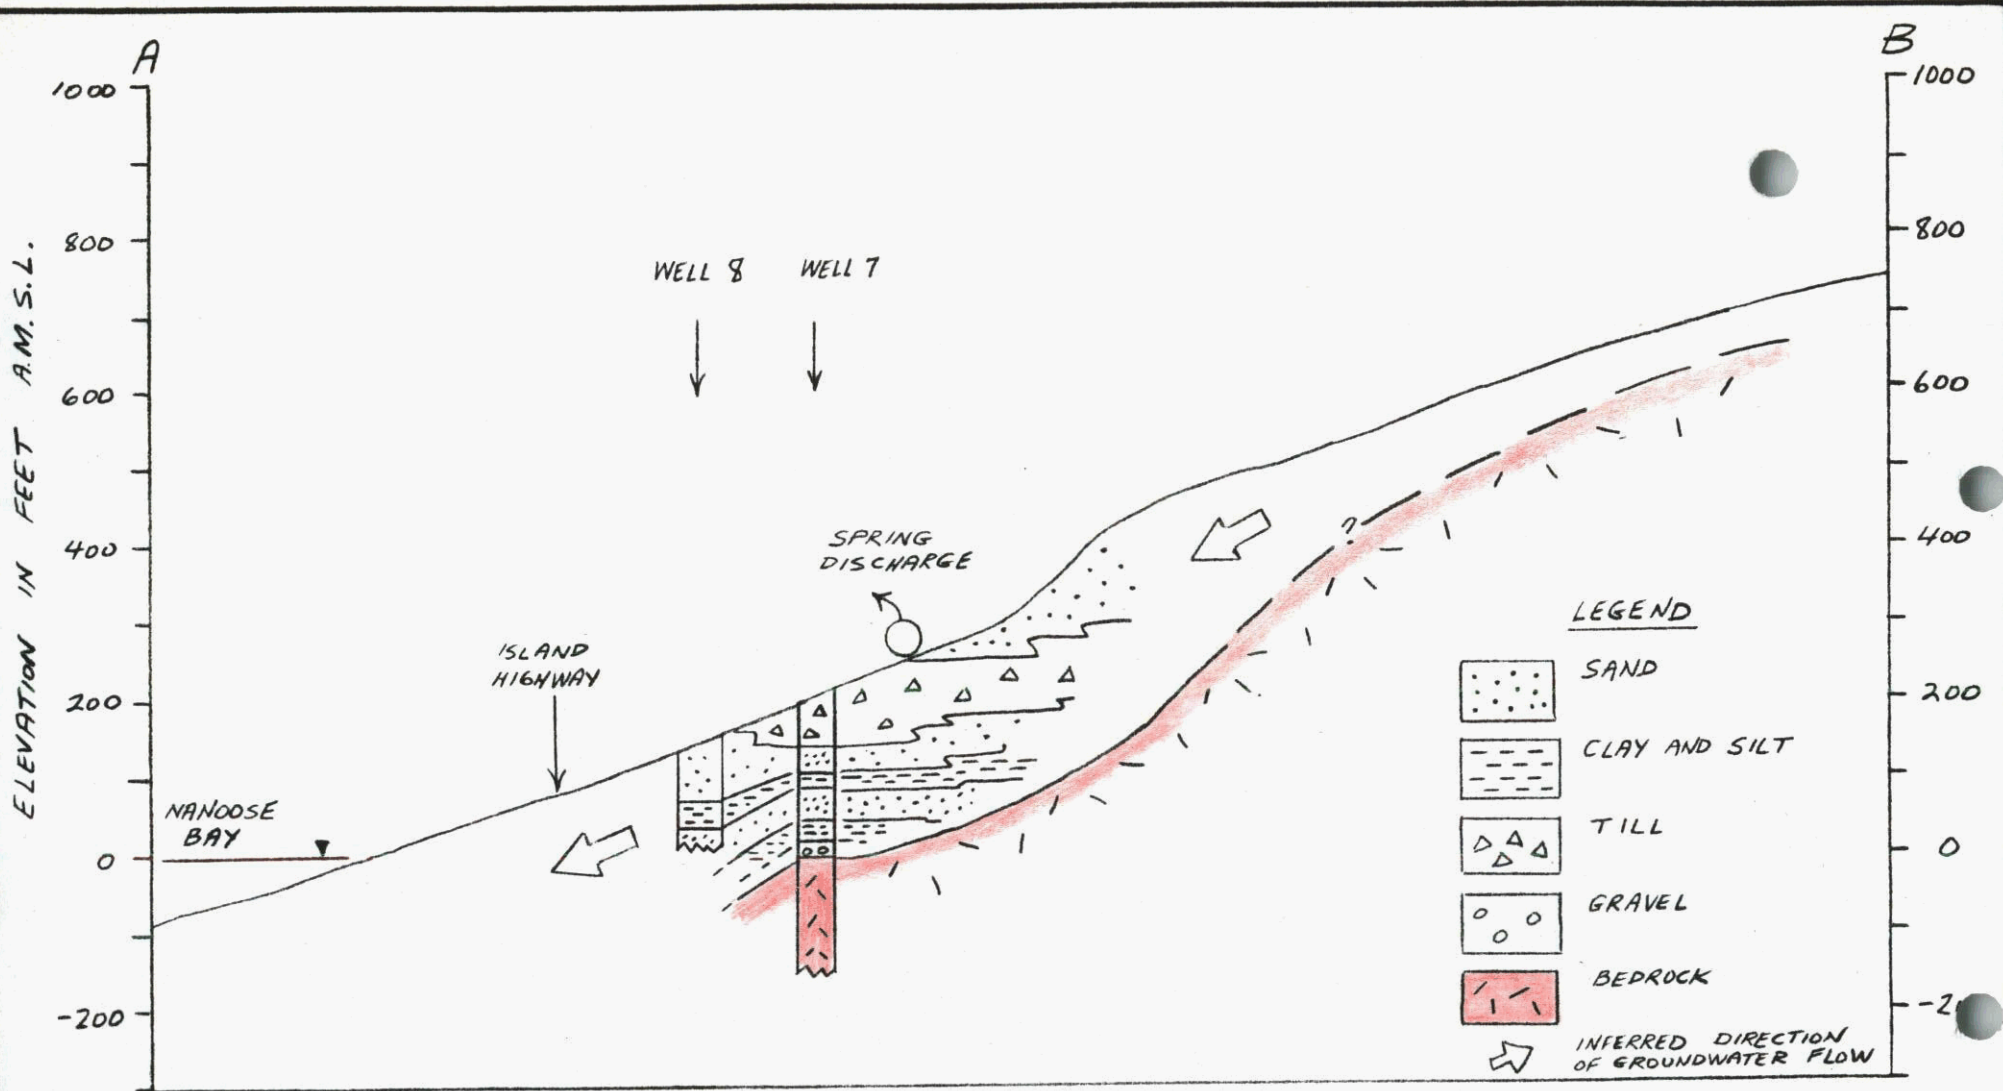
FILE No. 92.F1, FB DWG. No. FIG. 2

A north-south geologic cross-section depicting the probable stratigraphic relationships within the unconsolidated deposits is shown in Figure 2. Well records indicate the unconsolidated deposits comprise interbedded sand, silt, clay and glacial till.
