Eagle Creek Feasibility Assessment: Improving Kokanee Access to Spawning Habitat in Eagle Creek (2016 - 2017)

FWCP COL-F17-F-1456

April 2017

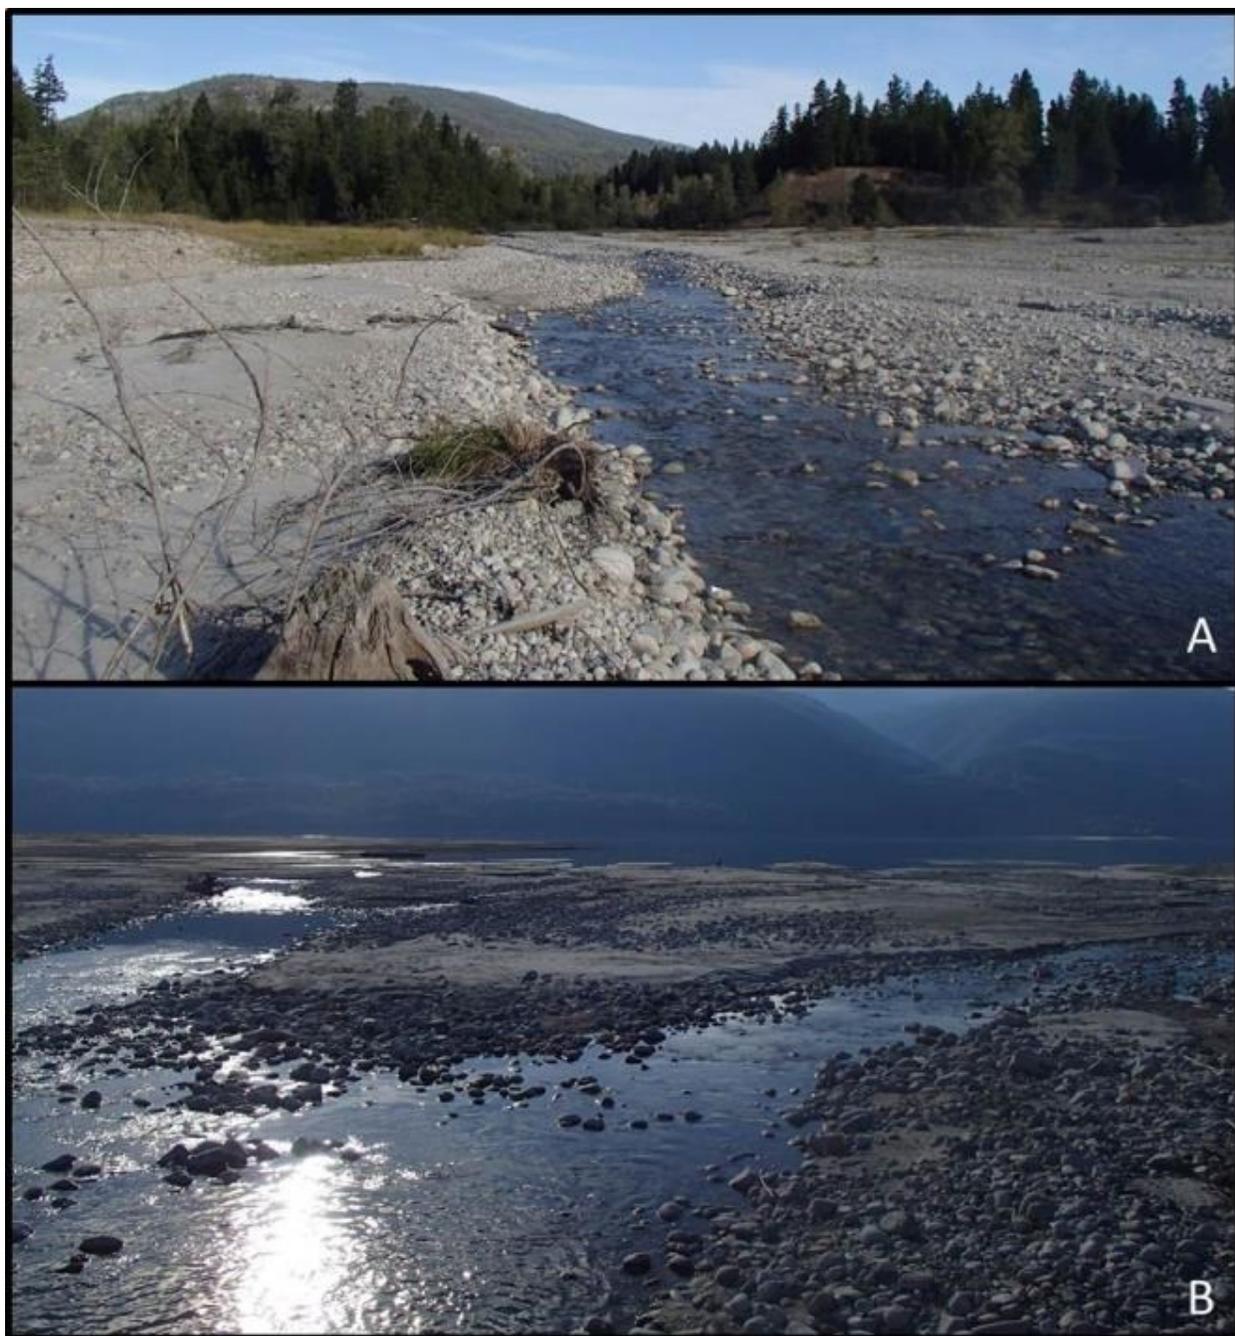
Figure 2. (A) An upstream view of Eagle Creek flowing through the Lower Arrow Lakes Reservoir's drawdown zone with low water depth and minimal habitat value. (B) Downstream view of Eagle Creek braiding and fanning within the drawdown zone to the Lower Arrow Lakes Reservoir (photos by Evan Smith, Okanagan Nation Alliance, August 2016).

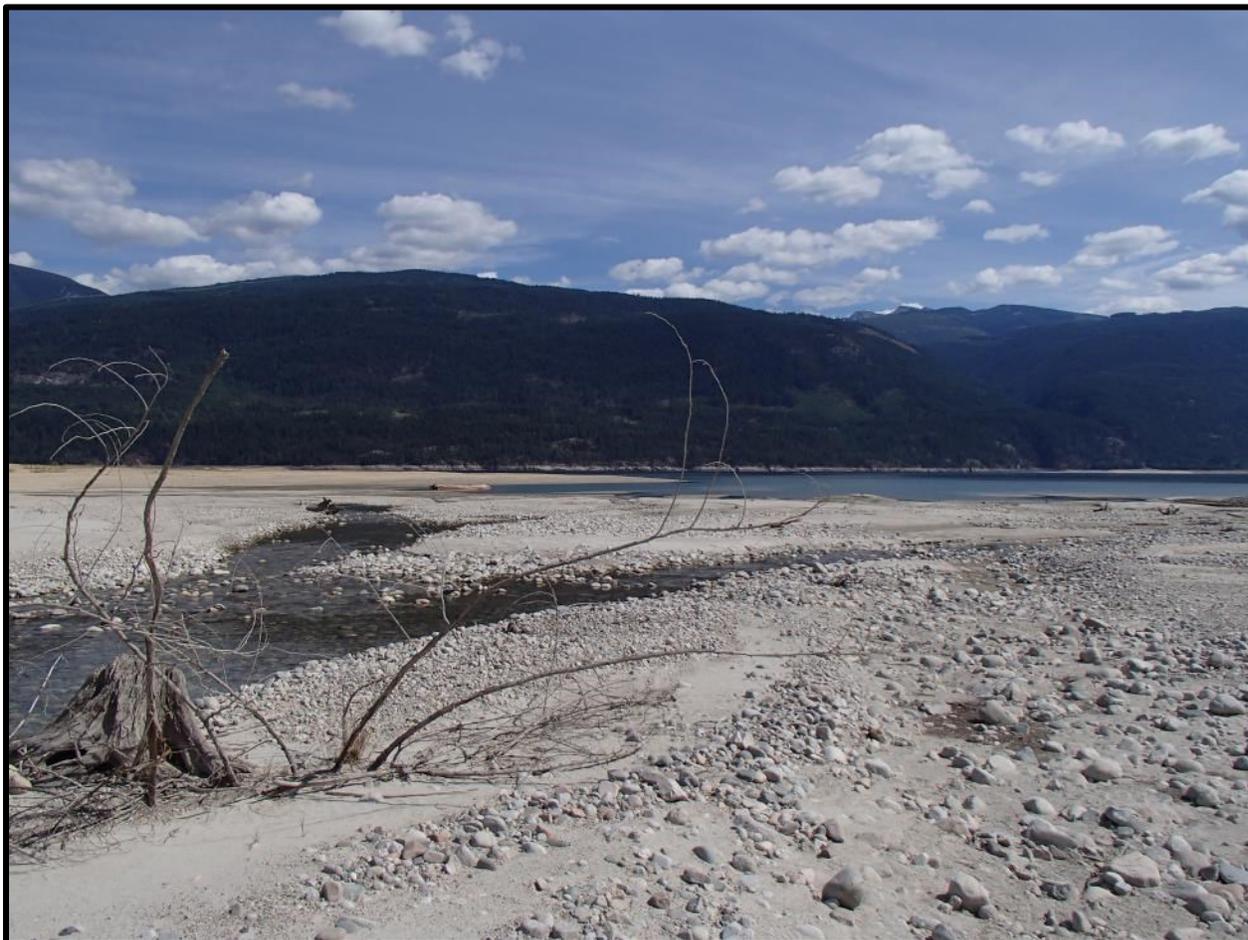
Management Zone (MZ) 1 is the lower drawdown zone. This zone is prone to lateral stream movement across the drawdown zone and stream bifurcation while the substrate is mostly sand and finer material (Davies 2016; Fig 5). Access for Kokanee is very limited in this zone due to shallow water and minimal cover. Substrate in MZ 1 may be suitable to support habitat structures but construction is only recommended after monitoring the effects of treatments in MZ 2.

Figure 5. A representation of bifurcation and sediment size in Eagle Creeks lower drawdown zone where the stream channel is prone to lateral migration (photo by Evan Smith, Okanagan Nation Alliance, 2016).

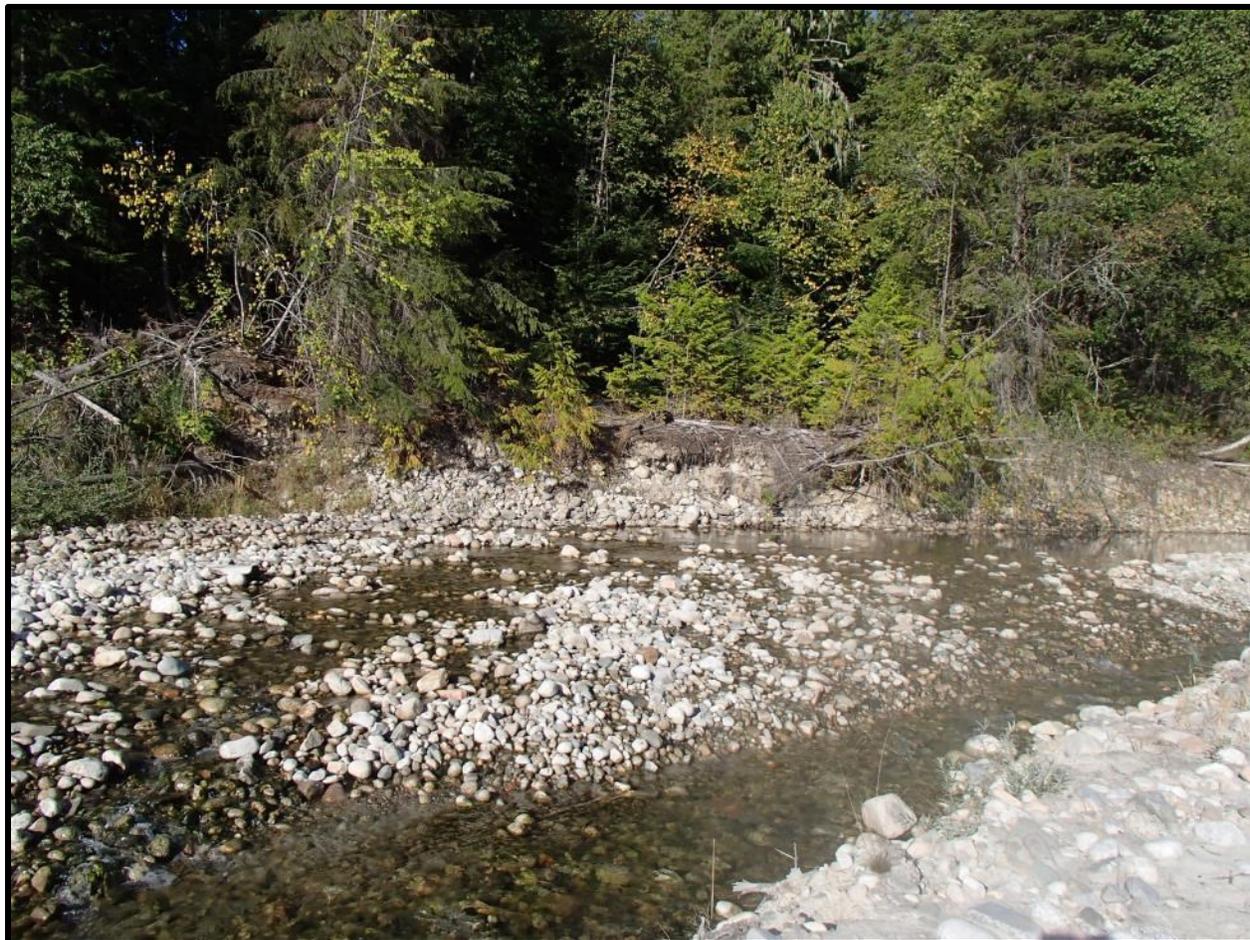
MZ 2 is the upper drawdown zone which is also prone to lateral stream migration and has been identified as a deposition zone for larger material (Davies 2016). Access for Kokanee is limited by shallow water, minimal cover, and barriers cause by material deposition (Fig. 6). The substrate in this zone is larger than MZ1 and will also support habitat structures which will confine the stream to a more natural width to depth ratio, to promote scouring which will deepen the channel and reduce deposited material in the stream. The substrate in this zone is similar to Deer Creek, where habitat structures have already been created (Smith and Zimmer 2016), and have been determined to be sufficient to support habitat structures.

Figure 6. Deposited material in MZ 2 which impedes Kokanee access to the upper reaches of the stream (photo by Evan Smith, Okanagan Nation Alliance, August 2016).

We recommend installing habitat structures in MZ 2 within the Eagle Creek drawdown zone using natural channel design principals to mimic analogous wetted and bank-full width conditions as assessed in MZ 4. Sinuosity should attempt to replicate upstream reaches with consideration to parent creek-bed material and channel slope by using the radius of the curvature of the channel and dominant channel characteristics in the drawdown zone. The stream itself should be designed to mimic a riffle-pool system in order to provide habitat associated with resident Kokanee spawning and rearing requirements (Hogan and Ward 1997). Structures consisting of boulders and large-woody debris anchored by large rock can be used to define a bank-full channel and structure for escape cover; which is otherwise absent in the drawdown zone. These methods were used with early indications of success in the Deer Creek drawdown zone (Smith and Zimmer, 2016). Once treatment in MZ 2 is complete, MZ 1 should be monitored for any resulting hydrological changes. If Kokanee access remains impeded in MZ 1 then treatment should continue into this zone.

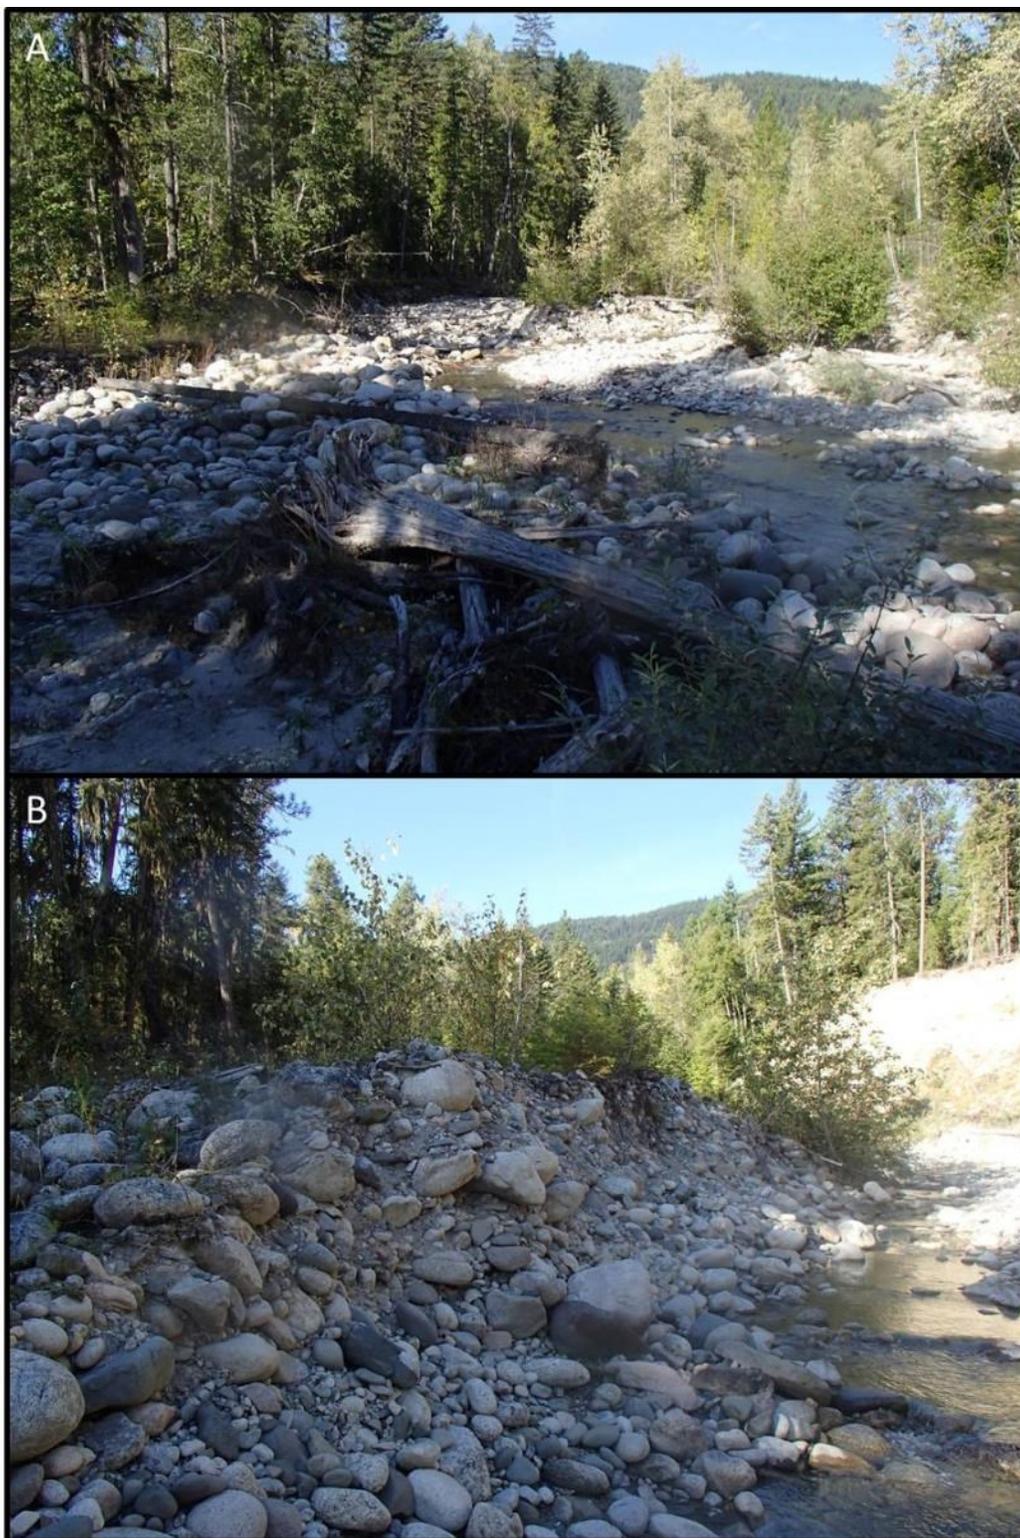
MZ 3 is the laterally unstable section. The stream in this zone is bifurcated and appears to shift from side to side increasing the wetted width over time (Davies 2016). There is a large amount of material in this zone as seen in the satellite image of Fig 4. It was originally thought material was being transported from upstream and deposited in this zone due to its lower gradient, which would have put downstream habitat structures at-risk of being buried. However, inspection of the zone indicated the material is a result of lateral erosion and is stabilizing (i.e. not moving downstream at an elevated rate). The bank material is made up of fluvial deposits (indicated by rounded rocks) which are less stable than glacial deposits (angular rocks and till) making them more susceptible to erosion (Fig. 7). When the bank is eroded, the rounded substrate falls into the stream but is not readily transported downstream due to its size. Therefore downstream structures are at minimal risk of being buried by upstream materials, which was previously thought (notwithstanding a catastrophic flow event). Approximately 40 - 60 Kokanee were observed in this zone during the field visit.

Figure 7. (A) Example of bed material found throughout MZ 3. (B) The river right bank of Eagle Creek reveals the bank material as fluvial deposits (rounded rock eroded by fluvial processes in the bank soil), a characteristic of stream banks in MZ 3 (Photos by Evan Smith, Okanagan Nation Alliance, August 2016).

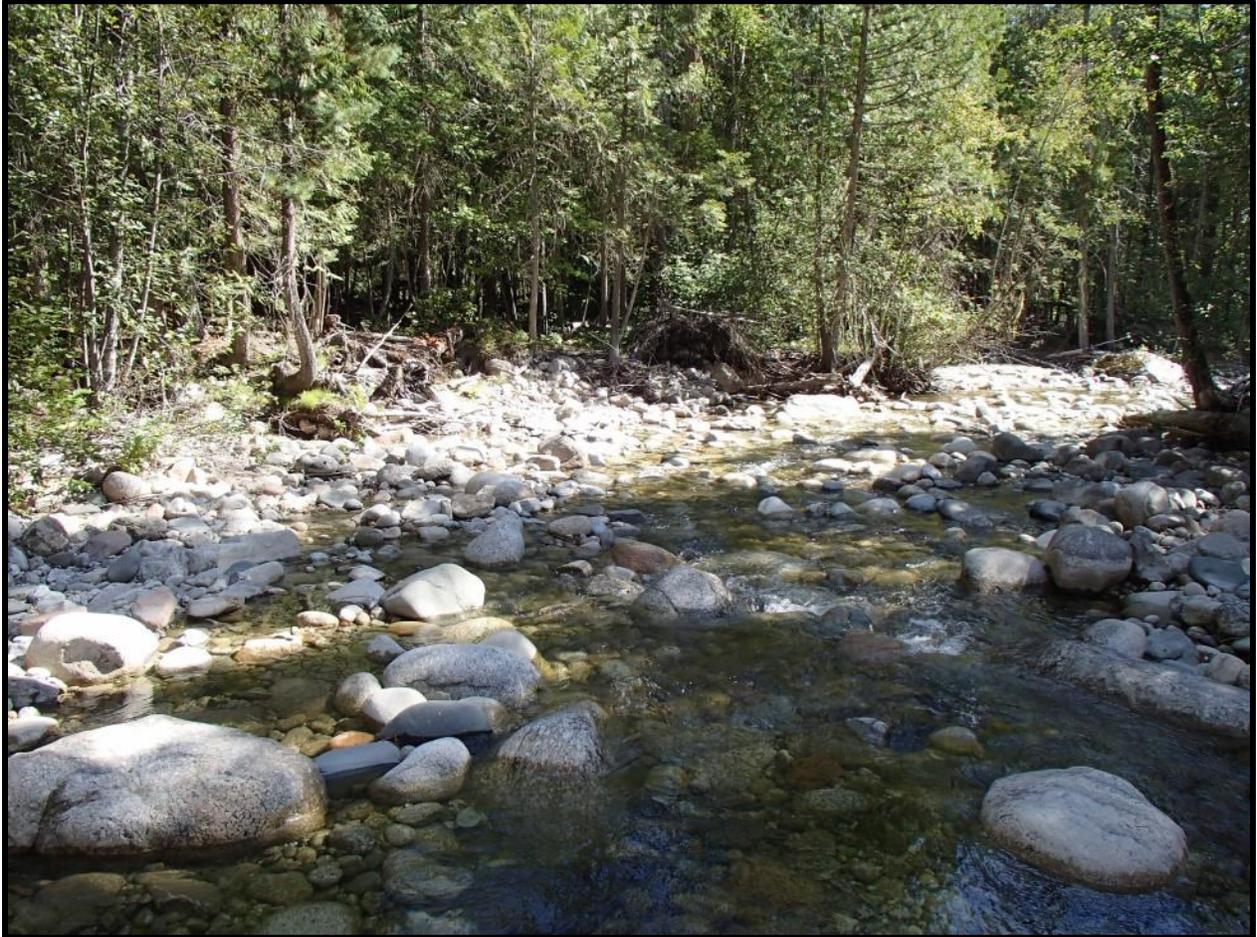
MZ 4 is the Narrow stable section upstream of MZ3. Its higher gradient may explain why it is more stable than MZ 3 as bank materials are similar in both zones (Fig. 8). Approximately 5 – 10 Kokanee were observed in this zone during the field visit and may have been in the process of spawning.

Figure 8. MZ 4 at low flow (photo by Evan Smith, Okanagan Nation Alliance, August 2016).

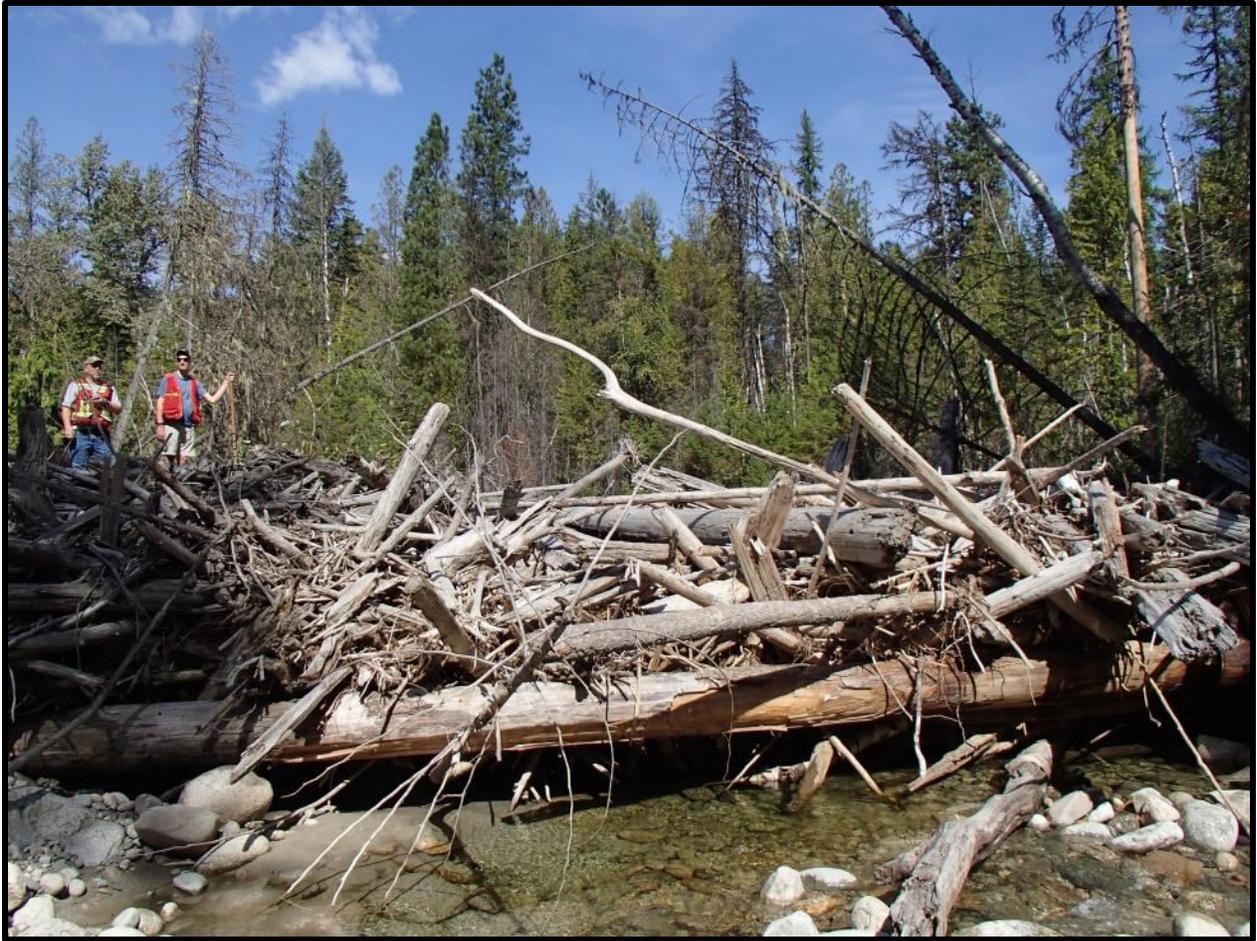
MZ 5 is a log jam located approximately 2.1 km upstream of Arrow Lakes Reservoir (560 m downstream of the Worthington Road Bridge, Fig. 9). By retarding flows at freshet, this log jam may be the cause of lateral erosion in MZ 3. This log jam is thought to be the result of landslides/debris torrents farther up the watershed (as seen on satellite imagery). Over the years it continues to collect debris growing in size and continuing to impede flows and sediment migration. This log jam also has the potential to be fish barrier as no fish were observed upstream.

Figure 9. Two meter high, channel spanning log jam (MZ 5) located approximately 2.1 km upstream of the Arrow Lakes Reservoir with Lorne Davies (Geostream Environmental Consulting) and Kevin Schiller (Misty Ridge Contracting) standing on top for scale (photo by Evan Smith, Okanagan Nation Alliance, August 2016).

A phased approach should be considered when removing the log jam (MZ 5). In conjunction with treatment in MZ 2, sections of the log jam should be removed annually to gradually improve downstream sediment migration and reduce upstream aggradation while minimizing risk for further detrimental debris accumulation and resultant erosion and avulsion risk.

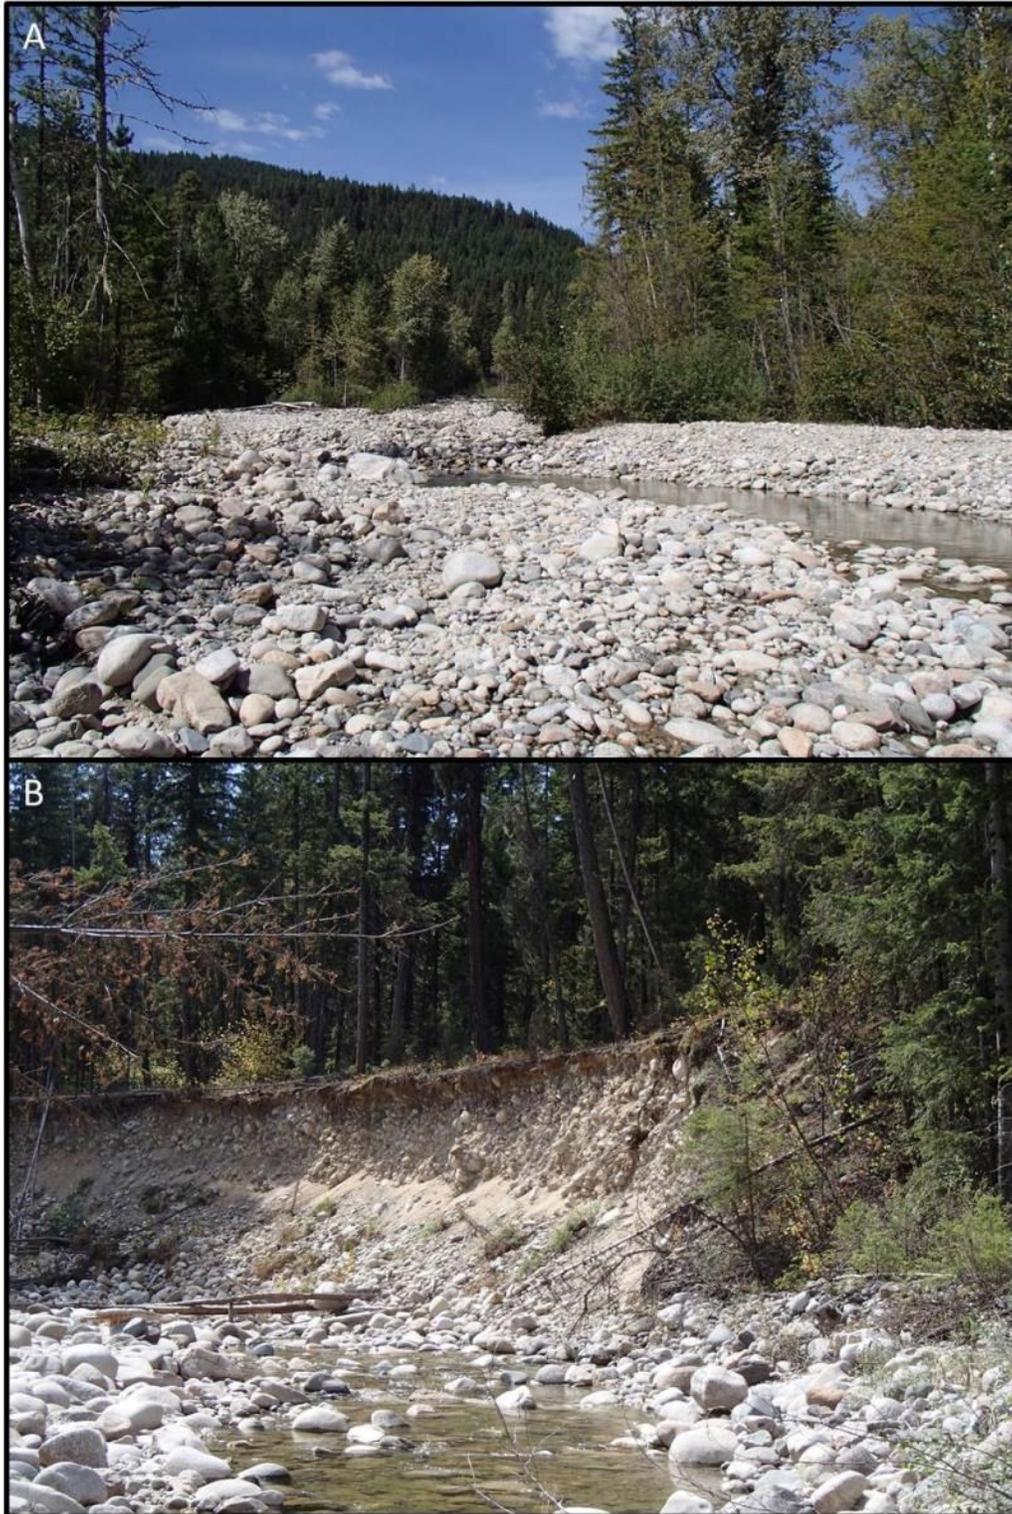
Located between the log jam and Worthington Bridge is MZ 6, an aggraded section of Eagle Creek. Here an estimated 10,000– 20,000 m³ of sediment has been deposited causing the stream bed to be higher than the stream bank (Davies 2016; Fig. 10A). A quick analysis was done on the previously mentioned landslides higher in the watershed and it was found this substrate could be a result of those landslides (Davies, pers. comm.). The log jam prevents substrate from moving farther downstream, resulting in continued deposition of material every year, causing elevation of the streambed. Old channels, large cut banks, and other erosion was observed in MZ 6 and can also be attributed to the log jam holding back sediment during freshet transport, causing deposition and lateral erosion (Fig. 10B). The height differential between upstream and downstream channel bed was 2 m, likely the reason no Kokanee were observed in MZ 6 in 2016. No upstream Kokanee observations were also confirmed by others (FLNRO pers comm 2016).

Figure 10. (A) An example of heavy aggradation found throughout MZ 6 thought to be a result of a downstream log jam. (B) Eroded banks found in MZ 6 thought to be caused by lateral erosion resulting from stream retardation from the downstream log jam (photo by Evan Smith, Okanagan Nation Alliance, August 2016).

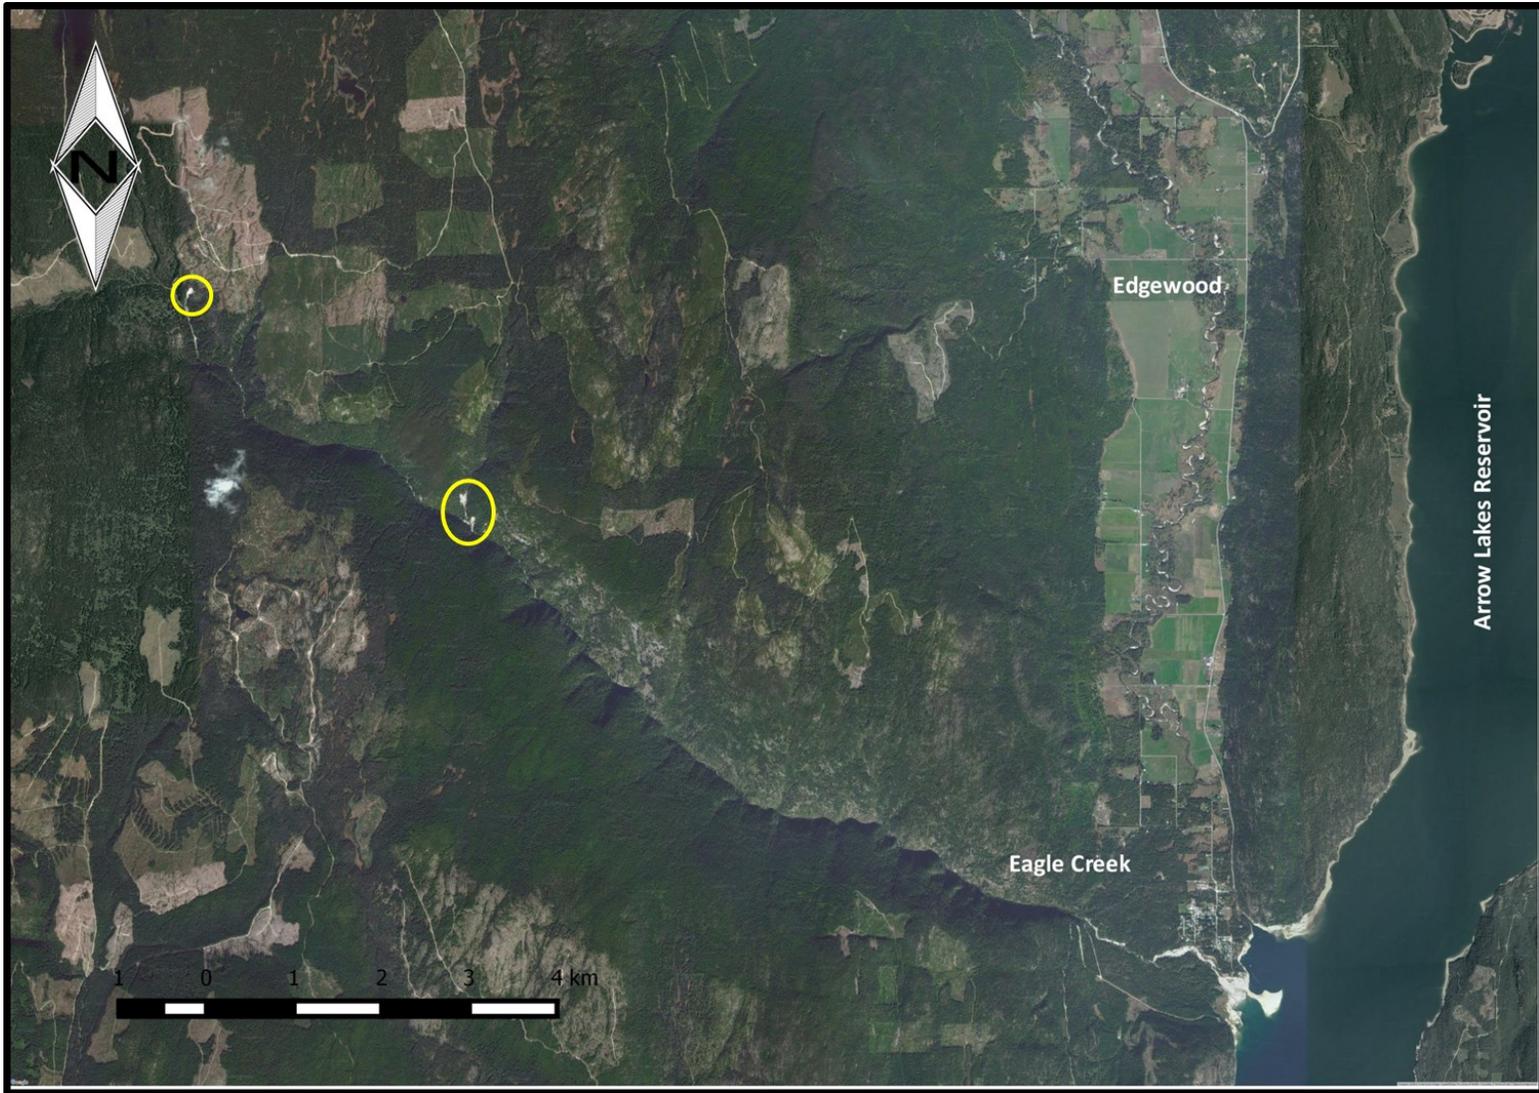
During the preliminary investigation prior to the site visit, two landslides were noted via air photo high up in the watershed. The cause and date of these slides is unknown. One water license holder was found within the Feasibility Assessment Study Area. If future work is to continue, this water license holder will be notified prior to any work taking place. The land in the drawdown zone is owned in part by BC Parks, Crown and BC Hydro, but it is unlikely BC Hydro property will be accessed for future habitat structure construction as it is outside the area recommended for treatments. For maps associated with the preliminary investigation on Eagle Creek see Appendix A.

Figure 12. Overview of Eagle Creek watershed. (Yellow) Landslides that have occurred on Eagle Creek, the cause and date of which is undetermined (created by Evan Smith using map data 2017, Google).
