# Englishman and South Englishman River Restoration Activities - 2005

**M.P. McCulloch  
Fisheries Technician  
BC Conservation Foundation  
Nanaimo, BC**

January 2006

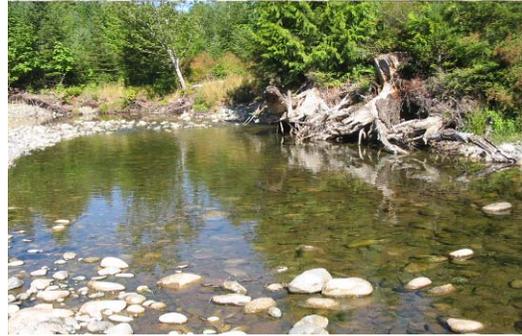
Photo 4. Typical pool in the South Englishman, note riparian stumps and limited scour (depth).

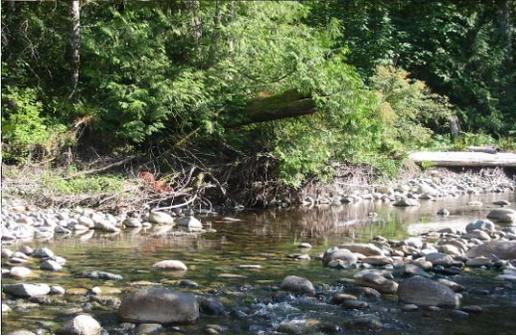
Photo 5. Typical South Englishman pool, note non functional wood and bank scour.

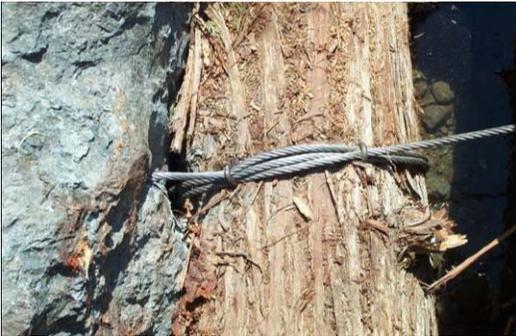
Photo 7. Key ballast secured to log with steel cable using a clove hitch and hog staples.

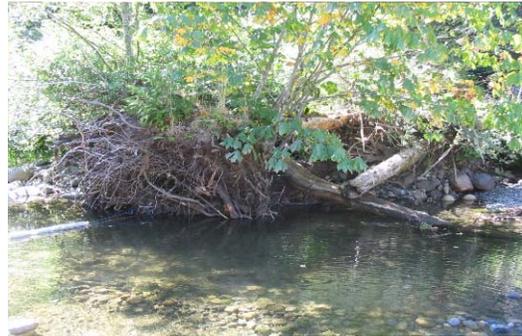
Photo 8. Mid-channel log jam splitting and diffusing flow in the South Englishman.
