**TERRAIN INVENTORY
FOR THE
CLAYOQUOT SOUND AREA

YEAR FOUR**

**British Columbia Ministry of Sustainable
Resource Management**

**MADRONE ENVIRONMENTAL SERVICES LTD.
1081 Canada Avenue, Duncan, BC V9L 1V2**

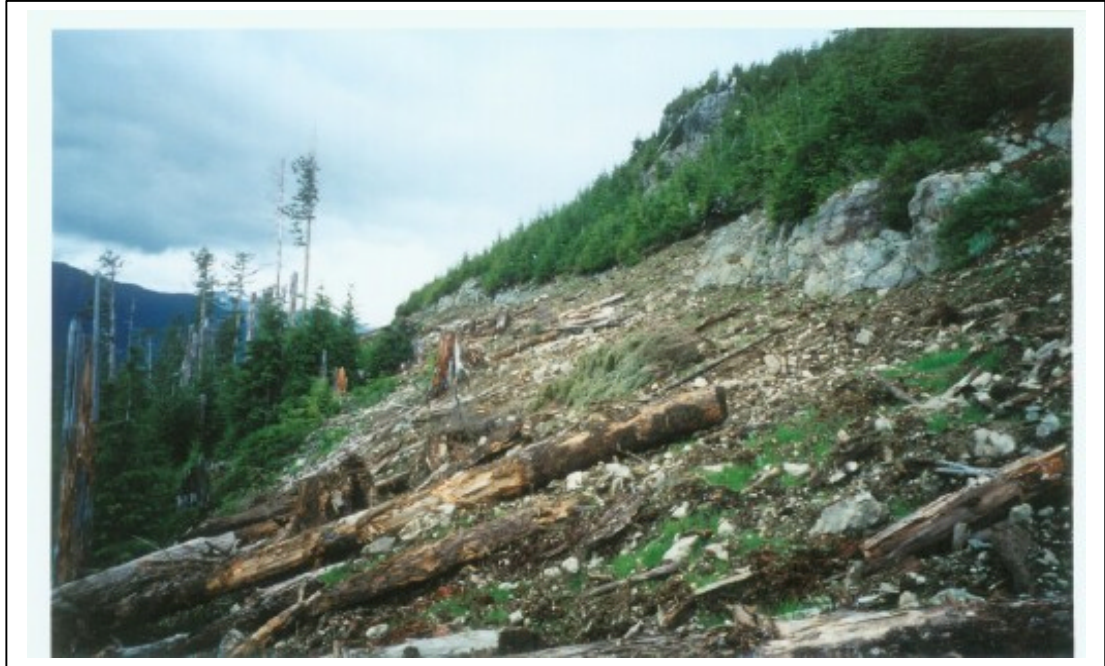
Photo 1

Road recently fully deactivated in Clayoquot River/Kennedy Lake project area.

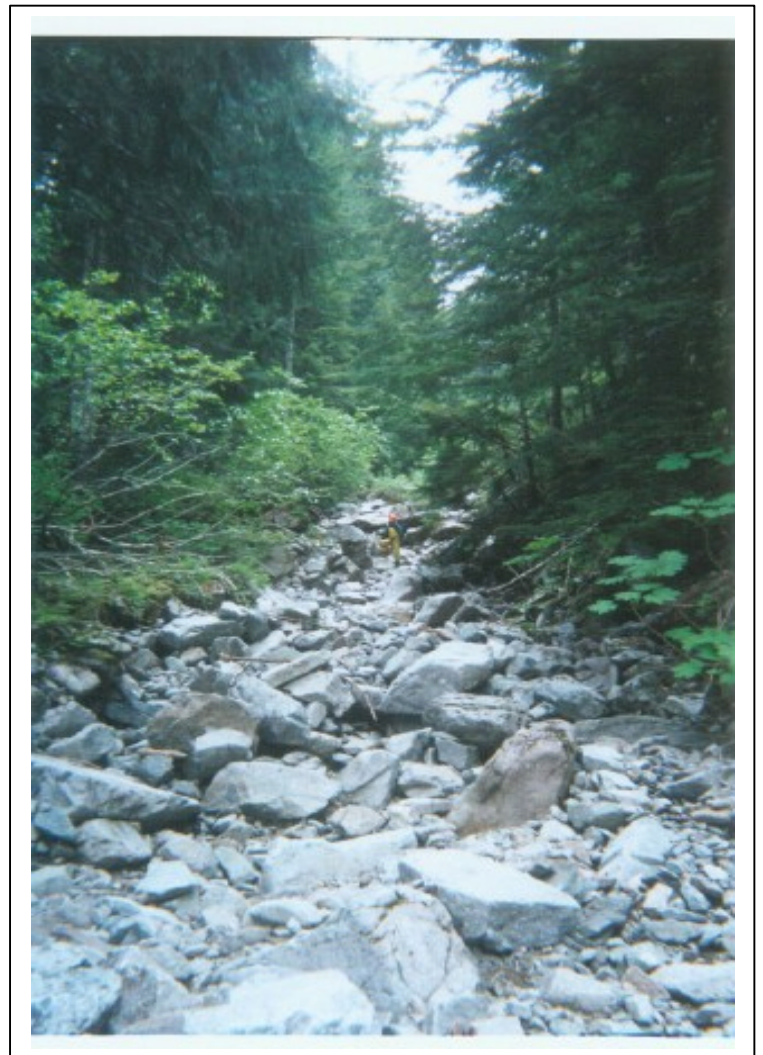
Photo 8

Typical gully in Bedwell area. Water flow is subsurface here but there is evidence evidence that the channel is actively scoured by rapid mass movements, small snow avalanches, and peak flow discharge.

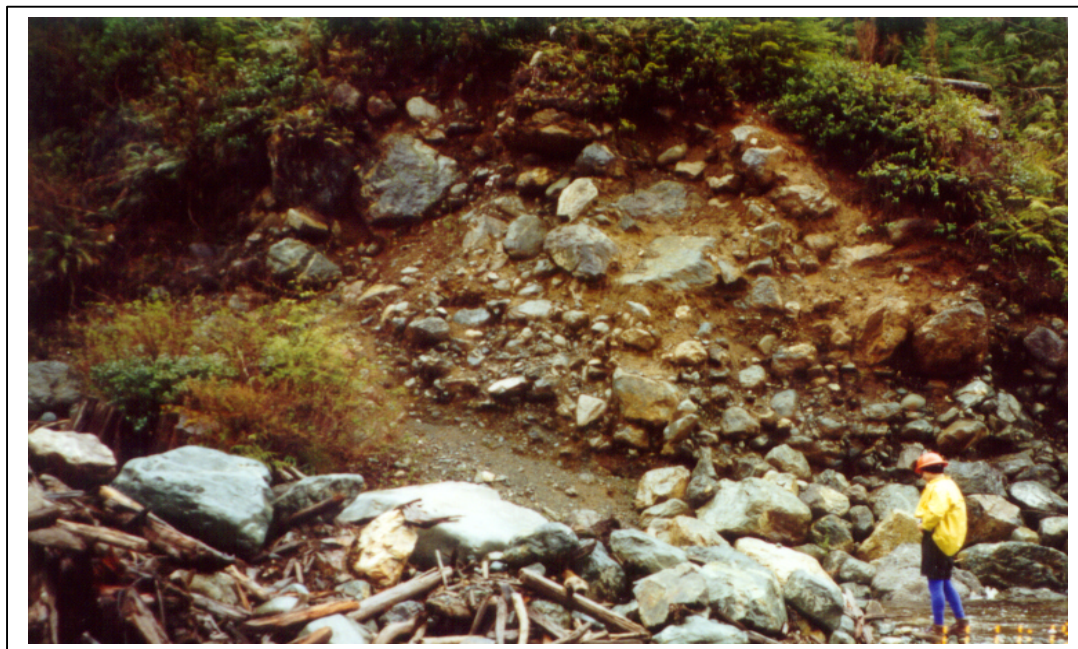
Photo 14

Cross-section at field plot #TD1046 of colluvial fan/cone complex formed by debris torrents.

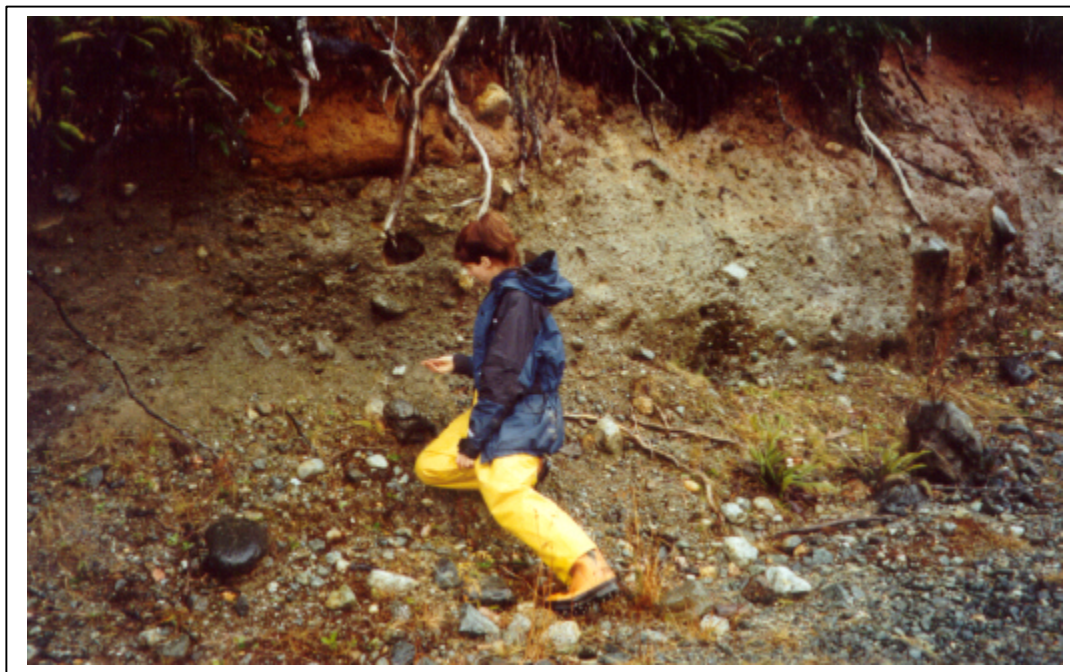
Photo 18

Since the time of deposition during glaciation, the upper meter of the material has weathered and is fairly permeable (Photo 18). The unweathered material is generally highly consolidated and impermeable. The coarse fragments in both the weathered and unweathered zones are variable in size and occupy 30% to 80% of the material volume. The matrix texture of the till ranges from clay-rich (*c*) to sandy (*s*). The matrix texture is a clayey silt (*cz*) with minor sand (*s*). The clast roundness ranges from sub-angular to round.

Exposure of highly consolidated till. Weathered zone is clearly visible over the unweathered zone.

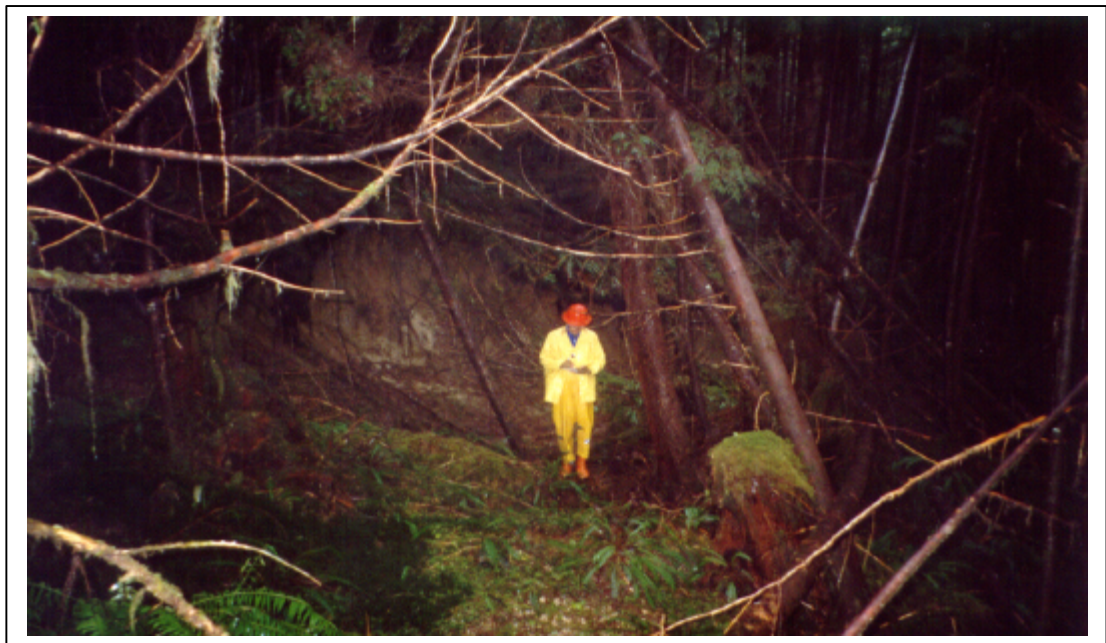
Photo 20

This geomorphic process has been mapped in two polygons in the Kennedy Flats area. Subclasses associated with these processes are a slump in surficial material (-u) and a slump-earthflow (-x). Both events have occurred in deep marine sediments and are presently or have been historically undercut by a stream. These unstable areas were observed on the ground (Photo 20) and although the mapped areas affected are small (total of 12 ha), these events have likely occurred elsewhere in these extensive fine sediments in the area. Both polygons have been mapped as terrain stability Class V.

Debris slump in marine sediments as evidenced by the lean in the trees on the right-hand side of the photo.

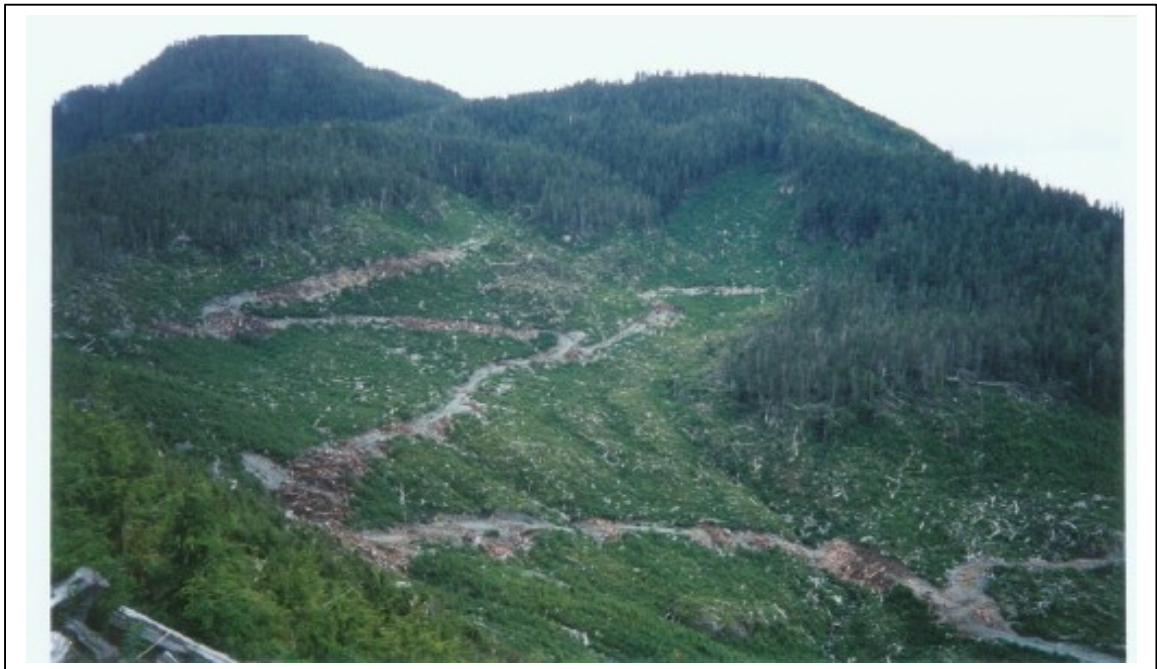
Photo 21

Logging-related landslides are densely spaced in several areas, including the slopes above Muriel Ridge, the southeastern slopes above Highway 4, the Sand River watershed, and the east side of Clayoquot Arm. Many of these have advance rehabilitation and are well vegetated (Photo 21).

Side valley on east side of Clayoquot Arm. Old road-related landslides are visible as linear strips of dense alder. Small more recent landslides are visible in places on the mid and upper slopes.

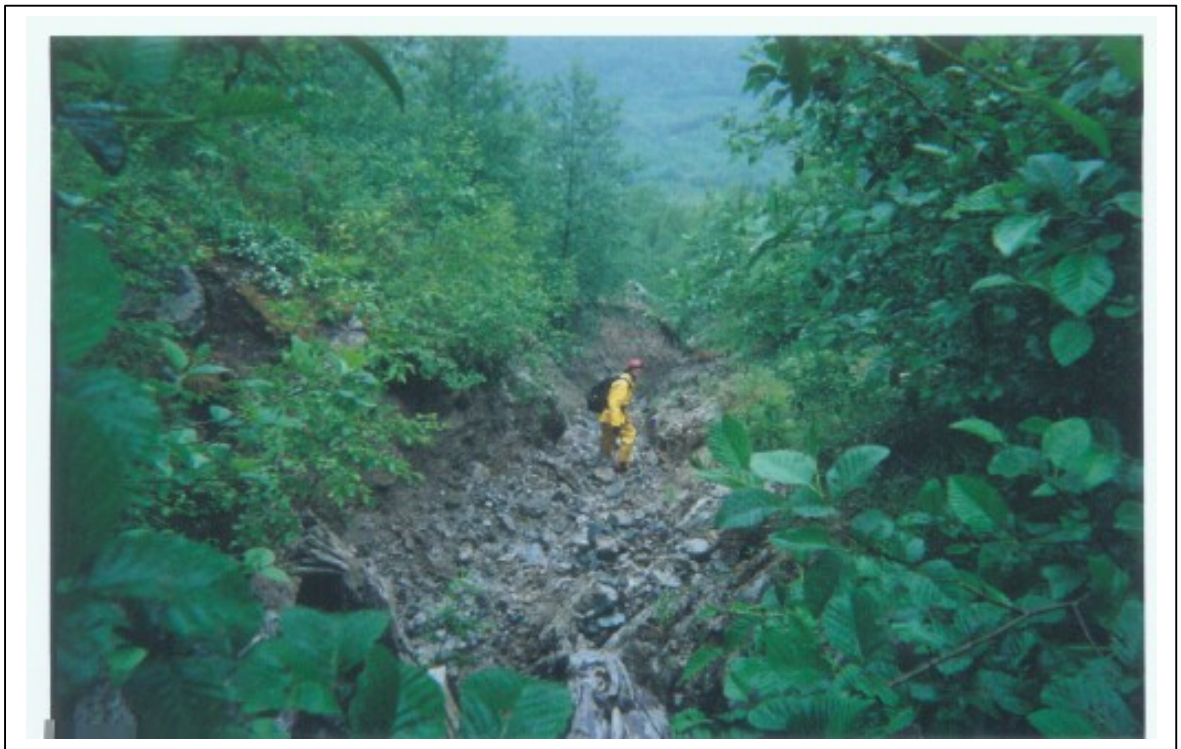
Photo 22

The debris flows in the project area have initiated on mid or upper slopes in till or colluvium and many have flowed into creeks or gullies, triggering a debris torrent (Photo 22). Many of the larger gully systems are inherently unstable, and debris torrents may occur relatively frequently (on a geologic time scale), flushing out any material that may have accumulated between events. The volume of the debris torrents is estimated to range from 1000 m³ to 10,000 m³, depending on several factors, including distance traveled to the deposition zone and the amount of material entrained in the transport zone.

View is downslope of a recently scoured channel by a debris flow/torrent down a shallow gully.
