**STAWAMUS RIVER  
Fish Habitat, Riparian and  
Channel Assessments**

## FISH HABITAT, RIPARIAN AND CHANNEL ASSESSMENTS

**FINAL**

**November 1998**

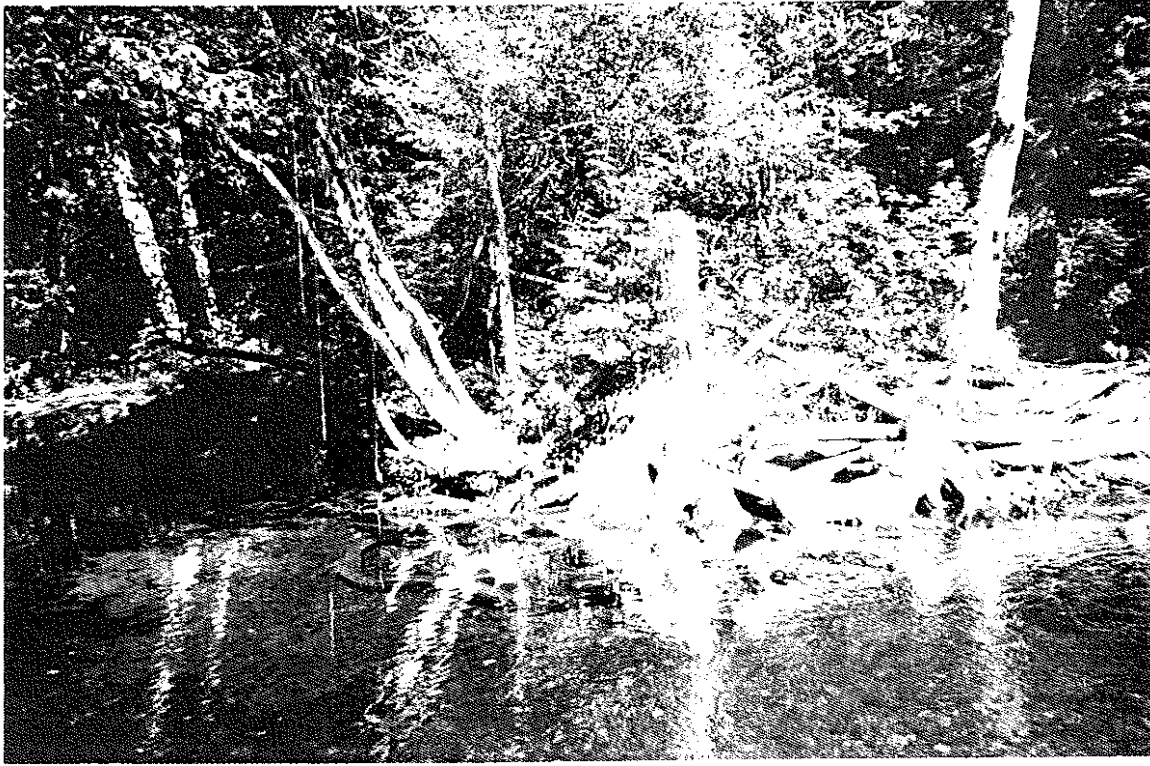
There were no off-channel habitats within this reach which may be a limiting factor for some species. However, there was abundant pool habitat (Photo 1) which provided excellent rearing habitat for juvenile salmonids. Overall, cover was rated as poor due to the limited availability of boulders, overhanging vegetation, and wood cover. Juvenile coho salmon were observed trapped in a small pool under the railway bridge (Photo 4).

**Photograph 1:** Looking downstream along right bank at pool used for swimming (Reach 3 - 08/98).

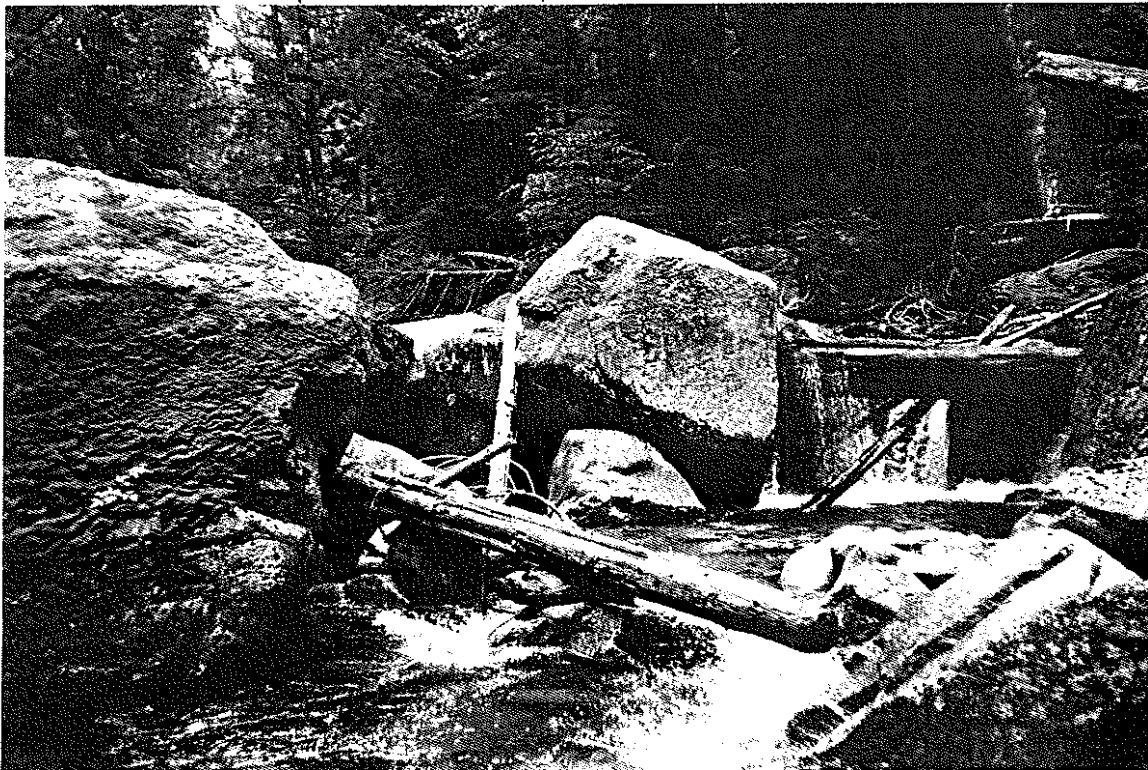
**Photograph 2:** Upstream view to falls/impassable fish barrier reach break 7 (Reach 7/8 - 08/98).

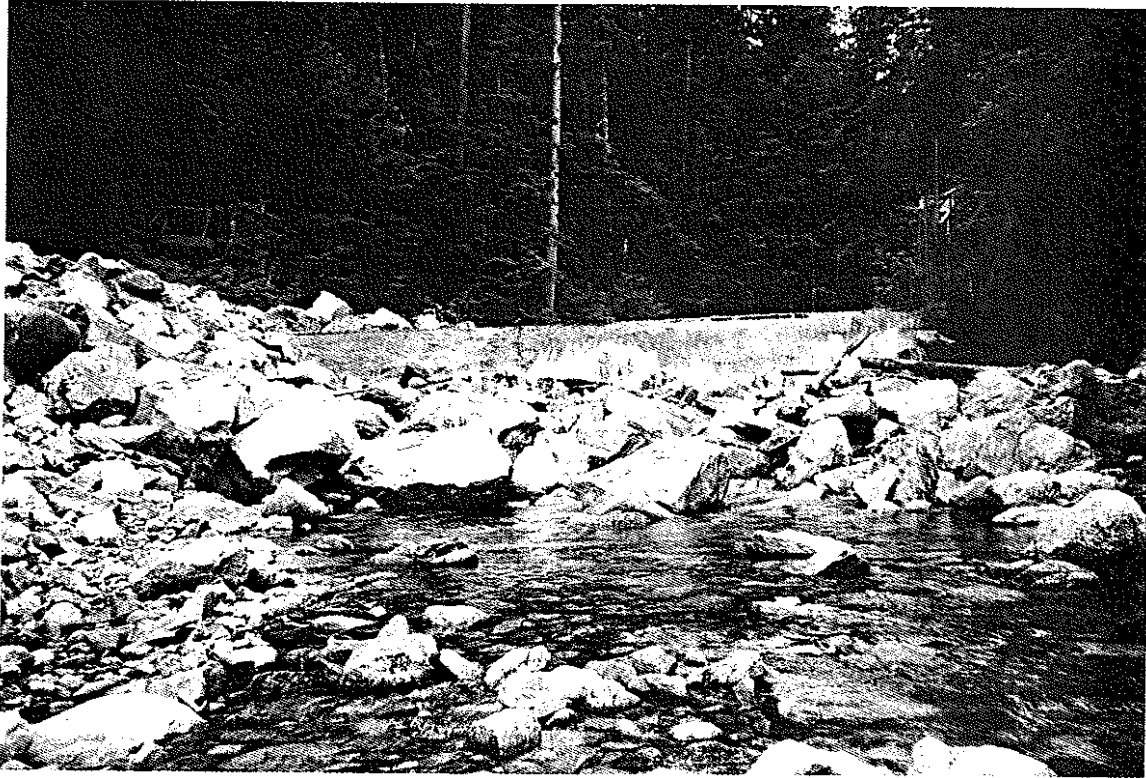
**Photograph 3:** Upstream view to weir and scour reduction/boulder zone associated with community water intake (Reach 8 - 08/98).

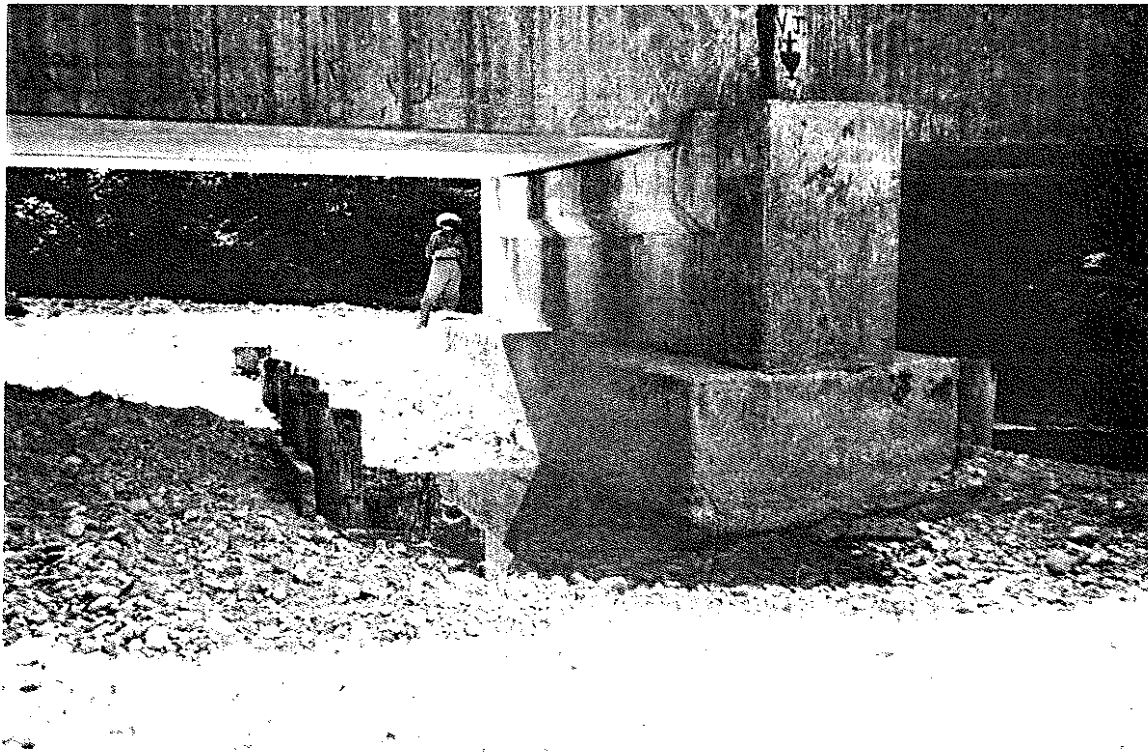
**Photograph 4:** Upstream view of confined pool created by railway bridge support block at the beginning of Reach 3 (Freshwater/Tidal boundary). Coho fry presence in pool (Reach 2/3 - 08/98).

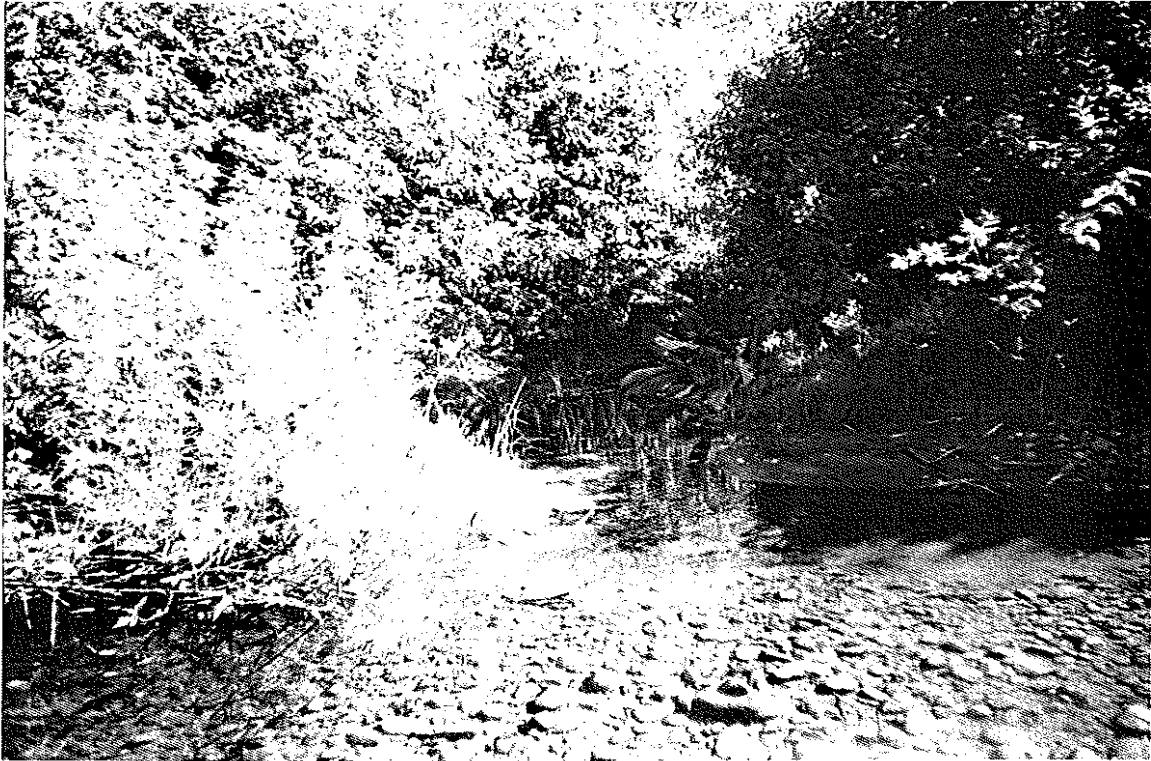
There was a large amount of off-channel habitat within this reach that is suitable for salmonid rearing habitat and where salmonids were observed. At approximately 65 m upstream of the highway bridge, two small off-channel areas (Photo 5) located on the left bank were utilized by juvenile coho salmon.

**Photograph 5:** Side channel on left bank under powerline R.O.W. Shrub dominant riparian/canopy zone (Reach 4 - 08/98).

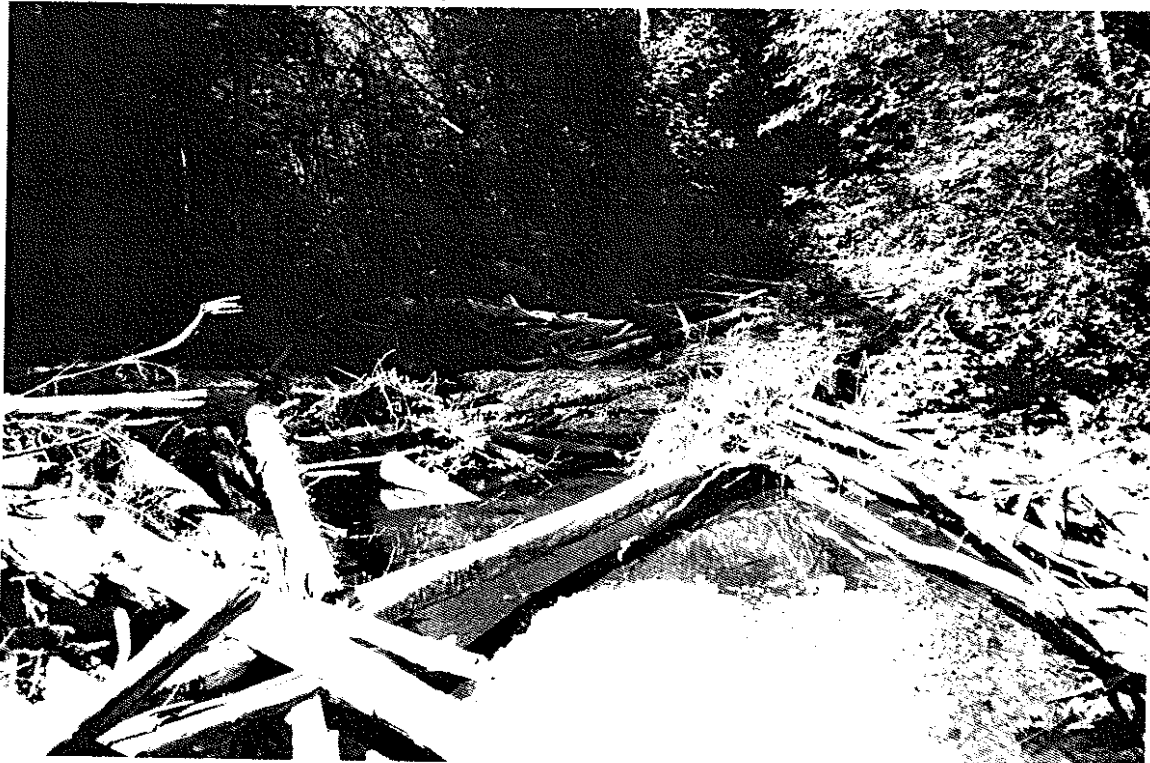
**Photograph 6:** Confluence of mainstem and Little Stawamus at boundary between Reach 4 and Reach 5. Significant large woody debris accumulation with notable cobble and gravel deposition (Reach 4/5 - 08/98).

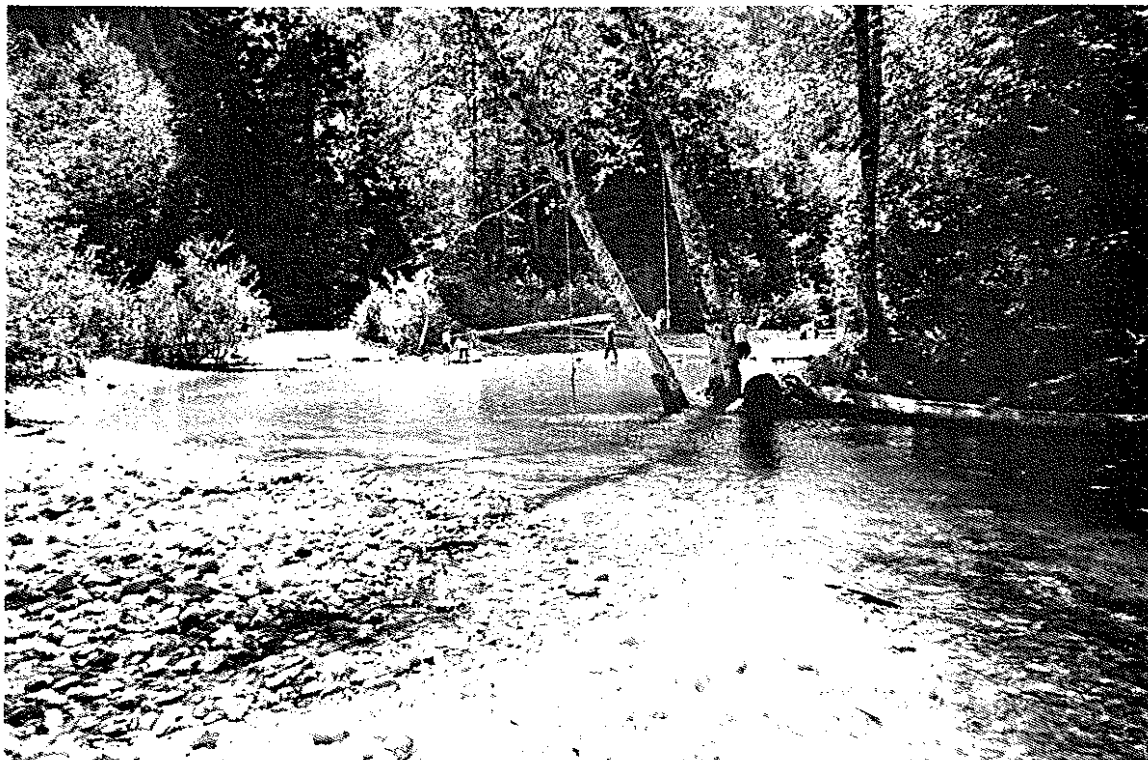
**Photograph 7:** Downstream view of swimming pool created in mainstem (Reach 5 - 08/98).

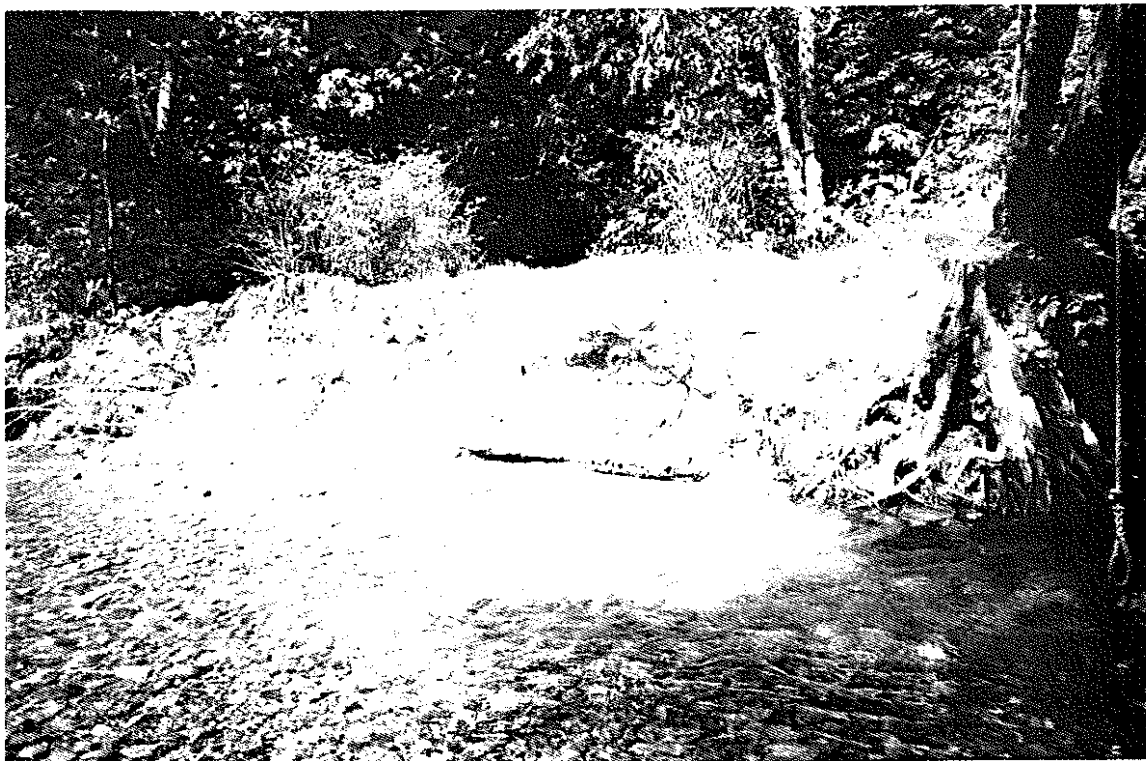
**Photograph 8:** Eroding banks - potential area for restoration (Reach 5 - 08/98)

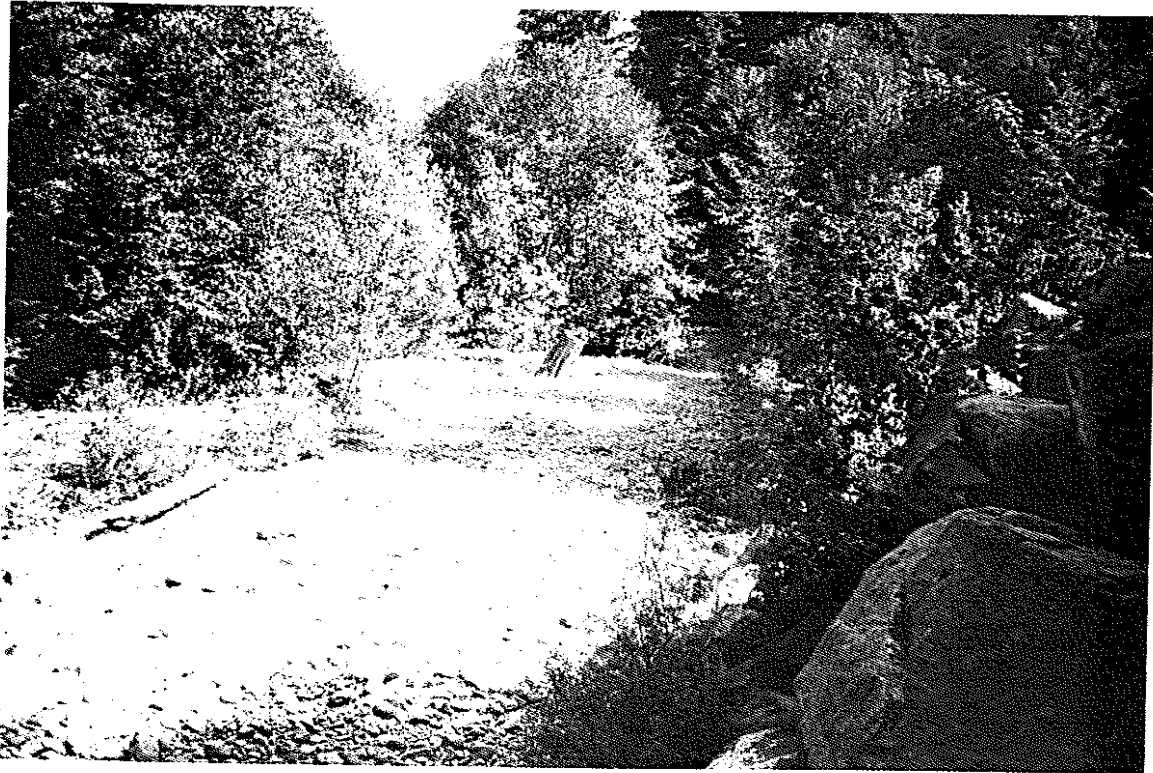
There was a large dry channel starting at the end of reach 5 and continuing for approximately 200 m into Reach 6 (Photo 9) with some isolated puddles. Reach 6 was poor in pool habitat, due to presence of extended riffles. The habitat was also very poor in cover, but LWD were fairly abundant in the lower portion of the reach before the stream reached the dike. Approximately 150 m downstream of where the channel diverges south of the dike, many fish were observed. This habitat appears to have abundant rearing habitat due to the presence of a large pool with plenty of LWD. Certain areas along the dike lack riparian vegetation (Photo 10). Large areas of eroding banks were located in the upstream portion of the reach on the left bank (Photo 11) and smaller areas are located at the downstream end of the reach. There were a few abandoned channels which could be excavated to re-create off-channel habitat at approximately 2 km from the mouth of the river (lower part of the reach). Several areas within the channel along the dike were dammed for swimming purposes.

**Photograph 9:** Upstream view of abandoned channel adjacent to logging road. Isolated pools created from low flow conditions (Reach 5 - 08/98).

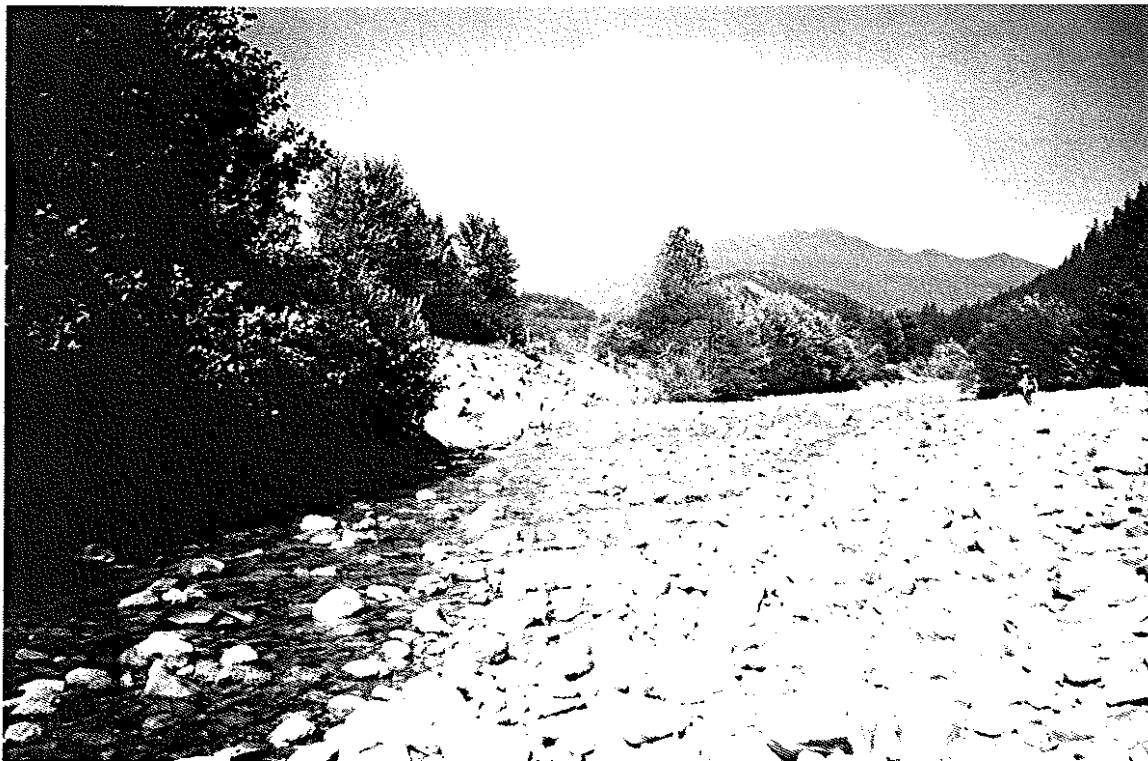
**Photograph 10:** Upstream view of dike on right bank, channel is trained and has an elongated riffle zone. Potential for restoration to vegetate the banks (Reach 6 - 08/98).

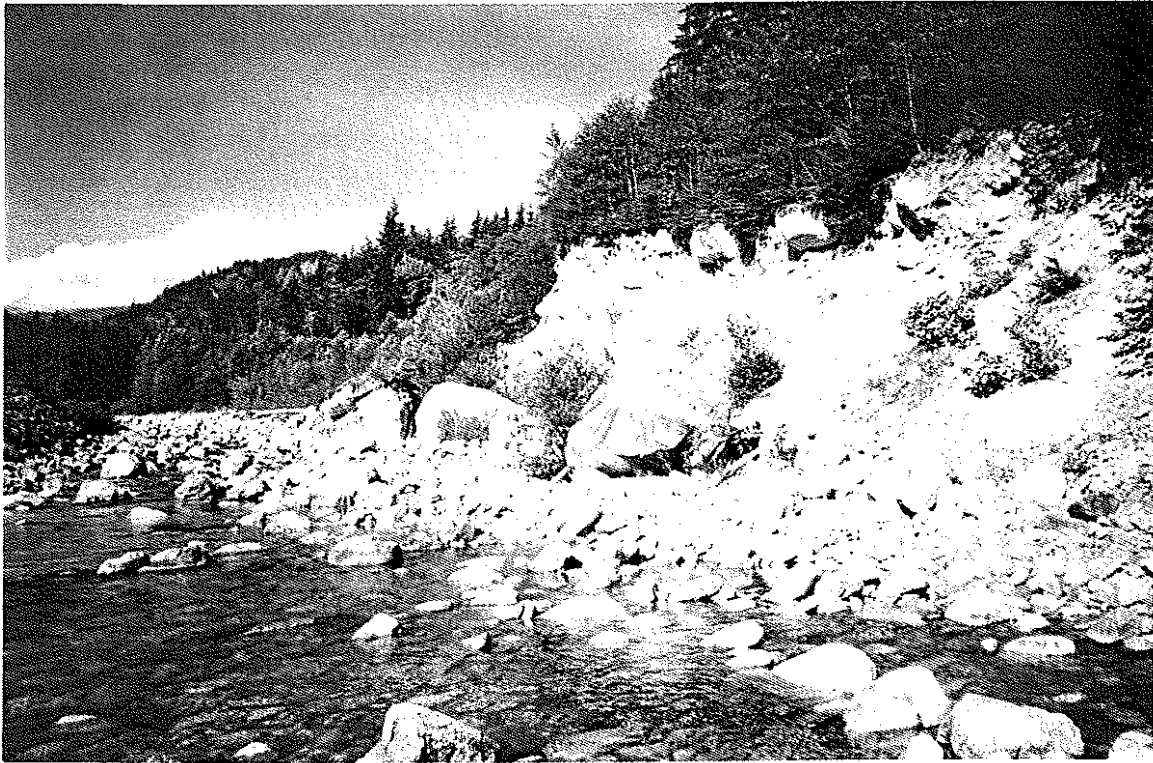
**Photograph 11:** Upstream view of eroded and highly unstable left bank. Potential for restoration to pull back and bioengineer the bank (Reach 6 - 08/98).

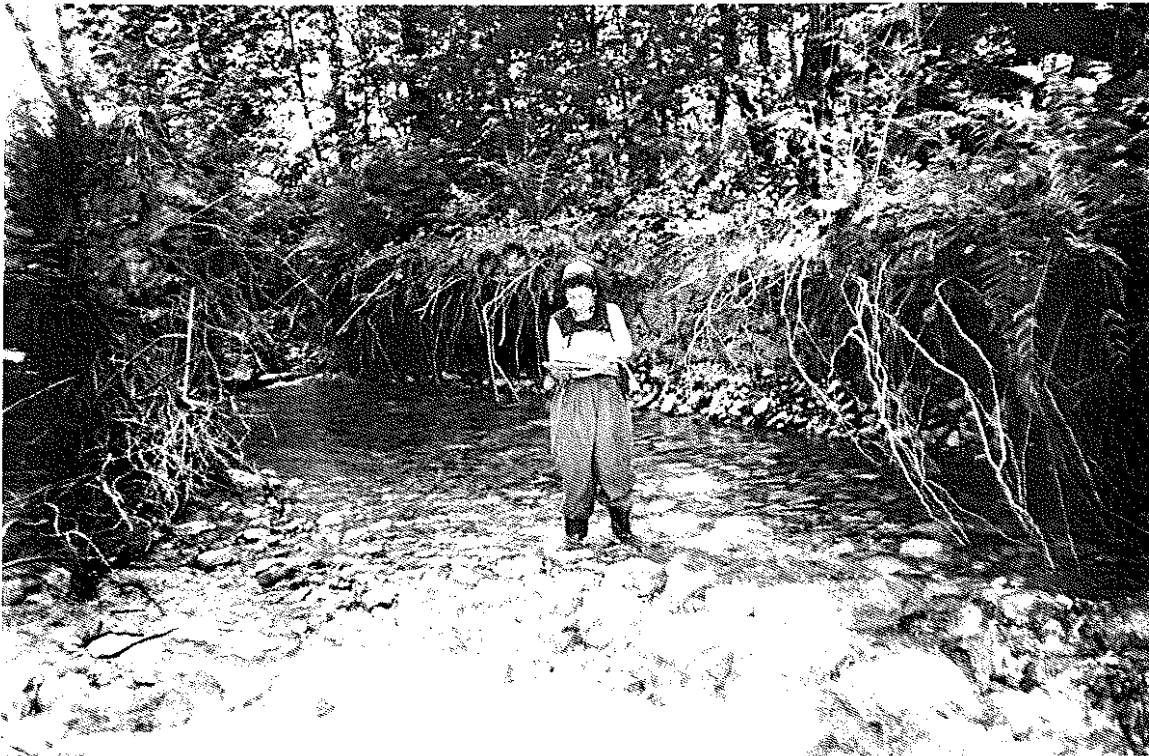
**Photograph 12:** Upstream view to eroding banks. Potential for restoration to stabilize bank (Reach 6 - 08/98).

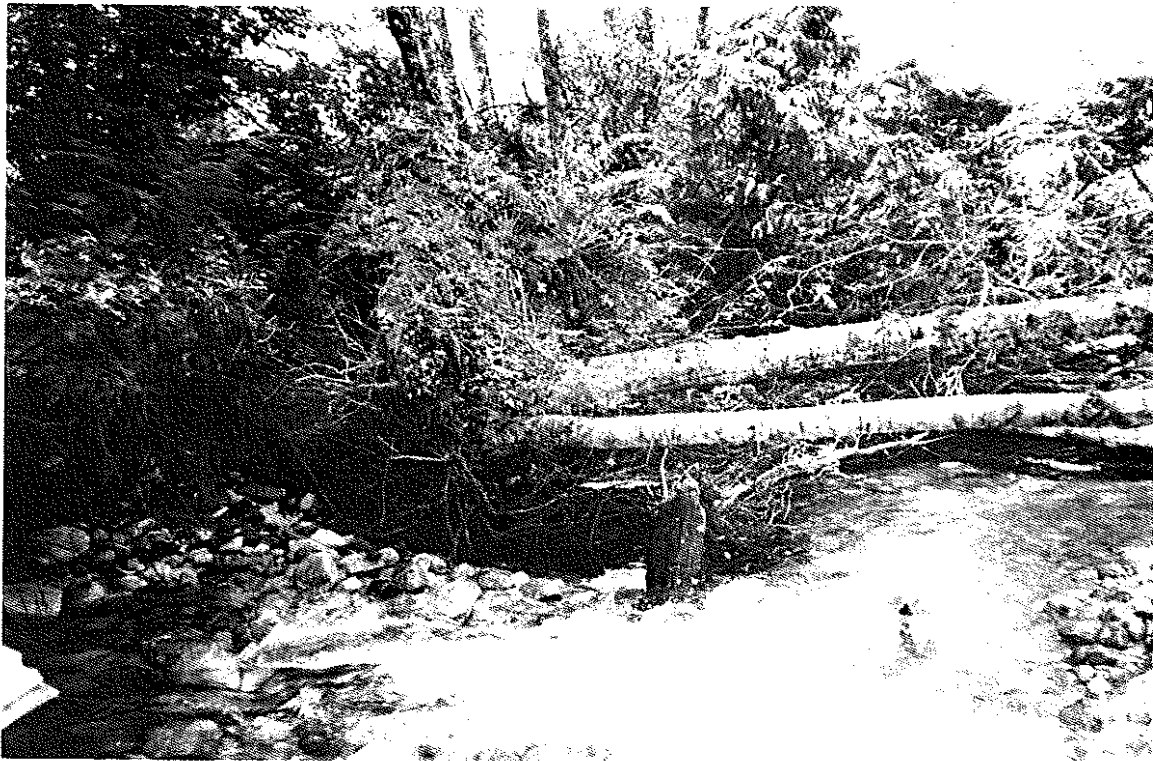
**Photograph 13:** Downstream view to recent bank failure and subsequent tree/root mass infilling mainstem along left bank. Erosion evident. Potential for restoration to stabilize bank (Reach 6 - 08/98).

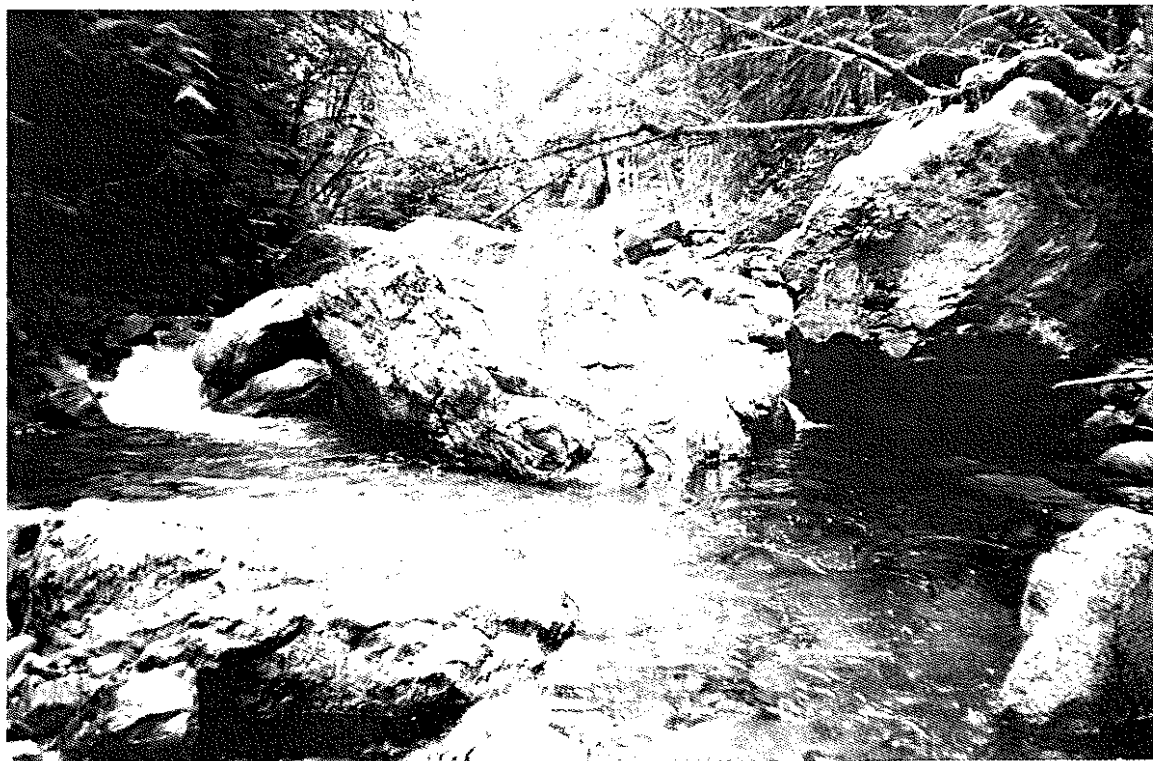
**Photograph 14:** Upstream view to large holding pool. Fry presence noted (Reach 7 - 08/98).

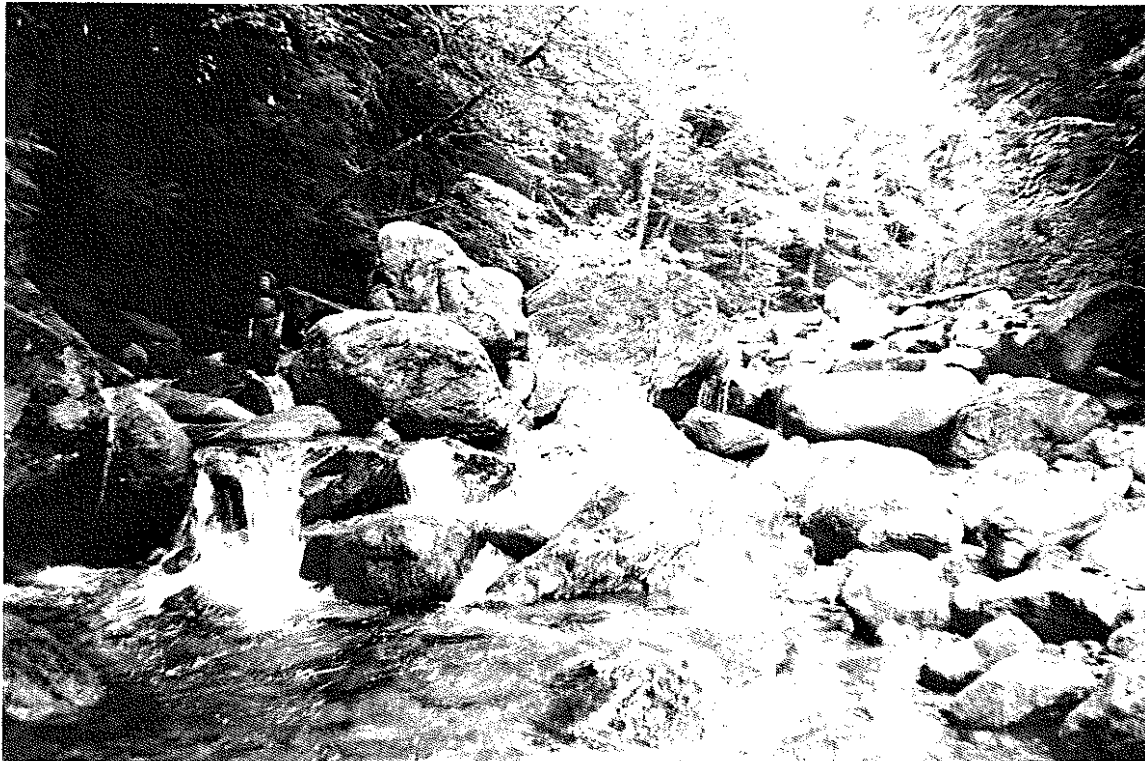
**Photograph 15:** Upstream view to extensive cascade/pool sequence. Impassable for fish at low flow (Reach 7 - 08/98).

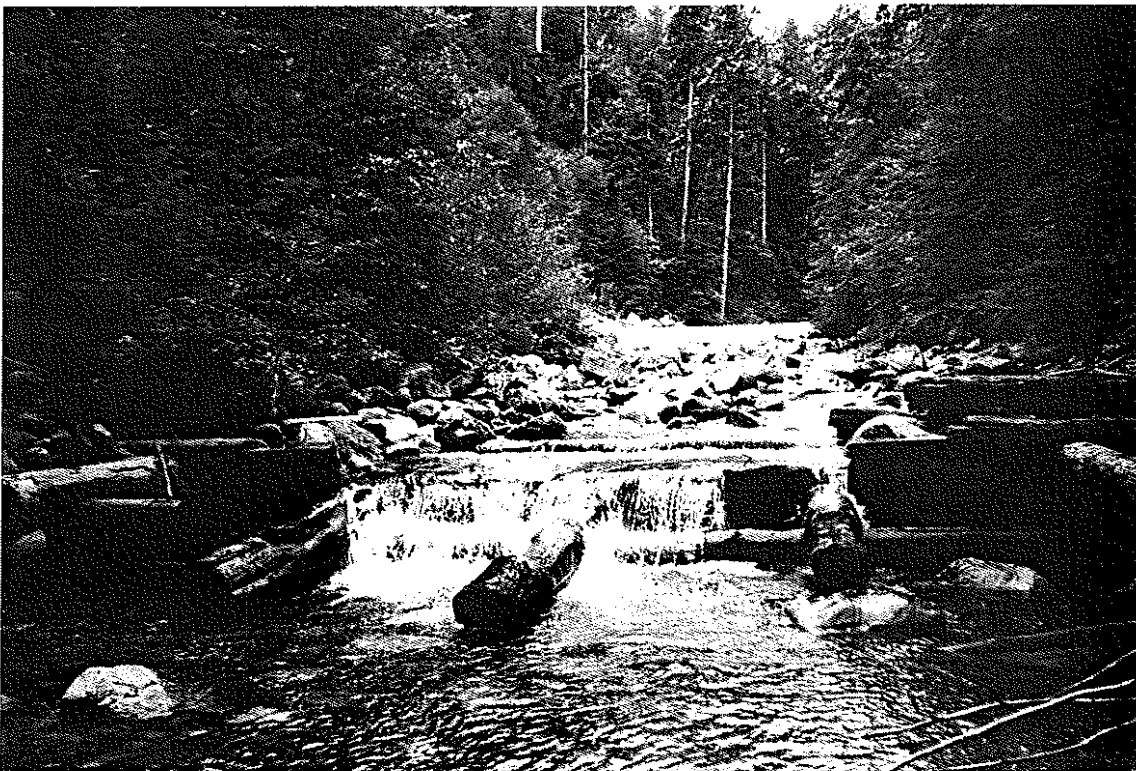
**Photograph 16:** Upstream view to both the old and active weirs associated with community water intake. Significant decrease in channel gradient and canopy cover (Reach 8 - 08/98).

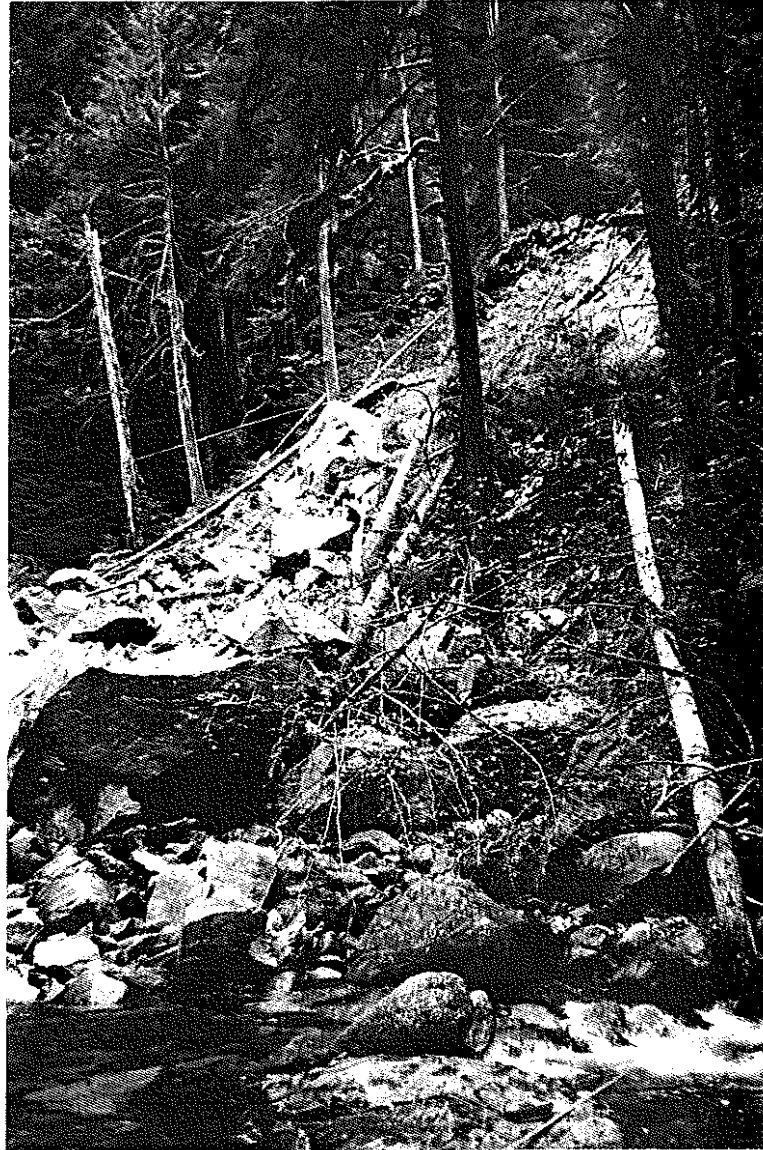
**Photograph 17:** Recent landslide on left bank. Major disturbance resulting in deposition of sediment, large woody debris and boulders to mainstem (Reach 8 - 08/98).

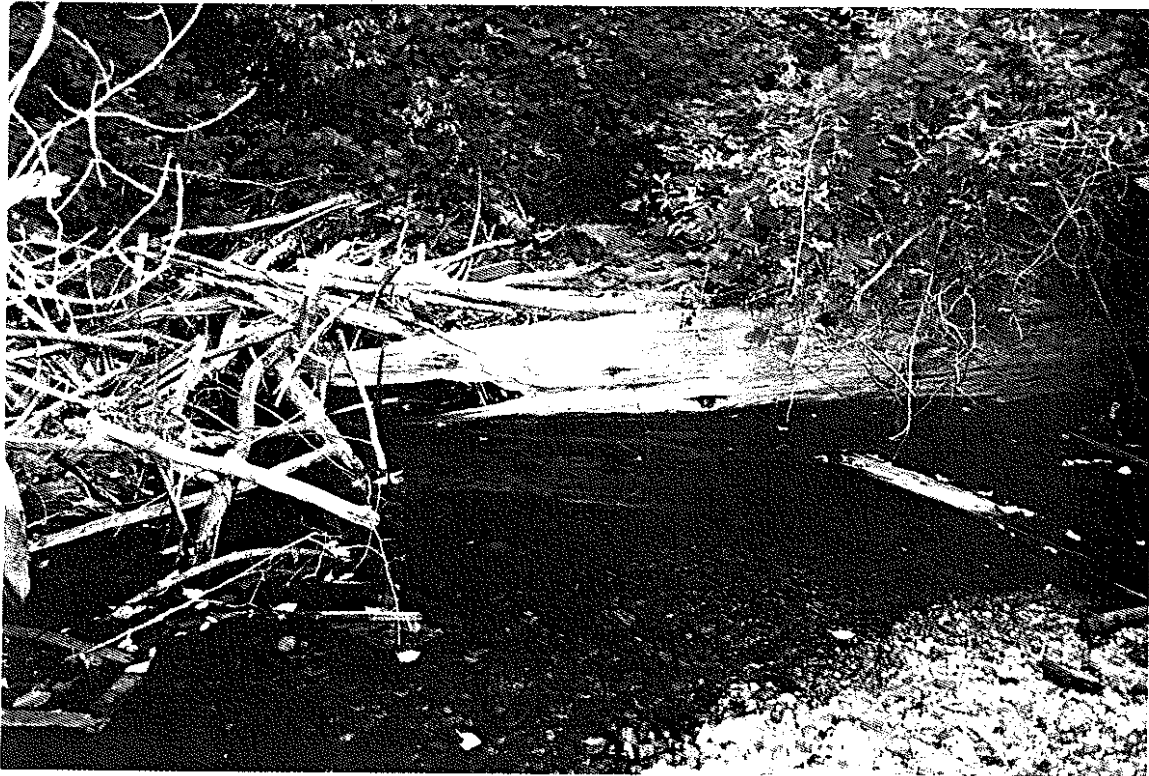
**Photograph 18:** Log and debris jam (wood, steel, garbage) (Little Stawamus - 09/98).

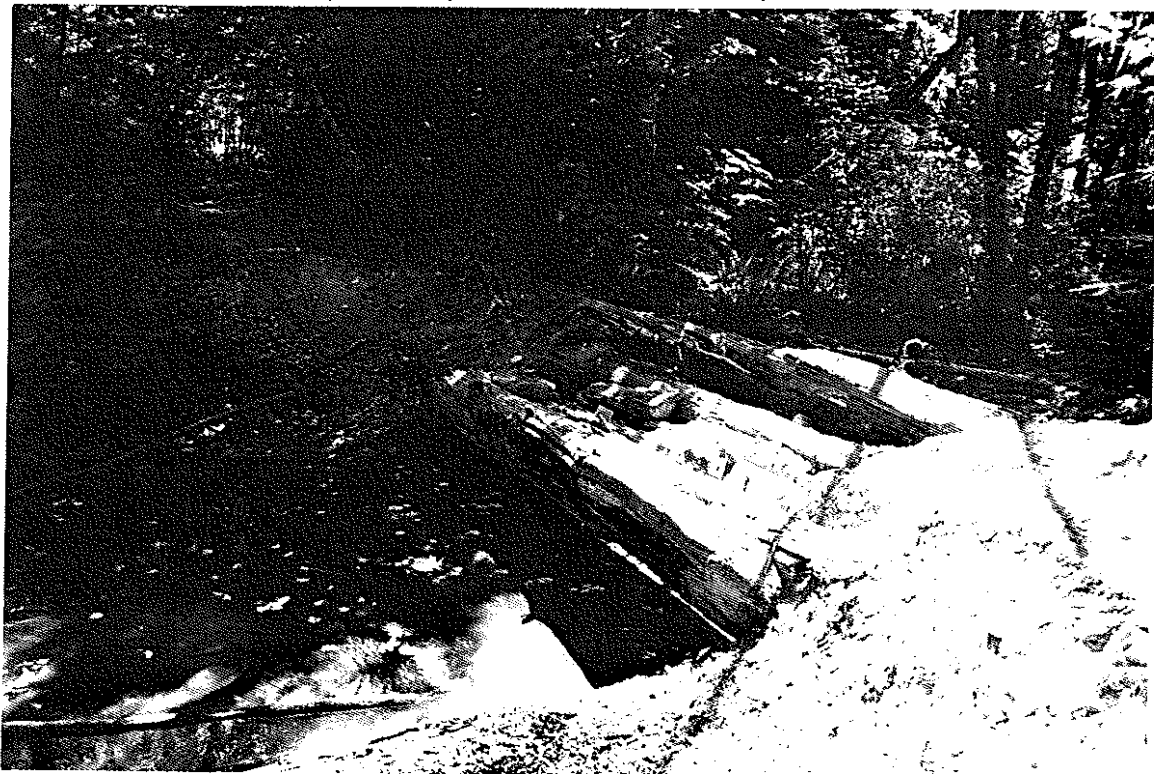
A deteriorated log bridge (Photo 19) located at 291m upstream of the confluence with the Stawamus River is a significant sediment source to the creek. The bridge may have contributed to the formation of a large pond (Photo 20). The blockage is resulting in stagnant water with high organic material decomposition. It also created a stagnant pool with highly turbid water and no flow downstream of the foot bridge. A pedestrian crossing through the creek located at approximately 450m could be a potential sediment source. Another deteriorated log bridge located at 1,181m (Photo 21) is acting as a sediment source.

**Photograph 19:** Foot bridge resulting in sediment deposition to stagnant water upstream (Little Stawamus - 09/98).

An existing log bridge 291 m upstream of the stream mouth (Photo 19) has fallen into the stream and caused ponding upstream, which has resulted in bank erosion. Replacement of the bridge to facilitate pedestrian crossing over the stream is recommended. Another bridge located at 1,181 m (Photo 21) would also require replacement. Culverts at the

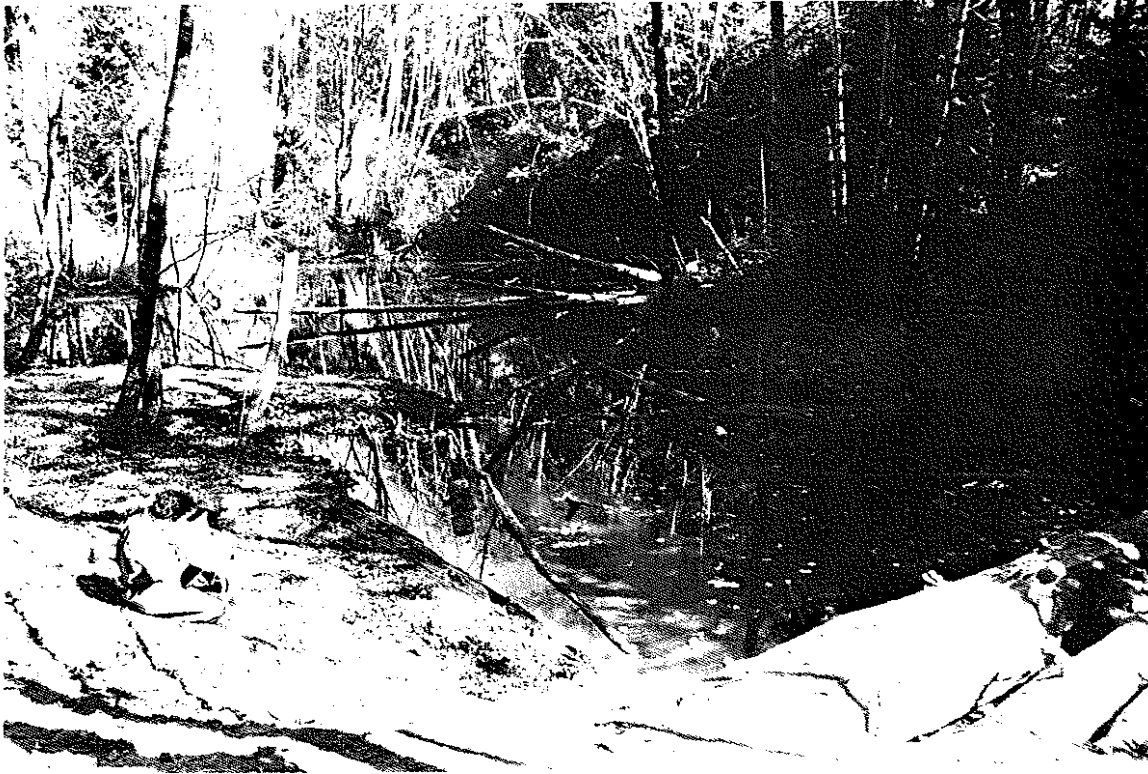
**Photograph 20:** Pond created as flow impeded by foot bridge (Little Stawamus - 09/98).

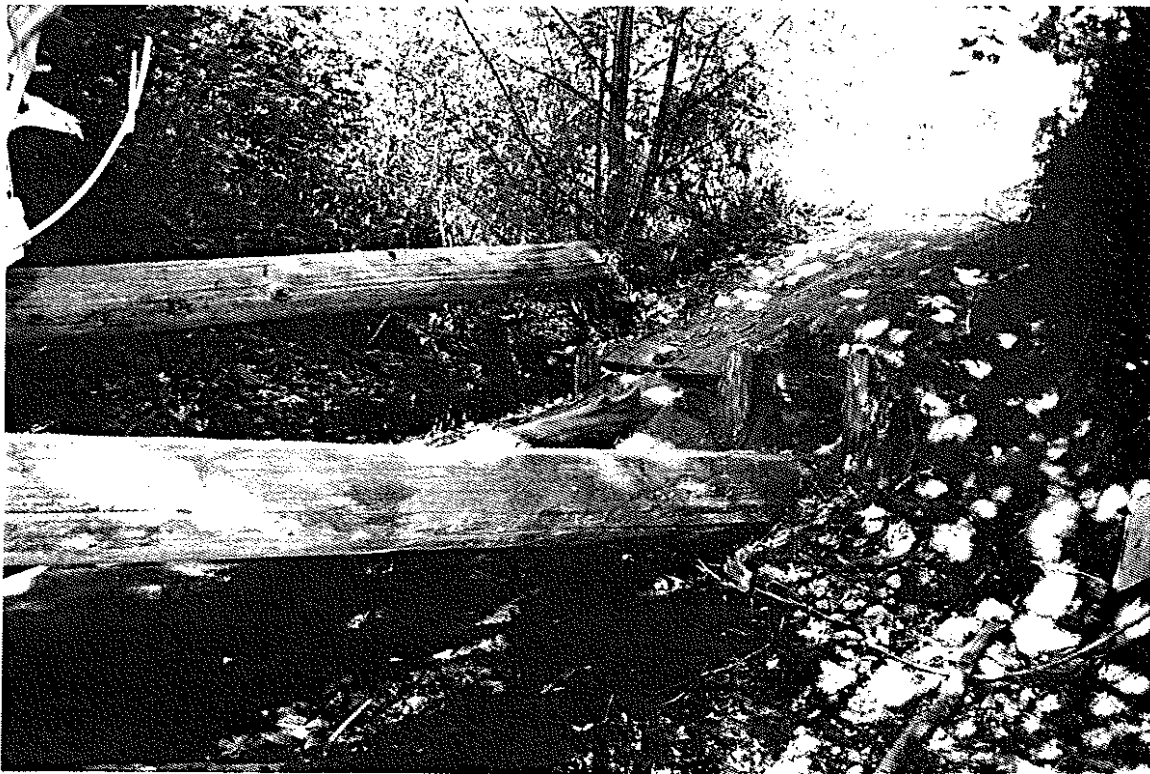
**Photograph 21:** Foot bridge and access path, resulting in sediment deposition to the channel (Little Stawamus - 09/98).

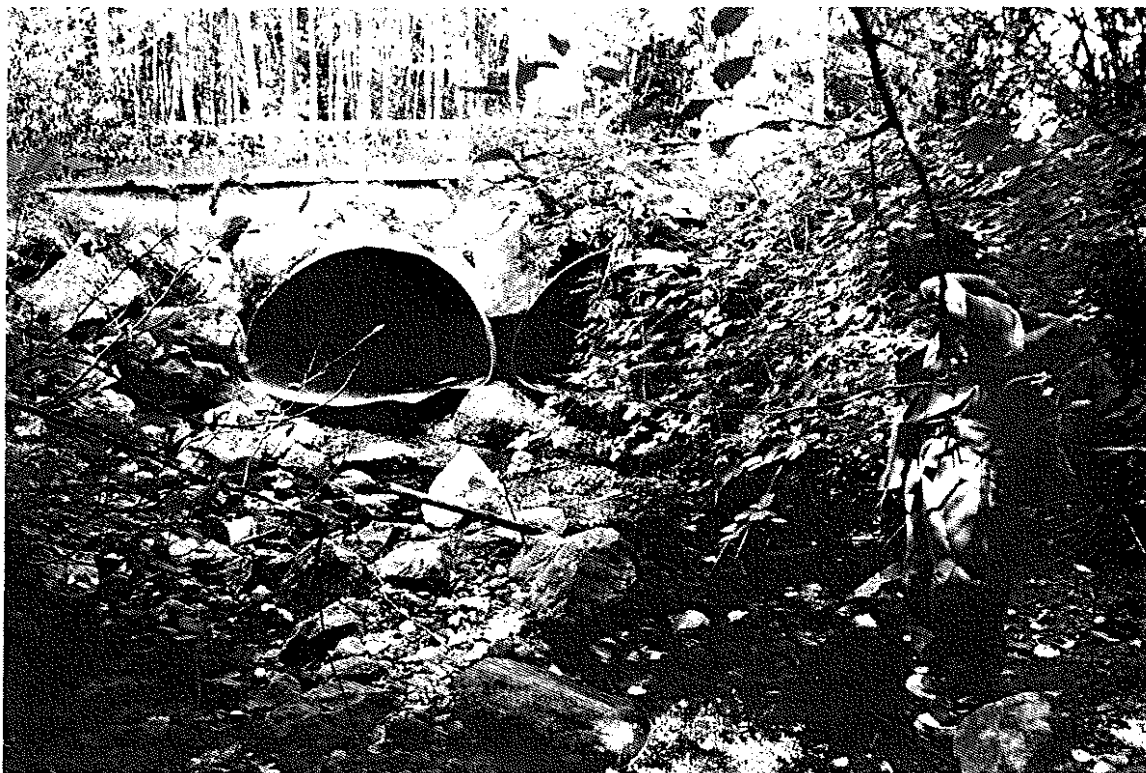
**Photograph 22:** Culverts under Guilford Road displaying low flow conditions (Little Stawamus - 09/98).

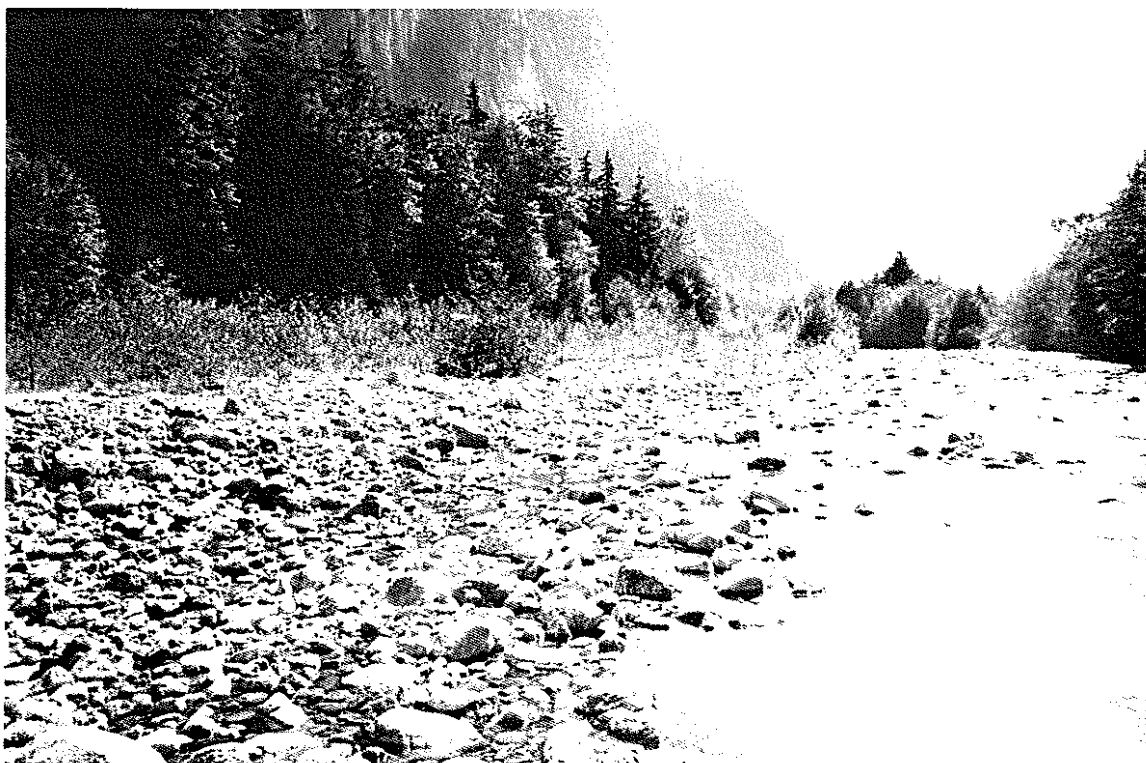
**Photograph 23:** Downstream view to potential off-channel habitat site (abandoned channel) which parallels the mainstem (115m). Potential for restoration to enhance side channel morphology to ensure flow during dry season (Reach 6 - 08/98).
