P/FR/SK/6  
MORRIS, M.  
MORICE RIVER STREAM SURVEY

MORICE RIVER  
STREAM SURVEY

AUGUST 1975

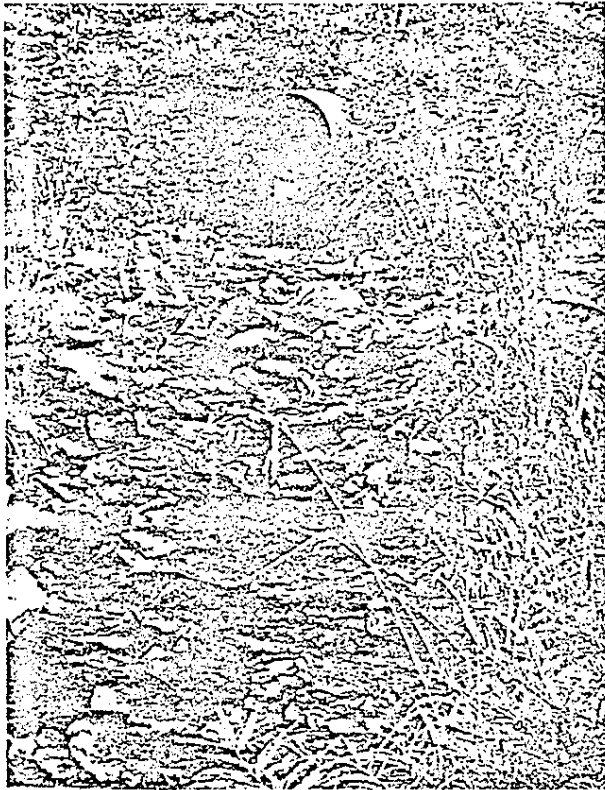
Fig. 1

These reaches were located near the end of Morice River road where it crosses Tributary 1 and 2. (Mile 36.4) The creeks were small (1 c/s) and only about 50 m apart and were therefore quite similar. Productivity of the creeks was limited by their size and lack of spawning gravel; the fish found there probably being of a resident population. The nearly closed canopy and instream branches and logs suggests potential habitat for cutthroat as well as the Dolly Varden found. (Figs. 1 and 2).

Tributary 1, note barrier.  
Dolly Varden from pool below  
culvert.

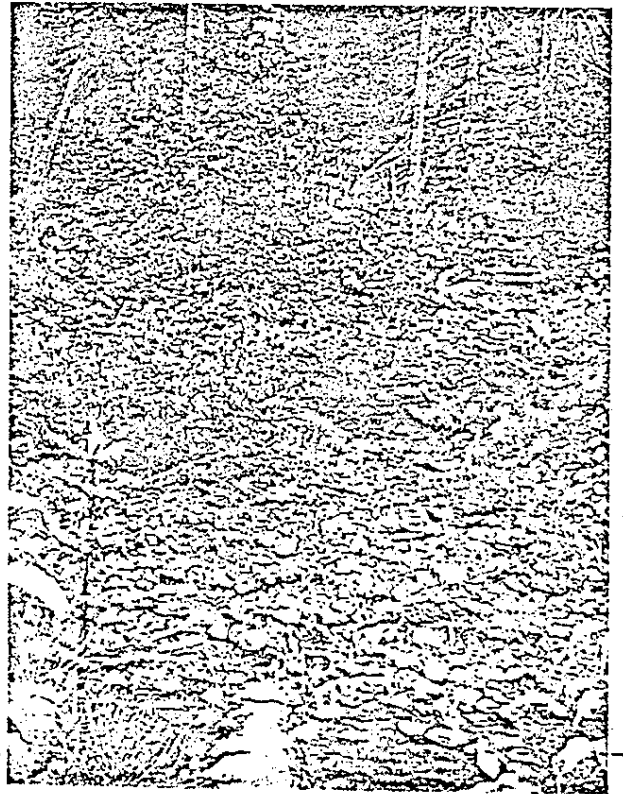
Fig. 2

Tributary 2, downstream from road  
crossing.

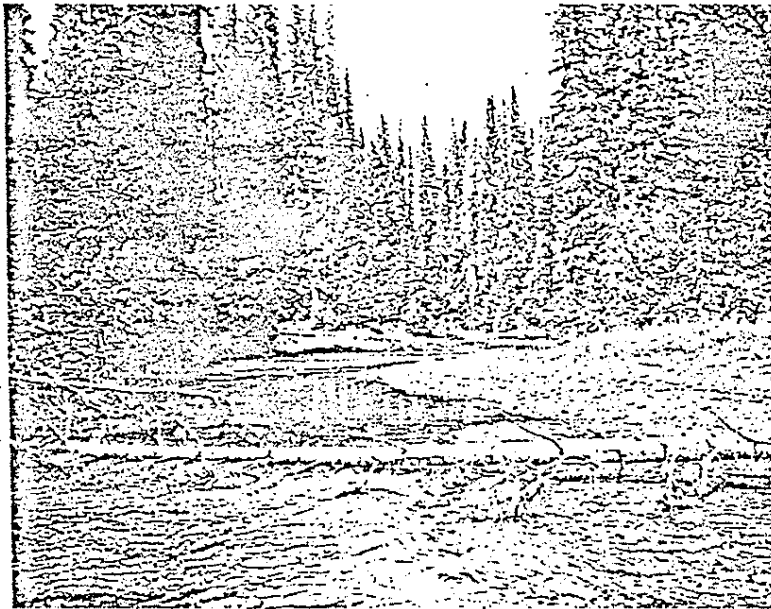
Fig. 6

This tributary was located across and slightly downstream from Cadric Creek. Observation was conducted upstream from side channel of the mainstem. Swampy terrain and low gradient provided excellent rearing habitat for coho. More than forty fry were observed in a ten meter flat section. There was fresh moose sign in the area. (Fig. 6)

Side channel to Tributary 5

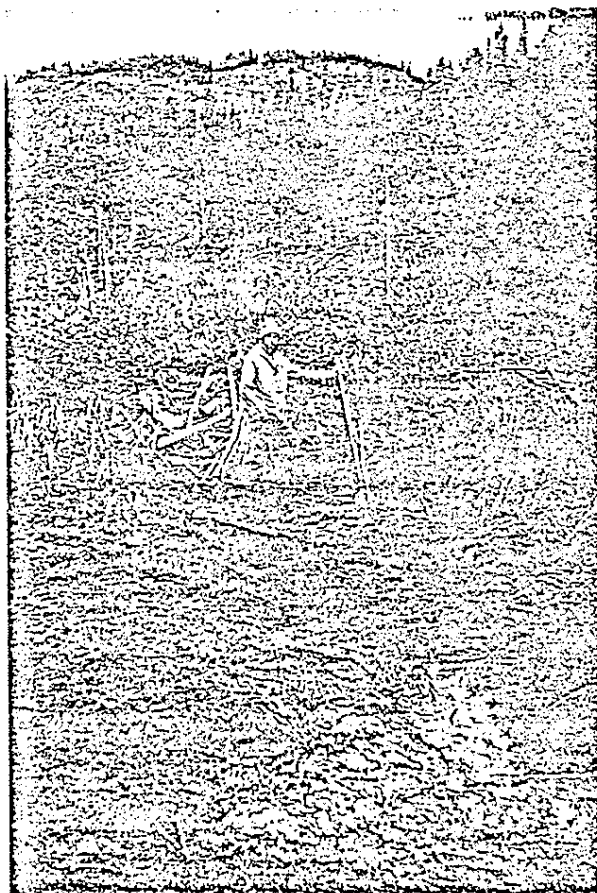
Fig. 13

These tributaries were found to be none productive in terms of fisheries. Tributary 11 was located in swampy terrain with only seepage entering main river. Tributary 12 was completely ponded by 2 meter beaver dam. (Fig. 13 ). Tributary 13 was a day channel running through steep rocky terrain.

Beaver dam blocking Tributary 12.

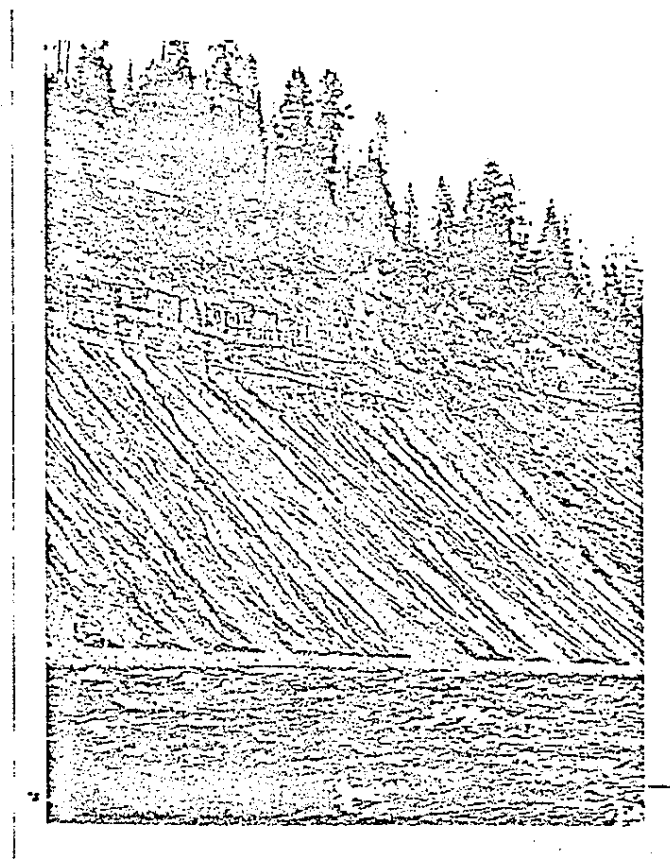
Fig. 14

Bank instability above mile 34 on the main river.

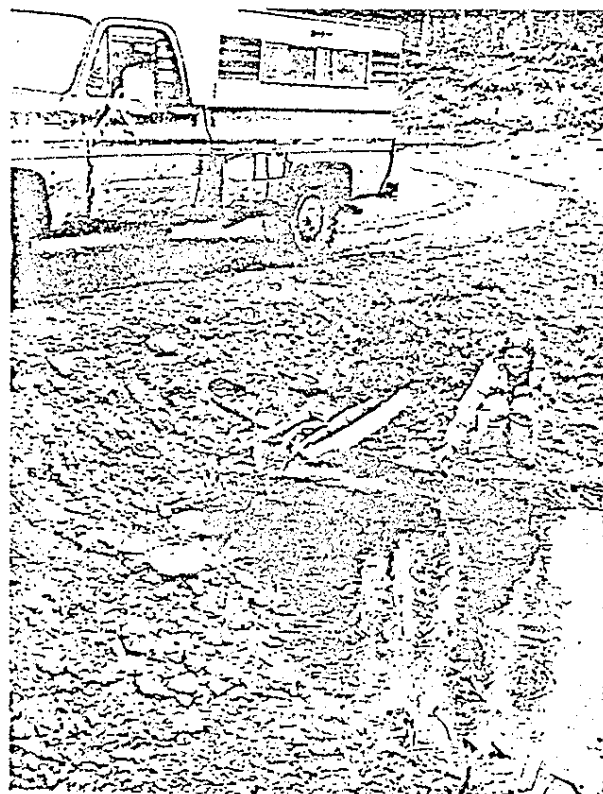
Fig. 18

Where the road to Tributary 1 crosses Lamprey Creek there is a barrier. The area is swampy and flat, the stream being crossed by log road through the water. The only way fish could pass this point is by crossing in the water which runs over the road. (Fig. 18)

Barrier at road crossing.  
Lamprey Creek near tributary 1  
confluence.

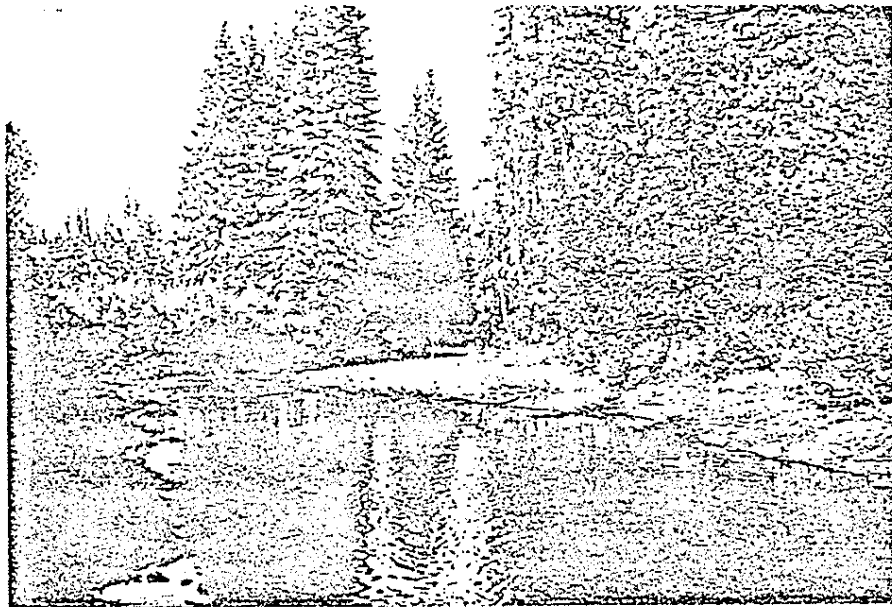
Fig. 19

Mid section of Lamprey Creek near confluence of Pimpernel Creek. looking downstream.

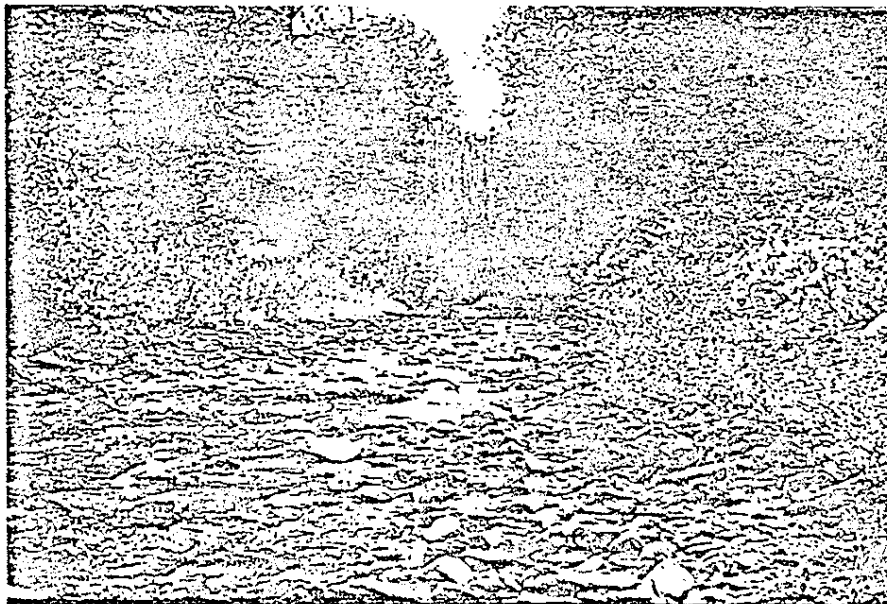
Fig. 20

Near the mouth of Lamprey Creek, the stream is mainly riffle and the bottom is covered with an algae mat. From air photo study, this type of habitat extends upstream about 2½ miles to the wider valley bottom, habitat described in Reach 29. Spawning gravel is limited the substrate being mainly rubble sized. Though some coho and rainbow smolts were found rearing here, it seems the main importance of this section of creek is passage to upper sections. (Fig. 20).

Lamprey Creek mouth. (Reach 30).

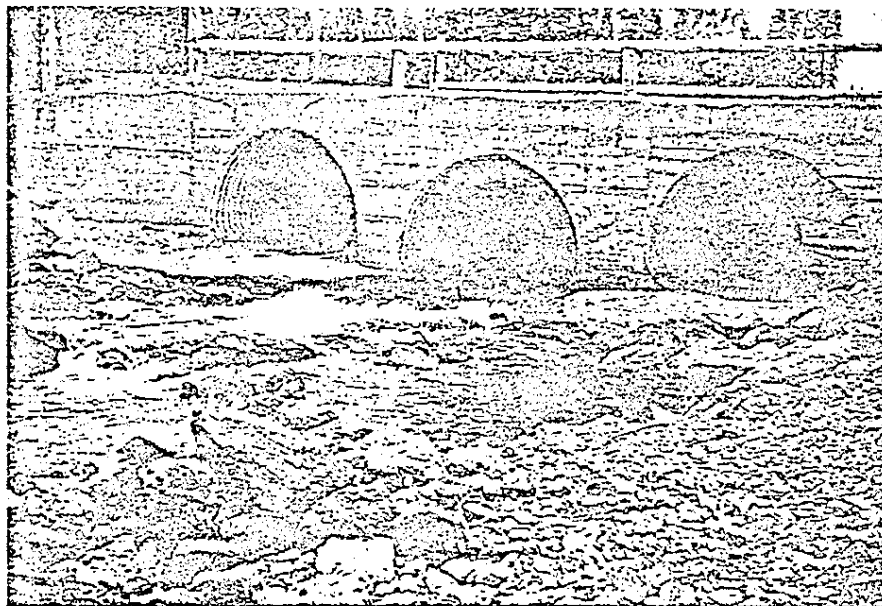
Fig. 21

Owen Creek. Compare this picture to the one in the Owen Creek report by Finsent. Culverts are no longer a barrier since riprap was dumped below cement apron.
