A FISHERIES SURVEY OF THE
UPPER ZYMOETZ RIVER SYSTEM
(HEADWATERS TO RED CANYON CREEK)
WITH PARTICULAR REFERENCE
TO STEELHEAD AND CUTTHROAT TROUT
HABITAT AND ENHANCEMENT OPPORTUNITIES

D.H. Humphries

C. Morley

Fisheries Report No. 78-6 (S.E.P.)
B.C. Fish and Wildlife Branch
Smithers, B. C.
December, 1978

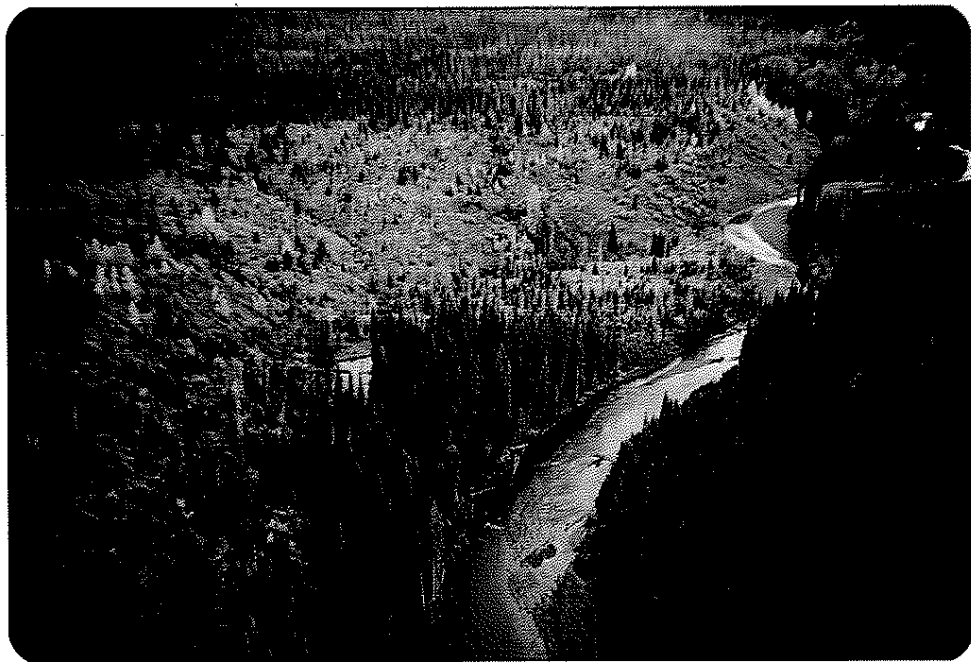
The Zymoetz forms a single channel and is occasionally confined by bedrock outcrops (Photo 3). Meander scars, gravel bars and bank slumps indicate moderate lateral channel movement (Photo 4 and 5) and one main channel diversion was seen at the mouth of Coal Creek (Photo 6). No barriers to fish passage were present. During September, the river below Serb Creek was clear and many areas appeared to have suitable gravel and water velocities for spawning coho and steelhead (Photo 7). Rearing areas and deep bedrock-controlled pools were also abundant. No fish were observed or captured in the lower reach during this time, but several juvenile rainbow trout and coho salmon fry were captured in July (Table 6).

Photo 4. September 1978. Zymoetz River shows some lateral channel movement in reach A. Note meander cut-off on left and shifting gravel bars.

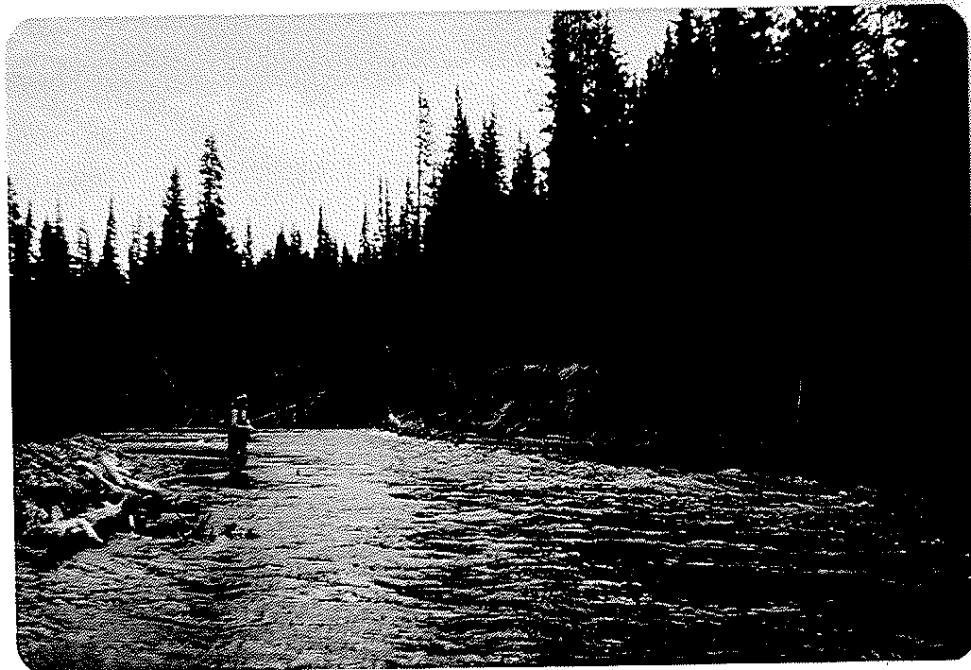
Photo 7. June, 1978. Point sample # 2
on Zymoetz River, below Serb Creek.
Water clear.

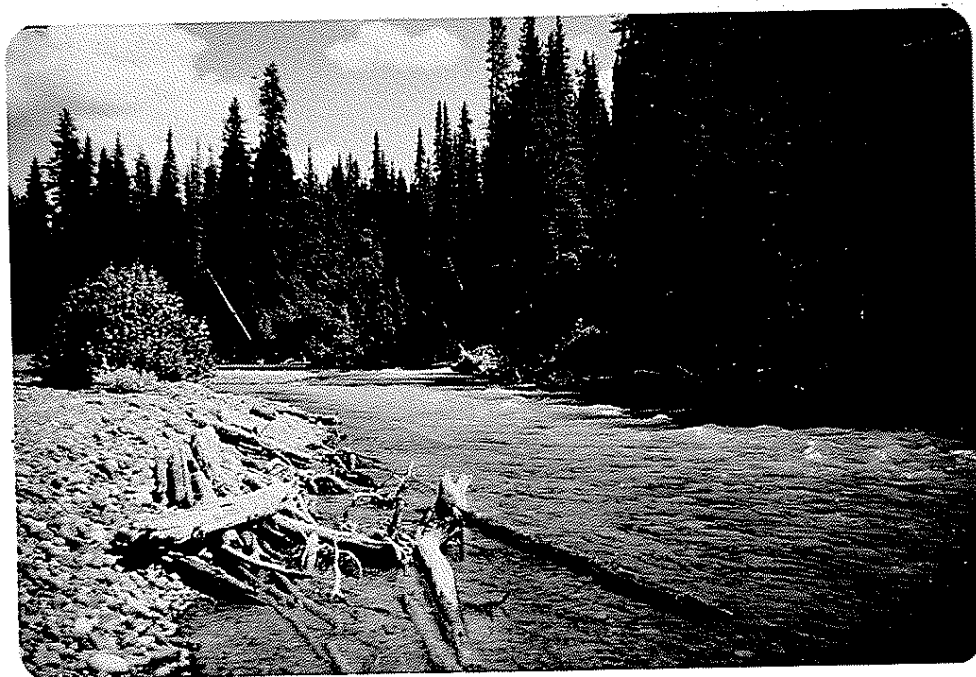
Photo 8. July, 1978. Same as Photo 7. Water
colour change due to glacial melt
from Serb Creek.

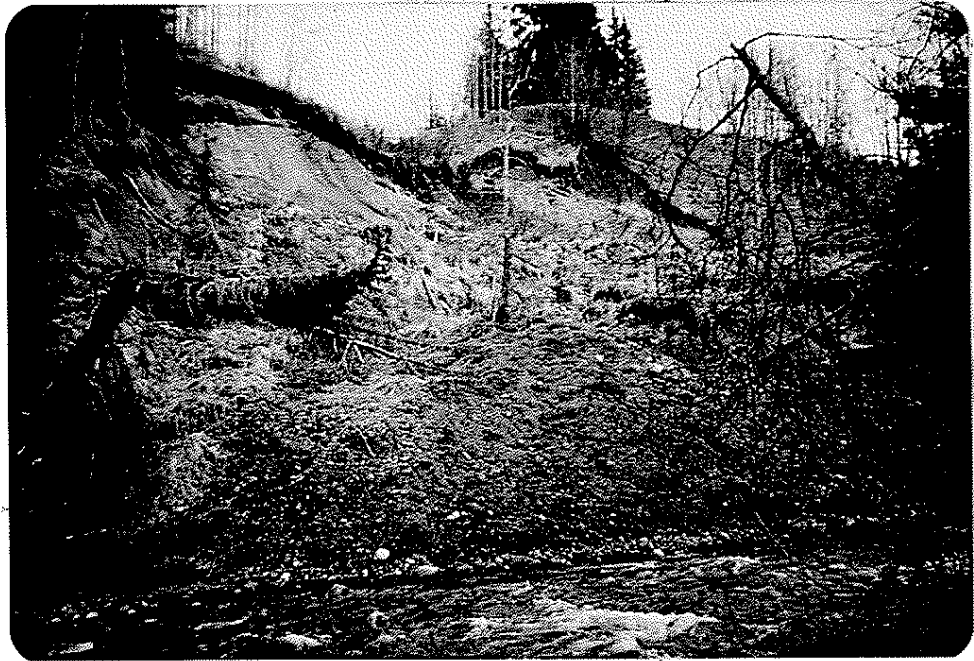
This reach extends from Serb Creek upstream to McDonell Lake (Fig. 5). The Zymoetz forms a single channel throughout the reach. No bedrock outcrops were noted and undercut banks occur on both sides of the river. Approximately 20% of the banks are unstable and contribute a moderate amount of debris and silt to the river. One major slump is located immediately above Serb Creek on the right bank (Photo 9).

Photo 9. May, 1978. Bank slump at the beginning of Reach B, Zymoetz River.

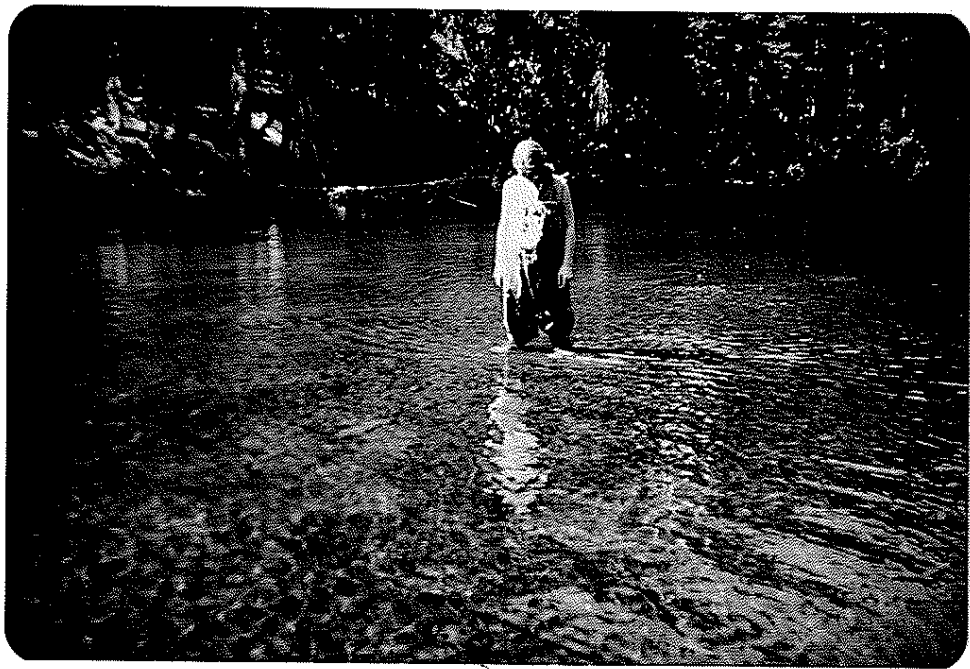
Photo 10. July, 1978. Steelhead spawning section immediately below McDonell Lake. River very slow-moving and algae growth was heavy, see Point Sample # 4.

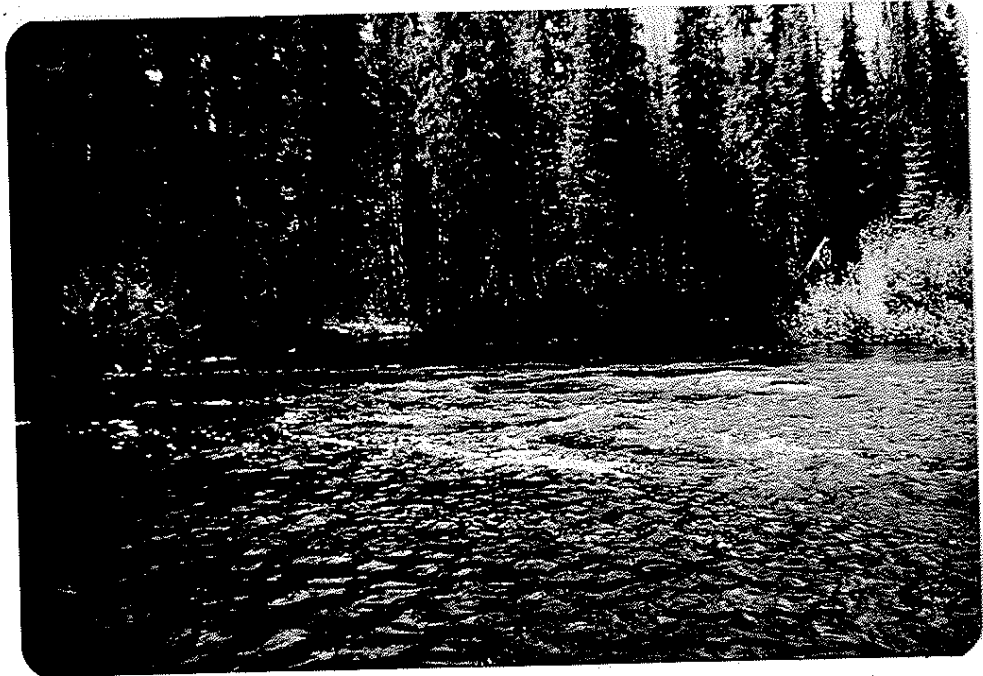
Photo 11. June, 1978. Looking downstream, steelhead spawning section (dated at end of riffle section. See point sample #3.

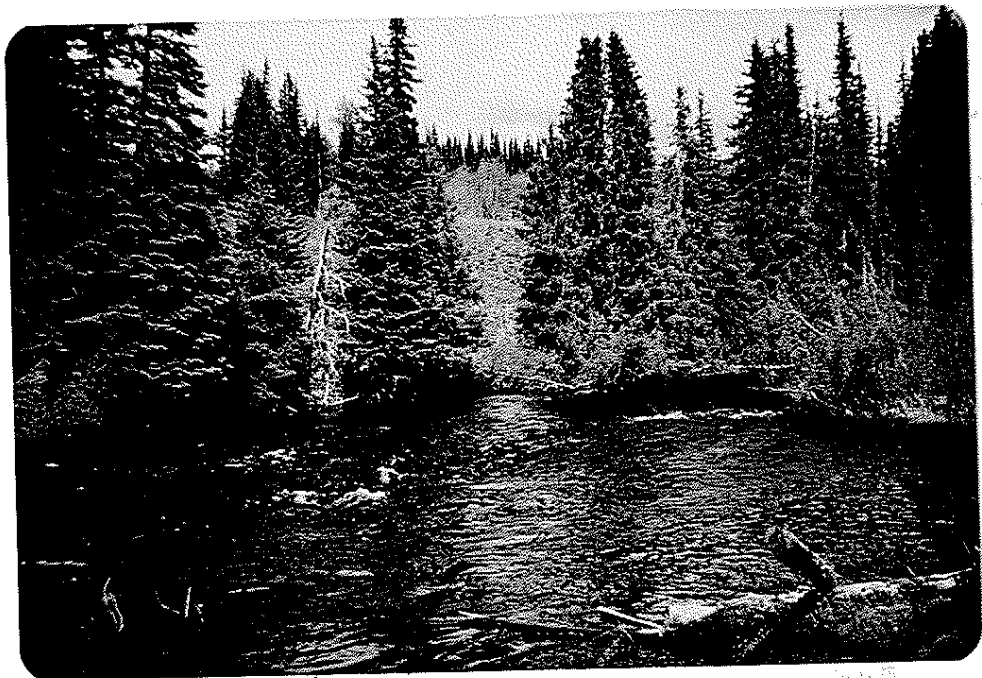
Photo 12. June, 1978. Upstream of Photo 11. Cutthroat angled throughout entire section. Large pool located above and below riffle.

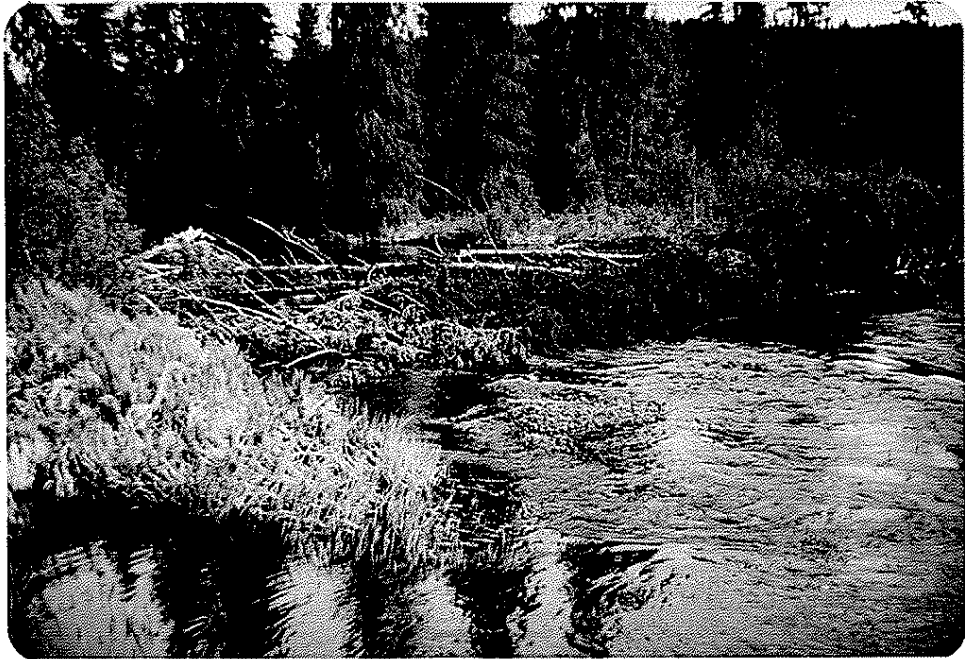
Photo 13. June, 1978. Debris accumulation in reach C has caused channel shift. Cut-offs areas provide good rearing habitat.

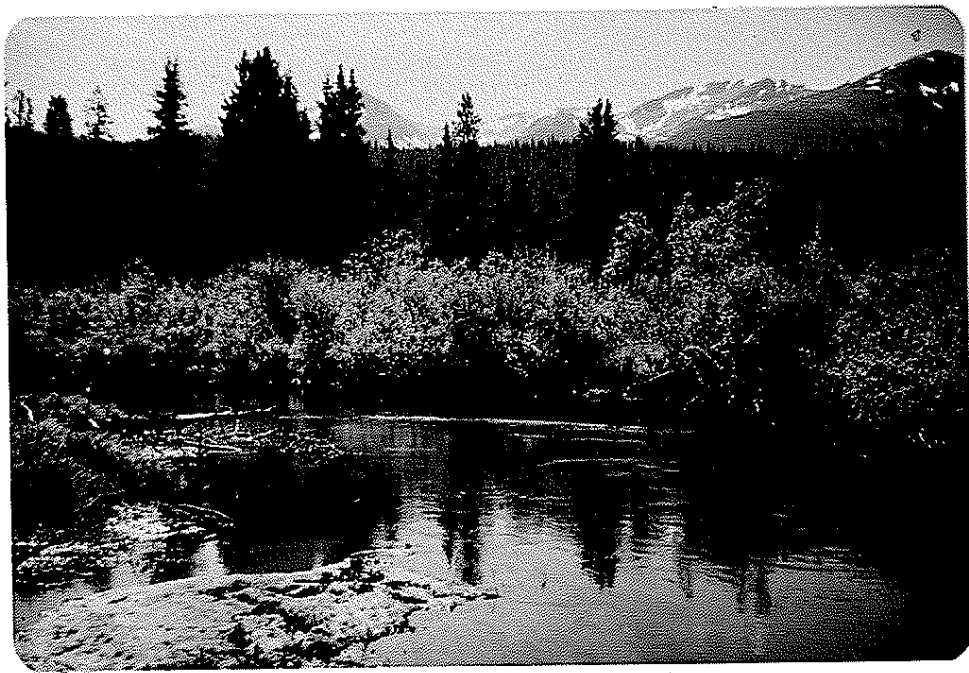
Photo 14. July, 1978. Point Sample # 5 in reach C. Although channel is unconfined, it is well-entrenched and banks are generally steep and/or undercut. Vegetation is typical of entire reach.

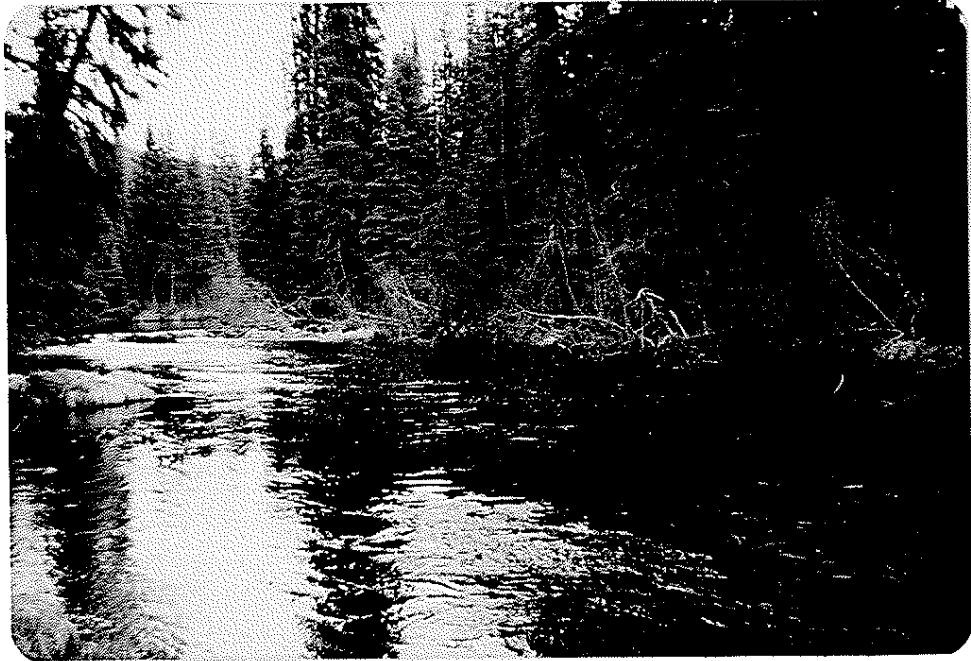
Photo 15. June, 1978. Reach D of the Zymoetz offers the widest range of fish habitat. Looking upstream, the top end of the reach is well-utilized by coho fry.

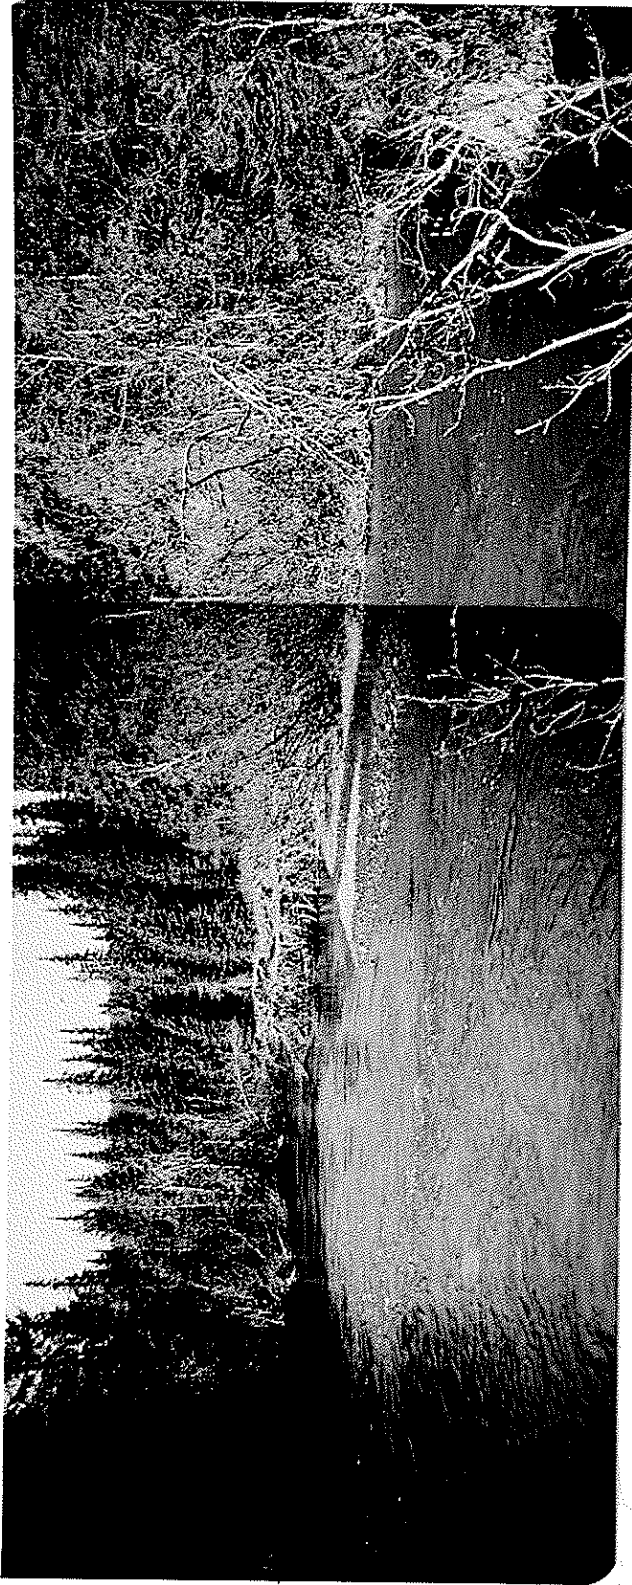
Dolly Varden, sockeye and steelhead were observed and captured from the deep pool formed at the Passby/Zymoetz confluence. Large amounts of clean, medium-sized (2-64 mm) gravel are deposited downstream of the confluence (Photos 16 and 17).

Photo 17. June, 1978. Looking downstream at Passby/Zymoetz confluence. Passby entering on right, note gravel fan and water turbidity resulting from three-days of rainfall.

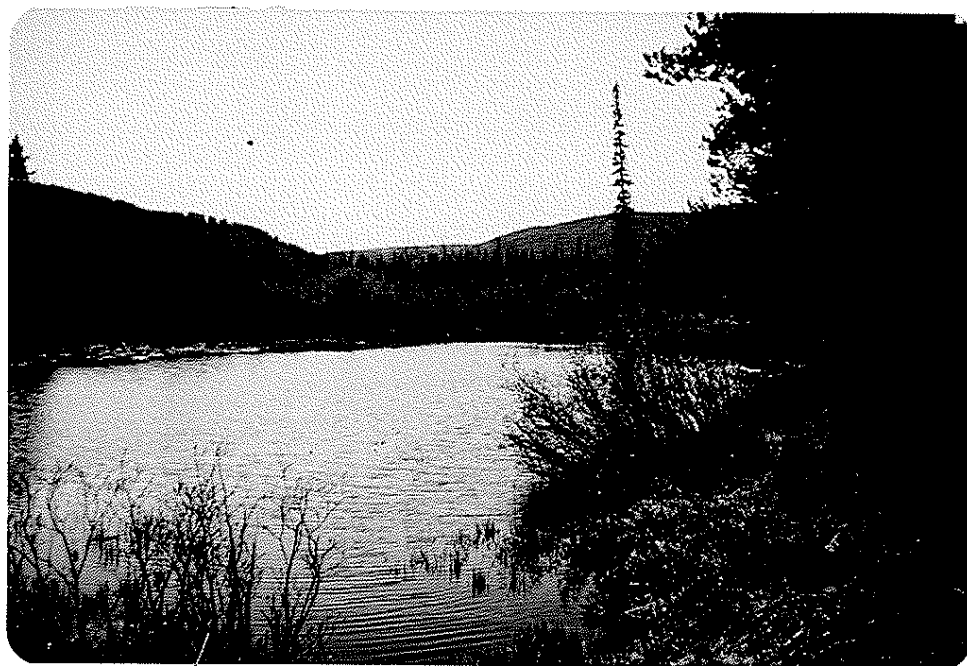
Photo 19. June, 1978. Meander cut-off in reach E that is utilized by coho fry and juveniles. Main Zymoetz in background of photo.

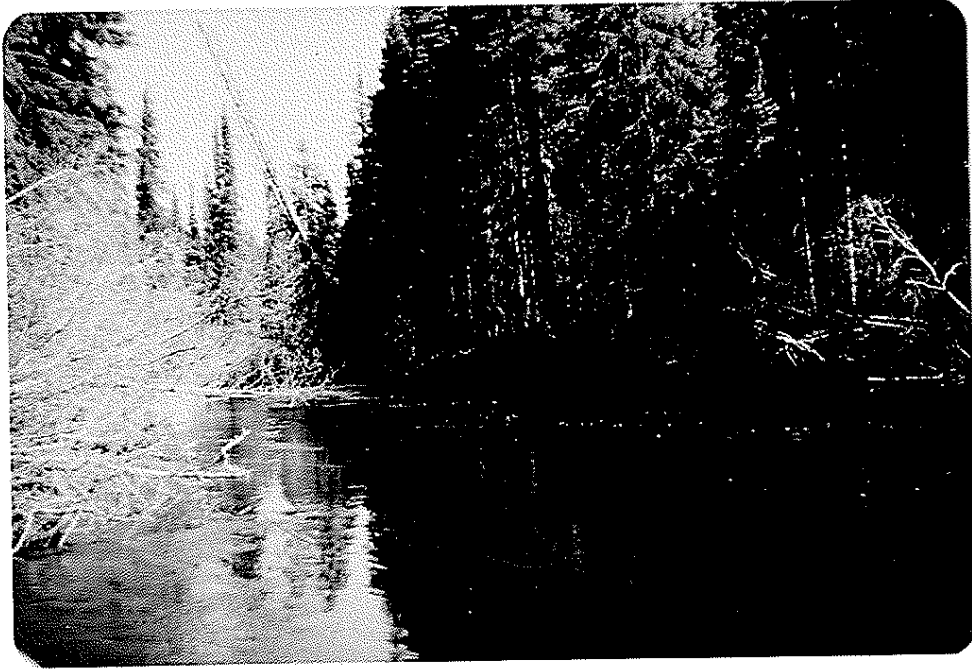
A 200 meter section of the reach below Dennis Lake contains some spawning-size gravel which is likely utilized by cutthroat, coho and Dolly Varden (Photo 20). All three species were found here (Table 10).

Photo 20. June, 1978. Top end of reach E immediately below Dennis Lake. Point sample #11 done here and Dolly Varden captured. Deep, slow-moving flow typical of reach.

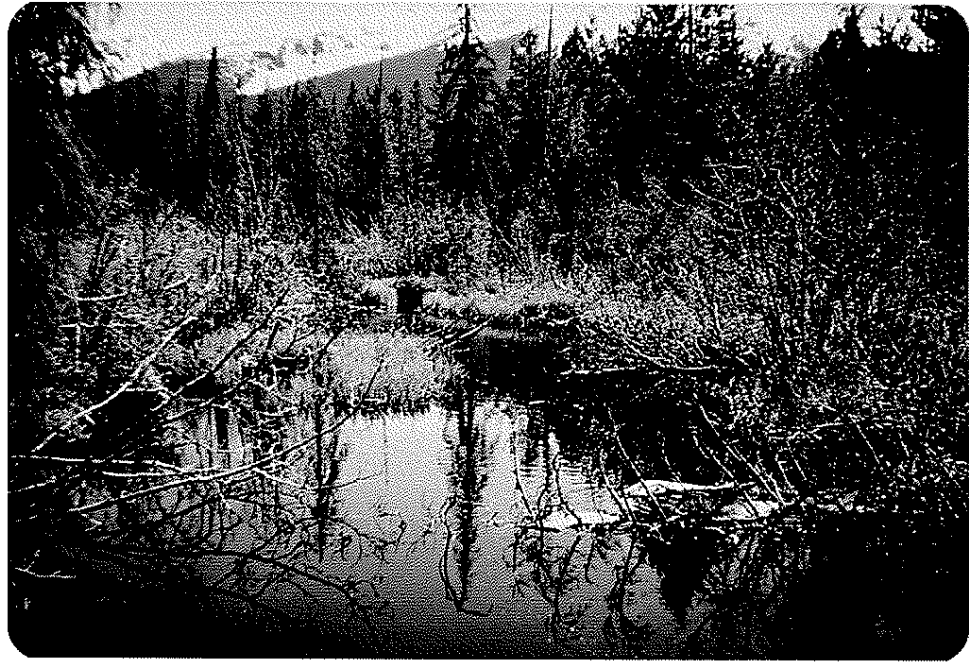
Photo 21. June, 1978. Beaver pond in reach F could provide good rearing habitat for Dolly Varden, coho and cutthroat trout.

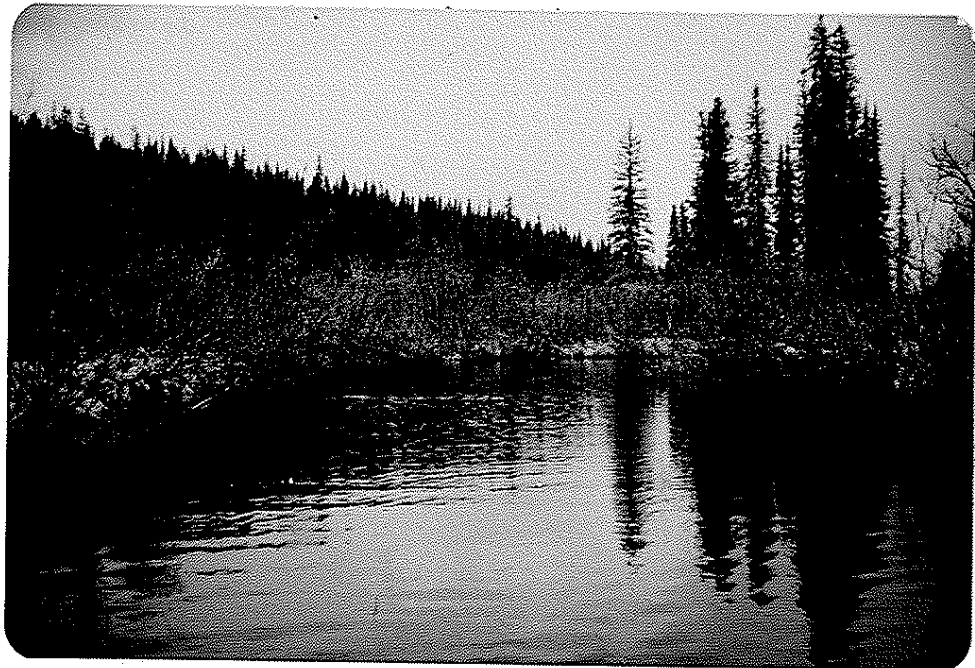
Photo 22. July, 1978. The Zymoetz River in the lower section of reach F is slow-moving and deep. Riparian vegetation is typically a continuous dense cover of grasses and sedges.

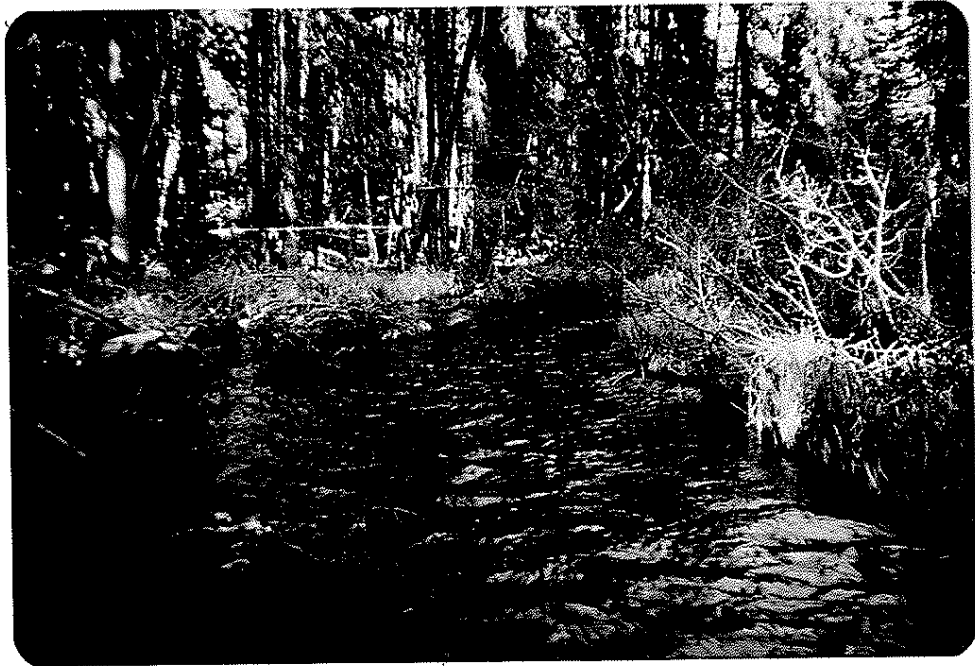
Photo 23. June, 1978. Reach G of the Zymoetz is mainly shallow riffle with large angular gravel substrate.

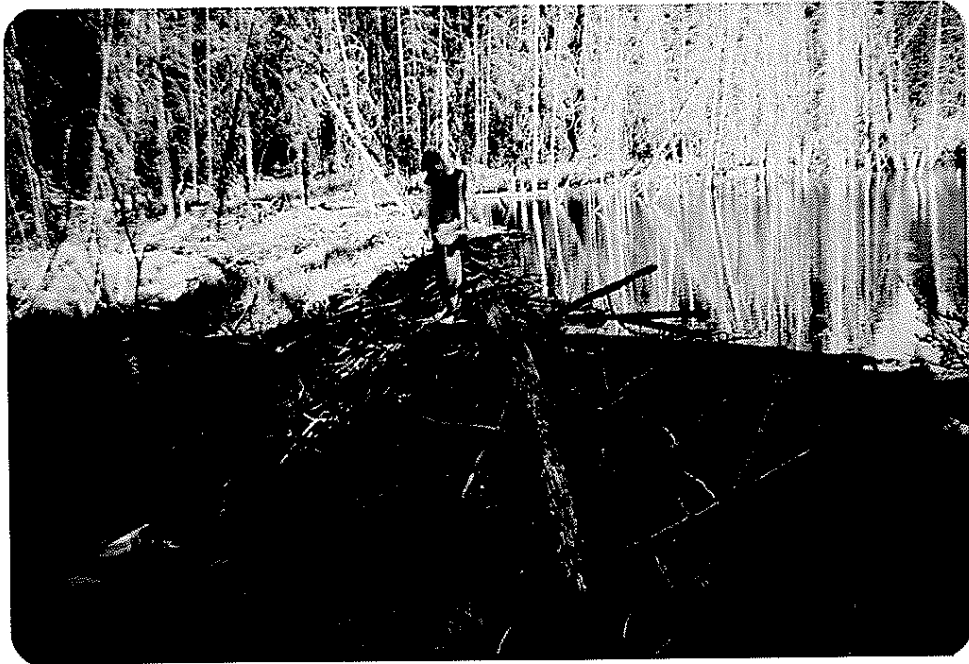
Photo 24. July, 1978. The flow from Aldrich Lake is obstructed by a two meter high beaver dam. This dam also presents a barrier to cutthroat trout.

Removal of the beaver dam at the outlet of Aldrich Lake. This may improve the substrate conditions by flush silt deposits and create spawning habitat for cutthroat trout.

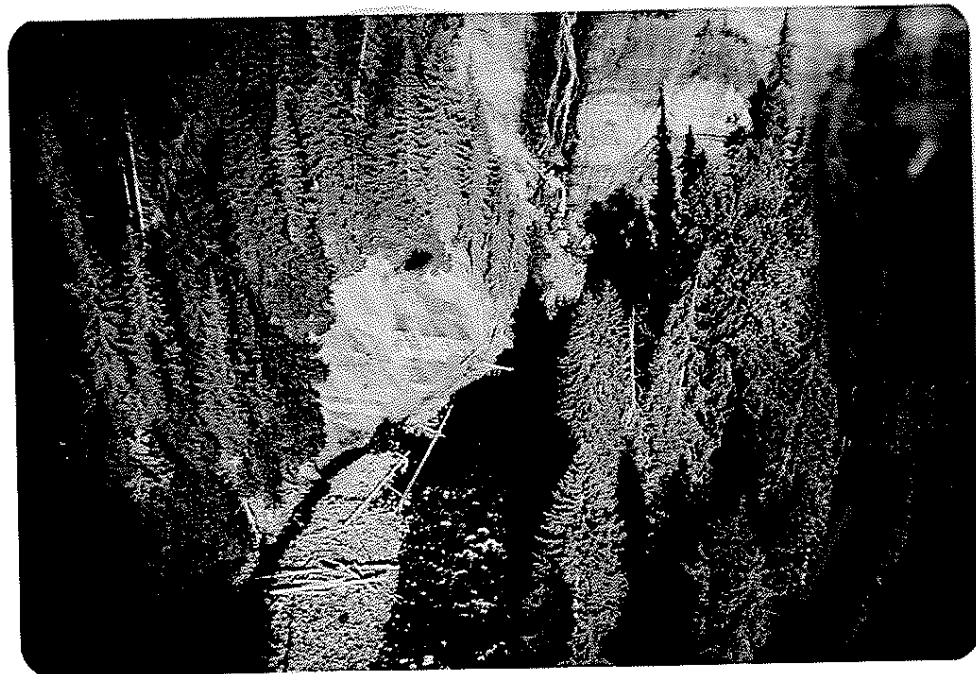
Photo 25. September, 1978. Reach 1 of Red Canyon Creek is characterized by steep canyon walls, tumbling flow character and boulder substrate.

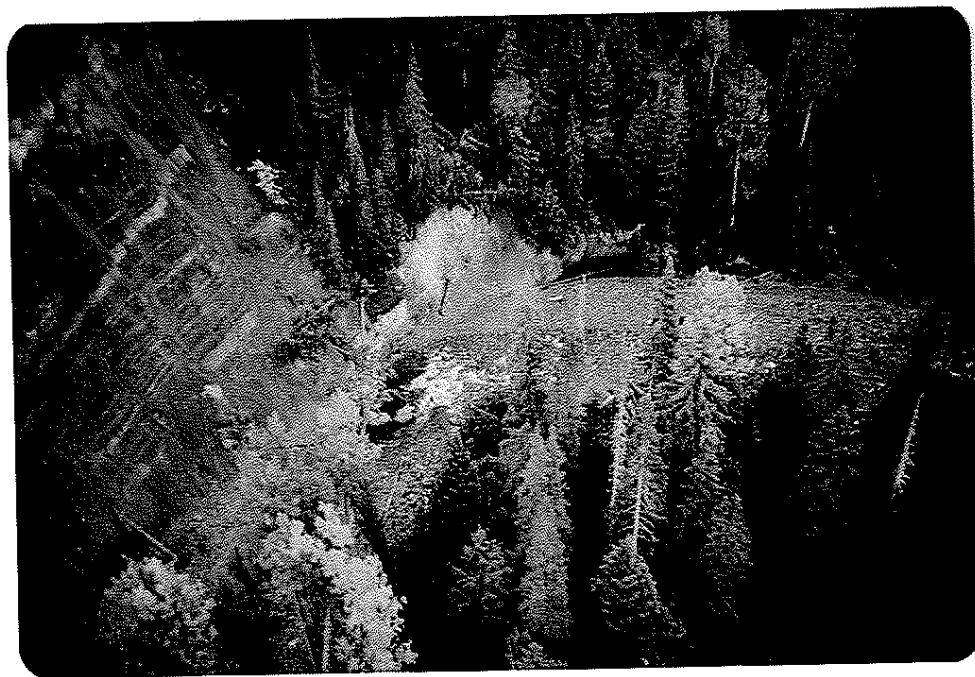
Photo 26. September, 1978. Slumps are frequent throughout reach 1 of Red Canyon Creek.

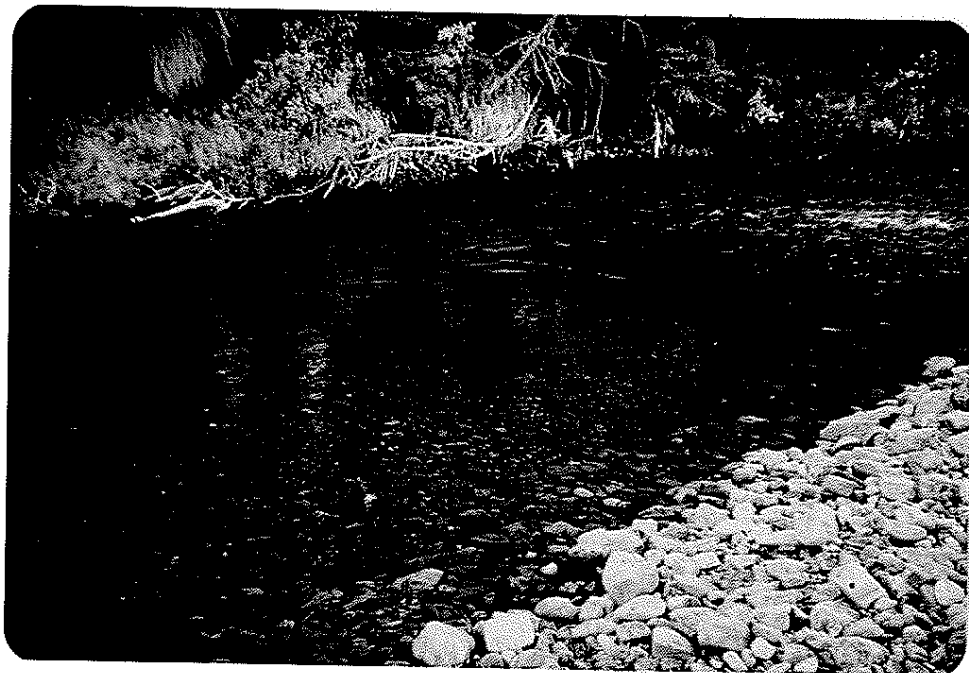
Photo 28. September, 1978. The substrate in reach 2 of Red Canyon Creek is mainly gravel but the low water temperatures limit spawning potential.

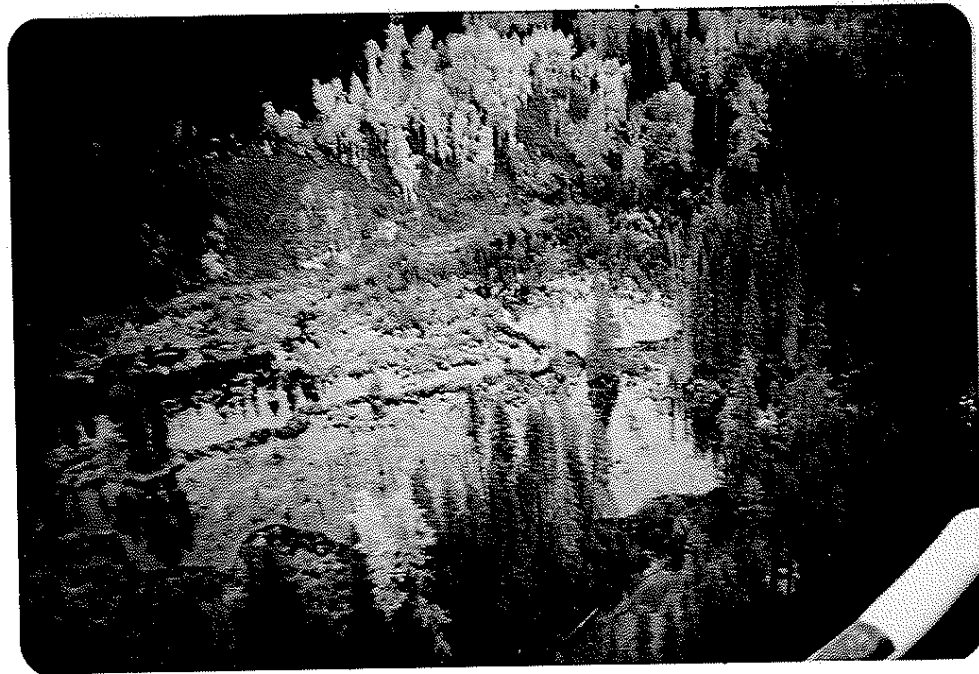
Sandstone Creek was flown in June. Very low water levels make this system unsuitable for steelhead habitat. A large beaver swamp is located at the mouth of Sandstone Creek (Photo 32). The creek supports a resident population of cutthroat trout.

Photo 32. September, 1978. Low water levels and the large beaver swamp obstructing the mouth of Sandstone Creek eliminate steelhead spawning habitat

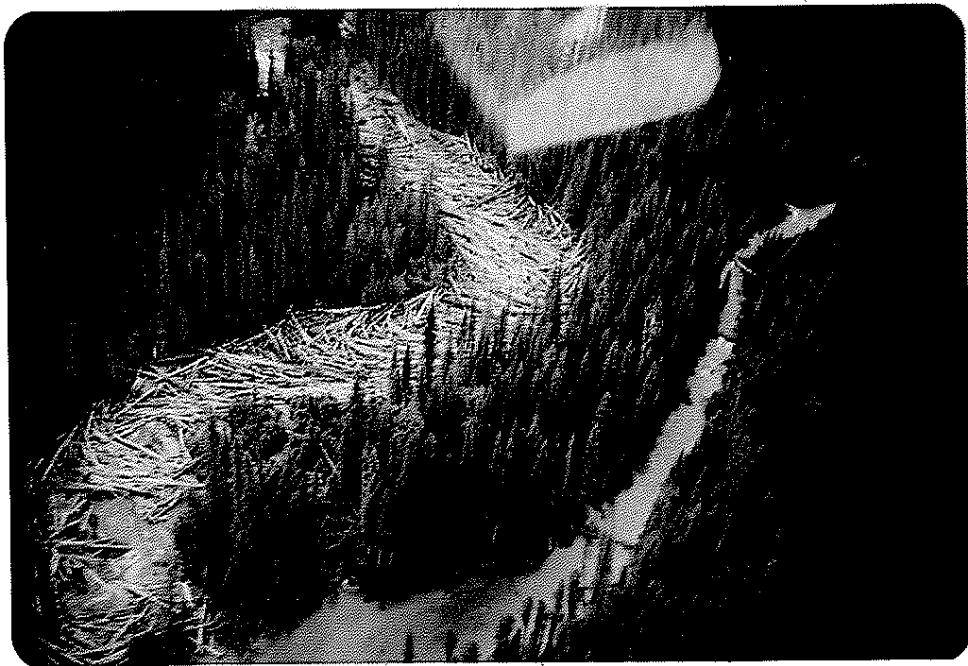
A log jam upstream from the mouth of Serb Creek has caused several small diversions of the main flow (Photo 34). The diversions indicate some instability in the lower end of Serb Creek (Photo 35). An increase in the flow through these diversion channels may result in a reduction of the quality of the large steelhead spawning areas on the Zymoetz (Figure 5, Photo 36).

Photo 34. June, 1978. This extensive log jam on the lower end of Serb Creek has caused several channel diversions.

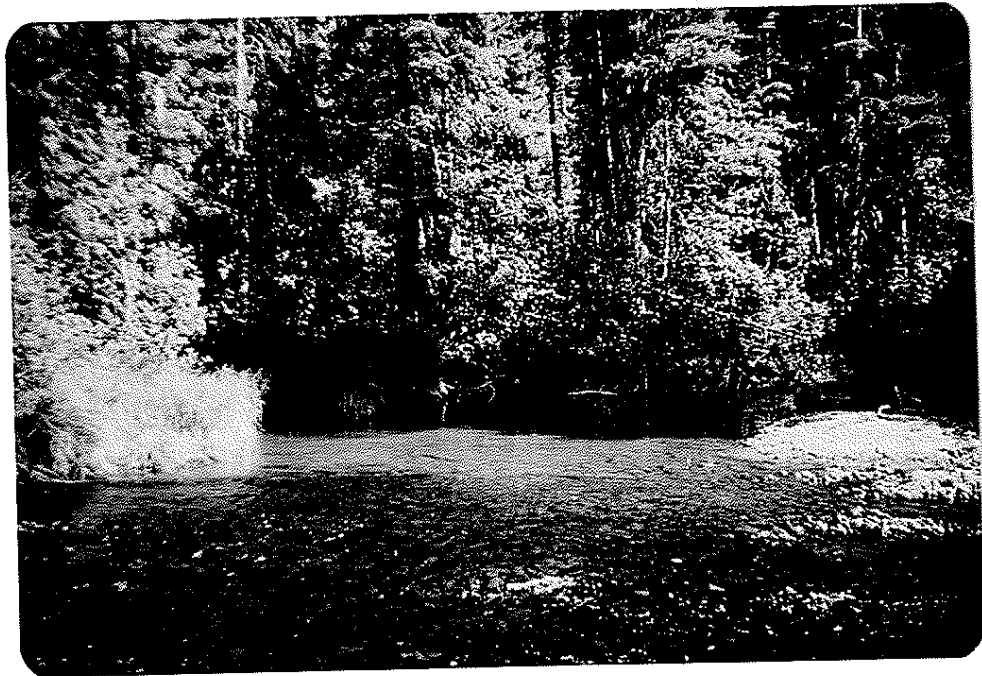
Photo 36. July, 1978. One of the small diversions from Serb Creek in the background. Note the difference in water colour. Temperature of diversion = 5°C ; Zymoetz River temperature = 11°C .

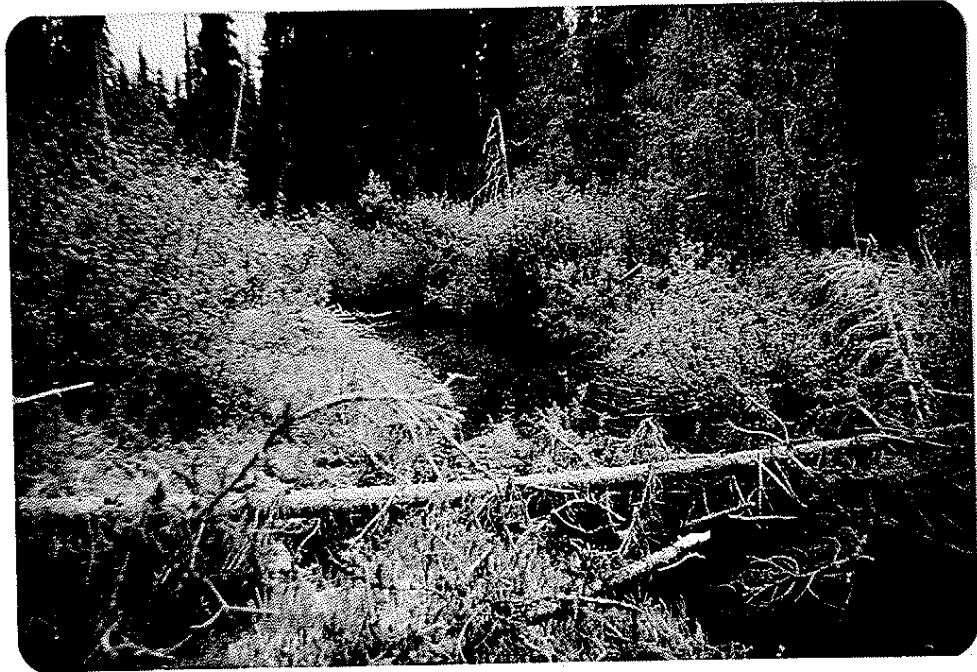
Photo 40. June, 1978. Old channel of Willow Creek. Beaver dam upstream has diverted flow. Note staining on willow, indicating previous high water levels.

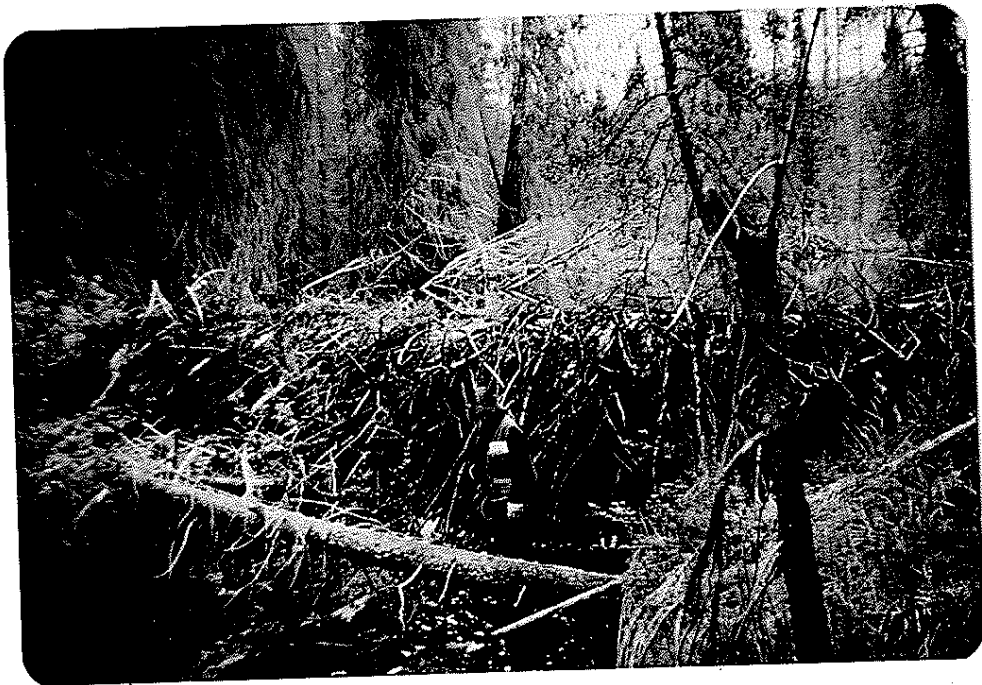
The second dam is two meters high with no breaks (Photo 41). Nearly an acre of land is flooded behind the dam. No fish were observed or captured in the pond and the dam is expected to be a barrier to upstream fish movements.

Photo 41. June, 1978. two meter beaver dam upstream of first dam. This is a probable barrier to anadromous fish.

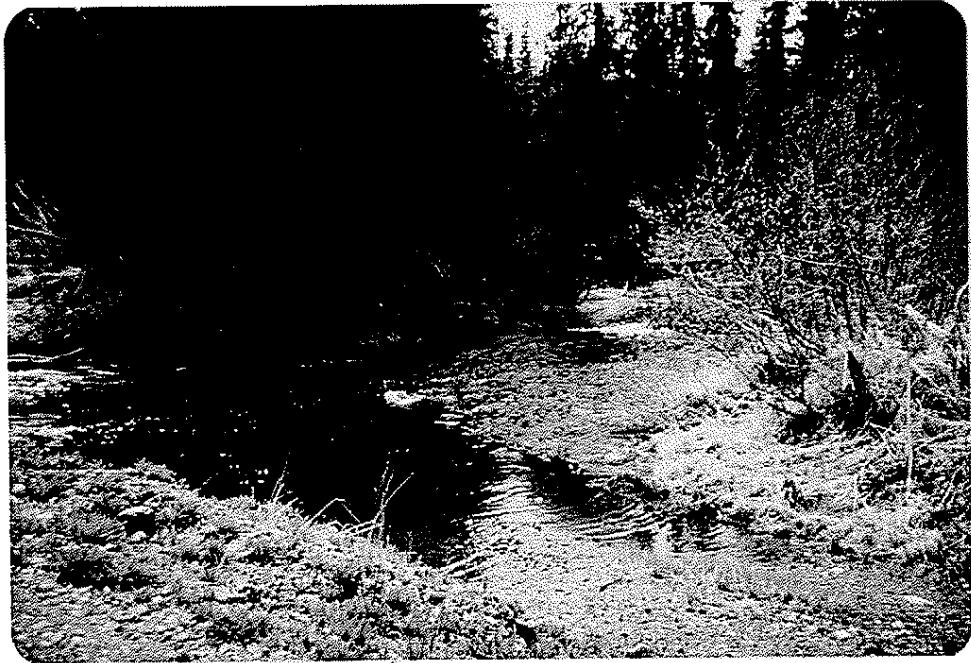
Photo 42. June, 1978. Willow Creek at road crossing. Vehicles frequently drive through creek. Cutthroat trout observed in pools at this point.

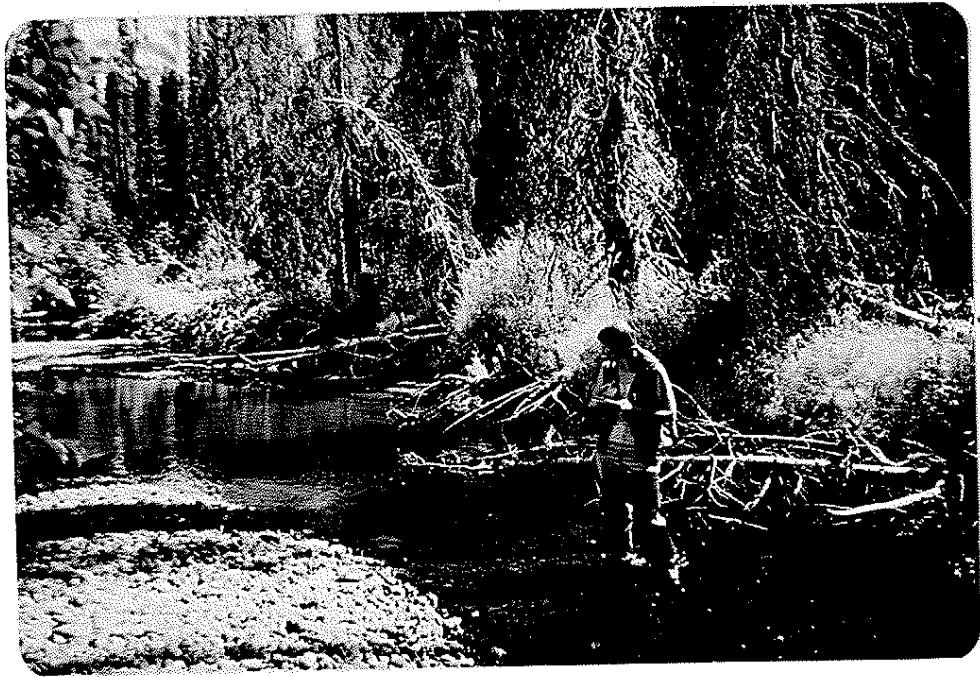
Photo 44. June, 1978. Old beaver pond in reach 3. Cutthroat trout spawning habitat available. Area subject to low flows due to upstream beaver dams.

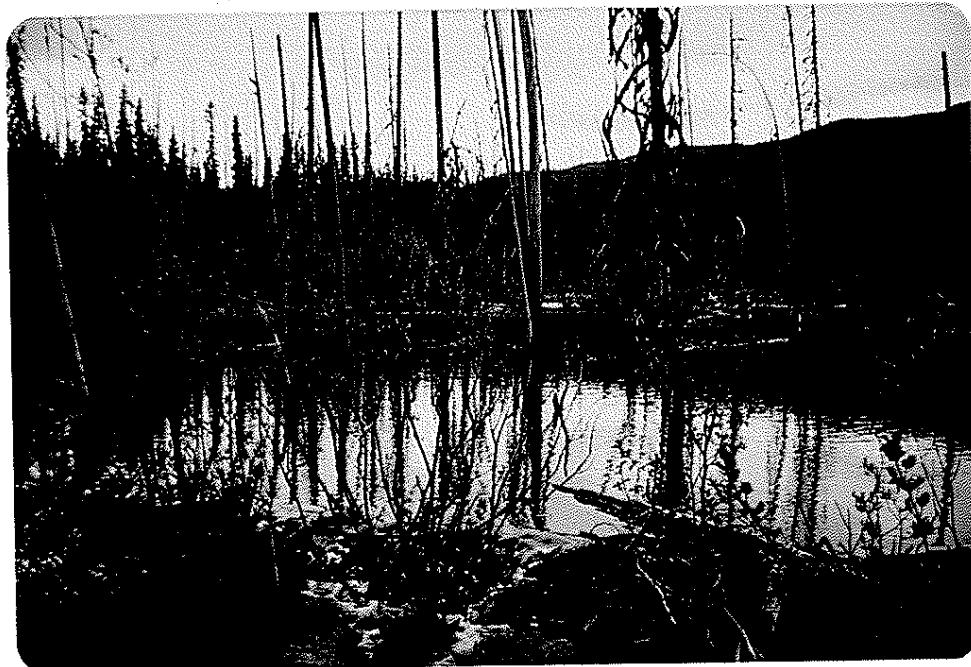
Photo 48. June, 1978. Reach 1 of Silvern Creek is a series of beaver ponds which are heavily silted. Numerous coho and Dolly Varden fry were captured in this area.

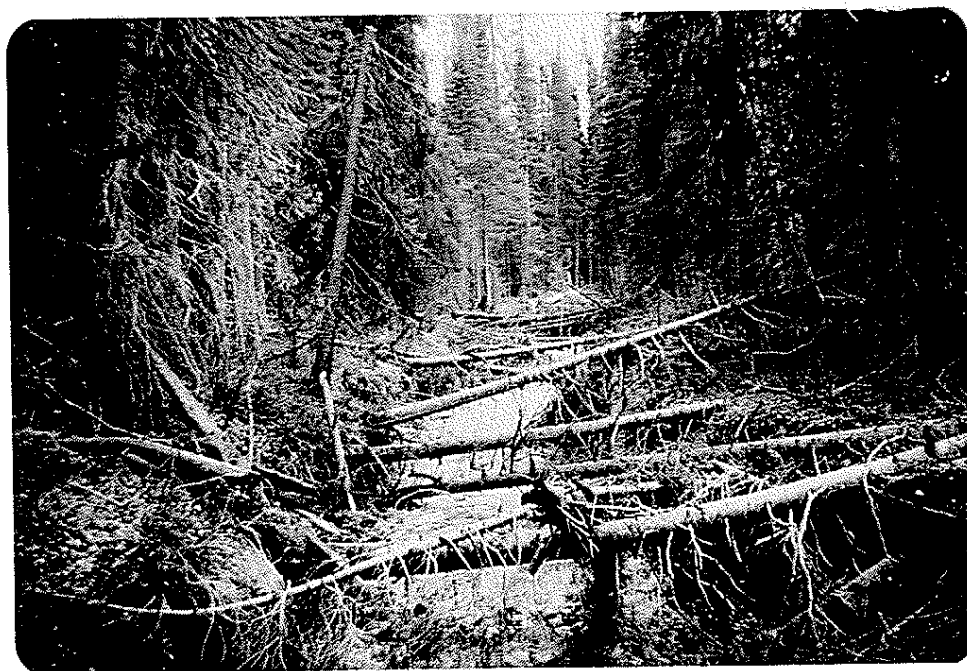
Photo 49. June, 1978. Debris in Silvern Creek obstructs flow in reach 2. Several coho carcasses were found in the log jams.

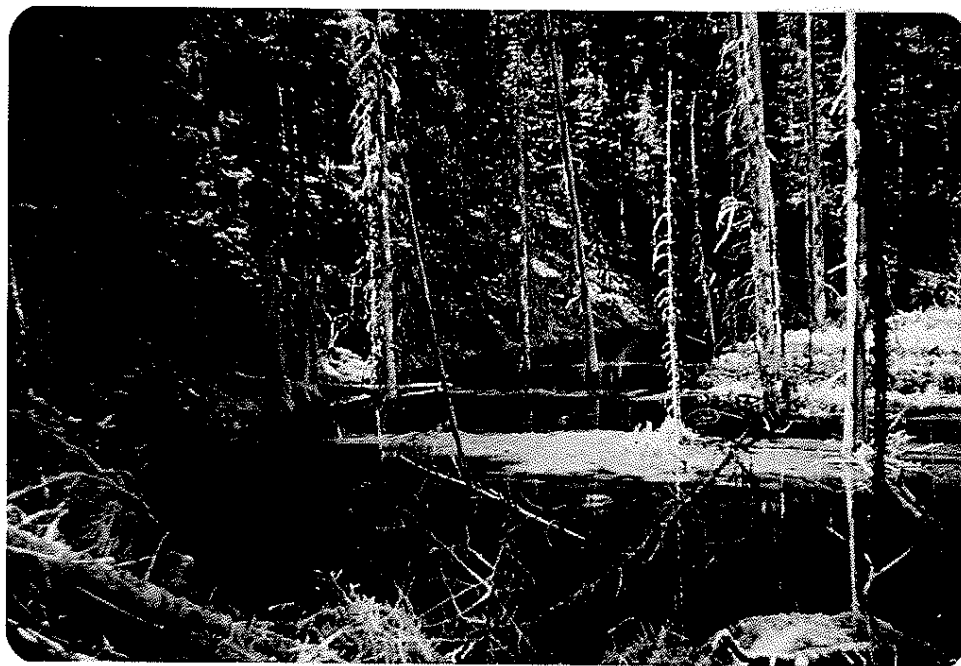
Photo 51. June, 1970. The lower pond above the road crossing supports many Dolly Varden and coho fry. No fish were observed above this pond.

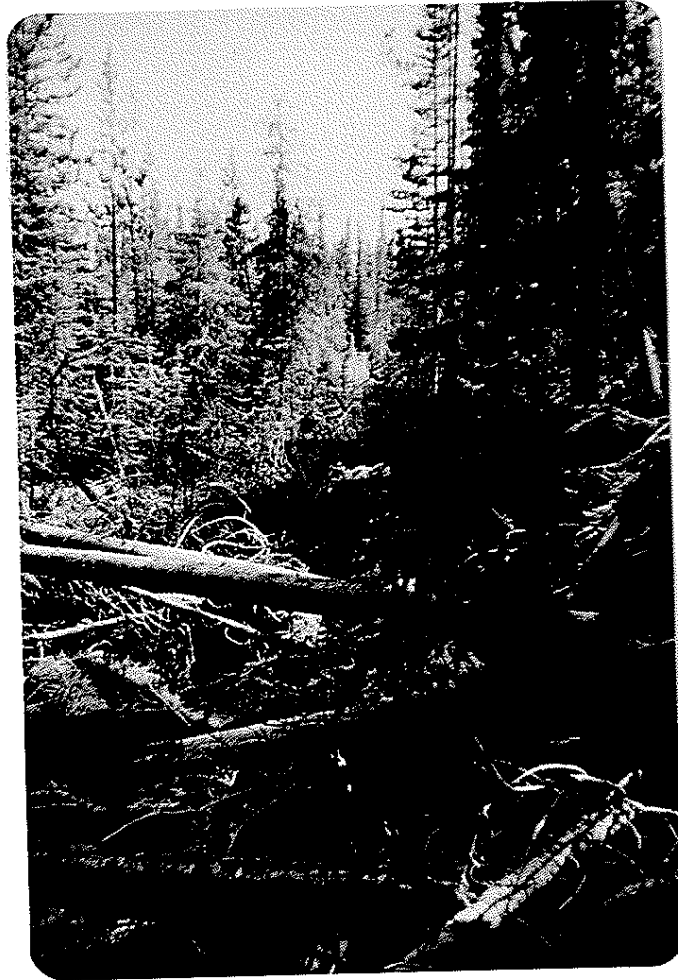
Photo 52. June, 1978. Silvern Creek above the beaver dam shows channel instability. Flow is obstructed by debris accumulations.

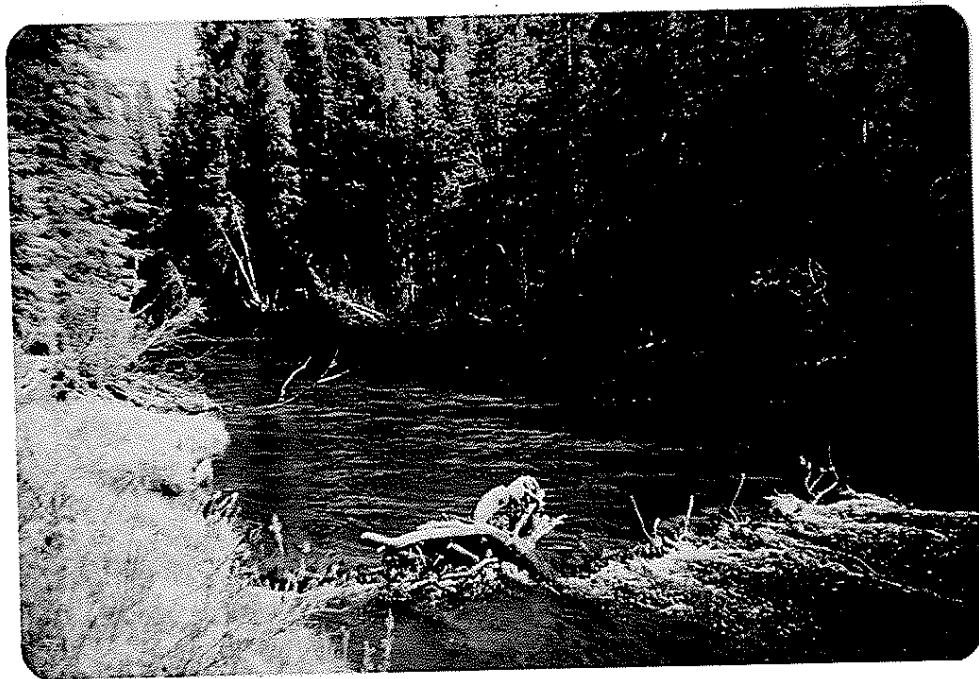
Point sample #8 on the Zymoetz above
Passby Creek. Note recent beaver activity.
June 1978.
