**Enumeration of Adult Steelhead in the  
Upper Sustut River 1998  
Appendix Report 1  
Fence Modifications**

Skeena Fisheries Report SK 121

March 1999

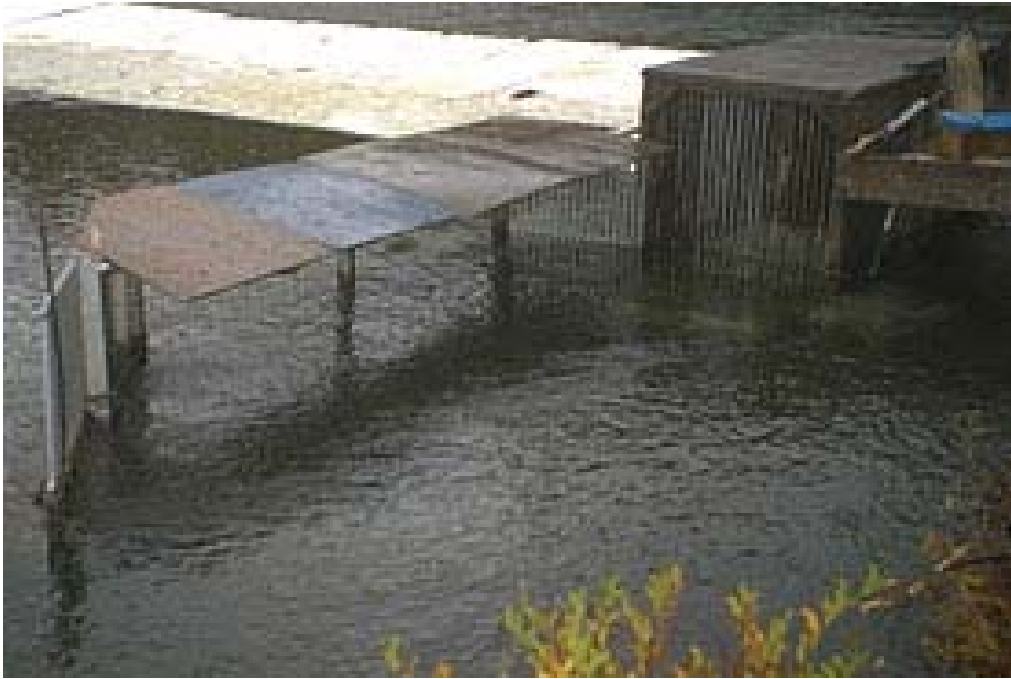
Several modifications to the fence trap box and holding area were made in 1998 to reduce repeat downstream swimming behaviour of handled fish. It can be assumed that for most fish entering the fence trap-box, the objective is to continue to migrate upstream after passing the fence. Fence personnel have observed that handled fish tend to look for holding areas to rest in before continuing migration. On the upstream side of the fence there is very little effective cover for at least 200 meters. Fish handled at the fence have three options: a) to hold under the trap deck or in front of the trap box, b) to swim upstream to look for cover c) to swim downstream to the deep pool below the fence. Prior to 1998, most fish chose to swim upstream or downstream. Fish swimming downstream most often became stranded on the fence and had to be rescued. Fish repeating this behaviour three times were released downstream to recover. For the 1998 field season, a covered holding area was constructed in the deeper water immediately in front of the trap box (Photo Figure 1). In 1997, over ten percent of the steelhead released upstream of the fence had to be

Photo Figure 1. View of holding area and the front of the trap box look downstream from the right bank.

rescued and approximately five percent had to be released downstream. In 1998 after constructing a covered holding area only three steelhead had to be released downstream. The main holding area in front of the trap box was constructed around a scour depression in the streambed immediately in front of the trap box. In previous years a section of the old upper Sustut fence was used as a lead in front of the trap box. For 1998, a 1.2 m x 1.5 m section of aluminum panelling from Babine River fence was used to extend the width of the holding area toward the river left bank (Photo Figure 2). A set of 0.6 m x 1.2 m wide panels from the Babine fence was added to the upstream end of the lead and angled toward the river right bank (Photo Figure 1). To support a plywood cover for shade, an aluminum pole was fastened to the trap box and to the top of the angled panels (Photo Figure 2).

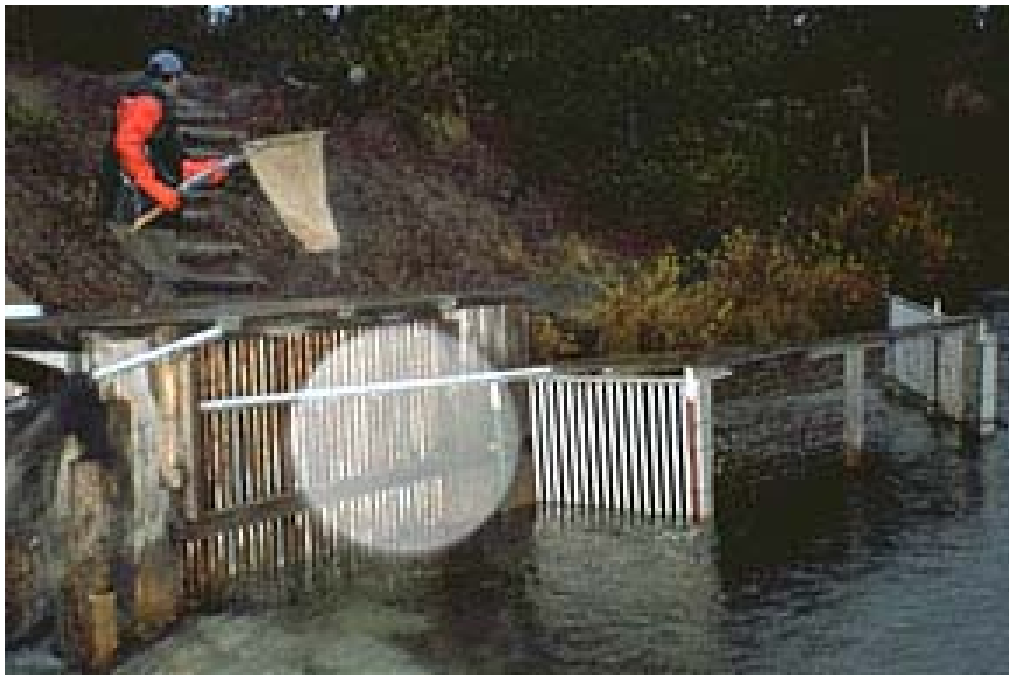
Photo Figure 2. View of the downstream end of holding area and left side of the trap box looking upstream towards the right bank. Note the 1.2-m wide aluminum panel in the center of the photo.

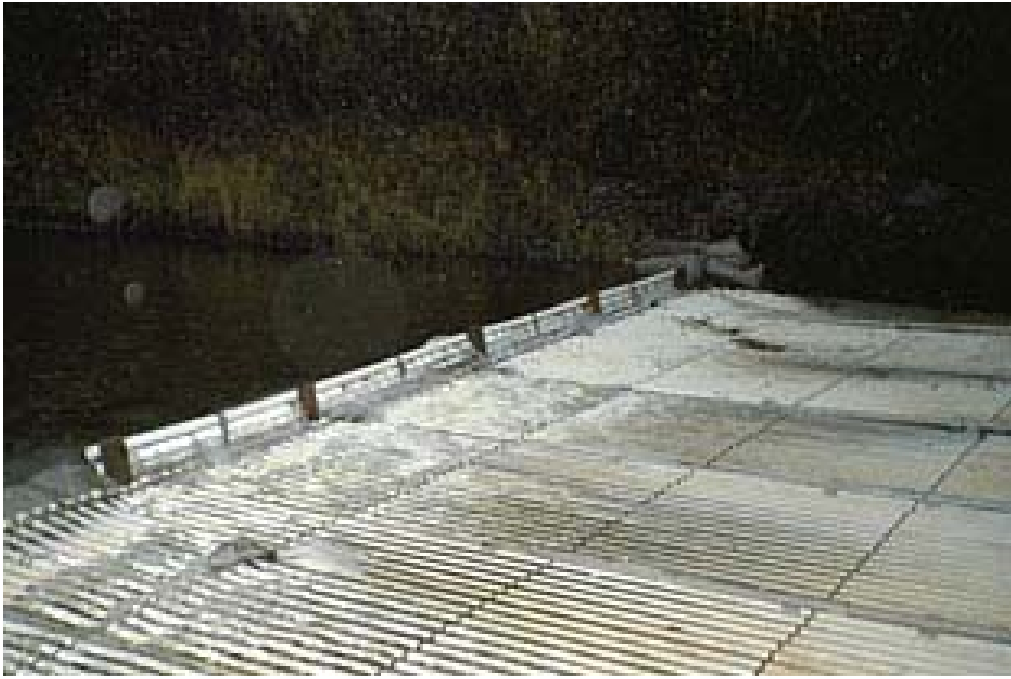
Seven out of ten steelhead mortalities at Sustut fence in 1997 were healthy fish that became stranded overnight on the river left side of the fence in low water (Williamson 1998). Williamson, recommended that a baffle-like device should be installed on the upstream leading edge of the fence in low water to prevent these mortalities. During the field season in 1998 fence personnel built and installed a baffle on the river left side of the fence (Photo Figure 3). There were no mortalities of healthy steelhead observed after installation of the baffle. The baffle was constructed from three 20 foot sections of 3.8 cm diameter PVC pipe that was attached to five approximately 40 cm lengths of 2" x 4" lumber. The pipe was attached using 2 inch hose clamps that were screwed on to the 2" x 4" with wood screws (Photo Figure 4). Duct tape was used to tape the pipes together between the 2" x 4"s for added strength. The 2" x 4" supports were wedged on end between the upstream edge of the fence panels and the steel railway rail on the streambed. The baffle was placed flush against the fence panels and sandbags were placed to block any gaps. One section of baffle was sufficient to prevent strandings in 1998; however, another section may be needed if the river falls to the levels recorded in 1997.

Photo Figure 3. View of low water baffle system. Note the lack of water on top of the panels.

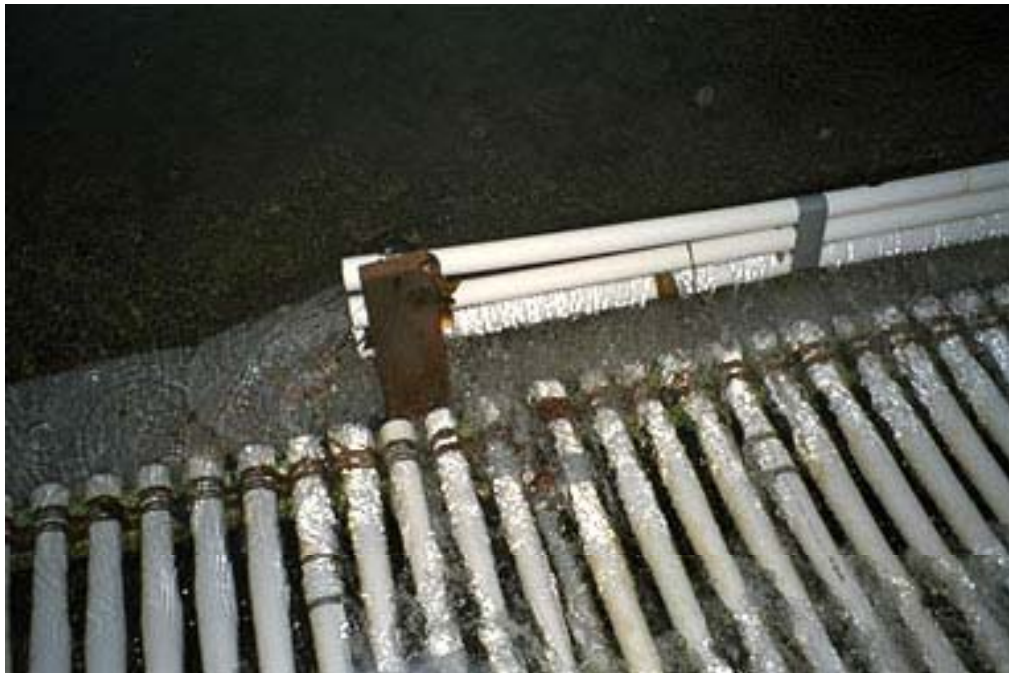
Photo Figure 4. Close-up, showing the baffle raised up off the panel. Note the 2x4 wood and the duct tape holding the P.V.C. pipes together.

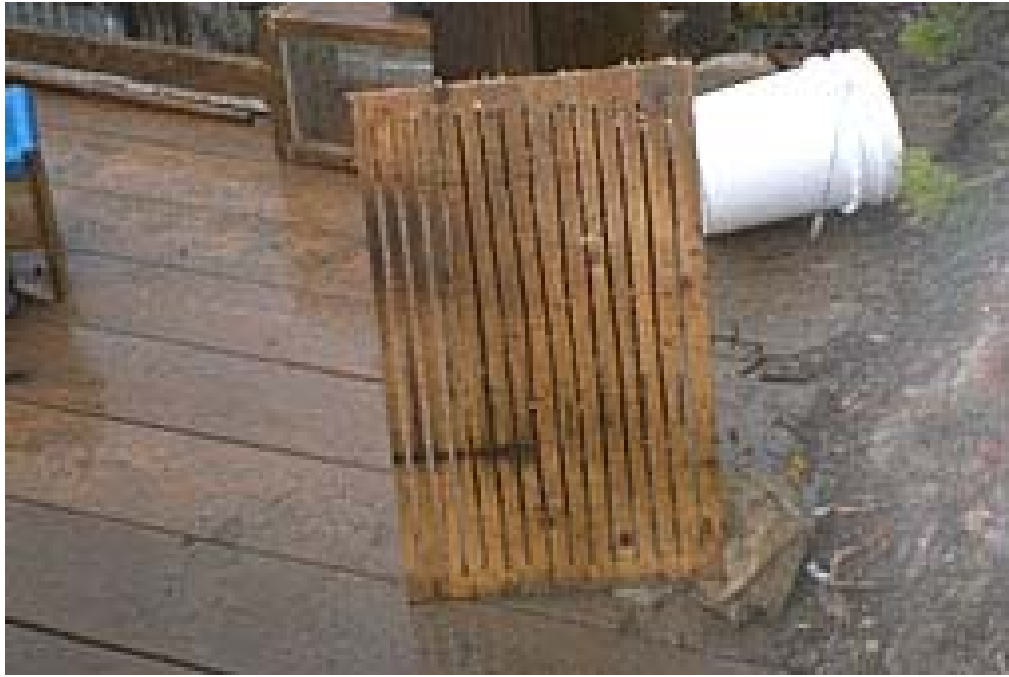
During operation of the fence in 1997 and 1998 eleven bull trout died in the Sustut fence trap box. Most of these fish would enter the trap box in the late evening and after dark. Mortalities would occur presumably because the fish would tire and slide backwards (downstream) and become 'gilled' in between the dowels in the rear of the trap box. The dowels form a 'vee' shaped opening into the trap box and are designed to prevent the escape of fish migrating into the box once they are in the box. A set of two plywood panels with 6-mm wide vertical slots were used to cover the upstream side of the dowels while allowing the passage of fish upstream into the box (Photo Figure 5). Further evaluation

Photo Figure 5. Slotted plywood panel.

of the effectiveness of the panels must be undertaken in future years. In 1998 the plywood panels were only used for the last four days of fence operation.

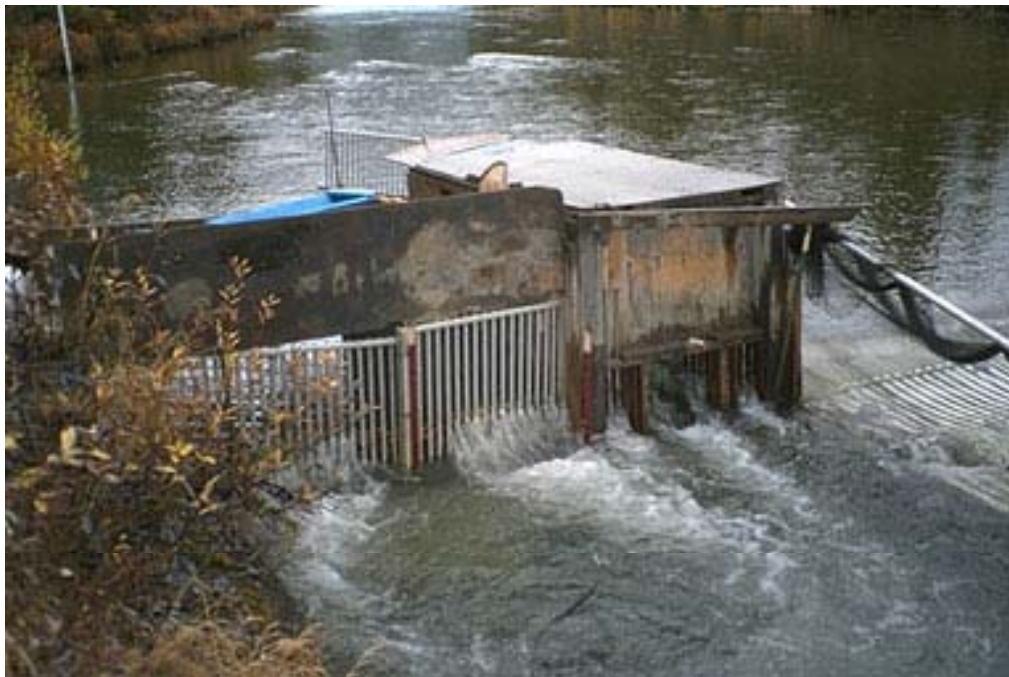
3. A piece of plywood was used to extend the height of the panels between the trap box and the right bank. Fish frequently attempted to jump over the panels. Without the plywood extension they would have easily escaped upstream uncounted (Photo Figure 6). On several occasions after installation of the board, sockeye and steelhead were observed attempting unsuccessfully to jump over the panels.

Photo Figure 6. View of downstream end of the fence trap box showing aluminum panels between the trap box and the right bank.

1. Personnel operating the fence in 1996 recommended replacement of the 2x4 and chicken wire panels used to block fish passage between the trap box and the right bank. The chicken wire panels were difficult to clean and often injured fish. In 1997, the chicken wire panels were replaced with aluminum panels (Photo Figure 6). Debris was more easily removed and fish that came into contact with the panels were less likely to be injured.

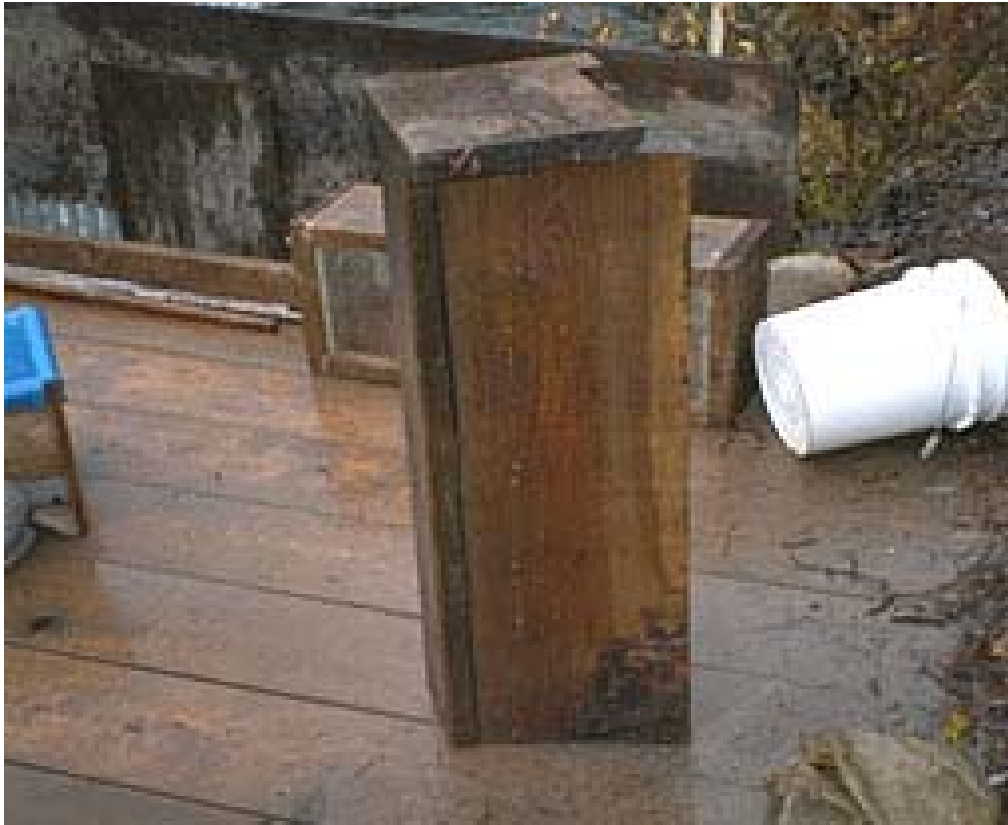
4. Metal doweling was originally used to block the 'vee' entrance of the trap box to prevent fish from escaping while they are being netted out of the box. Typically three or four dowels were used to block passage. Placing the dowels was cumbersome, especially in high turbid water and fish often escaped downstream. In 1997, a shroud was built that could be used to block the trap box entrance rapidly in one motion while minimising downstream escapees (Photo Figure 7).

Photo Figure 7. View of trap box shroud sitting on top of the fence work deck.  
Note the acrylic bottomed viewing box behind the shroud.

5. During rain events, run-off from the Omenica Mining Access Road enters the Sustut River. The increased turbidity of the river during these periods prevents visual observation of fish captured in the trap box. Fish in the trap box often have to be netted out in order to facilitate correct species identification. To reduce stress on the fish caused by handling in nets, an acrylic bottomed viewing box was constructed in 1997 to help fence personnel identify fish in turbid water (Photo Figures 7, 9). The box was made from a 2" x 12" lumber frame with a 3-mm thick acrylic plastic bottom.

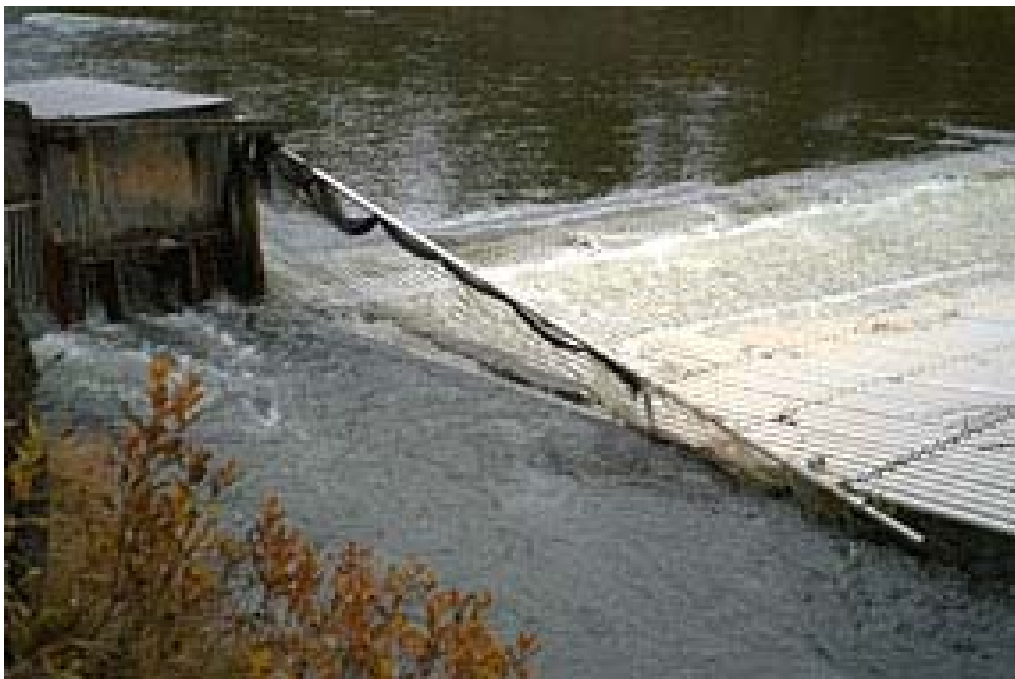
6. During a high water event in 1997, the netting used to block fish passage on the panel beside the trap box became extremely clogged with debris. The netting did not have anything holding it up vertically out of the water, which allowed it to become completely blocked. After the water receded an aluminum pole was added as a support to keep the net more out of the water preventing excessive debris accumulation (Photo Figure 8).

Photo Figure 8. View from right banking of aluminum pole holding up panel netting.

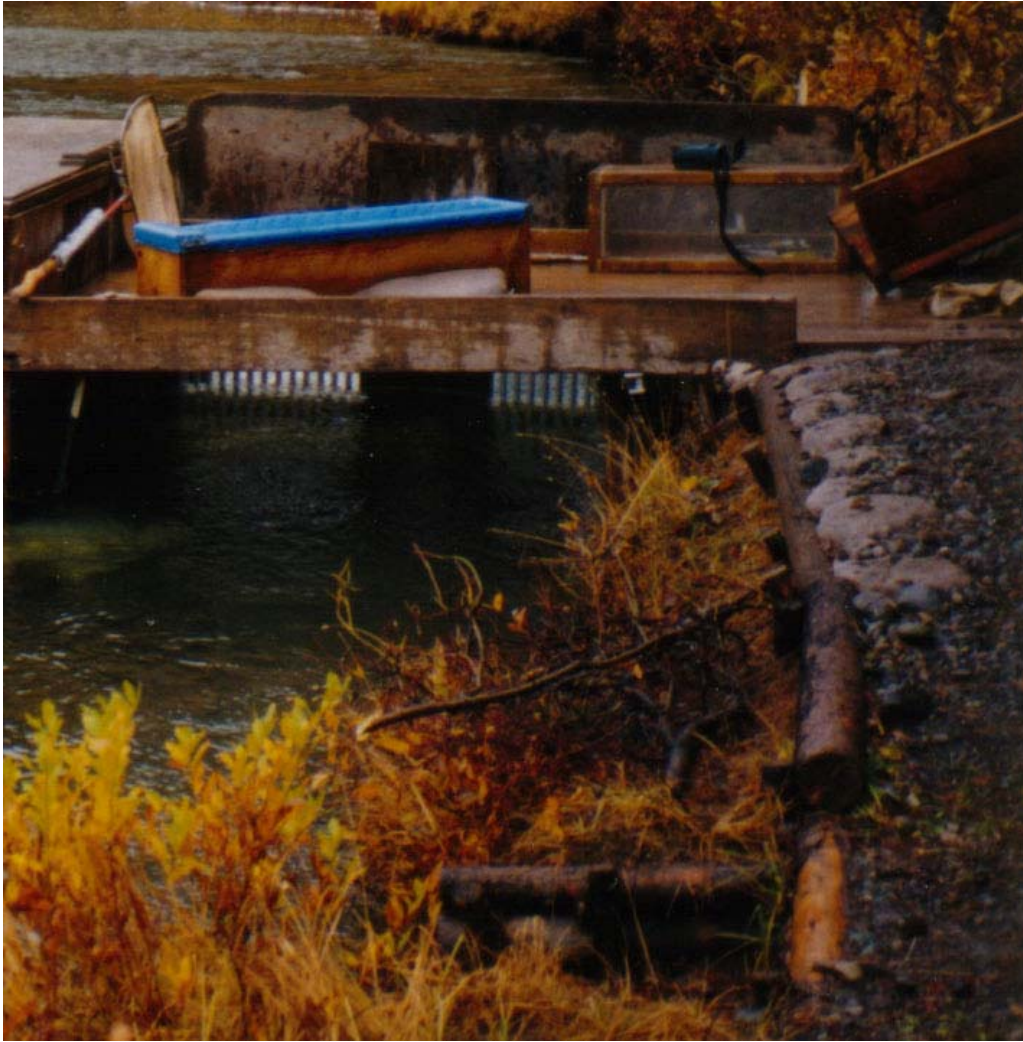
10. During the 1997 field season fence personnel noted that several years of activities around the fence had killed some of the vegetation along the right bank. The bank area immediately above the fence trap box was destabilised and was beginning to slough into the river. A walkway was built along the bank using sandbags, small logs and gravel to minimise future bank disturbance as well as to correct the existing problem (Photo Figure 9). Willows and other streamside vegetation were also planted in an effort to stabilise the bank. Sandbags were placed in the water along the right river margin to decrease undercutting.

Photo Figure 9. View of the right bank looking downstream towards the trap box deck. Note a) the blue foam lined measuring tray; b) the viewing box (top right); c) efforts to improve bank stabilisation around the fence working areas.
