INVESTIGATION OF SOIL AND GROUNDWATER CONDITIONS ON
A PROPOSED SUBDIVISION AT 34648 DANN AVENUE, HATZIC, B. C.
DISTRICT OF MISSION SUBDIVISION APPLICATION S89-07

PACIFIC HYDROLOGY CONSULTANTS LTD.

APRIL 18, 1989

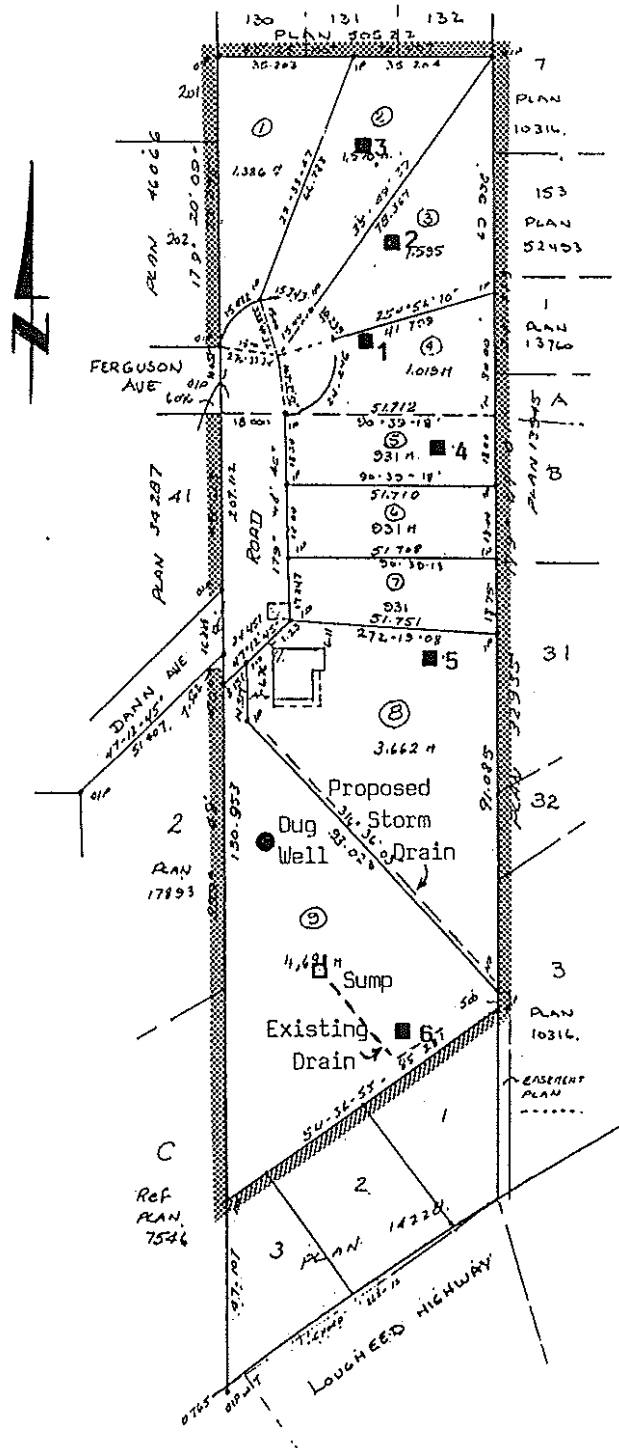
FIGURE 2

excavated in 1981 for a study carried out by Hardy Associates (1978) Ltd. partly to assess the feasibility of using rock pits for stormwater disposal. We have accepted the descriptions of the soil conditions in these pits and we have informed Hardy Associates that we are doing so. Three additional test pits were dug for the investigation covered by this report. The locations of all of the test pits are shown on Figure 2 in Appendix A and the descriptions of the soil profiles are contained in Appendix B.

Test pits one to five show that there is a minimum of 1.6 m (5.2 ft) of unsaturated sediment on the upper part of the property where the wastewater disposal facilities for eight of the lots would be located; therefore such facilities, which are located in a recharge area for local groundwater flow, are expected to perform satisfactorily assuming that they are properly constructed and maintained.

Conditions on the large south lot (9), as shown by Test Pit 6, are quite different. We understand that, because of access, a house on this lot must be located at the north end of the lot. Since there would then be little area remaining at the north end, the disposal field would probably be located on the south part of the lot. As shown on Figure 2 in Appendix A, Test Pit 6 on the lower lot is located in an area of lawn east of the drainage sump and at a slightly higher elevation. At the time we inspected the pit, it had

been open and undisturbed since the previous day; therefore, the water level in the Pit, which was at a depth of 1.4 m (4.6 ft) below surface is believed to represent the water table elevation. However, colour mottling extended above the water level up to about 0.9 m (3.0 ft) below surface indicating that water has repeatedly risen to this level in the past. It was not possible to see the material below the water level but an inspection of the spoil from the Pit indicates that it is probably a very silty grey gravel or perhaps a gravelly till. The experience with the dug well indicates that water is probably discharging from it.

TEST PIT LOCATIONS ON VOSBURGH PROPERTY
AT 34648 DANN AVENUE, HATZIC, B. C.

1. Ensure that all wastewater disposal facilities are constructed to the highest standard and are properly maintained.
2. To deal with the shallow groundwater conditions encountered on the lower part of Lot 9, locate the drain field east of Test Pit 6, close to the east boundary. Before installing the drain field, dig a test pit at the proposed site of the field to check for the presence of shallow groundwater and, if necessary, move the field a short distance upslope.
