PACIFIC HYDROLOGY CONSULTANTS LTD.
CONSULTING GROUNDWATER GEOLOGISTS

July 19, 1989

Subject: Water Supply Alternatives for Timberline Ranch North
of Haney, B. C.

TIMBERLINE RANCH AREA LOCATION MAP AND SITE PLAN

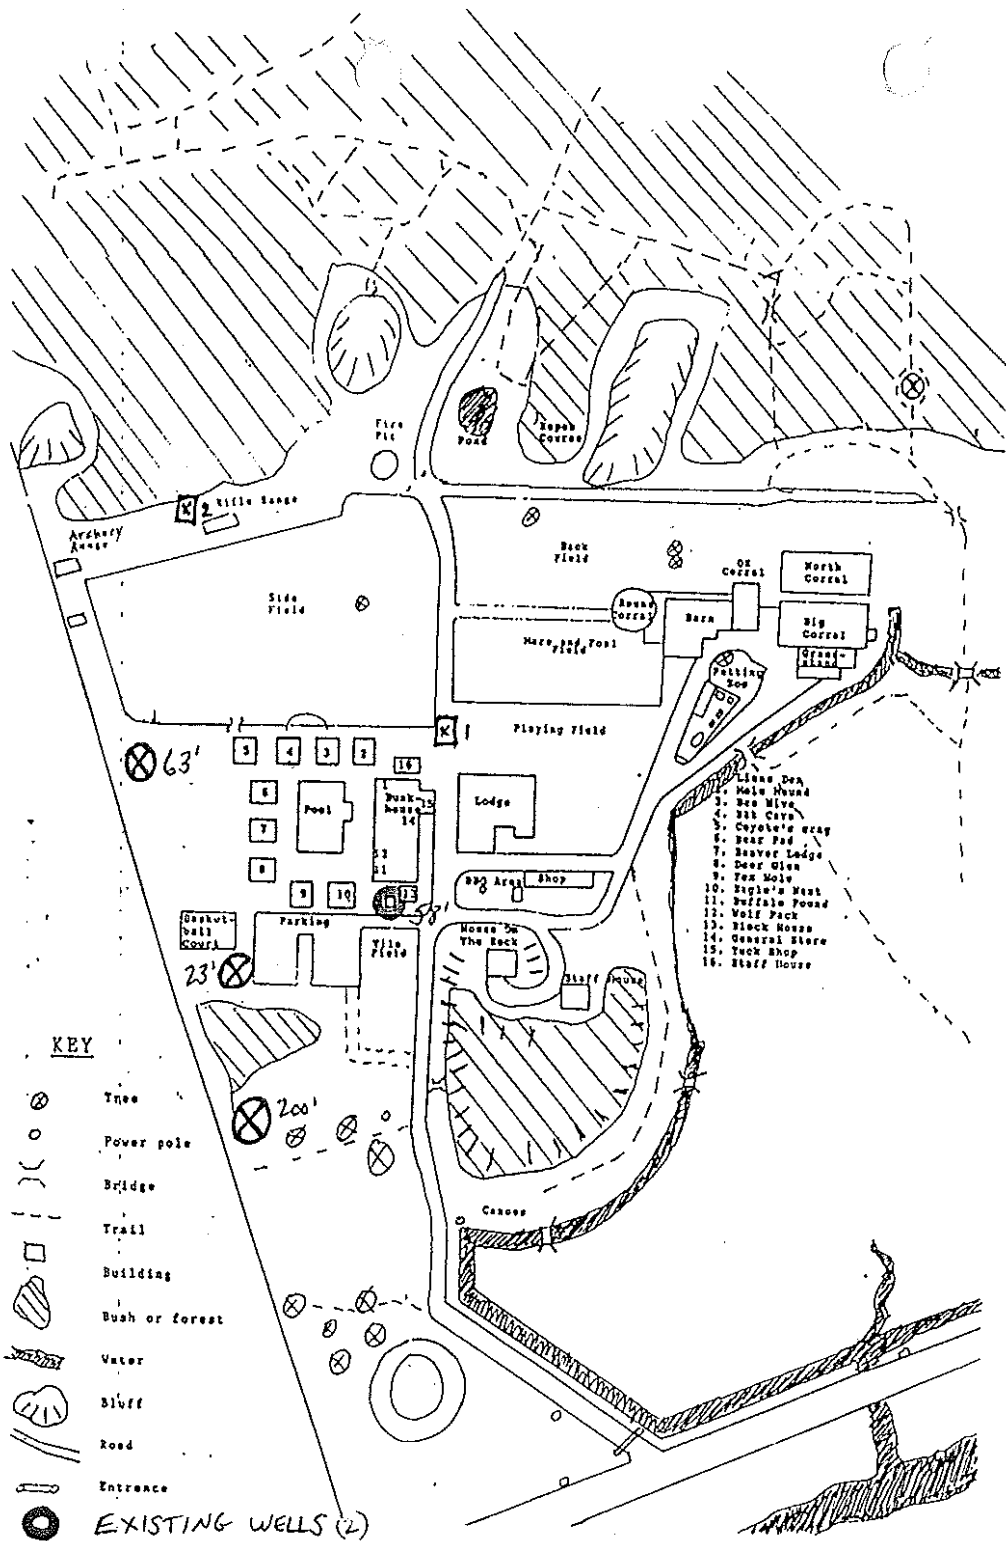
FIGURE 2

EXISTING WELLS (2)

DRY WELL HOLES

WELL ONE - GOT SULPHUR WATER (MANY YEARS AGO)

SPRING - STILL RUNNING BUT NOT NEAR AS MUCH AS IN PAST.

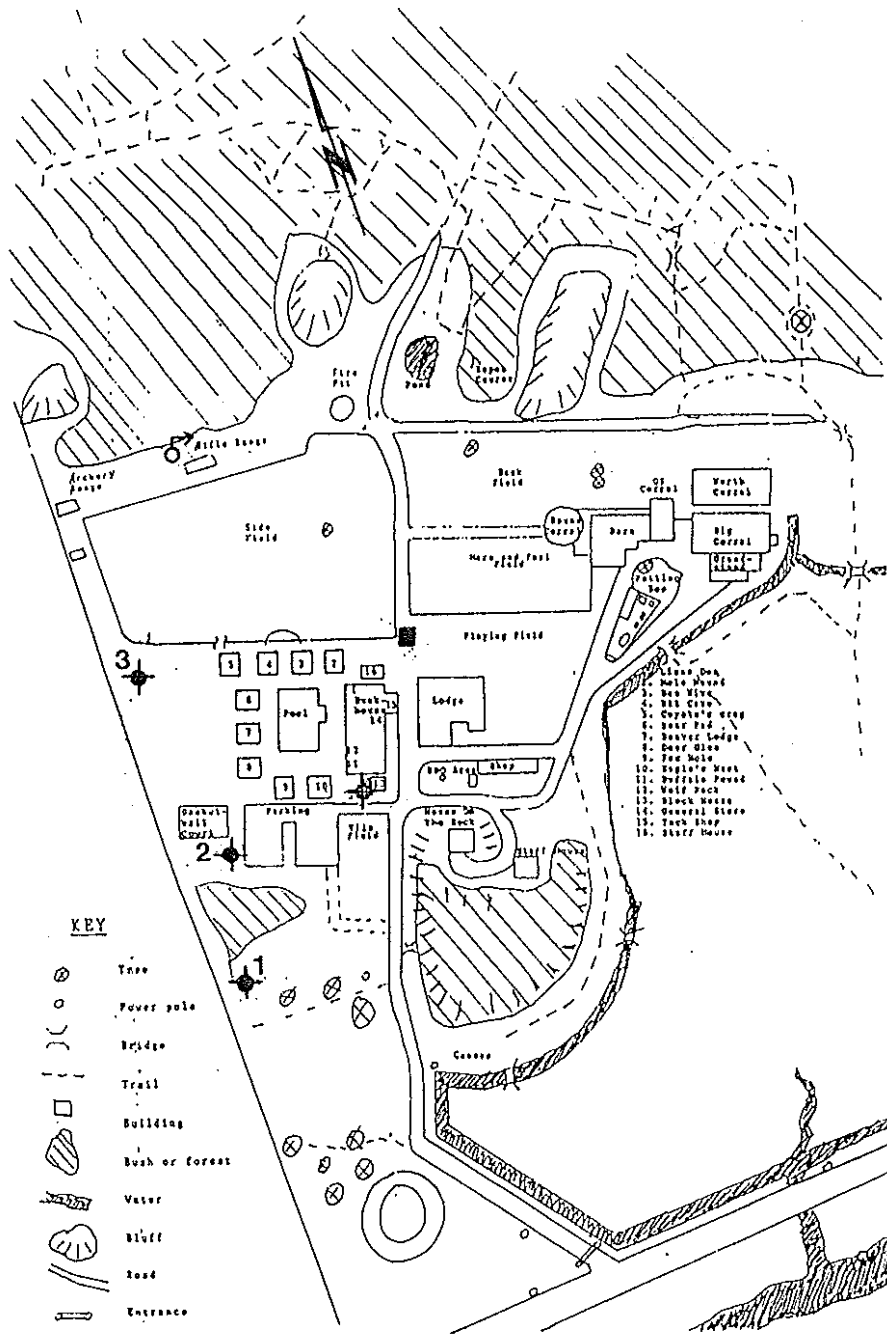
1. ⊕ designates the location of the existing drilled wells.
2. ⊕ designates the approximate location of a 1989 unsuccessful test well, as identified.
3. ⊕ designates the respective approximate location of a previously used dug well and spring.
