PROJECT NUMBER B730101

PRELIMINARY EVALUATION OF THE SUITABILITY
OF THREE PROPOSED SITES
FOR INSTALLATION AND OPERATION OF
PUMPED-TYPE EFFLUENT DISPOSAL FIELDS
TO SERVE EXPANSION OF
BRIDAL FALLS GOLF COURSE FACILITIES

Prepared by
PACIFIC HYDROLOGY CONSULTANTS LTD.
201 - 1537 West 8th Avenue
VANCOUVER, B.C. V6J 1T5

MAY 23, 1997

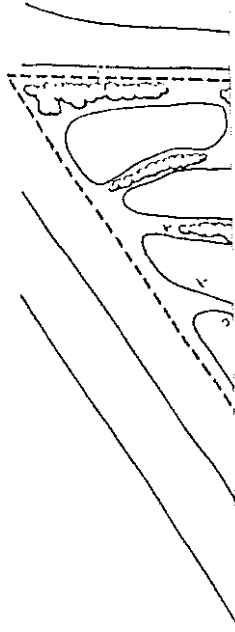
SEPTIC FIELD AND TEST PIT LOCATIONS

On May 12, 1997, Ed Livingston visited the BFGCC property. During the visit, a wheel-mounted backhoe was used to dig test pits at the three proposed field sites to permit an examination of subsurface conditions. The lithology of sediments exposed in each pit was logged; the lithologs of the pits are included in Appendix B. The approximate locations of the pits are shown on Figure 2 in Appendix A.

indicates the approximate (unsurveyed) areas of respective existing and proposed septic fields.
3.

denotes approximate (unsurveyed) location of a test pit (for test pit details, see Appendix B).
