HYDROGEOLOGIC EVALUATION

IN REGARD TO DISPOSAL OF WASTEWATER AND STORM WATER ON A PROPOSED SUBDIVISION BETWEEN TUNBRIDGE AVENUE AND THE SOUTH END OF HAMMOND STREET IN THE DISTRICT OF MISSION

(District of Mission Subdivision Application 90-56)

SEPTEMBER 10, 1990

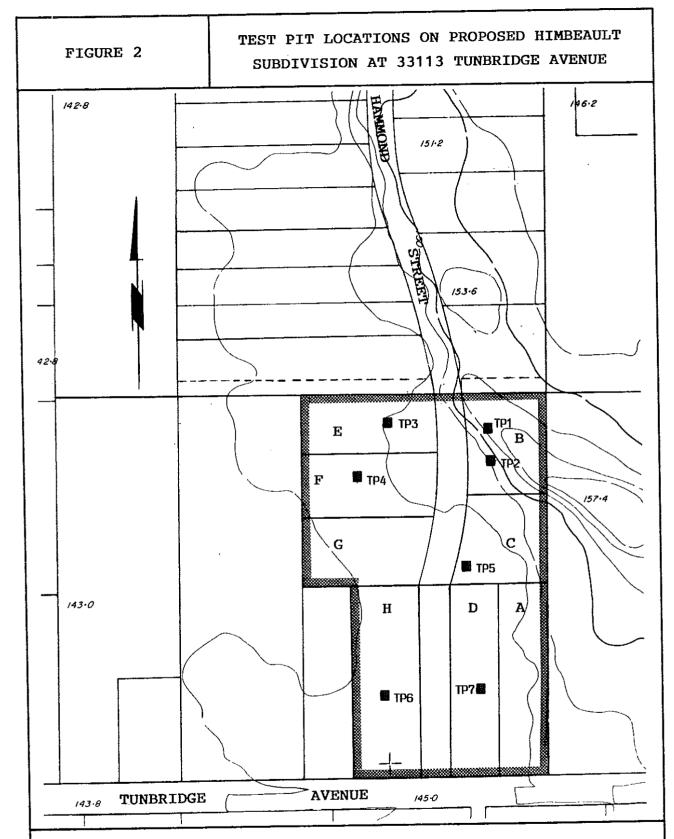
The investigation of shallow subsurface conditions on the proposed Himbeault Subdivision consisted of the digging of seven test pits by a wheel backhoe to depths ranging from 1.7 to 1.95 metres (5.6 to 6.4 ft). The approximate (unsurveyed) locations of the test pits are shown on Figure 2 in Appendix A. The lithologs of the pits are contained in Appendix B.

- The base map is 1:2,500 scale topographic plan Sheet No. 1733S of District of Mission; contour interval is two metres.
- 3. **ETP1** marks the approximate (unsurveyed) location of a test pit.
