# Monitoring Black Bear Den Enhancement and Creation in the Jordan River and Campbell River Watersheds: 2016 year-end report

December 2016

Prepared for the Fish and Wildlife Compensation Program  
(FWCP project **COA-F17-W-1186**)

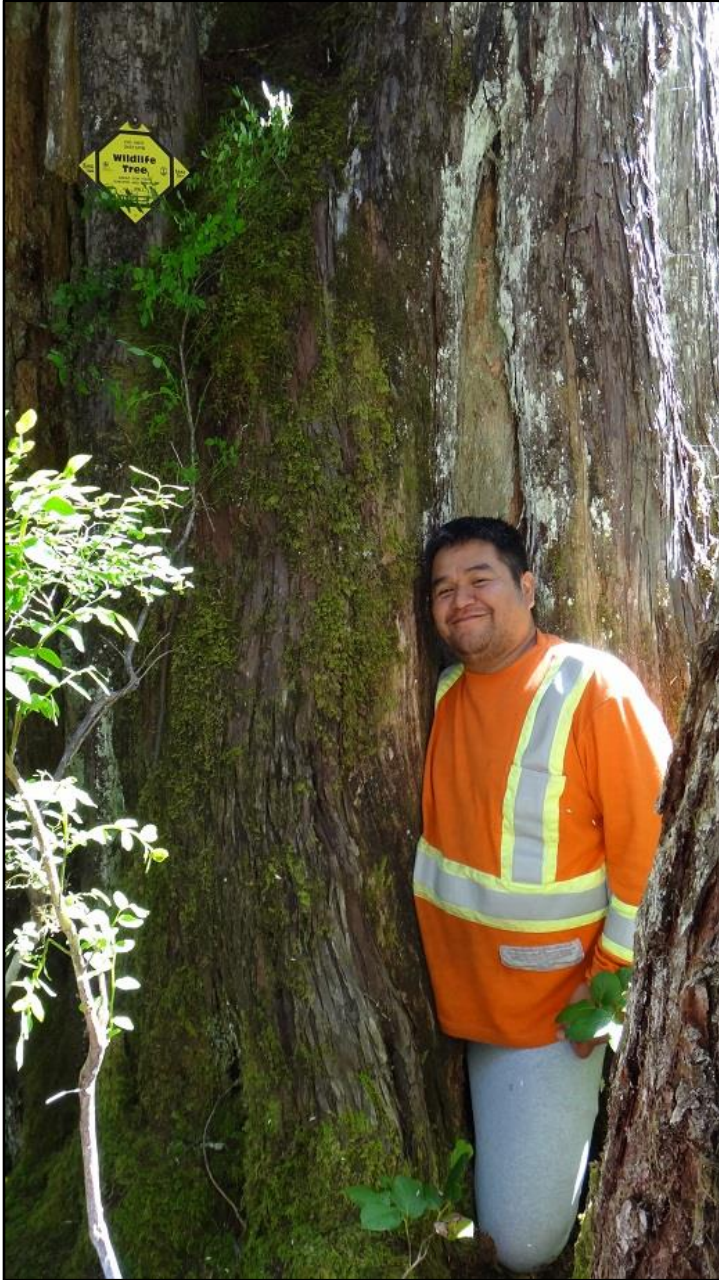
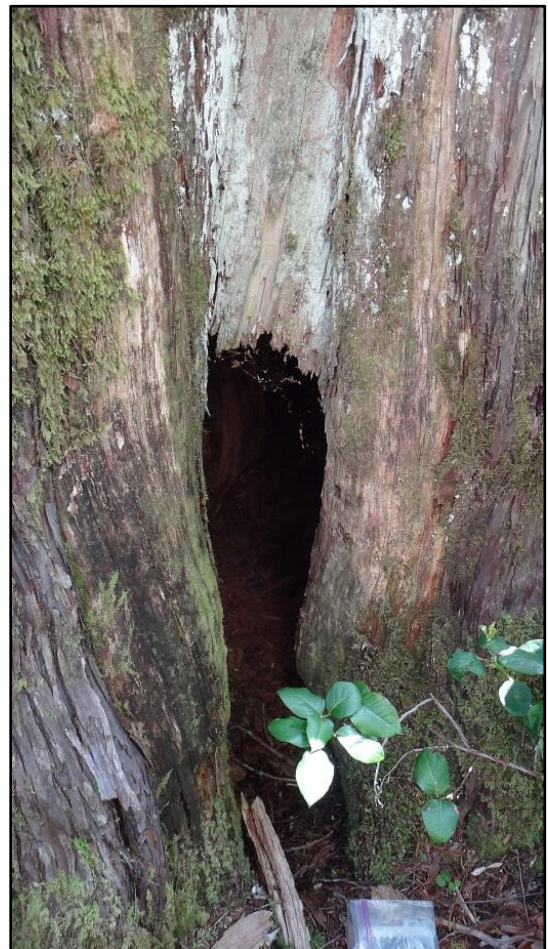
### Structure #1: natural den (tree)

Notes: The only potential natural den structure found in 98 ha of searching high-probability stands in 2014. Heavily chewed and clawed by bears (around entrance, photo below), unsure if it has been used or not because no bedding present. No camera. Located in a proposed Old Growth Management Area (OGMA).

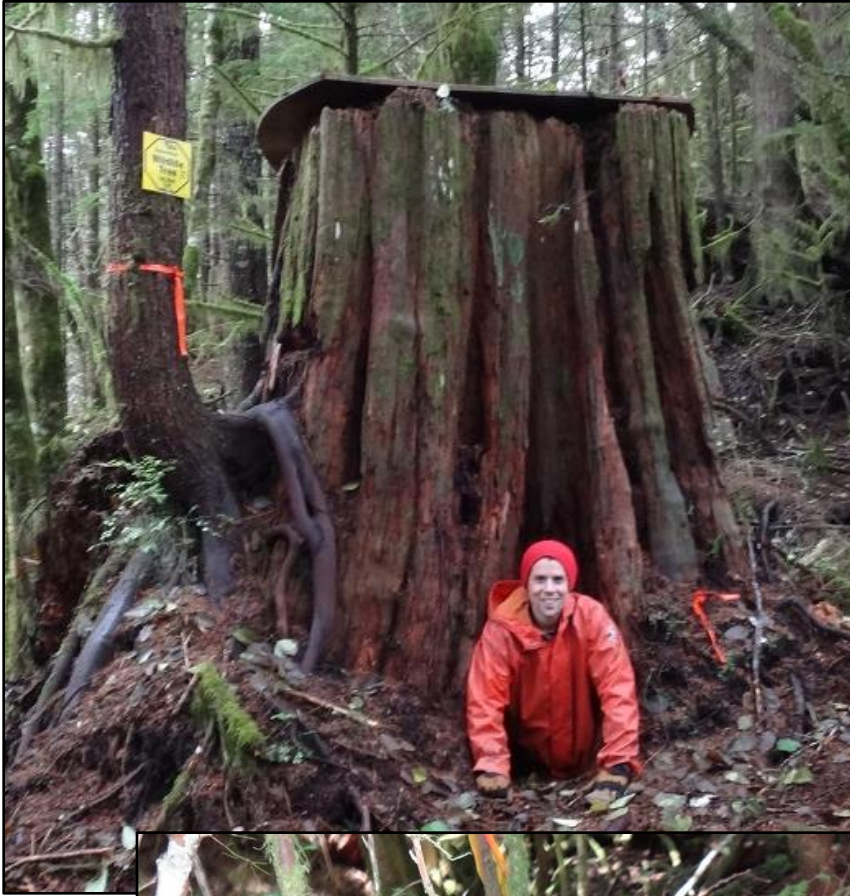
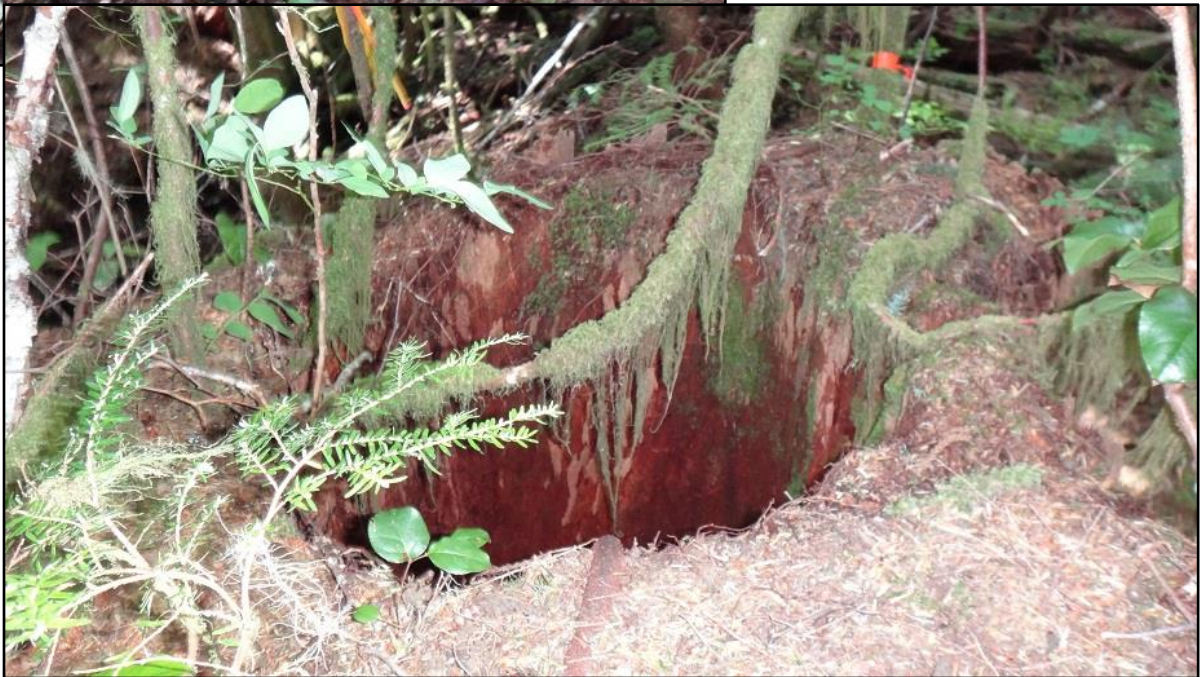
*Structure #3: Enhanced natural structure (stump)*

Notes: Stump had large hole in top (photo below) and was very wet inside. Inside of stump had dried out considerably by October 2014 after capping in June (much quicker than anticipated). Entrance is a bit too large but overall a very nice den.

Temperature data loggers and motion sensitive camera installed. Bears were recorded entering the structure 4 times between 2015 and 2016.

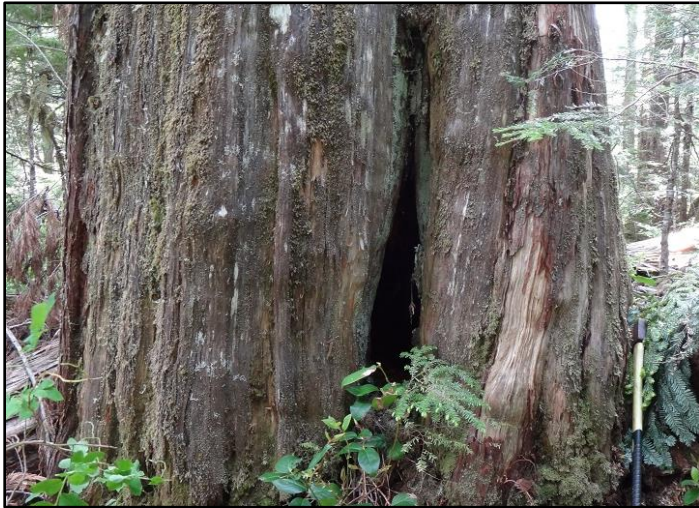
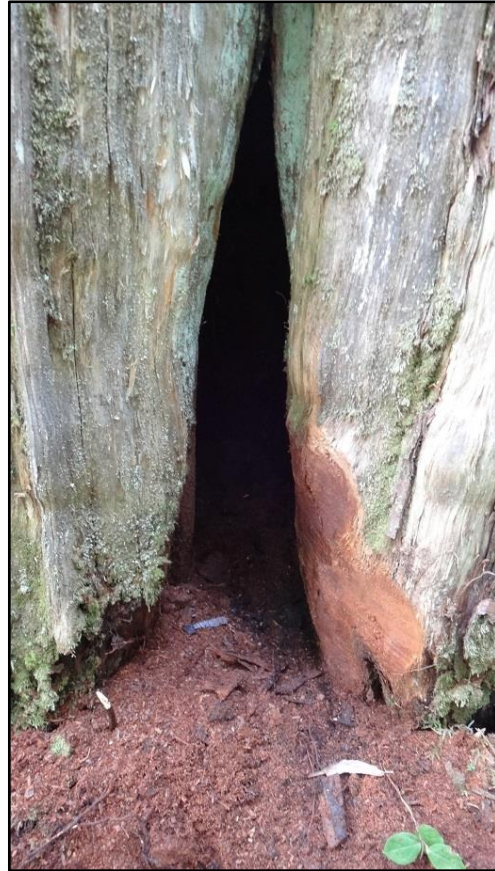
*Structure #4: Enhanced natural structure (tree)*

Notes: This hollow tree worked out the best of the ones we tried. The chamber is tucked in around to the left of the entrance. However, the chamber has consistently been wet (the tree is mostly dead and there may be cracks high up) which is greatly reducing its suitability. Temperature data loggers installed and motion sensitive camera added Oct. 2015. Located in a proposed OGMA. Bears were recorded investigating the structure twice in 2016.

Modifications (2014): entrance widened with chainsaw. Decayed wood inside excavated to create chamber. Bedding added.

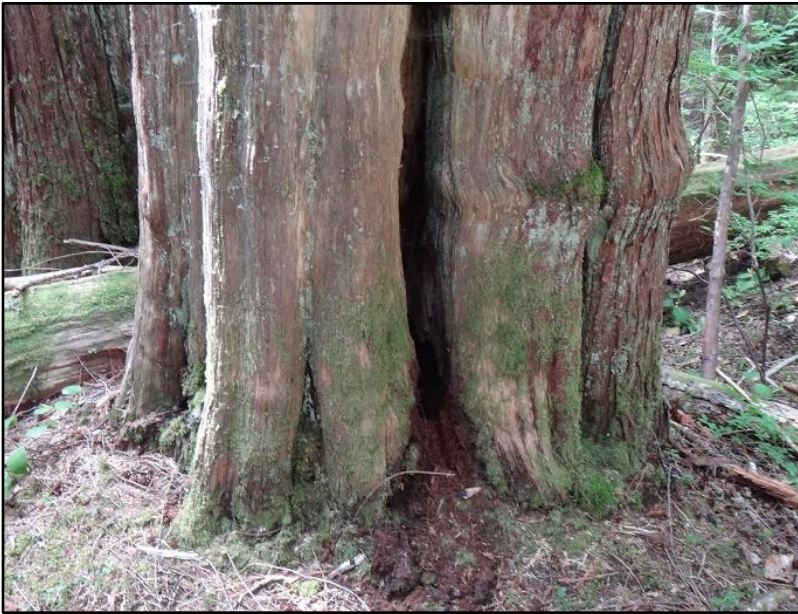
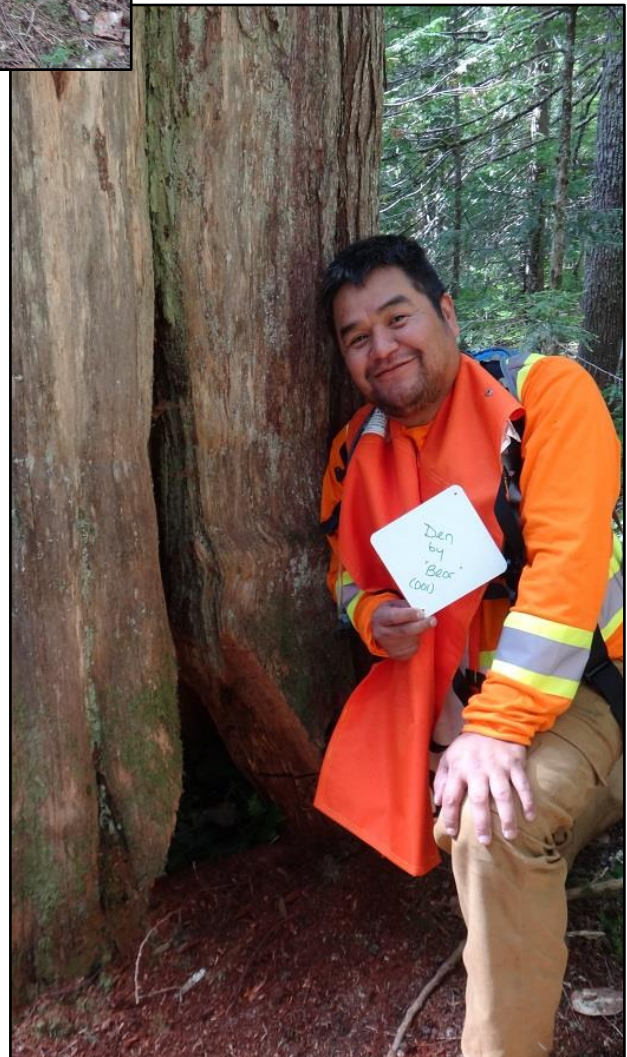
Structure #5: Enhanced natural structure (tree)

Notes: Resulting effort was not a very high quality potential den, the tree was a bit too small and the chamber ended up being too close to the entrance. No monitoring camera. Near edge of proposed OGMA.

Modifications (2014): entrance widened with chainsaw. Internal decayed wood removed to increase chamber size. Bedding added.

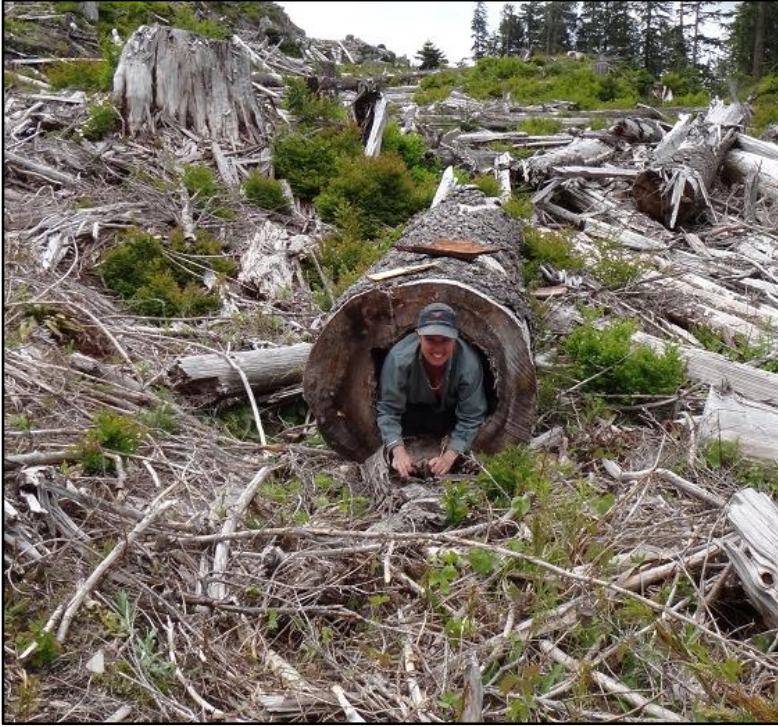
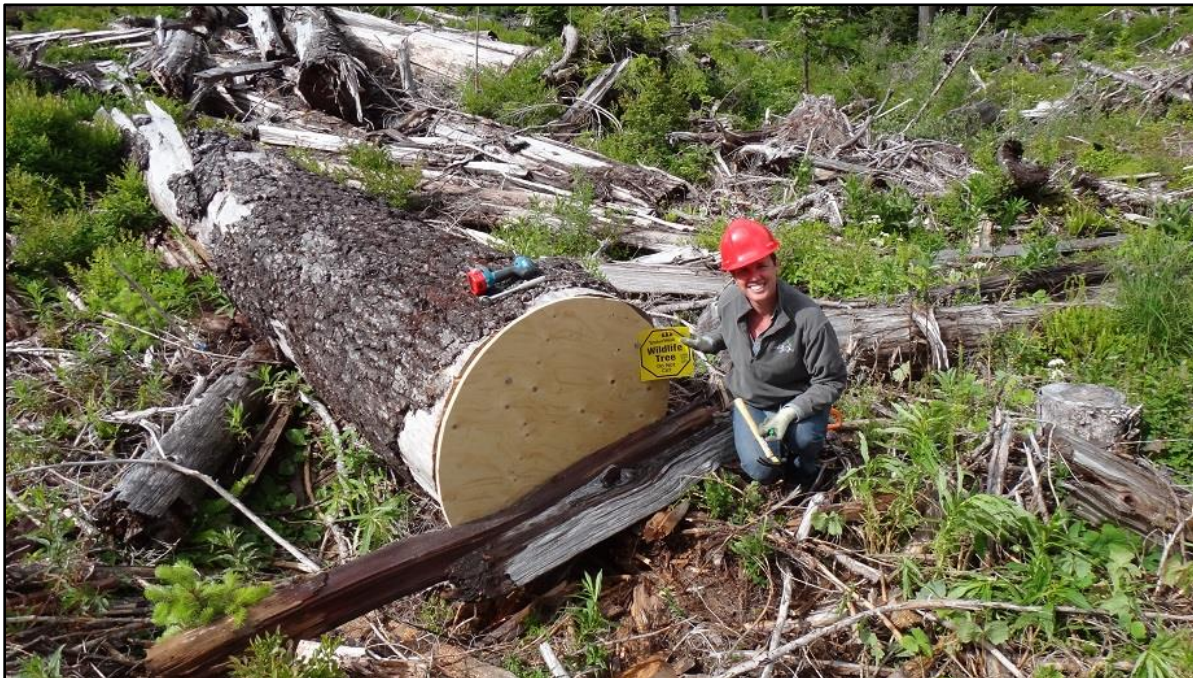
*Structure #6: Enhanced natural structure (log)*

Notes: Closing off the end of the log created a good quality chamber, however, the log has been very wet inside so it is unlikely it will be used as a den. A cedar log would be far more watertight and suitable as a den. No monitoring camera deployed.

Modifications (2014): End of log capped with plywood, no other modifications. Debris piled against plywood to hide it (much more than in lower picture).

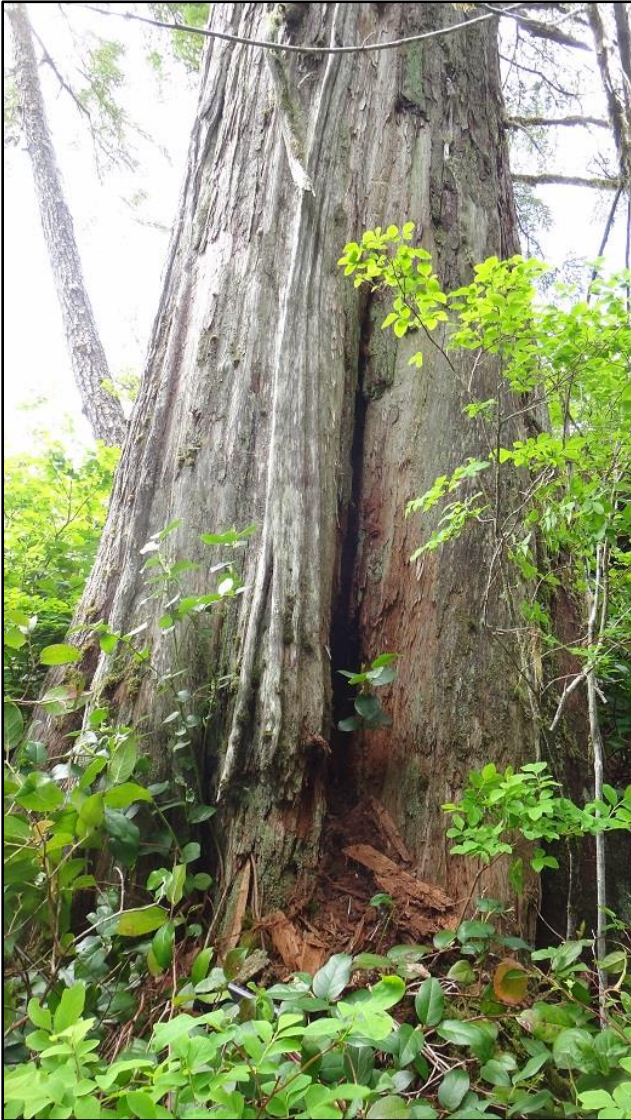
*Structure #8: Enhanced natural structure (tree)*

Notes: Cutting the entrance to this tree did not work very well. The thickness of solid wood was too wide to create a nice entrance into the cavity. In 2015 we did more cutting to improve the entrance. It will be interesting to see the progression of decay in this structure. No monitoring camera deployed.

Modifications (2014 & 2015): Entrance cut into tree at split, large amount of decayed wood removed from inside.

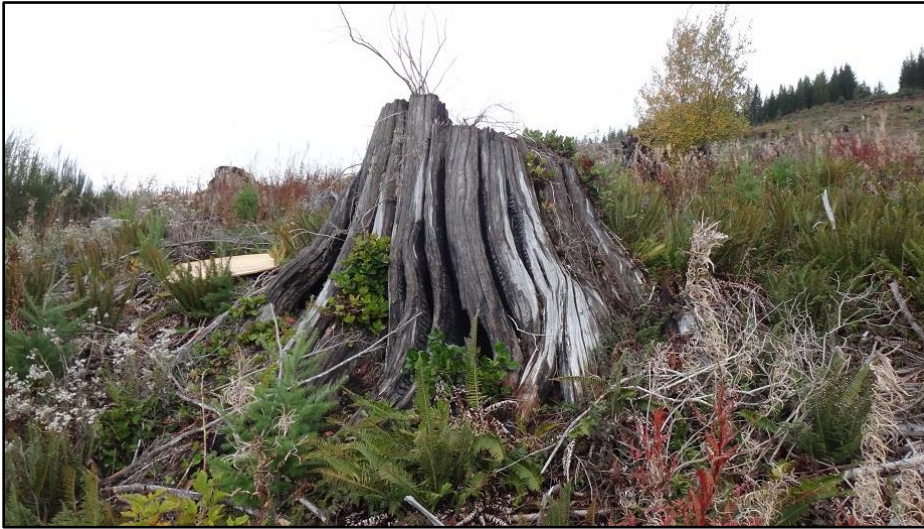
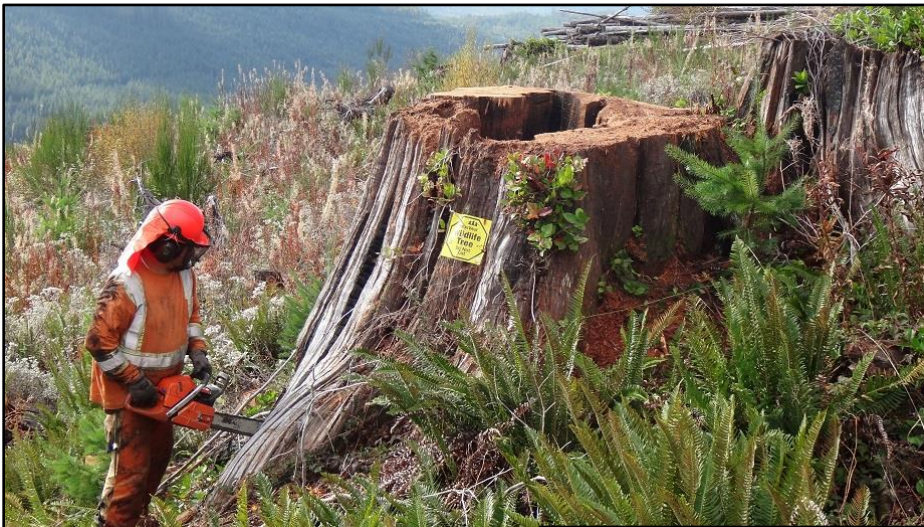
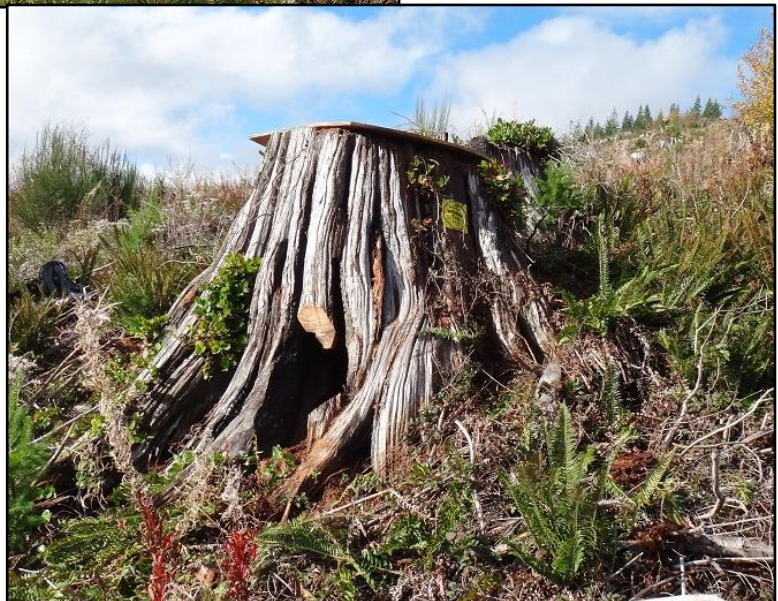
*Structure #9: Enhanced natural structure (stump)*

Notes: Before (left), during (middle), after (below). The entrance is a bit large, it was already present except for some cutting away of a piece covering the entranceway. Will likely be more suitable once trees grow up around it. Bear hair found on entrance in Oct. 2015 so a monitoring camera was installed, however its batteries didn't hold charge well so it was only operation for 33 days and no camera was available in 2016 to continue monitoring.

Diameter: 182 cm dbh  
Species: western redcedar  
Entrance: 50 cm (h) x 25 cm (w)  
Habitat: Clearcut, CWHmm1  
Modifications: In 2014, top cut off, covered with plywood. Stump burned so much that there were openings in various places, one large one was filled with debris and covered with plywood. Entrance cut into opening already present on side. Bedding added.

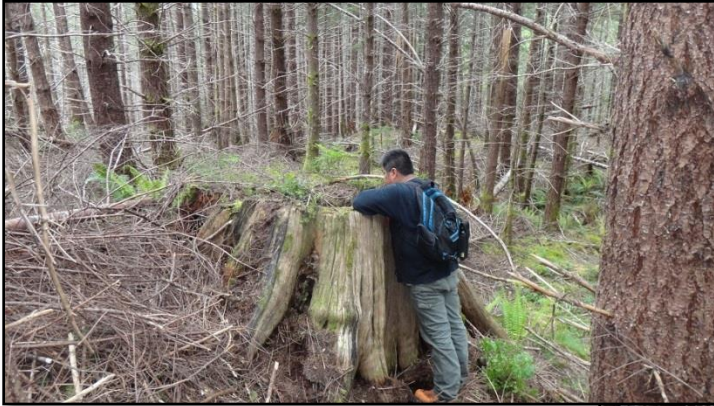
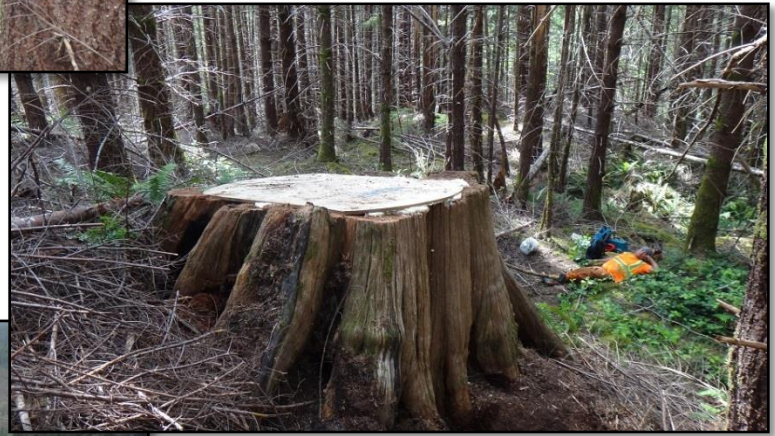
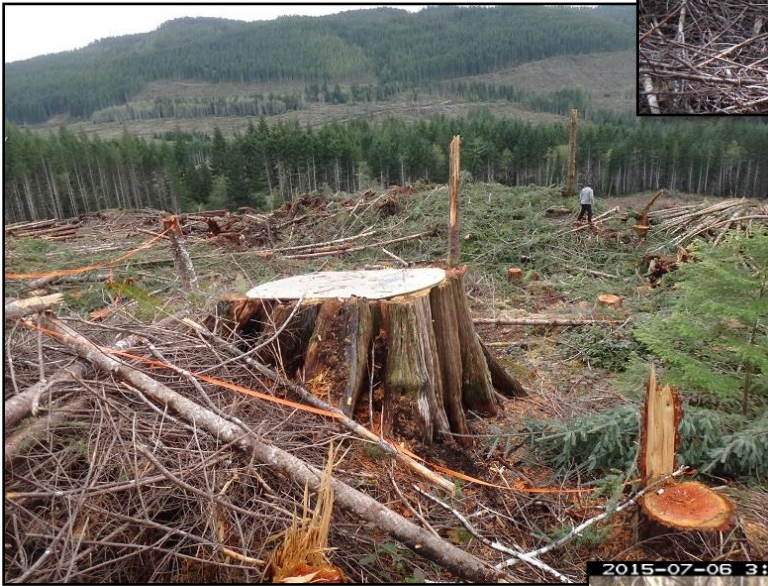
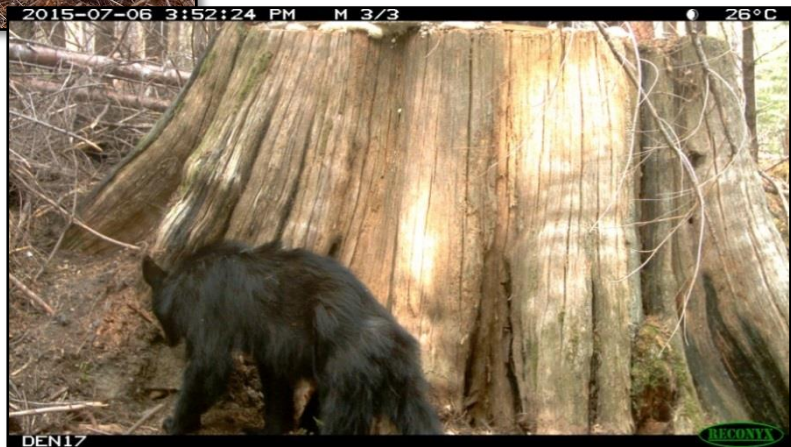
Structure #17: Enhanced natural structure (stump)

Notes: stump was found during search for stumps to enhance. After enhancement the location was sent to TimberWest who discovered the stand was due to be harvested in fall 2015. The harvesting forester chose to only leave short stubs around the enhanced structure (photo left), which effectively reduces the efficacy of this enhancement to zero in the short term.

An extremely malnourished bear investigated the newly created den structure 2 weeks after enhancement (photo right). A camera was installed at the stump in May 2016 but malfunctioned so no data was recorded in 2016. The camera was replaced in November 2016.

Modifications (2015): Entrance cut into base, top cut off and covered with plywood, foam insulation put under plywood edge, bedding added.

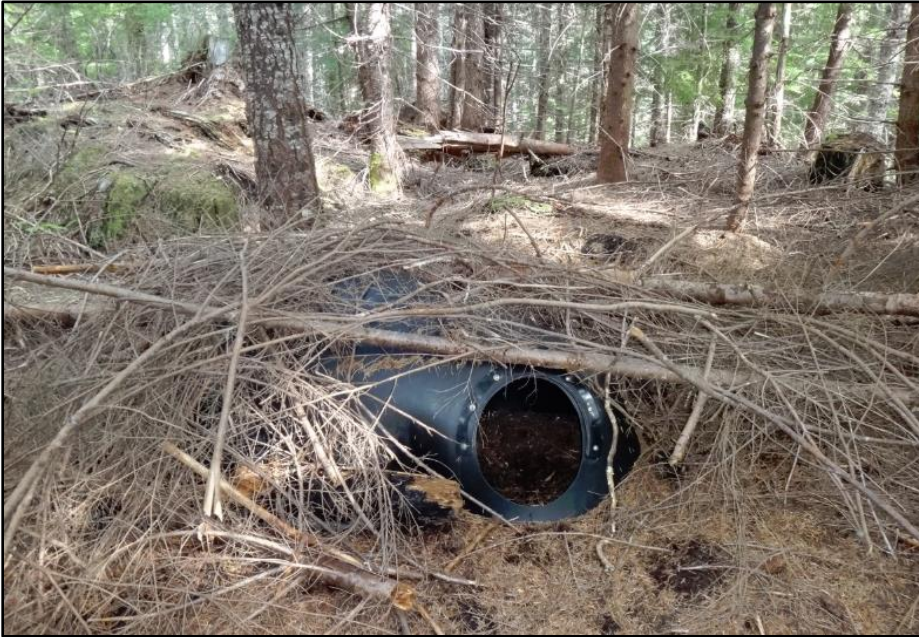
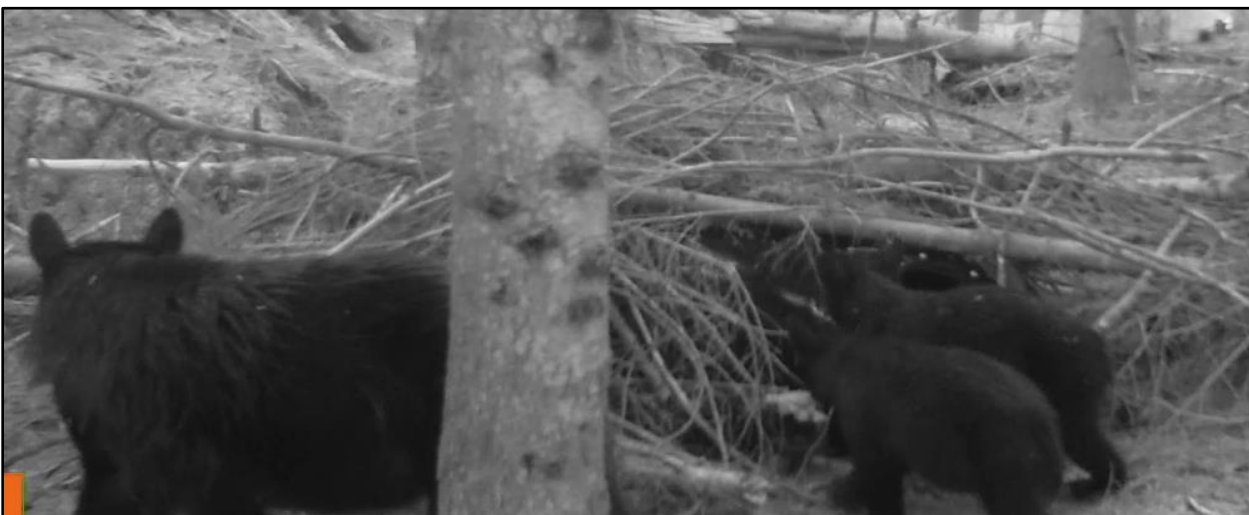
*Structure #22: artificial den (den pod)*

Notes: Installed 2015. This structure had a flaw in the hood covering the entrance, bears pulled it off within the first 2 weeks but we left it without one to see how wet it would get inside. There were 9 visits to this den pod by bears in each of 2015 and 2016, the first visit was 8 days after installation; **13 days after installation a bear climbed ¾ of the way in 3 times over a 7 minute period**. A female with 2 cubs visited the structure in 2016. This den has been covered with debris which is our intent for all of the artificial structures in 2017.

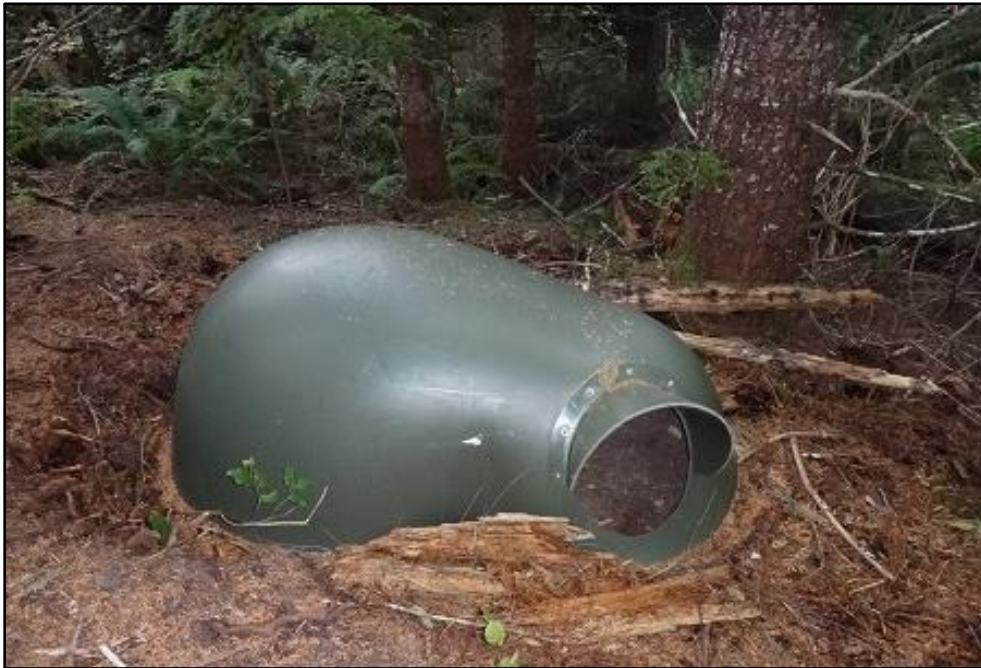
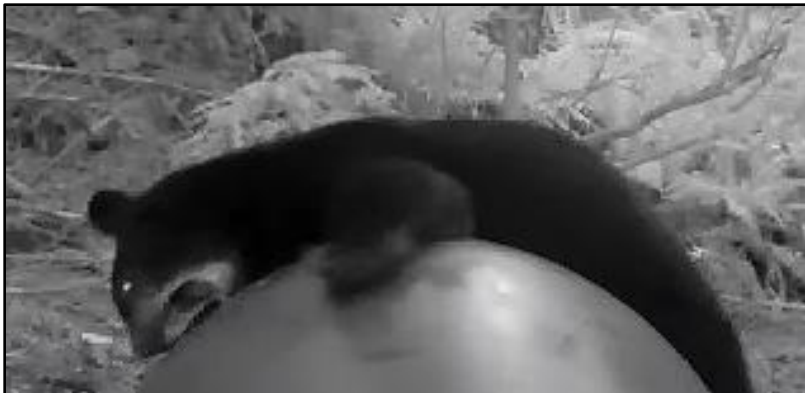
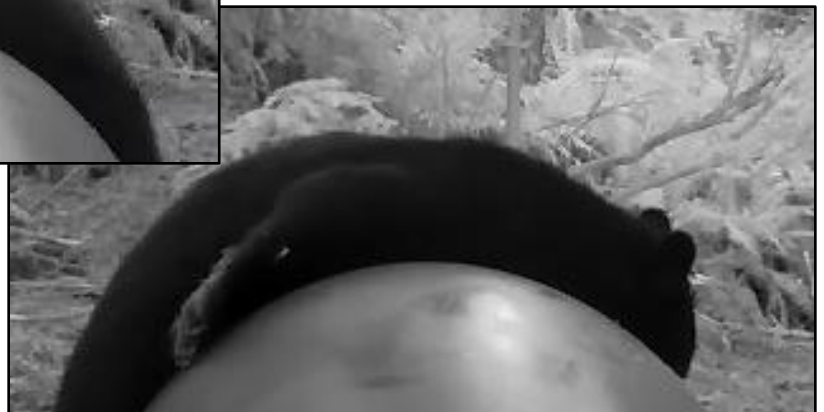
*Structure #23: artificial den (den pod)*

Notes: Installed 2015. There were 11 visits to this den pod in 2015 (starting 20 days after installation) including a bear climbing all over it and biting at it (photo below) and 13 visits in 2016.

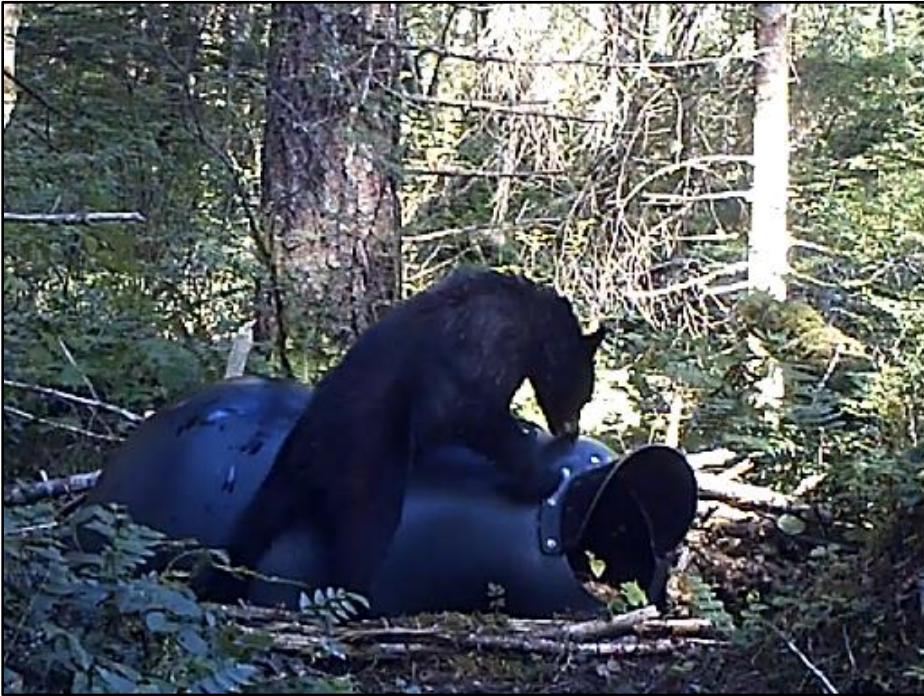
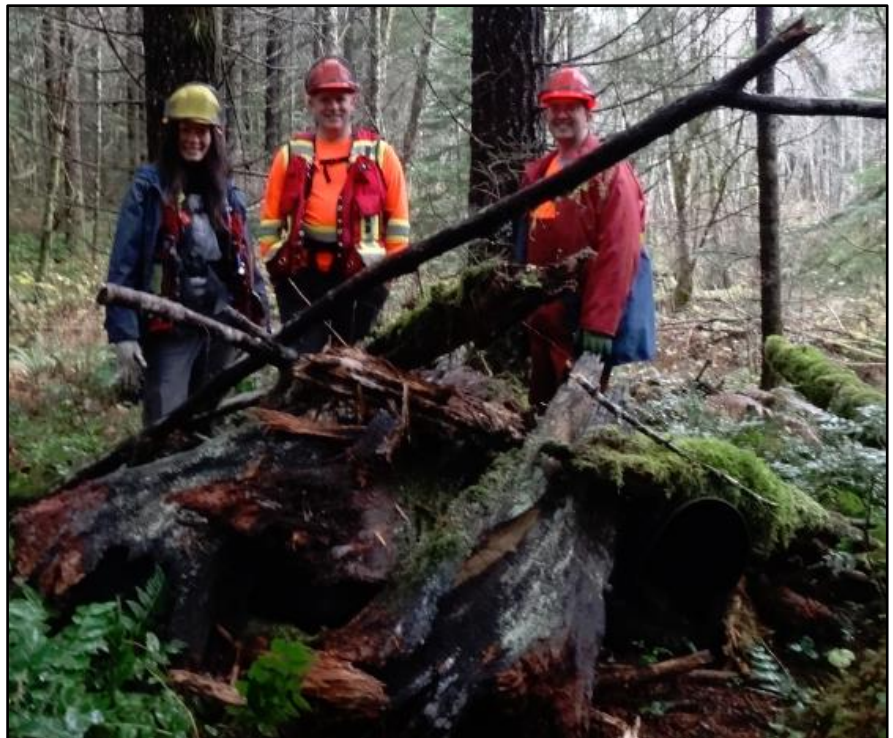
*Structure #CR005: artificial den (den pod)*

Notes: Installed May 2016, 2 bears investigated the structure in 2016. Bears removed the debris piled on the structure (photo, above) but more debris was piled on it in Oct. 2016 (photo, below)! In photo, Jeff Hamilton (BCTS), biologist Dave Vey and Keiko Arakawa (BCTS).
